## Inspection Photos: 2AM-JER1119 September 13<sup>th</sup>, 2012

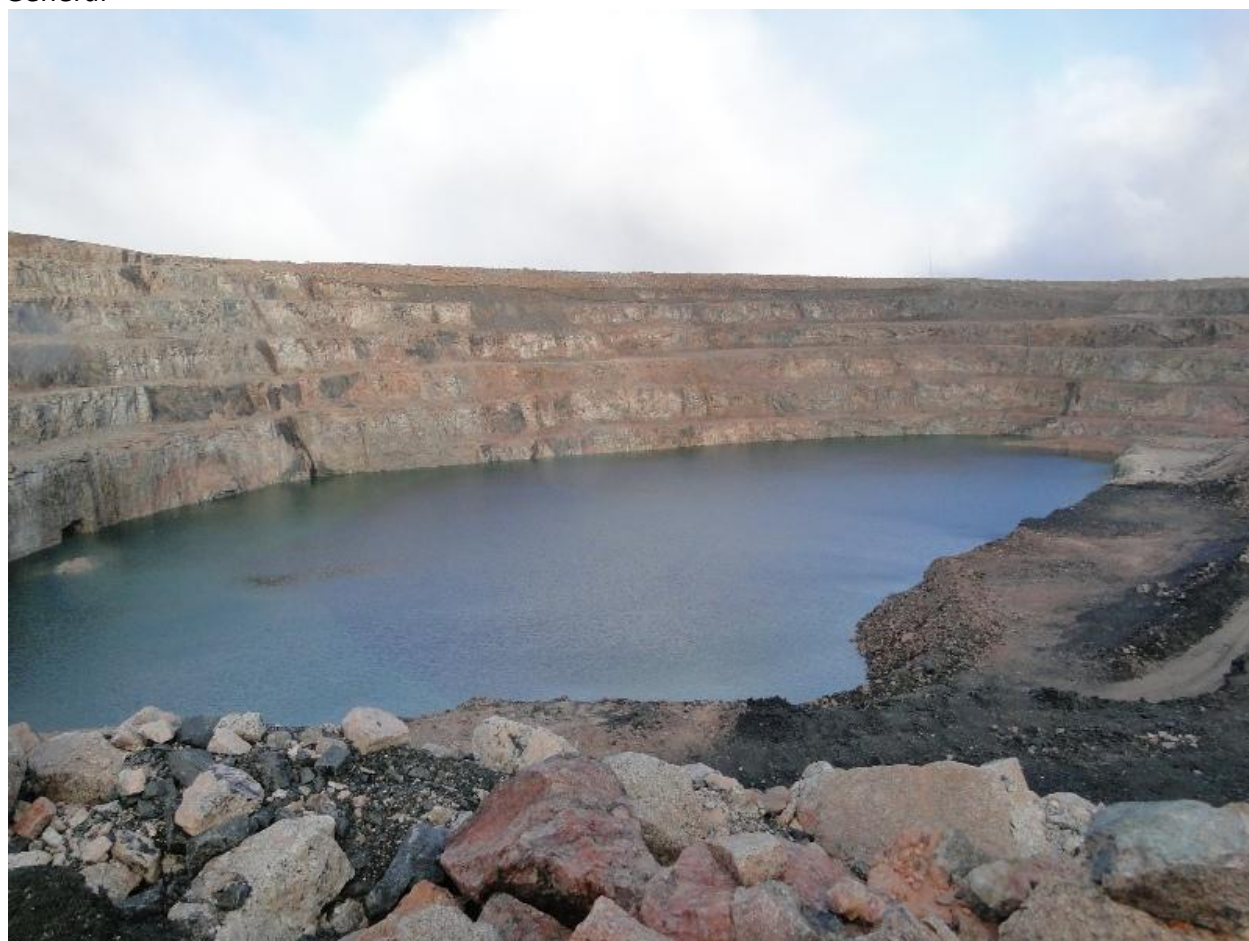
Figure 20. Record of pit-water levels. Samples taken at pit.
