LAND USE PERMIT INSPECTION FORM

Permittee	Representative
INAC Contaminated Sites	Mark Yetman
Permit No. / Expiry	Representative's Title
N2016U0013	Senior Project Advisor
Other Authorizations	Land / Other Authorizations
Spill Reports #17-262/#17-282/#17-308	NWB Letter of Decision from June 2017
Date of Inspection	Inspector
06 June 2018	Baba Pedersen
Activities Inspected	
<input checked="" type="checkbox"/> Camp <input type="checkbox"/> Drilling <input type="checkbox"/> Mining <input type="checkbox"/> Construction <input checked="" type="checkbox"/> Reclamation <input checked="" type="checkbox"/> Fuel Storage	
<input type="checkbox"/> Roads/hauling <input type="checkbox"/> :Other <input checked="" type="checkbox"/> Other: Mine Site Stabilization

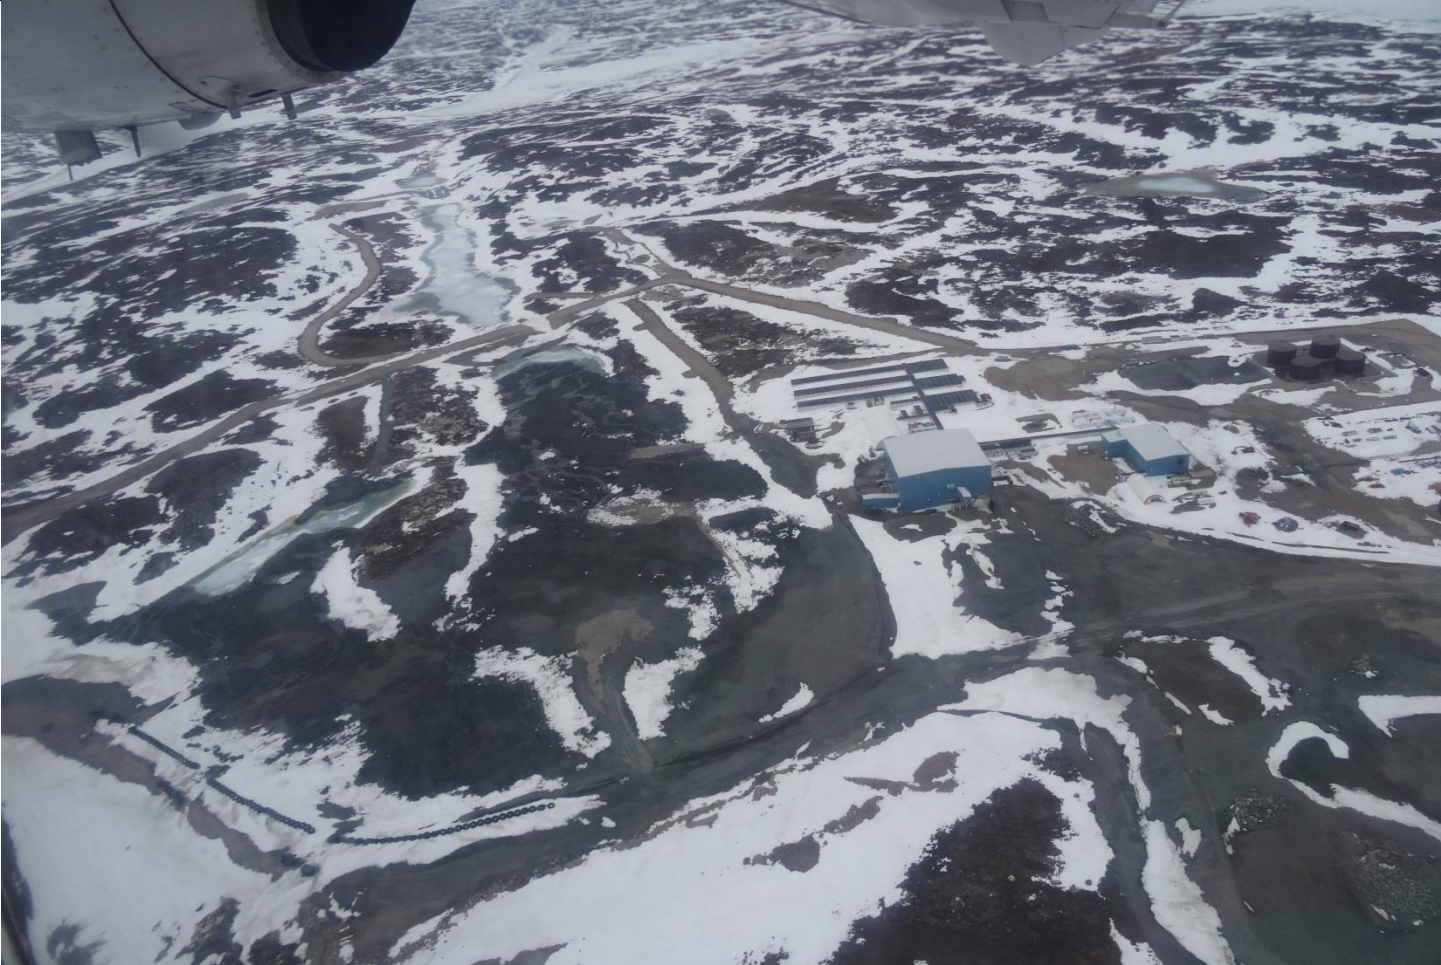
Date	Camera	Inspector	Authorization
June 6, 2018		Baba Pedersen	N2016U0013
Photo Log # 2633			
Photo 1			
Description: Aerial View of Jericho Mine Site showing the Camp/Processing Plant area, the PKCA Cells A, B & C over to the West Dam

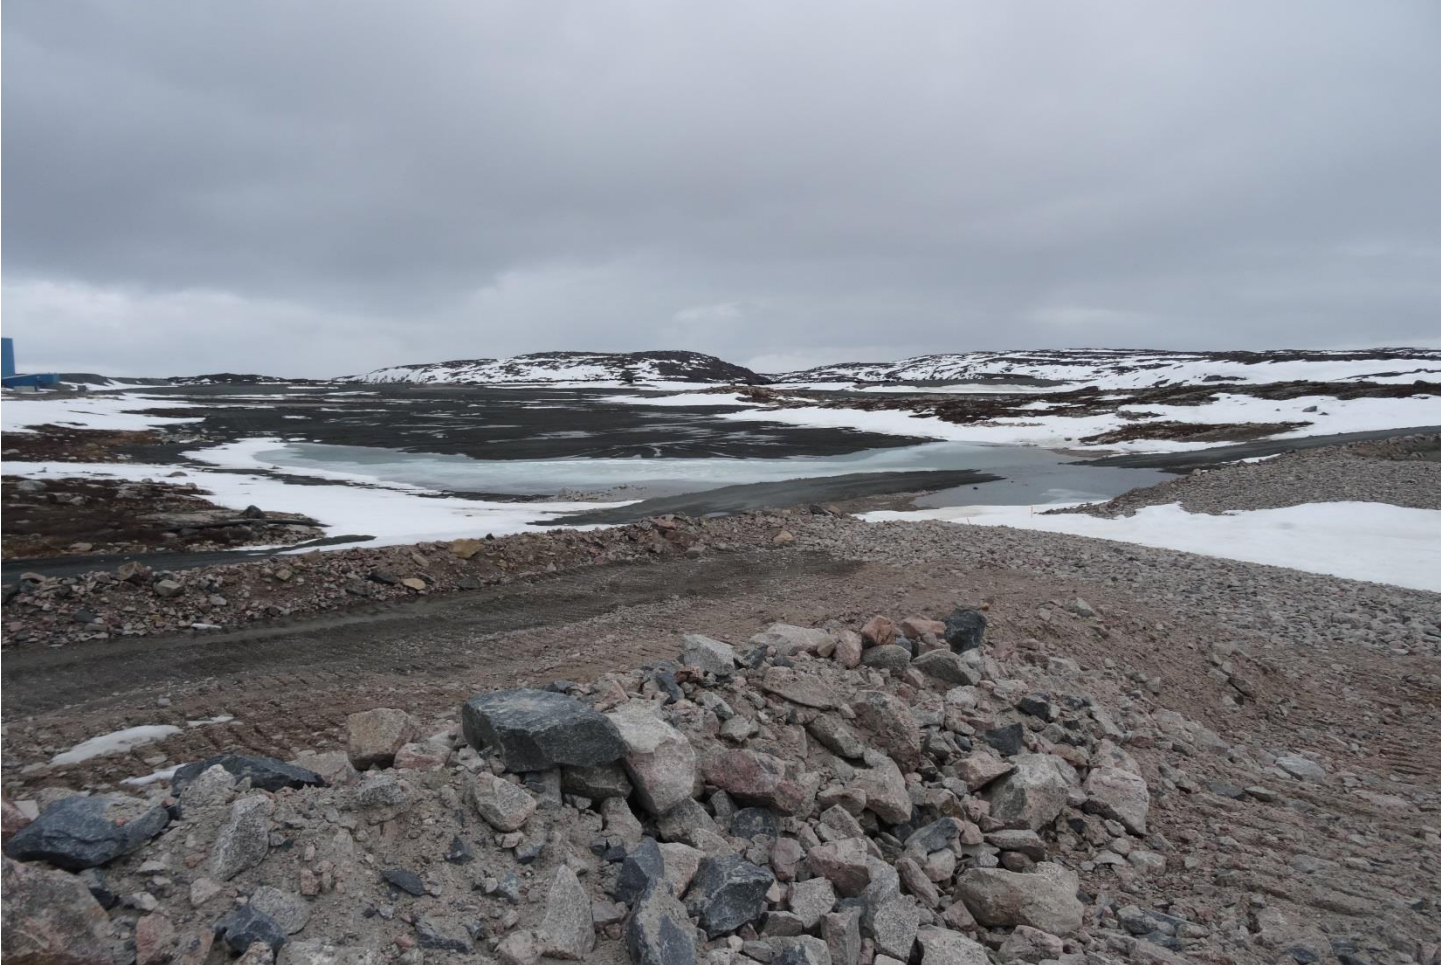
Photo 3

Description: PKCA Area/Cell A view from Divider Dike A

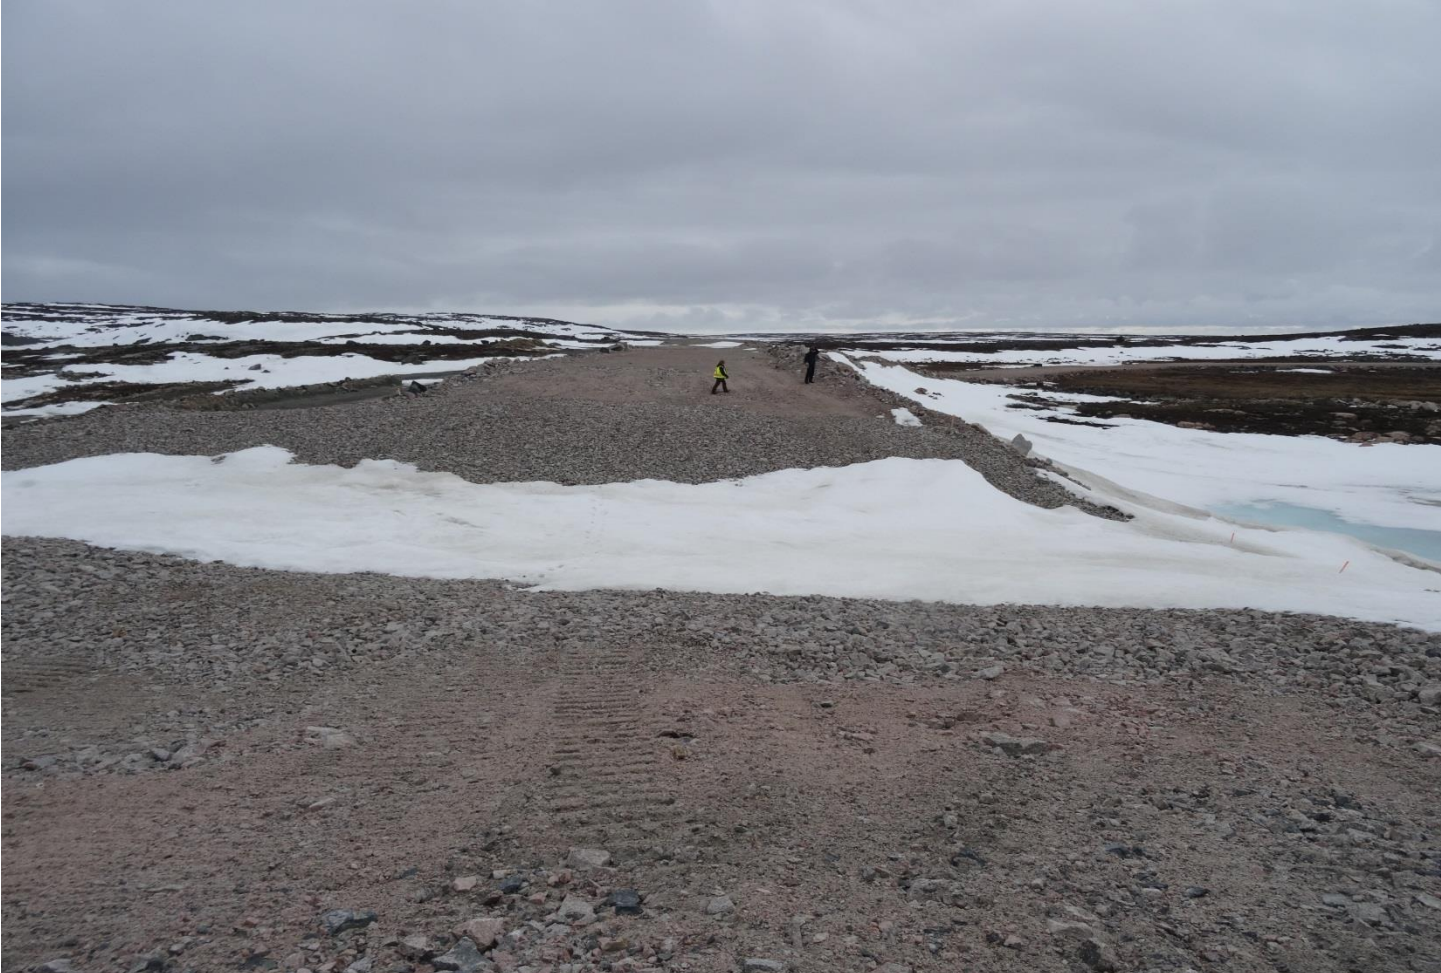
Photo 4

Description: Breach in Divider Dike A

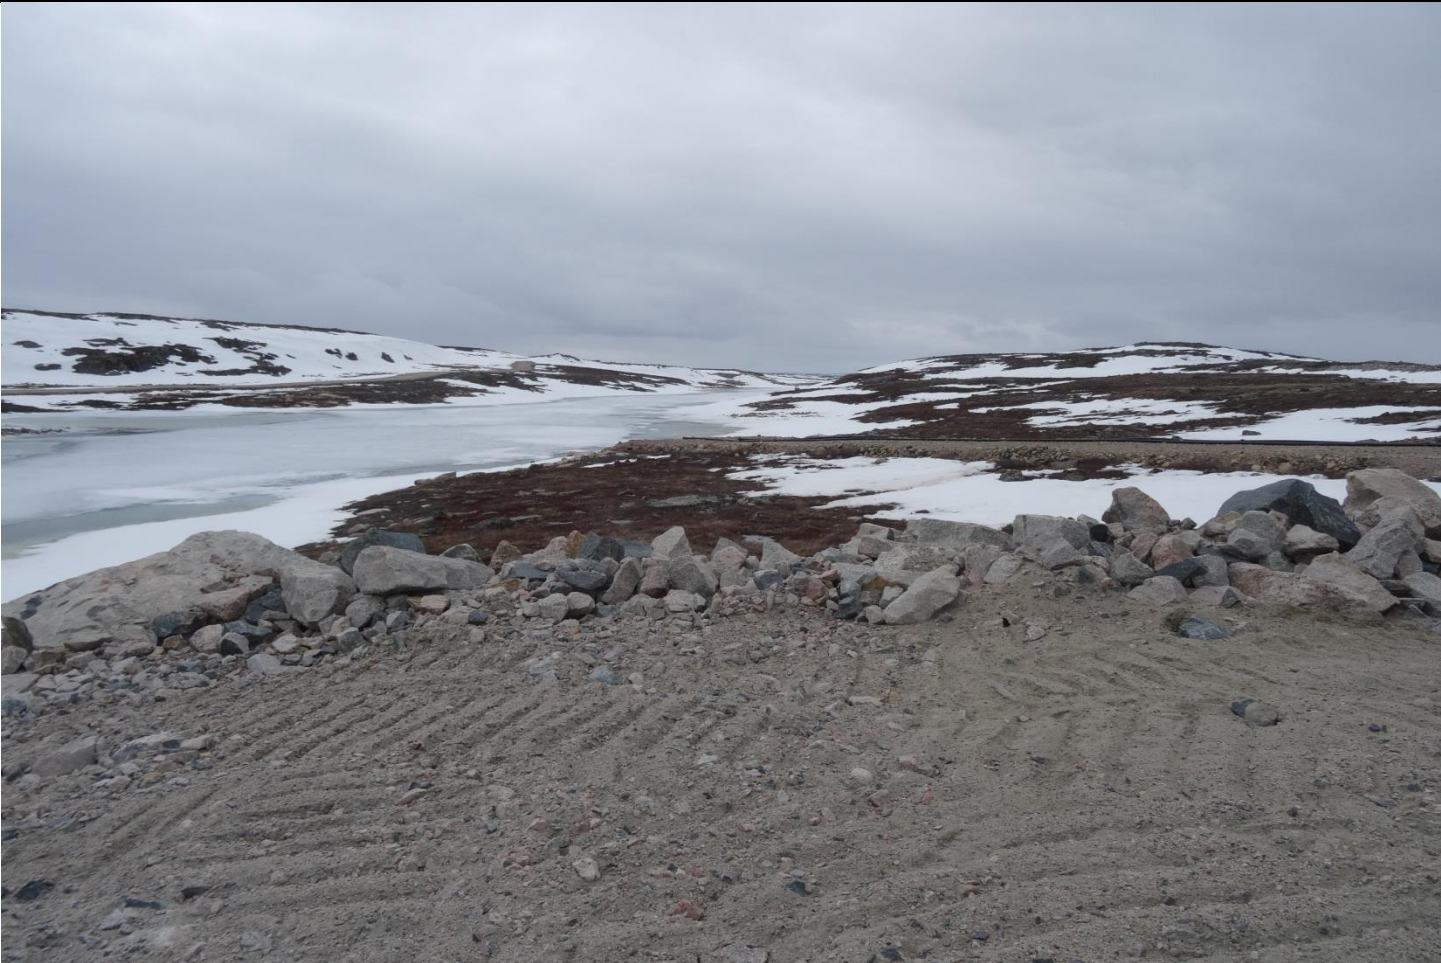
Photo 5

Description: Cells B & C of the PKCA looking towards the West Dam

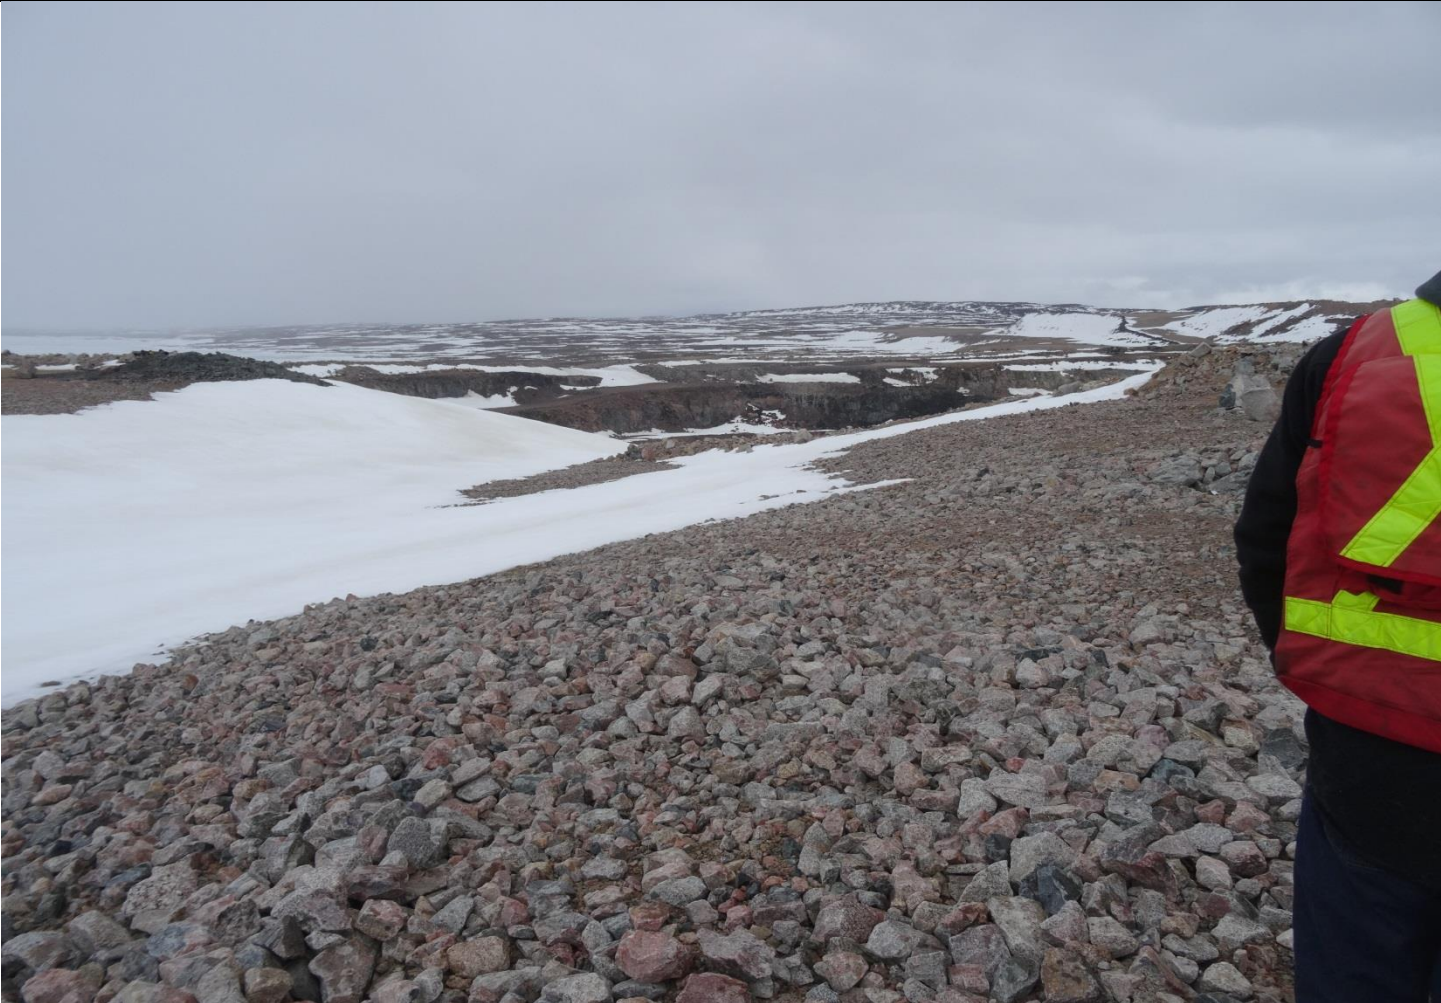
Photo 6

Description: Diversion to Allow Natural Drainage into Pit Lake

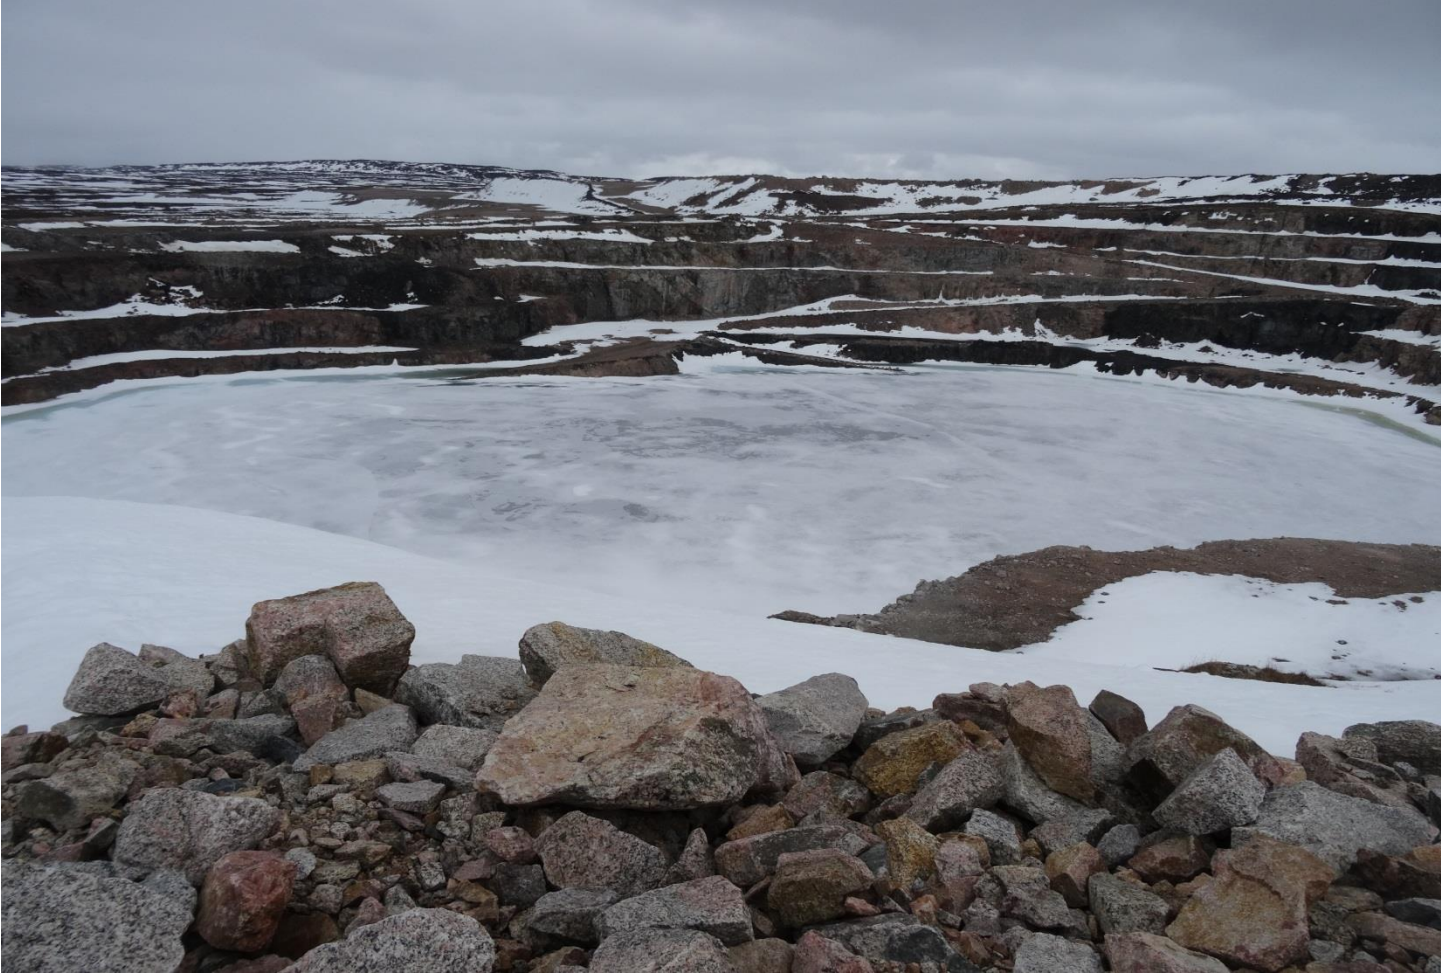
Photo 7

Description: Pit Lake still frozen

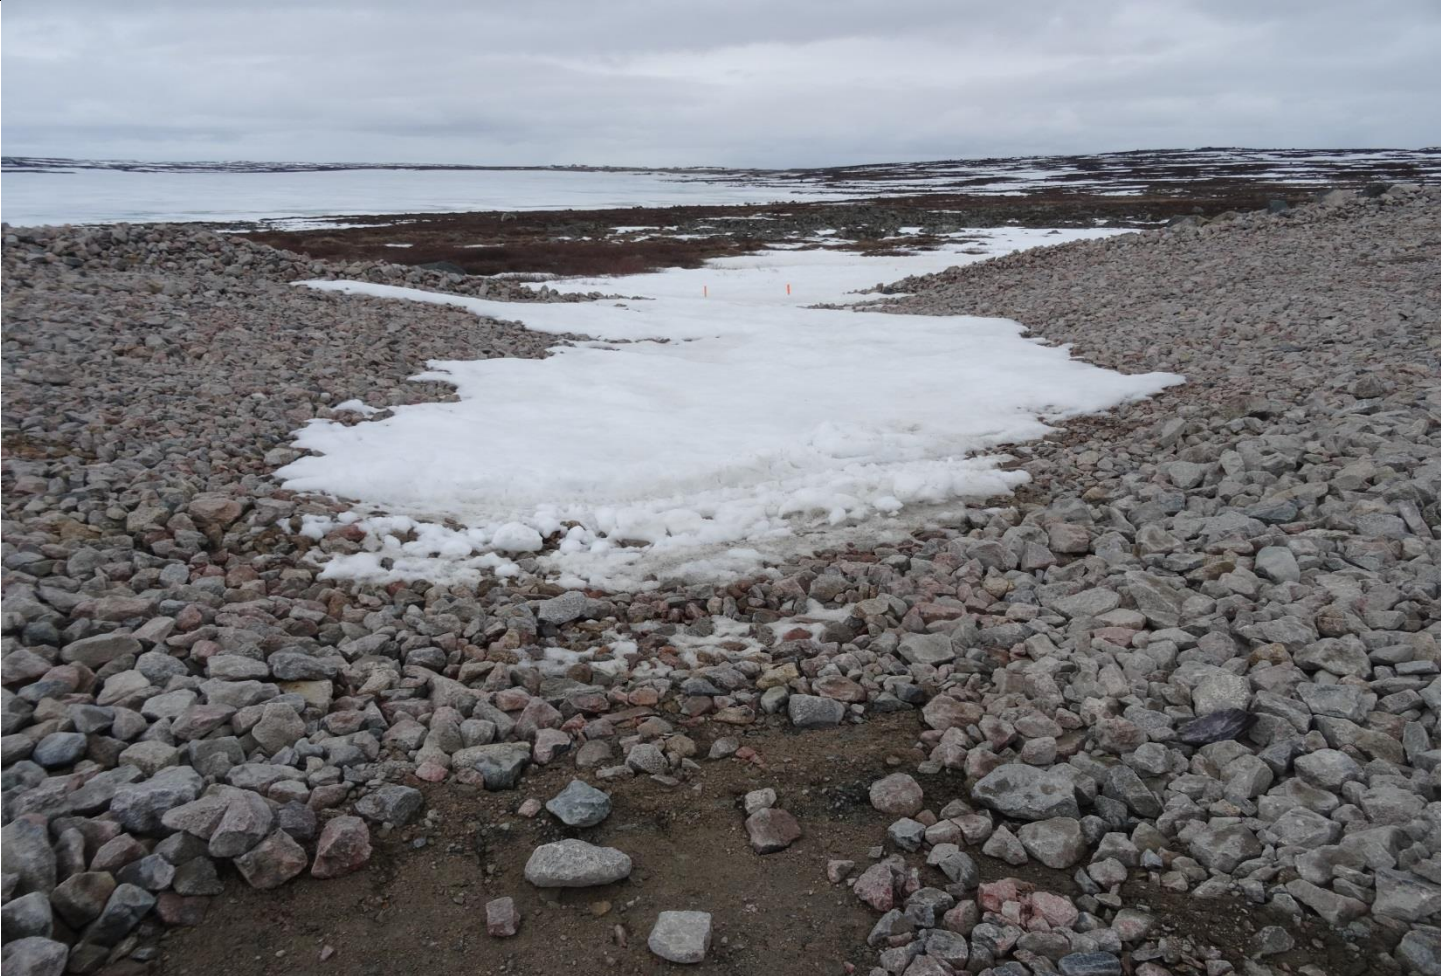
Photo 8

Description: Diversion to Allow Natural Drainage from Pit Lake to Carat lake

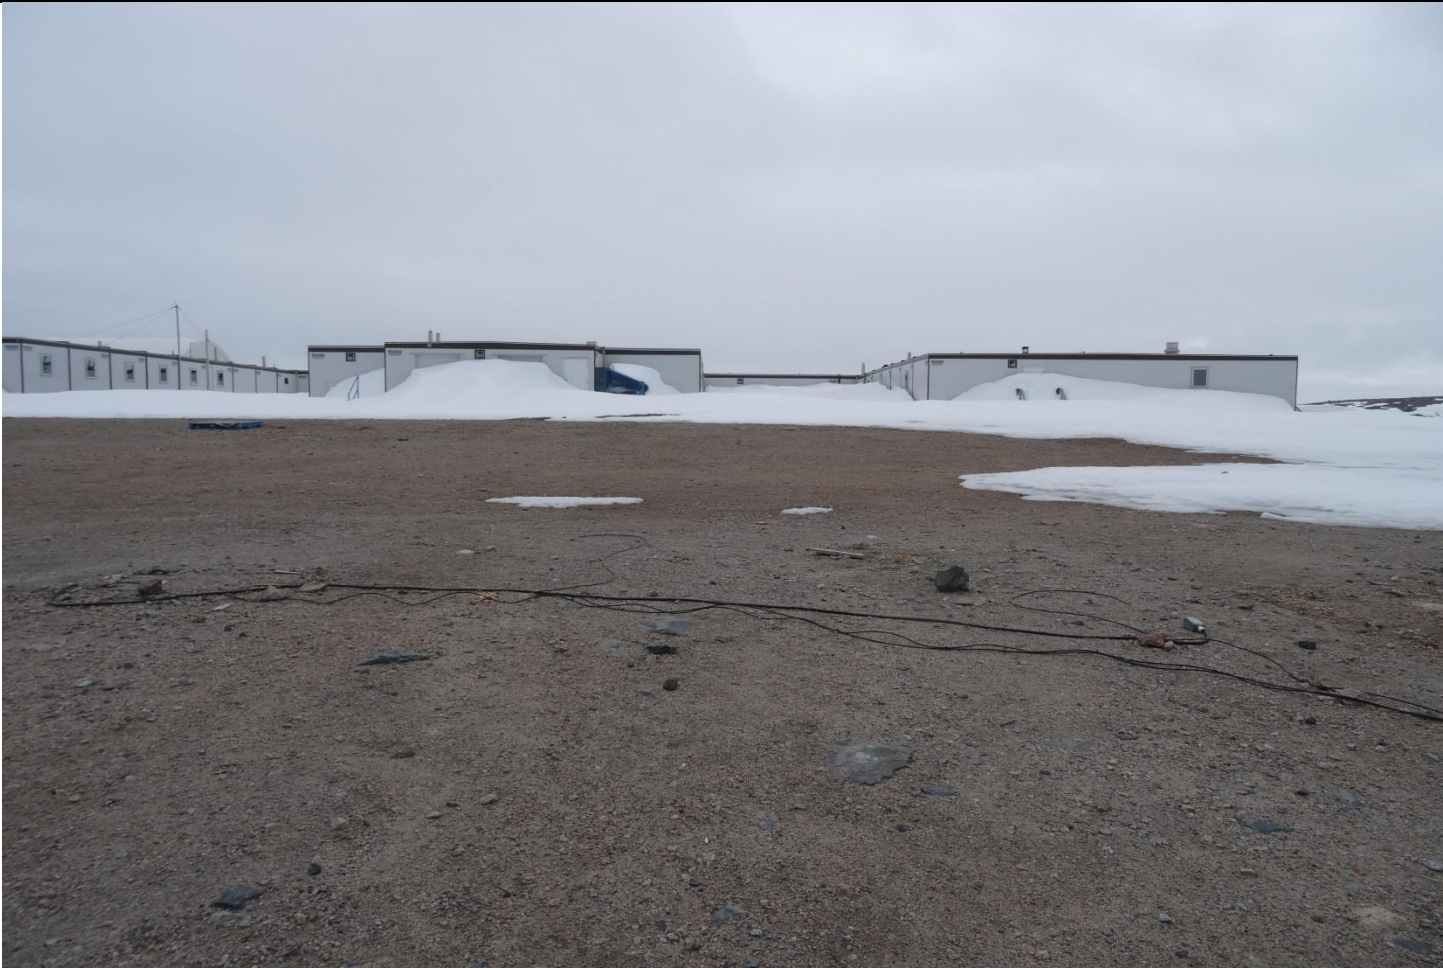
Photo 9

Description: Stabilization Project Camp Area showing Electrical Wiring left on ground

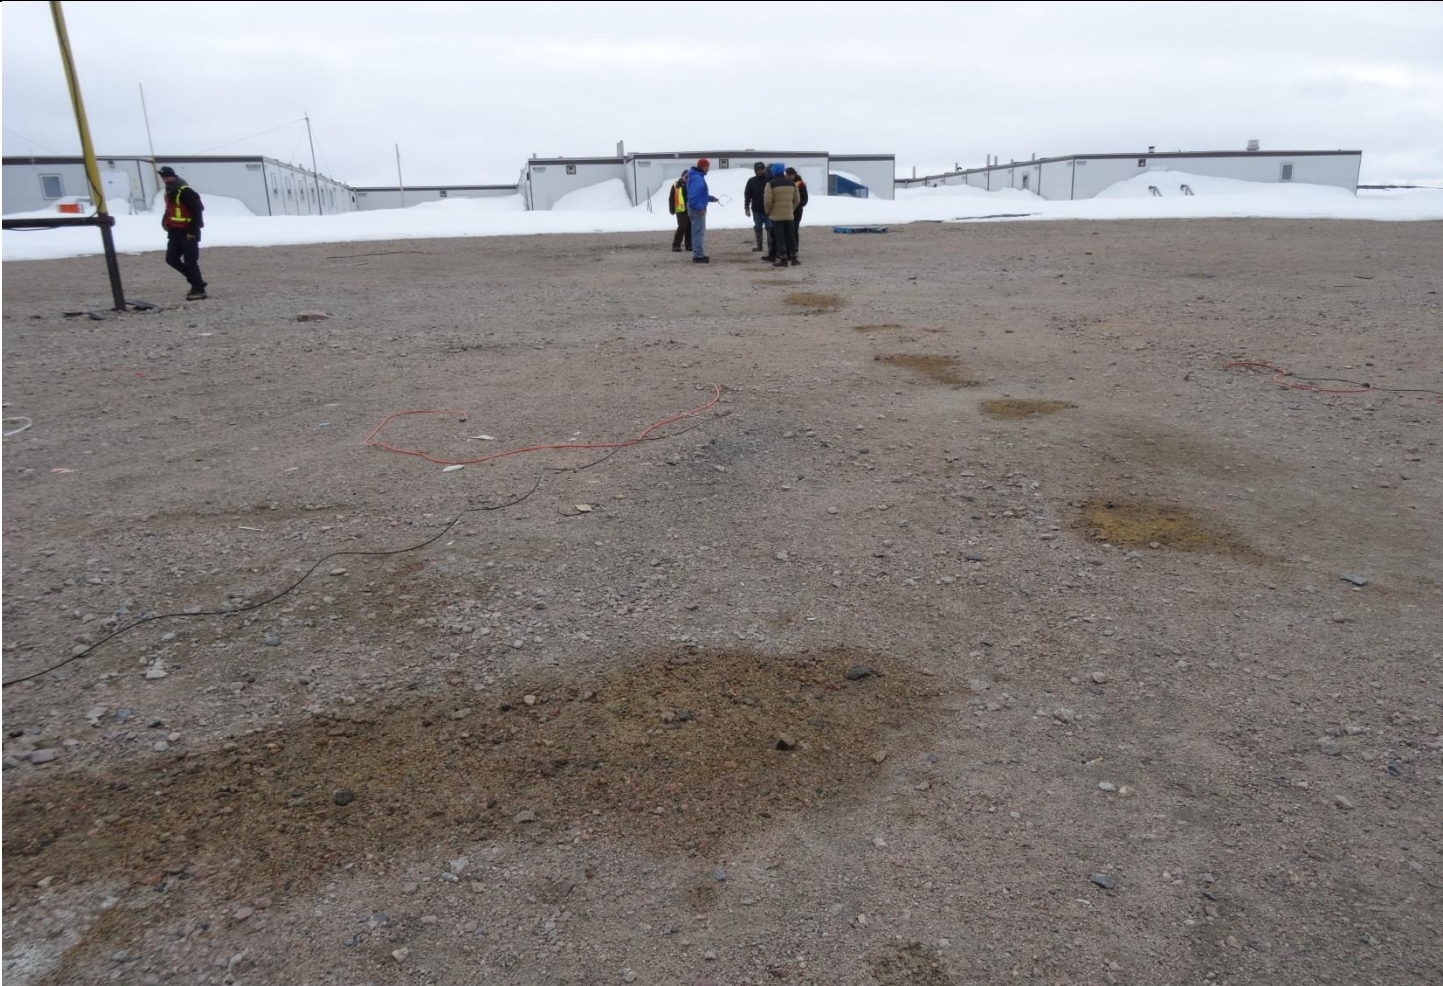
Photo 10

Description: Stabilization Project Camp Area showing 11 Stained Spill Areas

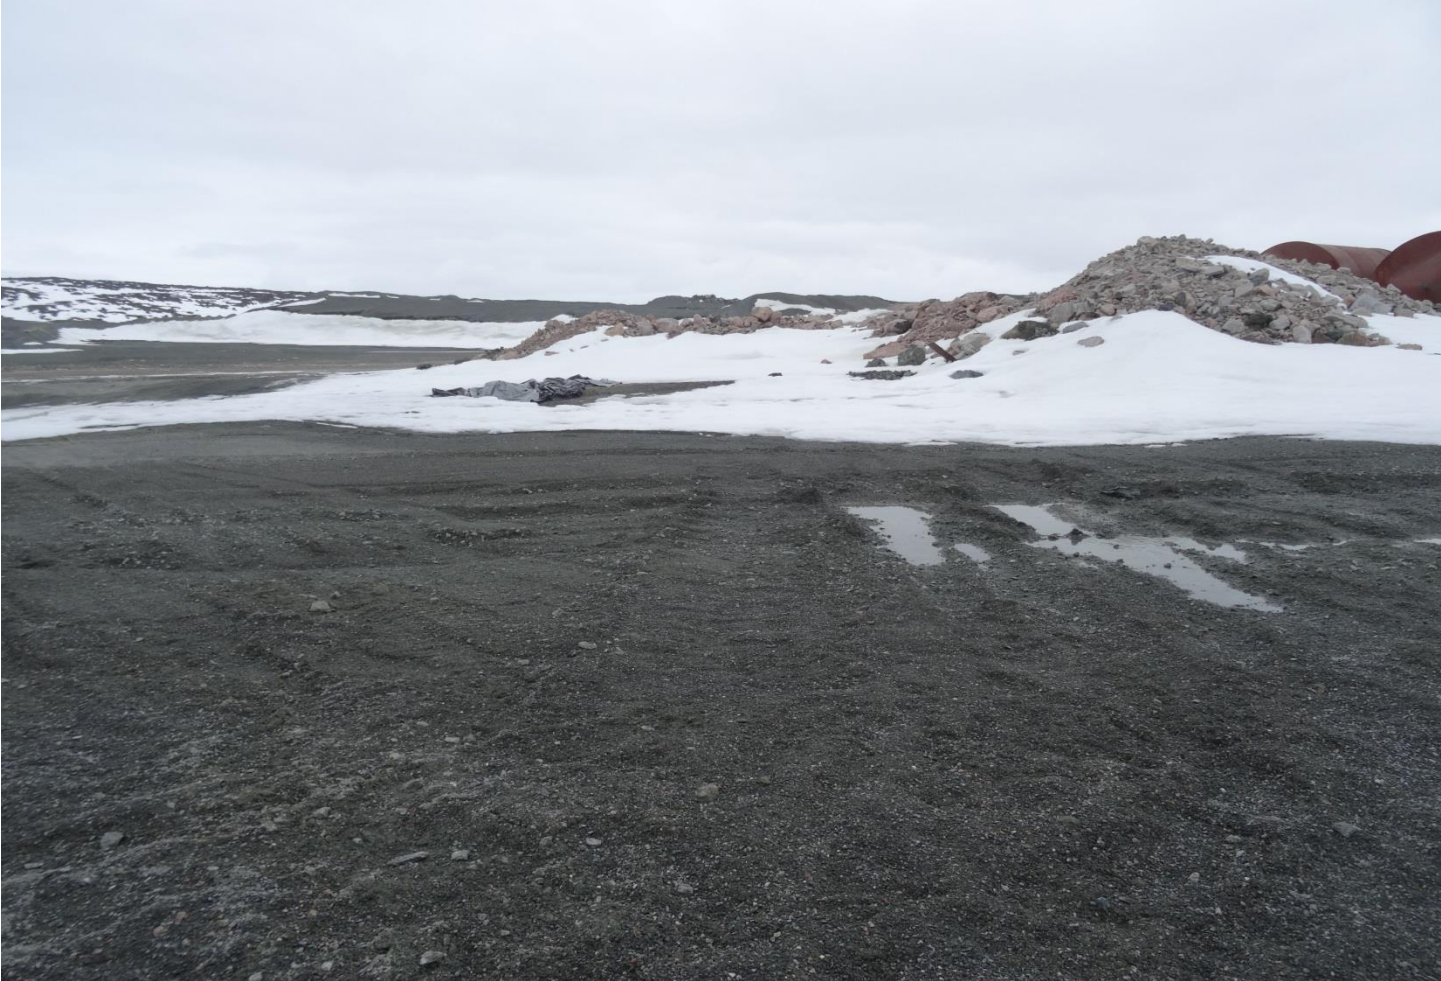
Photo 11

Description: Grey Water Lined Berm Sump Area showing part of Tarp Liner still on ground
