WATER LICENCE INSPECTION FORM

Licensee		Licensee Representative	
CIRNAC Contaminated Sites		Mark Yetman	
Licence No. / Expiry		Representative's Title	
2017-02-A1-04			
Land / Other Authorizations		Land / Other Authorizations	
Date of Inspection		Inspector	
2021 August 20		Baba Pedersen	
Activities Inspected			
<input type="checkbox"/> Camp	<input type="checkbox"/> Drilling	<input type="checkbox"/> Mining	<input type="checkbox"/> Construction
<input type="checkbox"/> Roads/Hauling	<input type="checkbox"/> Other:	<input checked="" type="checkbox"/> Other: Site Stabilization	<input type="checkbox"/> Reclamation
<input type="checkbox"/> Fuel Storage

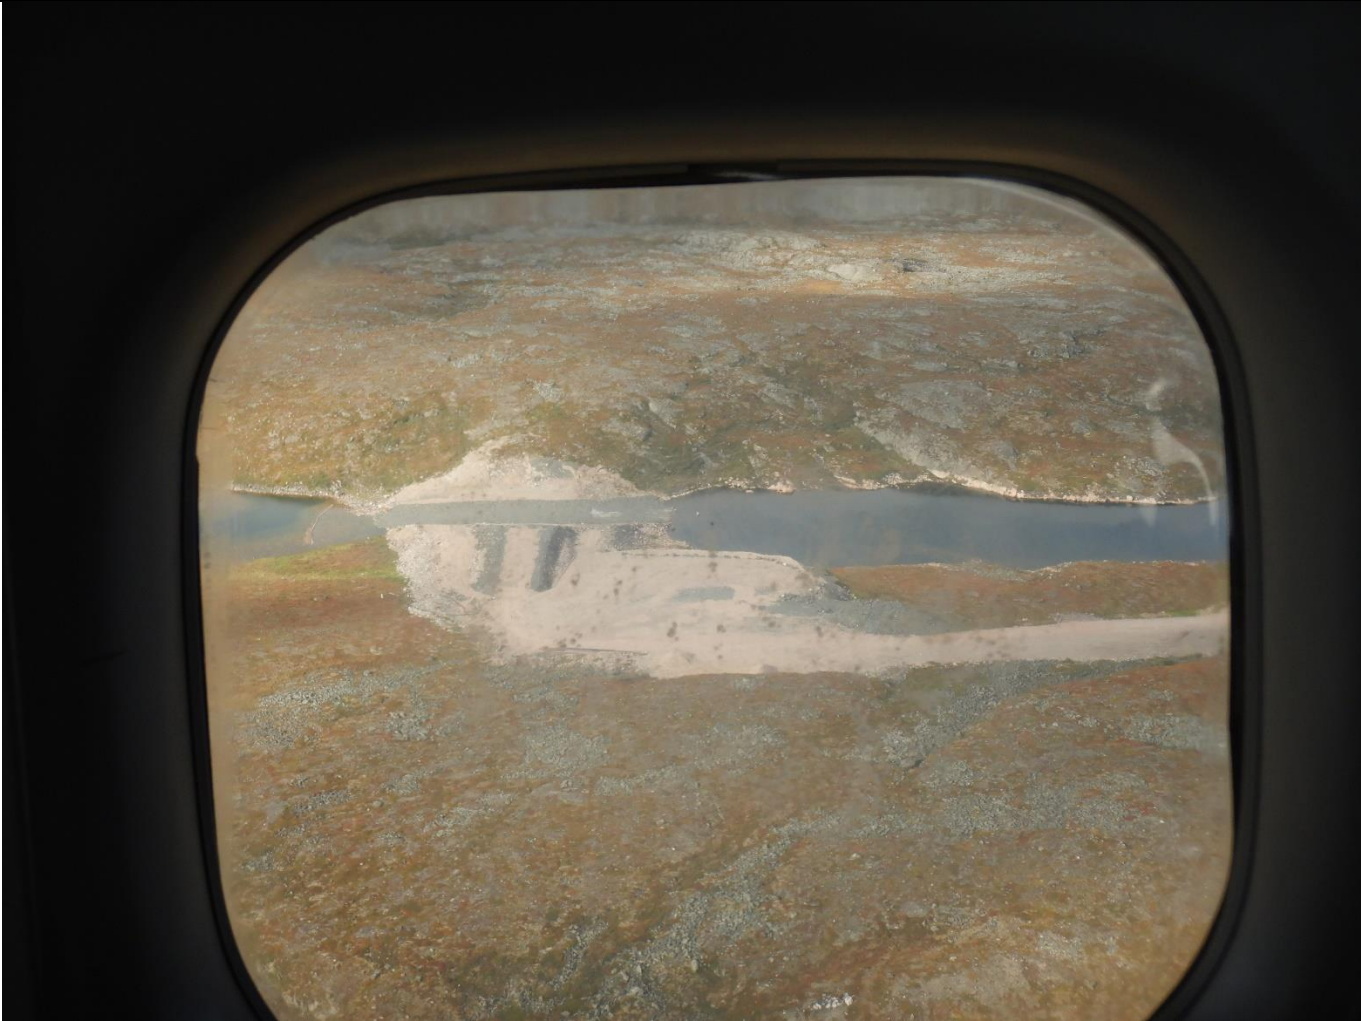
Photo 3

Description: Aerial View of the West Dam – View is from the South Side looking North

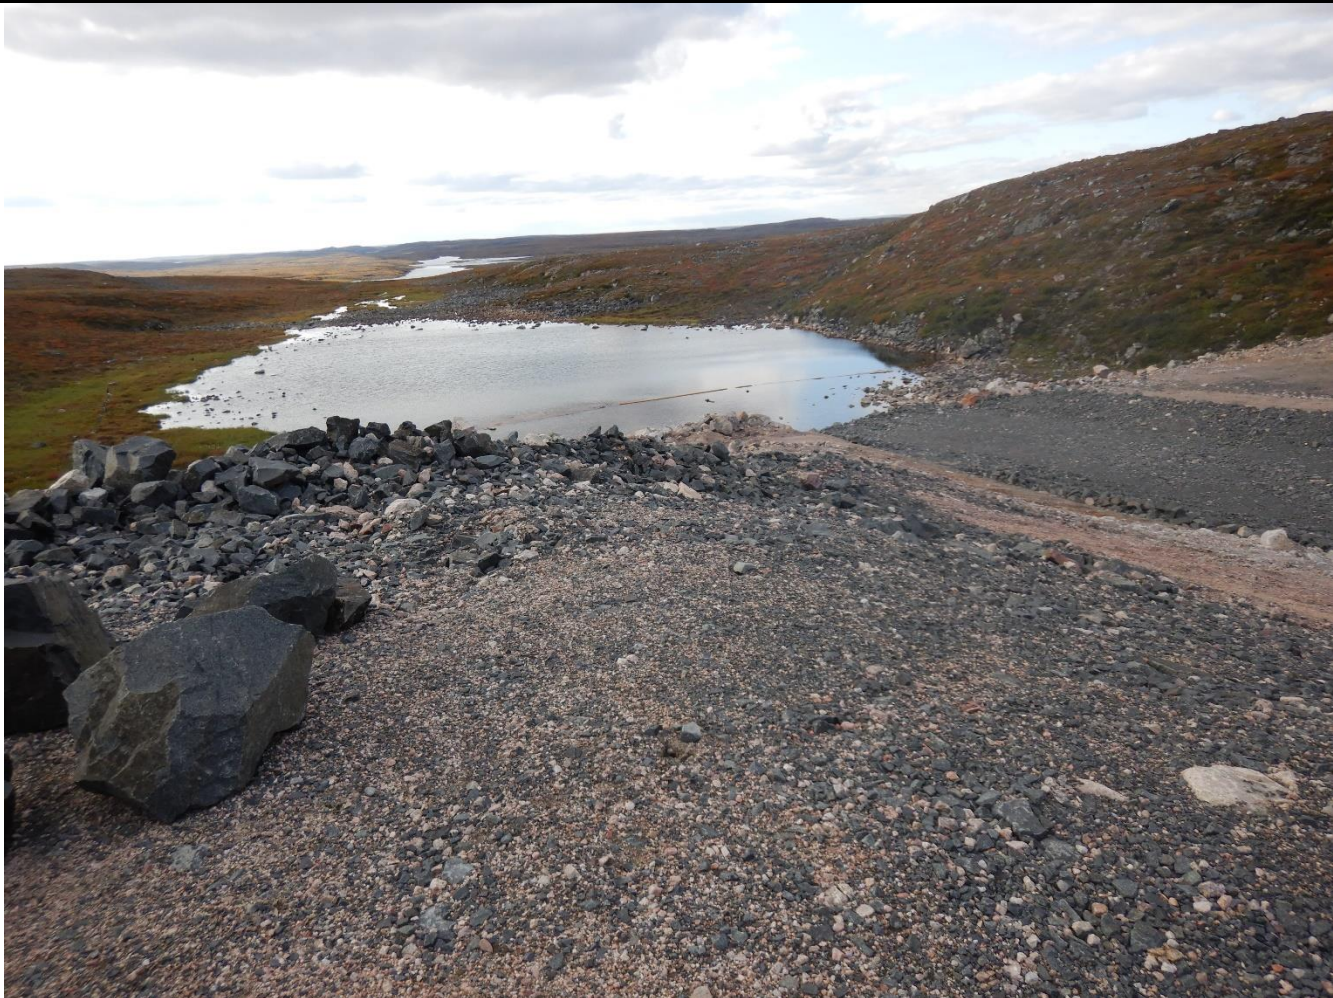
Photo 4

Description: Outflow side of West Dam, looking West to Lake C3

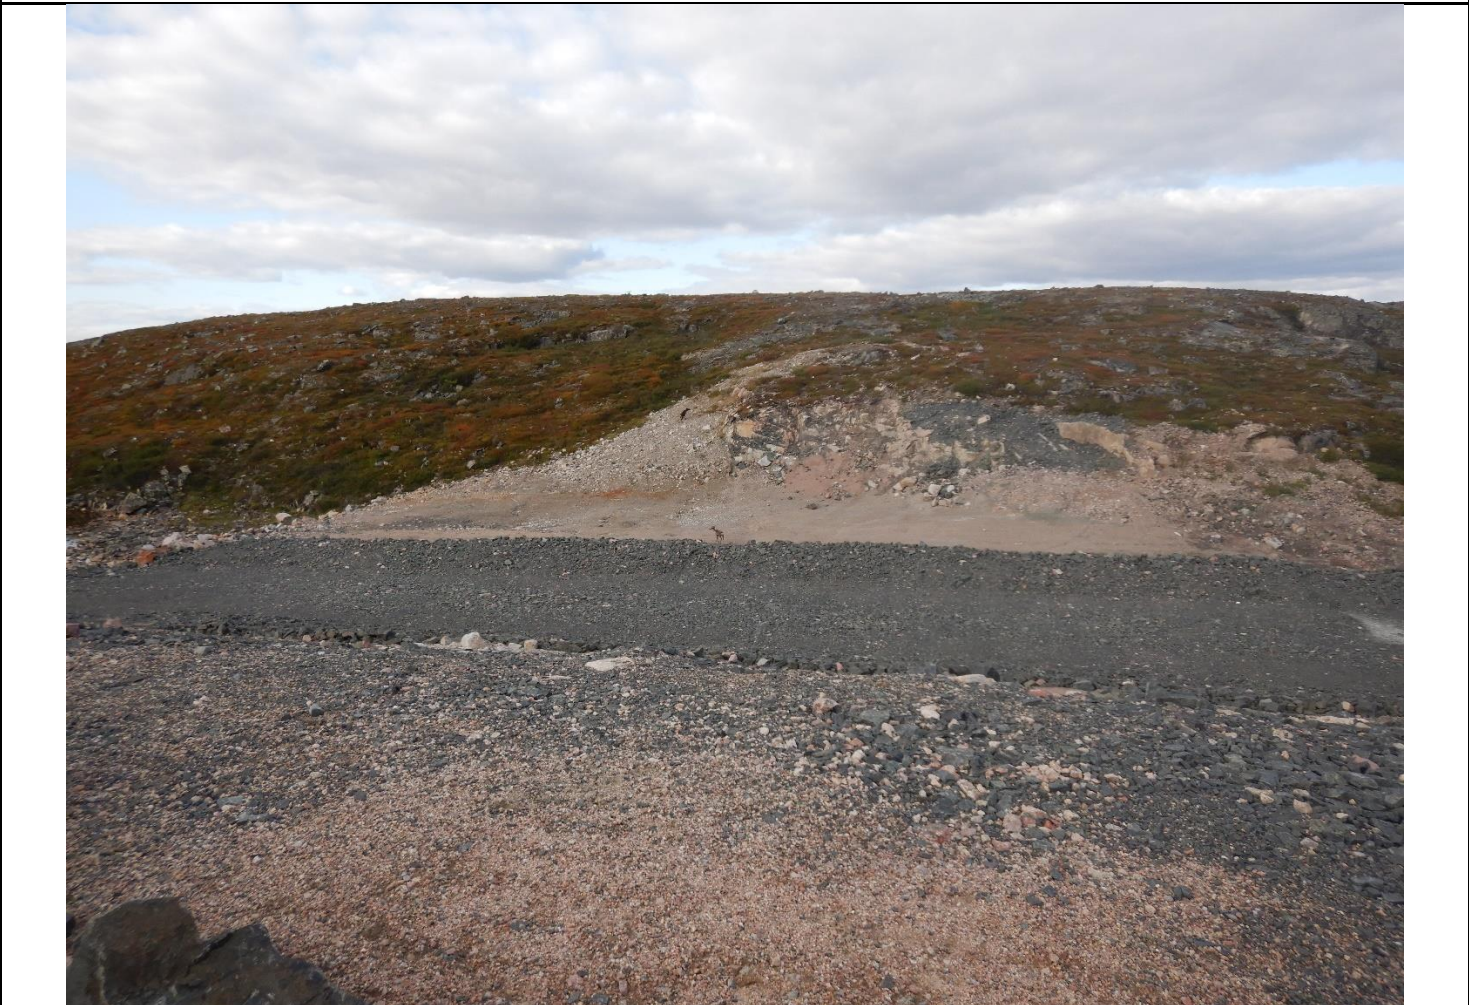
Photo 5

Description: View of the West Dam – from standing on the South side looking North – Notice the Caribou in the center of the photo on far side

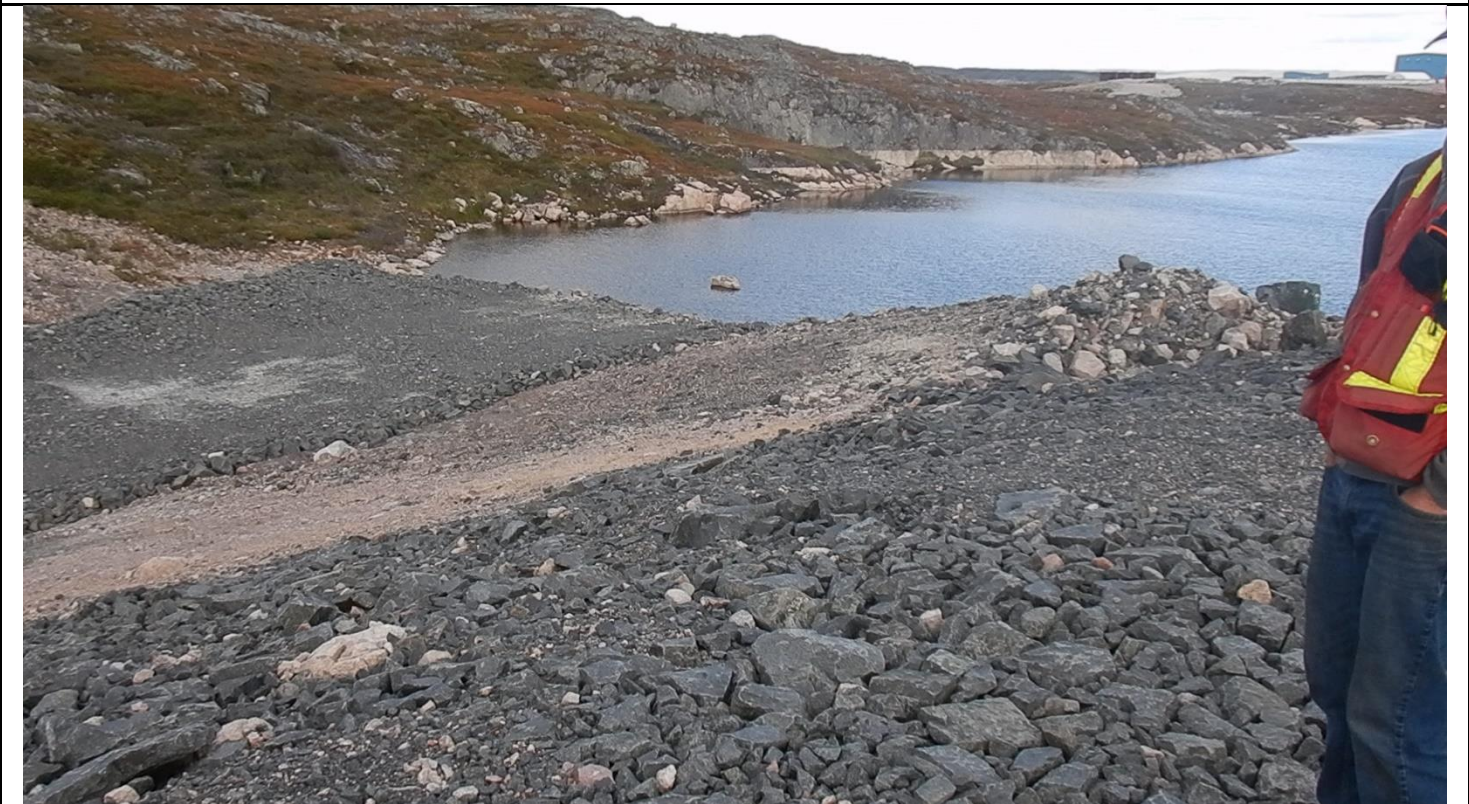
Photo 6

Description: View of the West Dam – Upstream (East) Side – as seen from standing on the South side

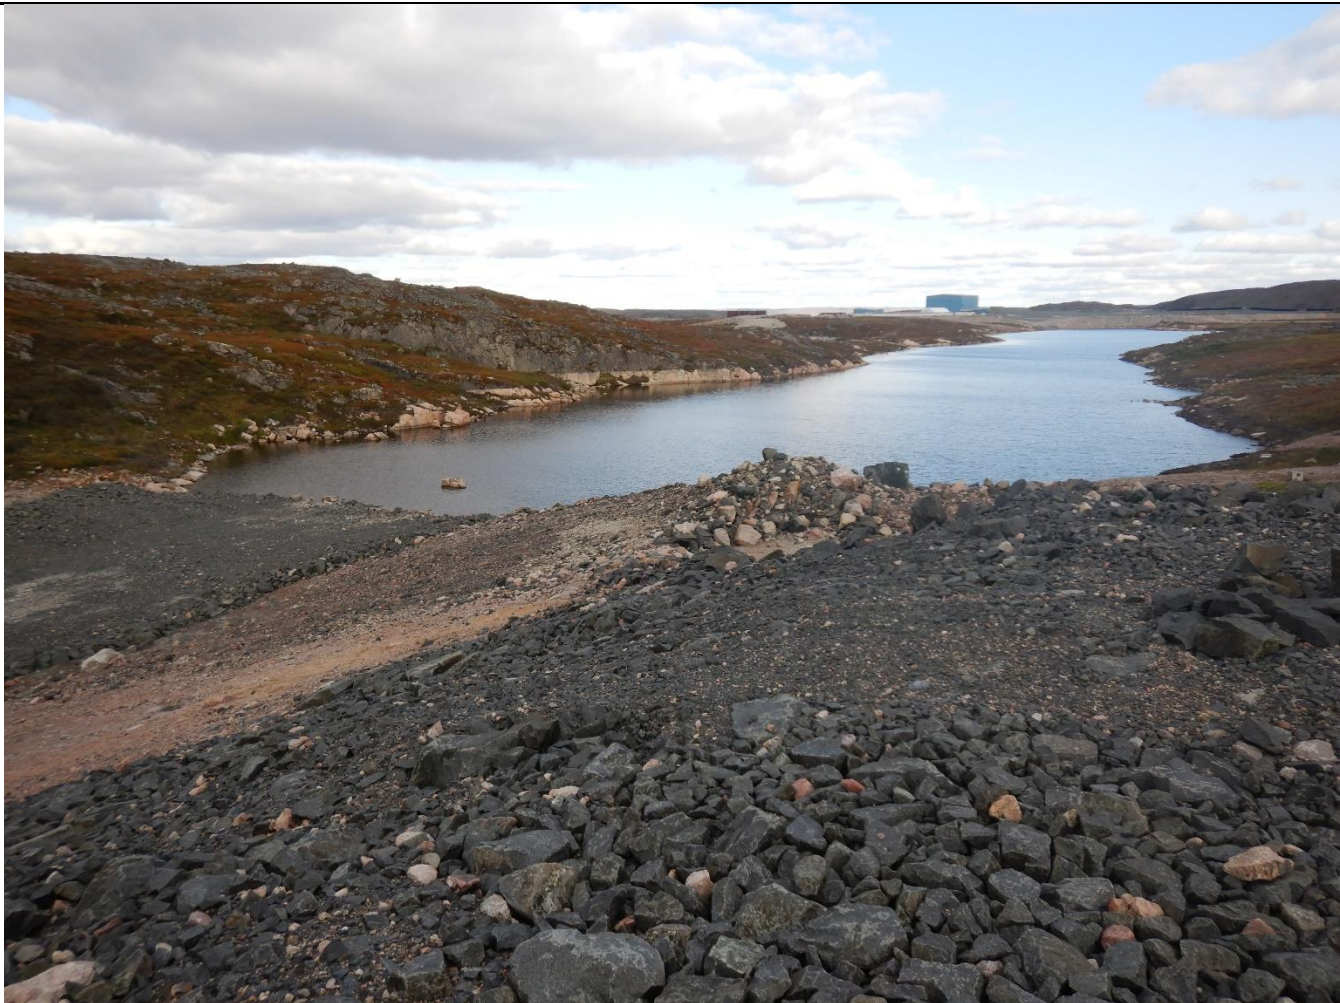
Photo 7

Description: View of Long Lake (PKCA Cell 2) as seen from Looking East from the West Dam

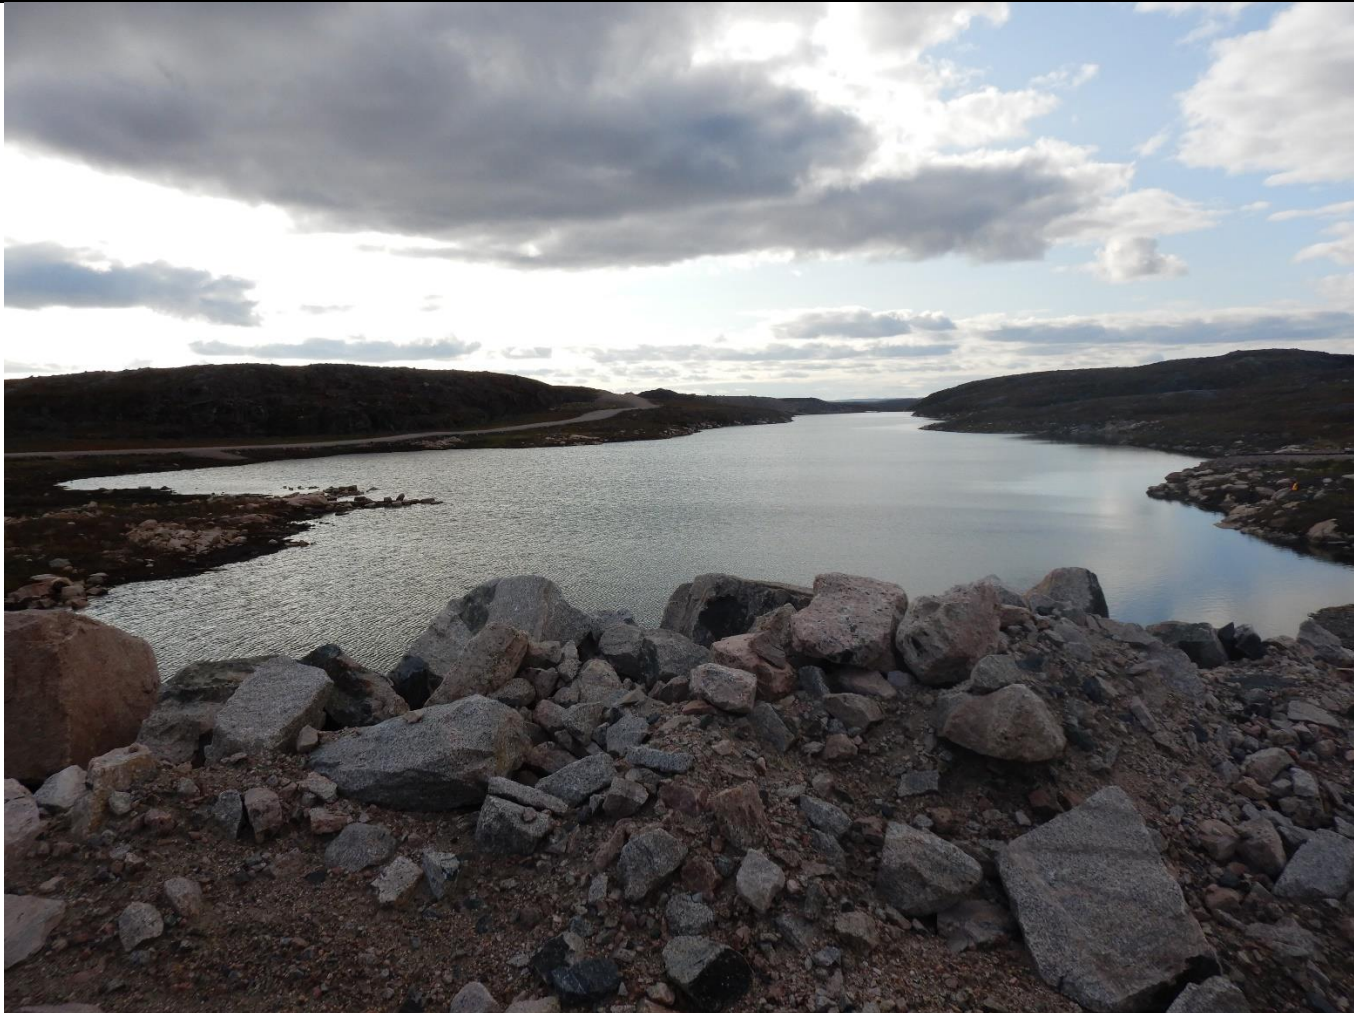
Photo 8

Description: View of Long Lake (PKCA Cell 2) as seen from looking West from the Divider Dyke

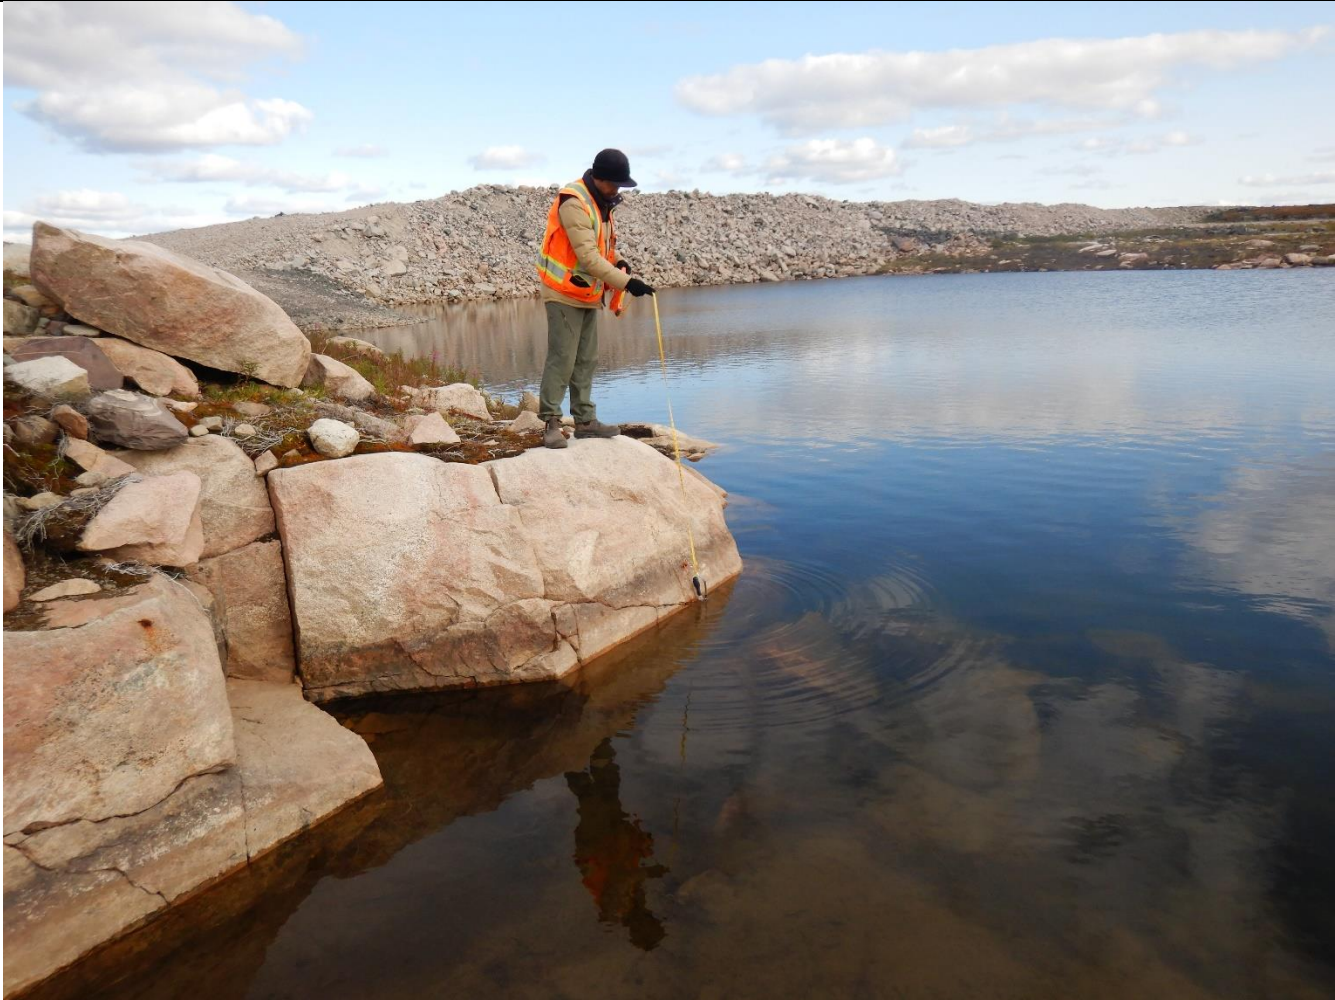
Photo 9

Description: Measuring the Level of Water to the Rock Bolt on the North Shore of Long Lake (PKCA Cell 2)

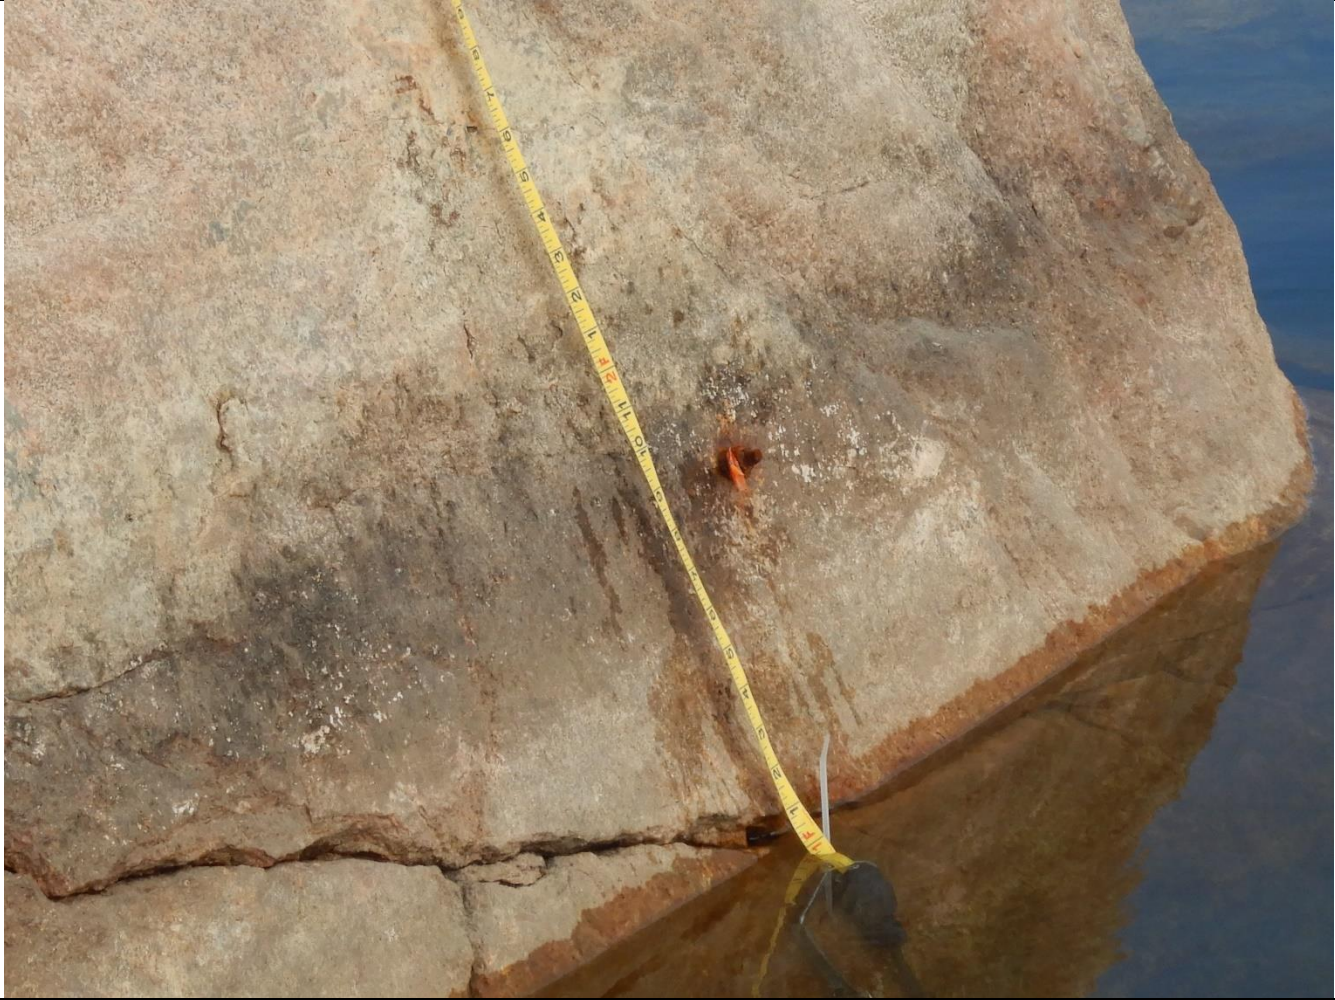
Photo 10

Description: Measurement from the Rock Bolt to the Water Line of Long Lake (PKCA Cell 2) showing at approximately 9 inches

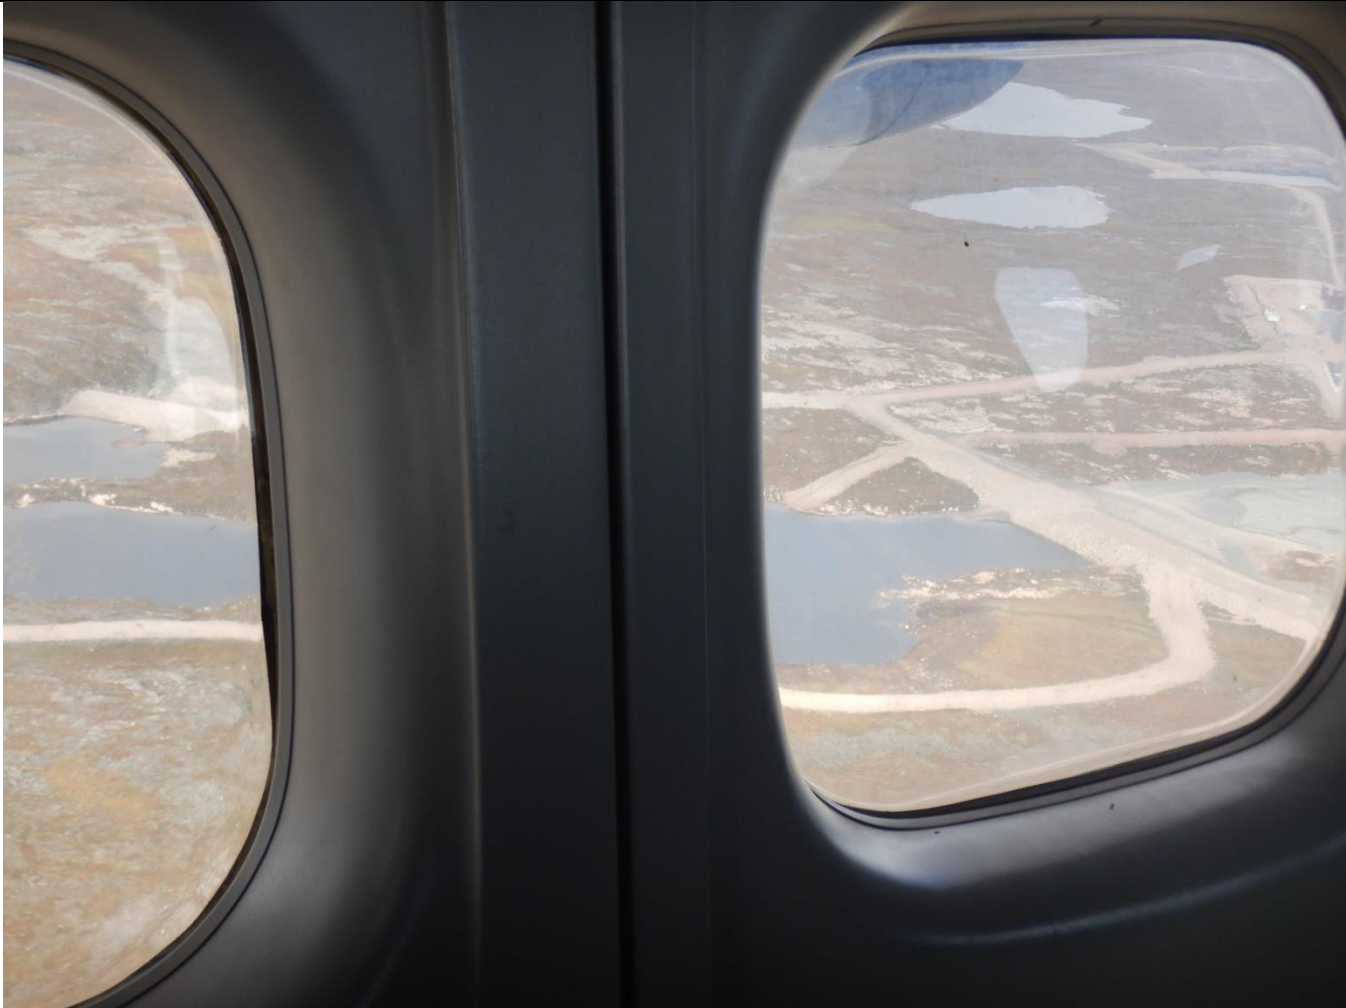
Photo 11

Runoff Water is going through the Filter Dyke from the PKCA Cell 1 to Cell 2 (Long Lake) as it was designed to do

Description: Aerial View 1 of the Divider Dyke as seen from the South Side looking North

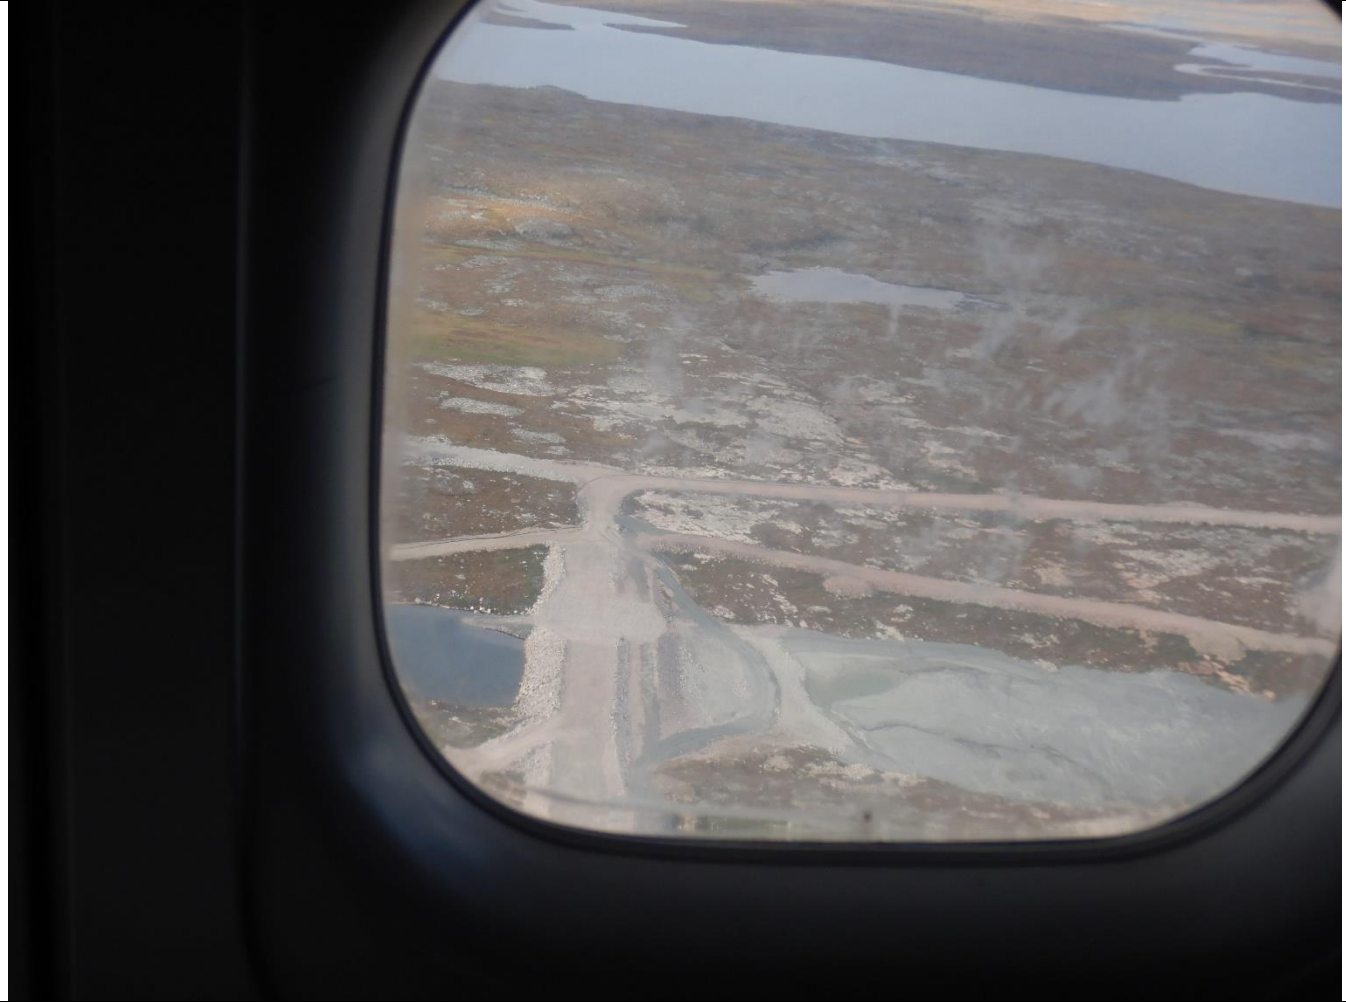
Photo 12

Description: Aerial View 2 of the Divider Dyke as seen from the South Side looking North

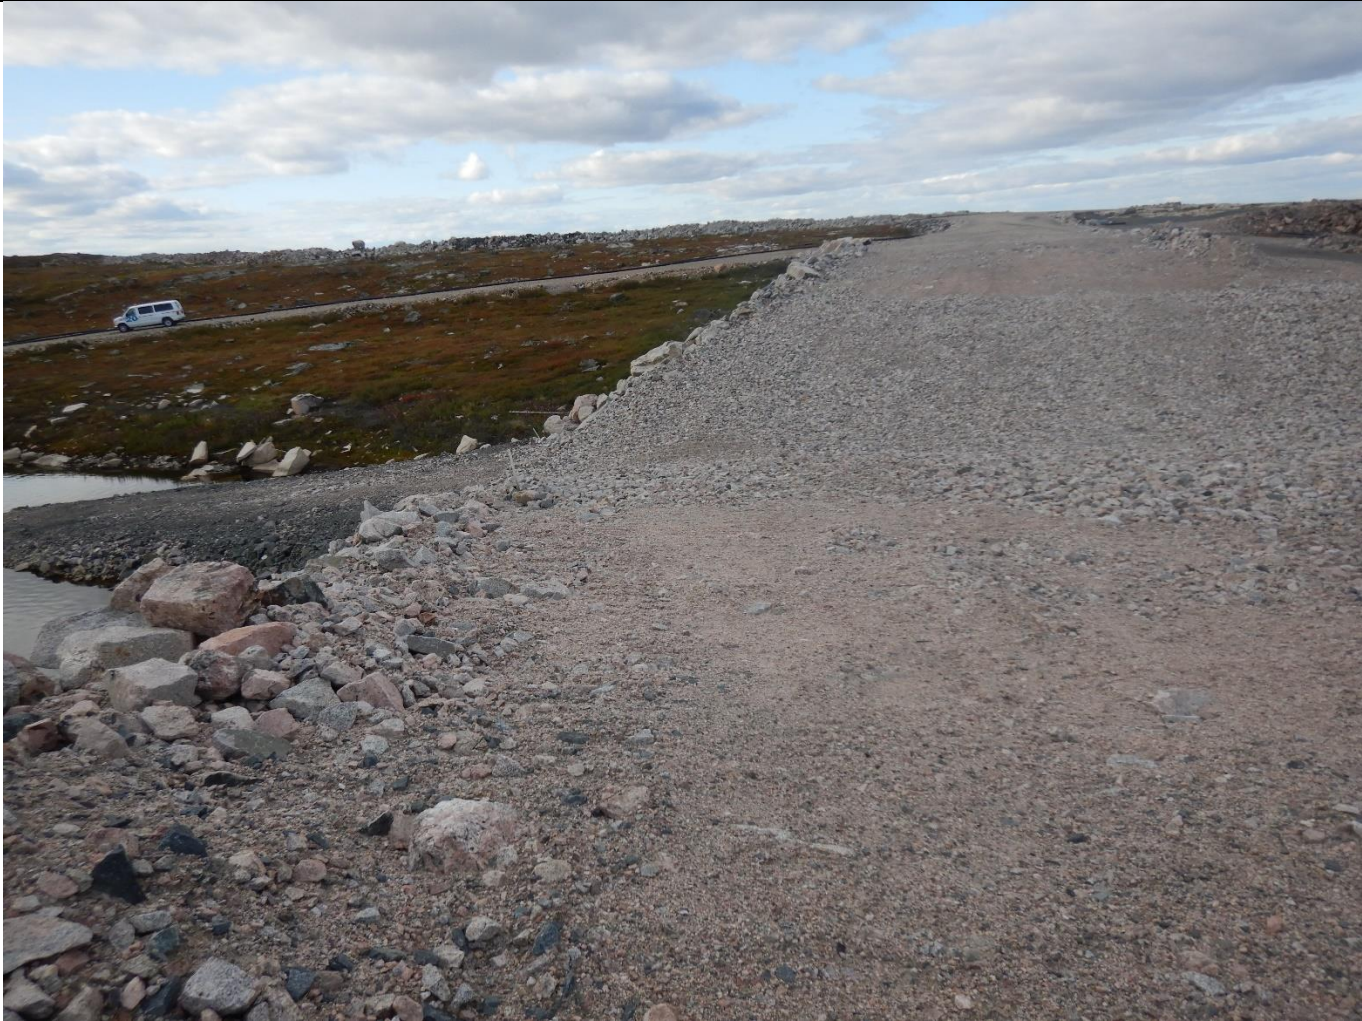
Photo 13

Description: Divider Dyke – West Side Slope

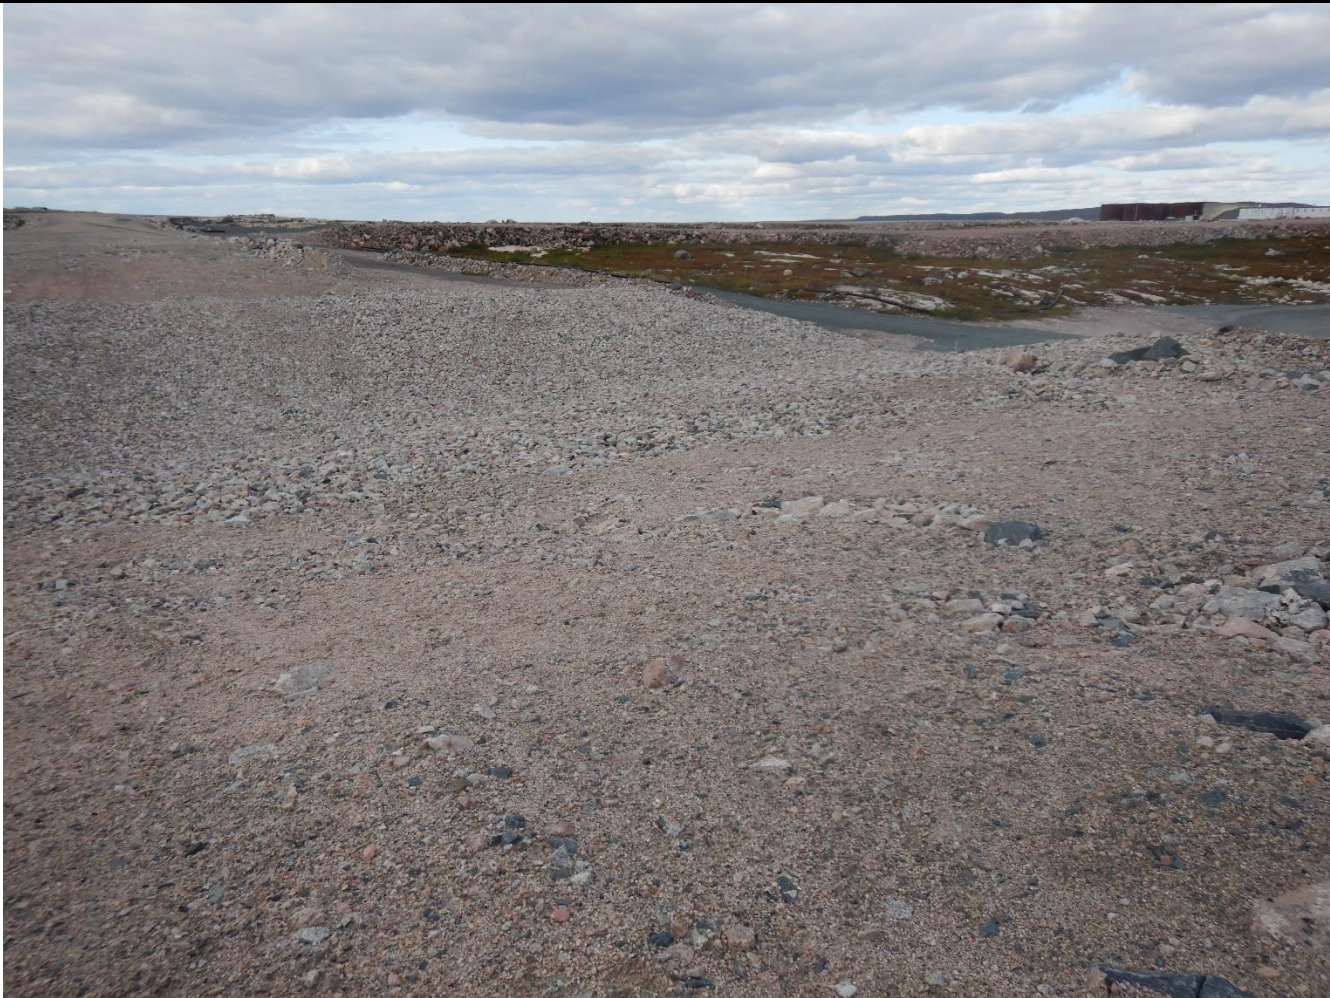
Photo 14

Description: Divider Dyke – Top and East Side Slope

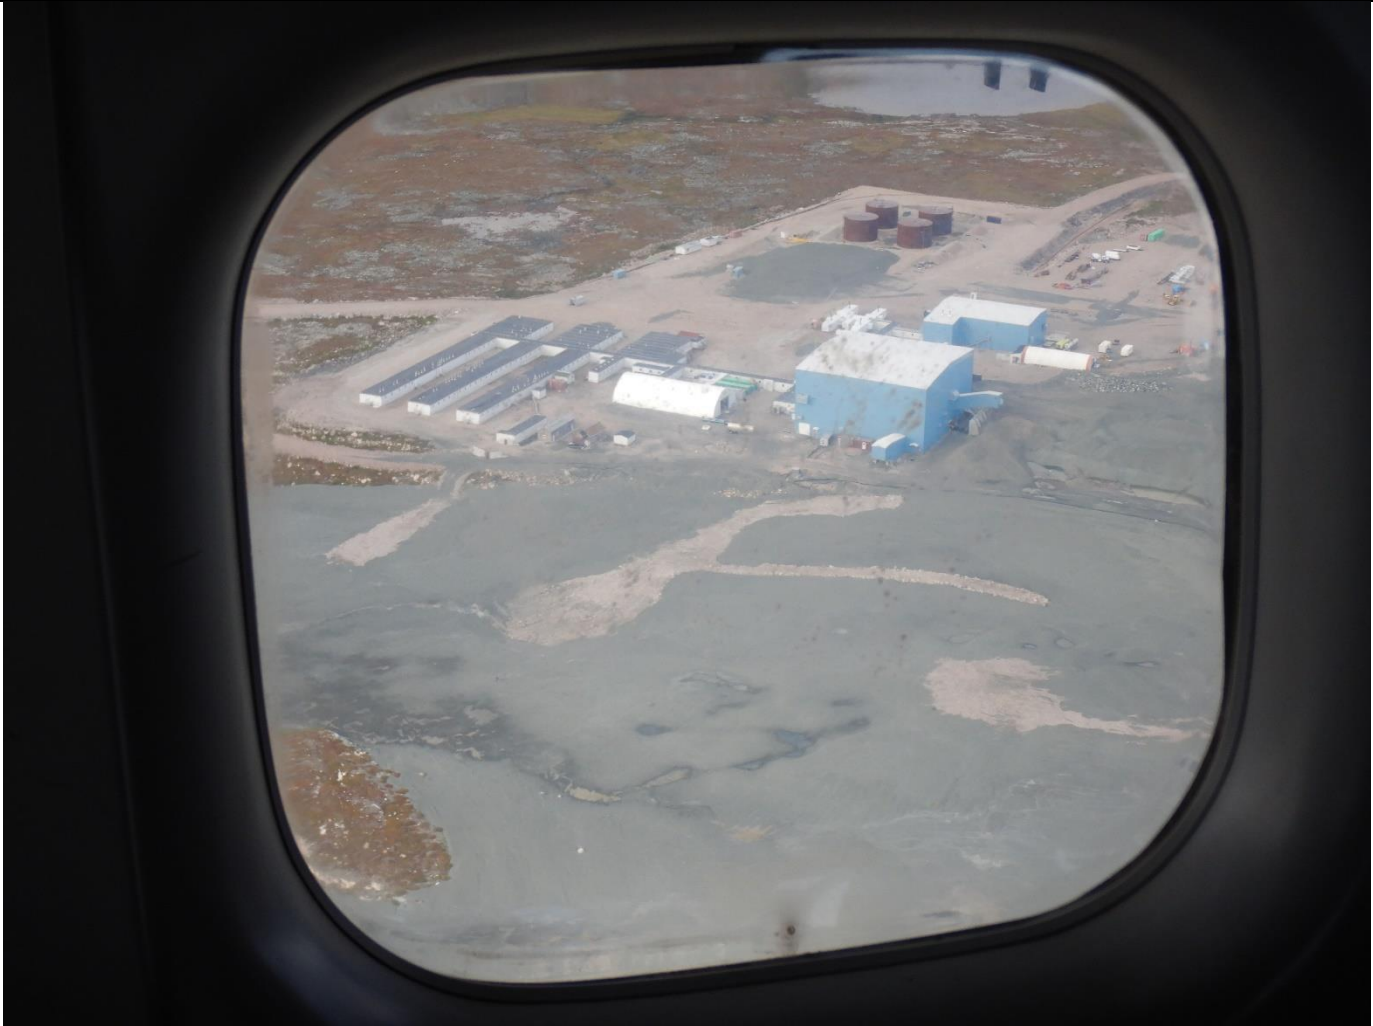
Photo 15

The entire PKCA Cell 1 area has been covered with a minimum of 30 cm of Course Tailings

Description: Aerial View 1 of the Mine Site Buildings and PKCA in the foreground

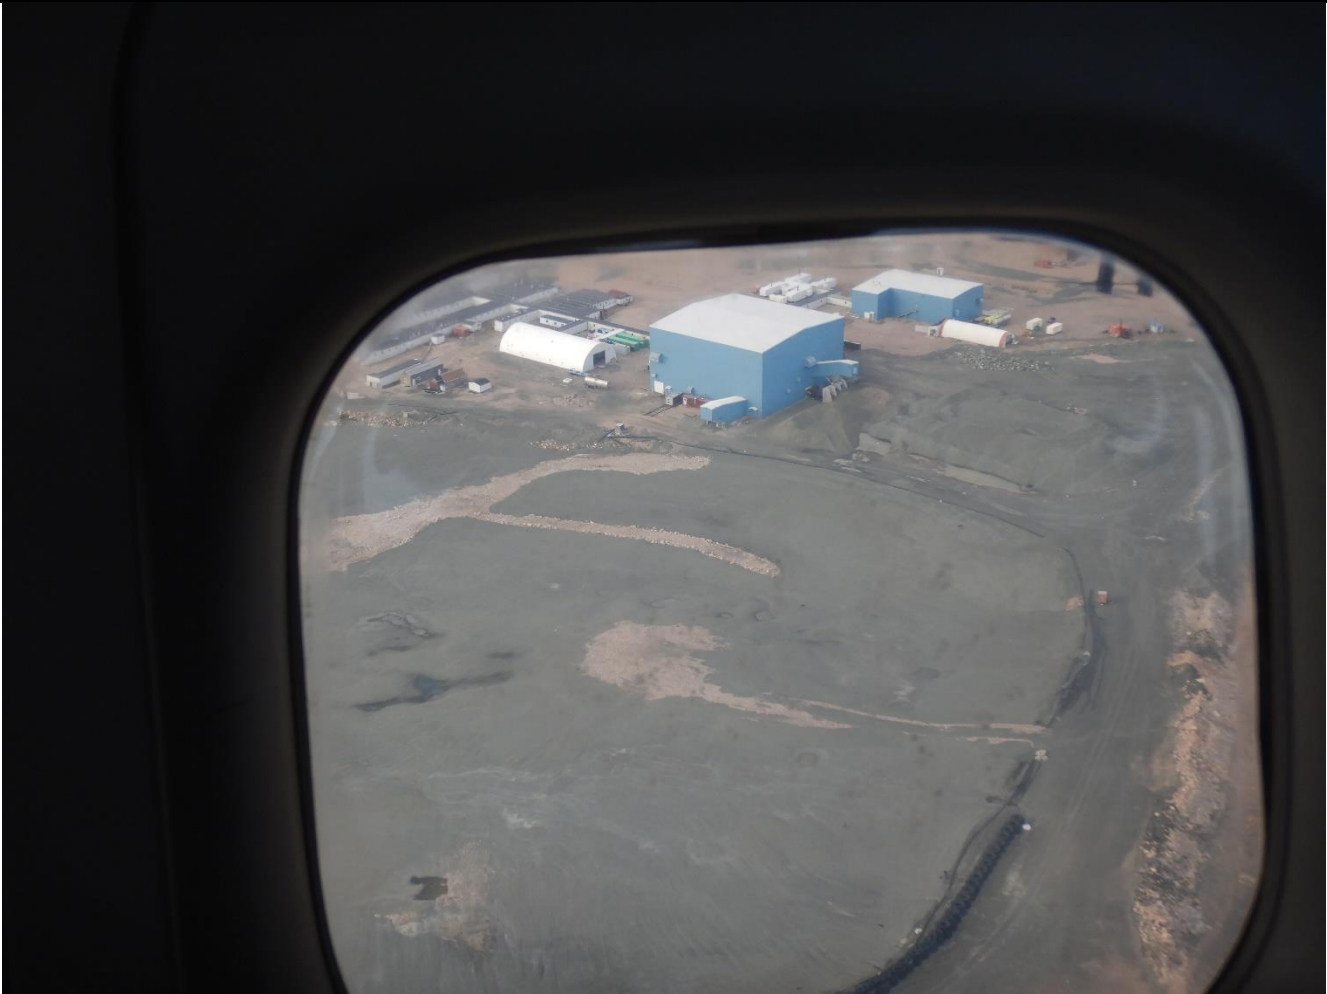
Photo 16

Description: Aerial View 2 of the Mine Site Buildings and PKCA in the foreground

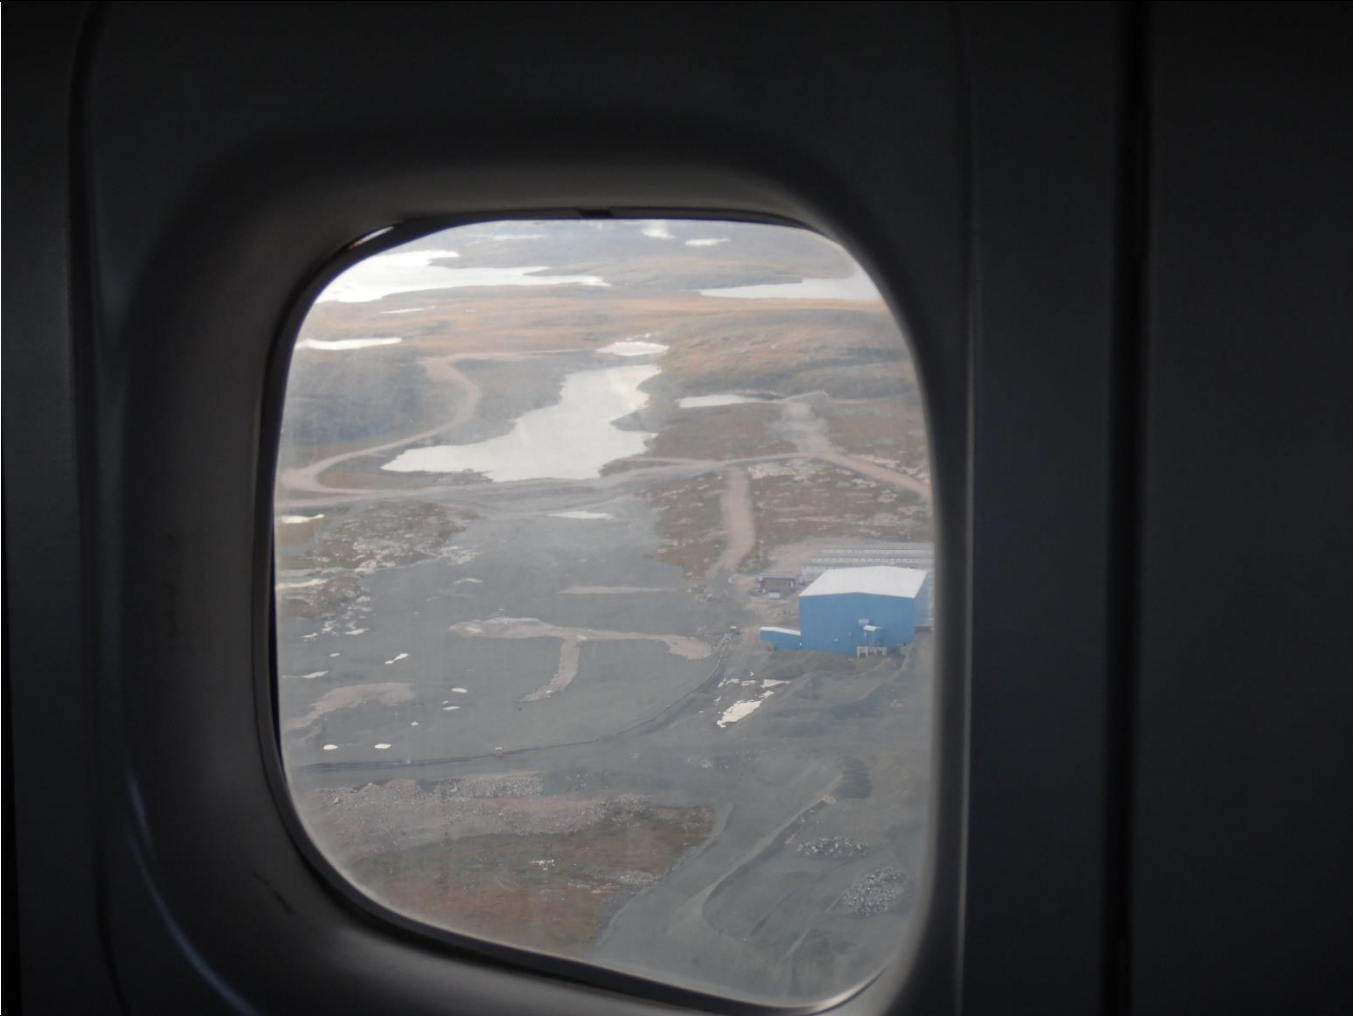
Photo 17

Description: Aerial View of the PKCA in the foreground and Long Lake (PKCA Cell 2) in the background – view is looking West

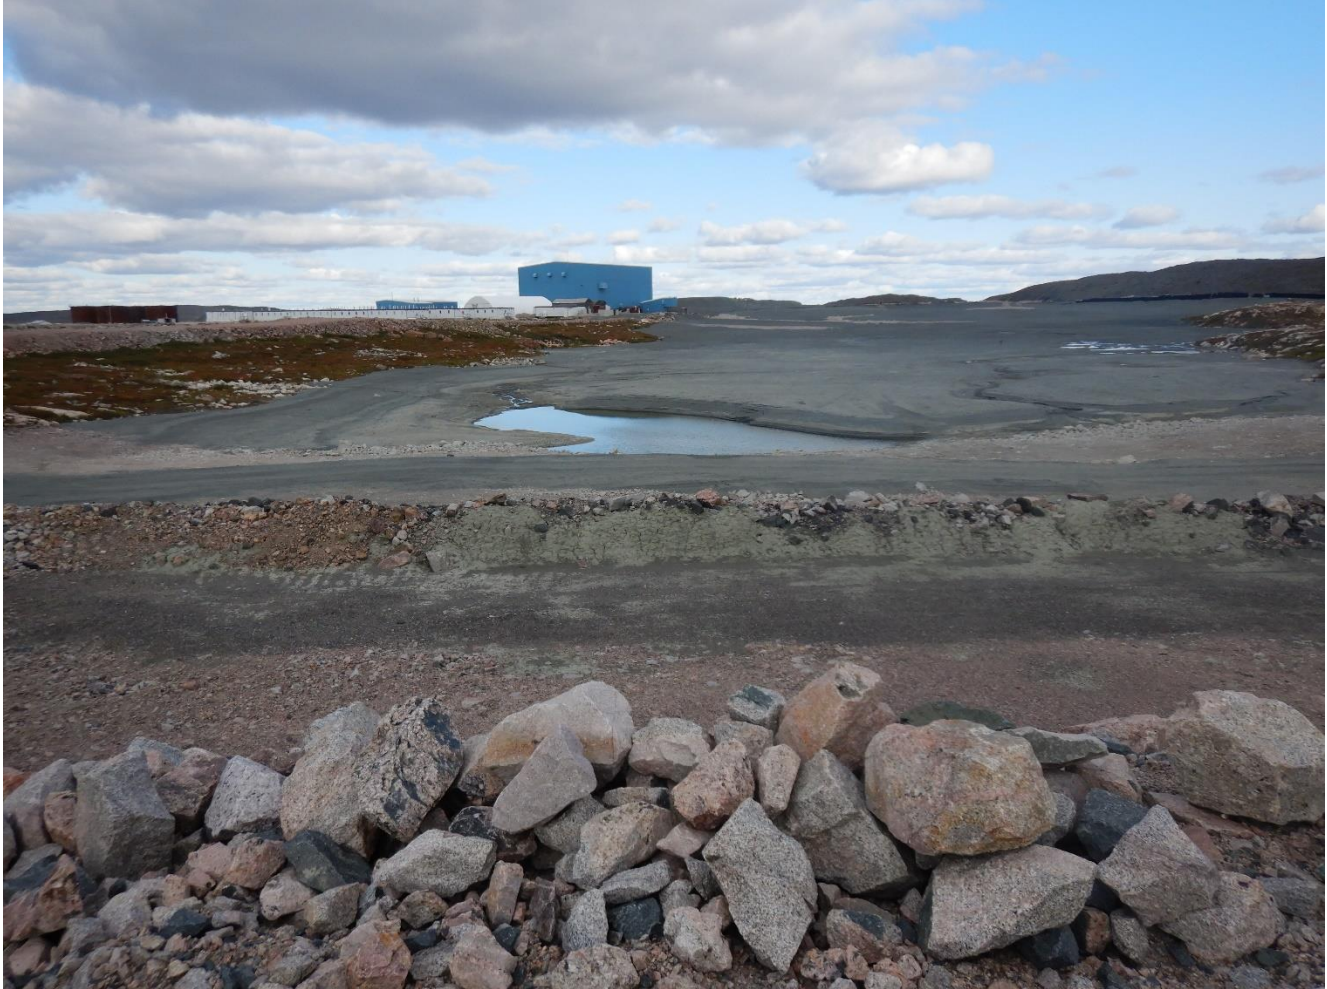
Photo 18

Description: PKCA (Cell 1) as seen looking East from on top of the Divider Dyke
