WATER LICENCE INSPECTION FORM

Licensee		Licensee Representative	
CIRNAC Contaminated Sites		Mark Yetman	
Licence No. / Expiry		Representative's Title	
2017-02-A1-04			
Land / Other Authorizations		Land / Other Authorizations	
Date of Inspection		Inspector	
2021 August 20		Baba Pedersen	
Activities Inspected			
<input type="checkbox"/> Camp	<input type="checkbox"/> Drilling	<input type="checkbox"/> Mining	<input type="checkbox"/> Construction
<input type="checkbox"/> Roads/Hauling	<input type="checkbox"/> Other:	<input checked="" type="checkbox"/> Other: Site Stabilization	<input type="checkbox"/> Reclamation
<input type="checkbox"/> Fuel Storage

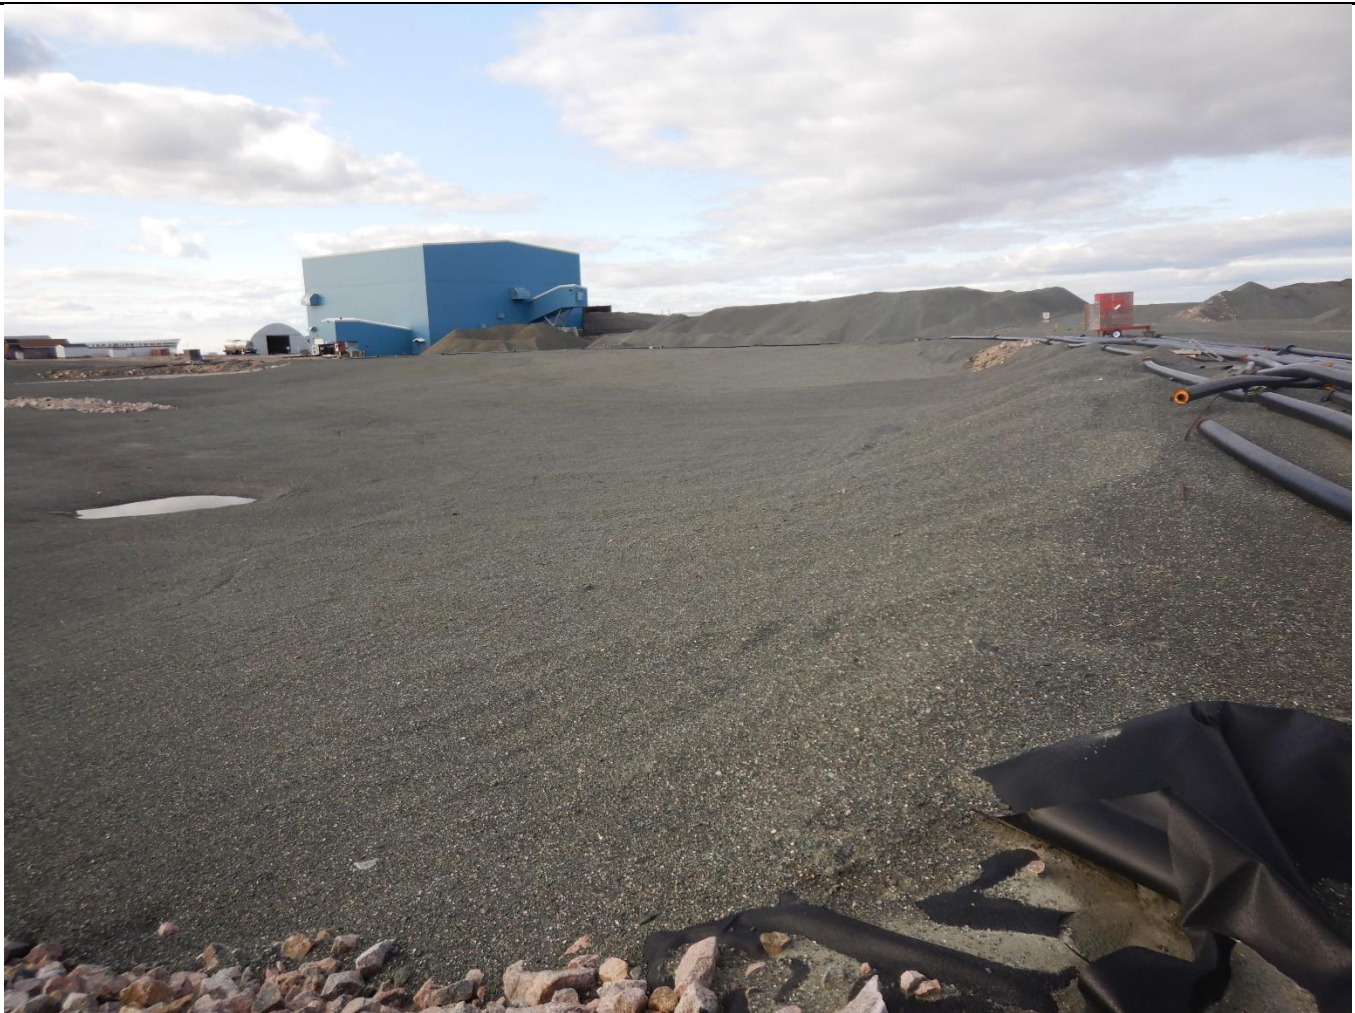
Photo 19

The entire PKCA Cell 1 area has been covered with a minimum of 30 cm of Course Tailings

Description: PKCA (Cell 1) – View 1 – East End looking North

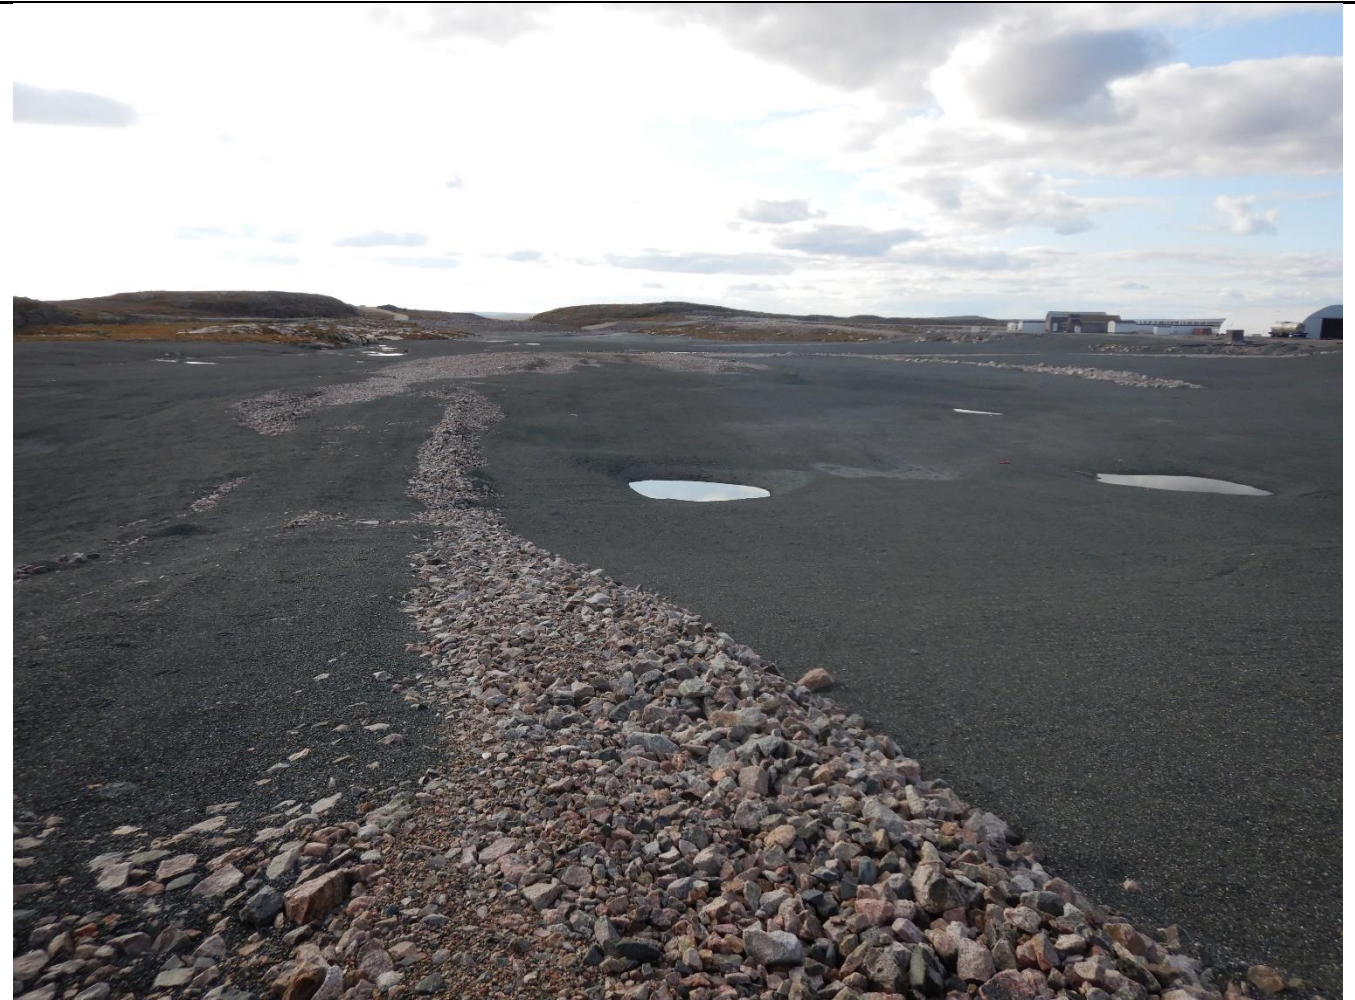
Photo 20

Description: PKCA (Cell 1) – View 2 – East End looking West

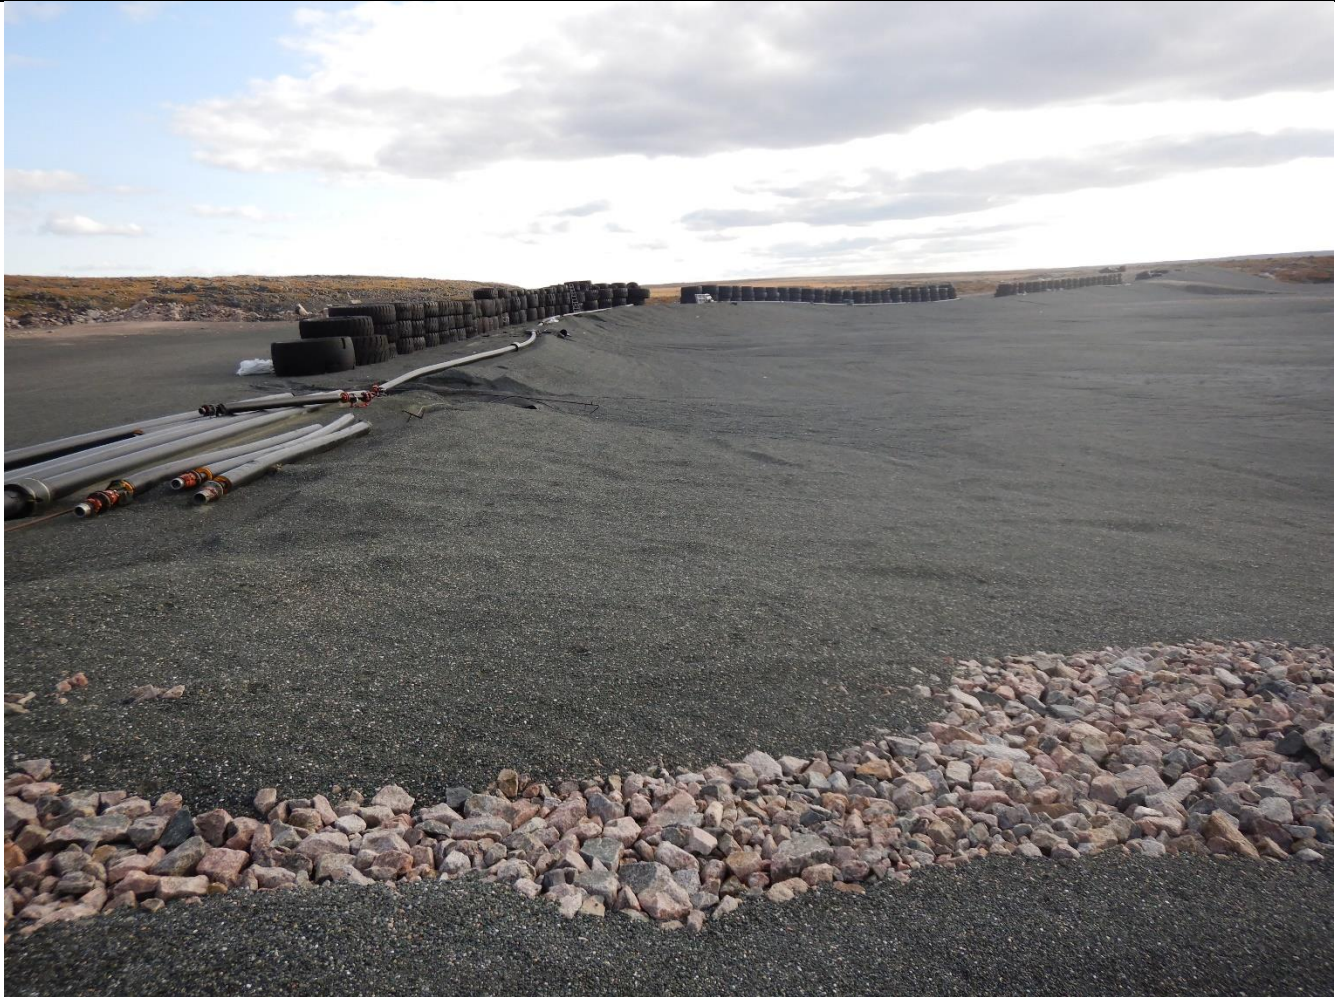
Photo 21

Description: PKCA (Cell 1) – View 3 – East End looking South

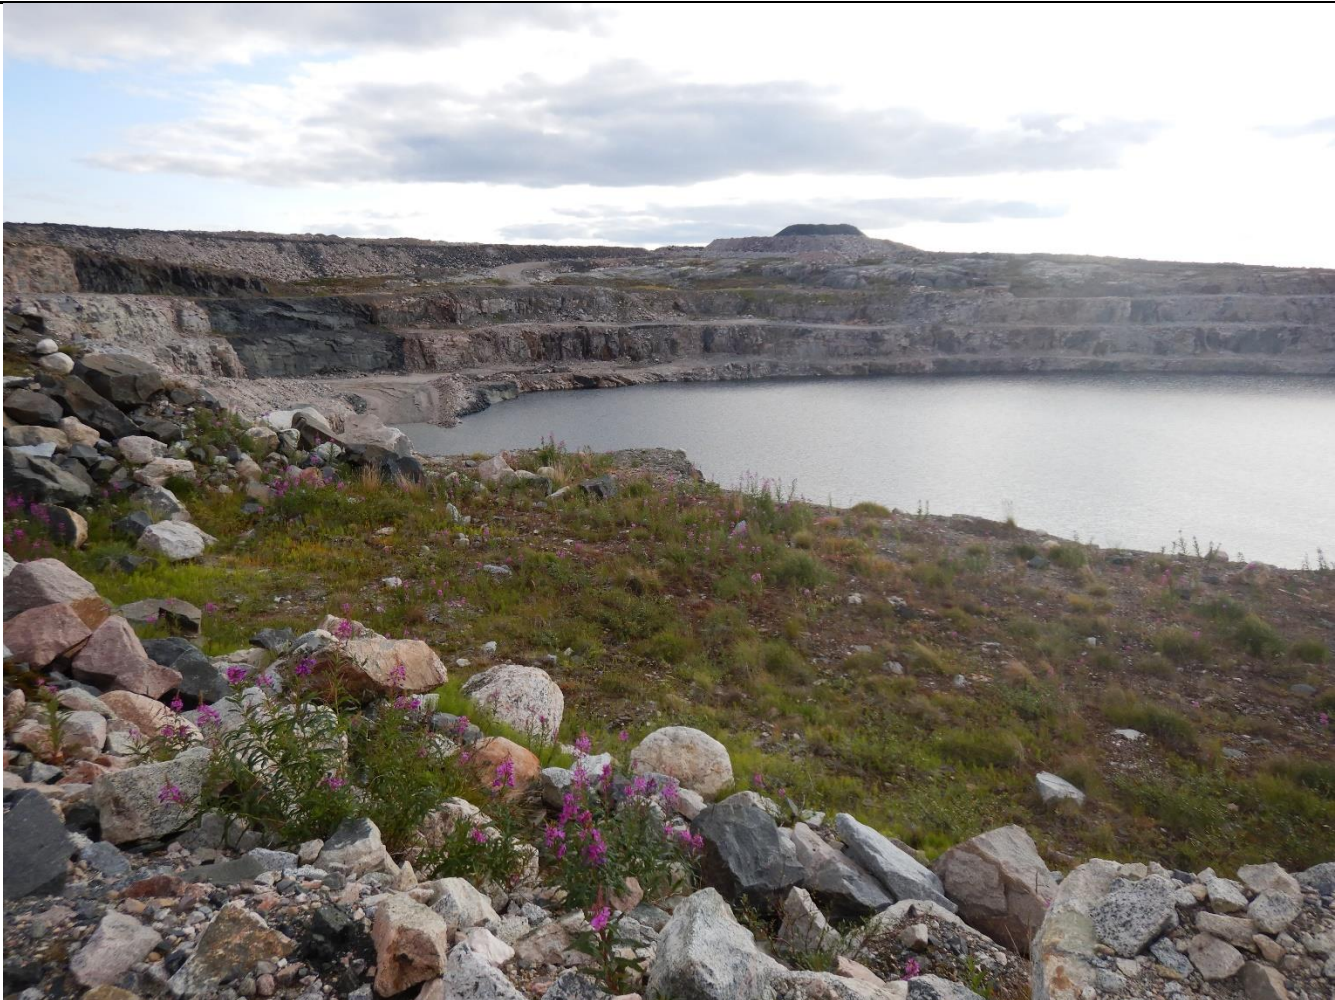
Photo 22

CIRNAC Contaminated Sites estimates that the Water Level in the Pit Lake has gone up approximately 5 Meters since last year

Description: Pit Lake – View 1 from South Eastern Side

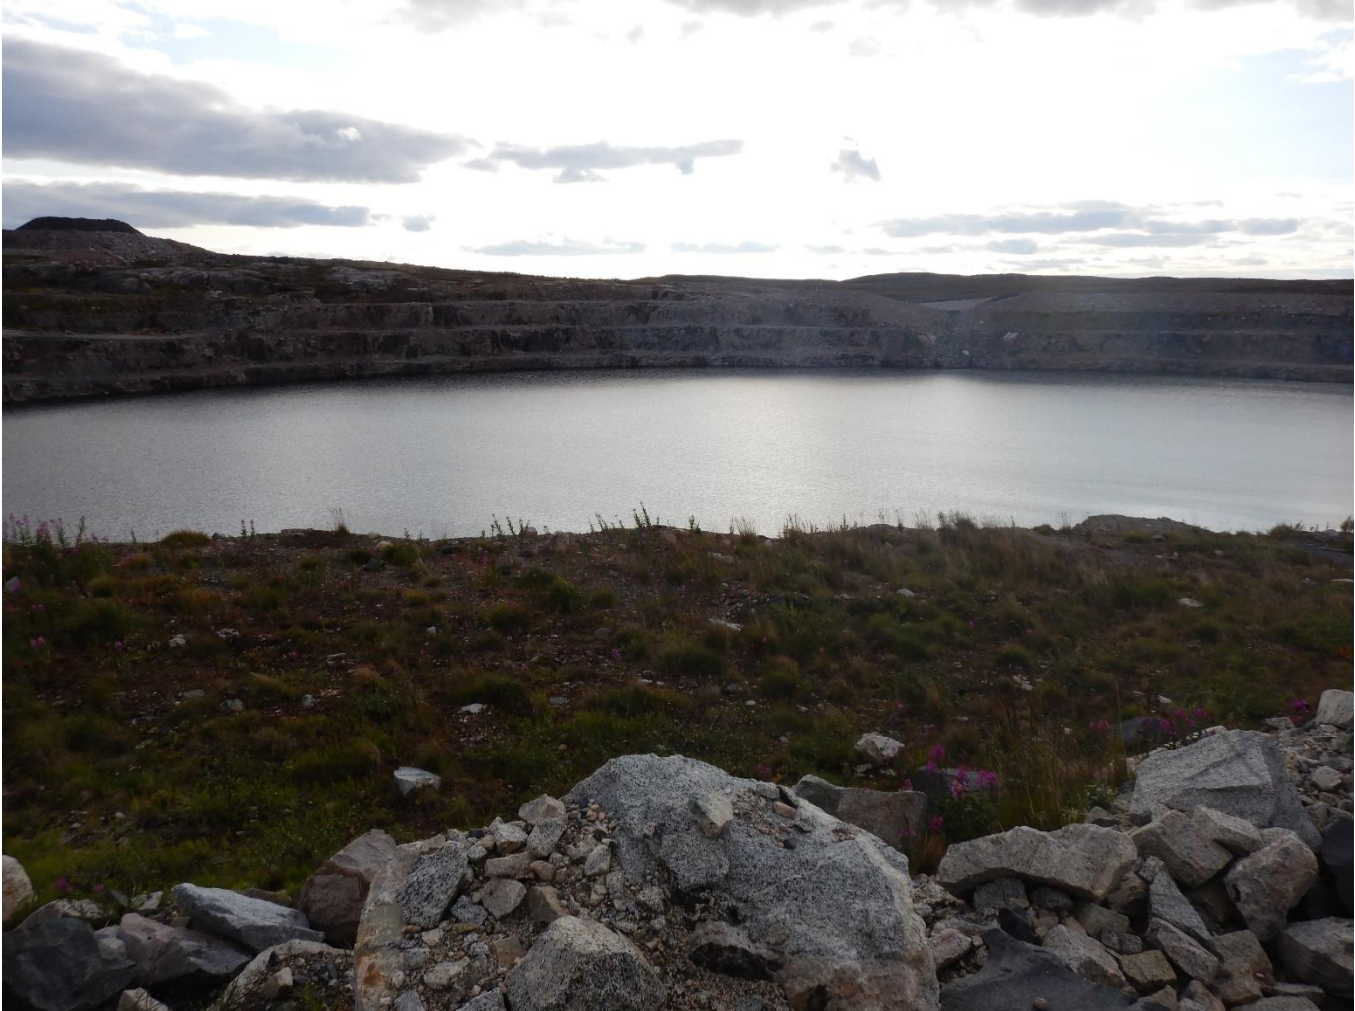
Photo 23

Description: Pit Lake – View 2 from South Eastern Side

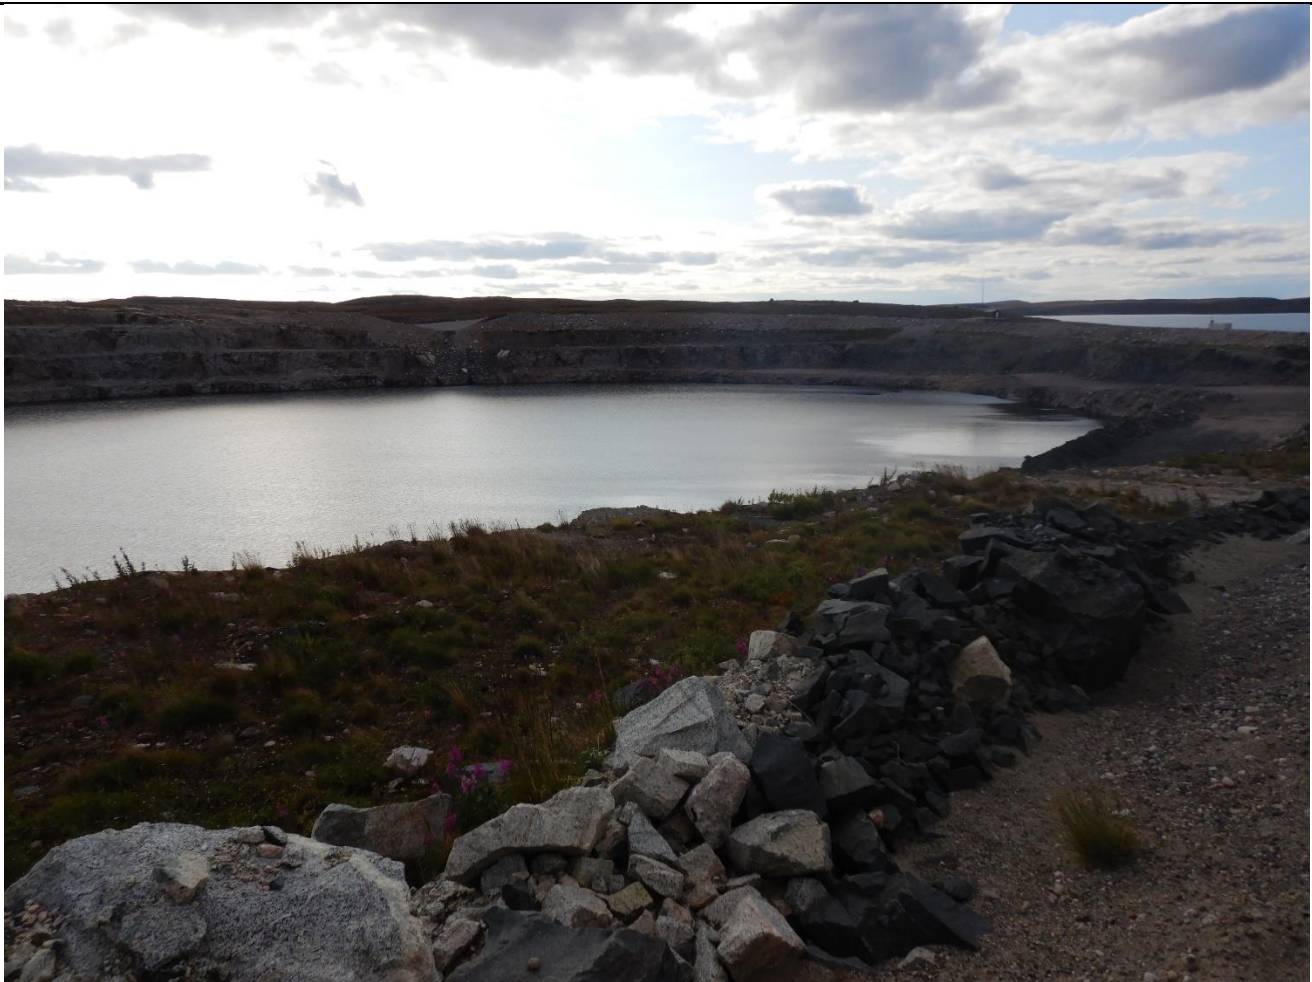
Photo 24

Description: Pit Lake – View 3 from South Eastern Side

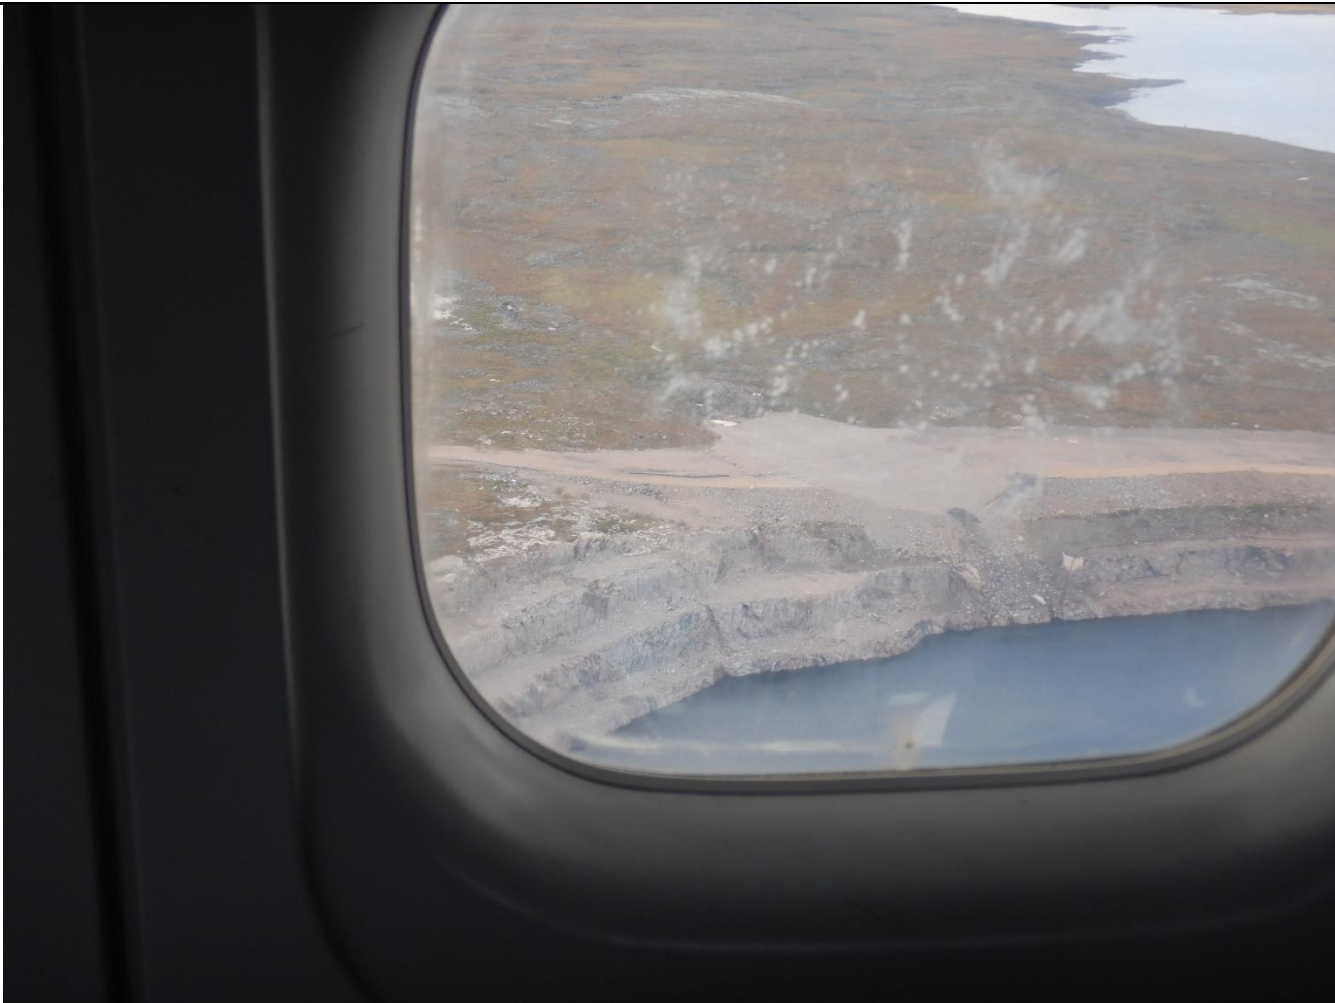
Photo 25

The Diversion to allow natural drainage INTO the Pit Lake is complete

Description: Aerial view of Built Up In-Flow Area - flow will be going INTO Pit Lake

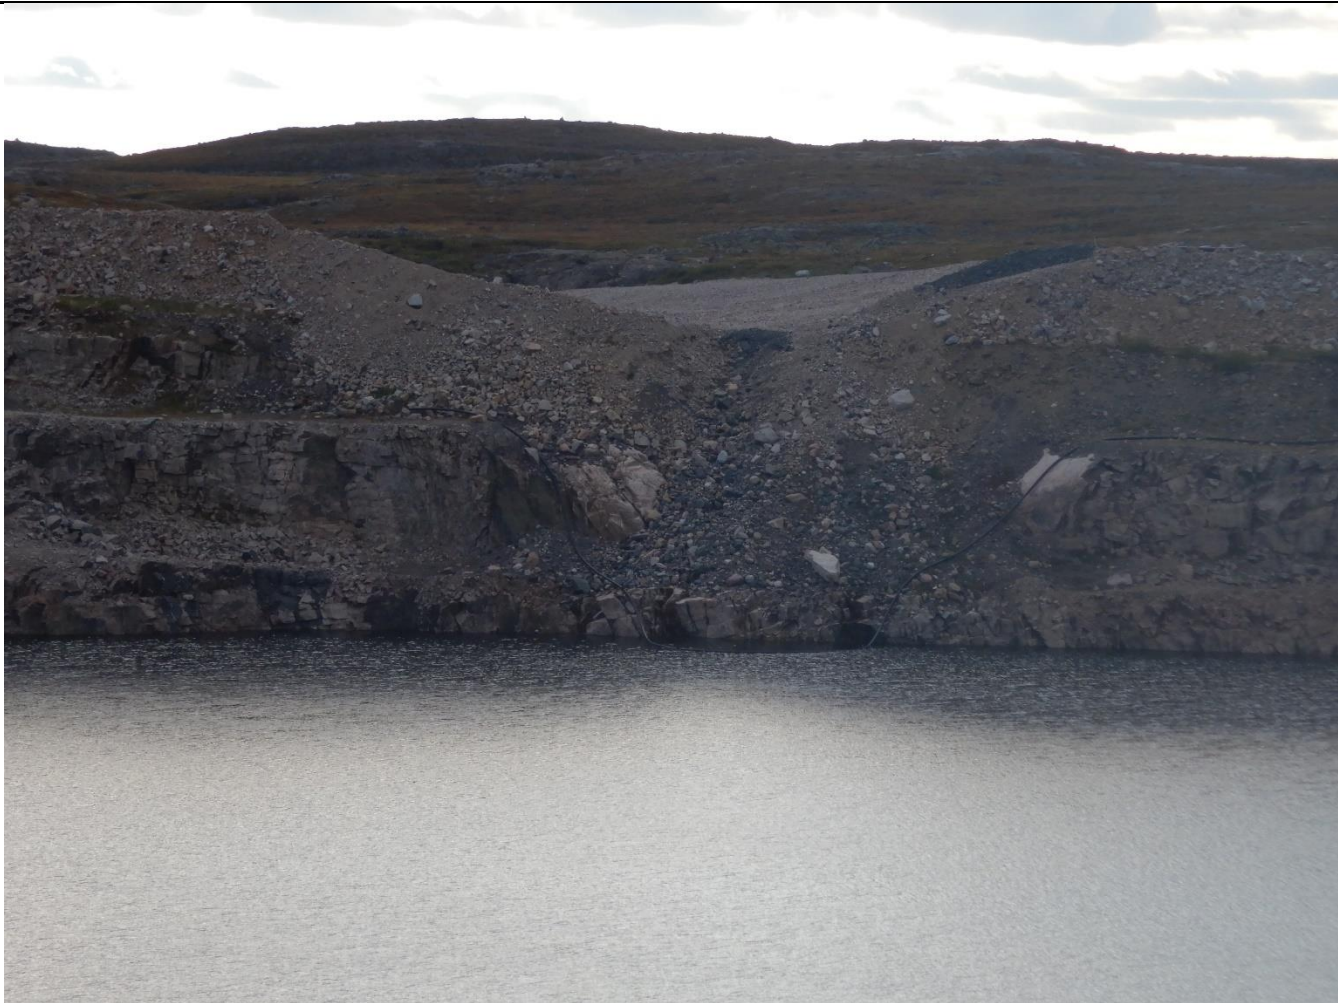
Photo 26

Description: View of Built Up In-Flow Area - flow will be going INTO Pit Lake – view from across Pit Lake on the South Eastern side

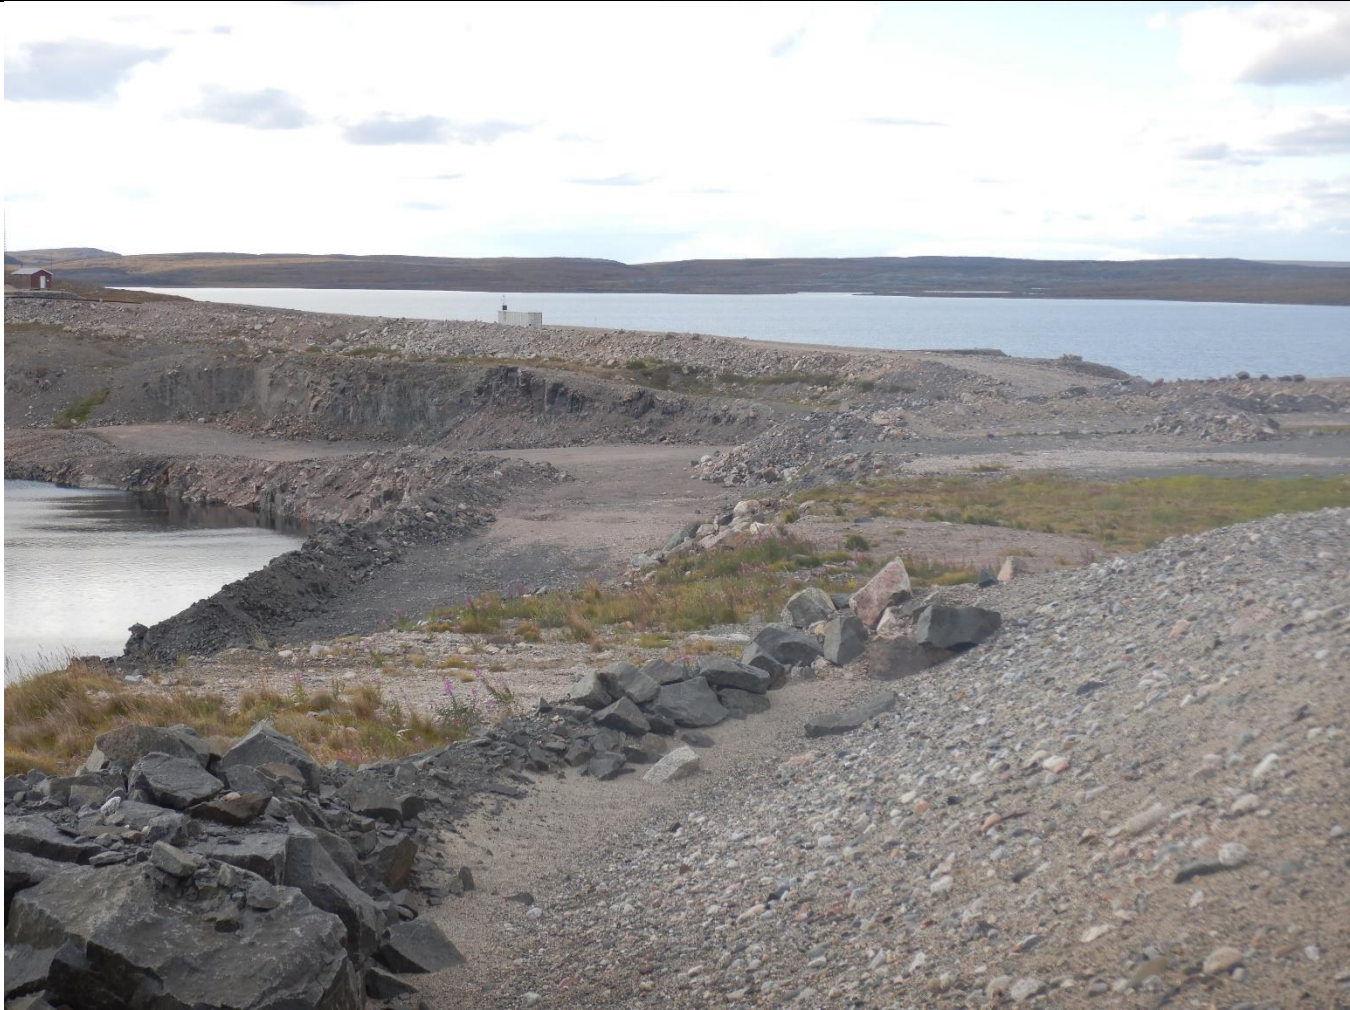
Photo 27

The Diversion to allow natural drainage OUT OF the Pit Lake and into Carat Lake is complete

Description: View of the built up Out-Flow Area of Pit Lake on the North Side as seen from the South-East Side

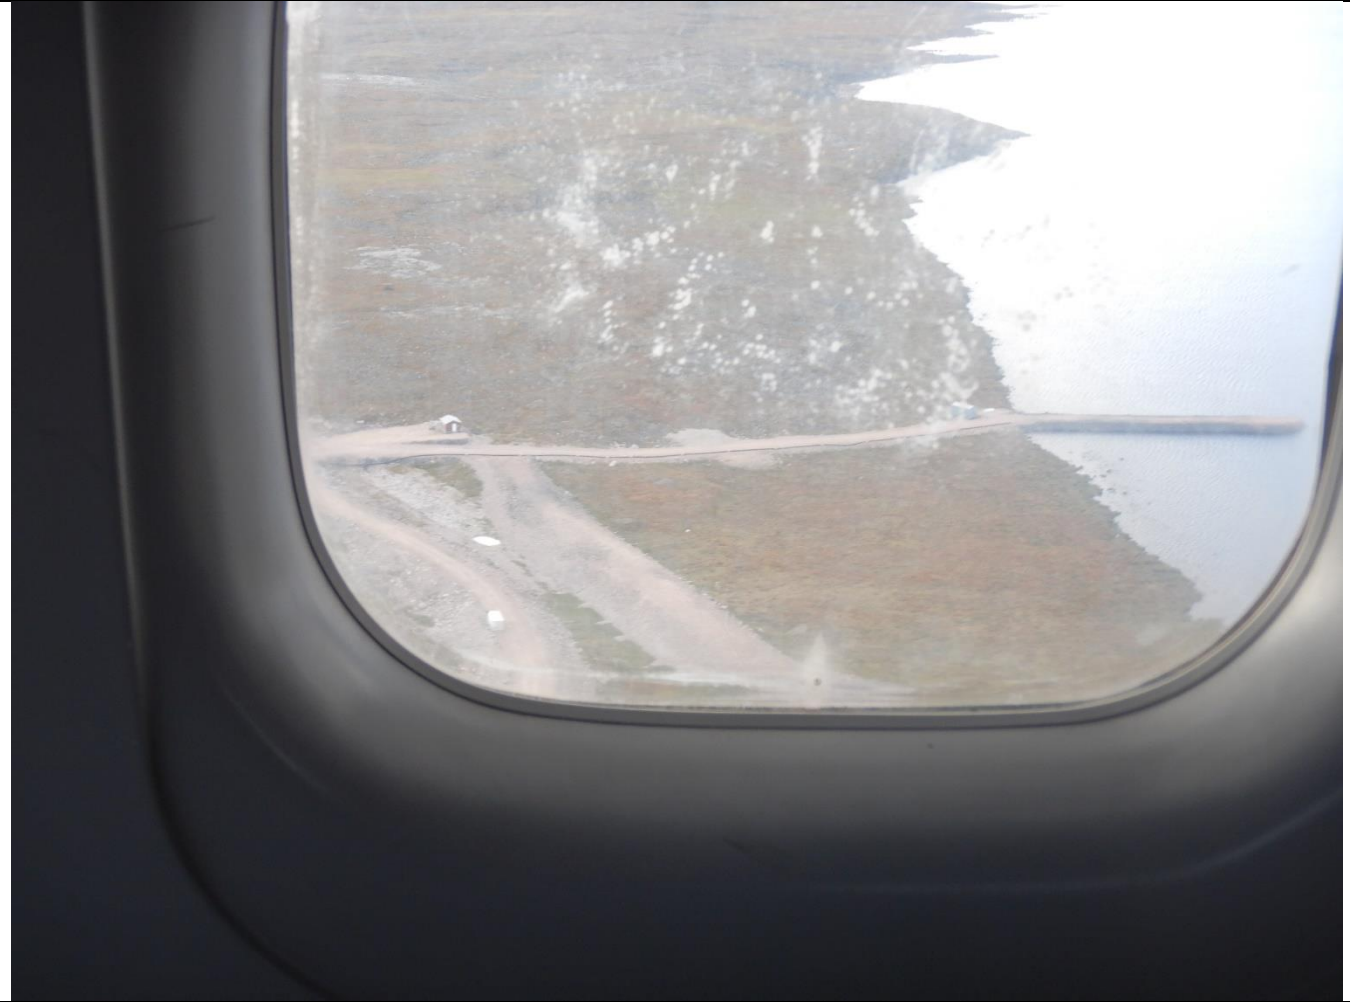
The Water Pump Shack has been moved off of the Jetty and up to higher ground as seen in Photo 28

Description: Aerial view of the Jetty as seen from the East Side looking West
