# **Tahera Diamond Corporation**

# CONSTRUCTION RECORD REPORT EAST AND SOUTHEAST DAMS JERICHO DIAMOND MINE, NU

October 2007

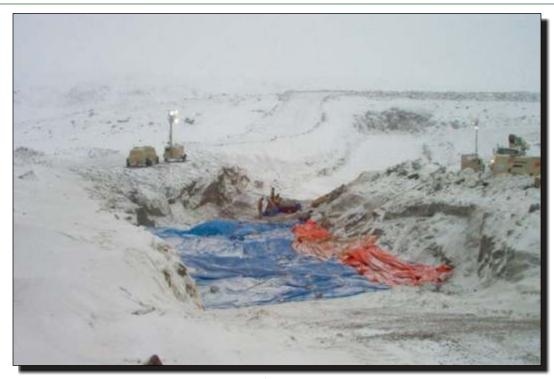
Clark Builders cleaned the base and walls of the key trench with compressed air hoses, hand tools and a skid steer loader. Nuna provided additional equipment support during cleaning of the key trench to remove waste material or snow. All loose frozen soil and bedrock in the key trench was removed from the dam footprint and cleaning was inspected and approved by EBA before fill placement was authorized. Sections of bedrock with ice on the surface were tarped and heated with indirect fired heaters to melt the ice. Levelling course material was placed immediately after the removal of the tarps. Key trench cleaning was ongoing until the levelling course was completed. Key trench cleaning is shown in Photos 4 through 6.

Photo 4
East Dam
Labour crew cleaning key trench with compressed air.
