RE: Mitigation Monitoring Program and 'As Constructed' drawings for Fresh Water Intake Causeway in Carat Lake

Report of Mitigation Monitoring Program and ‘As Constructed’ drawings for Fresh Water Intake Causeway in Carat Lake

FIGURE 1 PLAN VIEW
PHOTOGRAPHIC VANTAGE
POINTS

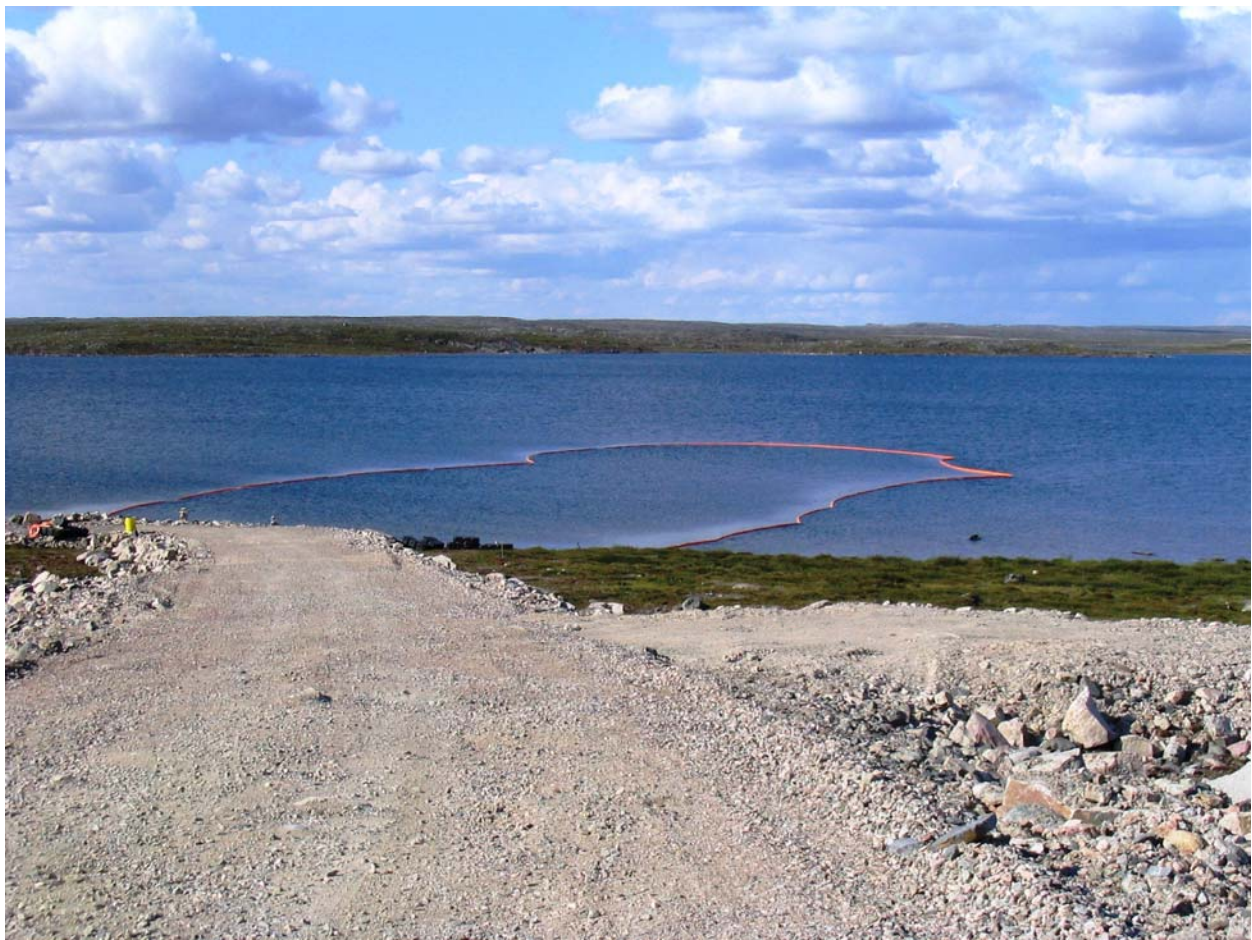
Prior to construction of the causeway in Carat Lake a sediment barrier was installed. The sediment barrier extended from the shoreline out around the construction area and tied back into the shoreline. Picture 1 shows the construction area with sediment barrier installed prior to construction commencing.

Picture 1: July 29, 2005 looking north from Carat Lake access road at sediment barrier around the construction area prior to construction

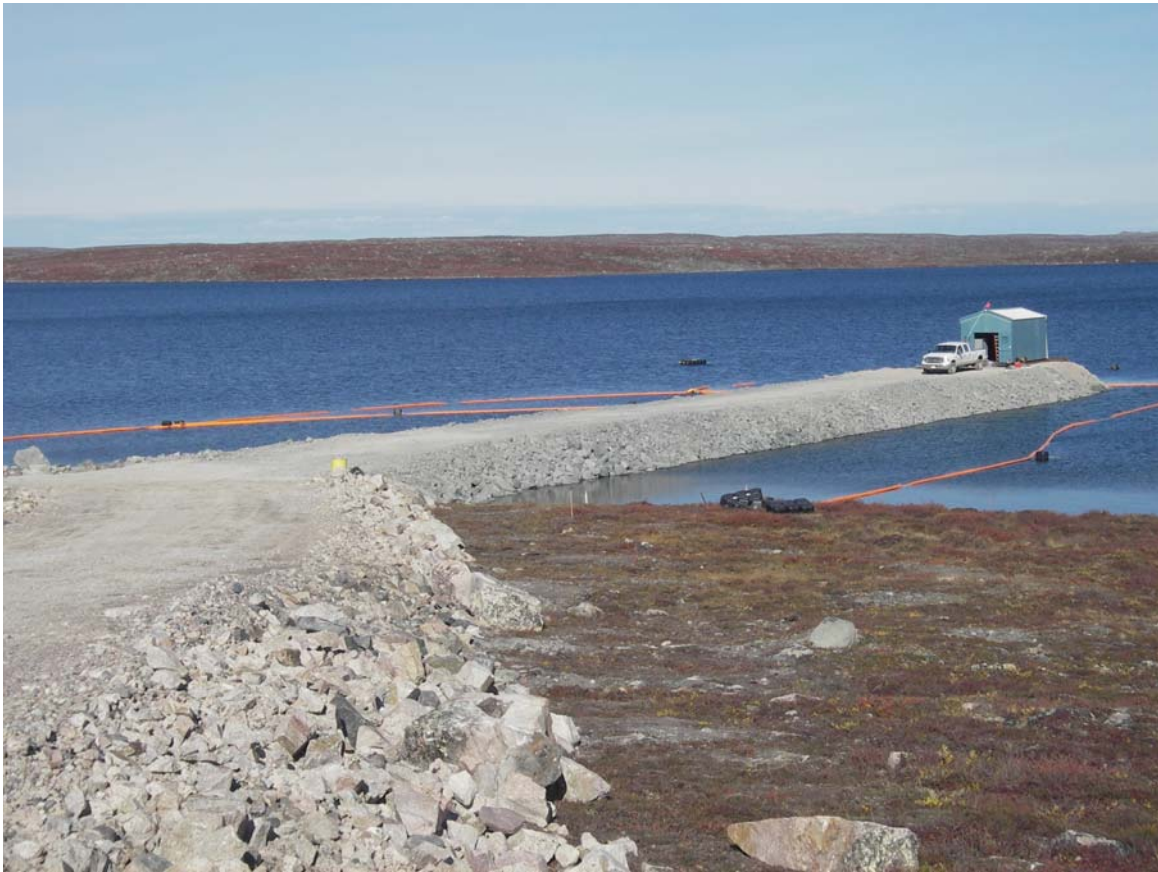
During a site inspection conducted by DFO on August 18, 2005 the top dressing on the Carat Causeway was identified as a potential source of sedimentation into Carat Lake. A layer of clean rock has been added as cover material to contain and prevent erosion of the fines into Carat Lake. The cap of rock extends over the shoulder and transitions into the run of mine. See Picture 2 and Picture 3.

Picture 2: September 6, 2005 looking north on Carat lake access road, causeway capped with clean diabase.

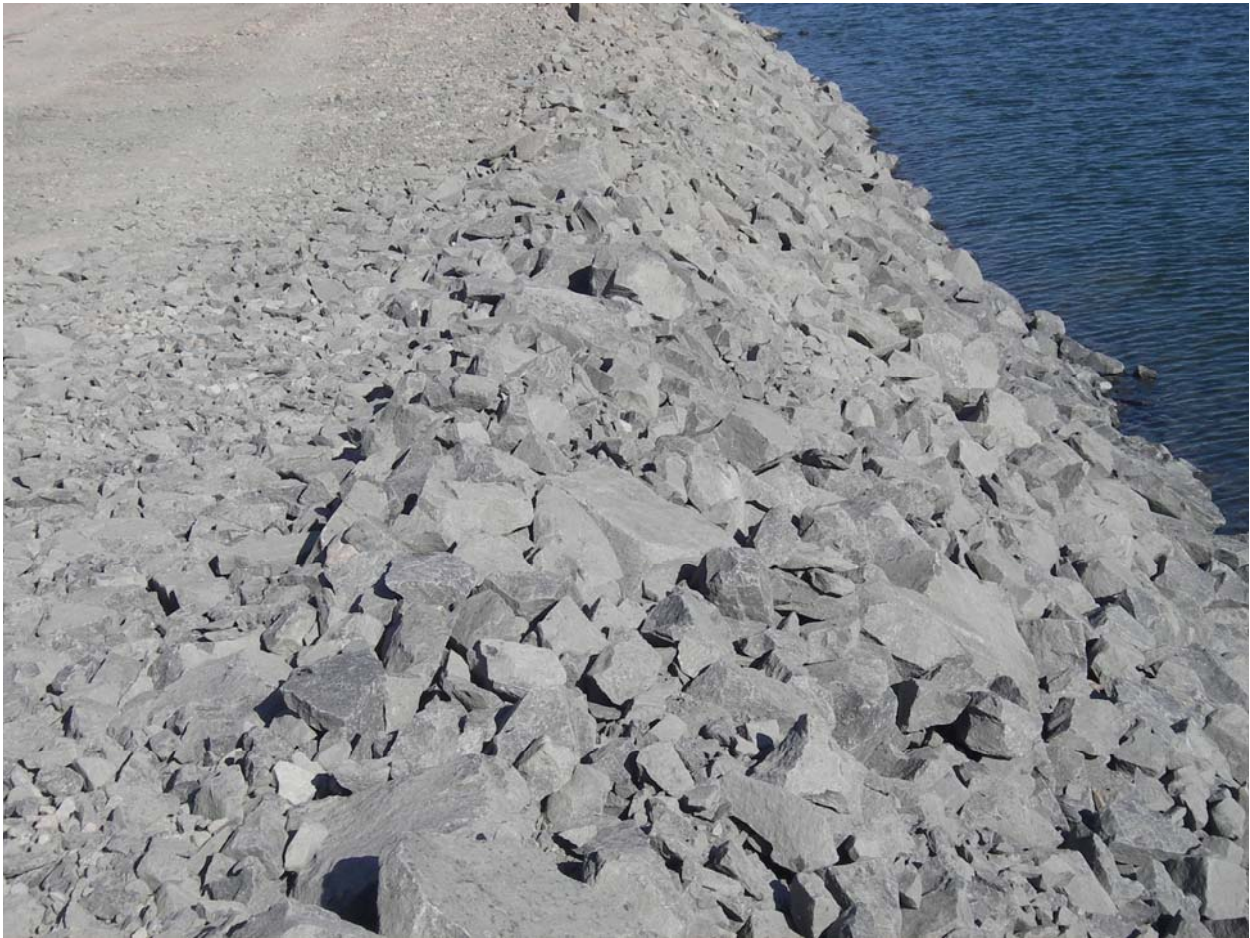
Picture 3: September 6, 2005 looking NE along eastern edge of the causeway, close-up of clean diabase cap material.

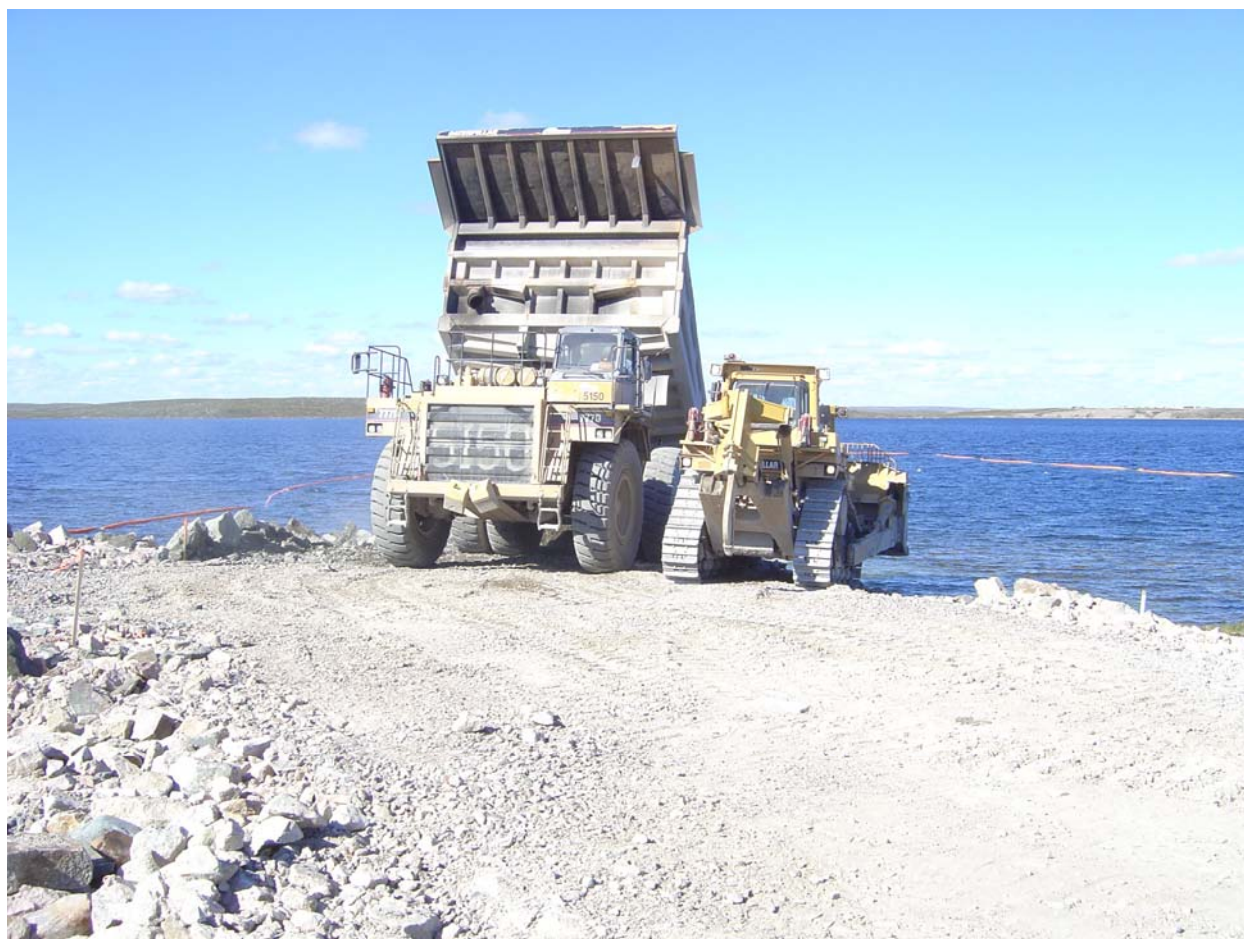
Picture 4: August 5, 2005 looking north from the end of Carat access road approximately 20m from Carat lake shoreline. The first load of material is being dumped.

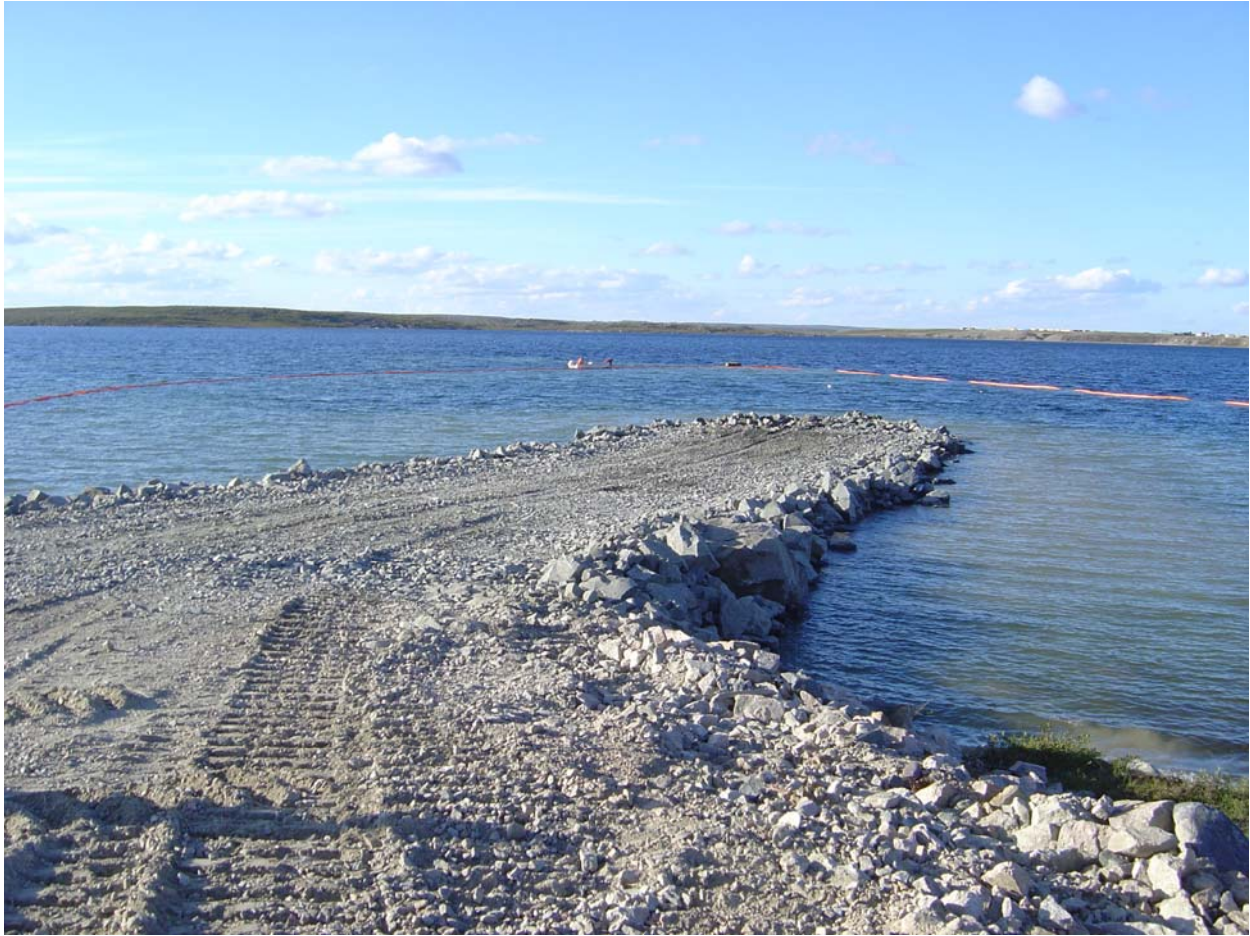
Construction of the causeway commenced on August 5, 2005 at 15:00, at 17:27 on August 5th, 2005 hauling was stopped when it was noticed that wind had caused the curtain anchors to drag pulling the curtain float below surface at the connections between curtain segments. Twenty three loads were hauled during this period and the causeway extended 46m from the shoreline into Carat Lake. Picture 4 shows the first load of material being dumped at the causeway construction site; rock was dumped onto the shoreline and then pushed using the D9 dozer. Picture 5 shows the extent of the causeway at the end of the day August 5, 2005.

Picture 5: August 5, 2005 end of the day looking north from the end of Carat access road approximately 20m from the Carat Lake shoreline, causeway extends 46m into Carat Lake.

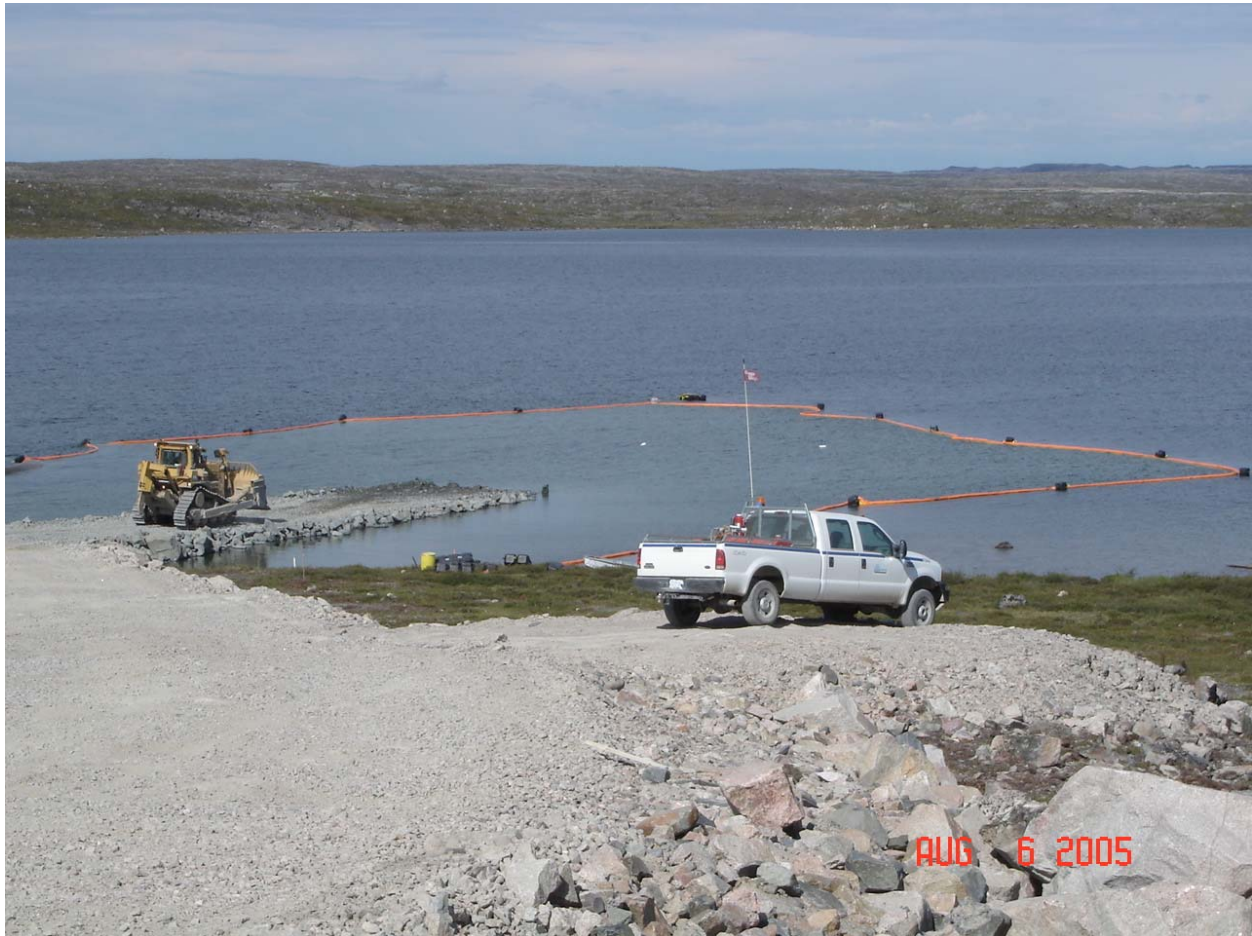
Mitigations were implemented to prevent the curtain from being pulled below surface at the connections between curtain segments. Floats were attached directly to the curtain and the floats were then anchored. Picture 6 shows the black floats attached at the connections between curtain segments.

Picture 6: August 6, 2005 looking north on the Carat access road, note the black floats attached to the curtain to prevent it from being pulled below surface.

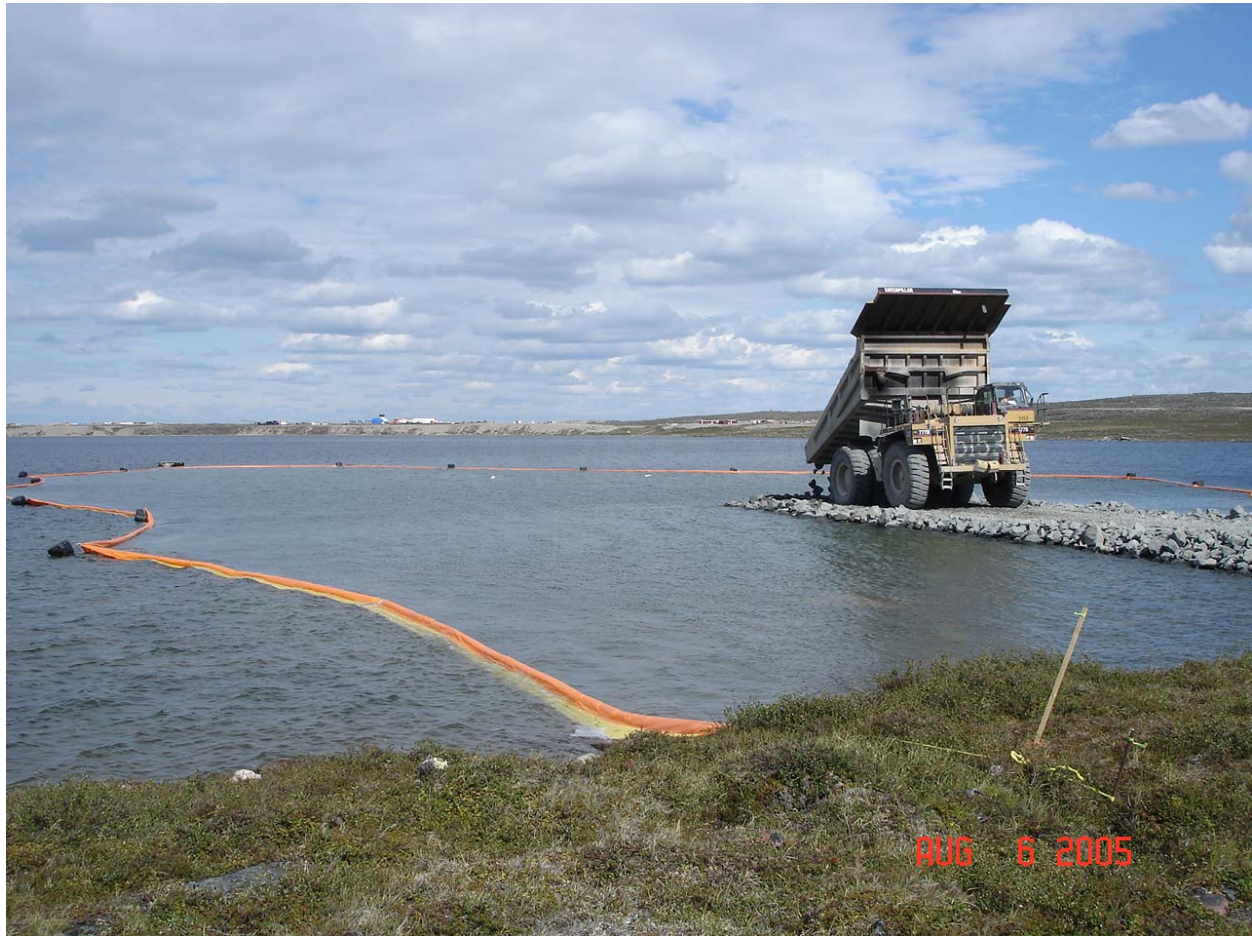
Construction commenced at 13:19 after mitigations (black floats) were implemented and was completed at 16:44. 47 loads were hauled on August 6, 2005. Inspections were conducted at 14:00 to 15:00, 16:40 to 17:30 and 18:30 to 19:30. Samples were collected at all 36 sample sites during the final inspection period of the day. Picture 7 was taken August 06, 2005, 1:24:20 PM, note the contrast of turbid water contained inside the curtain to the clear water outside.

Picture 7: August 6, 2005 looking north from Carat lake shoreline on the west edge of the silt curtain.

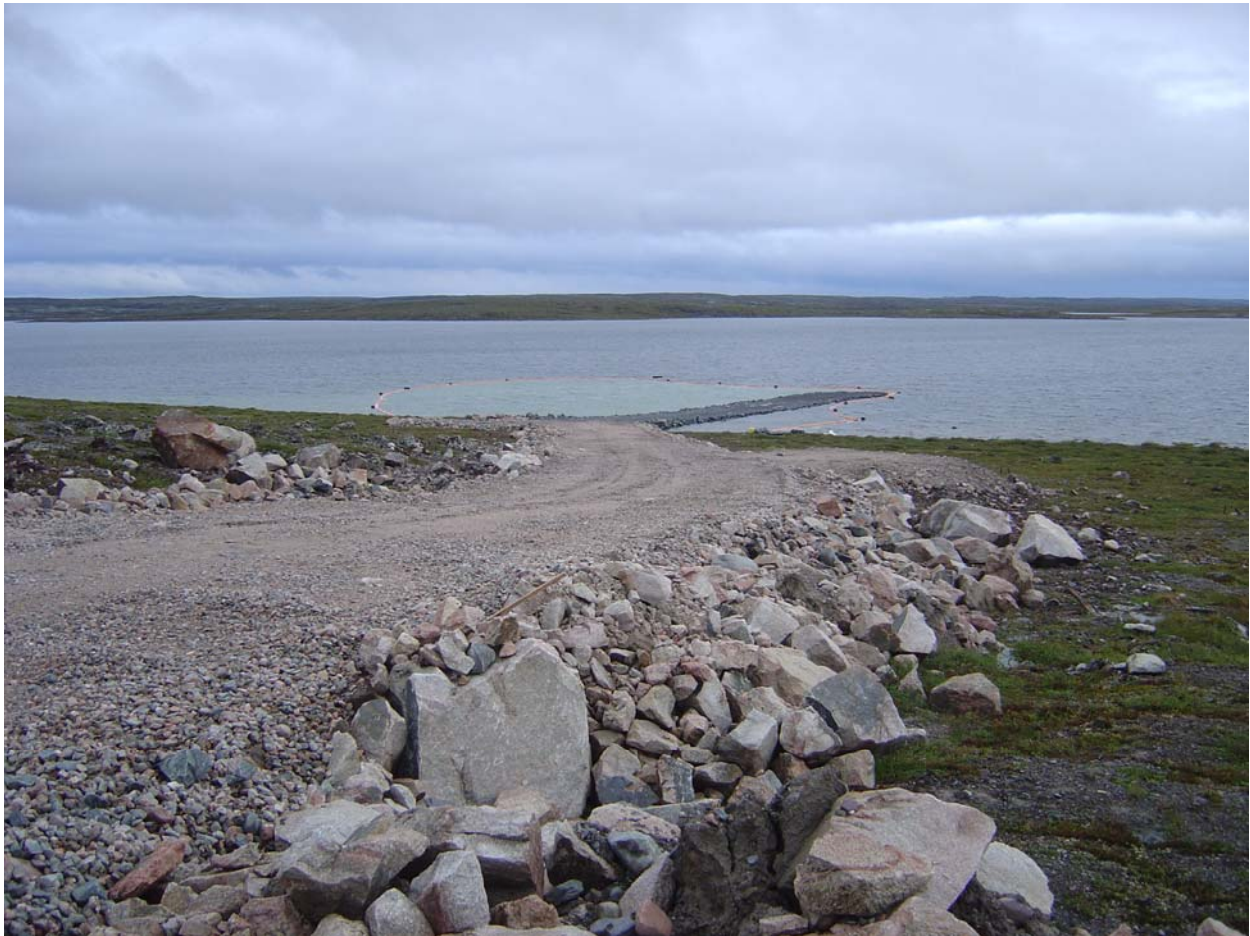
Prior to construction on August 7th, 2005 floats were readjusted to prevent escape of any suspended sediment. Construction commenced at 09:00 and was completed at 17:00, 34 loads were hauled to the jetty. Inspections were conducted at 10:00 to 10:30, 12:30 to 13:00, 14:30 to 14:45, and 18:30 to 18:50. Wind speeds were increasing throughout the day eventually reaching speeds gusting to 50 km/h. The high winds caused the sediment curtain anchors to drag; the curtain piled up against east side of causeway and ballooned out to the west. Sediment continued to be contained within the curtain. Picture 8 shows the curtain piled up on east side of causeway and ballooning out to the west. Containment of sediments inside the sediment curtain can be observed.

Picture 8: August 8, 2005 looking north along Carat lake access road. The effects of the high winds can be observed with the curtain ballooned out to the west side of the causeway.

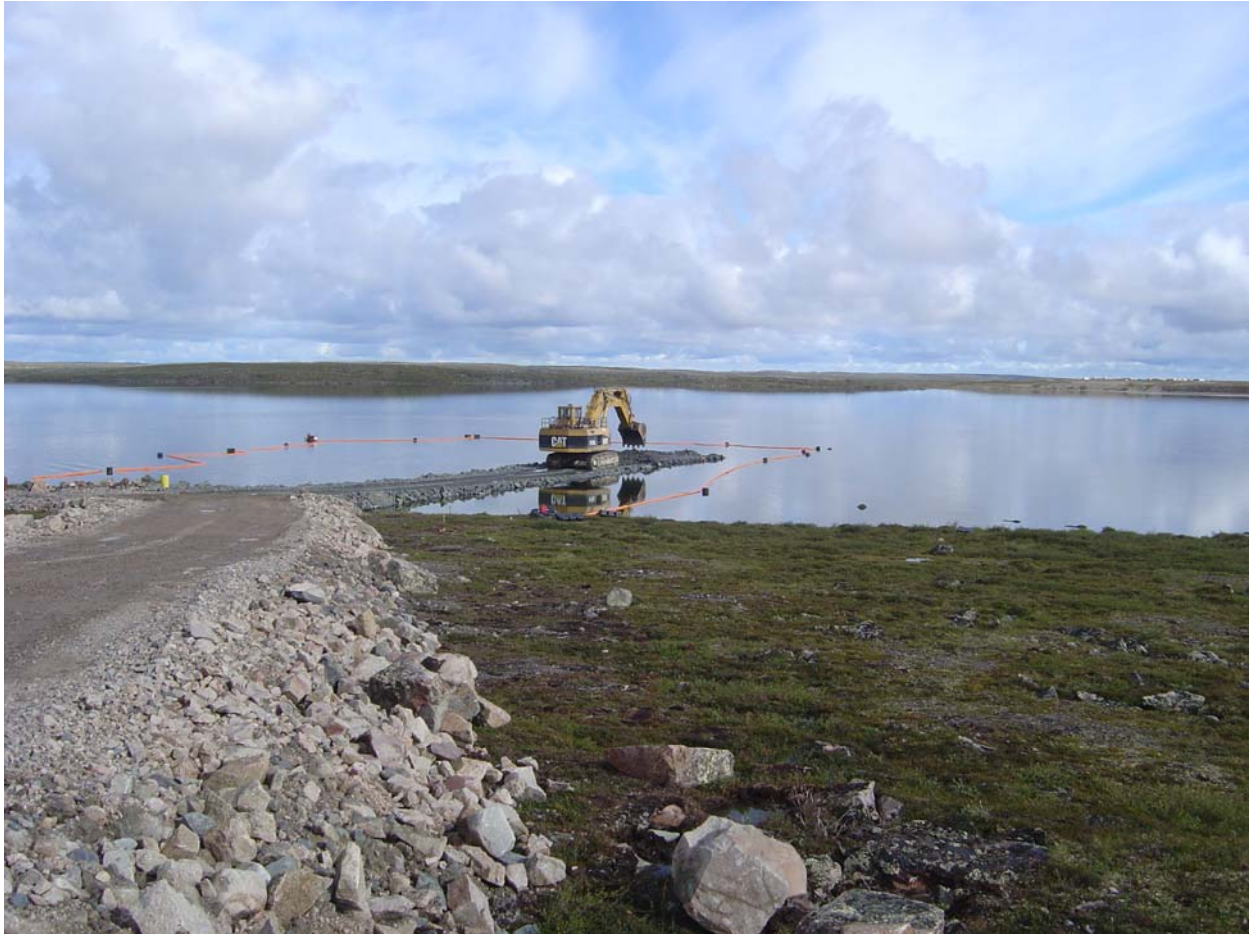
There was no construction on August 8, 2005. The focus of activities was repositioning of silt curtain after movement from high winds to ensure containment around the end of the jetty during the intake pipe installation. Samples were collected from the 36 sampling locations. Picture 9 was taken after the repositioning of the sediment curtain.

Picture 9: August 9, 2005 looking north along Carat lake access road. The sediment curtain has been repositioned to allow containment around the intake pipe during installation.

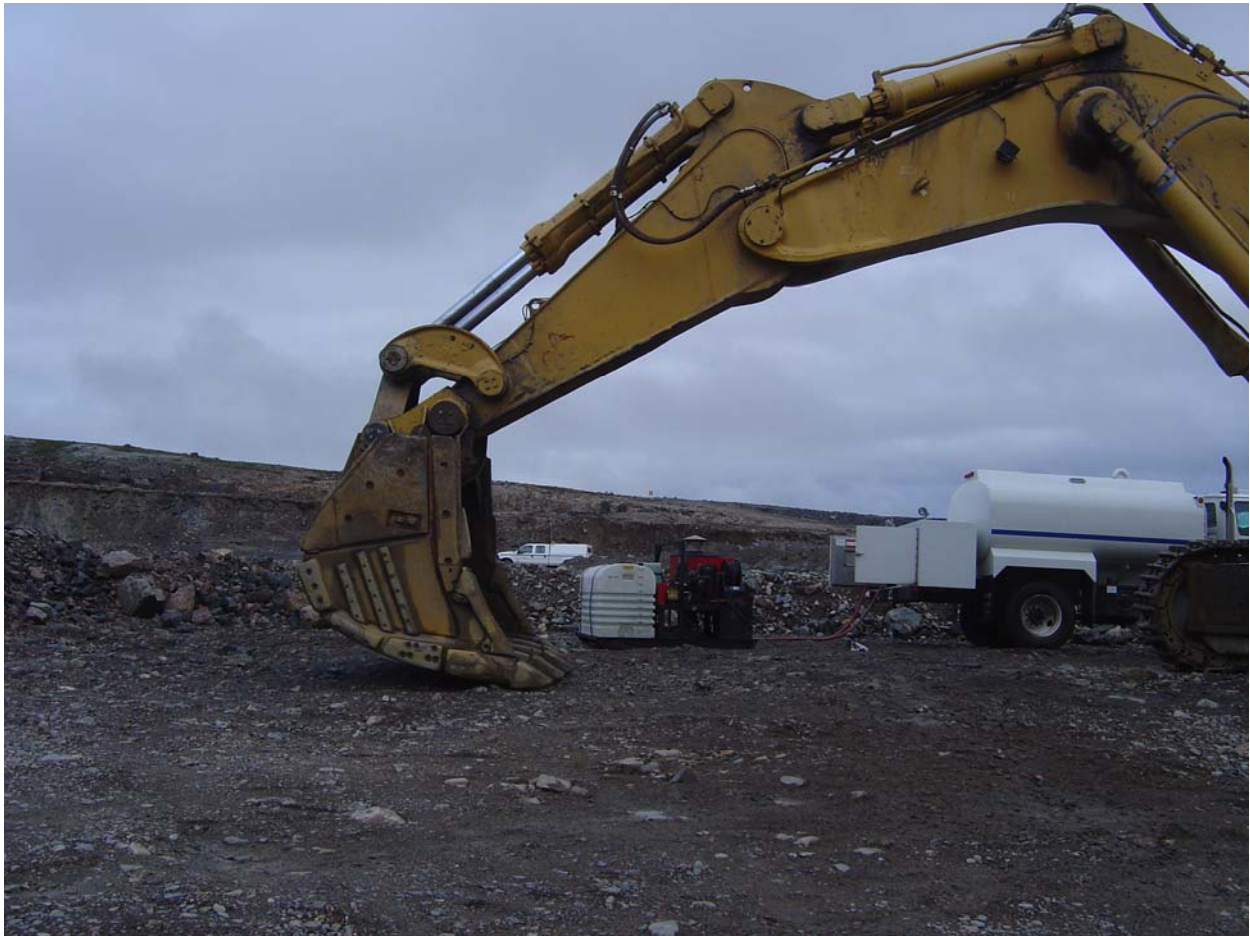
In addition to work conducted on the curtain the boom of the excavator to be used for the intake pipe installation was steamed to remove any grease. Picture 10 and Picture 11 show the cleaned boom of the 5130 excavator.

Picture 10: August 8, 2005 cleaned boom of the 5130 excavator.

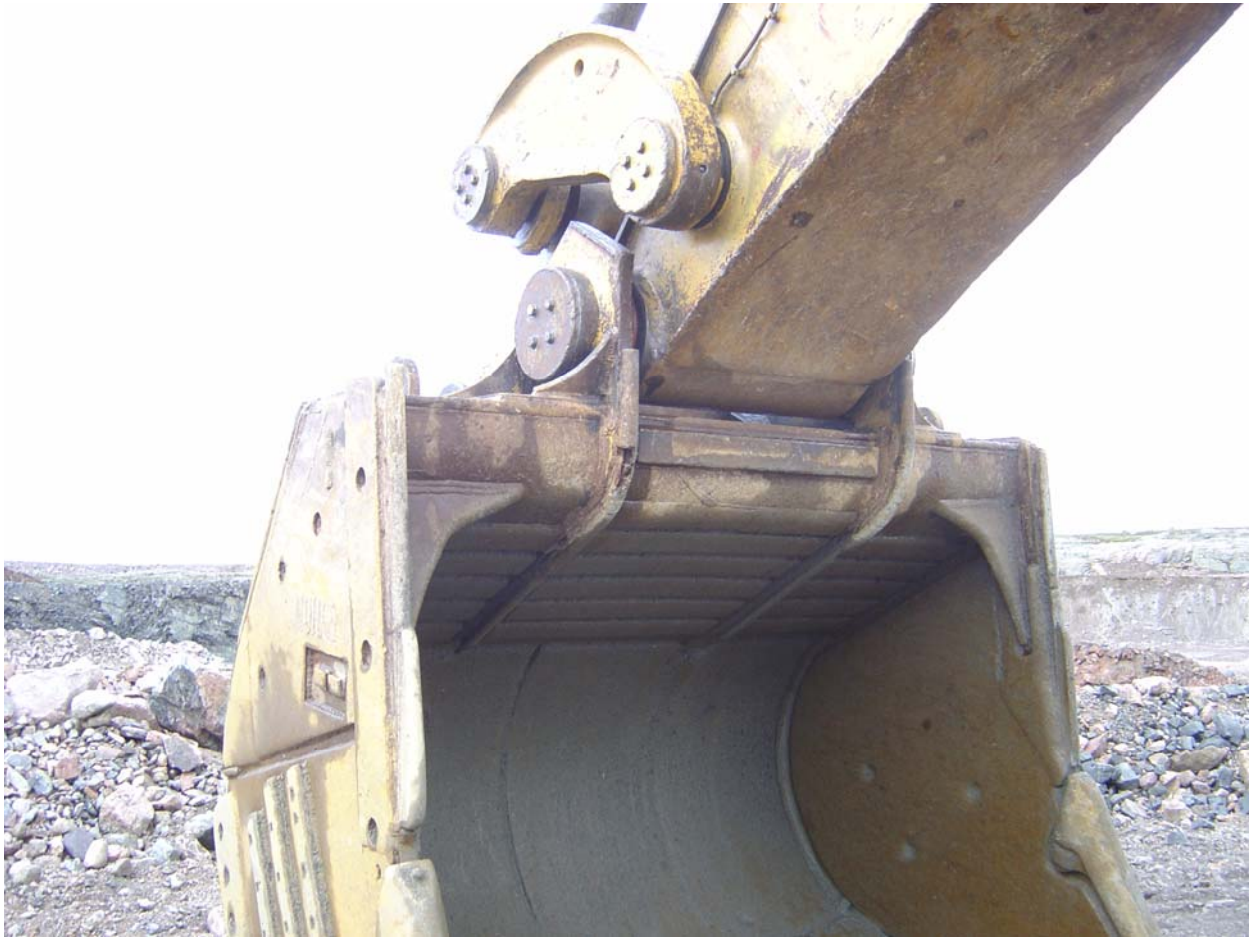
Picture 11: August 8, 2005 cleaned boom of the 5130 excavator.

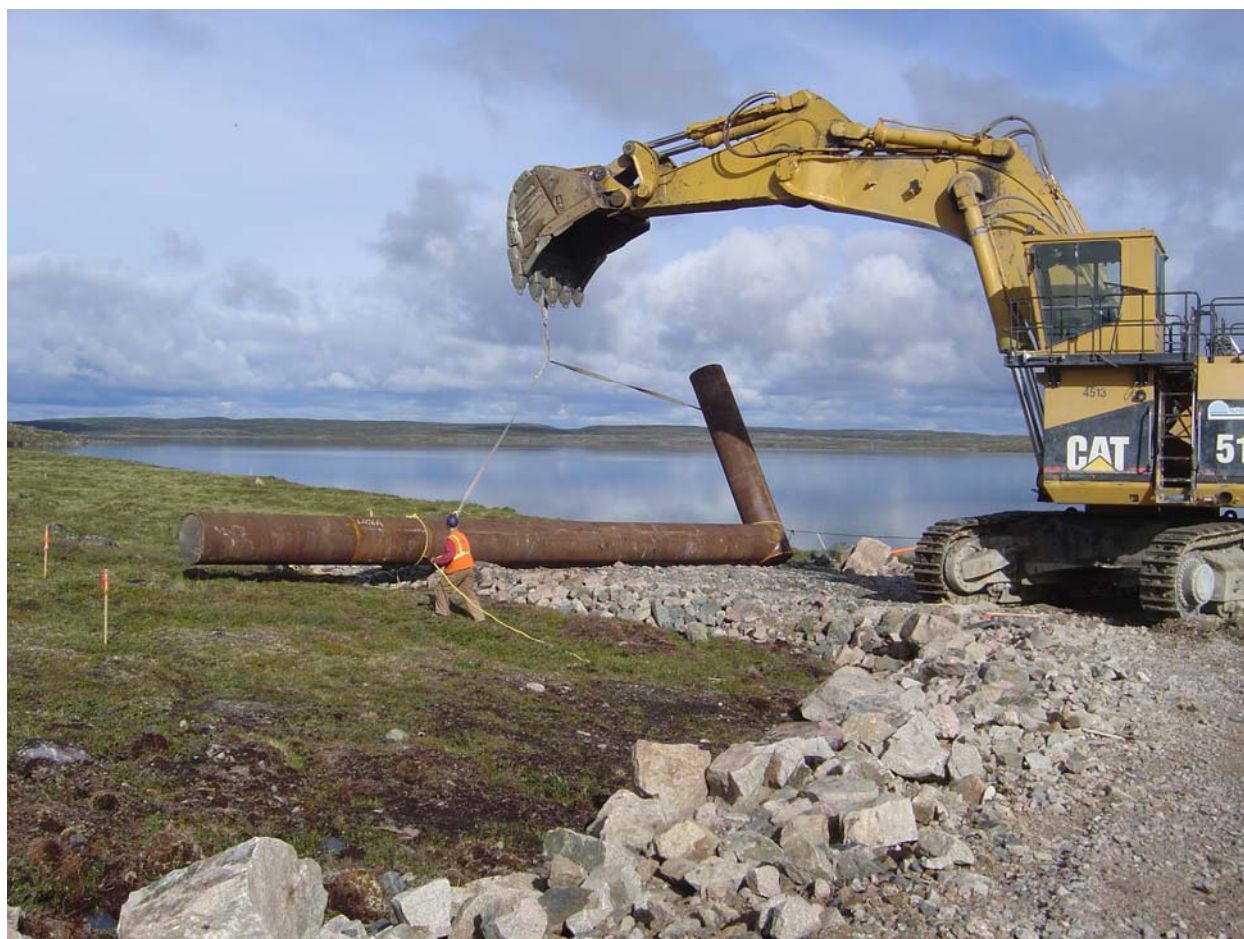
Construction activities on August 9, 2005 focused on installation of the intake pipe. Construction started at 11:57 and was completed at 16:26. Activities included seating of the intake pipe followed by 9 loads of run of mine to cover and secure the intake pipe within the causeway. Picture 12 shows the intake pipe being lifted for placement in the causeway. Picture 13 shows the intake pipe after placement in the causeway. Samples were collected at all 36 stations on August 9, 2005.

Picture 12: August 9, 2005 looking NW at the end of the Carat causeway access road. The 345 excavator is lifting the intake pipe for placement in the causeway.

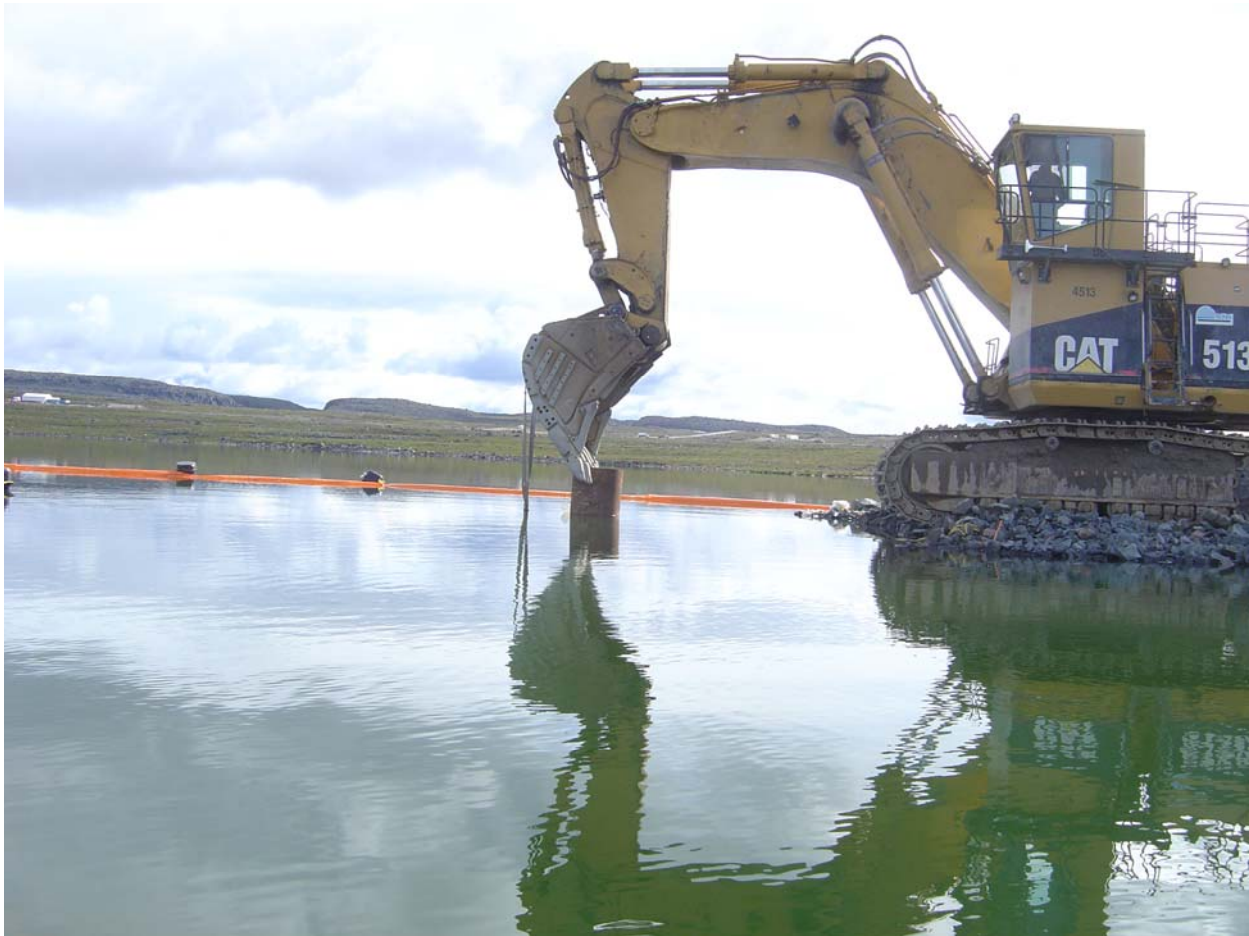
Picture 13: August 9, 2005 looking east from a boat 5130 excavator has placed intake pipe into causeway.

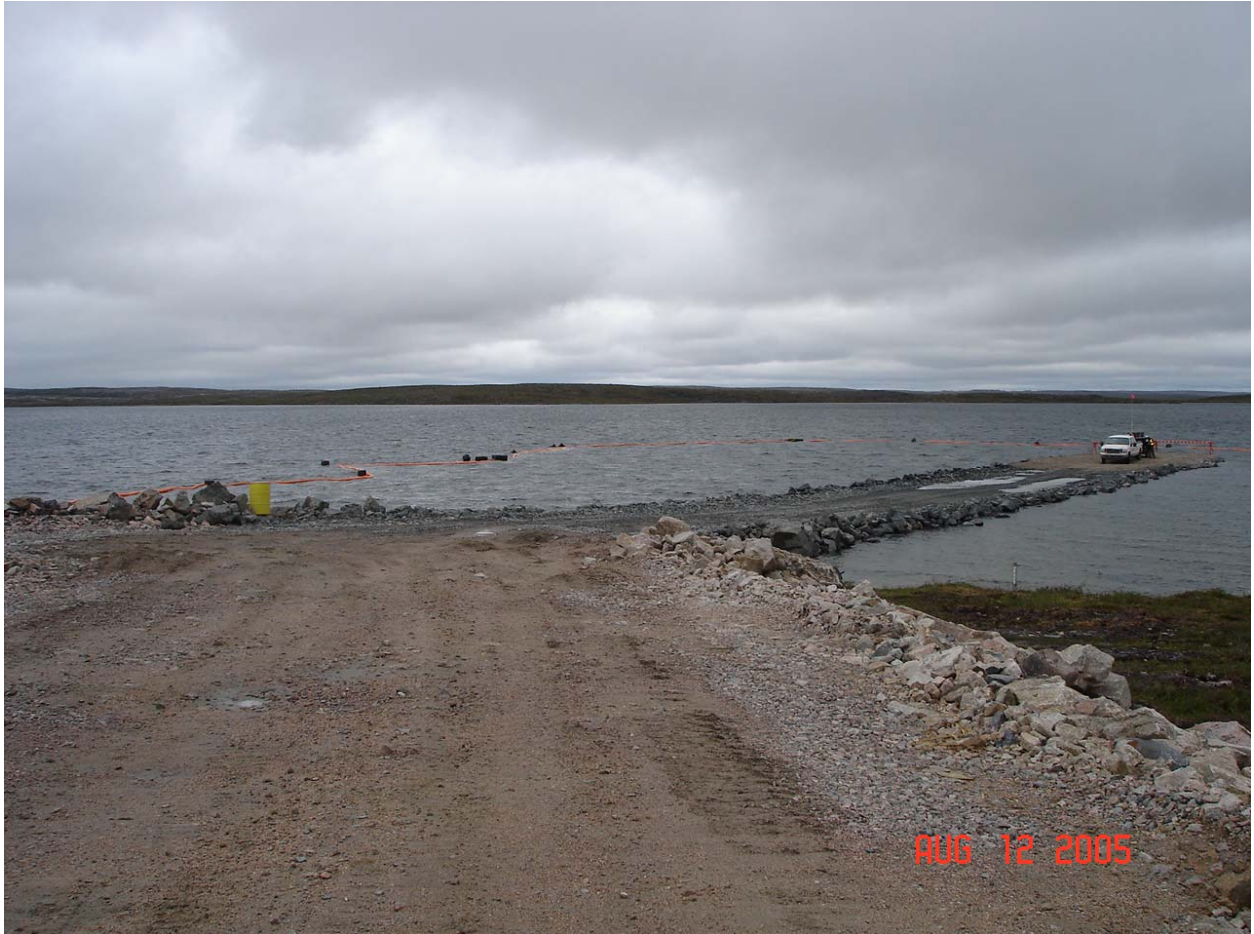
There was no construction activity conducted on August 12, 2005. Clark Builders welders worked on preparing the vertical section of the intake pipe for attachment to the pump house. Samples were collected to monitor turbidity levels. Inspections were conducted from 17:00 to 18:00. Picture 14 shows the extent of the causeway prior to application of the second lift of material to bring the causeway to final grade.

Picture 14: August 12, 2005 looking north from the causeway access road. Welder working on intake pipe.

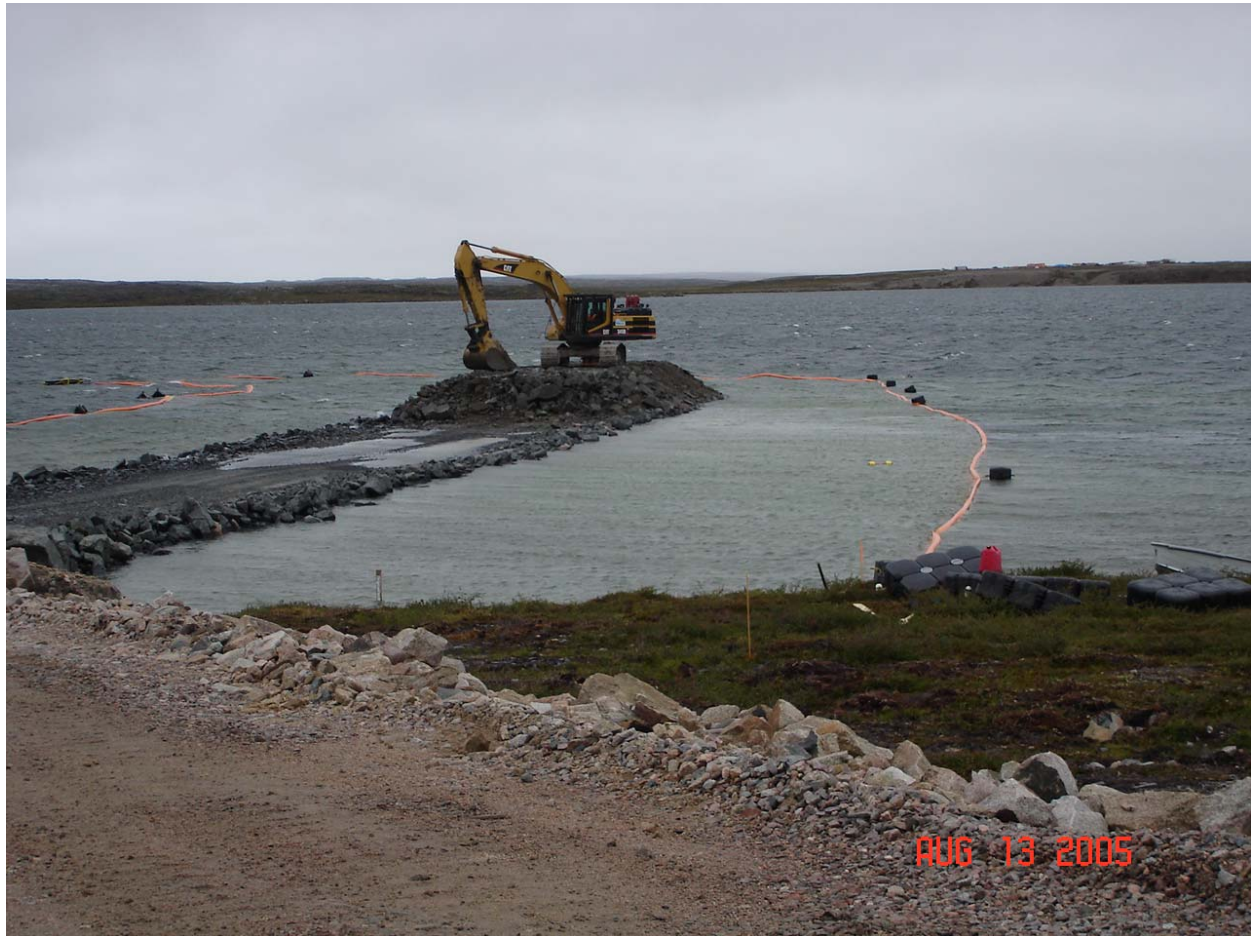
Application of the second lift of run of mine as well as capping with 2" crush to provide a road surface commenced on August 13. Construction activities occurred for the entire day. 26 loads of material were placed on the causeway. Inspections were conducted from 11:00 to 12:00. Wind speed increased throughout the day with gusts up to 70 km/h. The high wind speeds prevented collection of samples. Picture 15 shows the 345 excavator placing run of mine material on the causeway.

Picture 15: August 13, 2005 looking north from the causeway access road approximately 50m from Carat shoreline. The 345 works at placing the second lift of run of mine on the causeway.

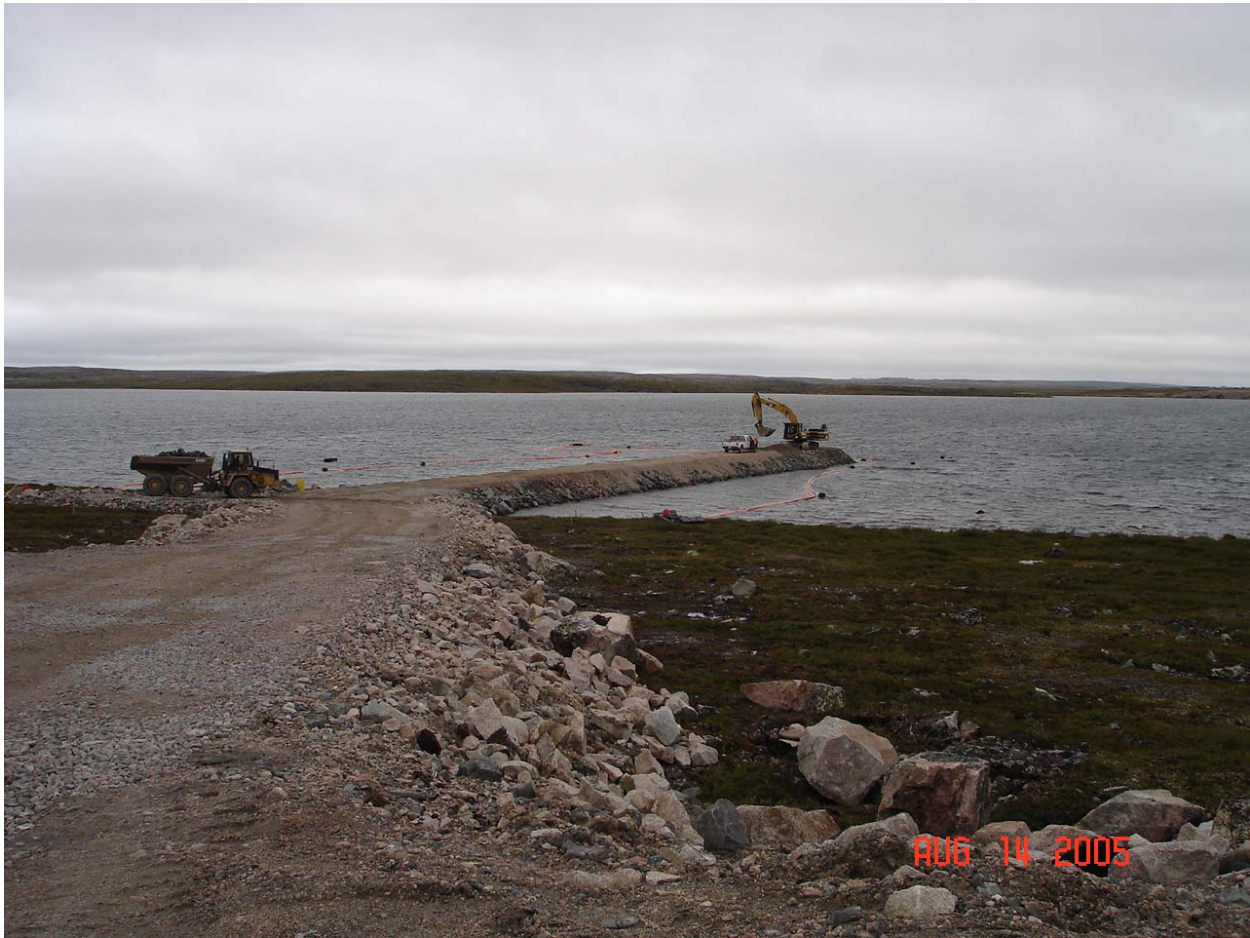
Construction activities occurred from 7:00 to 12:00 and consisted of the completion of the application of the 2" crush material to complete the road surface suitable for vehicle access. Winds from the previous day resulted in the sediment curtain being pushed up against the eastern and northern edges of the causeway. Movement of the curtain did not effect containment of sediments. Inspections were conducted from 10:00 to 11:30. Only 23 samples were collected as a result of windy conditions making sampling from the boat dangerous. Picture 16 shows the 345 working at placing the 2" crush on the causeway.

Picture 16: August 14, 2005 looking north down the causeway access road. The 345 works at placing 2" crush on the surface of the causeway.

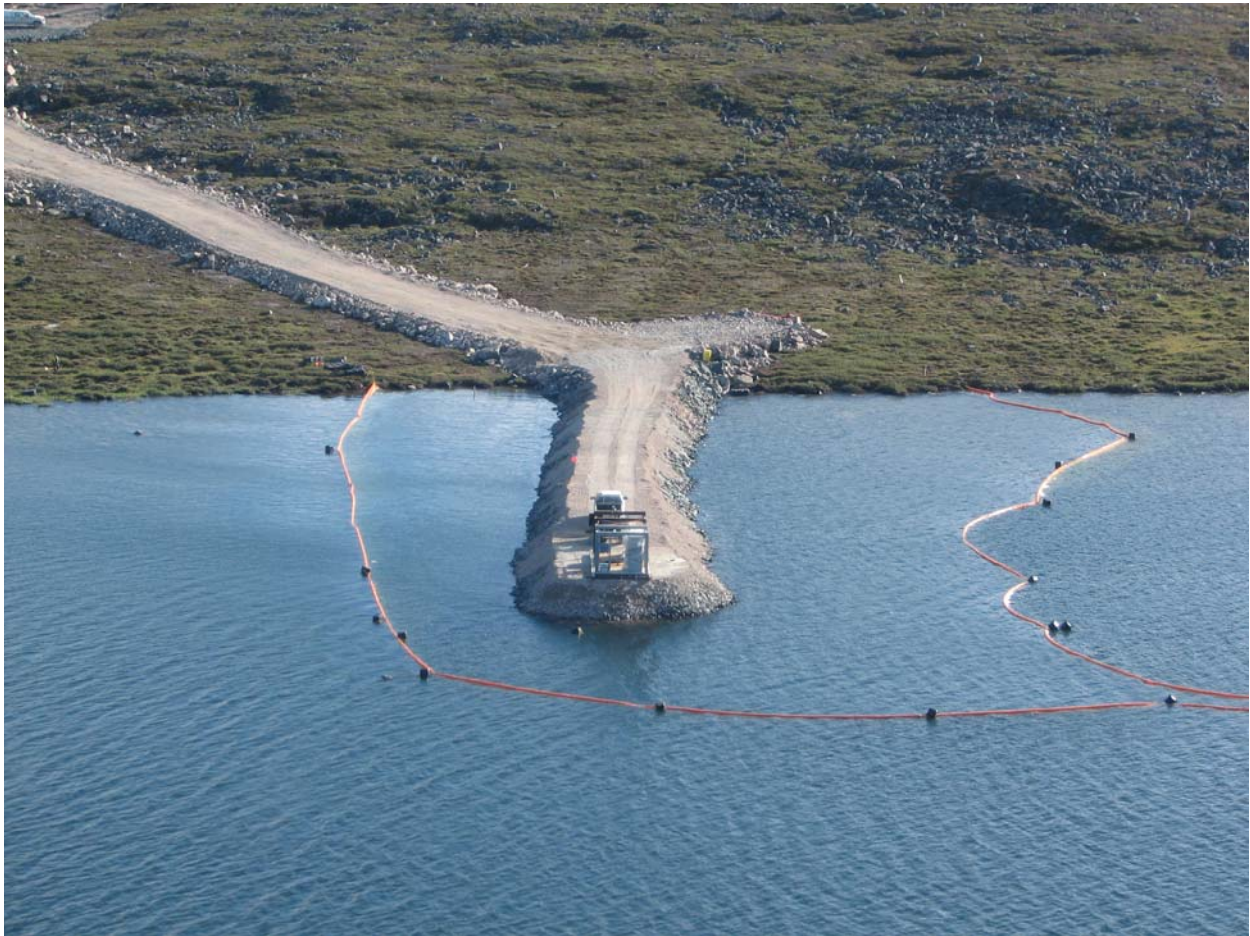
The pump house was transported to the causeway and placed over the intake pipe. There was no placement of construction fill conducted. Samples were collected and adjustments made to the floats on the sediment curtain. Picture 17 is an aerial picture of the causeway looking towards the south from above Carat Lake. The unclad pump house is visible positioned at the end of the causeway.

Picture 17: August 15, 2005 aerial photo looking south from above Carat Lake. The pump house is in position at the end of the causeway.
