RE: Mitigation Monitoring Program and 'As Constructed' drawings for Fresh Water Intake Causeway in Carat Lake

Report of Mitigation Monitoring Program and ‘As Constructed’ drawings for Fresh Water Intake Causeway in Carat Lake

FIGURE 1 PLAN VIEW
PHOTOGRAPHIC VANTAGE
POINTS

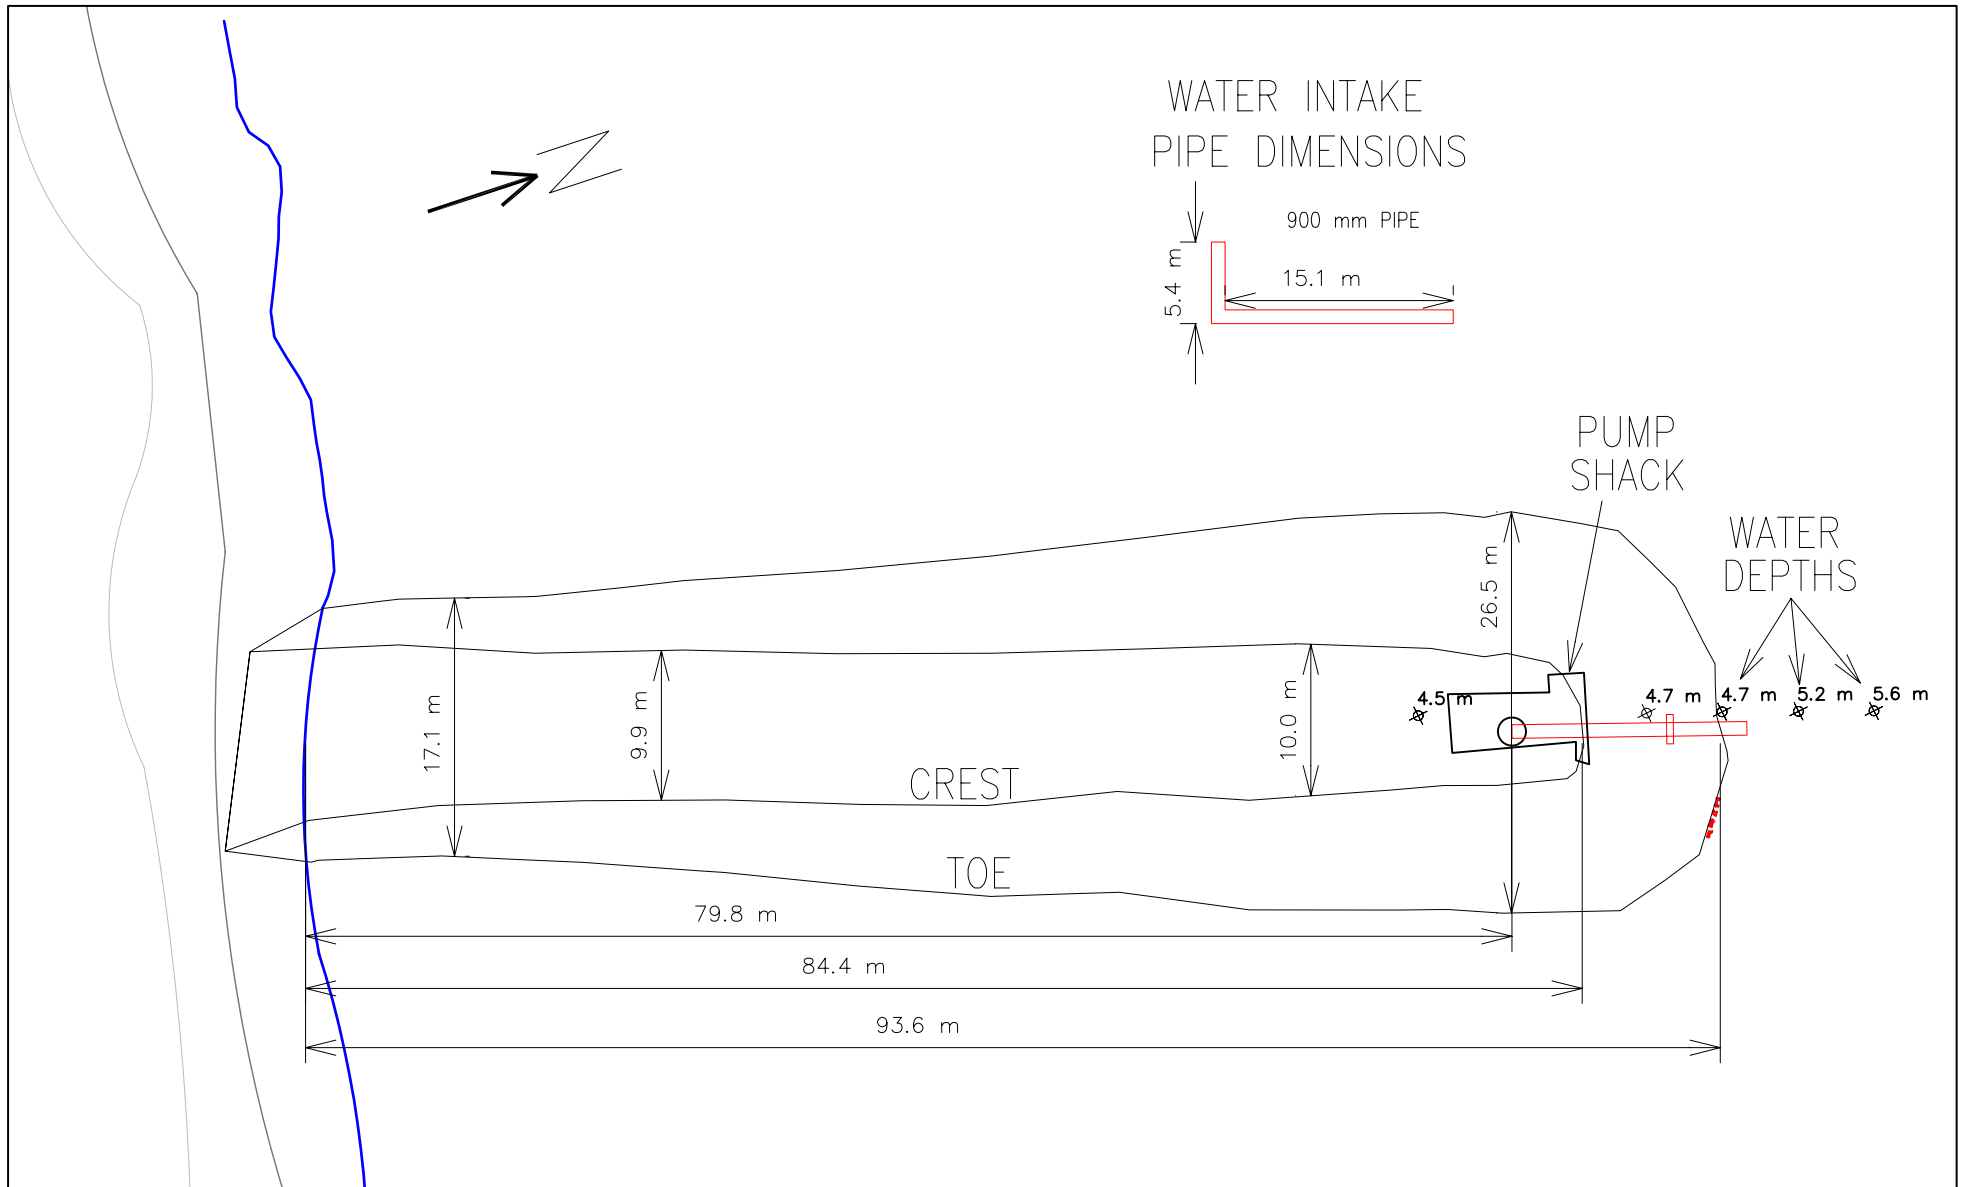
Figure 2: Causeway as
constructed drawings

- The length of the causeway was shortened to 93.6m which corresponded to the minimum length possible to insure that the intake pipe would be 0.5m off the lake bottom as well as being 2m below the design bottom of the maximum ice thickness.
- The widened area surrounding the pump house was eliminated
- The causeway width was constructed to provide a minimum 5 m maintenance roadway surface plus room for a pipeline and power cable as well as suitable safety barriers.

Causeway footprint 2021 m².
