RE: Follow up for spill #12-148 reported April 26th, 2012

Summary

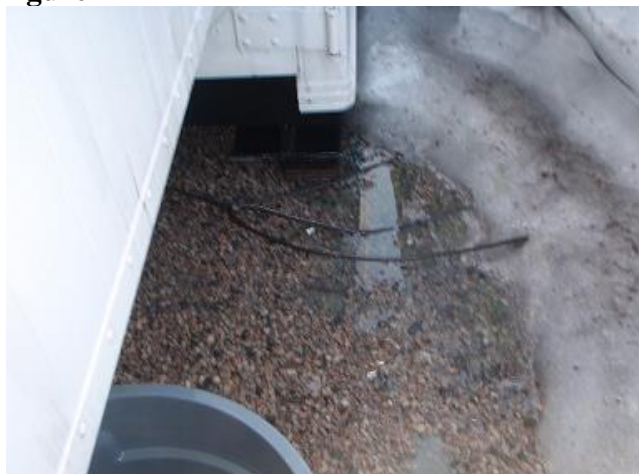
Figure 1

On April 25th, 2012 at approximately 4:30 AM it was discovered that a fuel tank located within the powerhouse, generator #3, was left to fill overnight. The tank overflowed into the powerhouse and eventually leaked out onto the ground beneath the powerhouse. At the time it was estimated that there was about 400L that spilled out of the powerhouse. This estimate was based on fuel dips that were taken around that date and comparing to normal fuel usage. The spill was reported to the Site manager and personnel were able to recover 100L of diesel that had pooled on the ground (Figure 1) by bailing it into a drum. The rest of the diesel on the ground was cleaned up by using absorbent pads.

The spill coordinates are N 65 59'26.7" W 111 29'56.9", approximately 550m northeast of Ash Lake and 1.4Km south of Carat Lake. The area of the spill was approximately 10 square meters. The indoor tank was being filled from tank EC-000158282. Once the spill was cleaned up the diesel that was collected was brought into the truck shop to fuel a waste oil burner.

An investigation into the cause of this spill has determined that it was due to human error. Fuel handling procedures are being reviewed with all applicable staff and everyone is taking part in a refresher on spill reporting and clean up procedures.

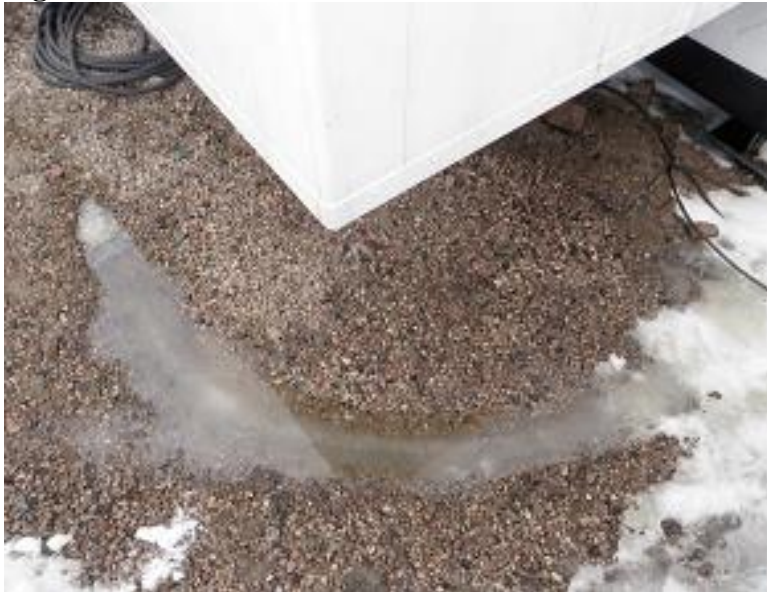
Figure 2

The spill was contained following the Diesel Spill Response Procedure outlined in Appendix A of our Contingency Management Plan. As soon as the spill was discovered the pump was turned off. A shallow trench was dug around the area to collect any contaminated runoff (Figure 2).

The trench that was dug around the area will have to be monitored and emptied whenever water pools up to minimize the spread of diesel to the surrounding area. Approximately 40L of diesel contaminated water has been removed from the trench and put in a drum for storage until it can be treated with the Oztek remediation unit. Contaminated dirt located beneath the generator is inaccessible due to buried cables and foundation issues of the building. Therefore the area beneath the building has been declared a contaminated site that will require on-going monitoring until such time as the area can be reclaimed upon mine closure.
