2AM-JER1119
Compliance Plan
September 30, 2012

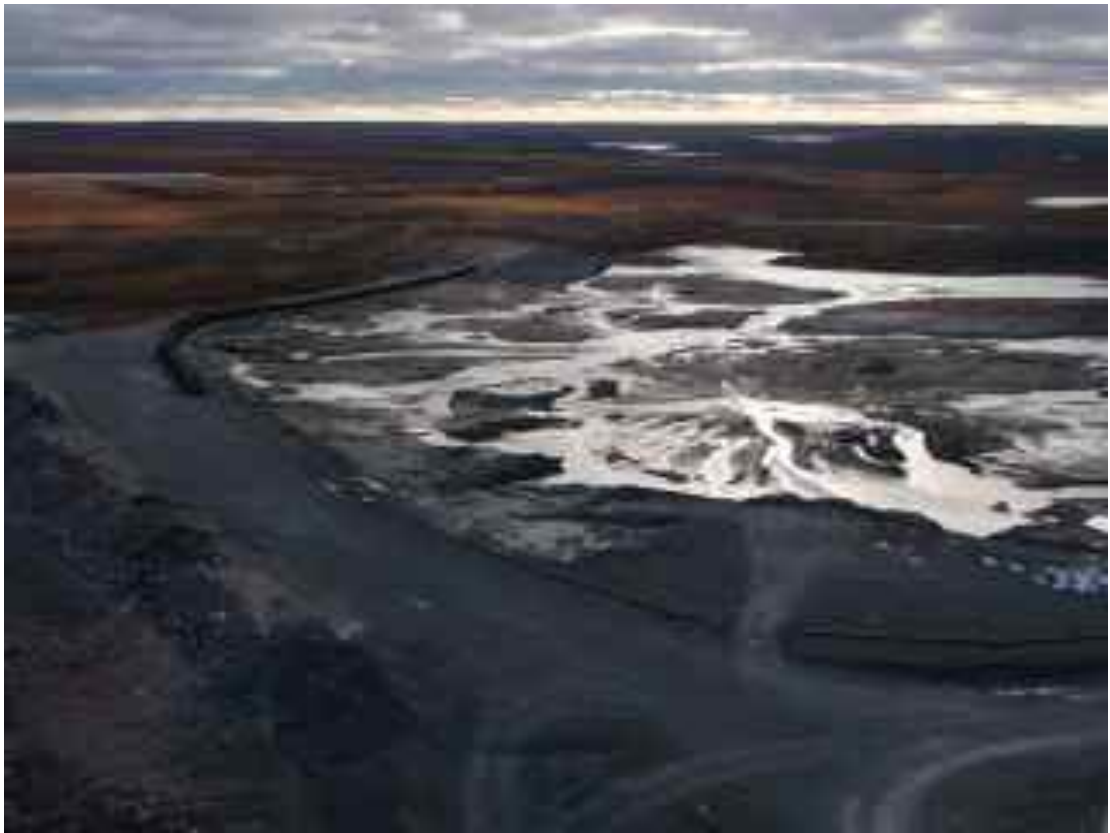
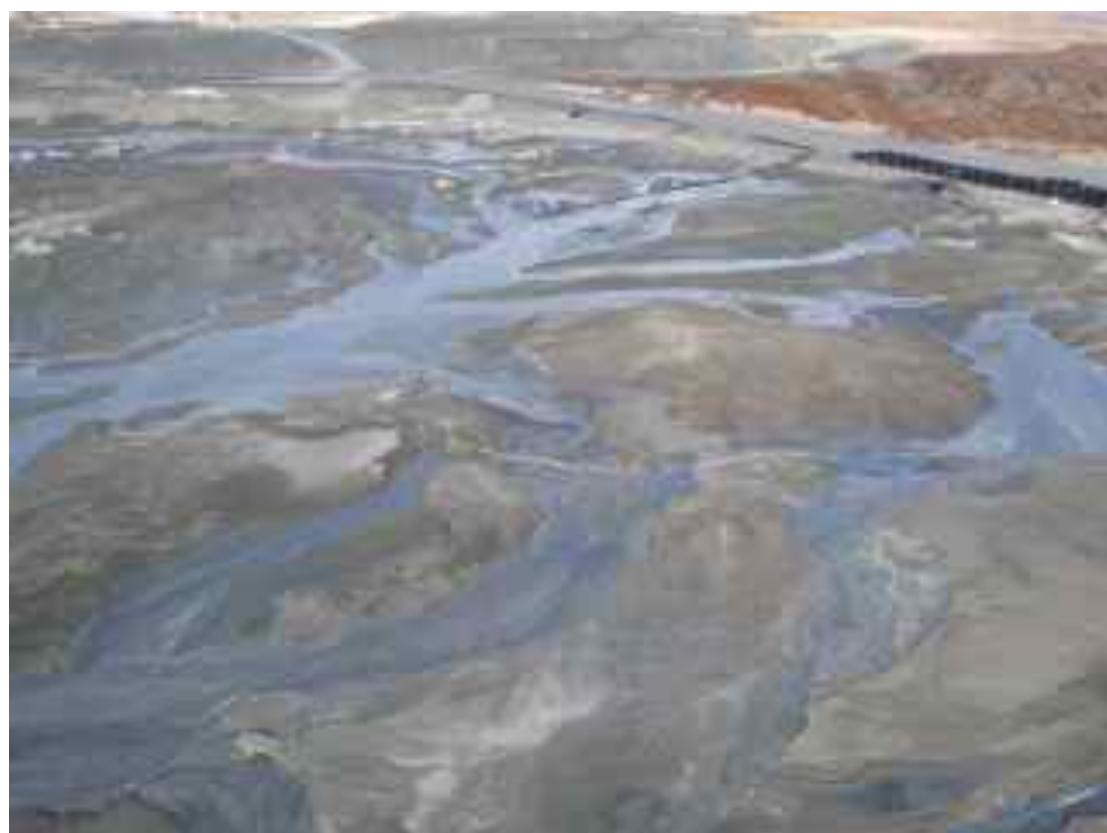
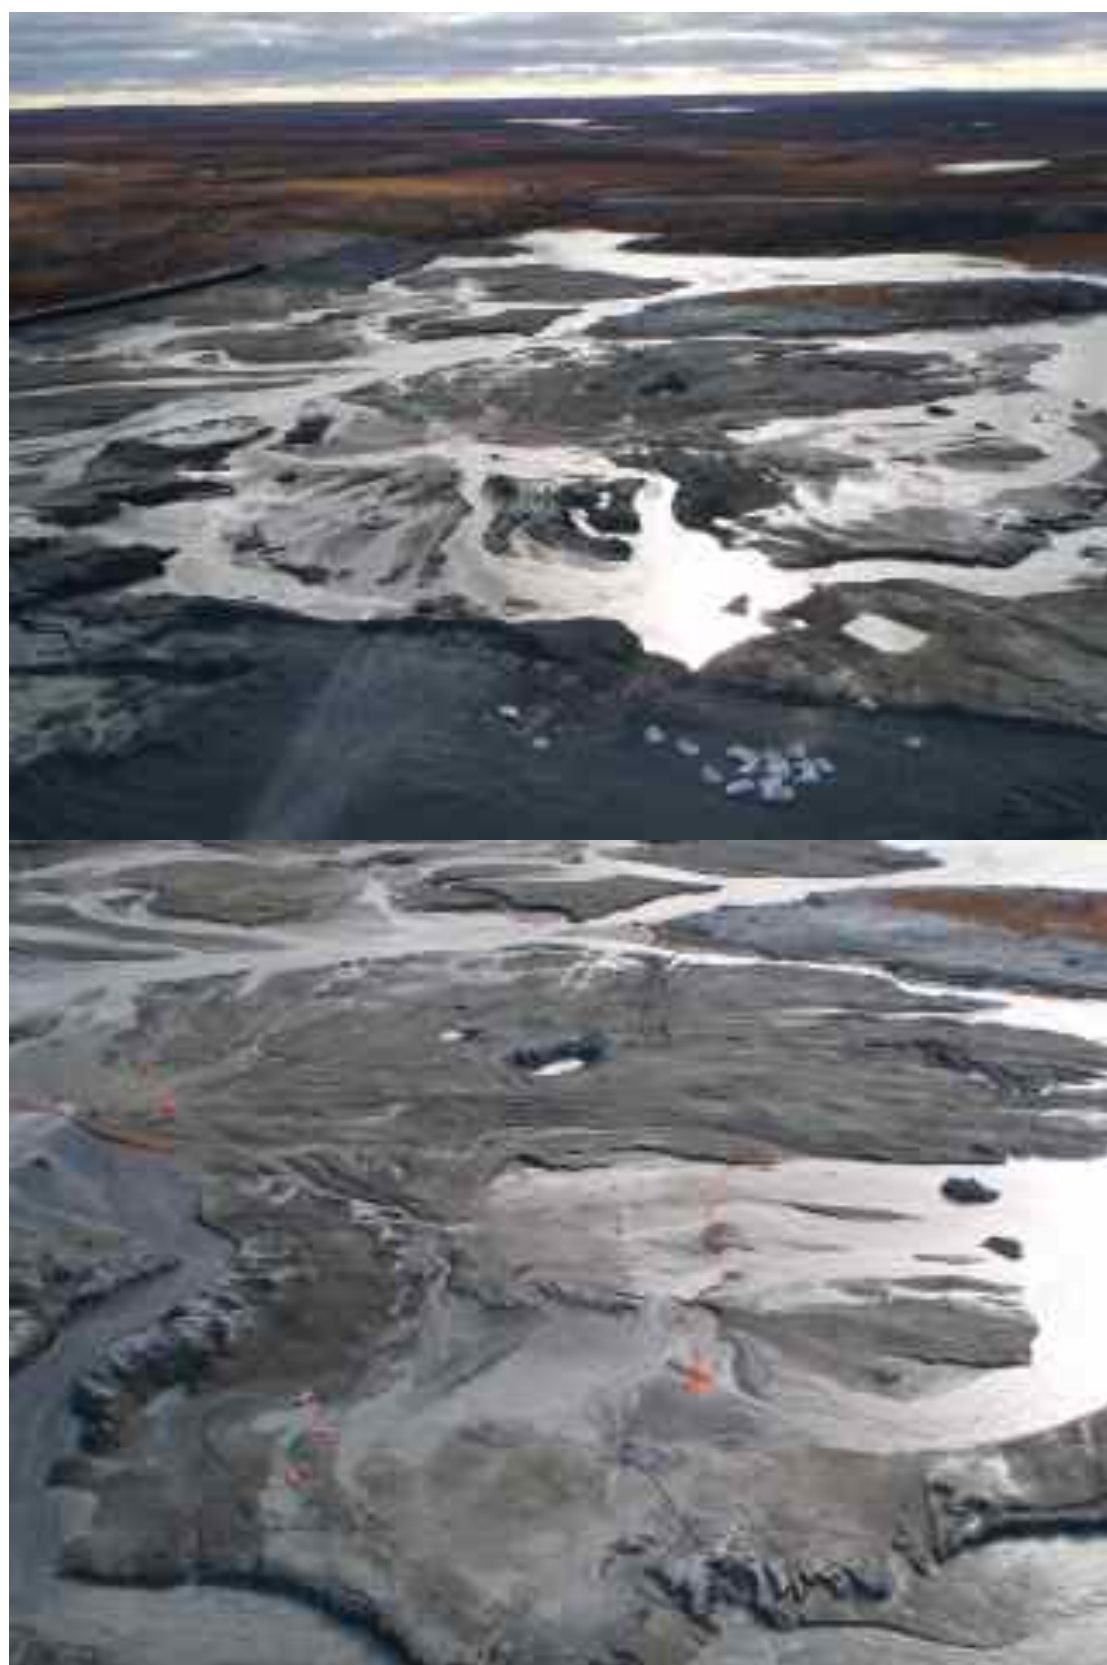
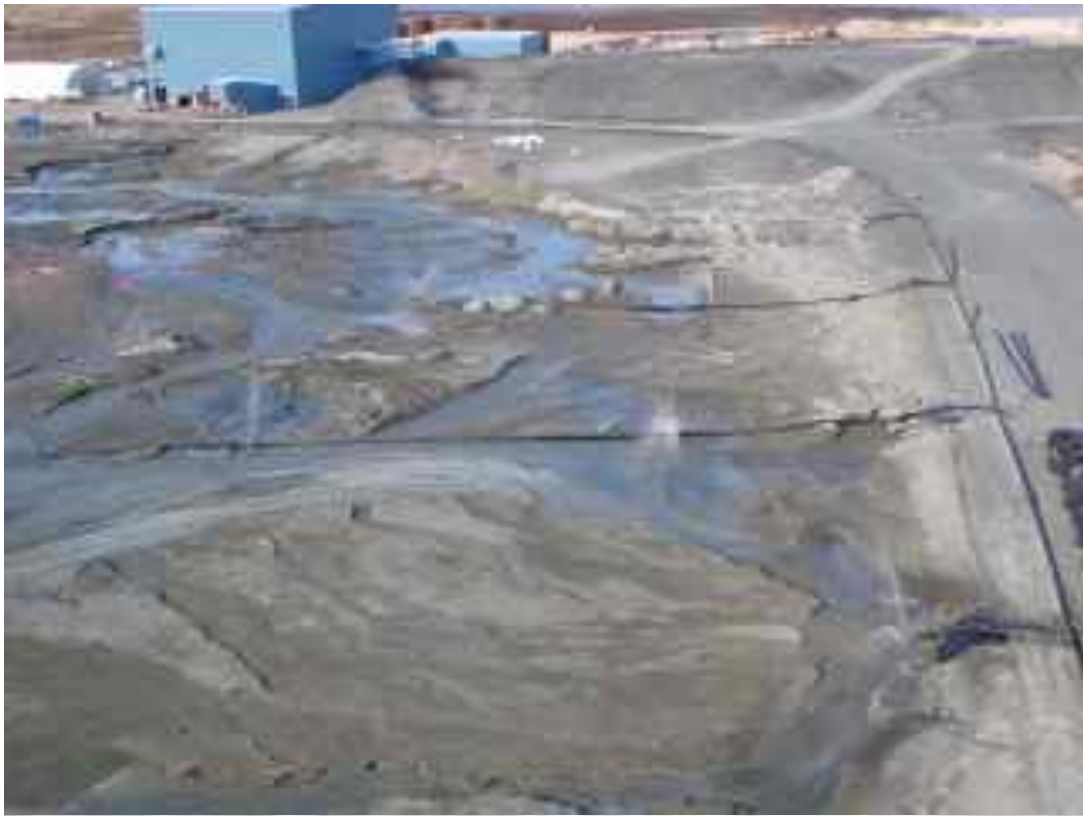
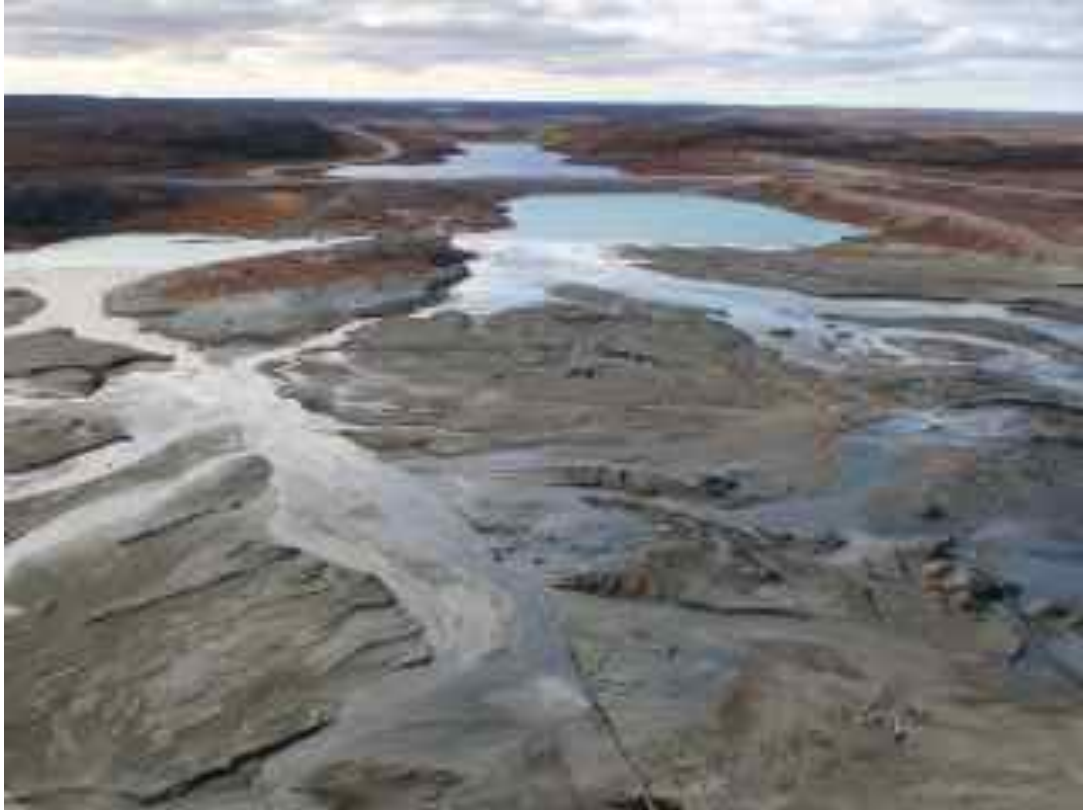
PHOTOGRAPHS OF CELL A AND THE SPRINKLER SYSTEM TAKEN AUGUST 25, 2012

FPK clean up activities continued throughout the summer. These activities included continued vacuuming efforts, shoveling and hand removal. Shear invested significant resources into developing a “sprinkler” system to wet the FPK and keep it wet. The sprinkler system was operational until the site was placed on Temporary Shutdown. Photos of the sprinkler system and the PKCA are provided in Appendix B. It had been Shear’s intention to continue wetting the FPK until freeze up in the hopes of developing a layer of ice as cover. This was not possible with the timing of the shutdown.

Shear constructed lengths of fencing, to be placed in Cell A of the PKCA to create windbreaks.

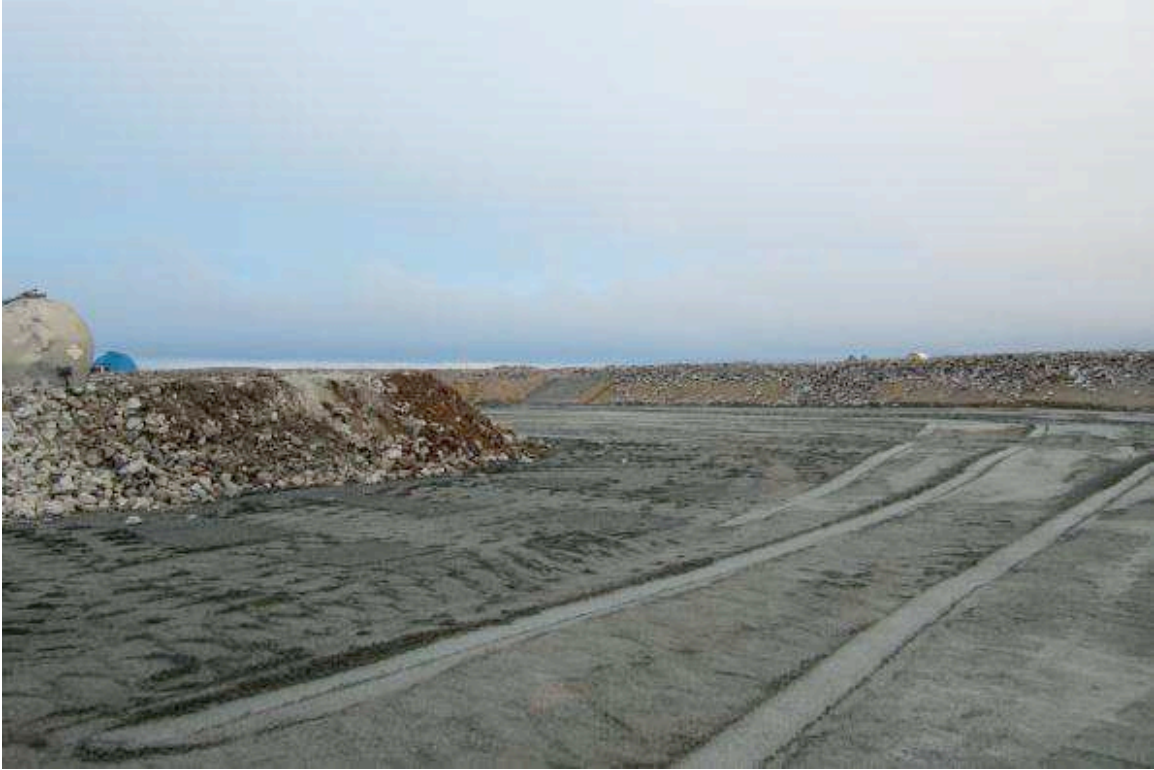
Figure 1: View of the inside L-shaped berm, final elevation. Area prepped and ready for geotextile fabric and liner installation.

A new liner was to be installed in the HWTa on the East side. The area was excavated; materials crushed and stockpiled, and, existing perimeter berms were built up. However, at the time of Temporary Shutdown, the liner had not yet been brought to site and installed. Photos are included in Appendix C.

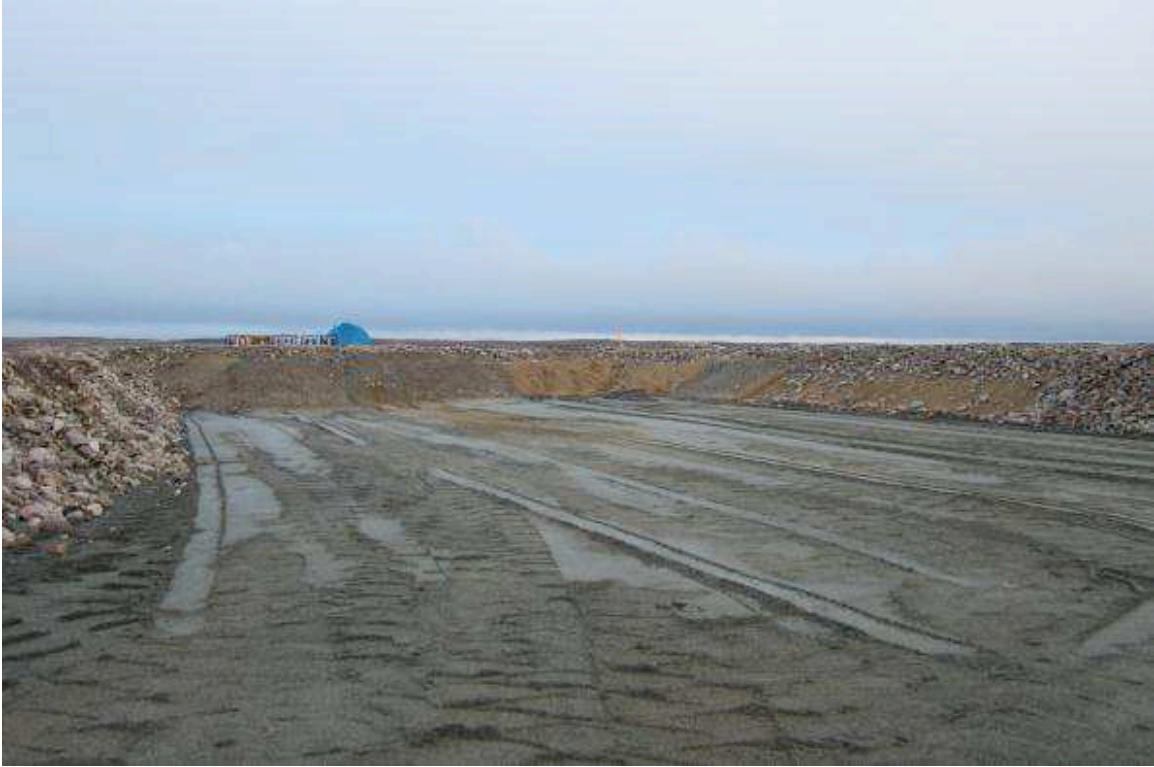
Figure 2: Exposed liner areas with steep slopes were reduced with 2" material.

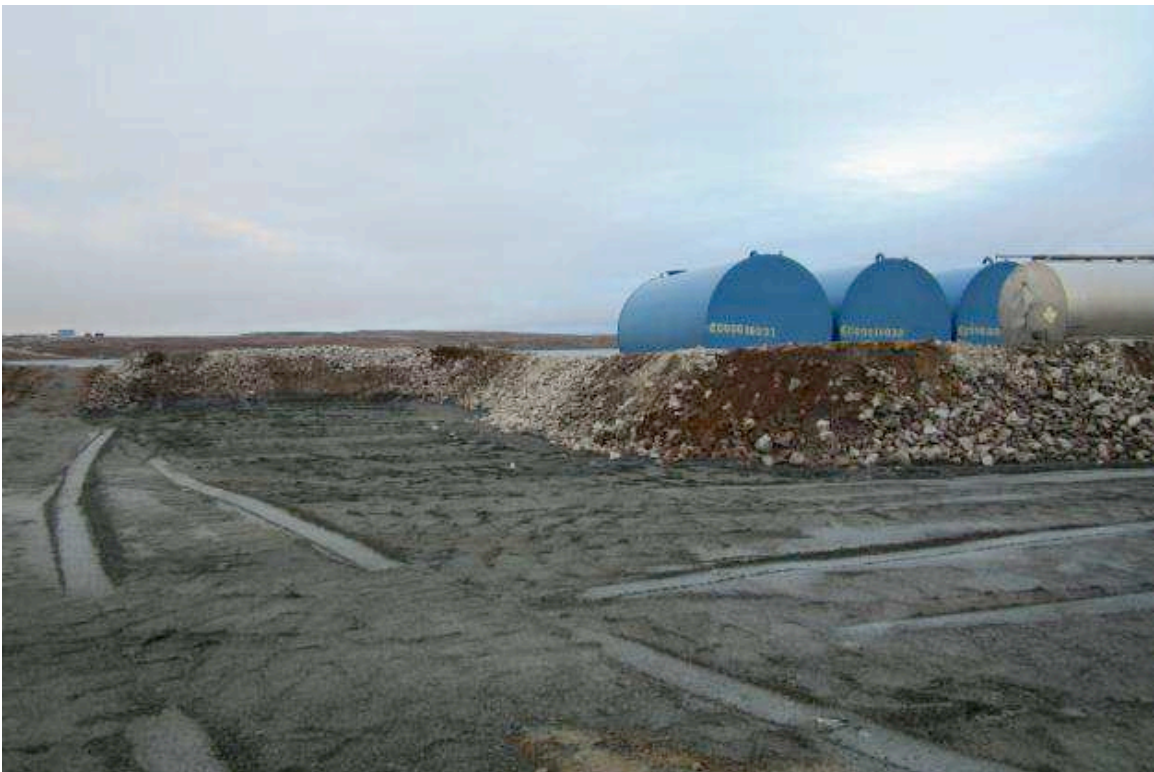
Figure 3: L-shaped berm, final elevation.

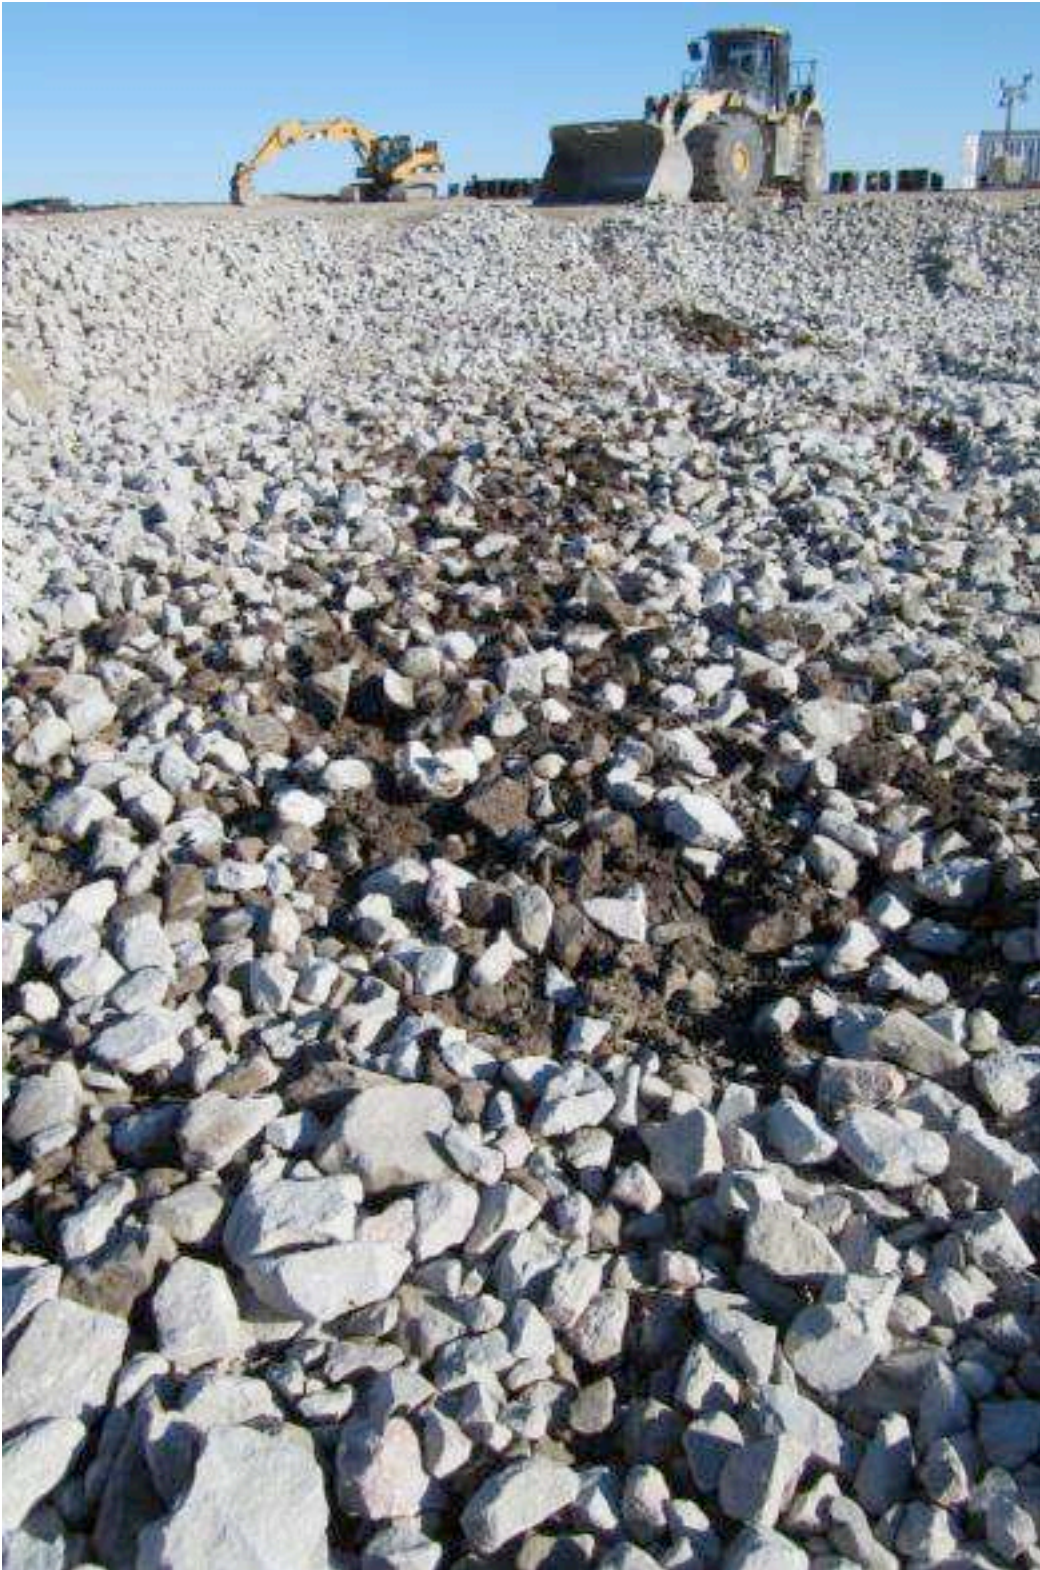
Figure 1: Excavation with layer of 6" crush material.

In the month of August, Shear excavated an area at the airport fuel farm, the Process Plant refueling area and at the Truck Shop fuel tank. These areas were prepped for geotextile fabric and liner. Shear excavated these areas in accordance with a design prepared by an engineer. Material was crushed, screened and stockpiled at each of these locations in readiness for the arrival of the liner and fabric. An engineer had been scheduled to come to site in September to oversee the installation of the liner and the construction of the bermed facilities. The mine was placed on Temporary Shutdown prior to the arrival of the liner and fabric. These facilities have not been constructed.

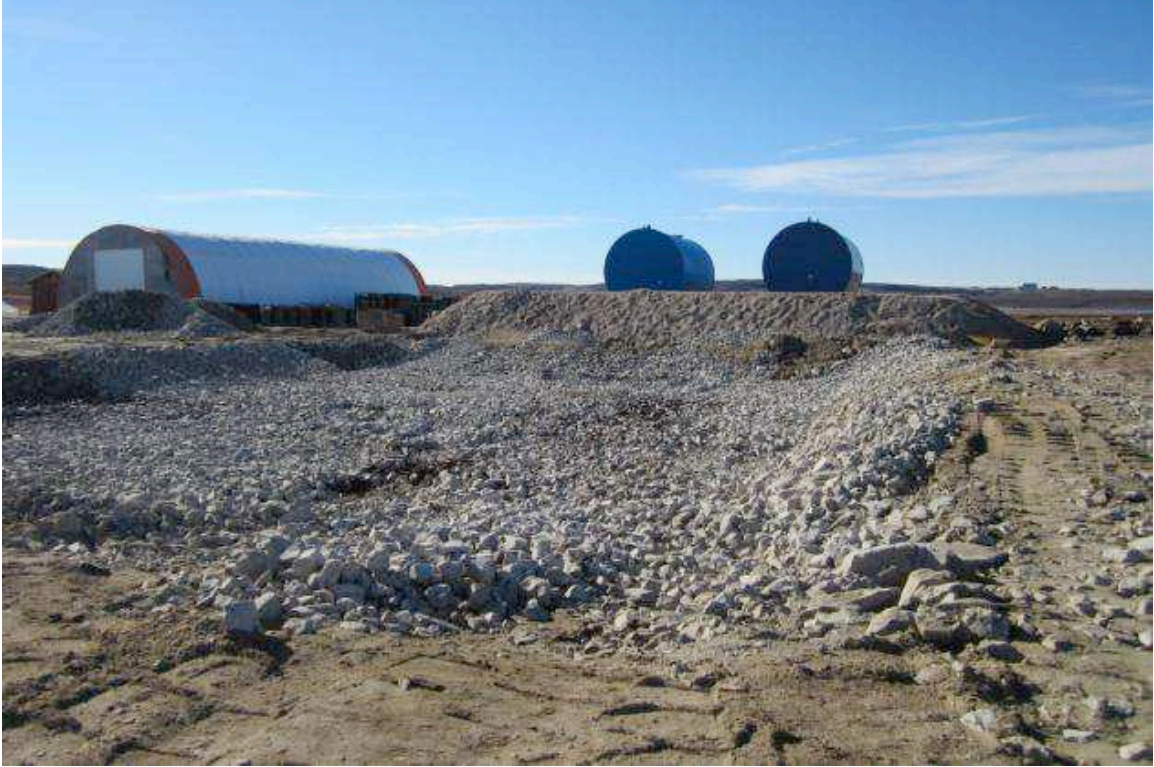
Figure 2: Final excavated area with layer of 6" crush material, view from North West.

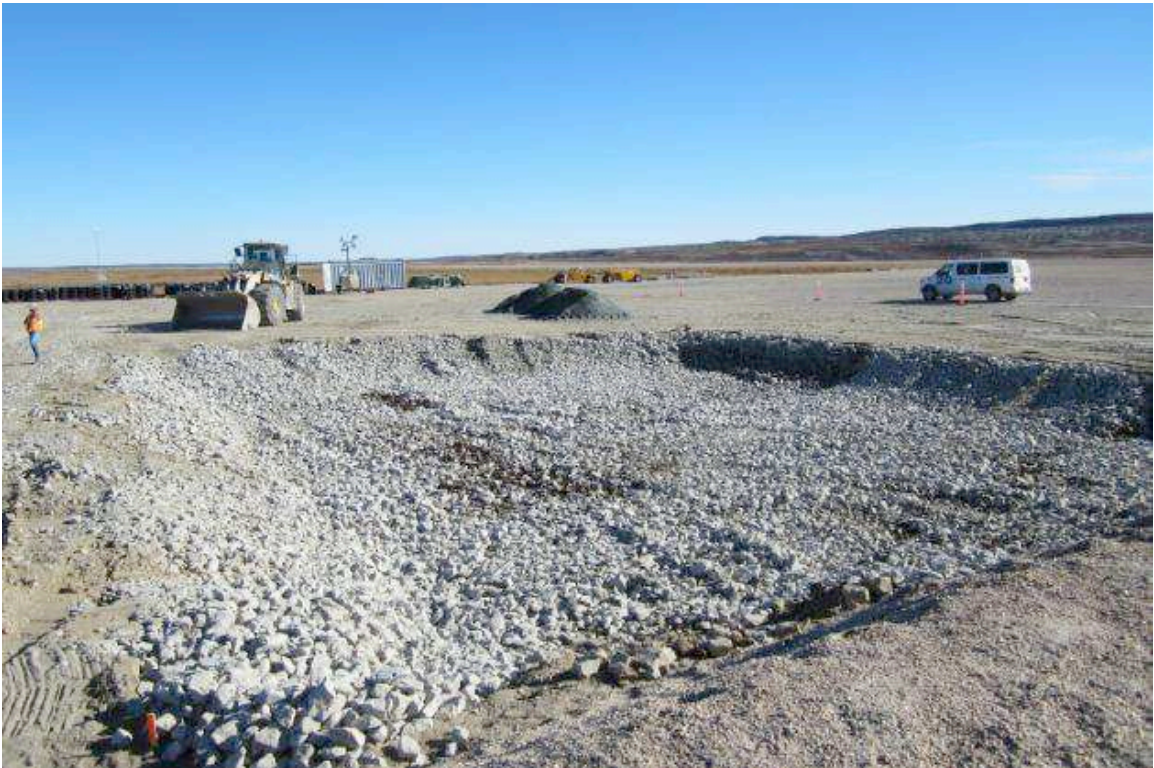
Figure 3: Final excavated area with 6" layer of crush material, view from South West.
