APPENDIX A

PHOTOGRAPHS

CLOSURE PLAN FOR

TAILINGS CONTAINMENT AREA

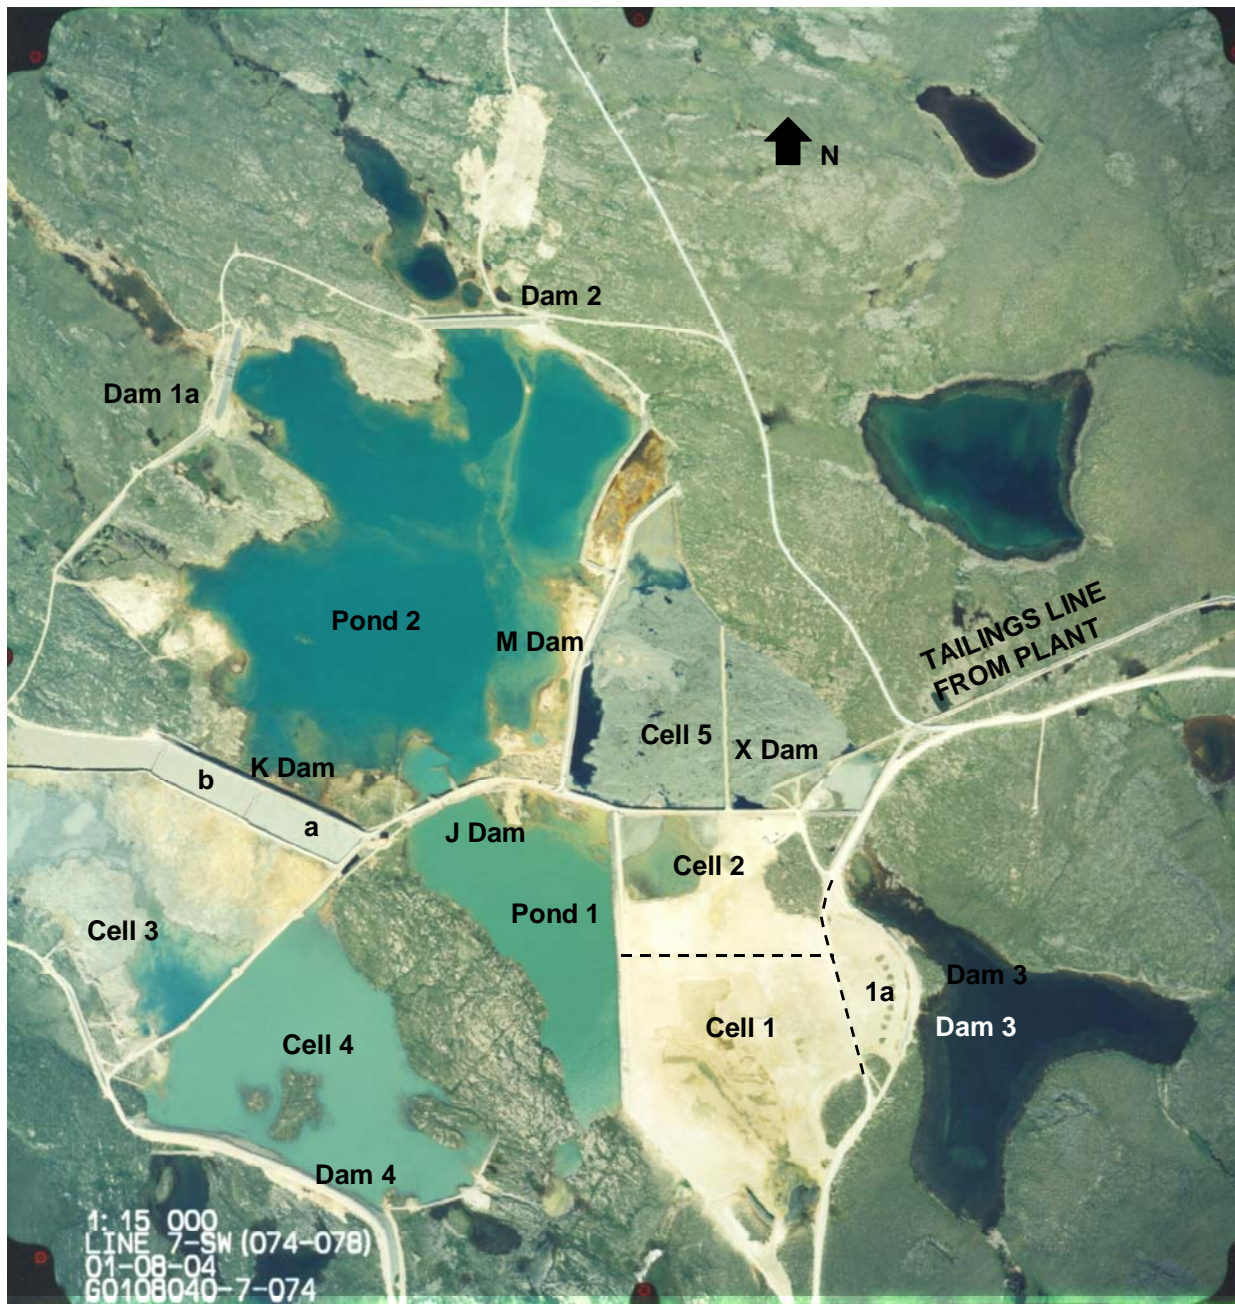
Photo 1. Lupin tailings containment area, 2001

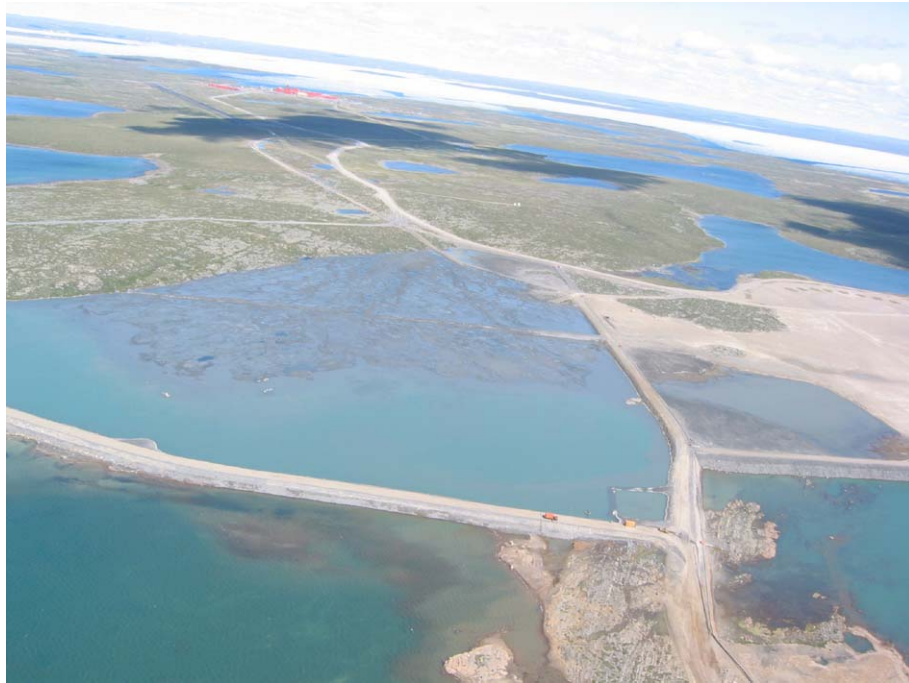
Photo 2. Looking north toward plant; Cell 5 in foreground and Cell 2 to the right

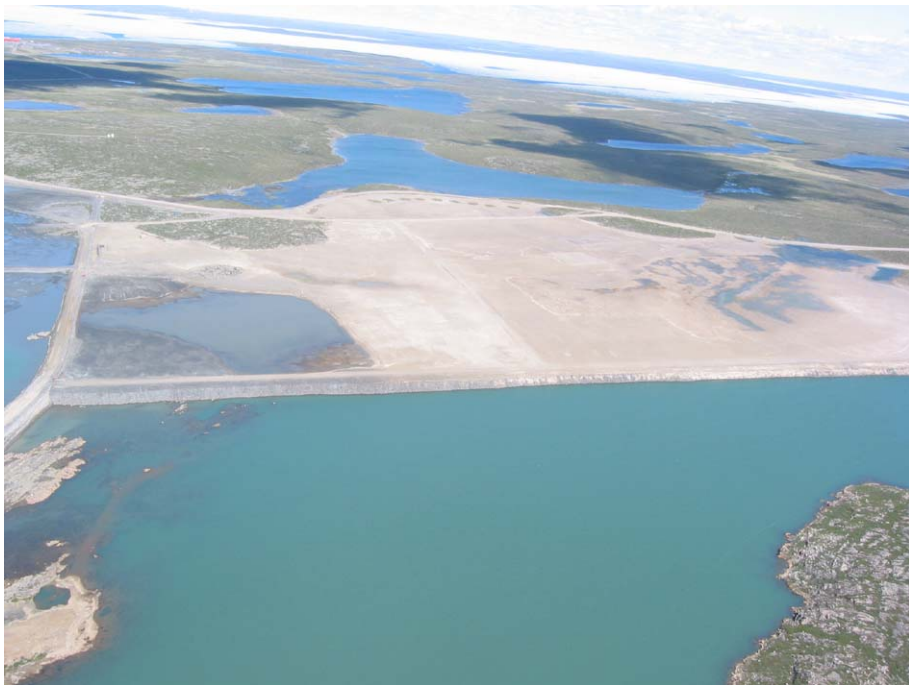
Photo 3. Cells 2 and 1 adjacent to Pond 1 in foreground

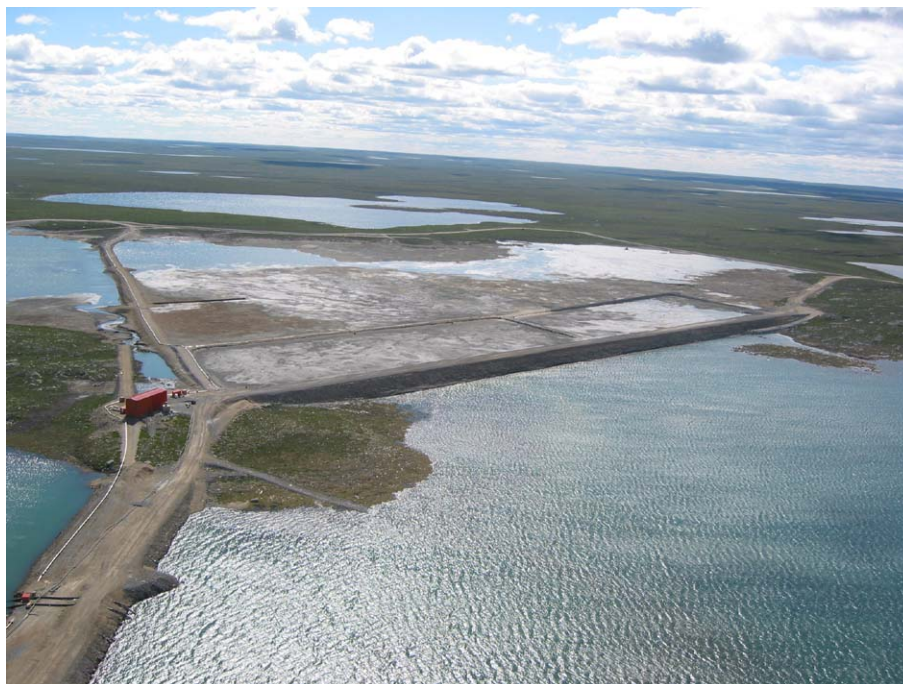
Photo 4. Looking southwest with Cell 3 bounded by Dams K & L and J Dam in lower left

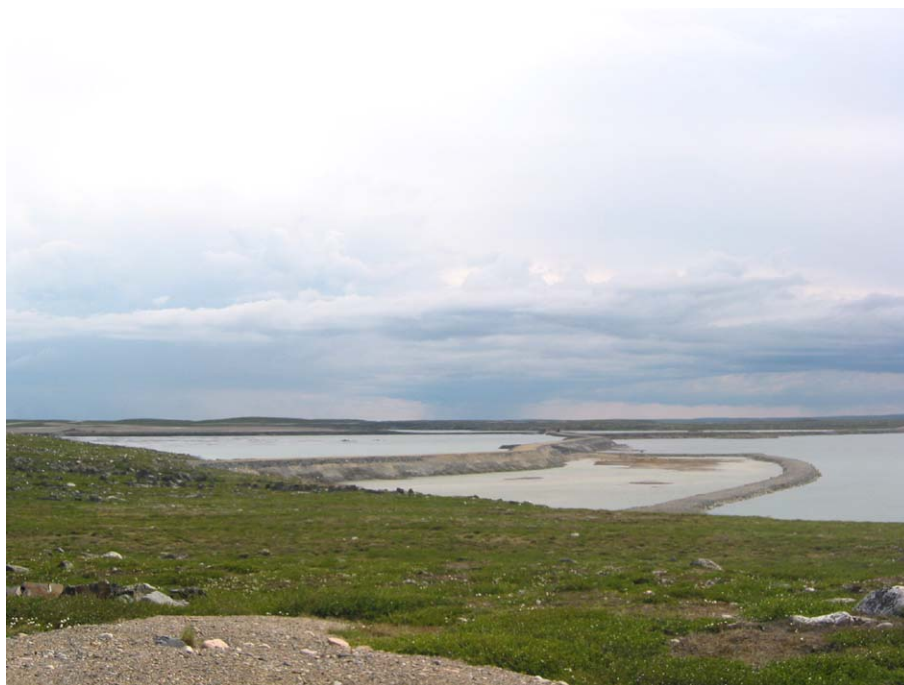
Photo 5. Looking east with N Dam to the right and M Dam to the left

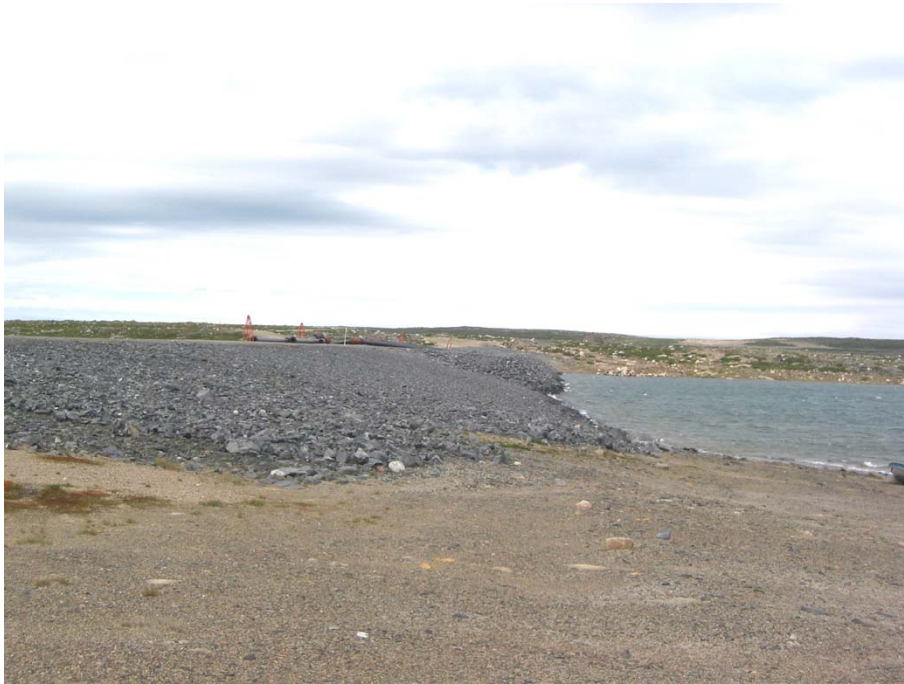
Photo 6. Dam 1a looking north

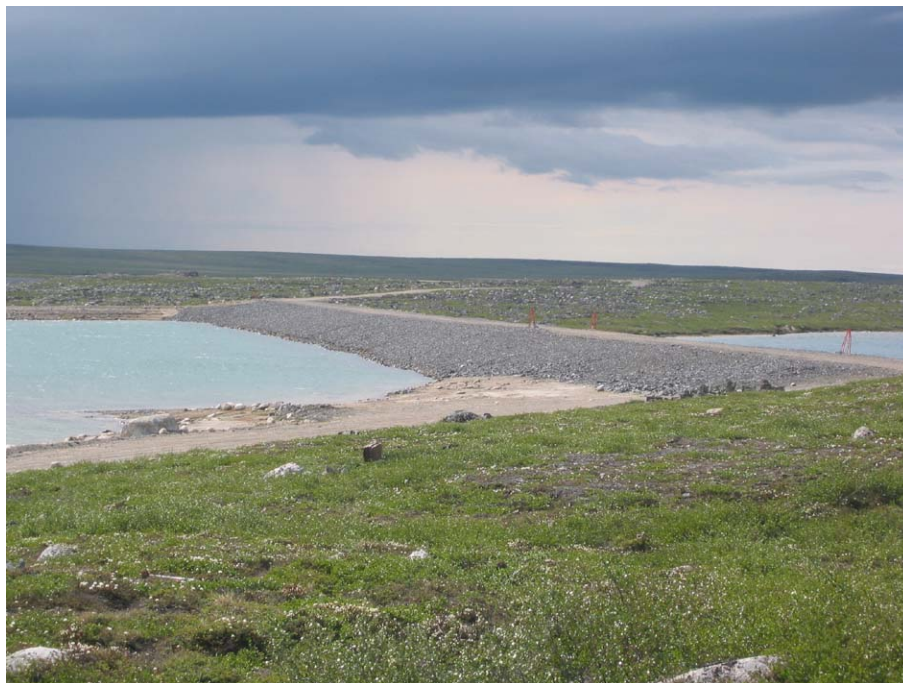
Photo 7. Dam 2 looking south

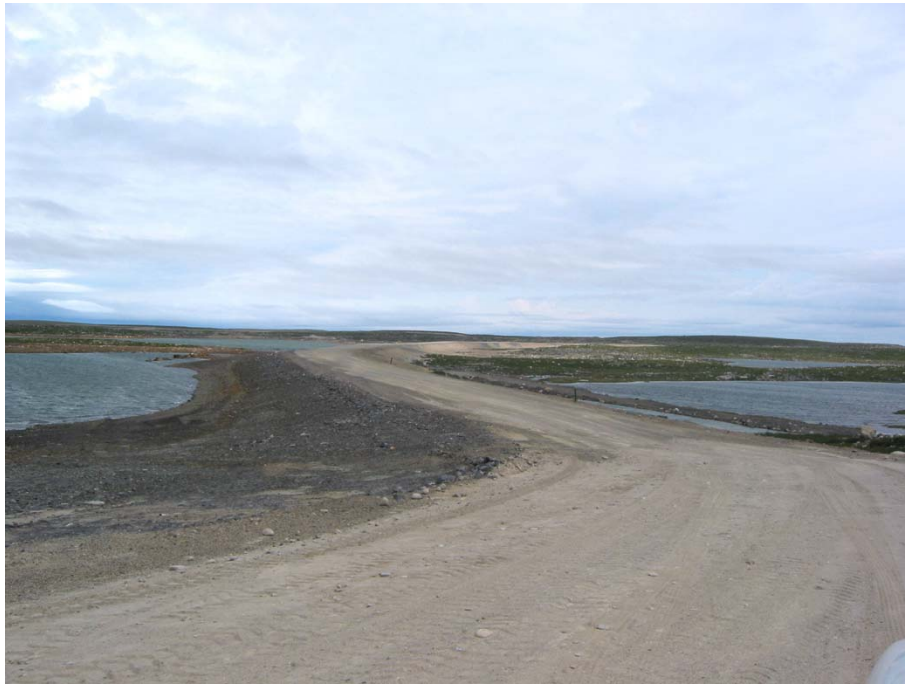
Photo 8. Dam 4 looking northeast, TCA on left

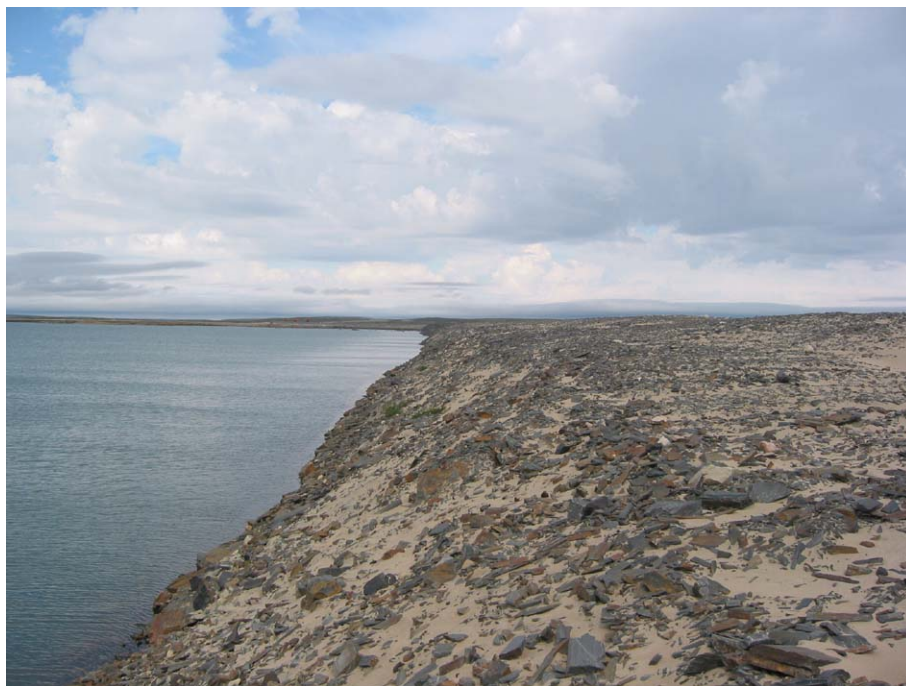
Photo 9. Dam 3D, looking west, Cell 1 to the right (not visible)

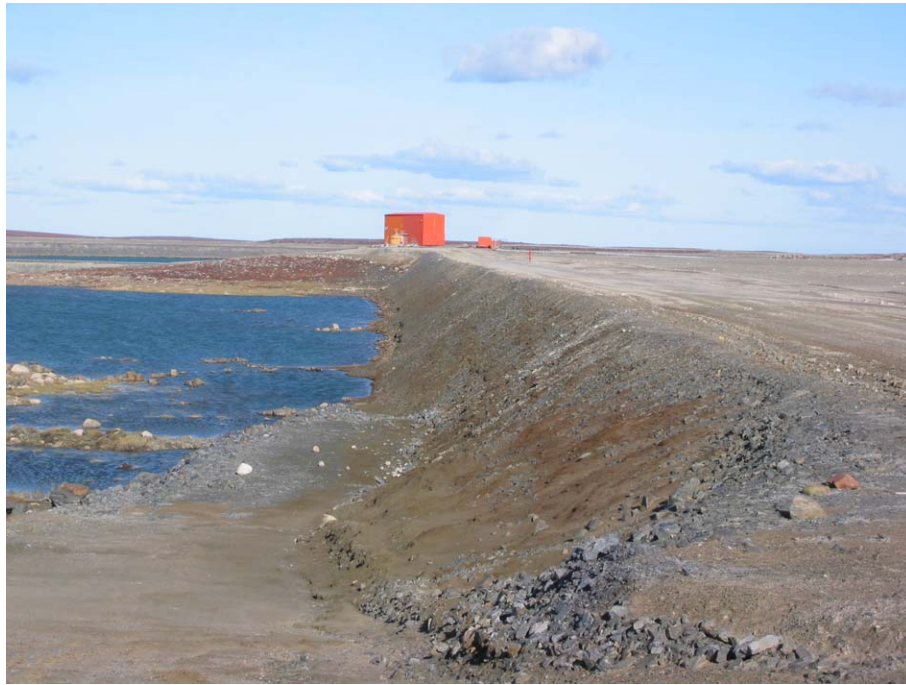
Photo 10, K Dam, looking northeast; Pond 2 to the left

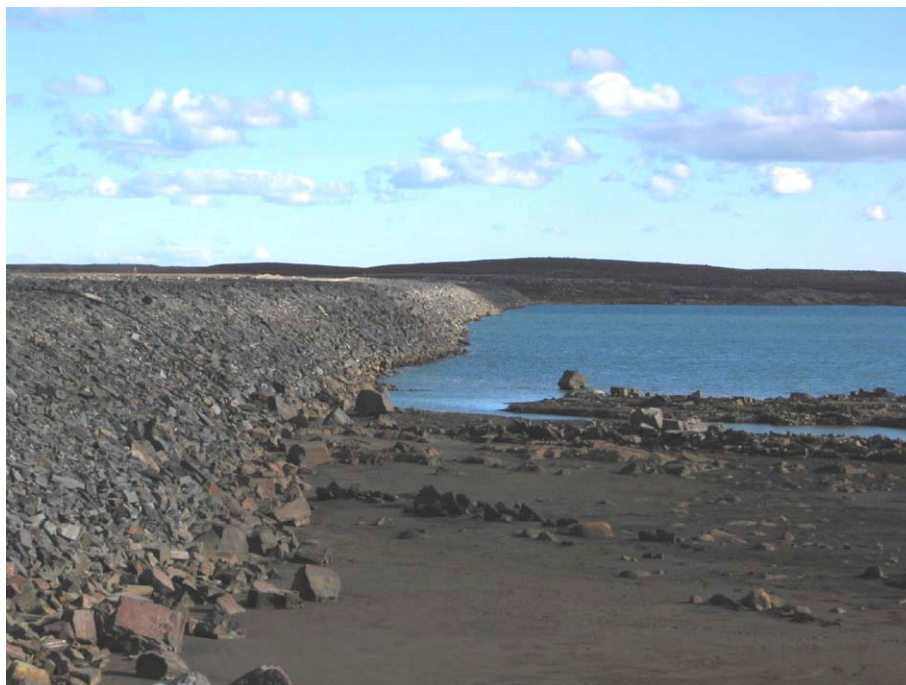
Photo 11. M Dam, looking east with Pond 2 to the right

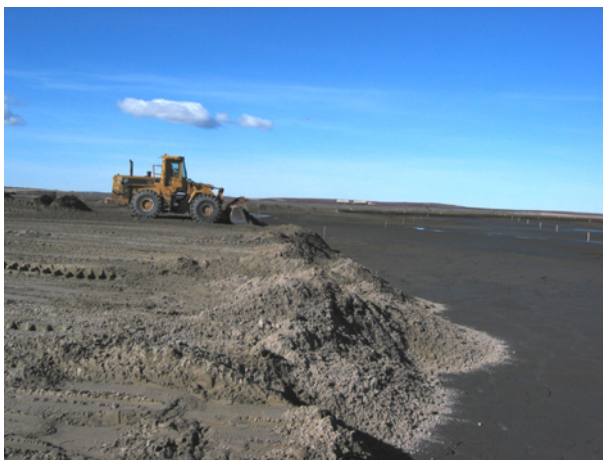
Photo 12. Tailings being covered with esker

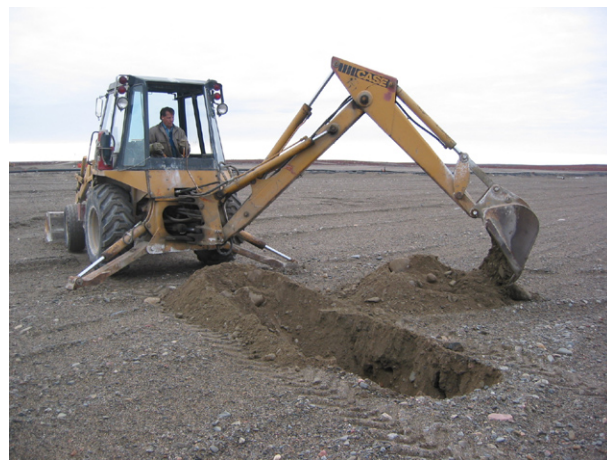
Photo 13. Test pit excavations, September 2004

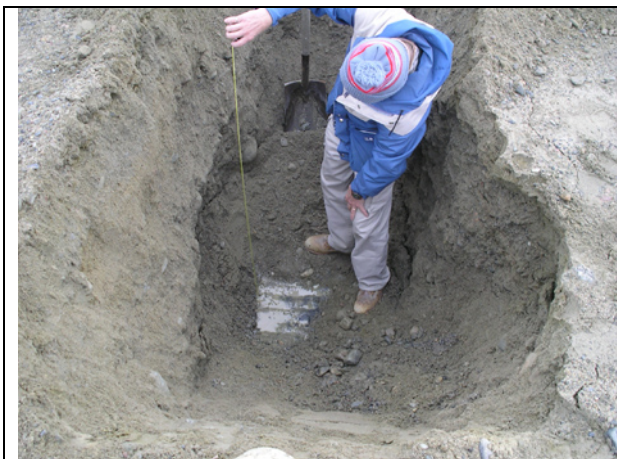
Photo 14. Test pit 1-1 in Cell 1, located at new pipe 7 installation

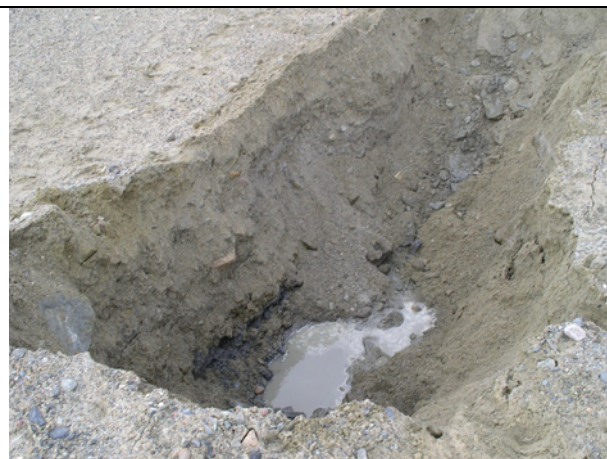
Photo 15. Test pit 1-2, in Cell 1, located at Pipe 1 location. Pipe removed and place in Cell 3

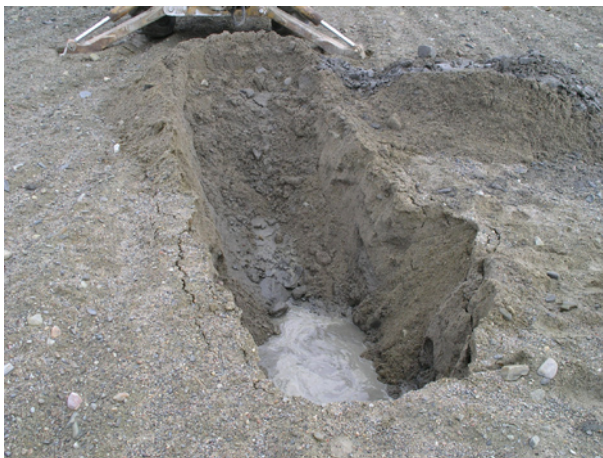
Photo 16. Test Pit 1-3 at test pad, south, excavation for pipe repositioning

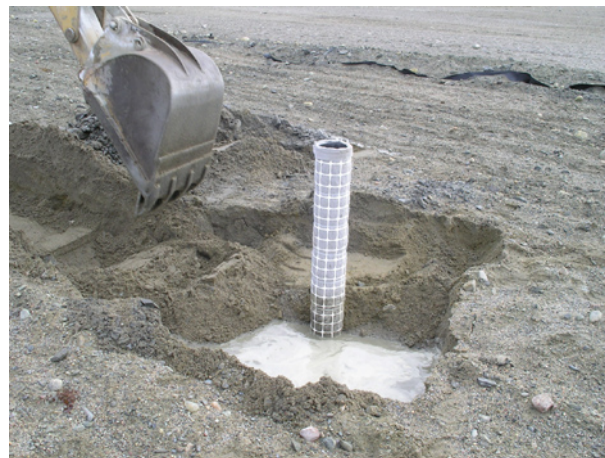
Photo 17. Test Pit 1-3 at test pad, south, new pipe being backfilled

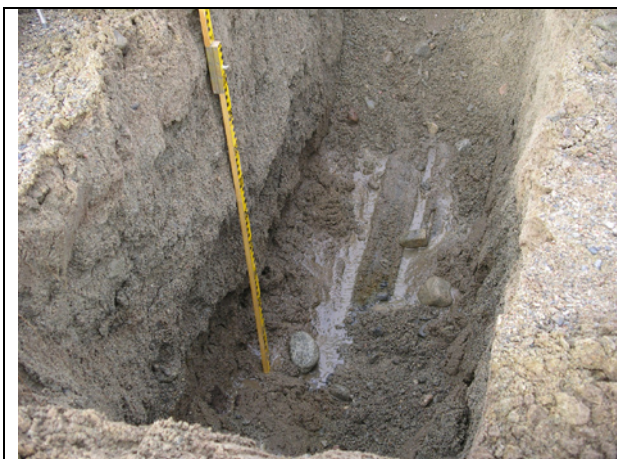
Photo 18. Test pit 1a-1 in Cell 1a; note coarser esker and wet base

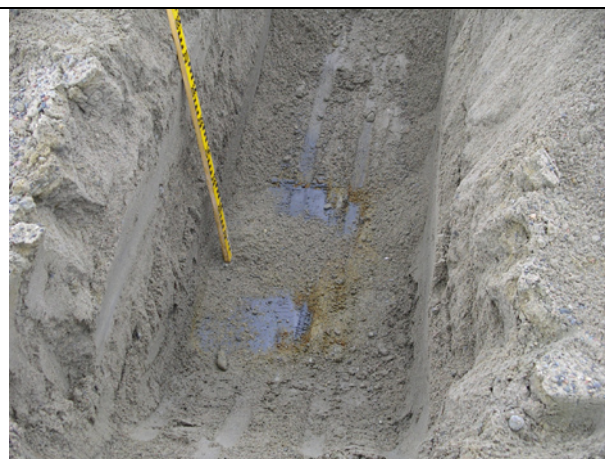
Photo 19. Test pit 2-1 in northern section of Cell 2 with older tailings; minor oxidation at tailings surface

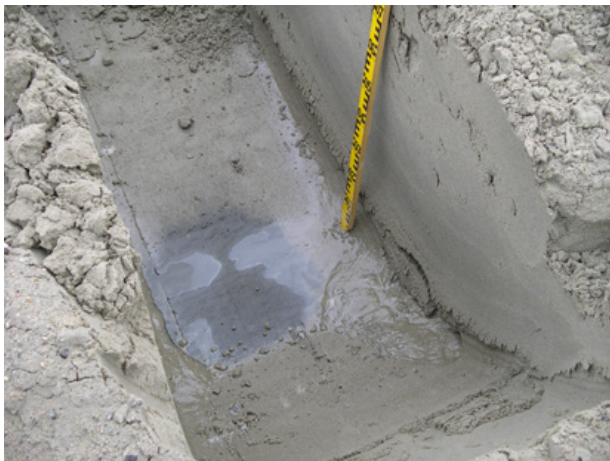
Photo 20. Test Pit 2-2 in southern area of Cell 2

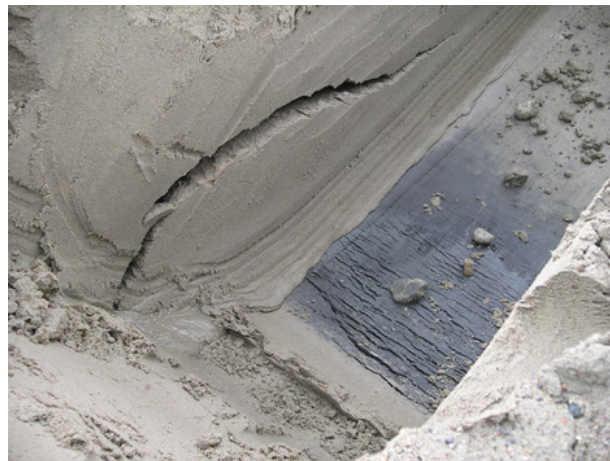
Photo 21. Test pit 2-3, in southern area of Cell 2, closer to mid point of cell

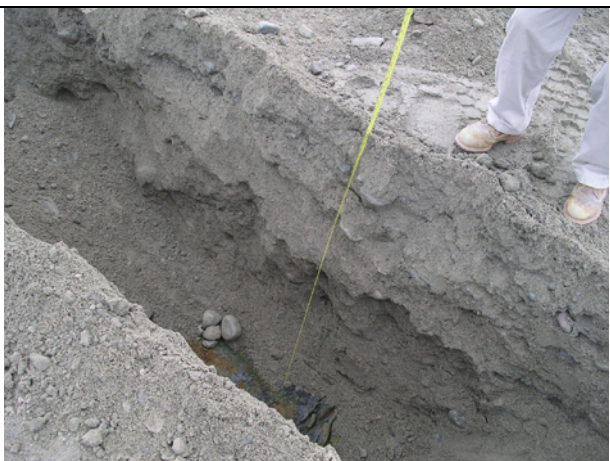
Photo 22. Test pit 3-1 in Cell 3. Minor oxidation of tailings. This part of cell was covered only weeks earlier.

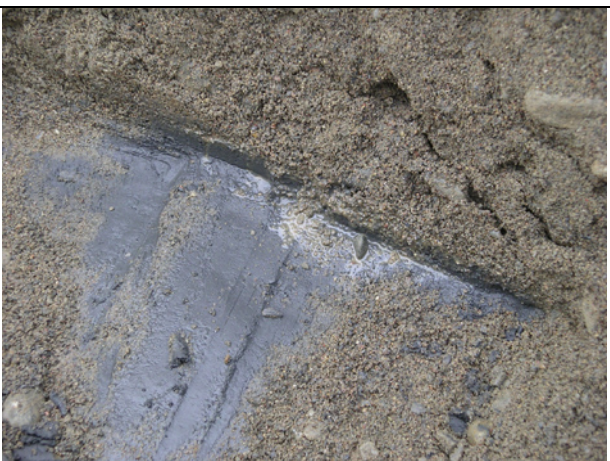
Photo 23. Test pit 3b-1 in Cell 3b.
