WATER LICENCE INSPECTION FORM

Licensee		Licensee Representative	
Lupin Mines Inc		Karyn Lewis/ Pat Downey	
Licence No. / Expiry		Representative's Title	
2AM-LUP09/14 (expired and amended)		Consultant/ Owner	
Land / Other Authorizations		Land / Other Authorizations	
8WLC-LUP1516			
Date of Inspection		Inspector	
20-23/08/2015		A. Keim	
Activities Inspected			
<input checked="" type="checkbox"/> Camp	<input type="checkbox"/> Drilling	<input type="checkbox"/> Mining	<input type="checkbox"/> Construction
<input checked="" type="checkbox"/> Roads/Hauling	<input type="checkbox"/> Other: Water Discharge	<input type="checkbox"/> Reclamation	<input checked="" type="checkbox"/> Fuel Storage
		<input type="checkbox"/> Other: Municipal

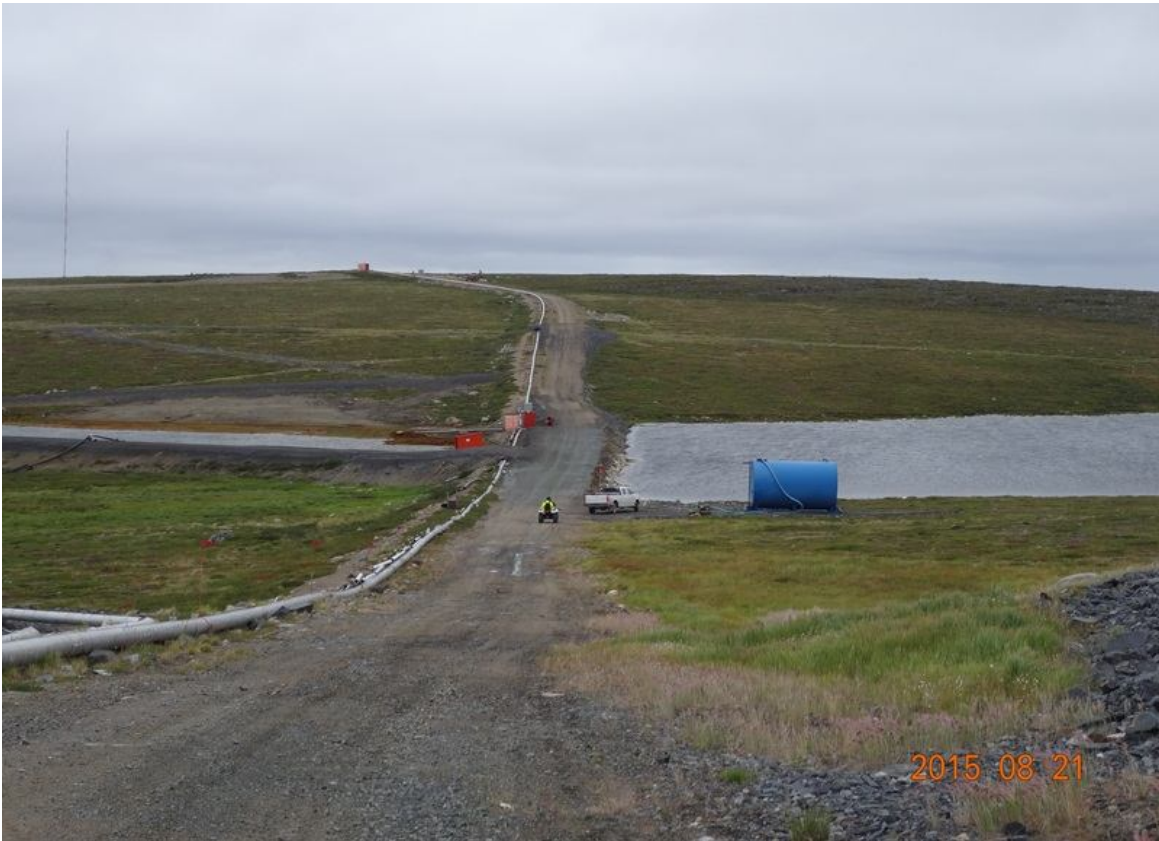
- While work had been undertaken at the Lower Sewage Lake, the berm had not yet been brought up to final grade and evidence of erosion at the south end was still visible and was documented.

Figure 1 Lower sewage lagoon lake -berm wall remedial work

- Work on raising the level of the roadway/berm wall at the foot of the lower sewage lagoon lake was as yet unfinished however work to complete the final lifts and compaction were on the work plan to be addressed prior to the end of the 2015 field season.

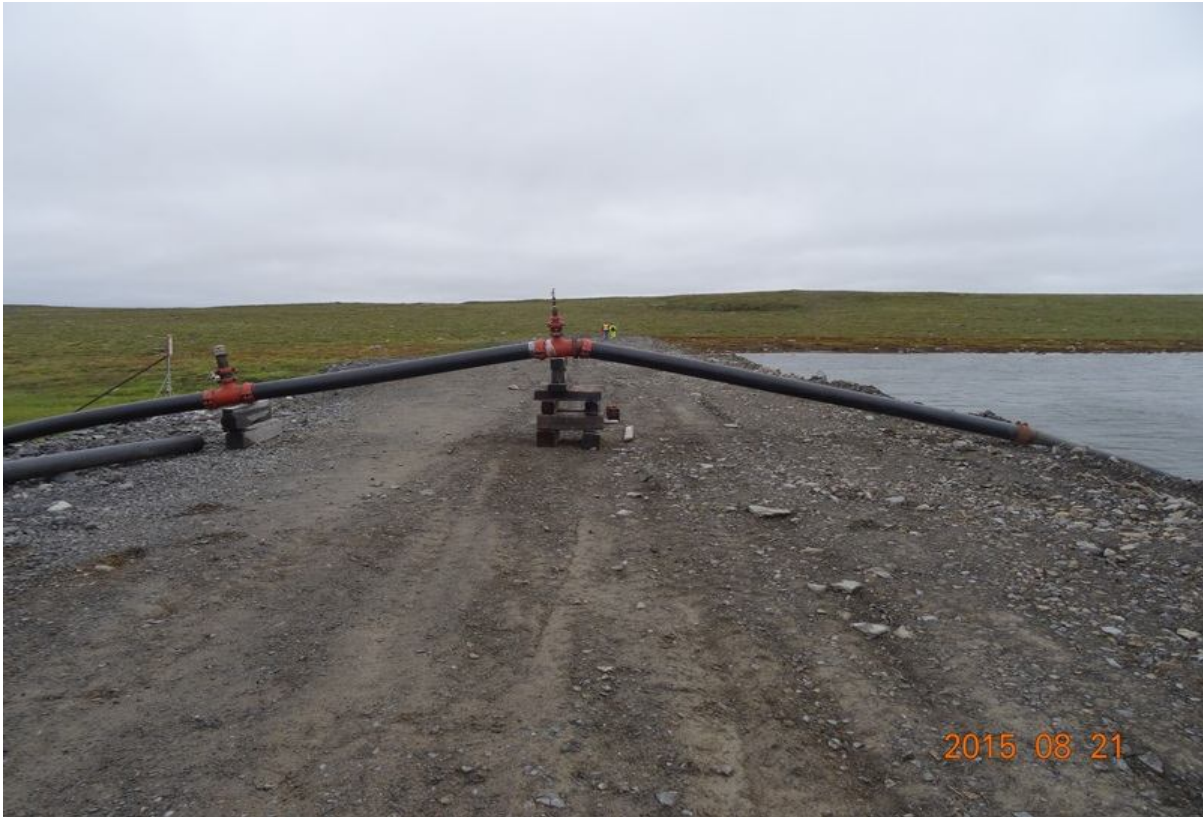
Figure 2 Berm wall - lower sewage lake with syphons installed

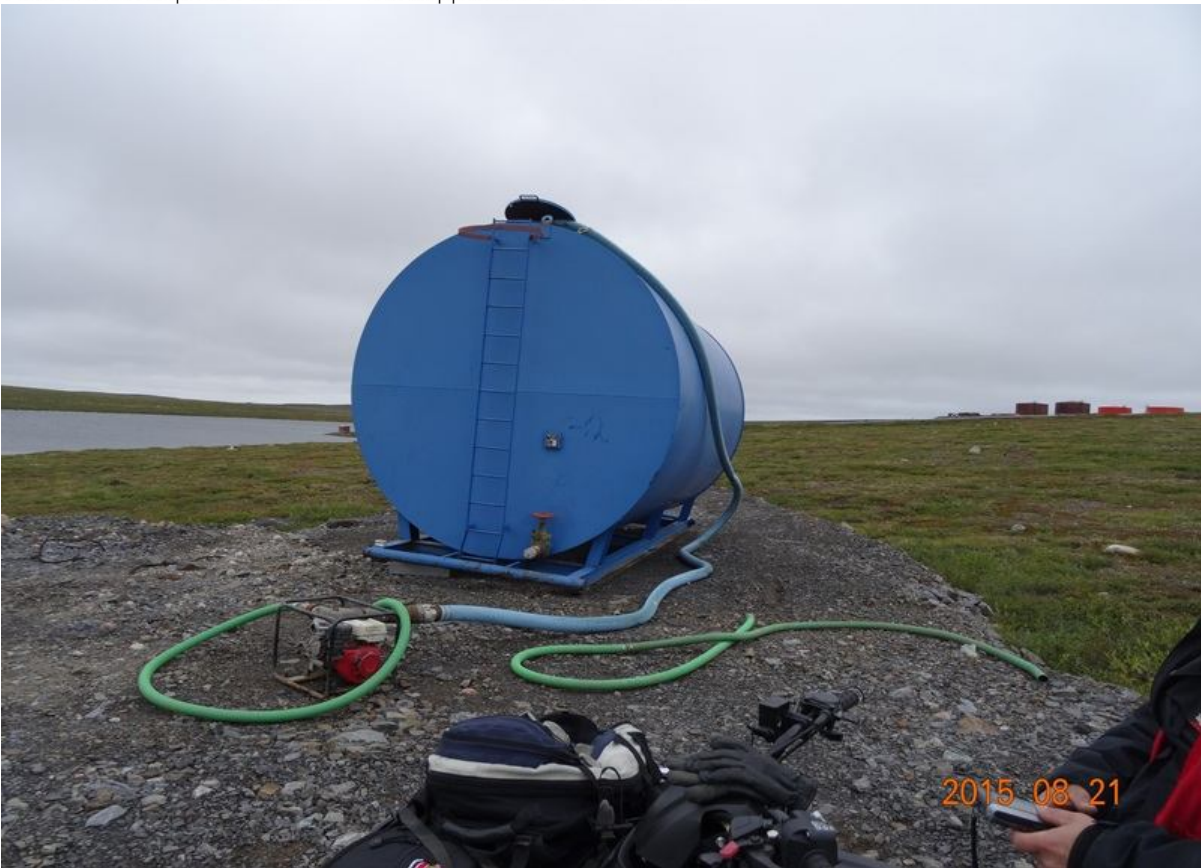
Water for the camp is pumped into a tank on a trailer that his hauled up to camp from the lake. This is done daily. Camp Water usage records were requested and subsequently provided via e-mail following the Inspection by Karyn Lewis of LMI. Wastewater is hauled in a tank down to the Sewage lakes and stored in a large blue water tank on the shoreline. This is in compliance with the Direction issued to LMI in 2014.

Figure 3 Sewage holding tank to be used pending completion of the required work

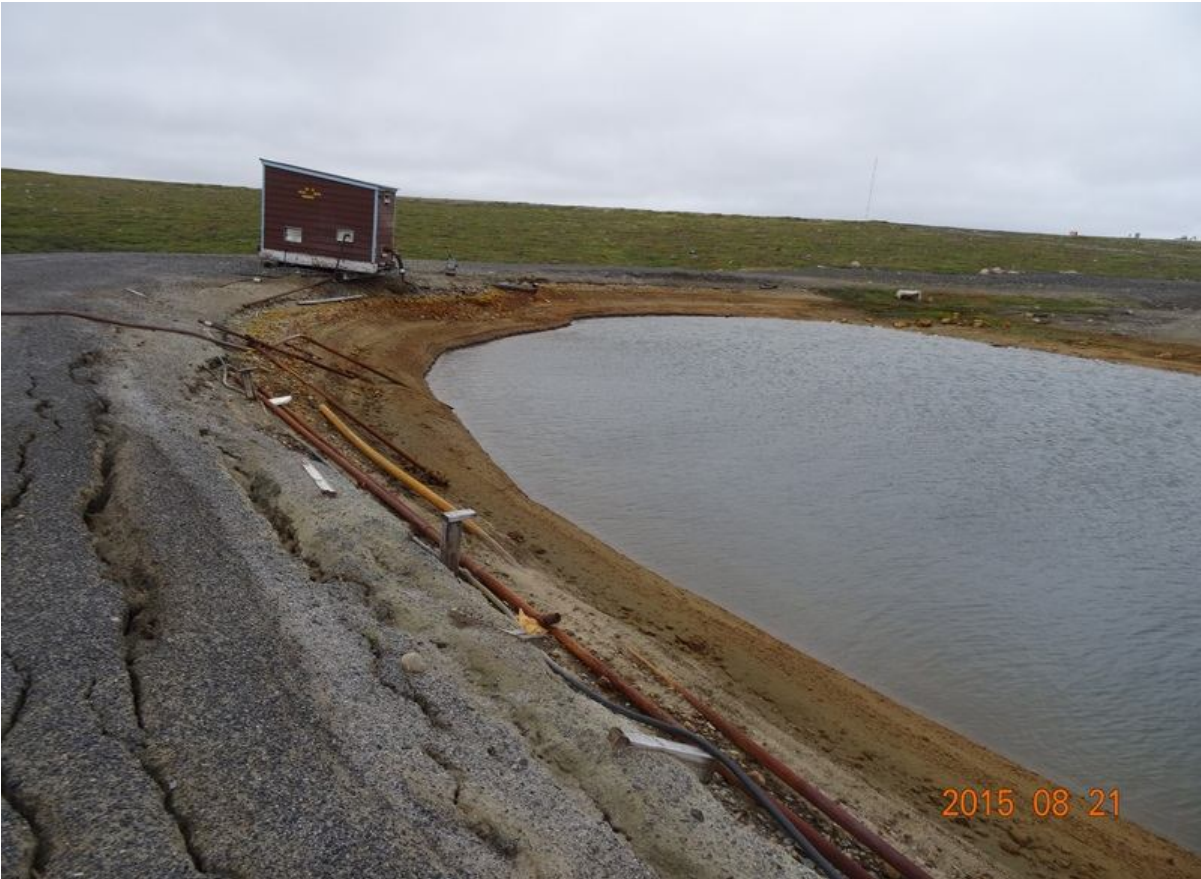
Figure 4 Tailings over flow area adjacent to lower sewage lake. Recently been decanted by the Licensee

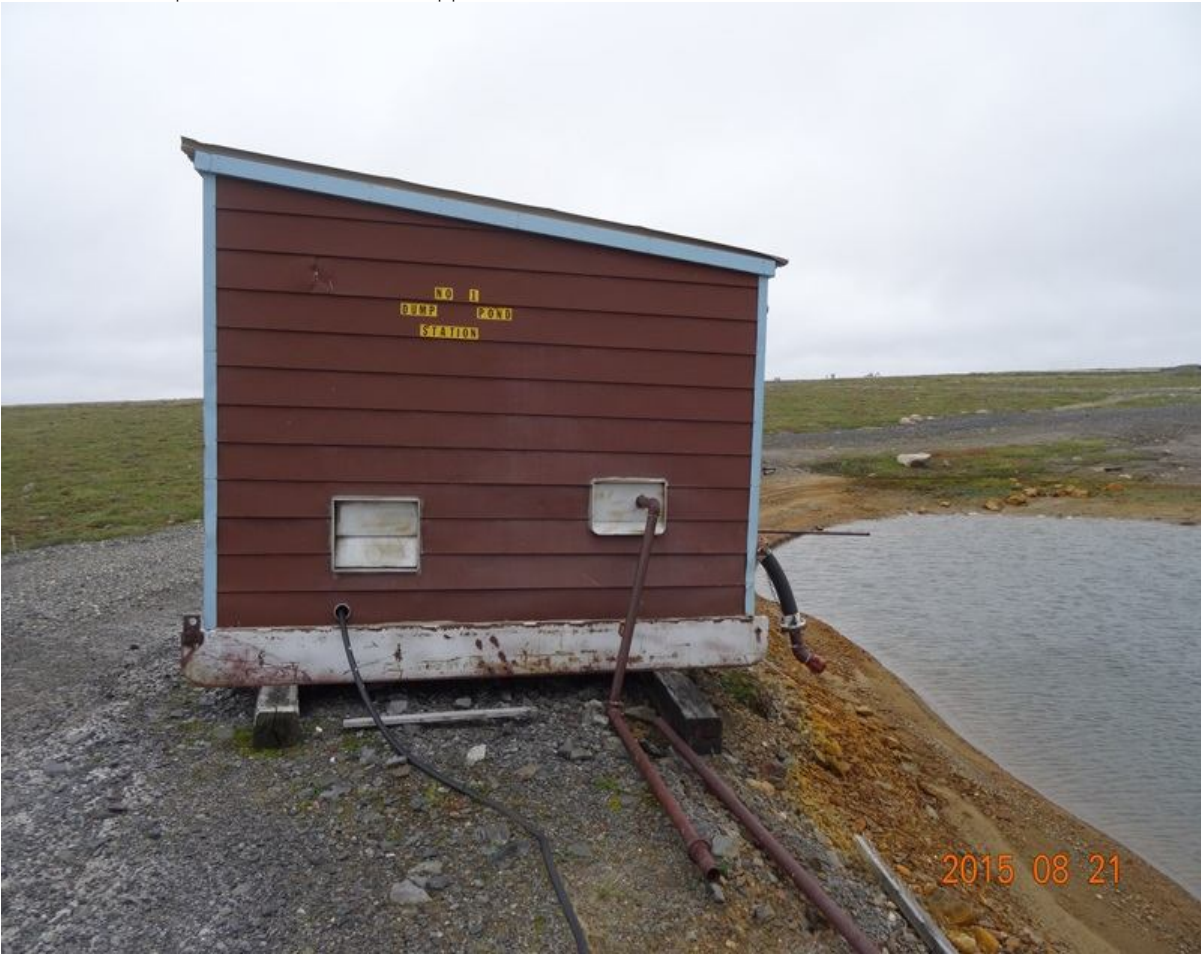
Figure 5 Pumping station at tailings overflow area.. Dump Pond Station

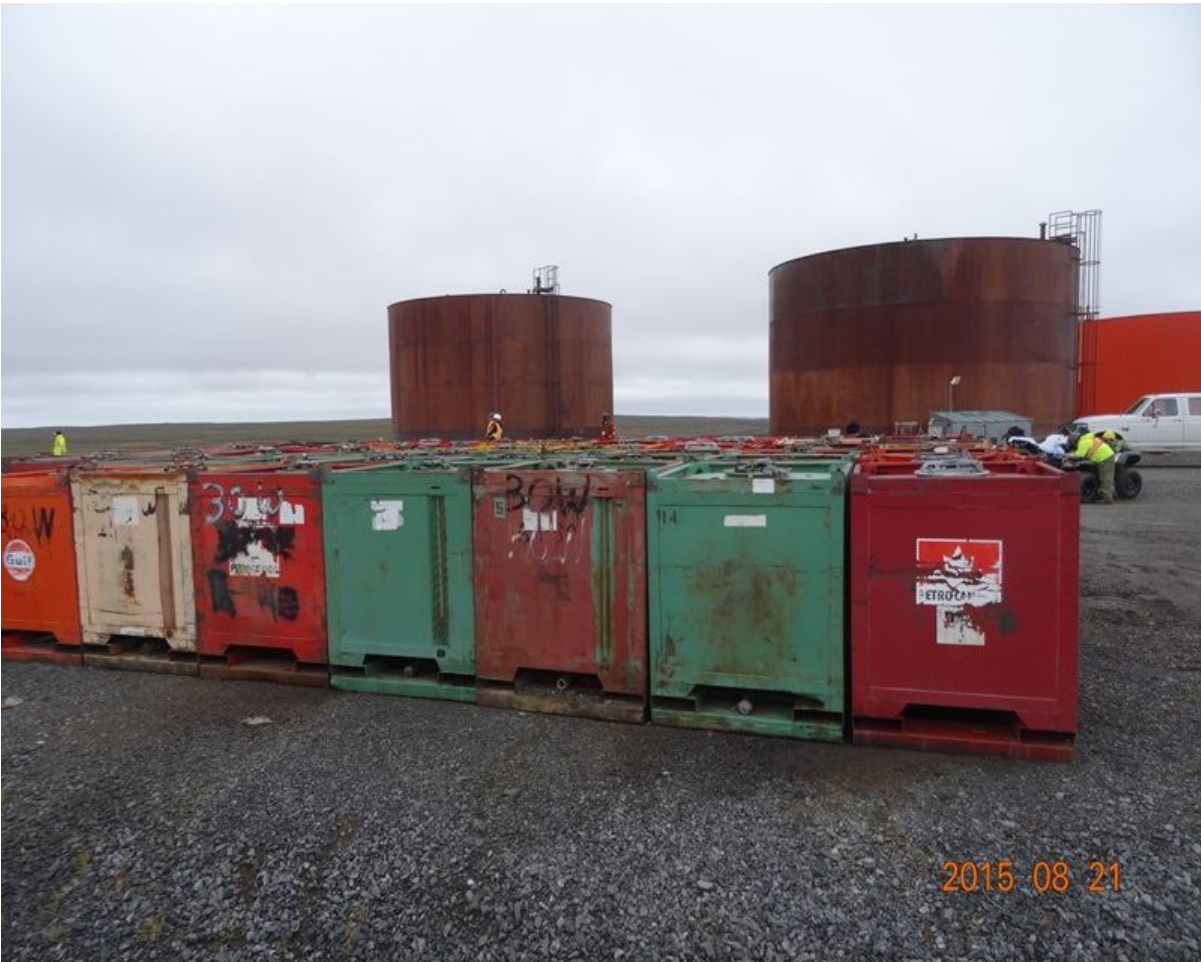
During the period of Inspection there were approximately 40 metal waste oil cubes, 200 45 gallon barrels of assorted waste oil and other lubricants plus approximately 50 5 gallon pails of drill oil.

Figure 6 Cubes of waste oil within the Haz Mat storage area

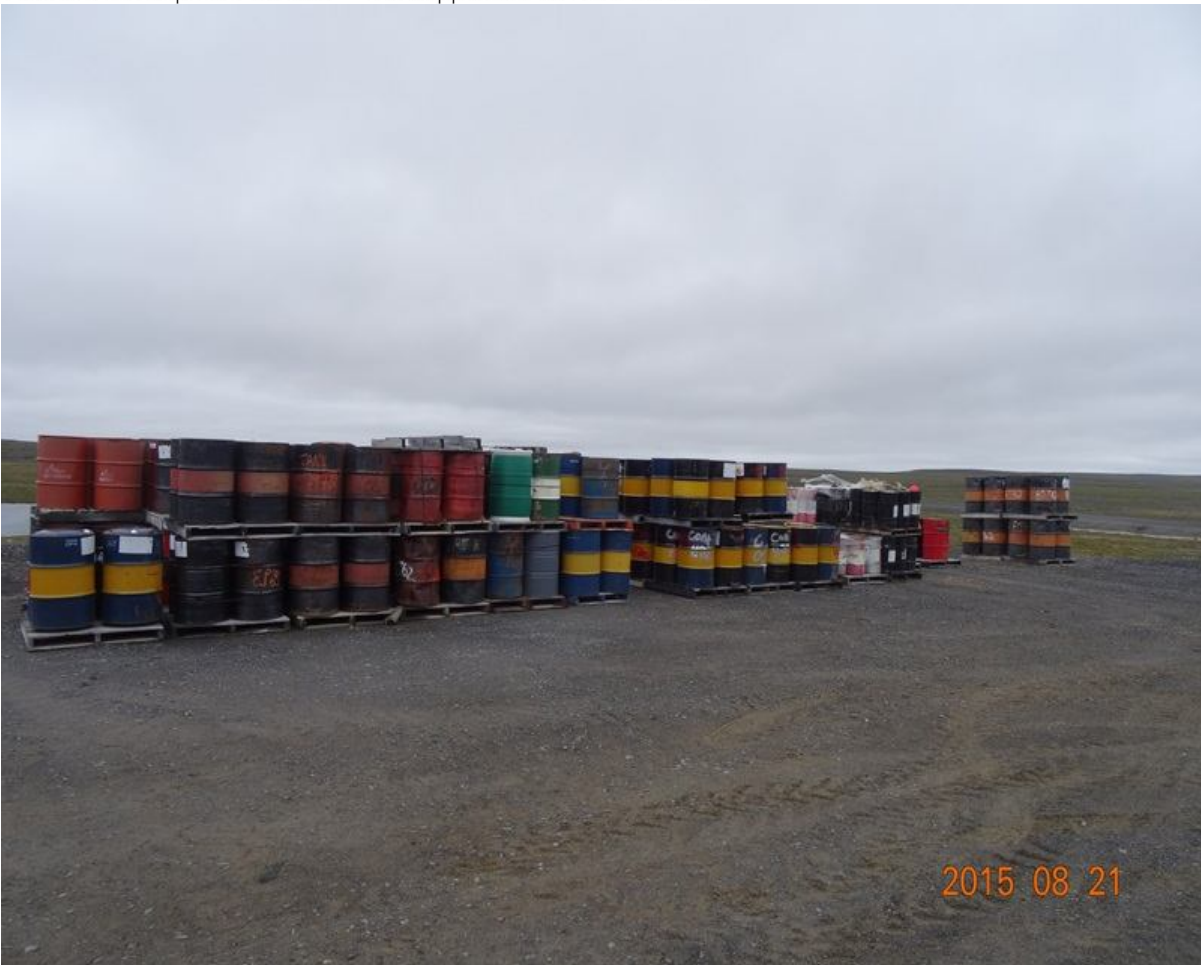
Figure 7 Barrels of waste oil and other waste fluids in Haz Mat Storage Area

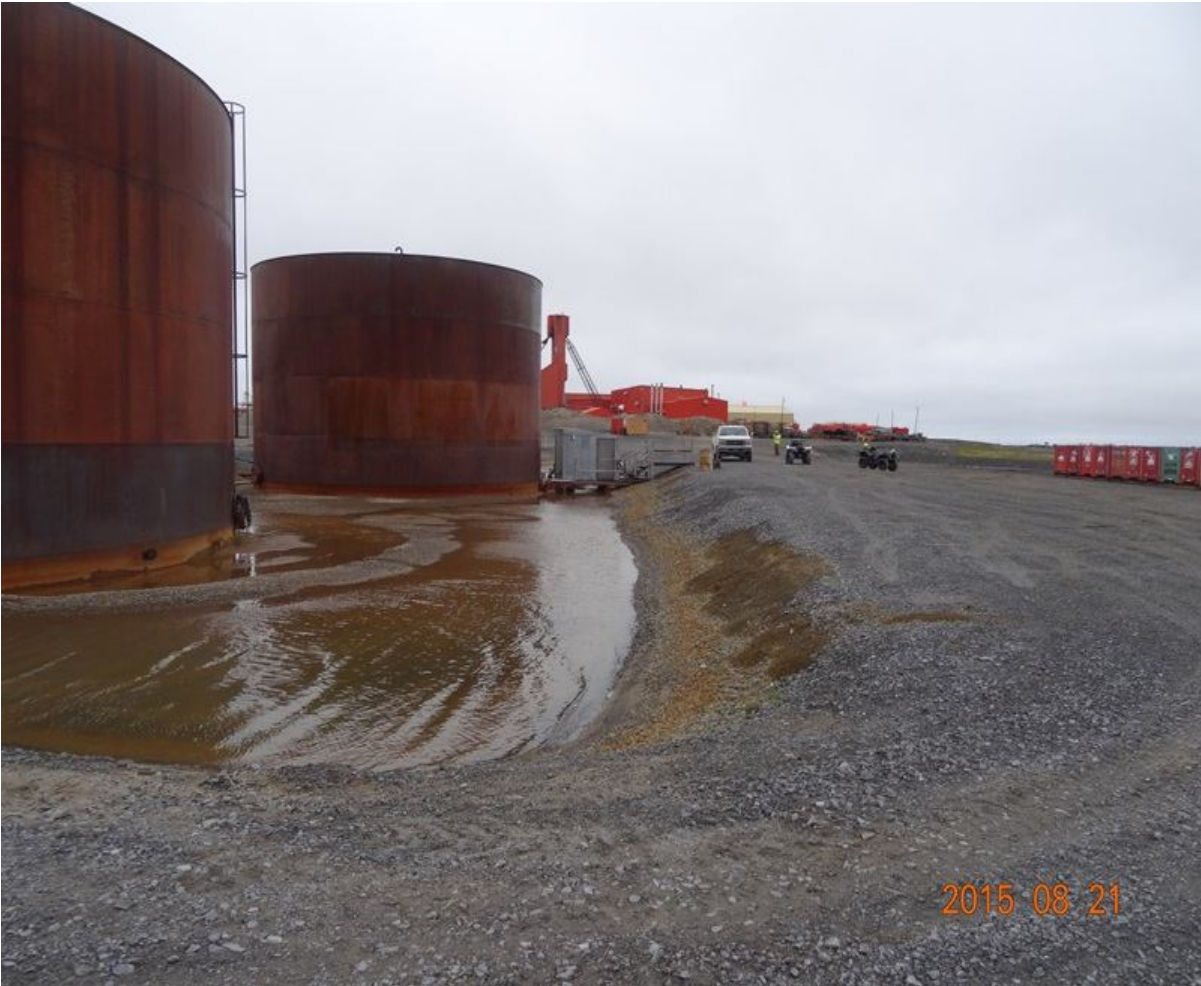
Figure 8 Main bulk fuel tank farm. evidence of work on berm walls

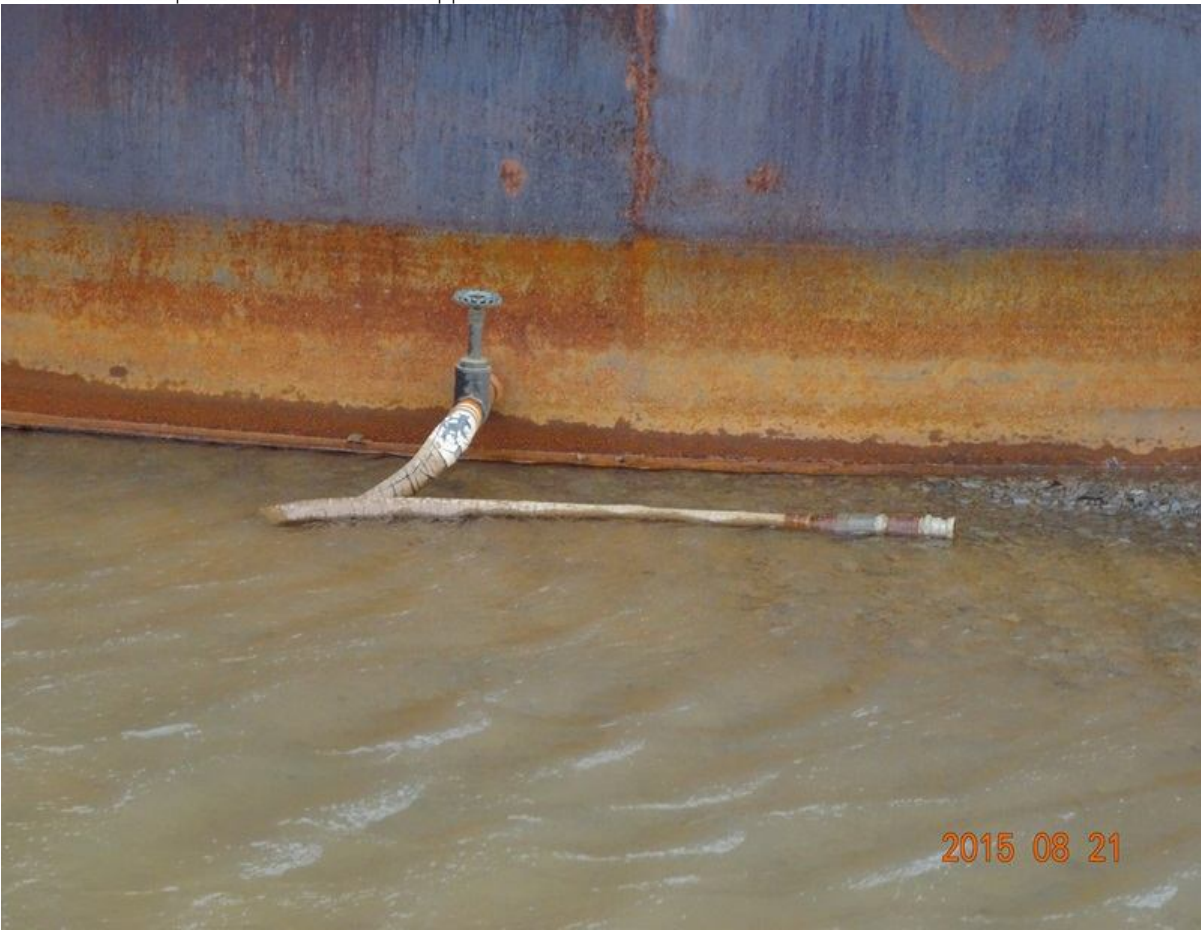
Figure 9 Hose attached to 5 million litre tank within the bulk fuel containment area

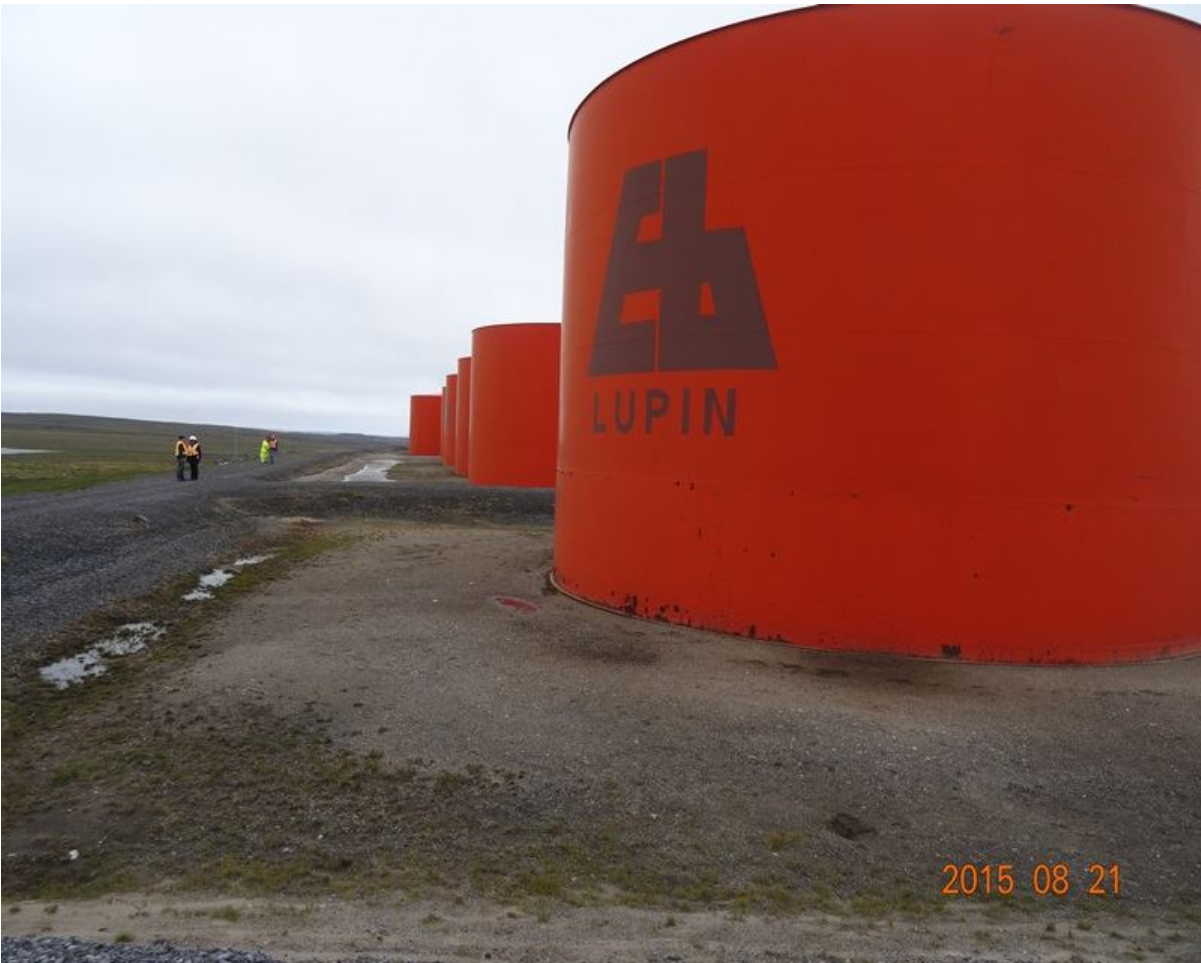
Figure 10 Bulk fuel containment area - painted tanks

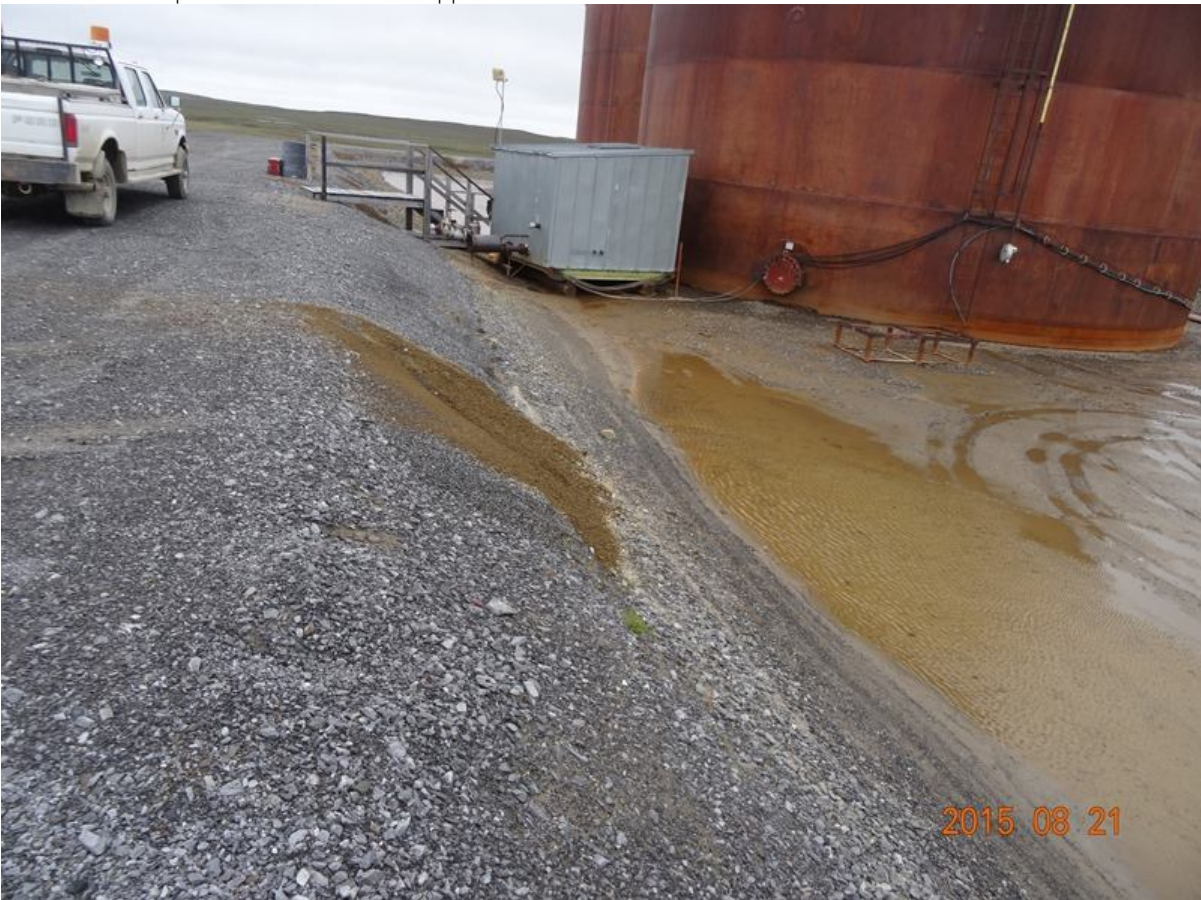
Figure 11 Bulk Fuel tank farm - evidence of work on berm walls.

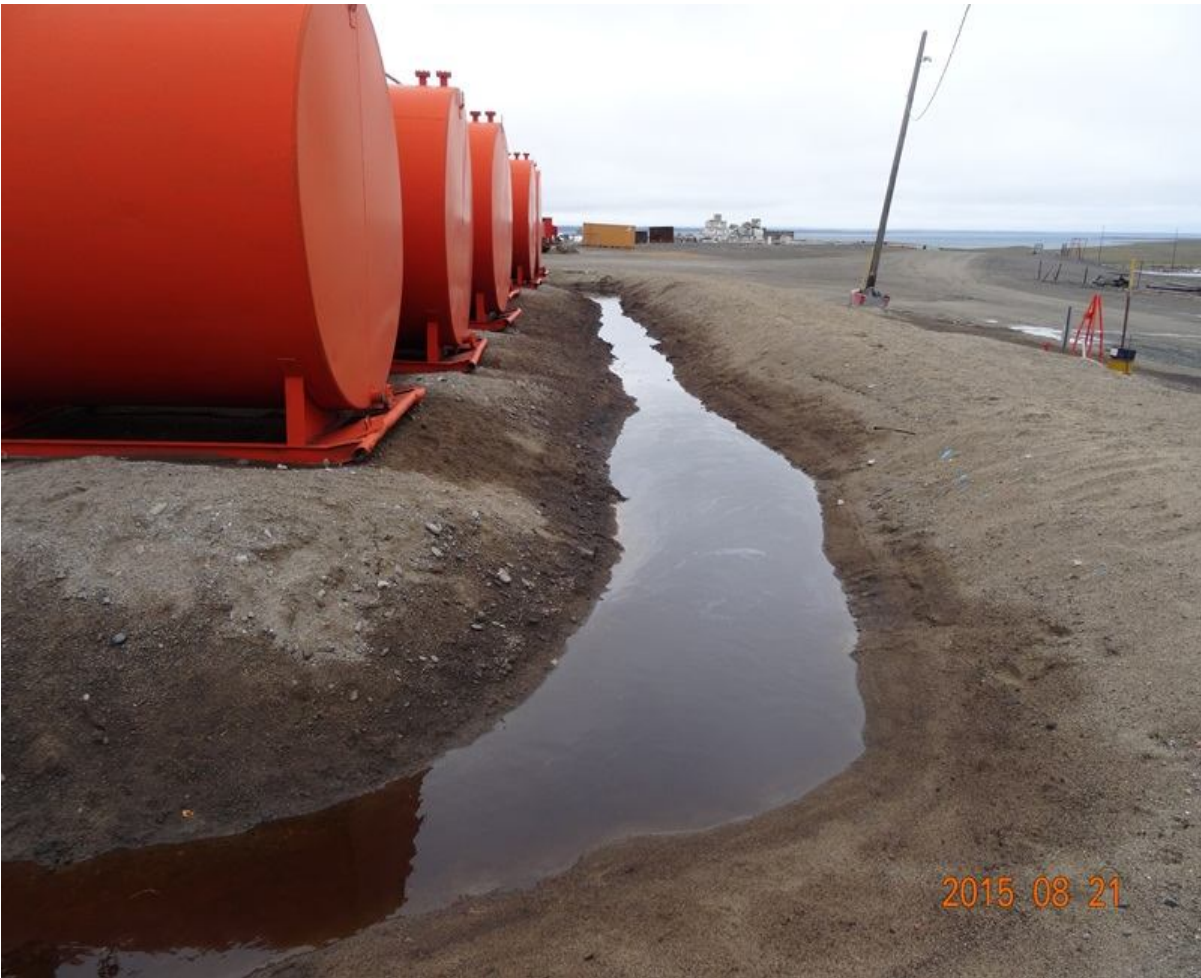
- Within the Bulk Fuel Storage area there were signs of staining and of past spills.
- The Haz mat storage area showed evidence of past spills and staining
- The satellite tank farm was highly contaminated with free product and emulsified fuel/ oil noted within the berm. This contamination had been identified on previous inspections and work to delineate the extent of the spread of contamination and remediate the spill was to have been undertaken. When questions regarding these activities Mr. Downey of LMI indicated that LMI had not undertaken any further work on the contamination pending the construction of a land farm and since the license had expired the only work that could be conducted on site was under the terms of the Inspector’s Direction(s) he could not proceed with this work until a new license was issued.

Figure 12 Satellite tank farm - free product and staining from previous spills

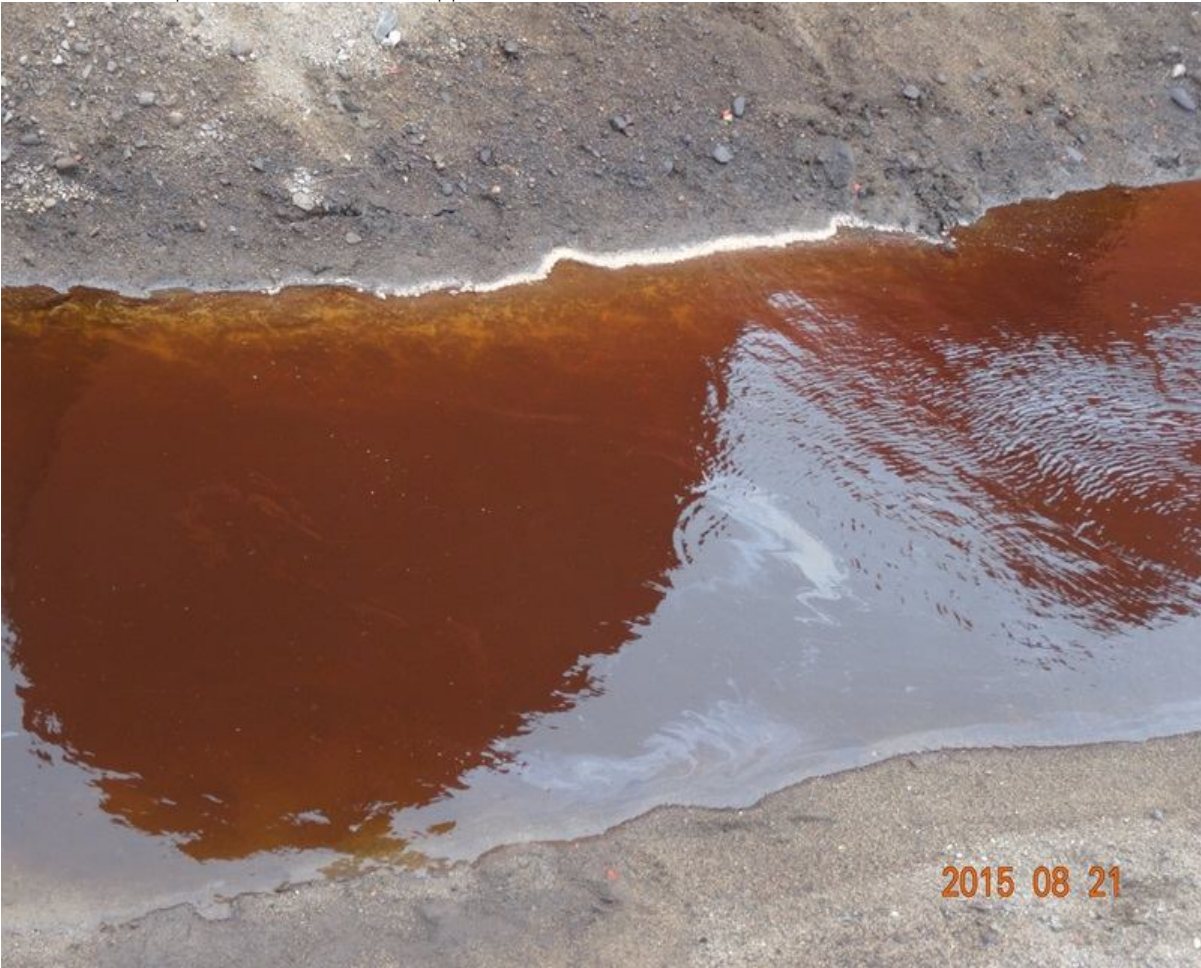
Figure 13 Satellite tank farm free product and emulsified oil on surface of water

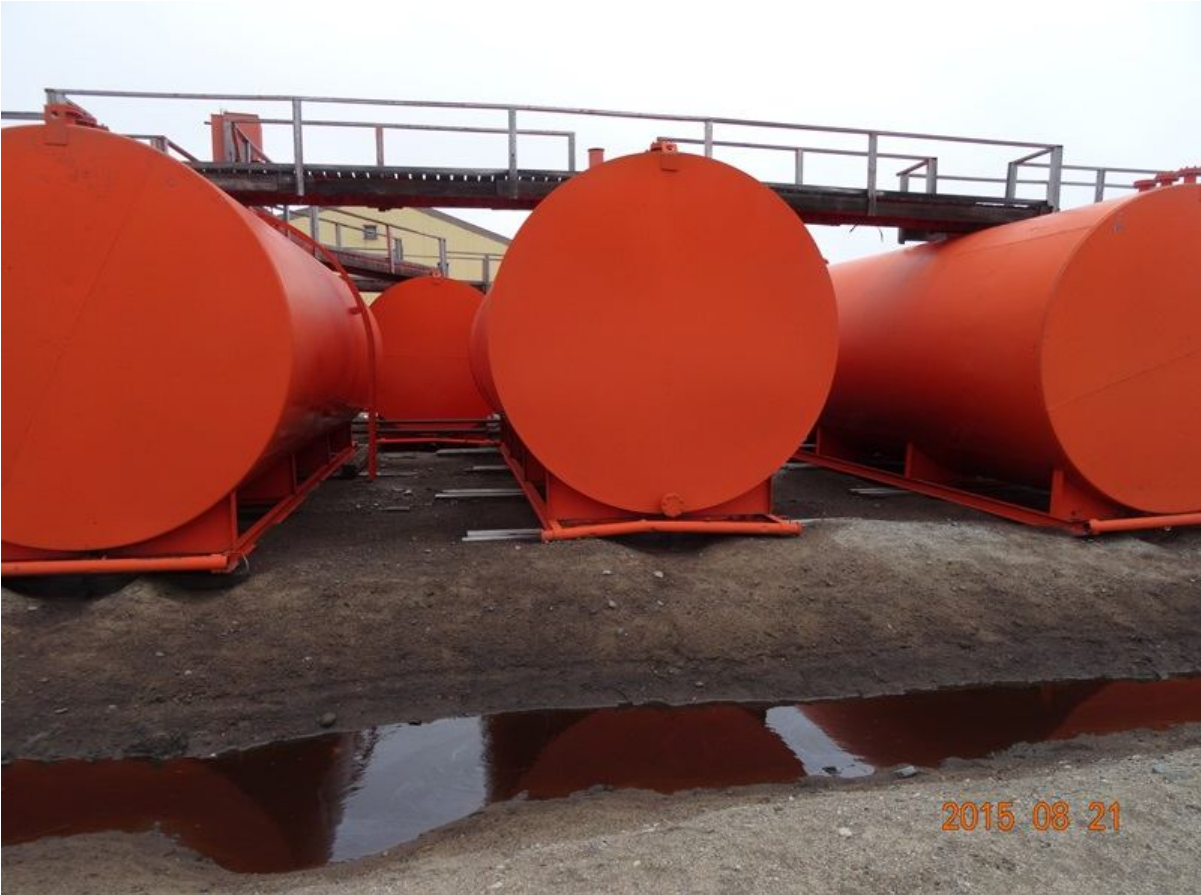
Figure 14 Satalitte tank farm - surface staining

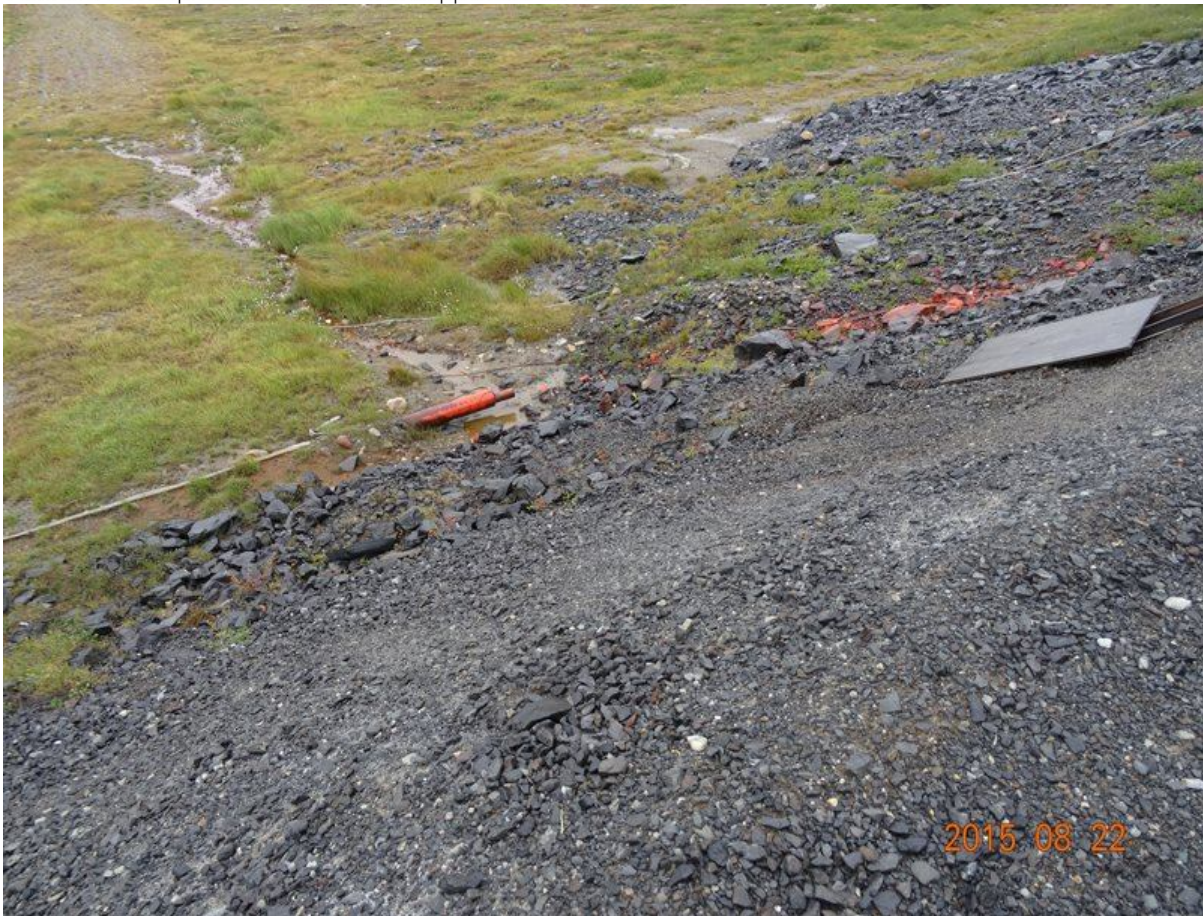
Figure 15 Drainage and flow from back side of Bulk Fuel storage tank farm berm

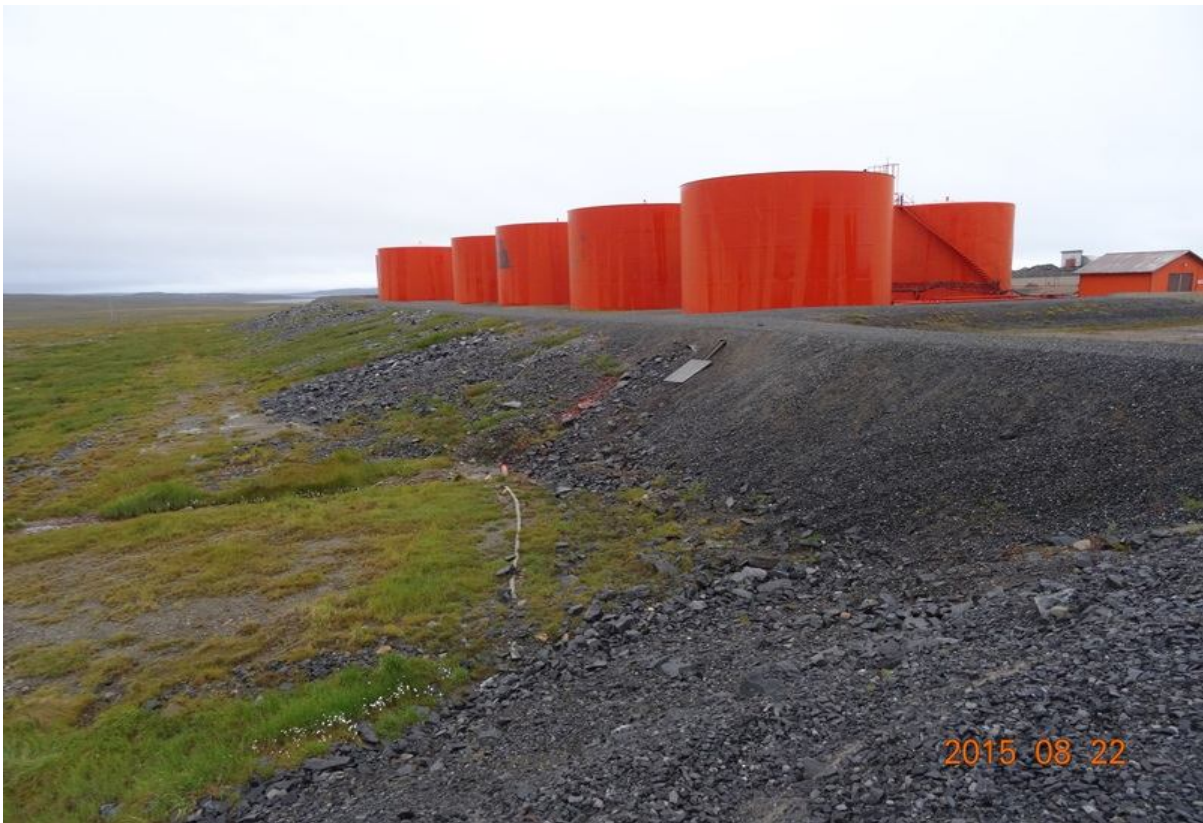
Figure 16 Back side of Bulk Fuel Storage tank farm.

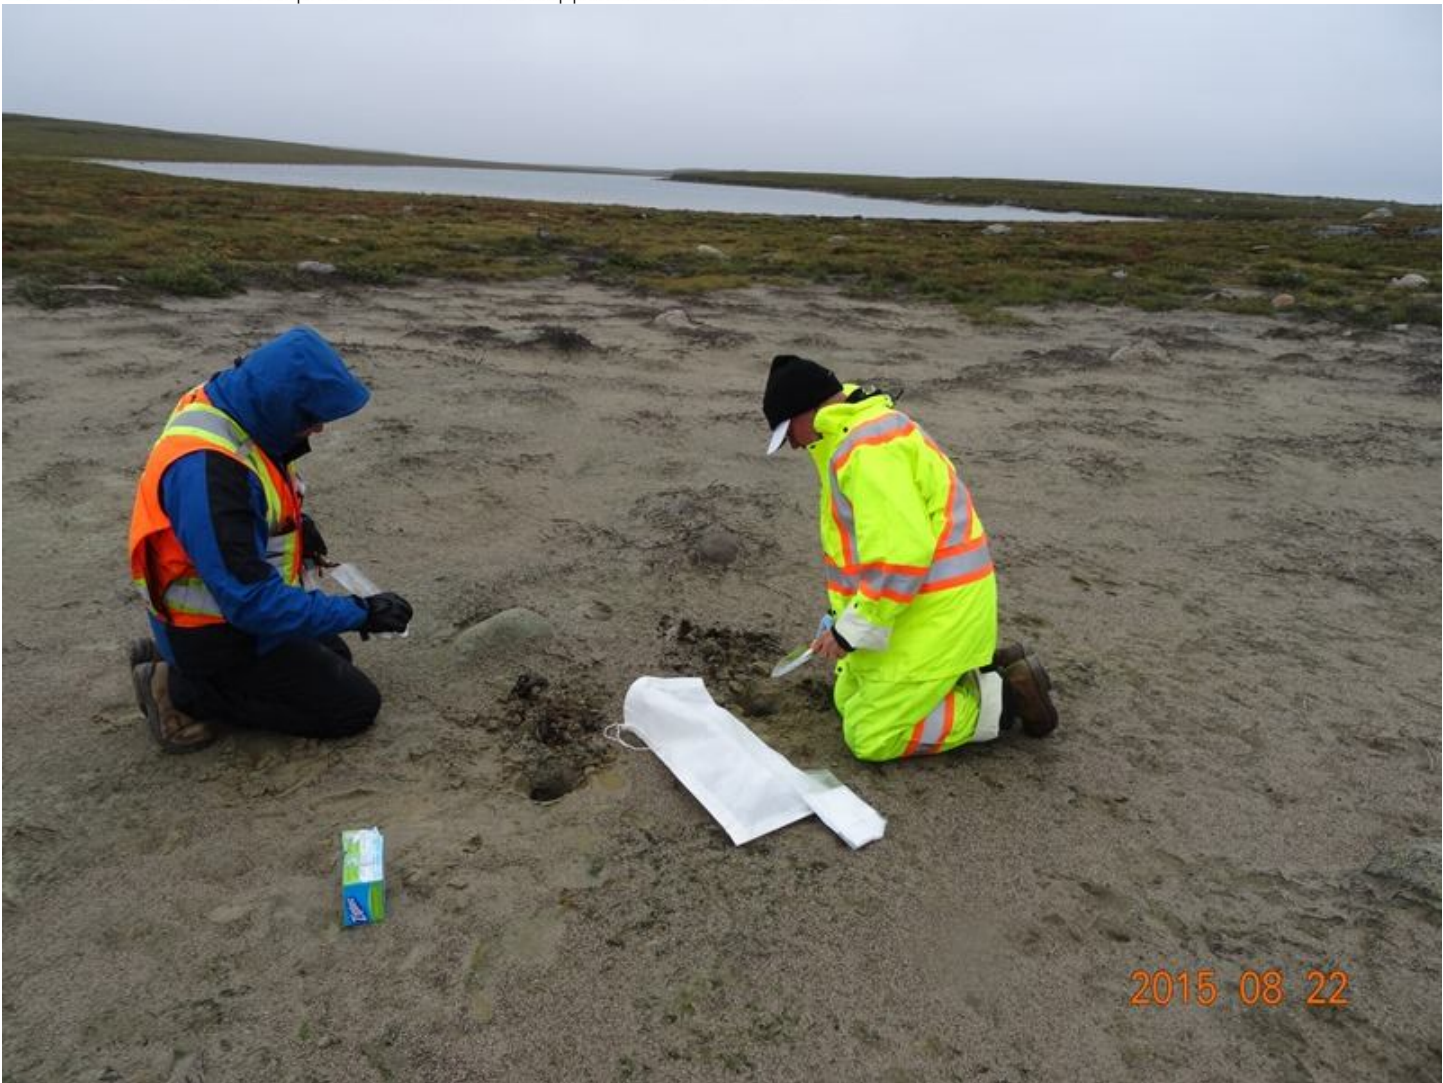
During the Inspection of the Tailings containment areas it was identified by the Inspector that areas within the facility contained tailings that were not covered by either granular material or water. These exposed tailings may pose a danger to the environment if they are transported outside the containment areas. This has been identified on numerous inspections of the site going back a number of years and to date there appears to have been no work undertaken to address this by LMI.
While on site the consultant, Mr. Barry Cook collected a number of surface samples both inside the tailings containment area and adjacent in an effort to determine if uncovered tailings are being ejected outside the containment area. Mr. Tong of SRK collected duplicate samples for the licensee at the same time.

Figure 17 Site of soil sample collection

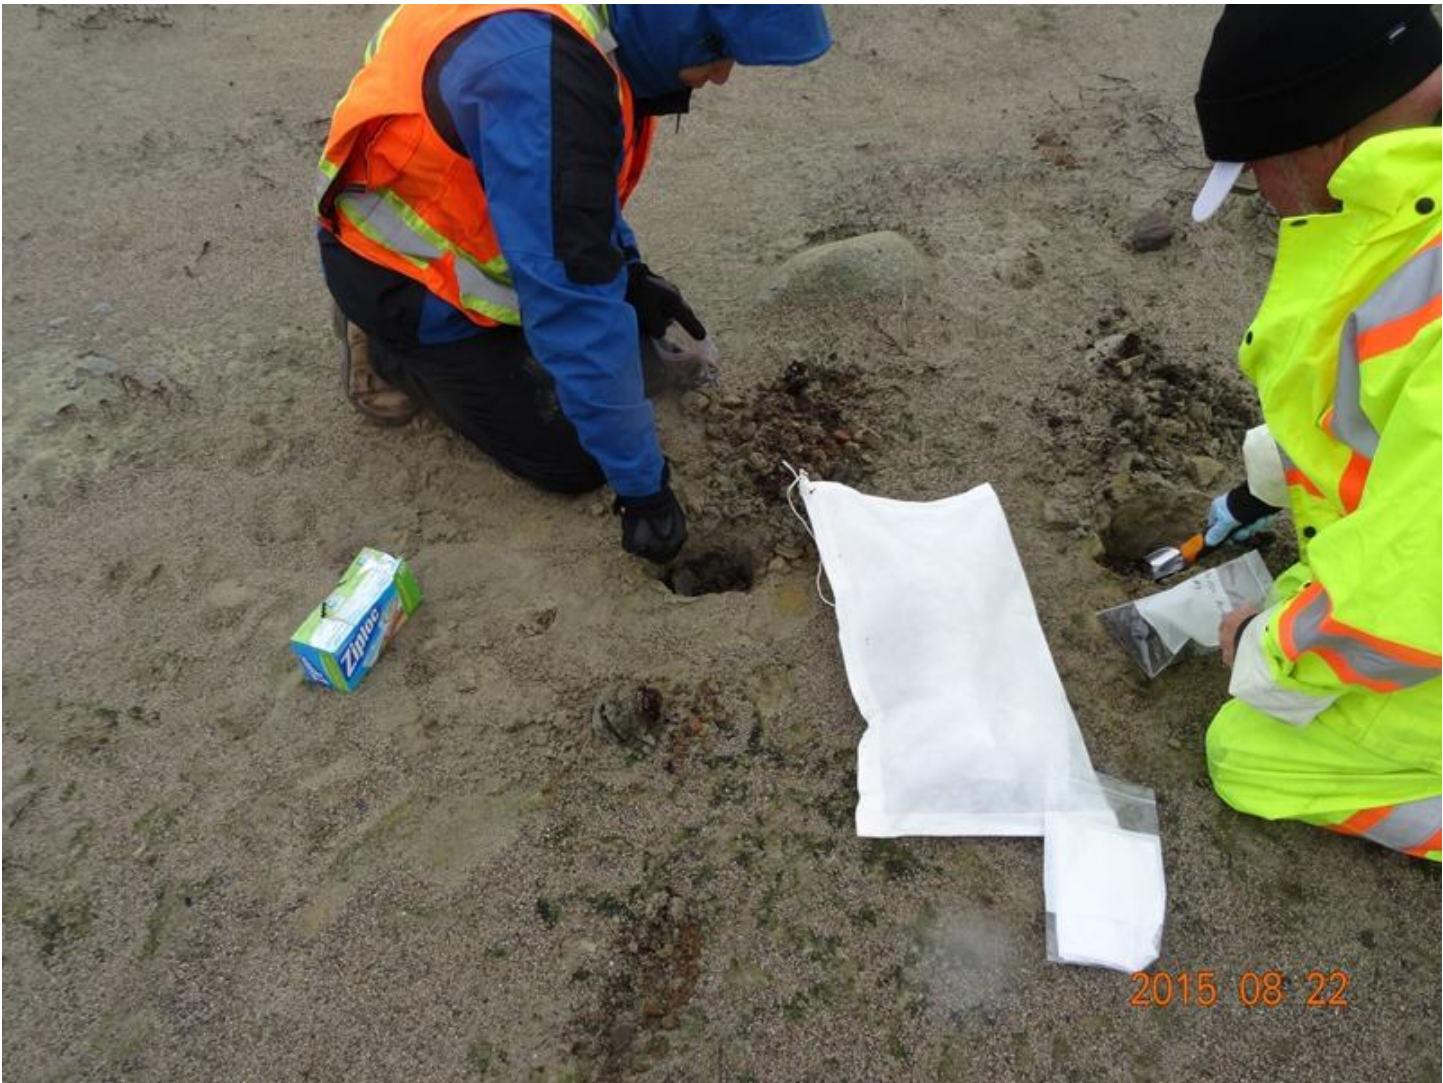
Figure 18 close up of duplicate samples collected by Consultants

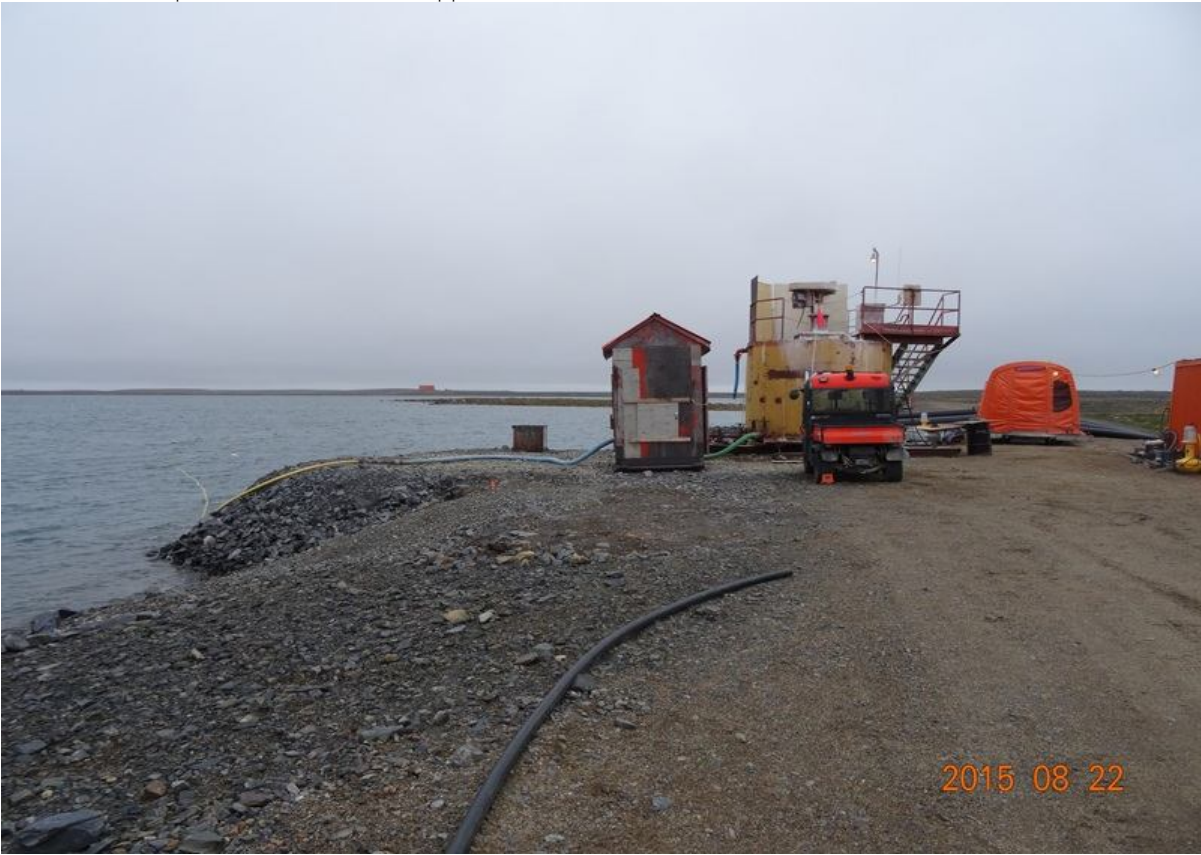
Work to treat the contact water within the tailings containment area was on-going during the period of Inspection. This work is required during the 2015 year to prevent damage to the facility as no treatment or decanting within the facility has been undertaken in a number of years. The resulting accumulation of contaminated contact water has resulted in a risk to the integrity of the Water Management structures in place. As the Licensee does not have a current water license the activities are being undertaken under the authority of an Inspector’s Direction issued pursuant to Section 87 of the Nunavut Water and Nunavut Surface Rights Tribunal Act.

Figure 19 Contact water from within the tailings containment area - Lye mixing station on berm wall
