WATER LICENCE INSPECTION FORM

Licensee		Licensee Representative	
Lupin Mines Inc		Karyn Lewis/ Pat Downey	
Licence No. / Expiry		Representative's Title	
2AM-LUP09/14 (expired and amended)		Consultant/ Owner	
Land / Other Authorizations		Land / Other Authorizations	
8WLC-LUP1516			
Date of Inspection		Inspector	
20-23/08/2015		A. Keim	
Activities Inspected			
<input checked="" type="checkbox"/> Camp	<input type="checkbox"/> Drilling	<input type="checkbox"/> Mining	<input type="checkbox"/> Construction
<input checked="" type="checkbox"/> Roads/Hauling	<input type="checkbox"/> Other: Water Discharge	<input type="checkbox"/> Reclamation	<input checked="" type="checkbox"/> Fuel Storage
		<input type="checkbox"/> Other: Municipal

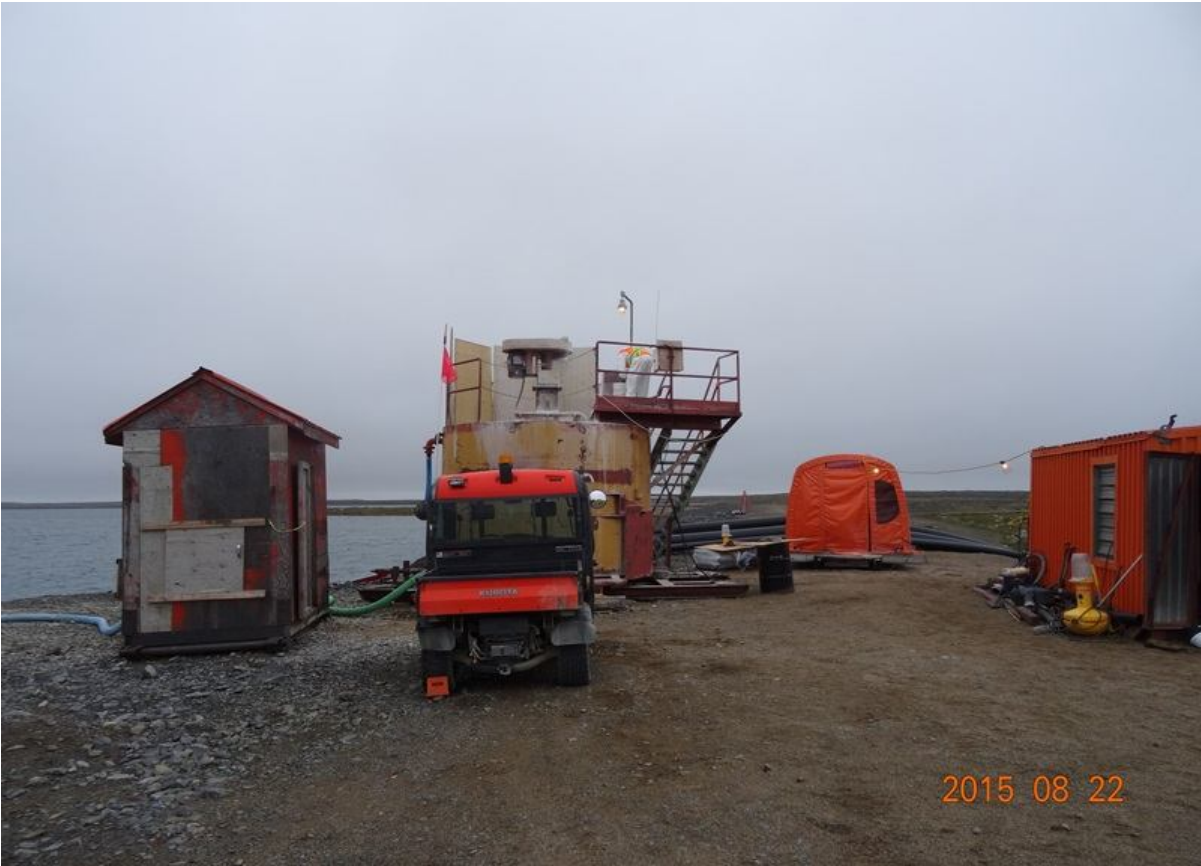
Figure 20 Mixing station

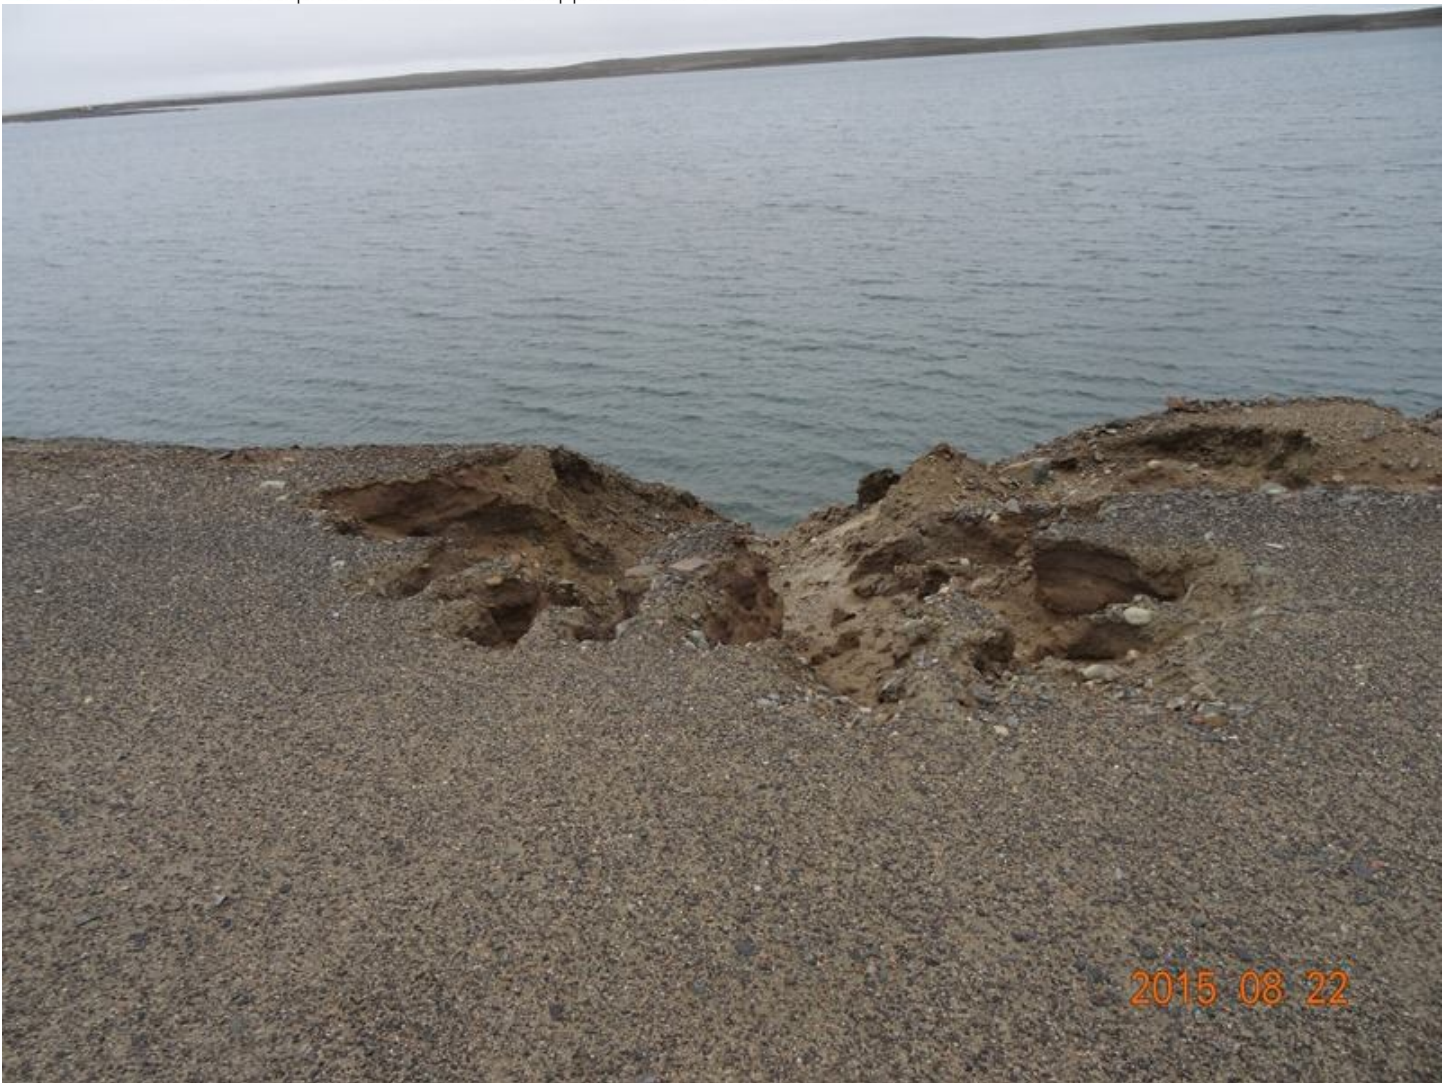
- Erosion and wind/water scour were identified as present on internal water management/ containment berms (Dams M and K) within the Lupin Mine footprint during the period of Inspection. These were photographed and documented by the Inspector. Work on Internal Dam M had not yet undertaken by the licensee.

Figure 21 Erosion at Berm M

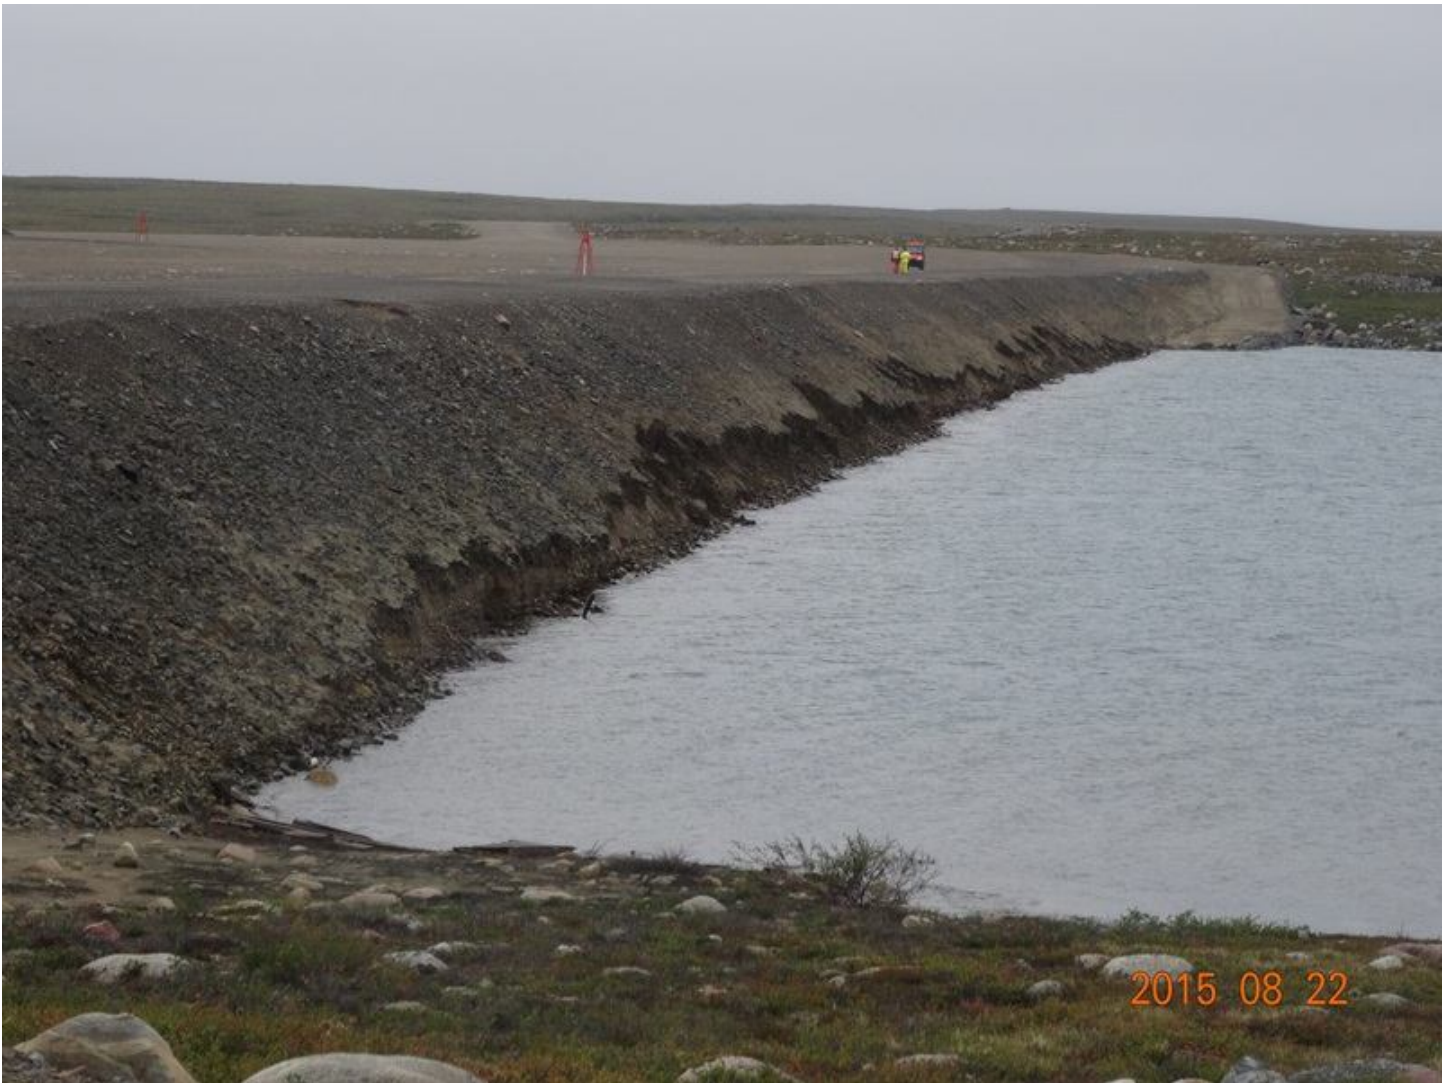
Figure 22 Water / surf scour and erosion of berm walls within the TCA.

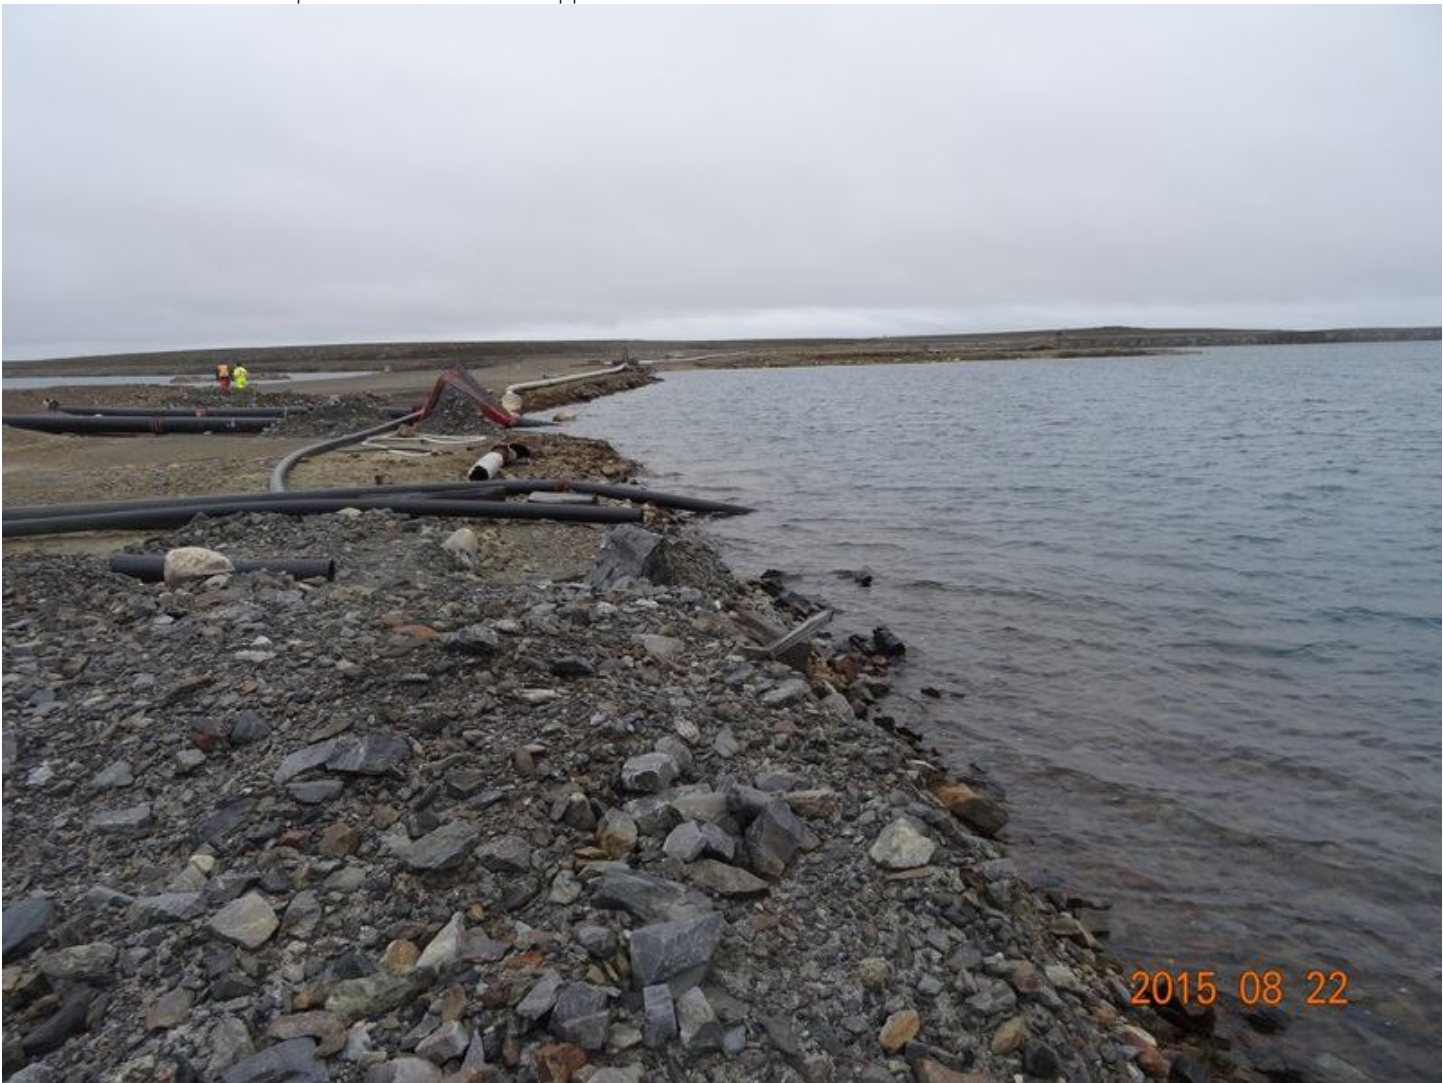
Figure 23 Berm wall less than 1 meter of free board as required by License

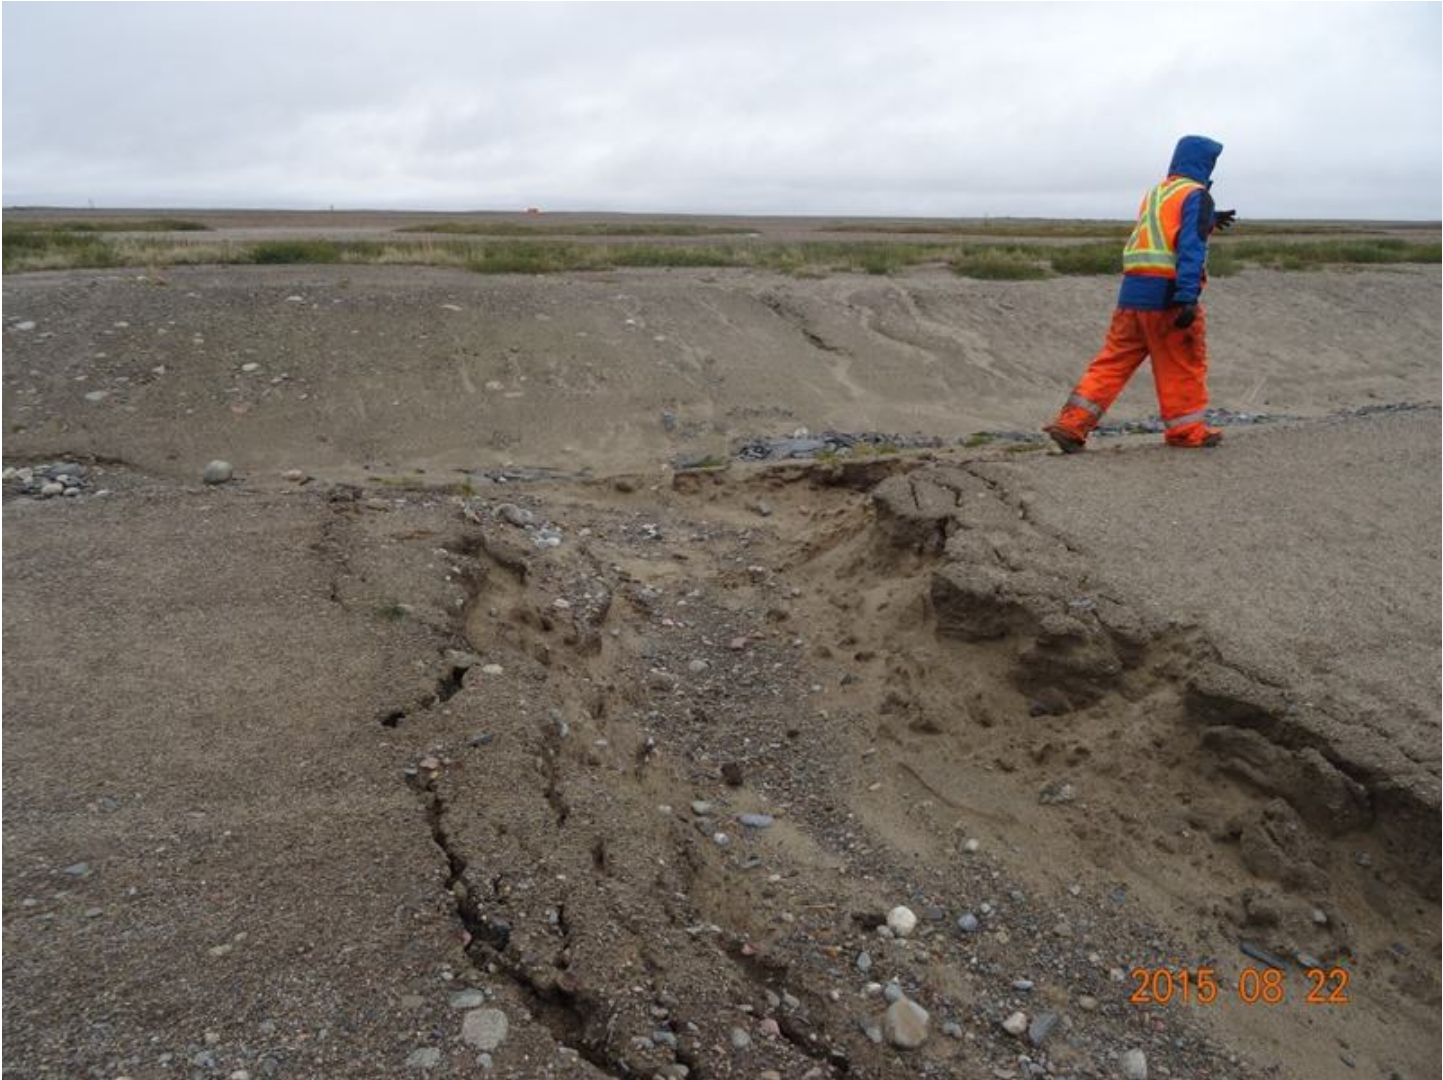
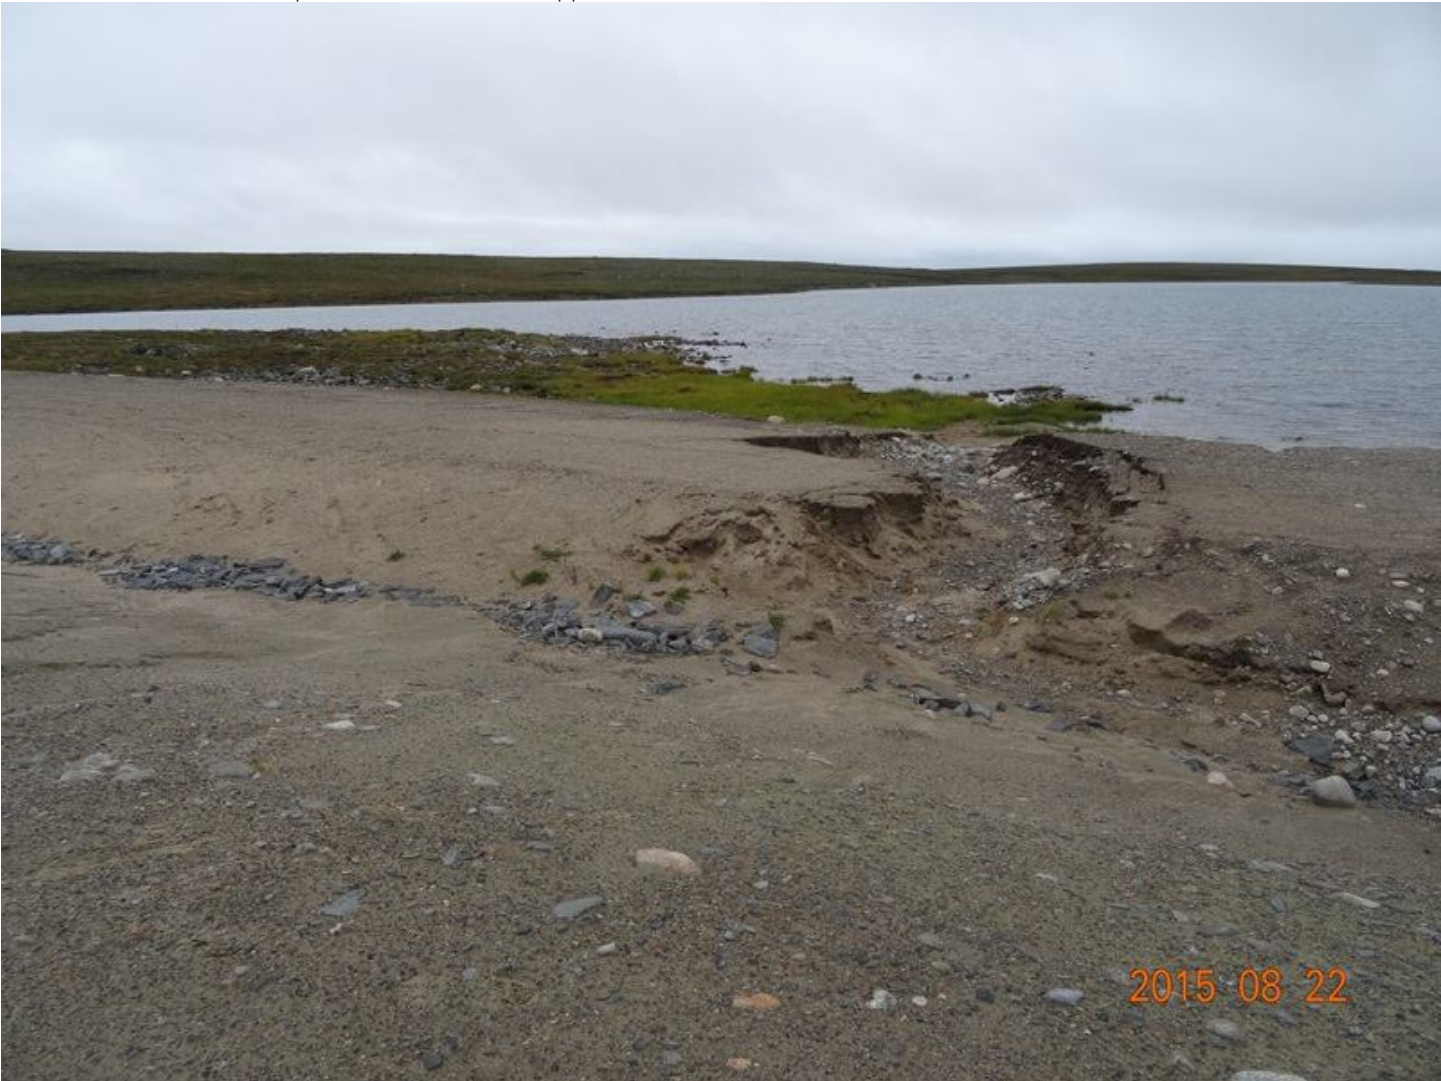
Figure 24 Wash out at Dam 3

Figure 25 Wash out at Dam 3 (2)

- A wash out of Dam 3 (tailings impoundment area) was identified and the Licensee committed to addressing this through the construction of a saddle dam, reinforcement of the berm in the wash out location, and a regrading of the run-off ditch to prevent melt water accumulation at this point prior to the end of the 2015 field season.
