Re: 2AM-LUP0914- Lupin Mines Incorporated – Lupin Mine Project – Renewal Application

Appendix 1: 2AM-LUP0914 PHOTOS OF INSPECTION, July 15 2014

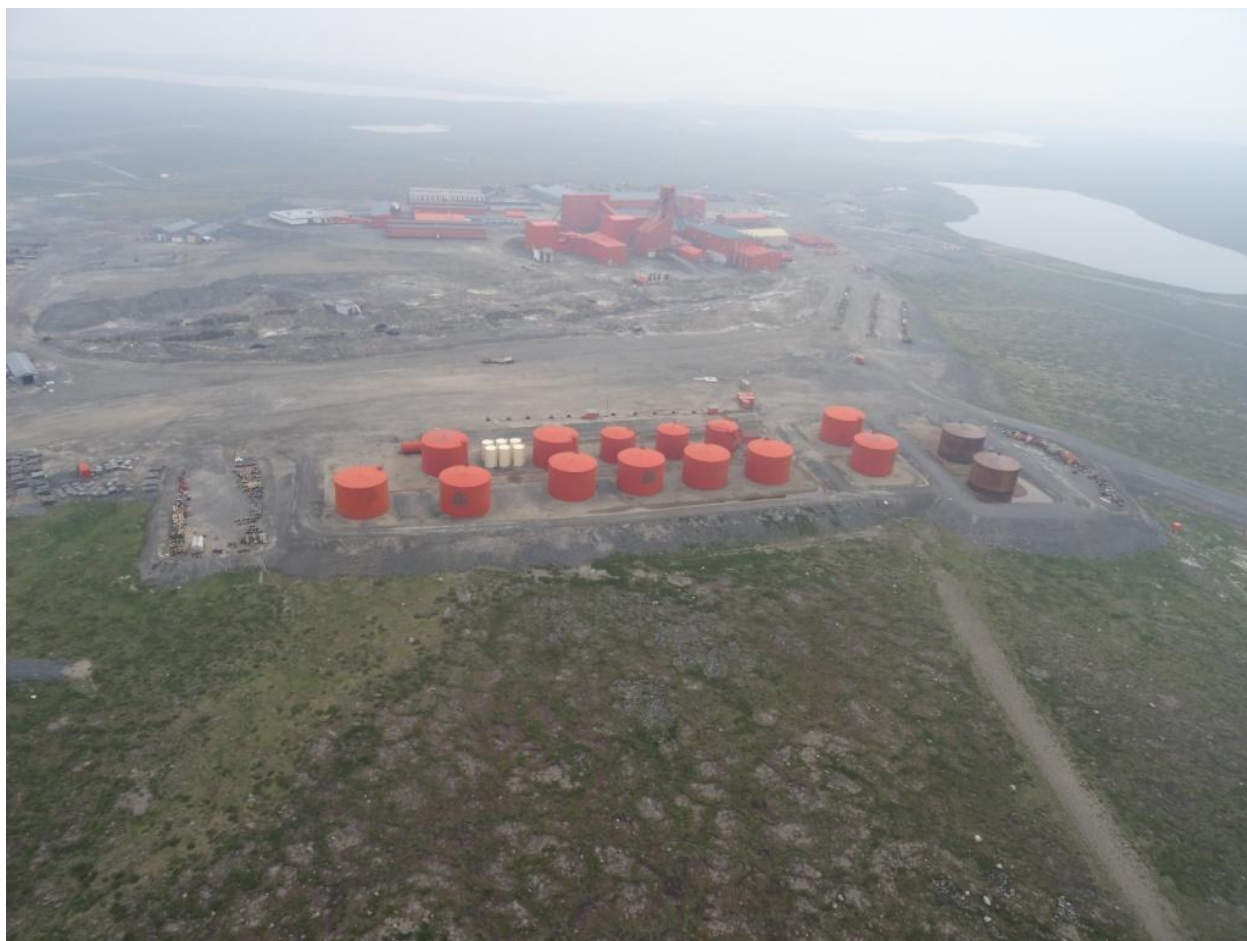
Figure 1. Lupin Mine Site from the air July 15 2014. Main tank farm in the foreground.

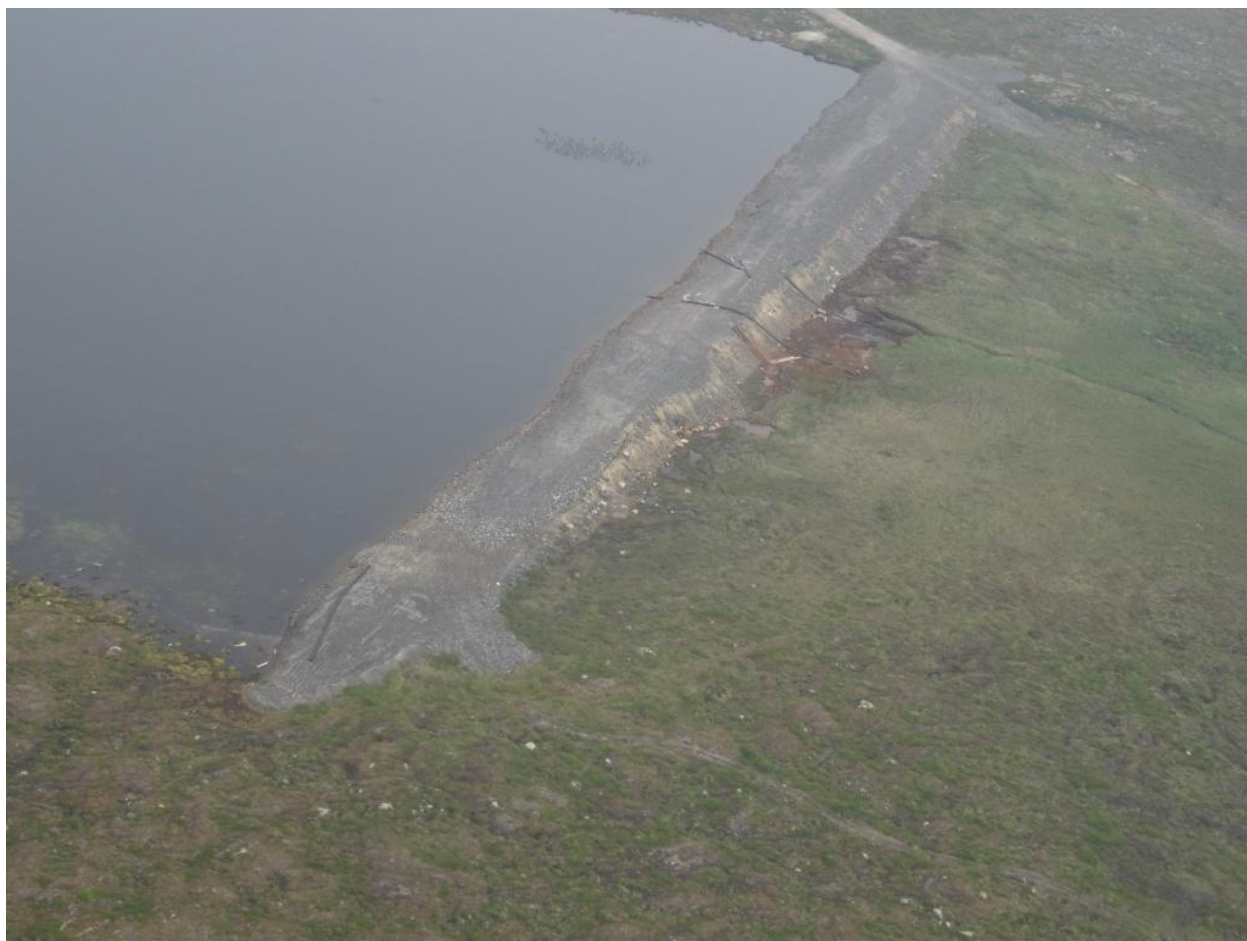
Figure 2. Aerial view of the dam at Lower Sewage Lagoon (LSL).

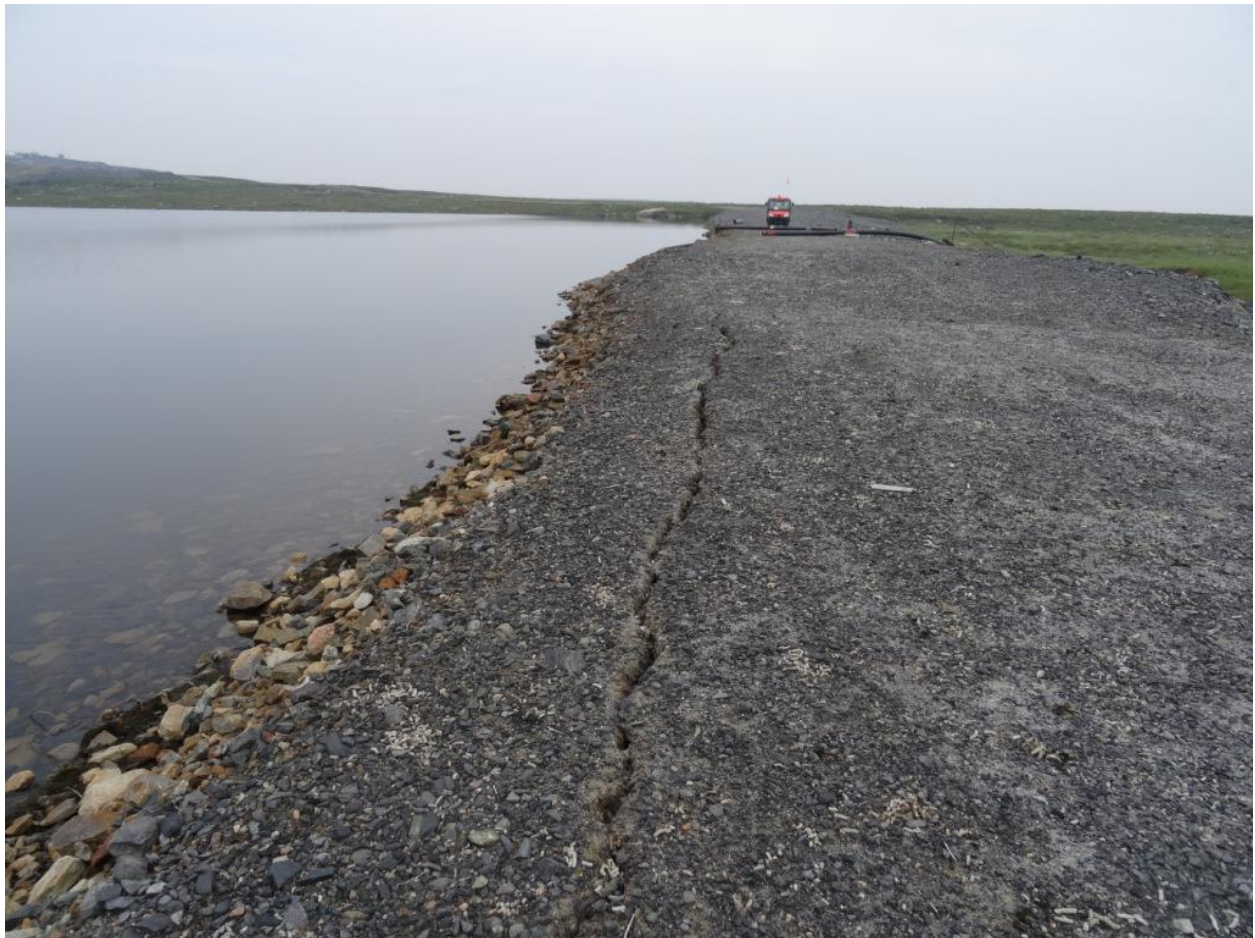
Figure 3. Crack in the dam at LSL.

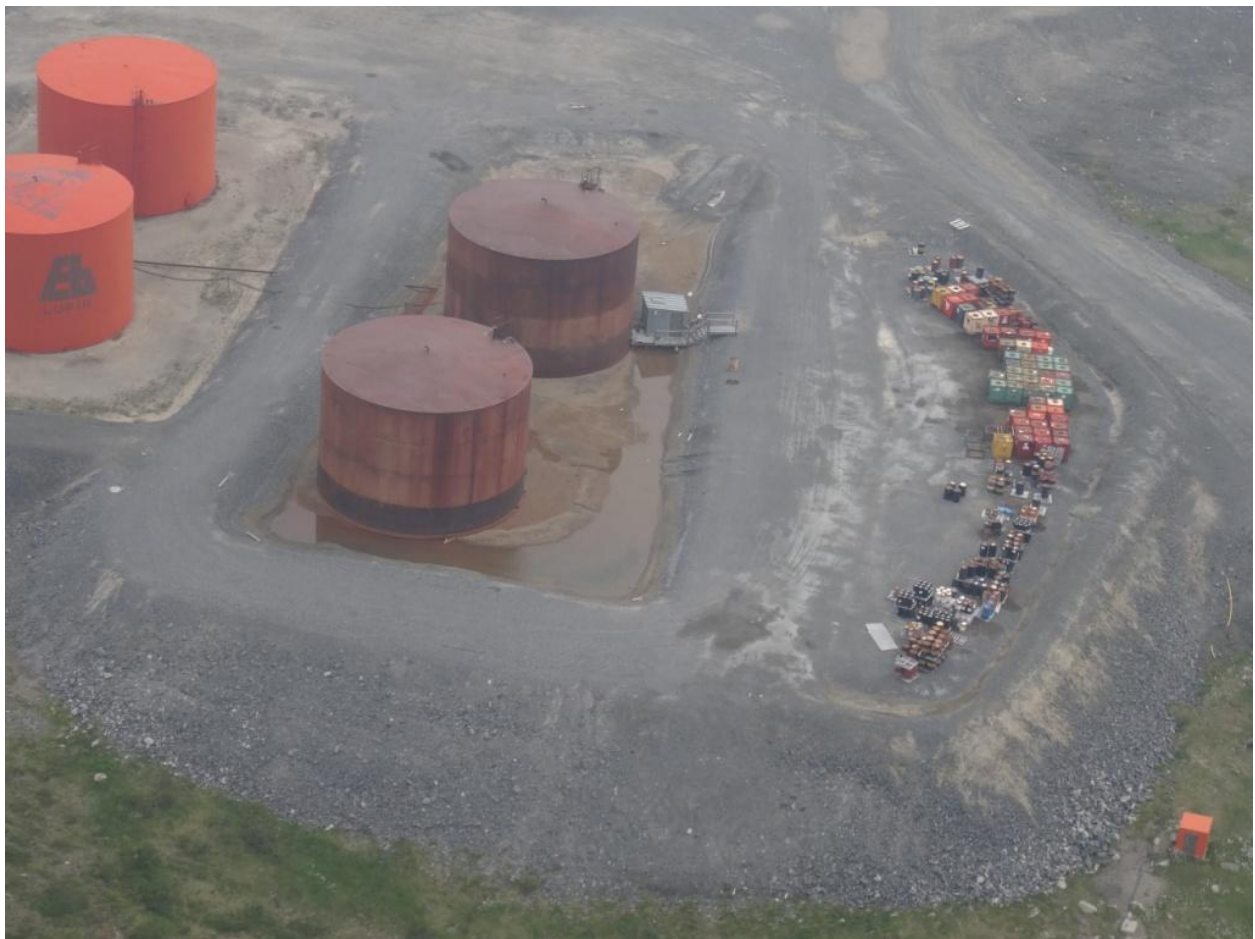
Figure 4. Main tank farm (MTF) and Hazardous Waste Storage.

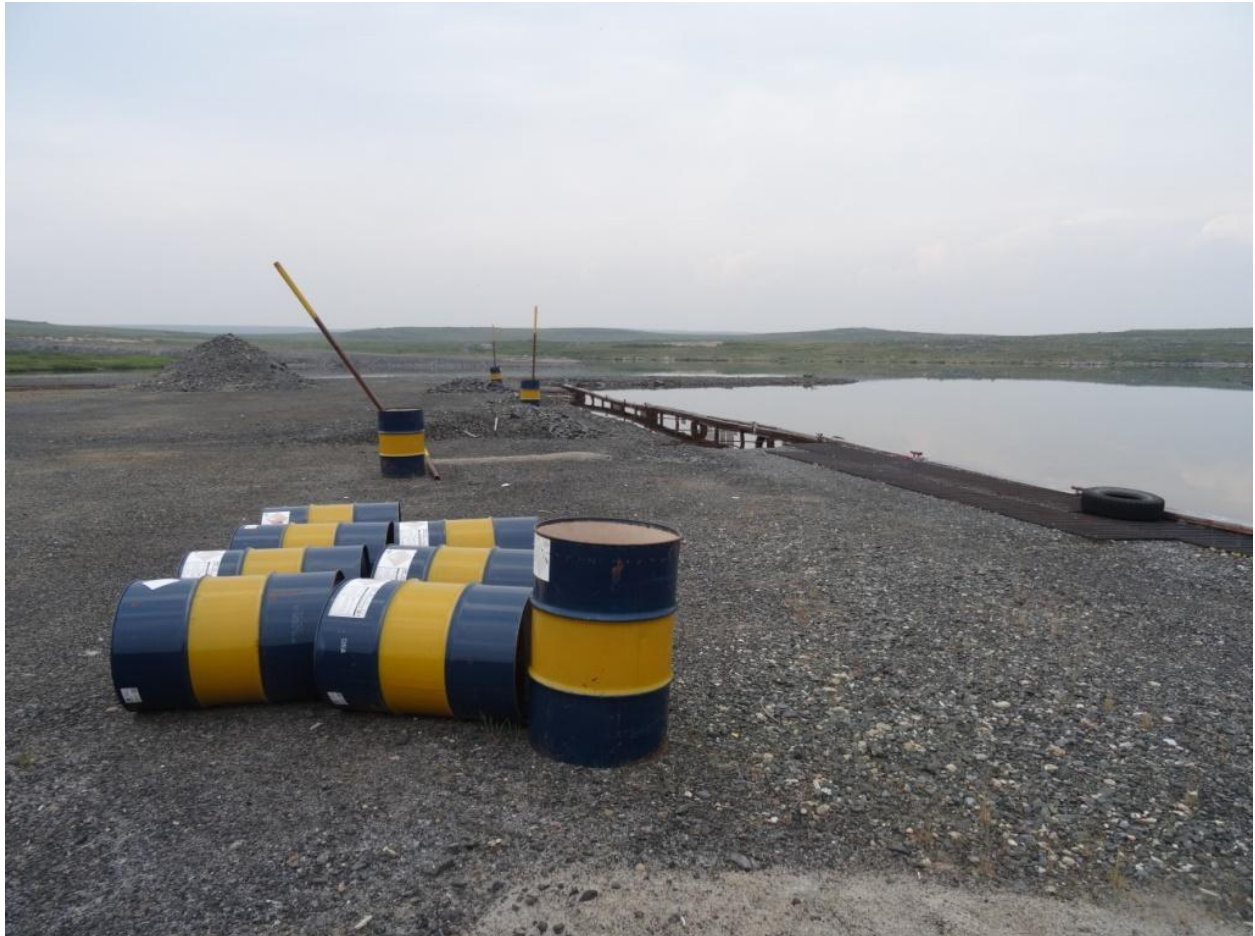
Figure 5. Barrels left near the lake at the water intake. Barrels were left by Water Survey Canada without authorization.

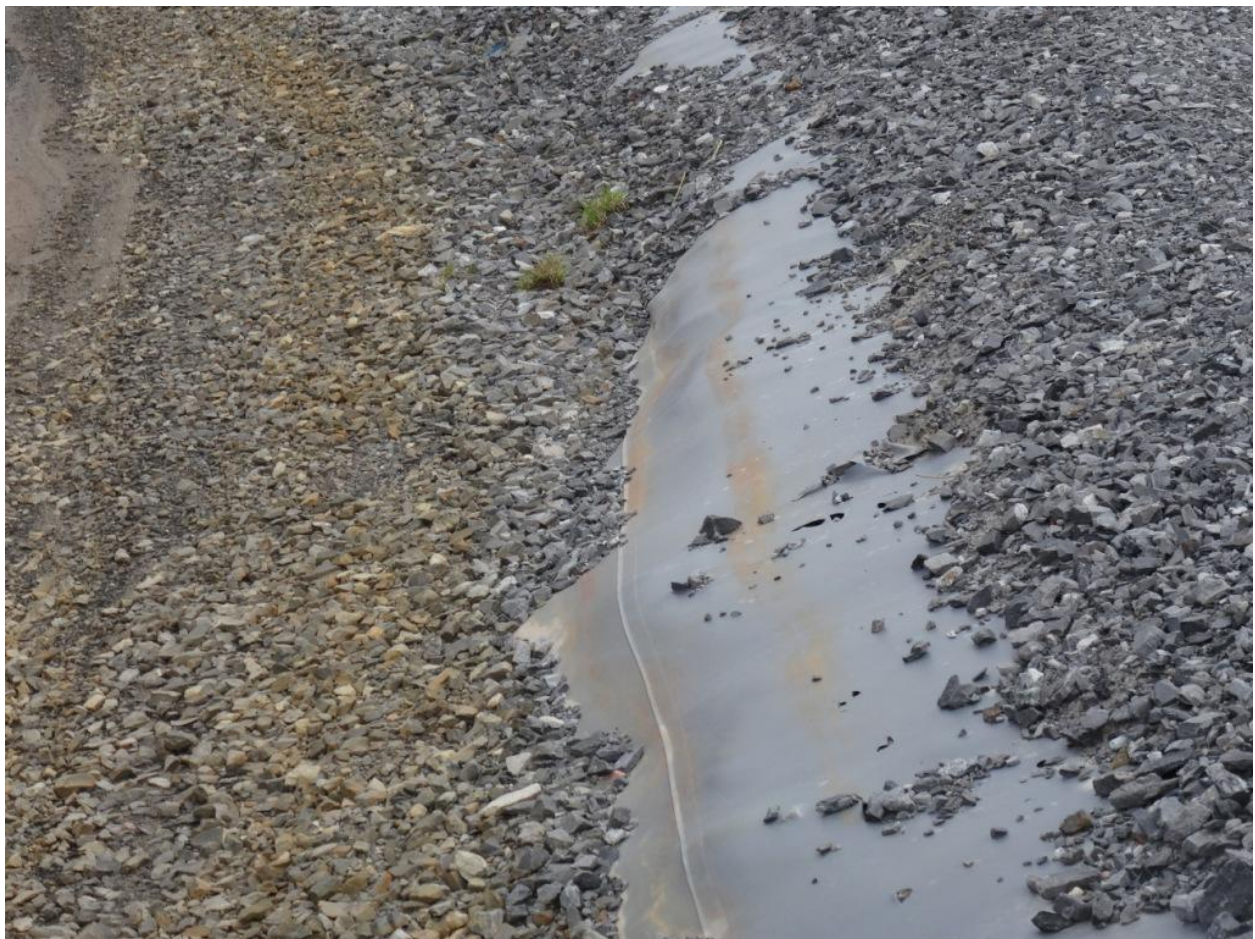
- no significant reduction in hazardous waste on site since 2012;
 - un-repaired erosion of TCA Road at Dam 6;
 - un-tended rips in the lining of the main tank farm;

Figure 6. Rips visible in the exposed liner at the MTF.

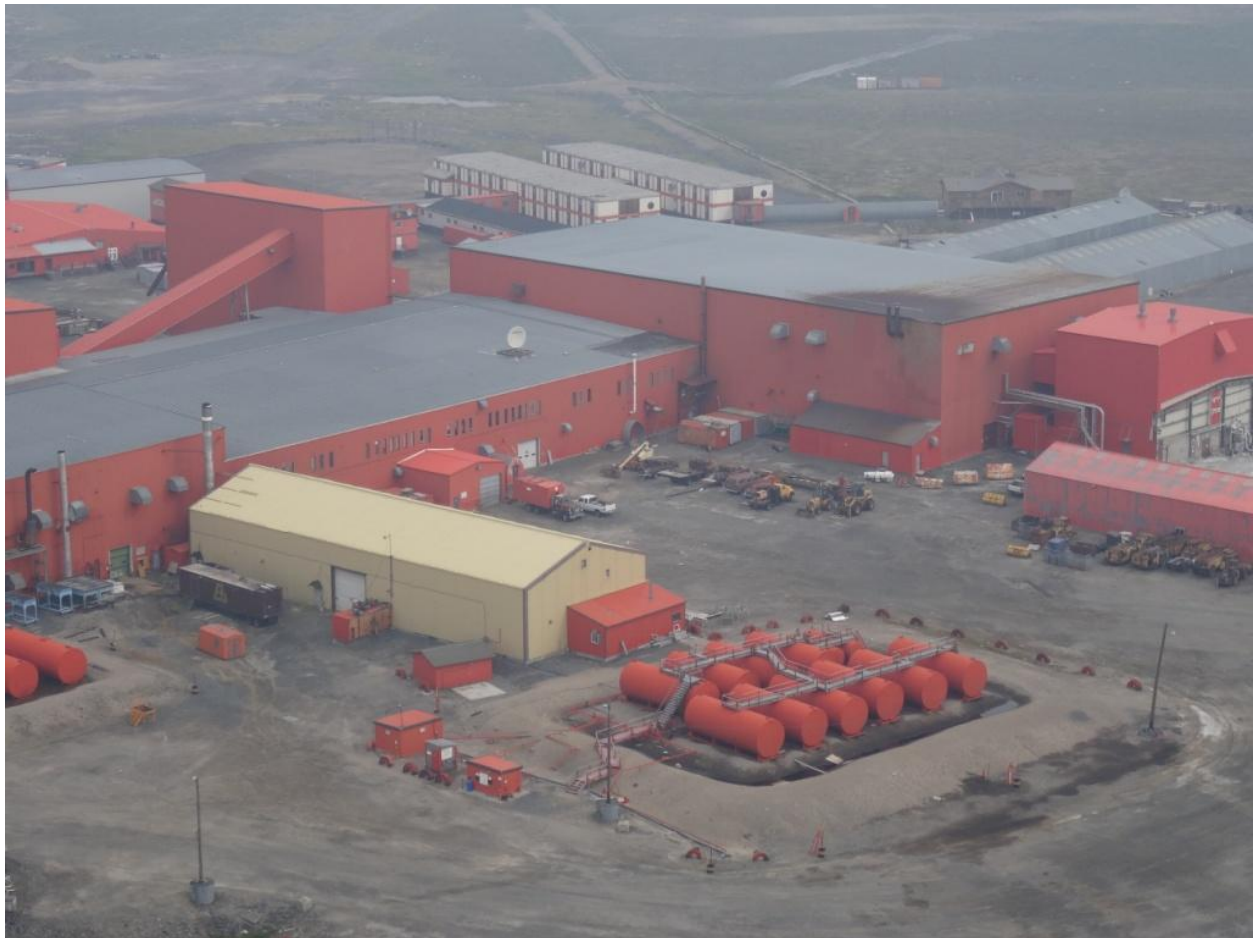
Figure 7. Satellite Tank (STF) Farm from the air. Heavy staining visible within and without.

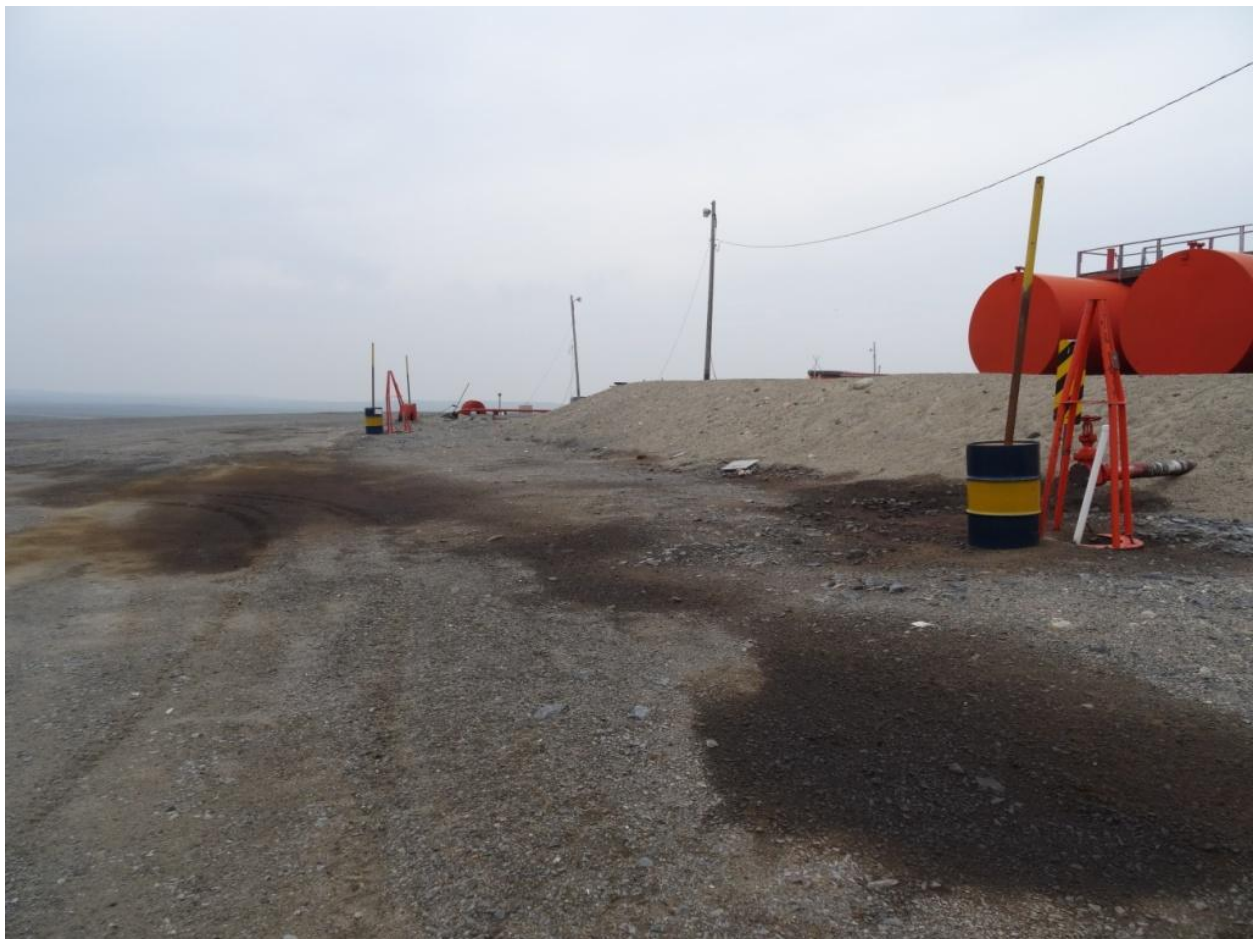
Figure 8. Staining outside the STF berm.

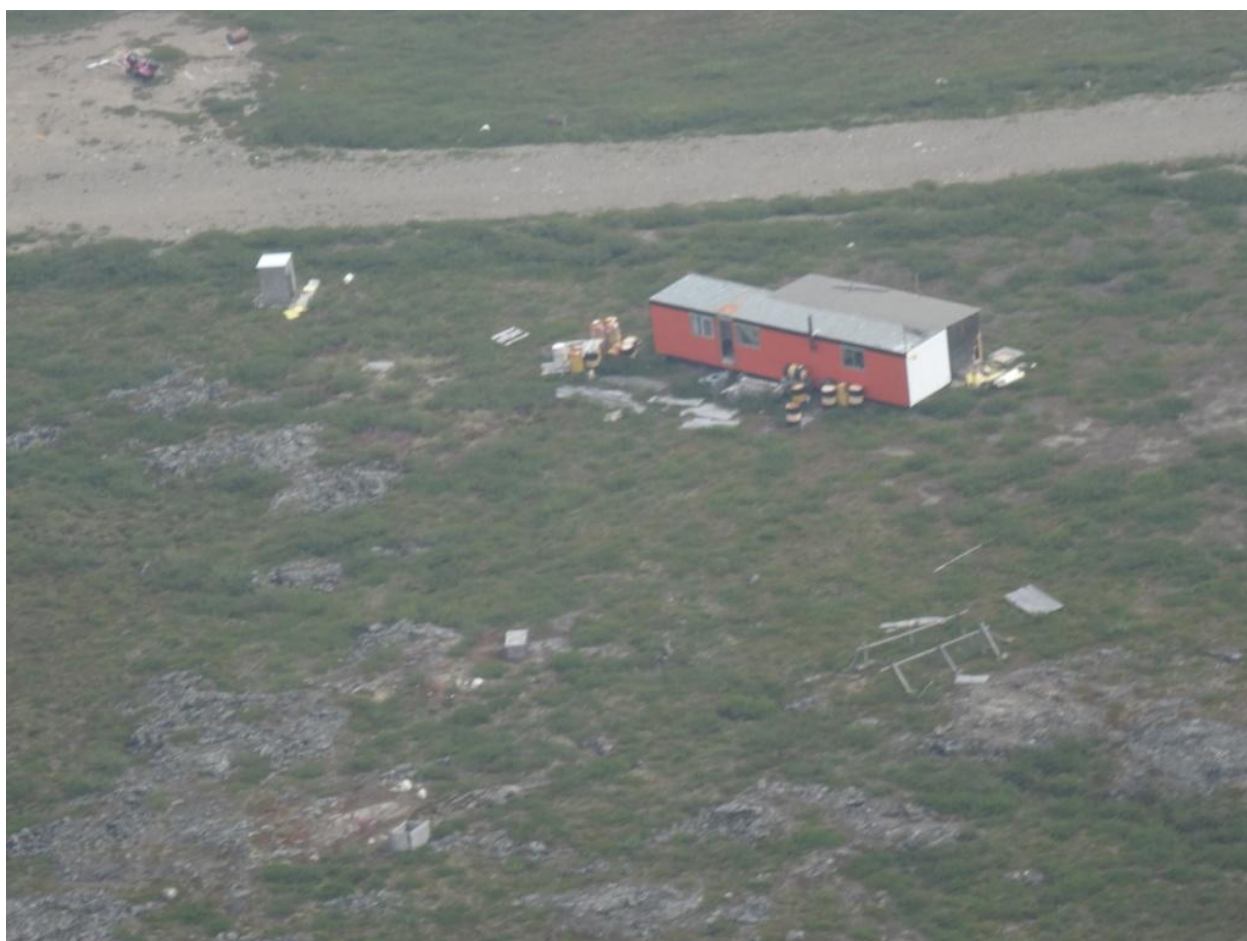
Figure 9. Barrels noted at shack past the quarry.

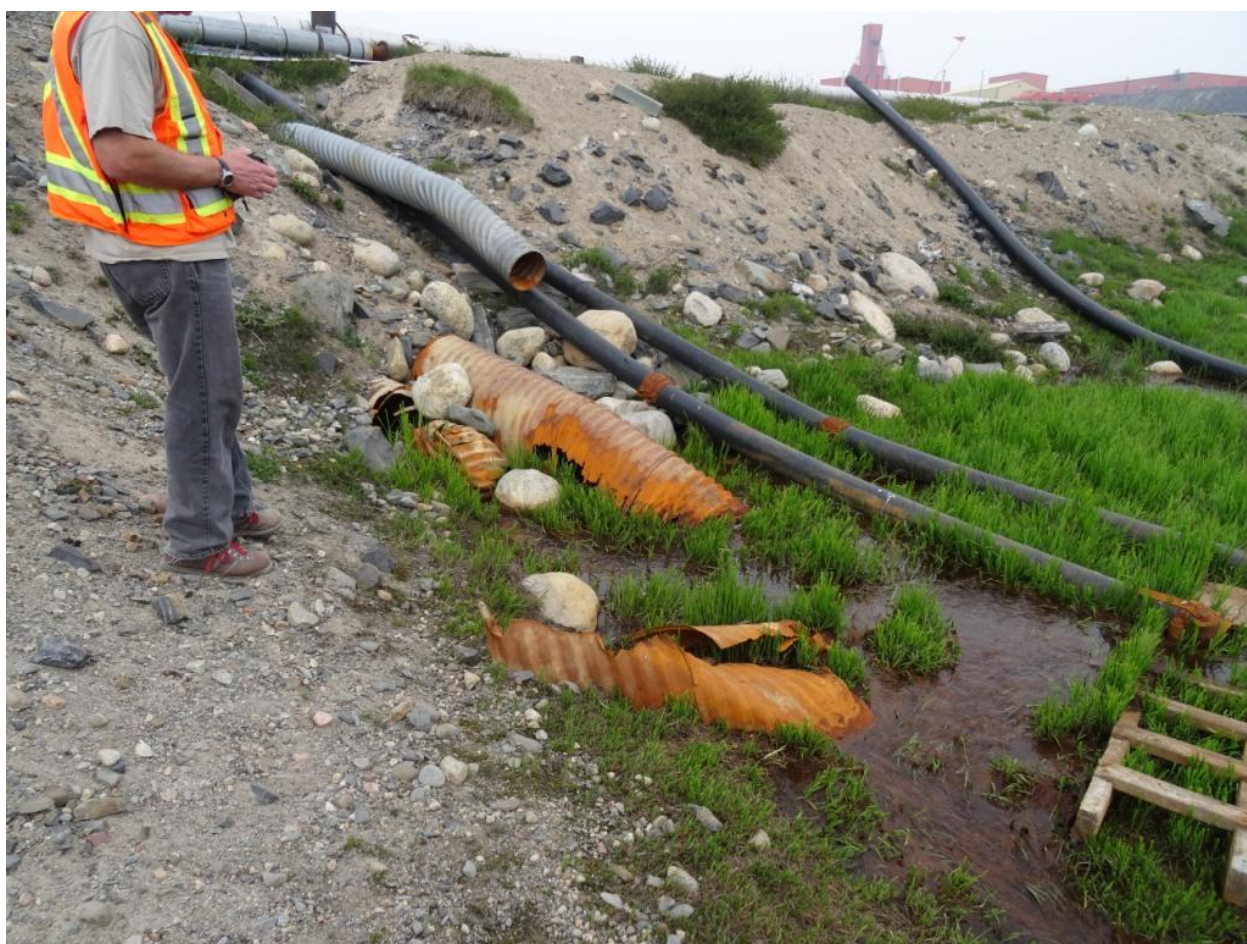
Figure 10. Steady flow seen through rusted culvert from the Upper Sewage Lagoon to the Lower Sewage Lagoon.

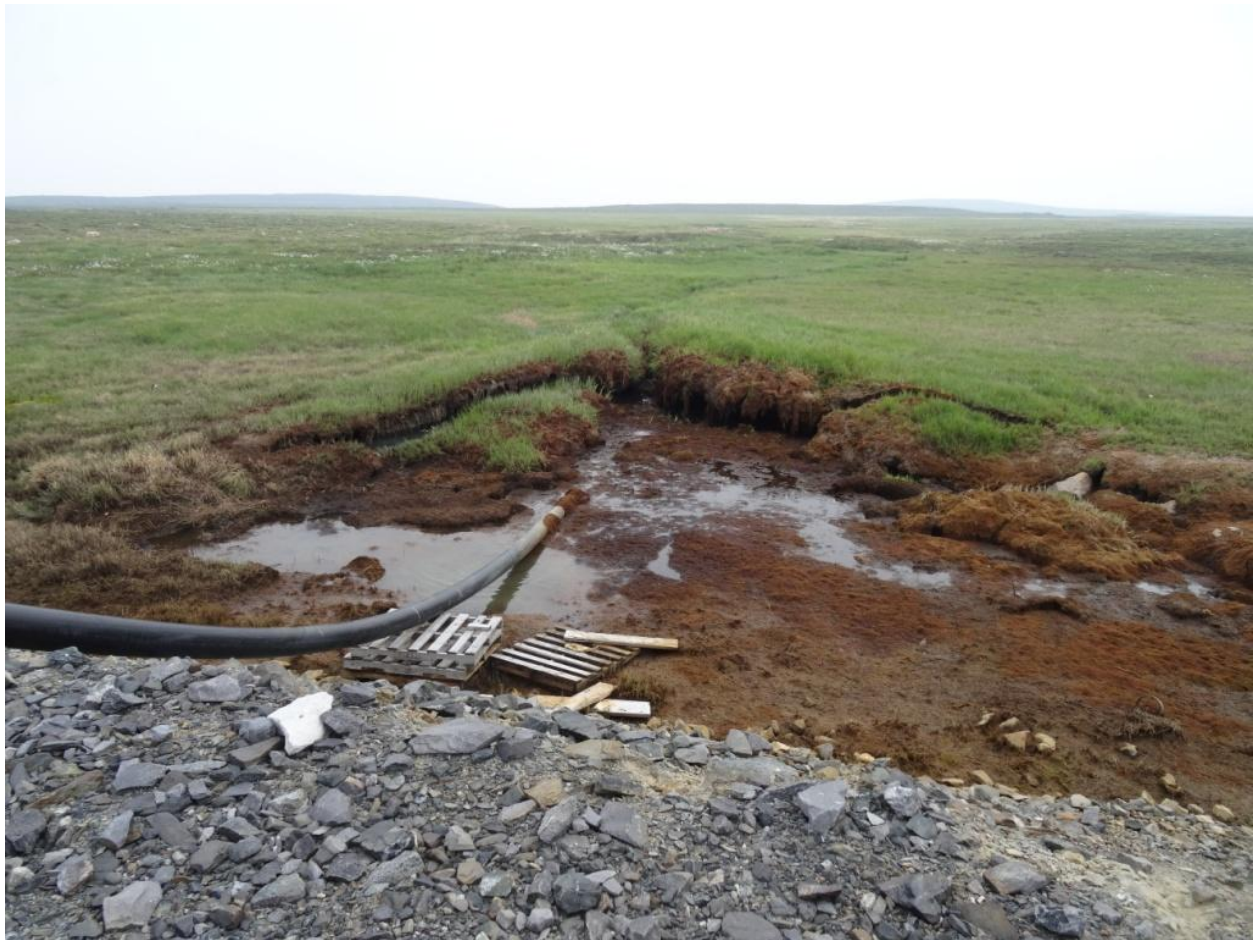
Figure 11. Permafrost degradation noted at discharge from LSL.

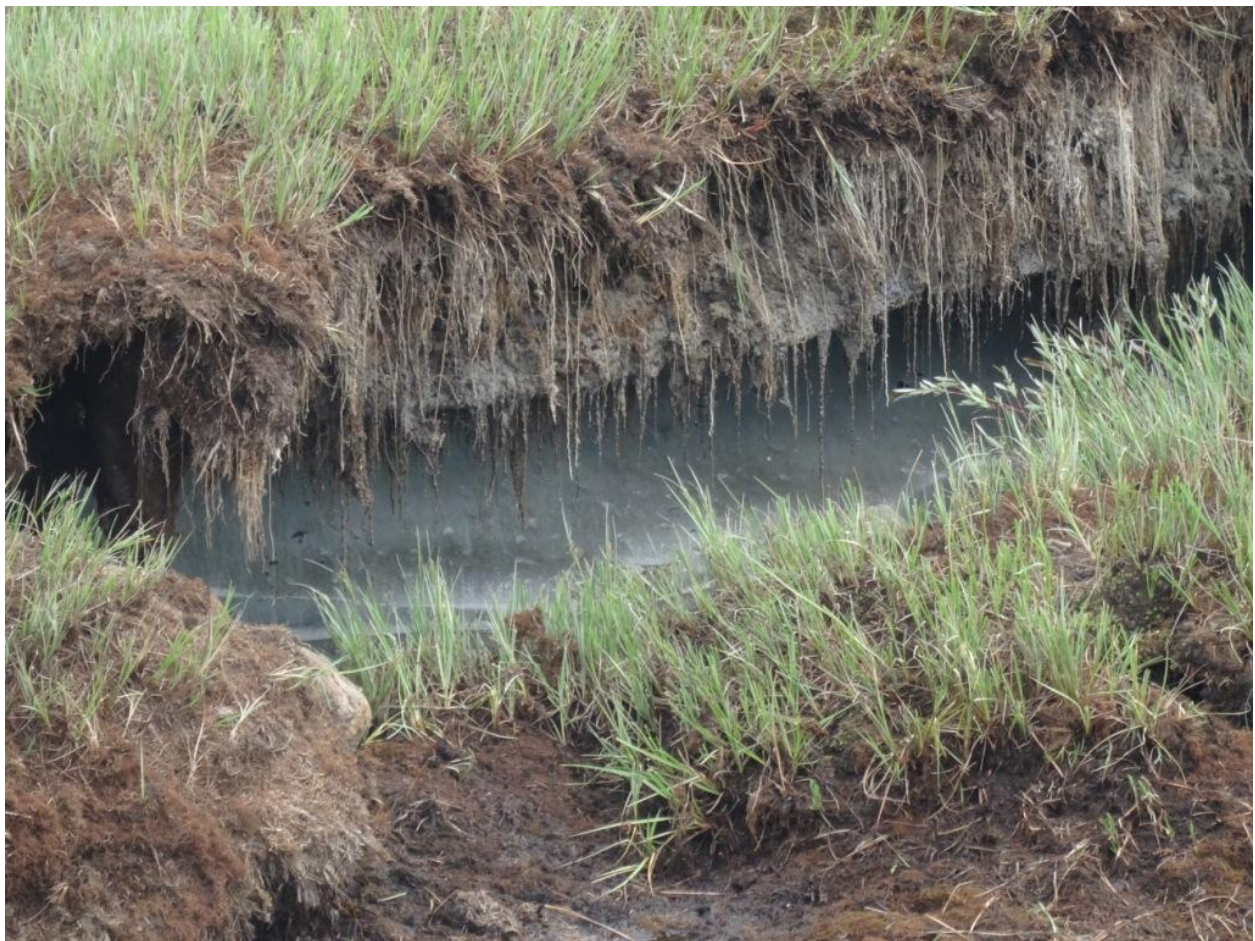
Figure 12. Ice lens forming at discharge from LSL. Closeup of Figure 11.

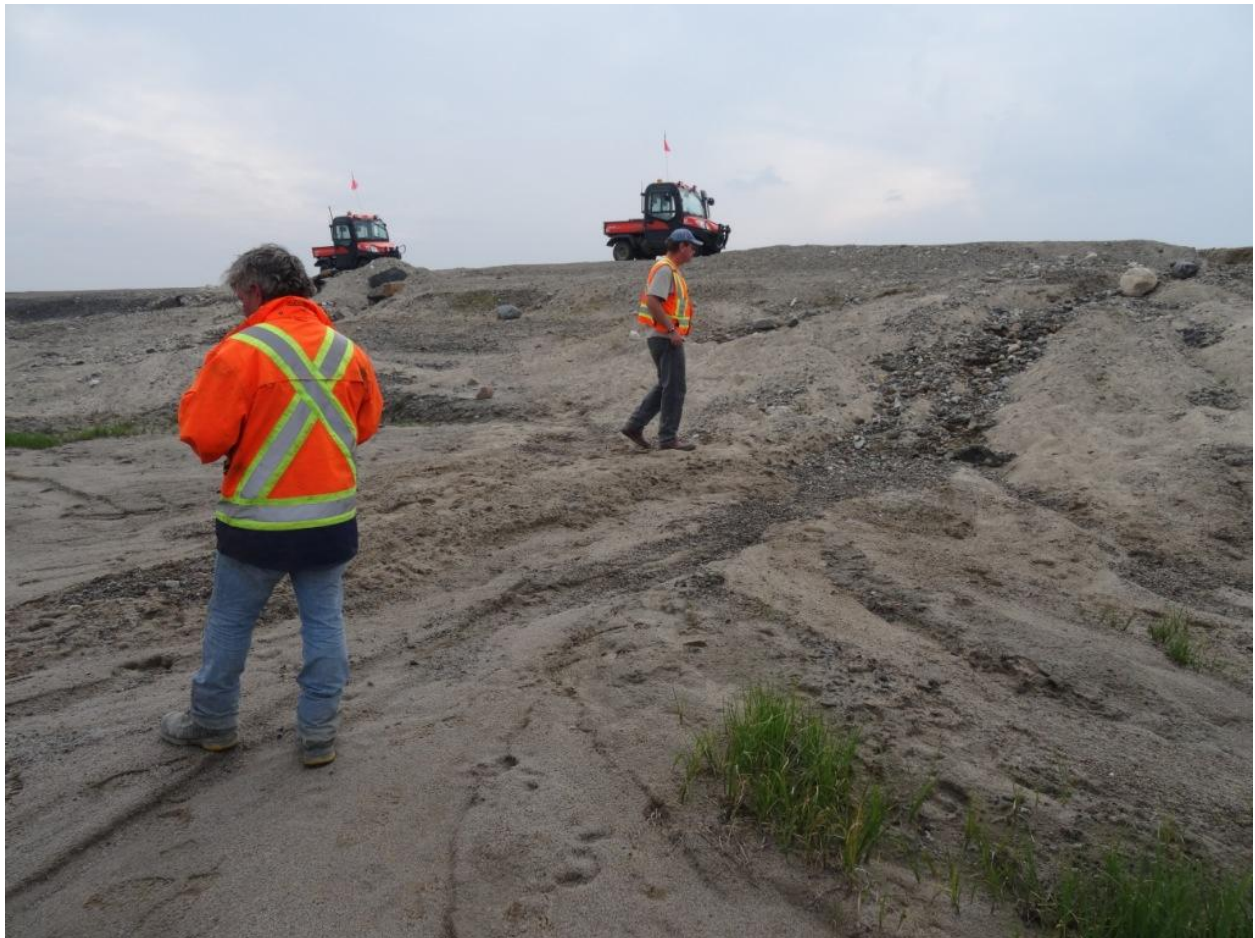
Figure 13. Recurring wash-out location at Dam 6. Aerial view in Figure 17.

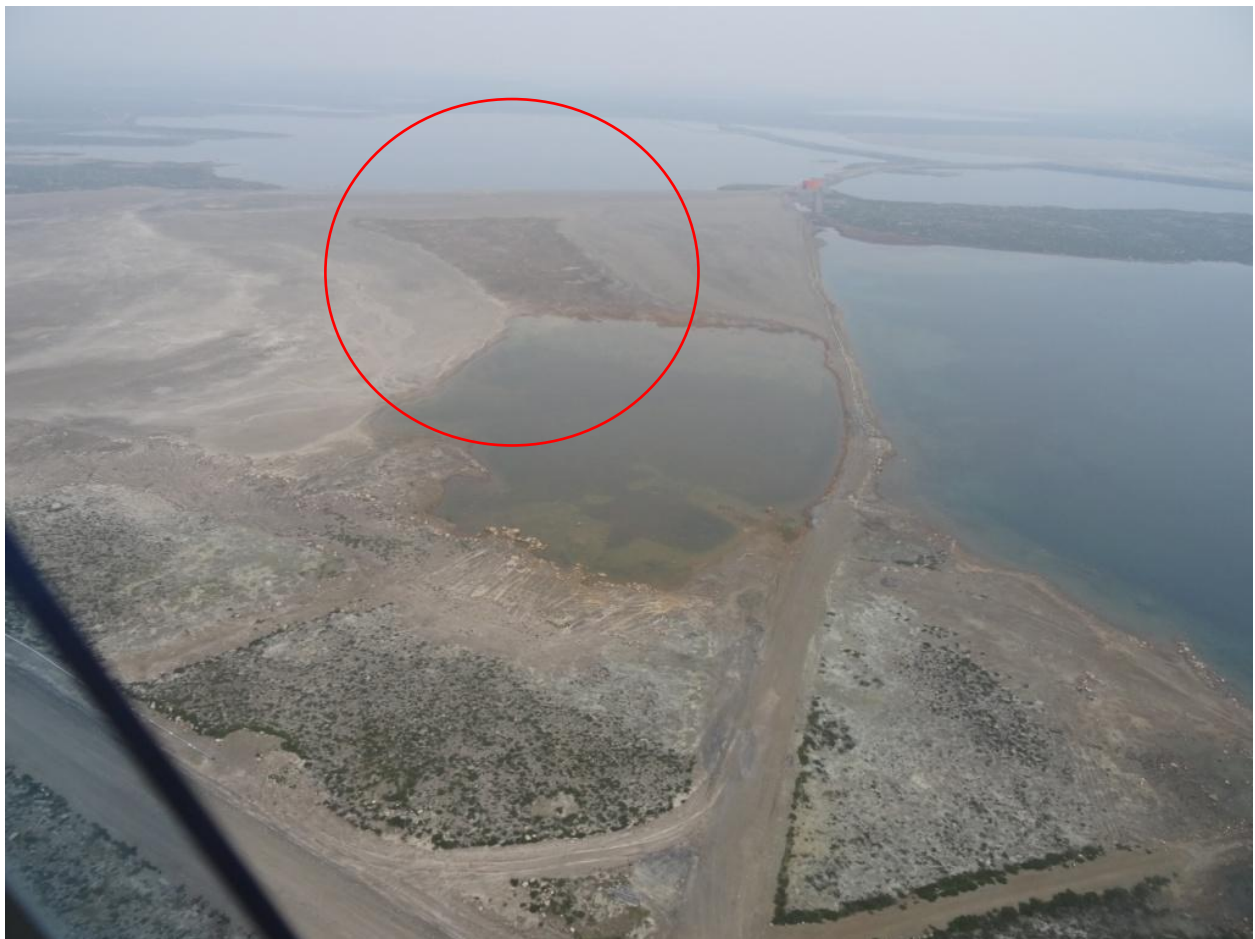
Figure 14. Dark patch shows the area of tailings still uncovered.

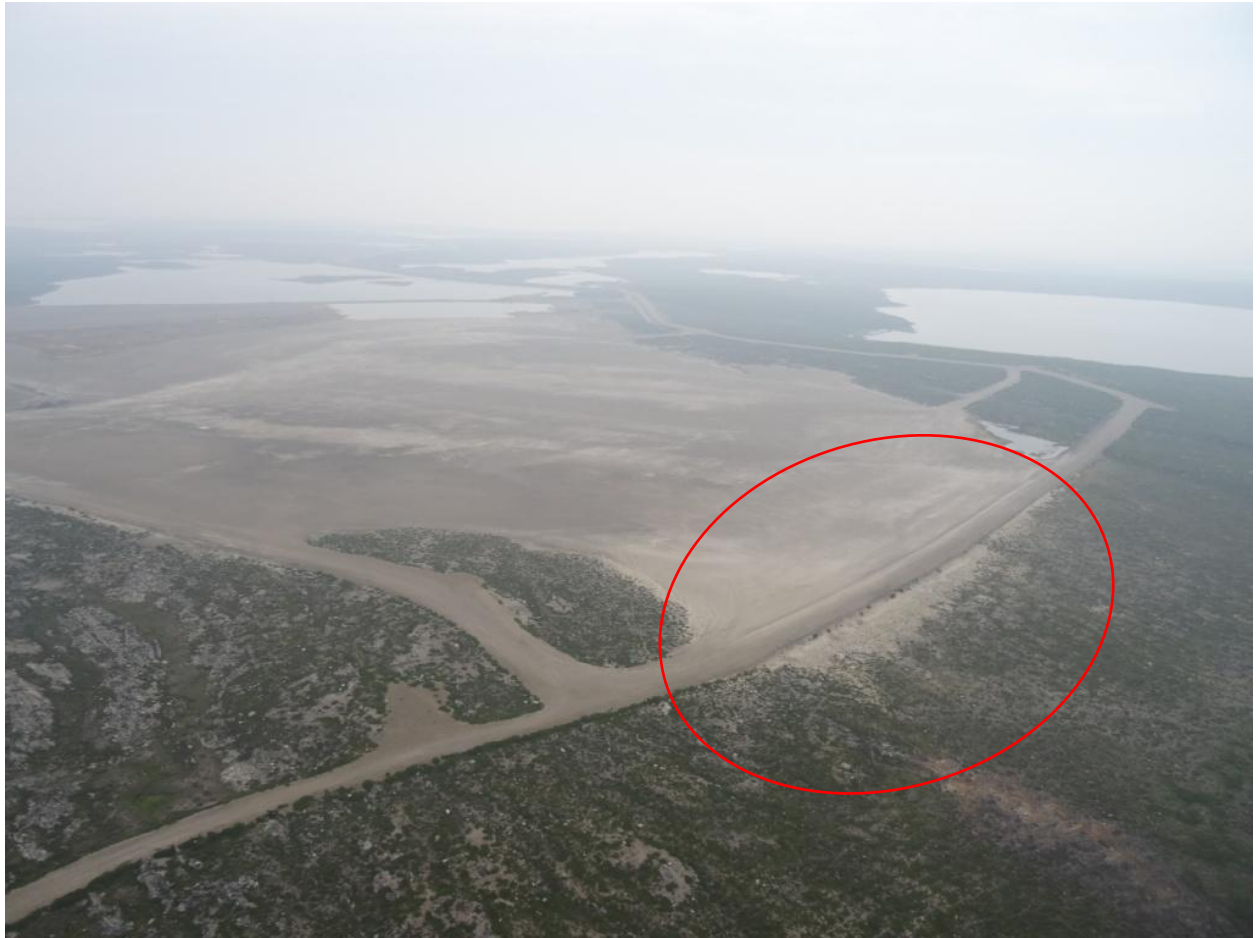
Figure 15. Material deposited outside the TCA.

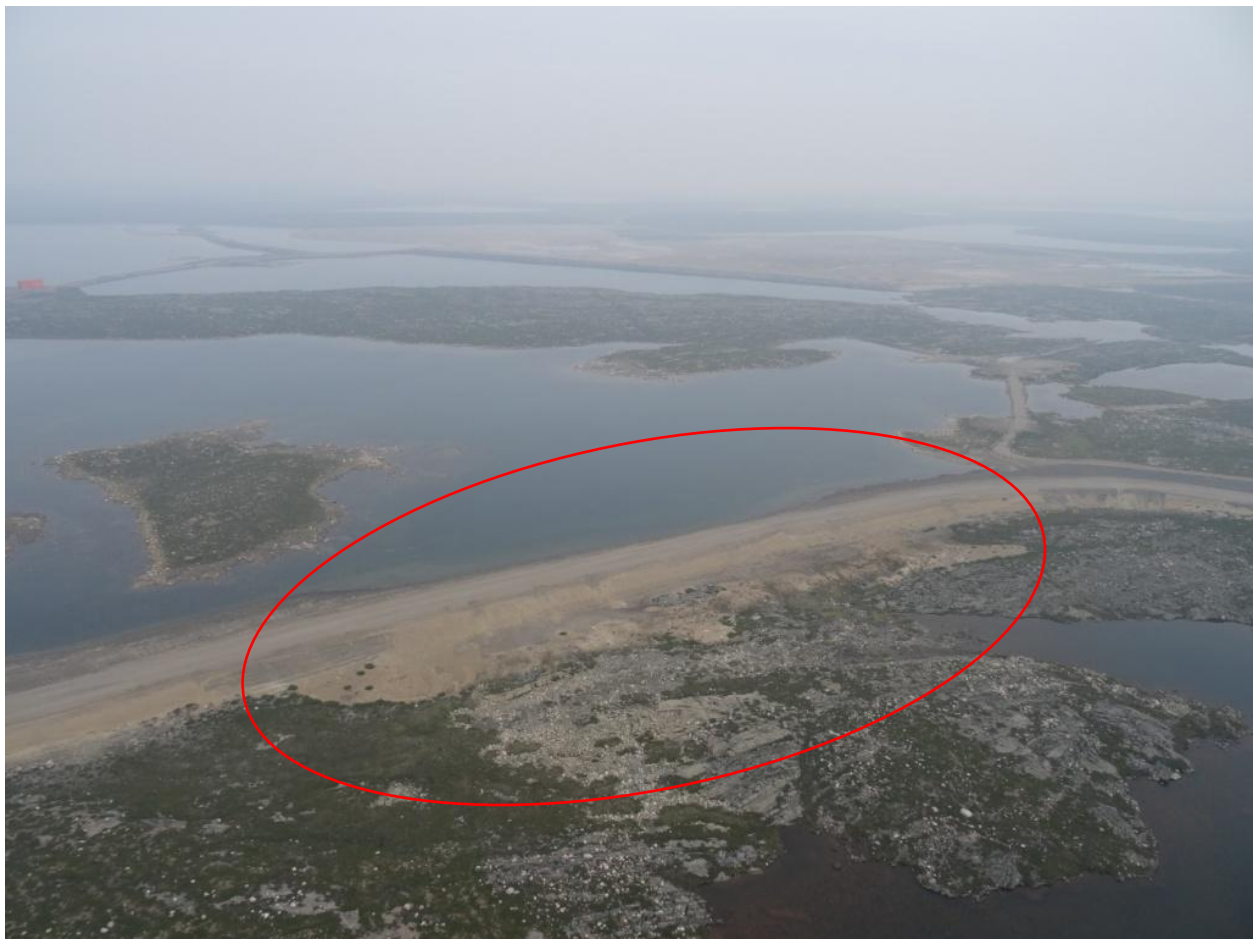
Figure 16. Material deposited outside the TCA.

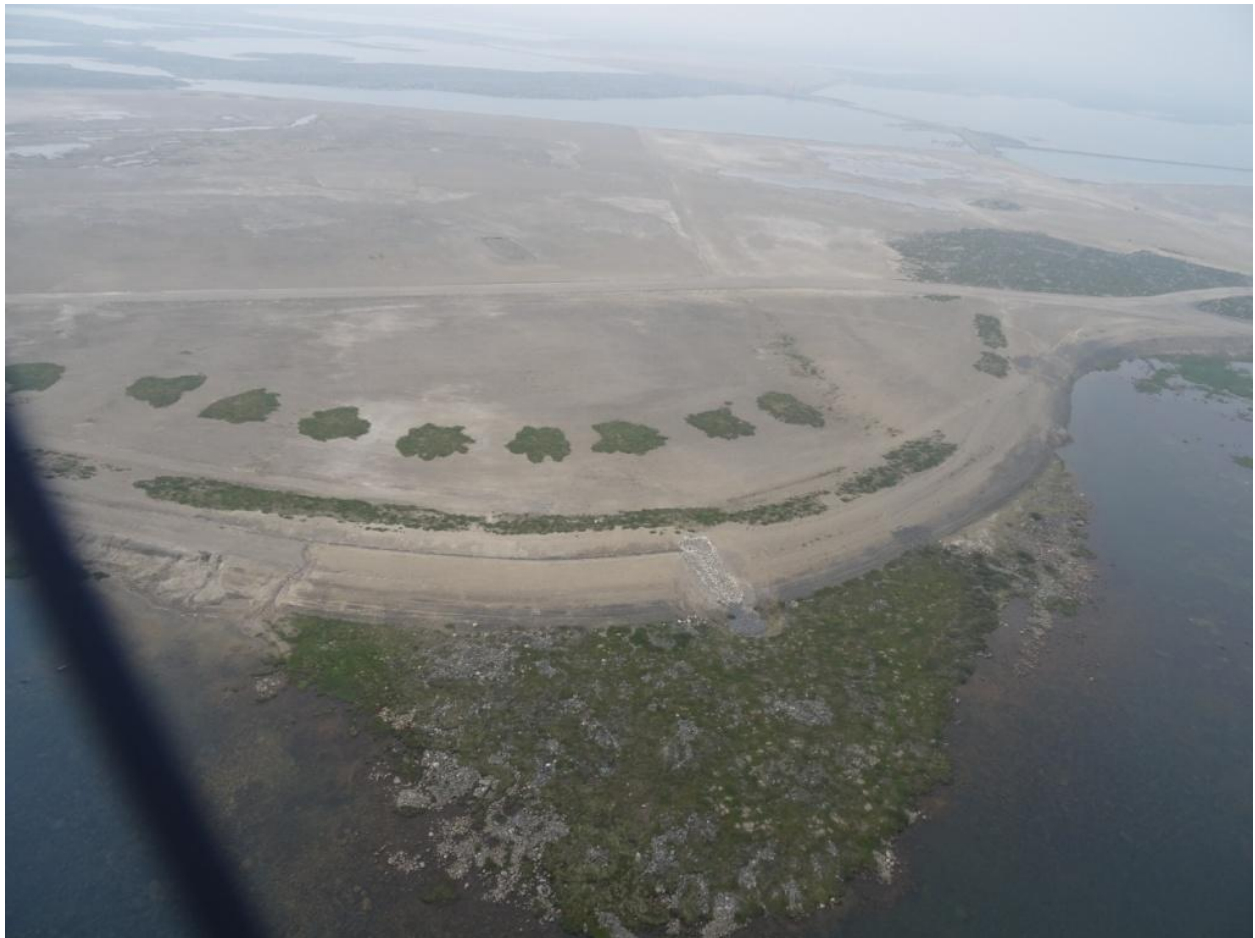
Figure 17. Growing vegetation cover near Dam 6. Recurring washouts also visible on left, resulting in deposit to water.

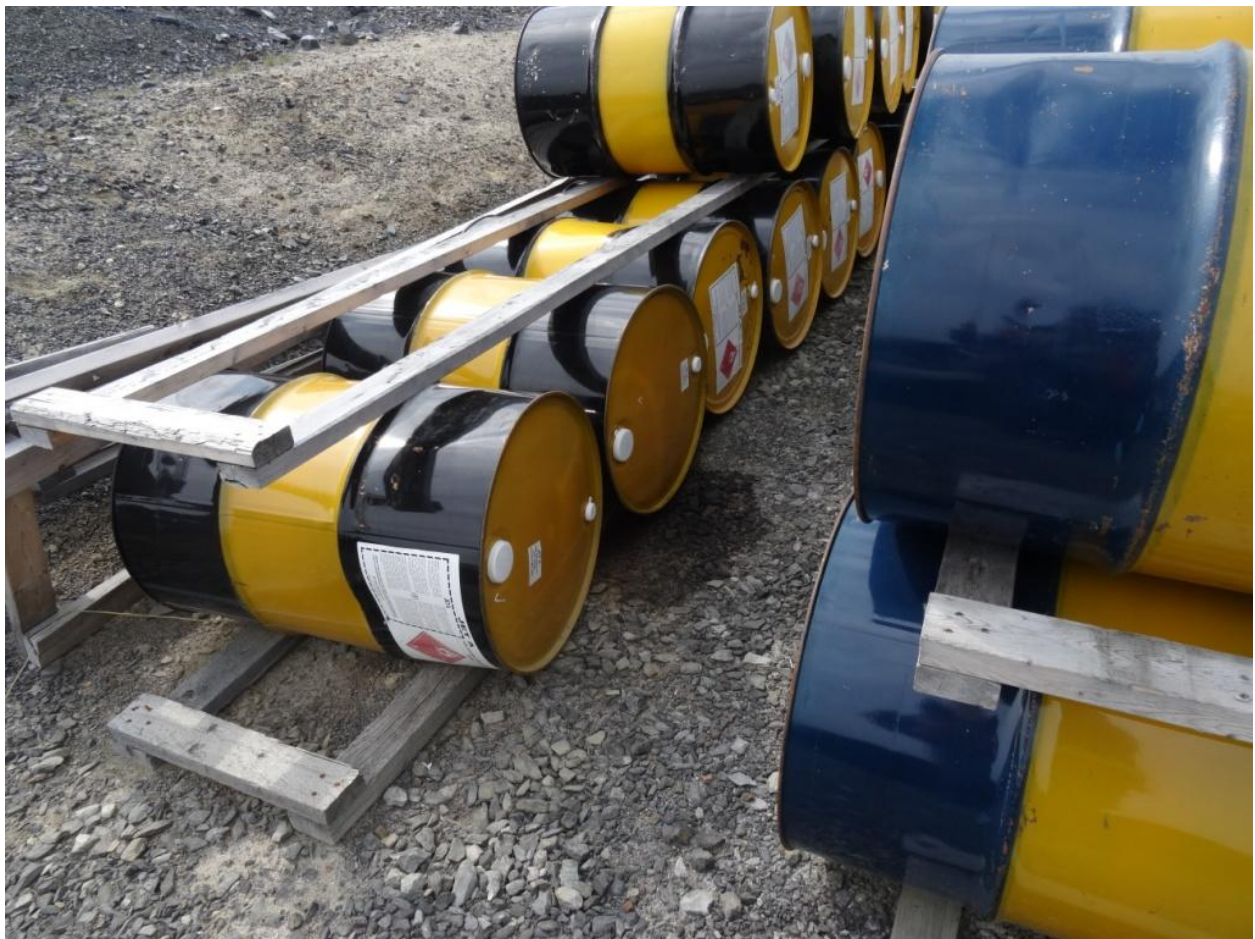
Figure 18. Barrel leaking in the 'Third Party' fuel berm.
