# 2013 Annual Geotechnical Inspection – Lupin Mine Tailings Containment Area, Nunavut

Lupin Mines Incorporated

SRK Consulting (Canada) Inc.  
1CL008.001  
October 2013

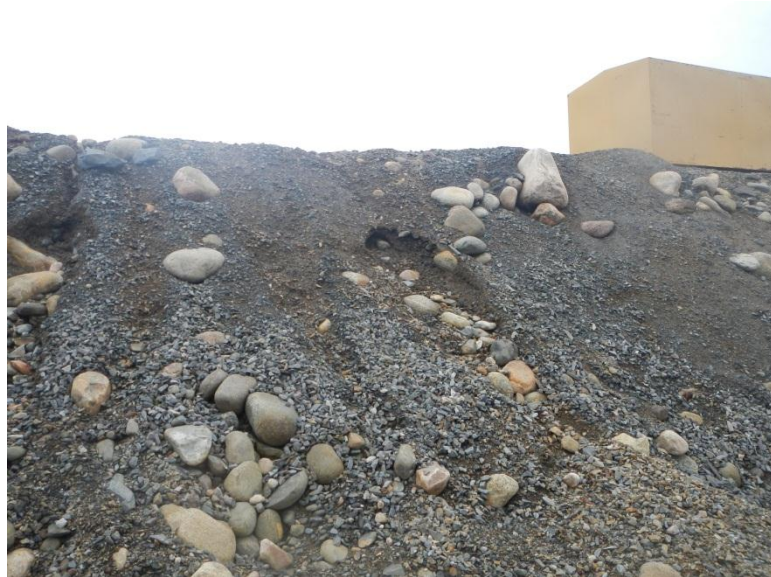
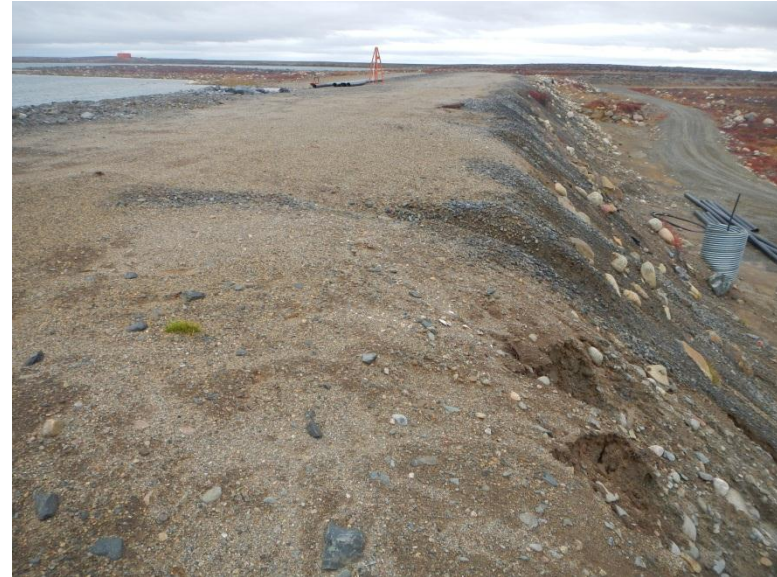
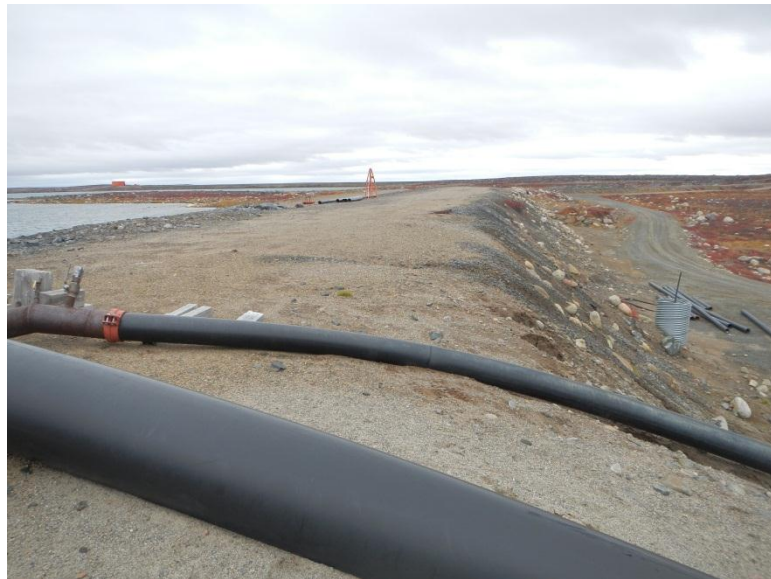
The perimeter dams are generally in good condition in terms of stability and performance. There are minor erosion issues which are typically associated with sand and gravel construction material. These should be monitored and repaired as required to prevent continuous erosion that could worsen and impair the dam. While most of the erosion is minor, some along Dam 1A is more serious and should be addressed in 2014.

**Lupin Dam 1A DS surface**

**Lupin Dam 1A Crest and DS surface**

**Lupin Dam 1A Crest and DS surface, view further south**

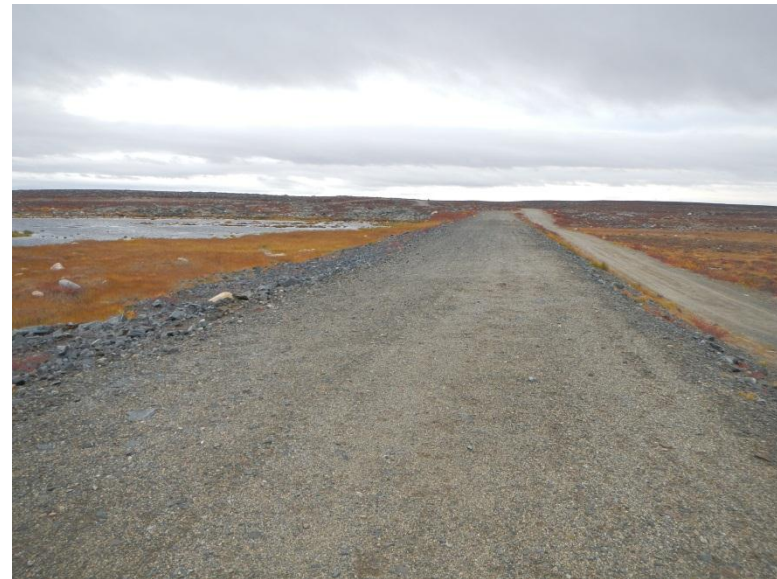
**Lupin Dam 1B Crest**

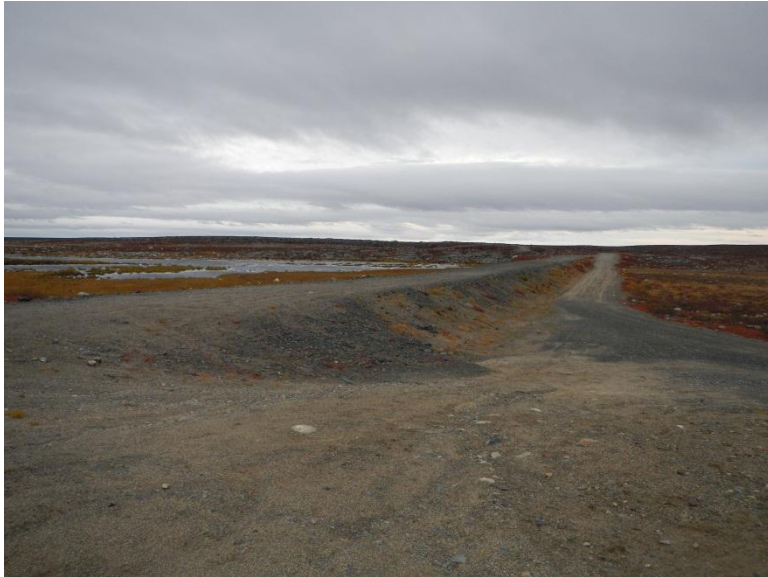
**Lupin Dam 1B DS Slope**

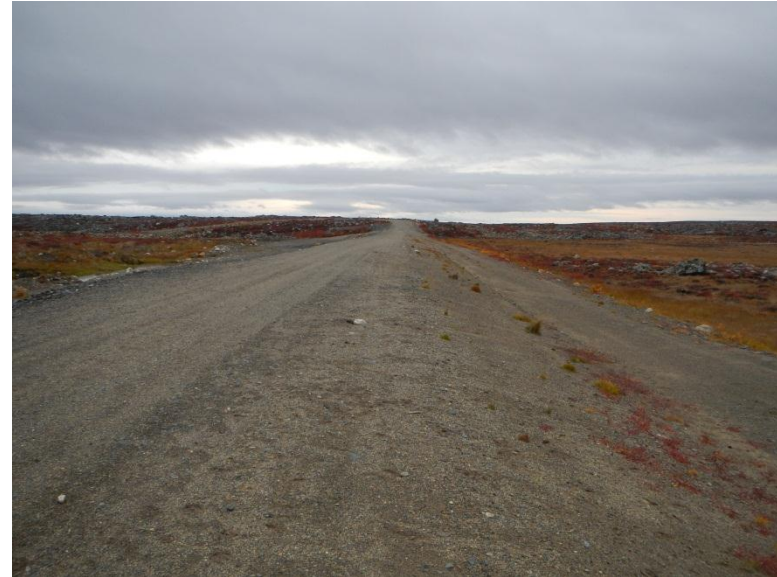
**Lupin Dam 1C DS Slope**

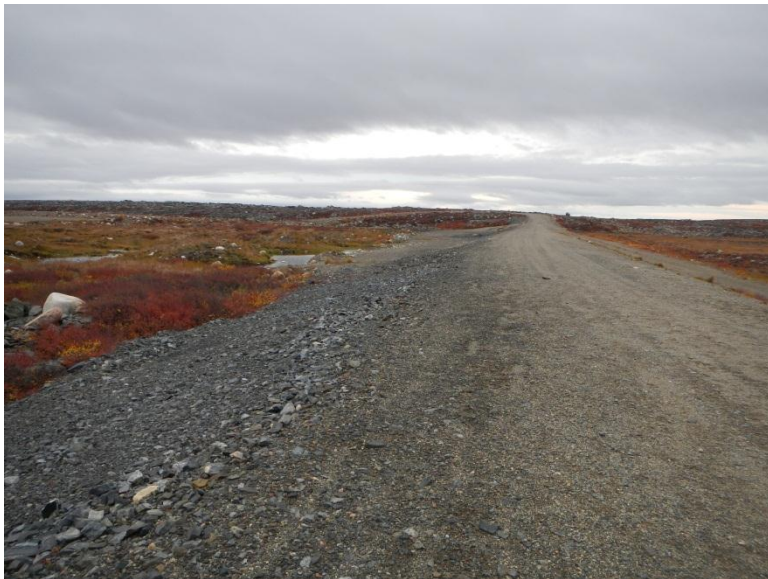
**Lupin Dam 1C US Slope**

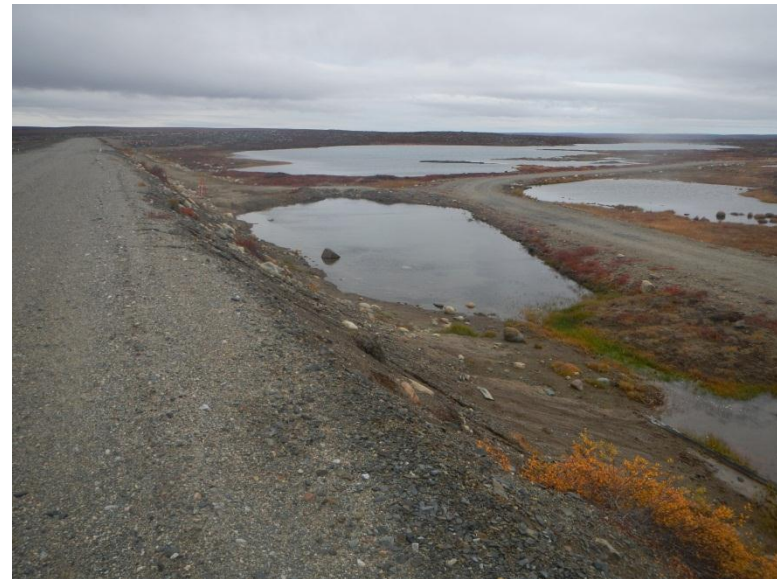
A previous annual inspection found seepage in the western buttress toe of Dam 4 into Ferguson Lake and the northern buttress toe of Dam 2 into Dam 2 Lake. It was not observed during the current and 2012 inspections. A cofferdam was placed at the toe of Dam 2 to collect seepage to be pumped back into Pond 2 when it pooled. This pool is observed to be quite full and should be pump back to Pond 2 during maintenance in 2014.

**Lupin Dam 2 DS slope and seepage collection pond**

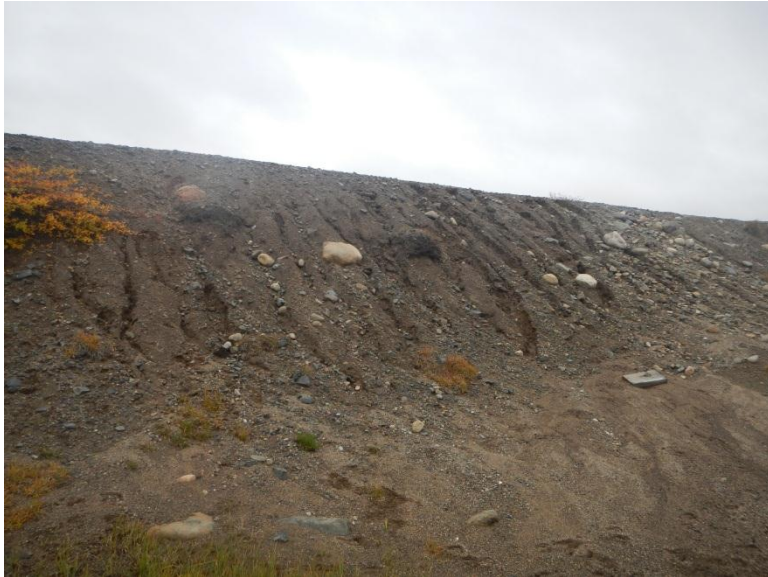
**Lupin Dam 2 DS surface**

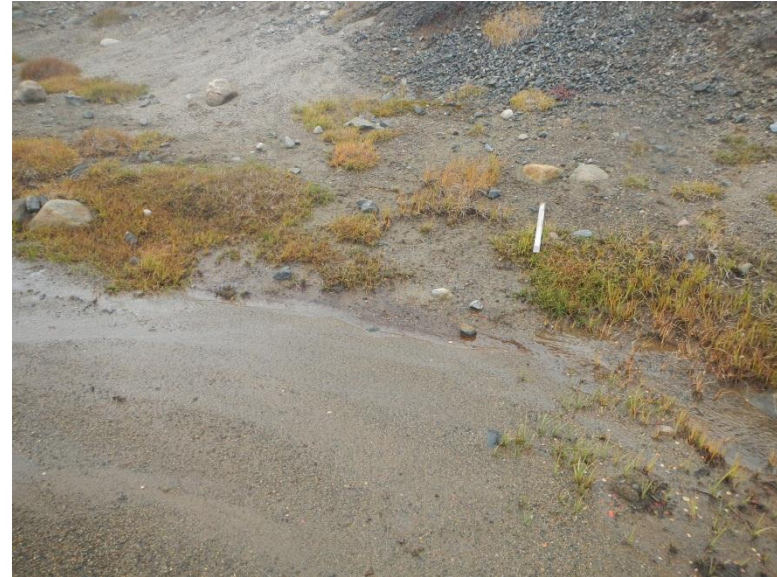
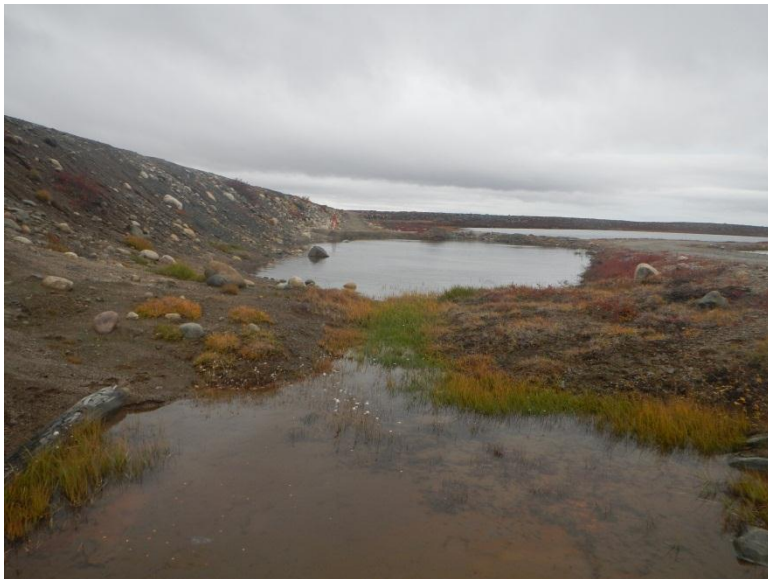
**Lupin Dam 2 North abutment seepage**

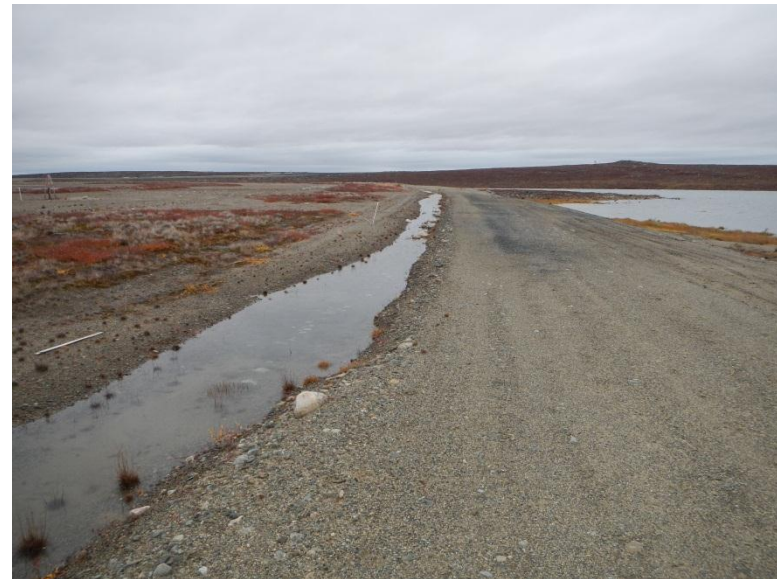
The storm ditch built within top 2 m of Dam 3 was suffered minor damages from the 2012 freshet. The damage has since been repaired and additional grade work was completed in an attempt to allow the freshet runoff water to free drain. Pond in this ditch appears to be the main cause of the previous damage. Because of the poor grading, the water pooled, froze, and created an ice dam; which in turn forced the freshet water to breach the ditch and a small portion of Dam 3. At the time of the inspection in 2013, minor ponding are observed in the ditch. Additional earthwork should be carried out to improve the ditch grade to limit these ponding.

**Lupin Dam 3 Crest with ponding in ditch**

Dam 3	Minor surface erosion. Despite repairs to the storm ditch, it does not yet have a free-draining grade.	Consider surface maintenance. Regrade ditch to minimize ponding and monitor during freshet to prevent ice blockages.	Despite repairs to the storm ditch, there are still some ponding.	Consider re-grading ditch to minimize ponding and monitor during freshet to prevent ice blockages.
Dam 4	Surface erosion with a number of deep erosion gullies. Exposed geogrid or similar synthetic reinforcements observed near the eastern downstream toe of the dam.	Repair the deep erosion gullies and maintain the surface. Monitor the exposed geogrid for erosion and water seepage.	Surface erosion with a number of deep erosion gullies. Exposed geogrid or similar synthetic reinforcements observed near the eastern downstream toe of the dam.	The geogrid exposure does not seem to be degrading, hence immediate remedial action is not required. Repair the deep erosion gullies and maintain the surface. Monitor for erosion and water seepage.

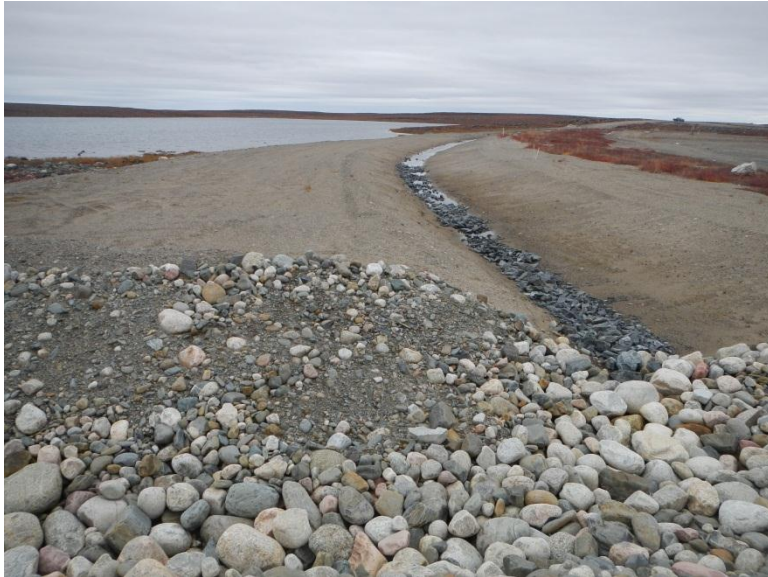
**Lupin Dam 3 Diversion Ditch**

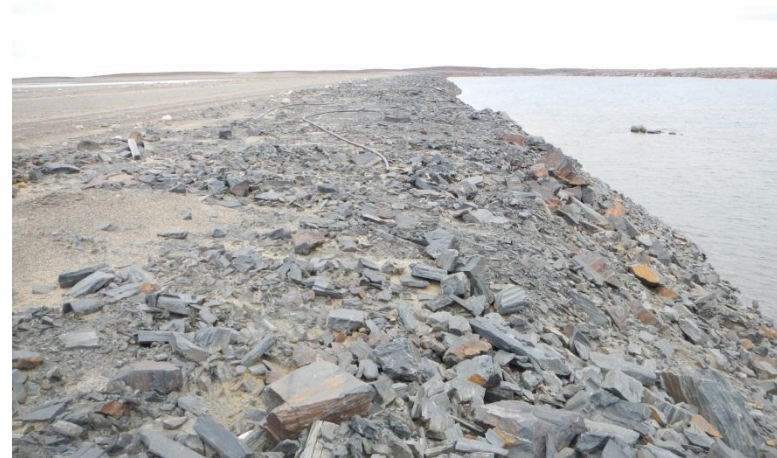
**Lupin Dam 3D DS slope**

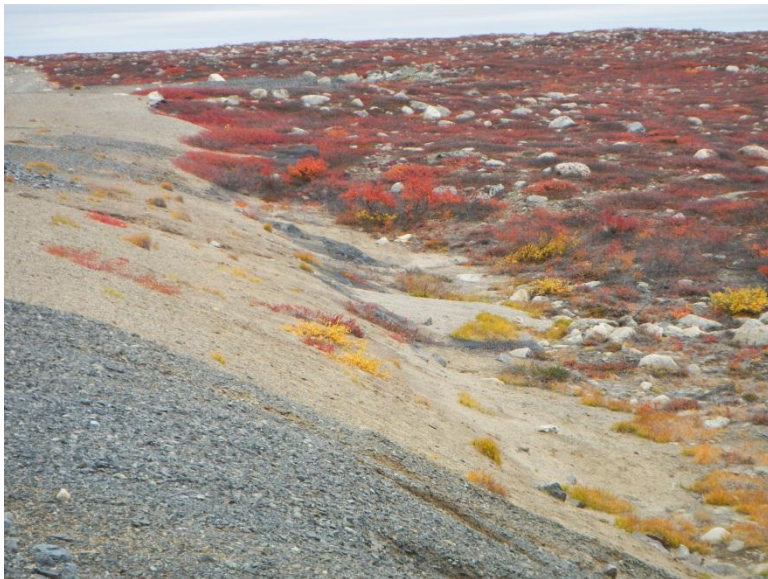
**Lupin Dam 4 eastern DS slope exposed geogrid**

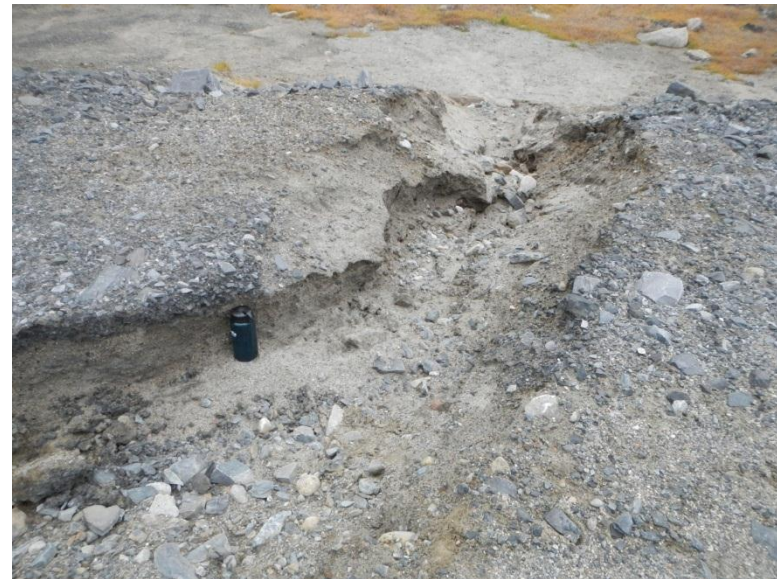
**Lupin Dam 4 eastern DS slope erosion**

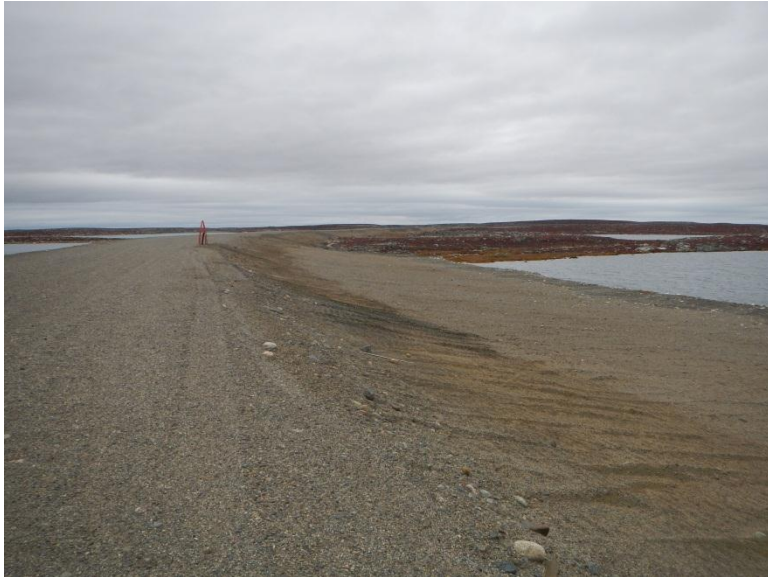
**Lupin Dam 4 western DS Slope**

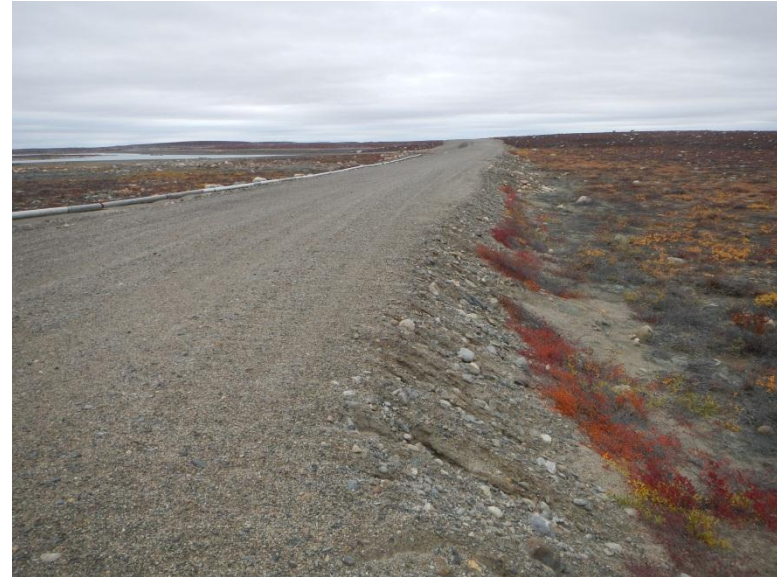
**Lupin Dam 5 DS Slope**

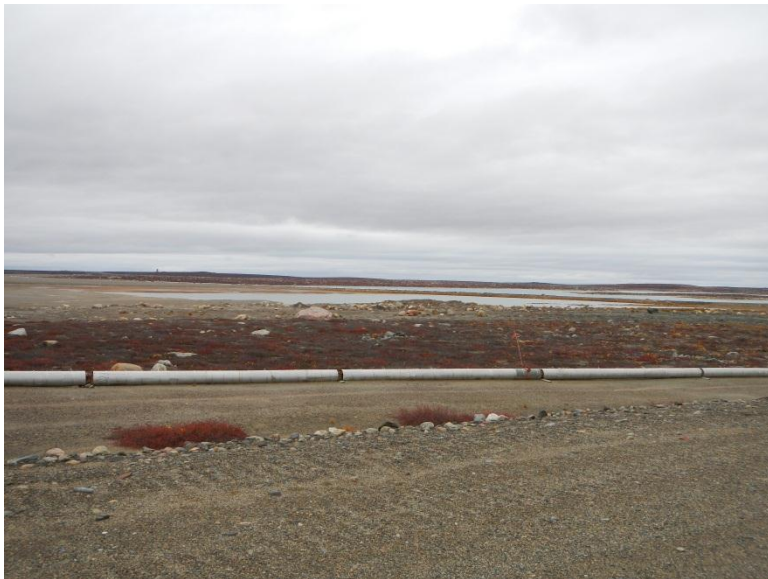
**Lupin Dam 5 US Slope**

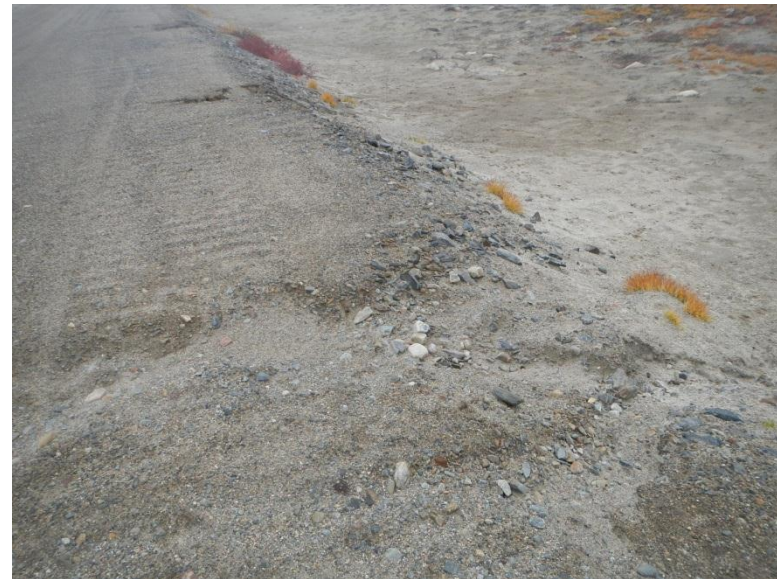
**Lupin Dam 6 DS Minor Erosion**

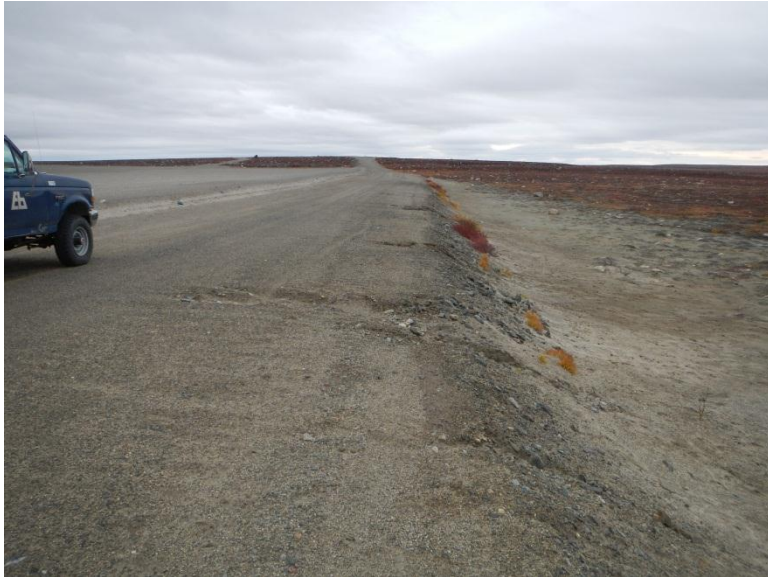
**Lupin Dam 6 DS Slope**

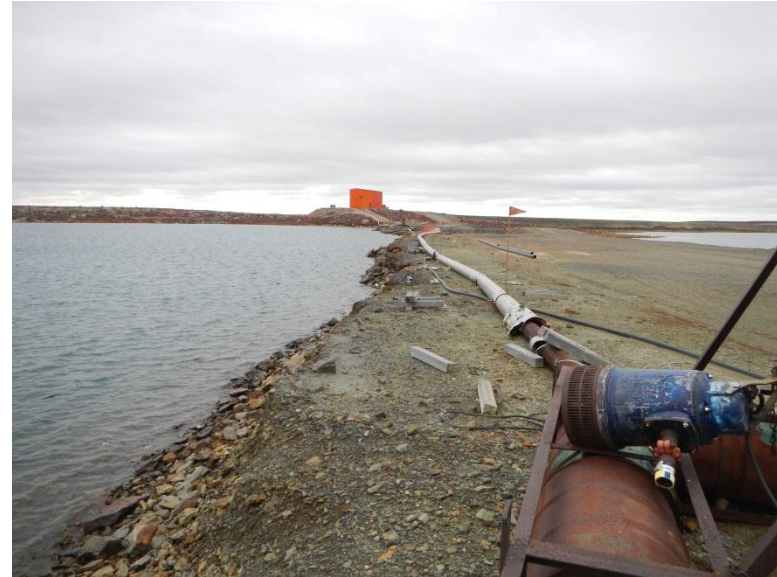
**Lupin Dam J**

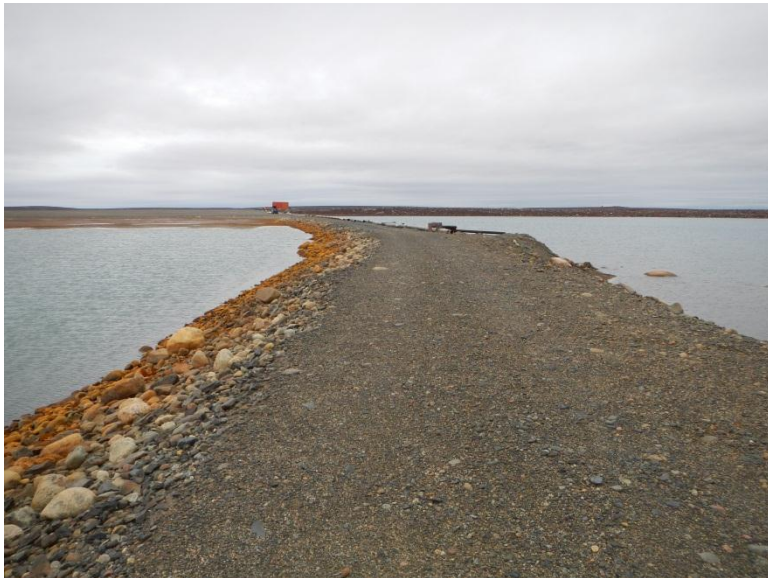
**Lupin Dam K Crest**

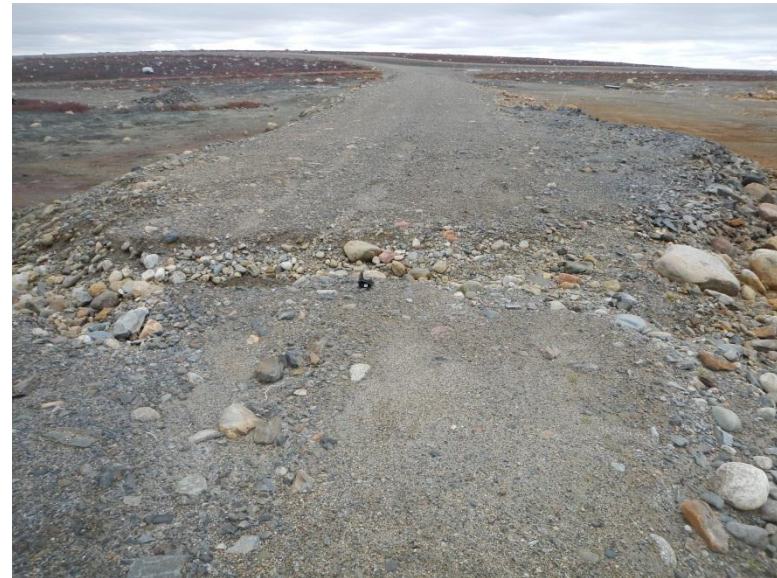
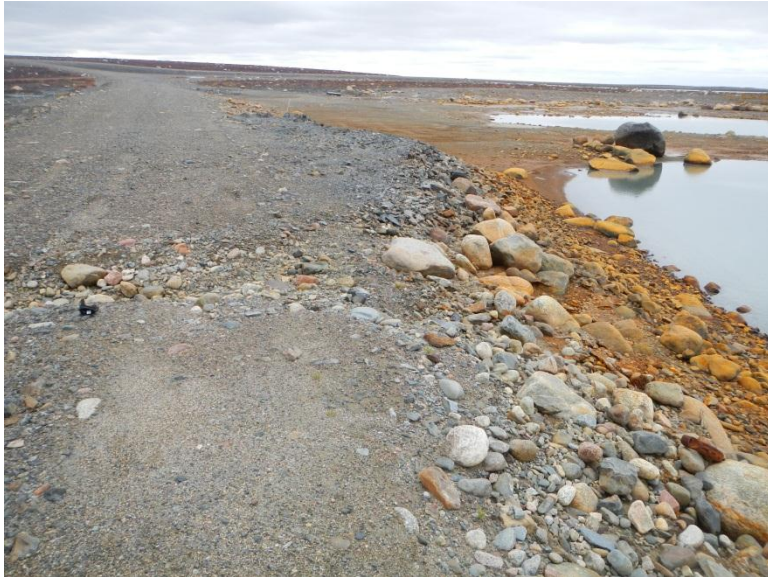
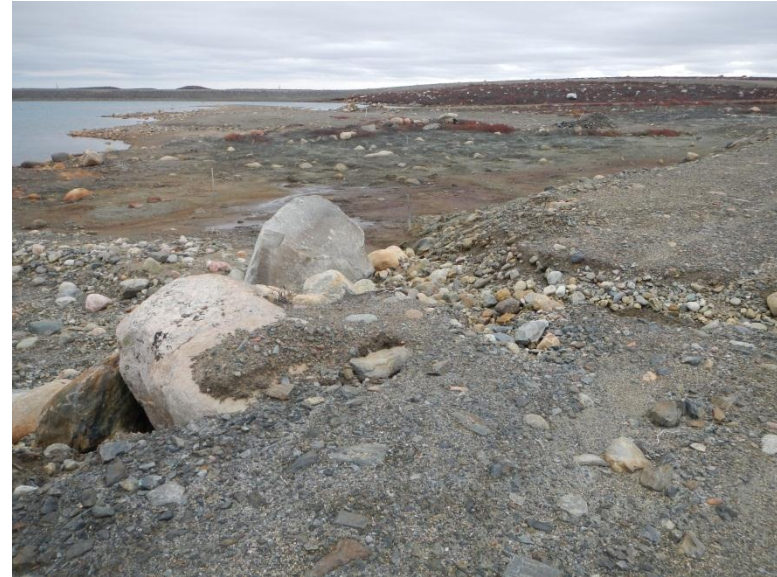
During the 2012 inspection, a substantial erosion breach was observed at the south end of Dam L. It is appears that the erosion was caused by the 2012 freshet where the water from the uncovered portion of Cell 3 breached into Cell 4. Cell 3 water level was reduced in 2012 from the treatment process and it is unlikely that Cell 3 water could breach this location again in 2014 freshet. However it is still recommended that this erosion to be repaired. Section 4 of this report provides recommendations to deal with the breached section in Dam L. The slope facing Cell 3 is observed to have considerable erosion near the toe. Monitoring should be carried out to prioritize the repair on the erosion to minimize propagation to the crest of the dam.

**Lupin Dam L erosion channel**

**Lupin Dam L erosion channel, Cell 3 view**

**Lupin Dam L erosion channel, Cell 4 view**

Dam K	Minor downstream slope surface erosion and some undercutting at toe; appears to be tailings material, from Pond 2 wave action.	Consider surface maintenance. Monitor regularly to ensure dam toe is not undercut. If so, place riprap there for protection.	Minor downstream slope surface erosion and some undercutting at toe; appears to be tailings material, from Pond 2 wave action.	Consider surface maintenance with grading and placement of fill erosions. Monitor to ensure dam toe is not undercut. If so, place riprap there for protection.
Dam L	Minor slope surface erosions and some minor undercutting at toe. Breach at southern section of dam near buttress. Seepage observed at 0.5 L/min below breach.	Consider surface maintenance. Monitor regularly to ensure dam toe is not undercut. If so, place riprap at the problematic area for protection. Repair with compacted well-graded esker material. Monitor and manage water in Cell 3 to prevent freshet overflow.	Slope surface erosions and undercutting at toe.	Consider surface maintenance with grading and placement of fill erosions. Monitor to ensure dam crest is not undercut by toe erosion. If so, place riprap at the problematic area for protection. Consider repair the breach with compacted well-graded esker material.

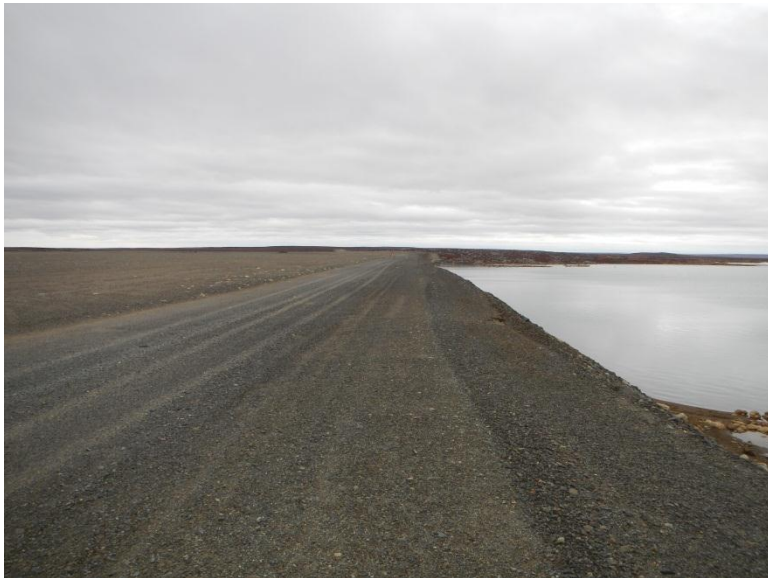
**Lupin Dam L crest**

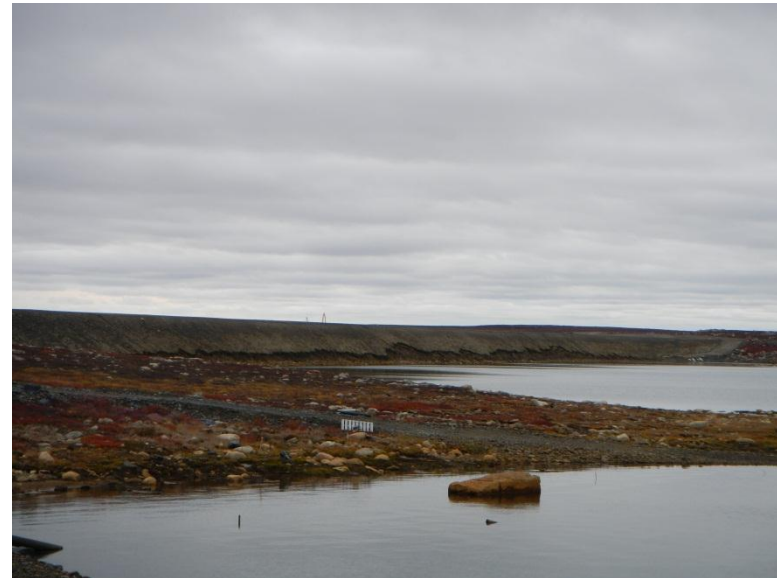
**Lupin Dam L DS erosion, Cell 4 view.**

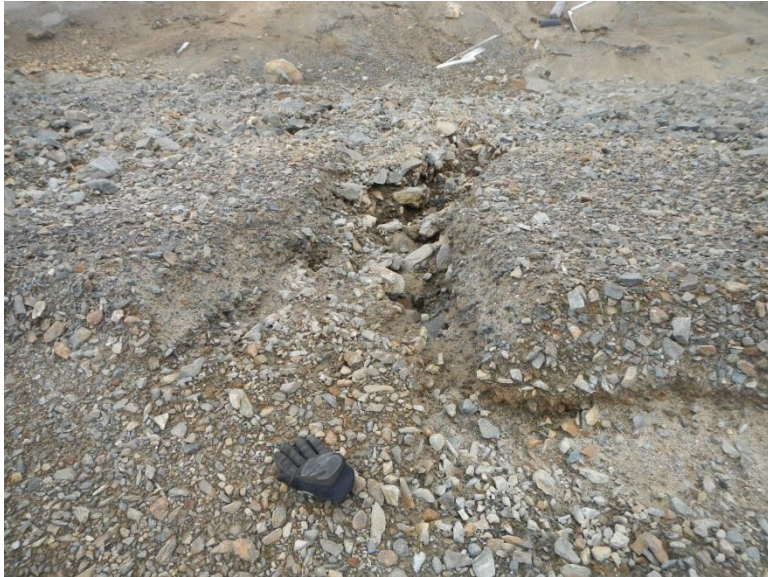
**Lupin Dam L crest erosion**

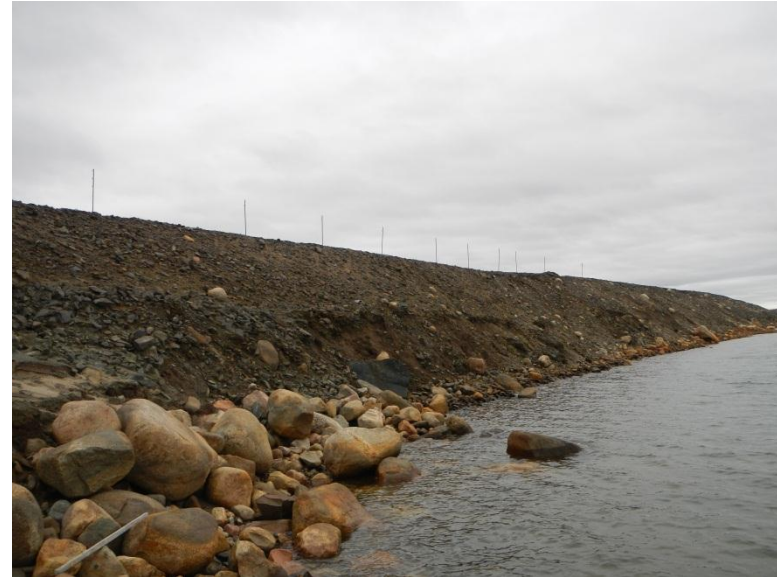
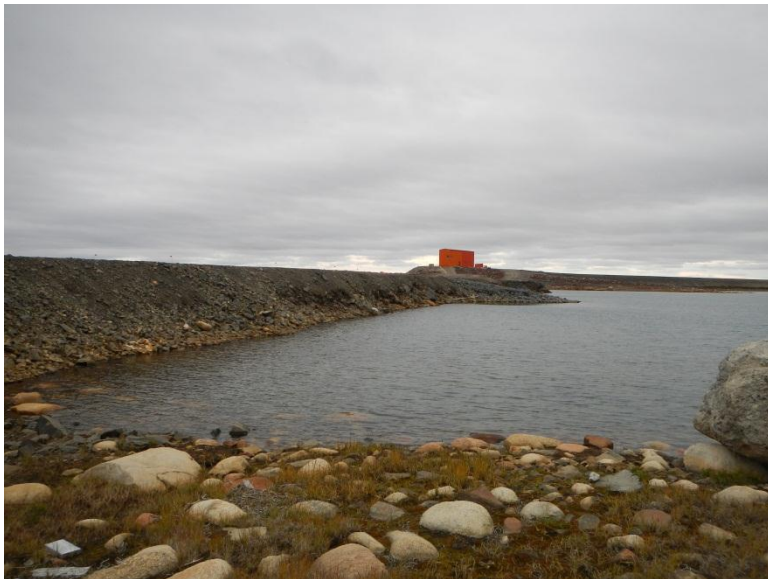
Four significant tension cracks observed on Dam M are a cause for concern in term of geotechnical stability. Potentially, this failed portion of the dam could breach and allow the supernatant water and tailings from Cell 5 into Pond 2. Visual comparison between 2012 and 2013 photographs showed the cracks are widening. Because of the severity of the cracks and potential breach, Mr. George Friesen was advised that all vehicle traffic should avoid this section

Based on a visual inspection of the tension cracks in Dam M, possible causes could include pore water pressure from Cell 5, and/or foundation “creep” (movement between the active layer and

**Lupin Dam M DS slope of tension crack, Pond 2 view.**

**Lupin Dam M DS tension crack, Pond 2 view**

In the short term, all vehicles should avoid this section of the dam for safety reasons. SRK further recommends that a monitoring program be established to determine the rate of movement. The program should include three pairs of monitoring monuments placed perpendicular to the cracks: one at each end and one in the middle of the failing section, each with a matching monitor on the stable section of the crest. Site personnel should measure and record the distances between each set of monuments on a seasonal basis. Results should be compiled and reviewed each year.

The risk assessment and water quality review (SRK 2012b) provided a summary of potential impact in the event of these cracks resulted in a full breach of Dam M. In the event of a full breach, resulting water quality impact would not prevent discharge from Pond 2 to the receiving environment. Thus, the risks associated to a dam breach are mainly related geotechnical stability where personnel health and safety, and accessibility for traffic around site are of concerns rather than environmental concerns. To mitigate some of the stability risks, SRK recommends that one of these measures should involve the construction of a toe buttress with a minimum crest width of 3m. The buttress should be constructed of compacted, well-graded esker material, and placed with a downstream slope of 2H:1V (horizontal to vertical) and extend up to half the height to the existing dam crest. The buttress should extend a minimum of 5 m beyond the failing section at each end. LMI should make preparations for the placement of this buttress in 2014 if stability failure of the dam is deemed unacceptable.

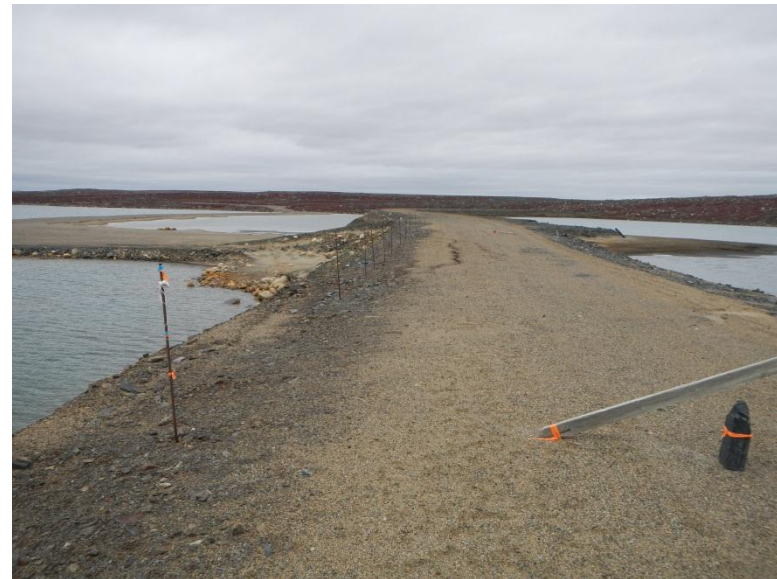
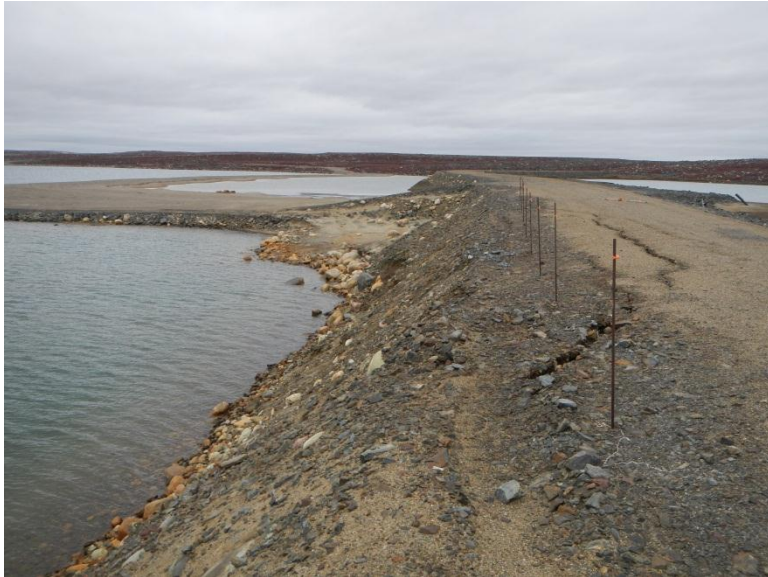
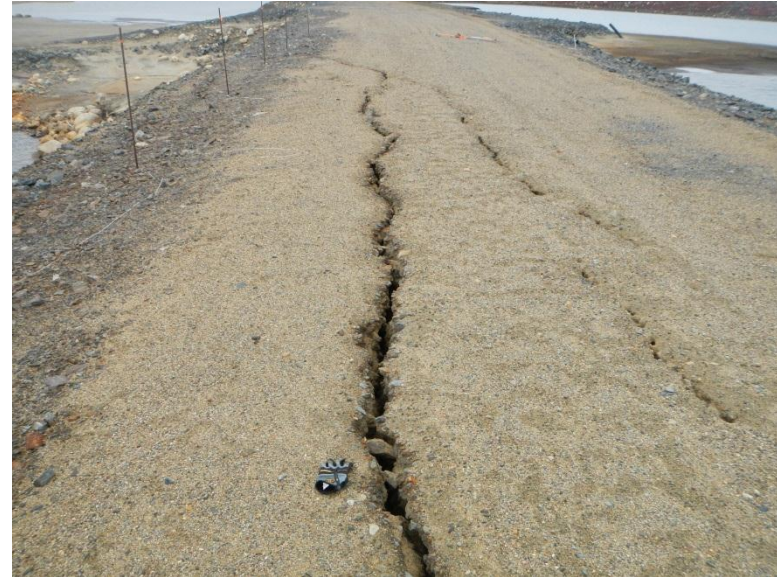
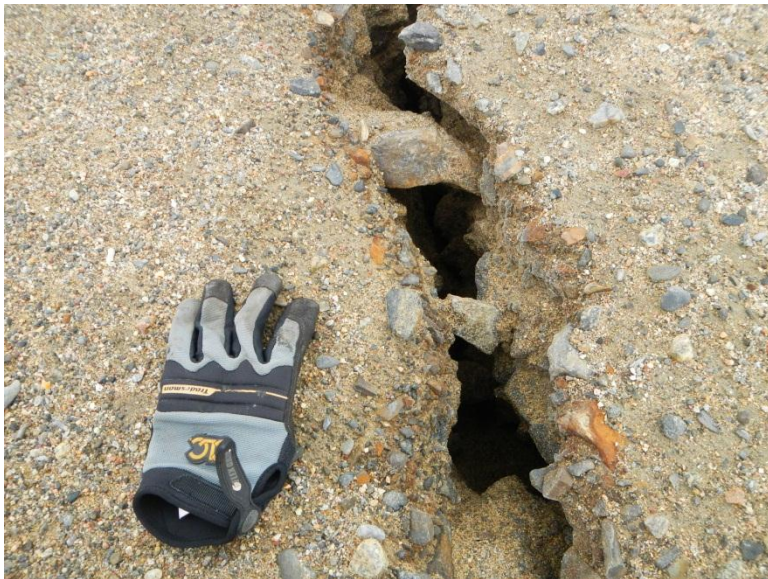
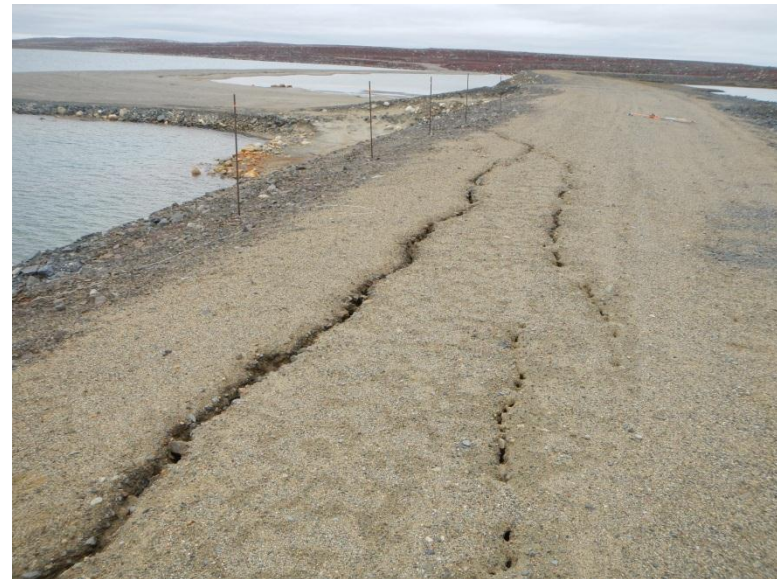
Dam M	Slope surface erosion. Major tension crack observed over an approximate 15 m section near Dam N. Cracks are up to 6 m long and deeper than 30 cm.	Consider surface maintenance. Reference section 4.1 for detailed mitigation measures.	Major tension crack observed over an approximate 15 m section near Dam N. Cracks are up to 6 m long, 5 cm wide, and deeper than 50 cm.	Consider surface maintenance. Reference section 4.1 for detailed mitigation measures.

permafrost). If LMI wants to better understand the mechanism behind the tension cracks to better determined the rate and risks of failure, then a detailed investigation would be required.

**Lupin Dam M tension crack**
