#### 2.1.1 Windblown Tailings

## 2.1.2 Acid Control in Closed Out and Reclaimed Tailings Basin

### 2.1.3 Inventory and Management of Hydrocarbon Contaminated Soils

### *2.1.4 Management of Hazardous Materials*

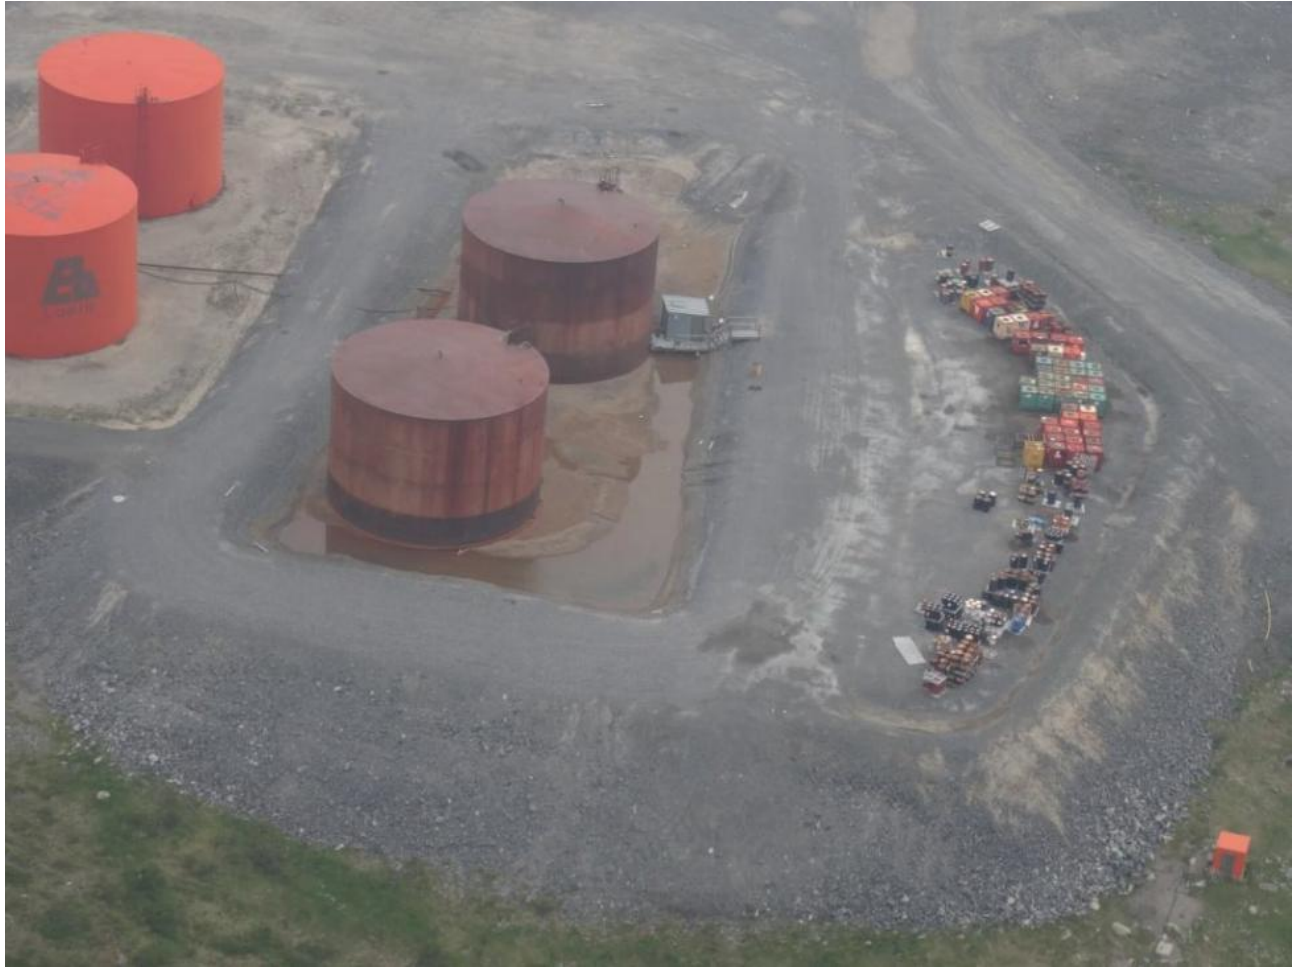
Hazardous Waste Storage Facility

*Hazardous waste is placed in a lined and bermed facility pending backhaul. LMI has backhauled considerable hazardous waste and continues to do so on available flights when safety and proper protocols so allow. Below is a current photo of the facility and attached is the manifest list from KBL from 2010-2014.*

It is recommended that LMI update the management plans for hazardous waste to include the location and design of the storage facility and provide a schedule for removing the inventory of waste from the site.
