| File: | Lupin Gold Project - 129500081 | Date: | November 14, 2019 |

**Reference: 2 AM-LUP Technical Meeting Commitment Number 6 Response – Geotechnical Review on the Long-Term Stability of TCA Dams**

Slope Stability Analysis  
(Rev 0)

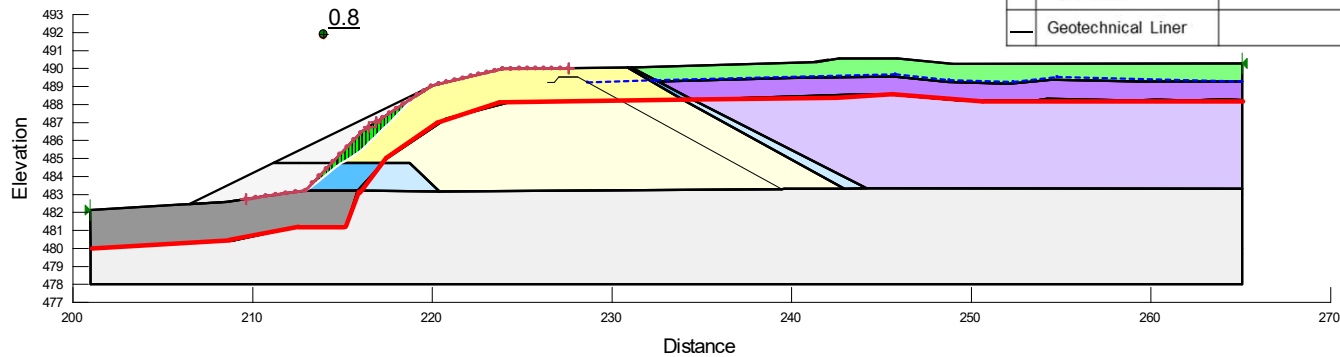
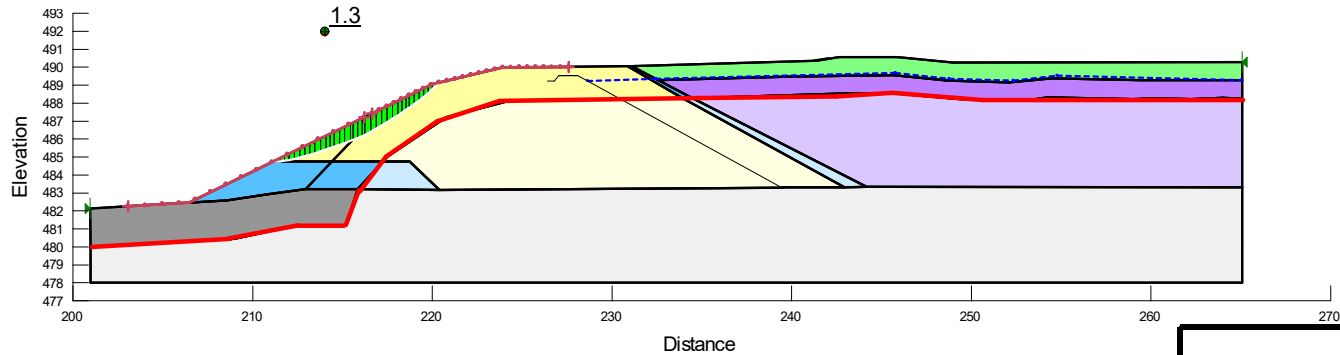
SLOPE STABILITY ANALYSIS  
SECTION K – PERMAFROST CONDITIONS  
STATIC CASE – LOCAL FAILURE

| Cross-section | Configuration | Scenario | | |
|---|---|---|---|---|
| K | As-built | 0.8* | 1.8 | 1.5 |

\*FOS value does not meet design criteria for as-built configuration, repair and re-sloping is required for closure.

**Details:****Current Permafrost Conditions:** permafrost is present at depth 2m below ground surface**Re-sloped Conditions:** regraded to 2H:1V to reach minimum FOS criteria

- Dam M: re-slope to 2.1H:1V;
- Dam K: re-slope to 2.1H:1V

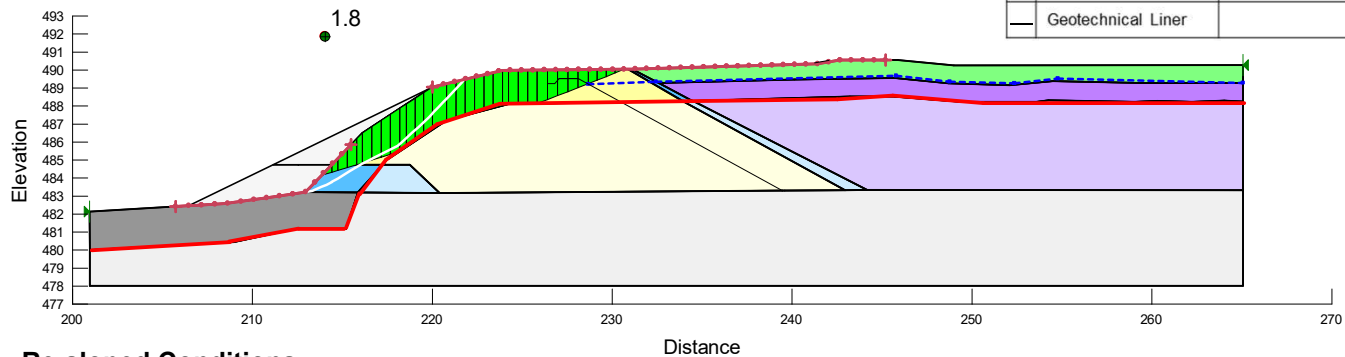
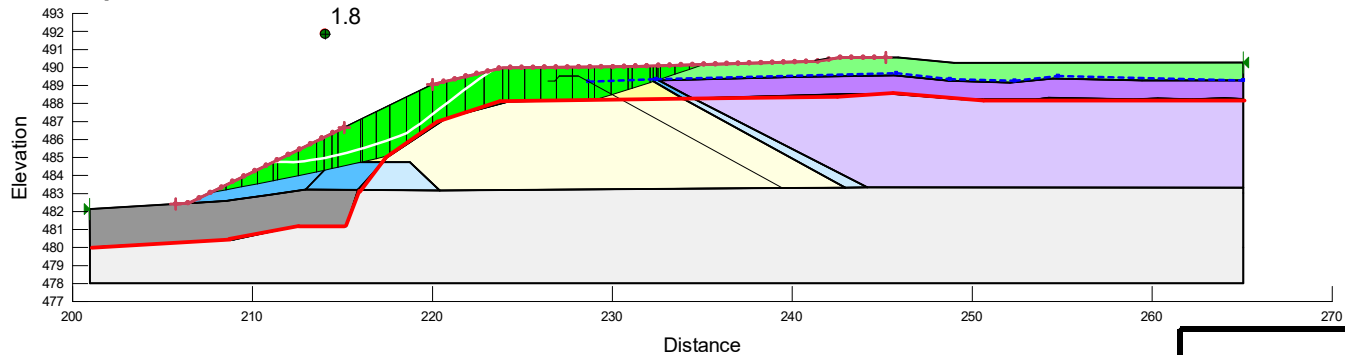
SLOPE STABILITY ANALYSIS  
SECTION K – PERMAFROST CONDITIONS  
STATIC CASE - GLOBAL FAILURE

**Details:****Current Permafrost Conditions:** permafrost is present at depth 2m below ground surface**Re-sloped Conditions:** reggraded to 2H:1V to reach minimum FOS criteria

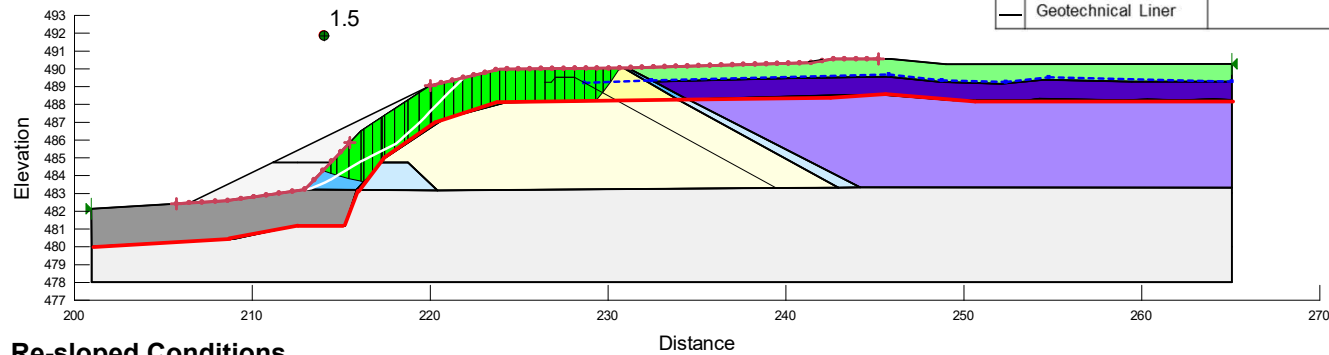
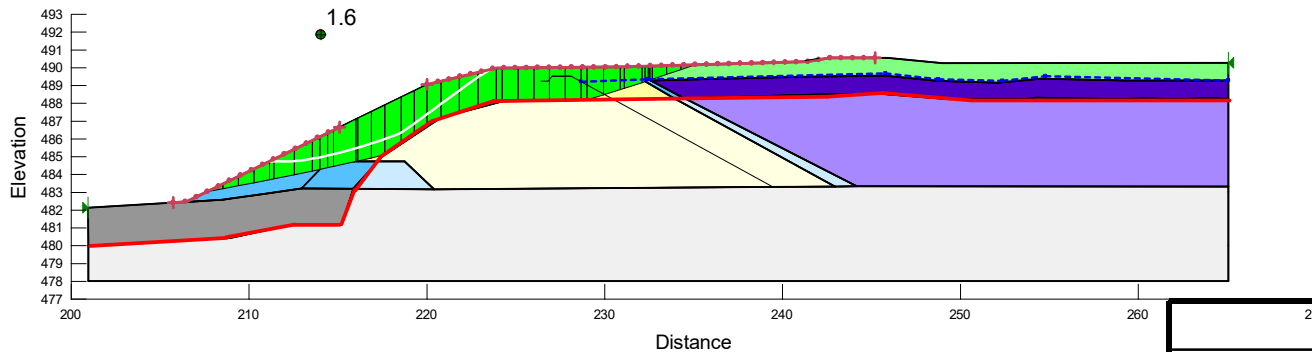
SLOPE STABILITY ANALYSIS  
SECTION K – PERMAFROST CONDITIONS  
PSEUDO-STATIC CASE – GLOBAL FAILURE

**Details:****Current Permafrost Conditions:** permafrost is present at depth 2m below ground surface**Re-sloped Conditions:** regraded to 2H:1V to reach minimum FOS criteria

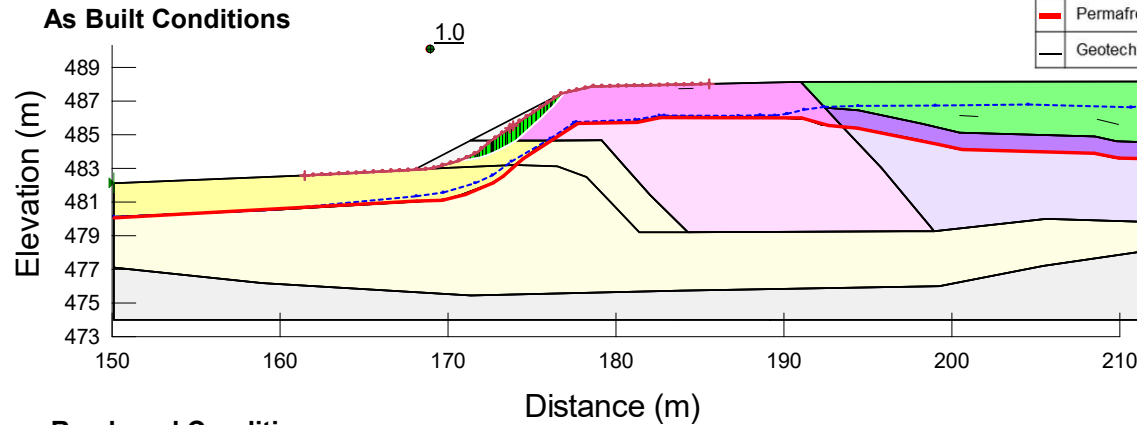
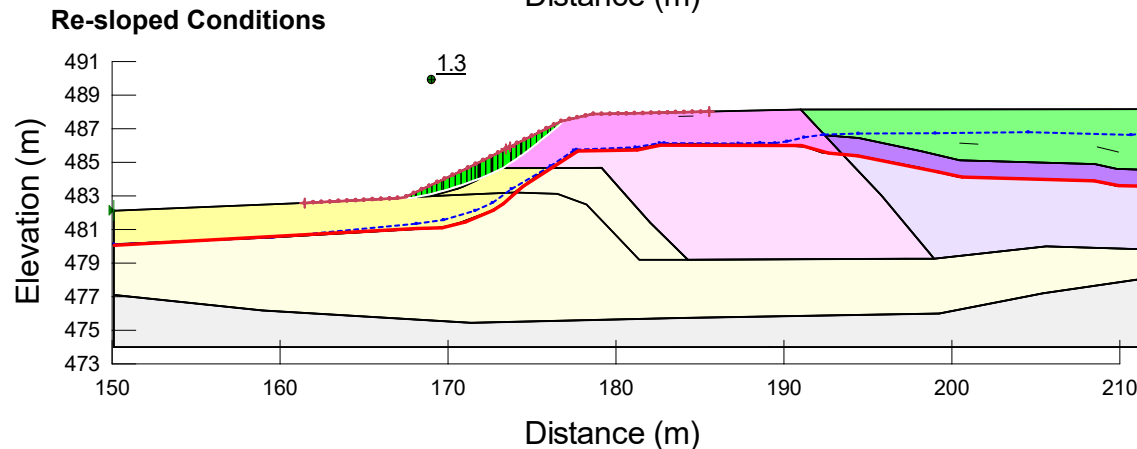
SLOPE STABILITY ANALYSIS  
SECTION M – PERMAFROST CONDITIONS  
STATIC CASE – LOCAL FAILURE

| Cross-section | Configuration | Scenario | | |
|---|---|---|---|---|
| M | As-built | 1.0* | 3.0 | 2.6 |

**Details:****Current Permafrost Conditions:** permafrost is present at depth 2m below ground surface**Re-sloped Conditions:** reggraded to 2H:1V to reach minimum FOS criteria

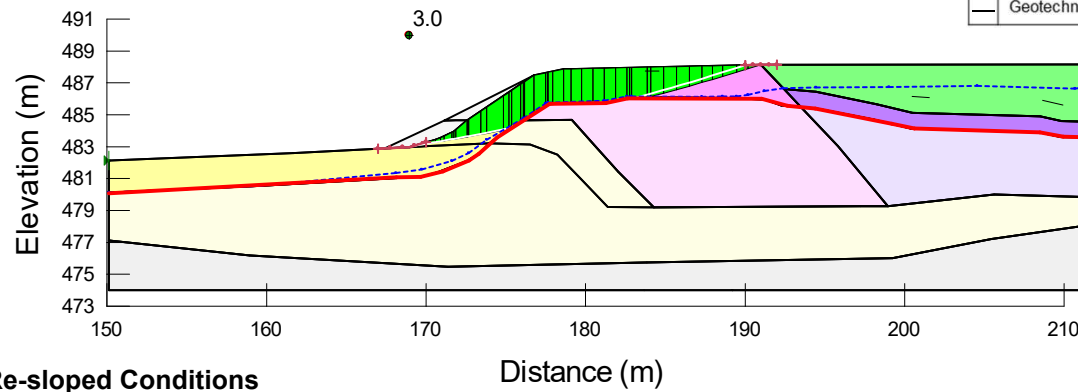
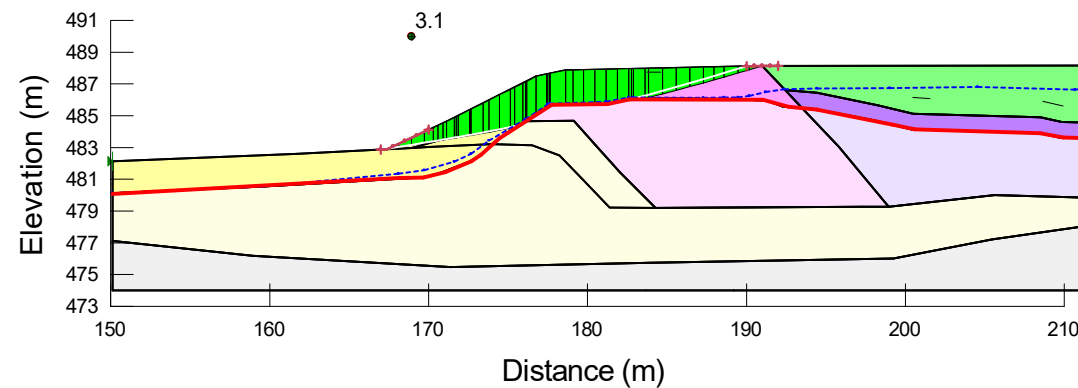
**SLOPE STABILITY ANALYSIS  
SECTION M – PERMAFROST CONDITIONS  
STATIC CASE - GLOBAL FAILURE**

**Current Permafrost Conditions:** permafrost is present at depth 2m below ground surface

**Re-sloped Conditions:** reggraded to 2H:1V to reach minimum FOS criteria

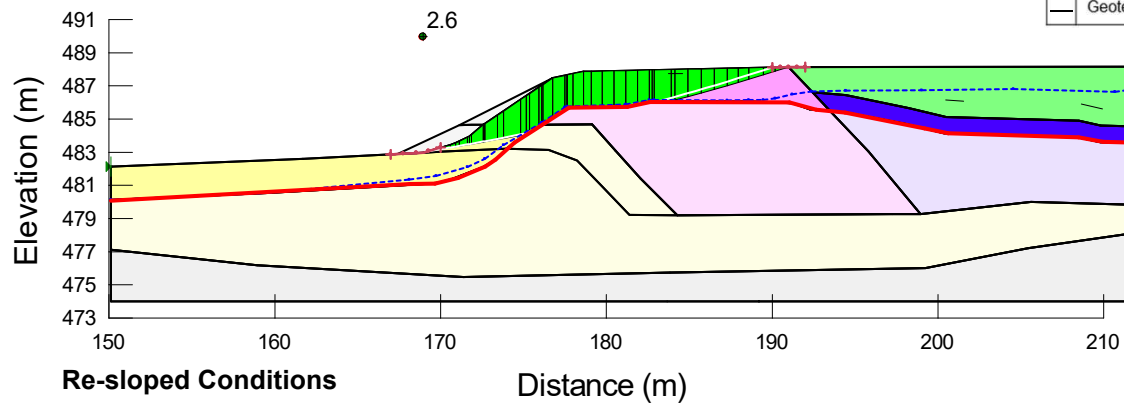
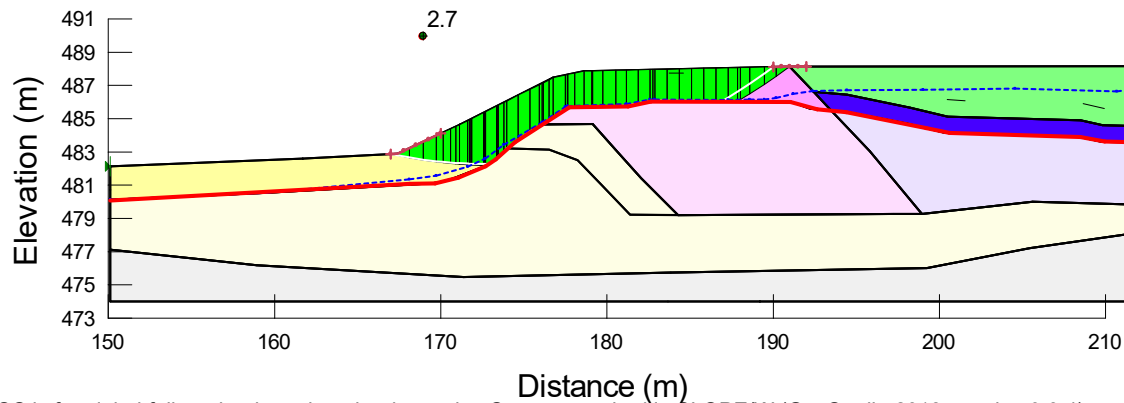
SLOPE STABILITY ANALYSIS  
SECTION M – PERMAFROST CONDITIONS  
PSEUDO-STATIC CASE – GLOBAL FAILURE

**Current Permafrost Conditions:** permafrost is present at depth 2m below ground surface

**Re-sloped Conditions:** reggraded to 2H:1V to reach minimum FOS criteria
