July 8, 2001 Water Licence Inspection - Report

INDUSTRIAL WATER USE INSPECTION REPORT

Date: 2001/07/08 Company Rep. (Name/Title): David Hohnstein / Environmental Coordinator Licensee: Echo Bay mines Ltd., Lupin Operations Licence No.: N7L2-0925 (expired)

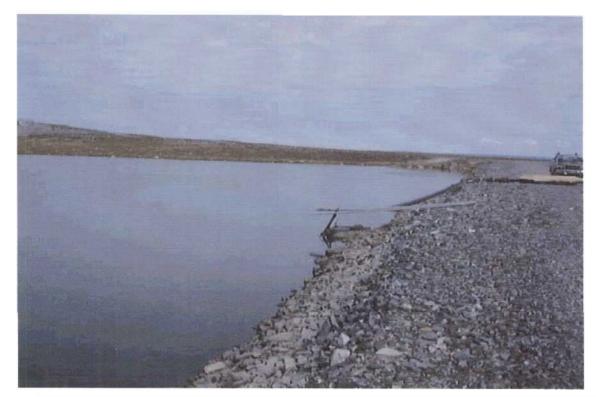
• Sewage disposal: Due to abundant spring runoff, the level of the Lower Sewage Lake was markedly high at the time of the inspection (figure 4). In light of this, damage to the decant gate was noted, and signs of erosion along the final retention berm hinted at a breach in the underlying discharge culvert (figure 5). As concerns regarding the decant structure of the Sewage Lakes Disposal System were raised during the previous inspection, the Licensee ensured that repair/replacement work would be undertaken once the level of the Lower Sewage Lake was sufficiently drawn down to enable adequate access to the decant structure. This being said, the attached analytical results relating to a sample collected from SNP station 925-14 (figure 6) indicate that while all licenced thresholds are satisfied, concentrations of ammonia (3.48 mg/L vs 2.2 mg/L), arsenic (13.2 μ g/L vs 5 μ g/L), copper (12 μ g/L vs 4 μ g/L), iron (802 μ g/L vs 300 μ g/L), and zinc (52 μ g/L vs 30 μ g/L) exceed the Canadian Water Quality Guidelines for the Protection of Freshwater Aquatic Life. However, the Microtox sample, which constitutes a reliable toxicity indicator (IC₅₀), did not attribute toxicity to the sewage effluent discharge.

figure 4. Final retention dam of the Sewage Lakes Disposal System; 2001/07/08.

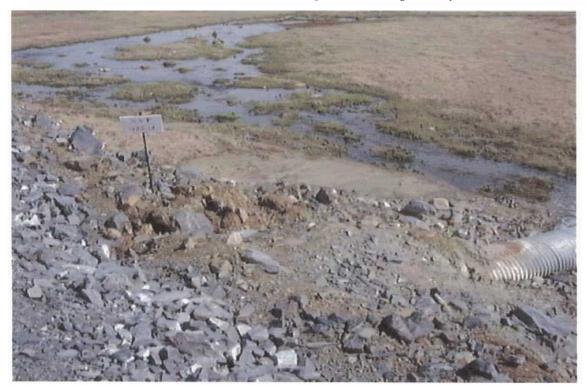
figure 5. Signs of berm erosion along the discharge culvert at SNP 925-14; 2001/07/08.

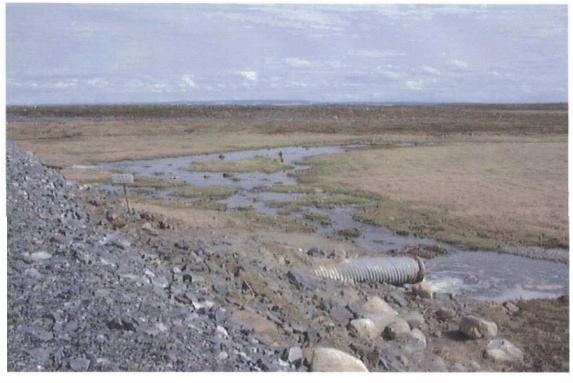
Violations of Act or Licence: The deficient decant structure at Surveillance Network Station (SNP) 925-14 does not allow for the accurate measurement of the onset of discharge from the Sewage Lakes Disposal System; Licensee ensured that repair/replacement work would be undertaken.

figure 6. Discharge from the Sewage Lakes Disposal System, SNP 925-14; 2001/07/08.

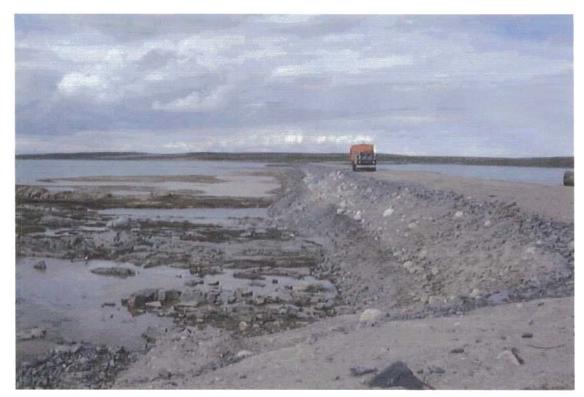
- Tailings disposal: A seepage zone along M Dam, separating Cell 5 from Pond 2, was recently discovered (figure 1). Consequently, measures were taken to initiate the draw down of the cell in order to enable the sealing of the upstream toe of the dam with a geotextile liner and/or a tailings beach. The extent of the seepage is believed to have been relatively limited, and no significant alteration of Pond 2 water quality is expected. In addition, considerable retention time will be provided since the Licensee already had planned to forego the annual discharge from the Tailings Containment Area (TCA).

Comments: Discharge from the Tailings Containment Area (TCA) not planned for this year; no noticeable flow from the Pond 2 discharge at Dam 1A, SNP station 925-10. Seepage from Cell 5 into Pond 2 detected through M Dam; makeshift diversion ditch has been trenched along the upstream toe of the dam in order to limit the extent of seepage. Accumulated water observed in both emergency tailings line dump ponds. Damaged decant gate and culvert at the Sewage Lakes Disposal System; discharge onset and volume estimated. Flow noted from both the siphon line and the discharge culvert, where signs of erosion were observed. No concerns noted at the well-managed solid waste disposal facility. Kitchen wastes are incinerated. Hazardous materials are stored in sealift containers, waste oil in two bulk tankage by the mill.

figure 1. Seepage zone along M Dam, separating Cell 5 from Pond 2; 2001/07/08.

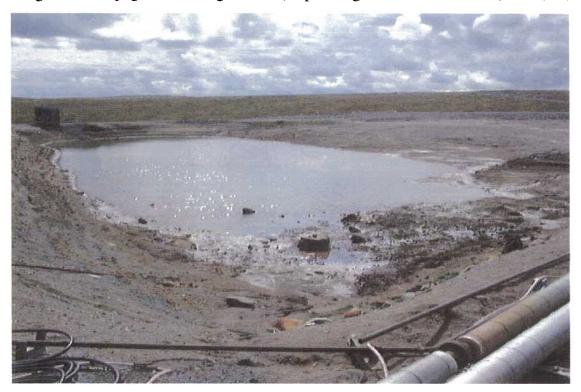
In related matters, accumulated water was noted in both upper (figure 2) and lower (figure 3) emergency tailings line dump ponds. Thus, the Licensee had scheduled both dump ponds to be pumped dry within the following week. In this regards, the Inspector nonetheless points out that given the likelihood of tailings material to be present in the emergency tailings line dump ponds, the pooled water ought to be directed to the tailings circuit unless prior sampling demonstrates otherwise.

figure 2. Upper emergency tailings line dump pond; 2001/07/08.

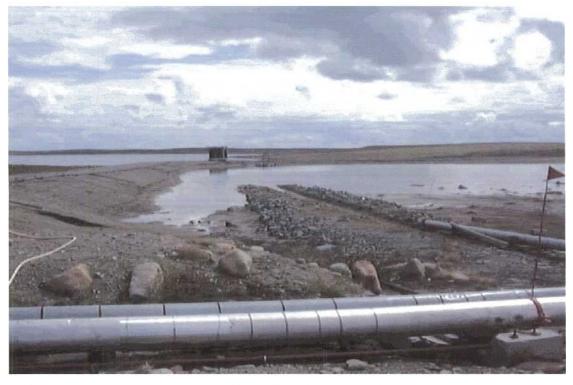
figure 3. Lower emergency tailings line dump pond; 2001/07/08.
