2012 Annual Geotechnical Inspection – Lupin Mine Tailings Containment Area, Nunavut

Lupin Mines Incorporated

SRK Consulting (Canada) Inc.
1CL008.000
November 2012

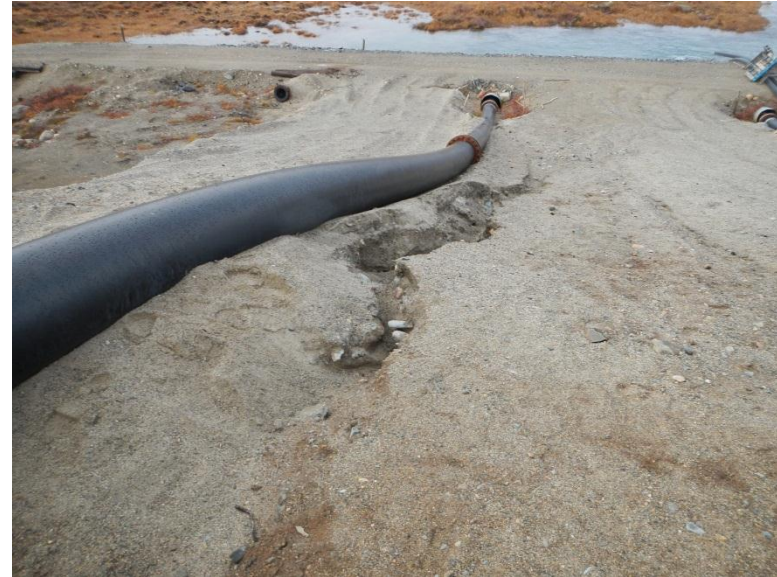
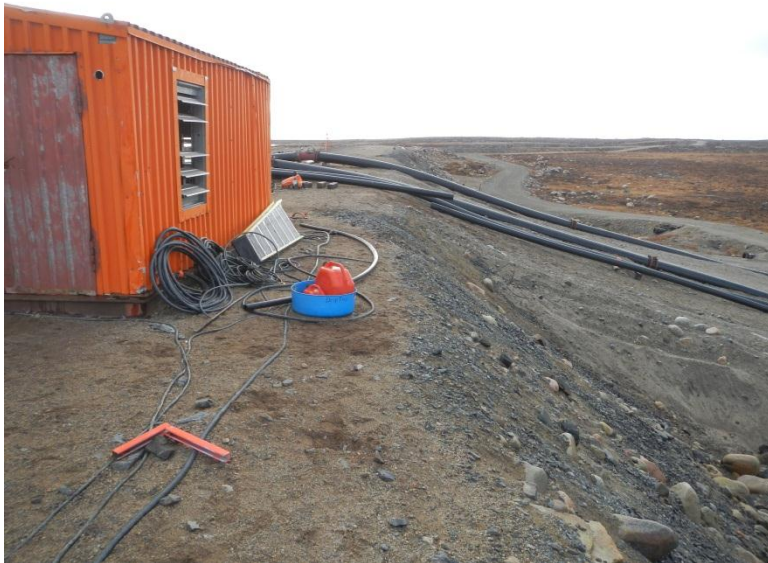
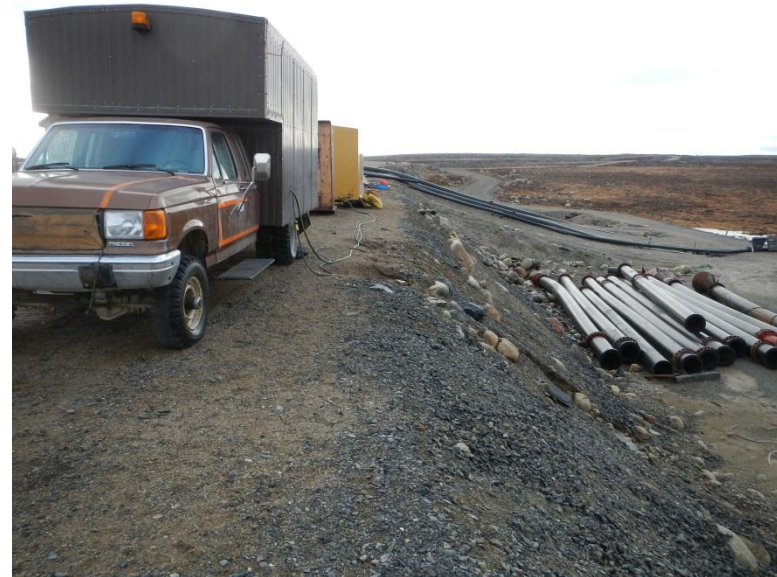
The perimeter dams are generally in good condition in terms of stability and performance. There are minor erosion issues which are typically associated with sand and gravel construction material. These should be monitored and repaired as required to prevent continuous erosion that could worsen and impair the dam. While most of the erosion is minor, some along Dam 1A is more serious and should be addressed in 2013.

Erosion Gully in Dam 1A

Erosion Gullies in Dam 1A

With the exception of Dam M, the majority of the dams were generally found to be performing well and stable. SRK recommends that the observed erosion on Dams 1A, 3, 4, 6, L and J be monitored and repaired as required to prevent the risk of instability.

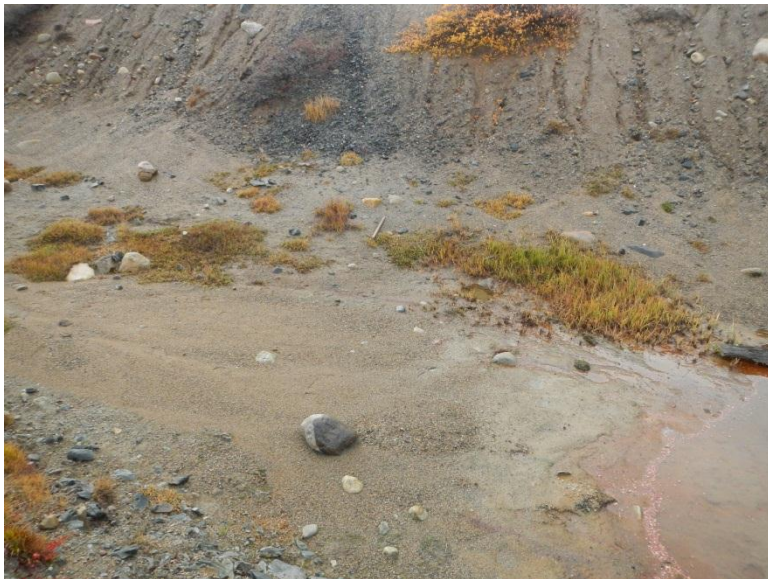
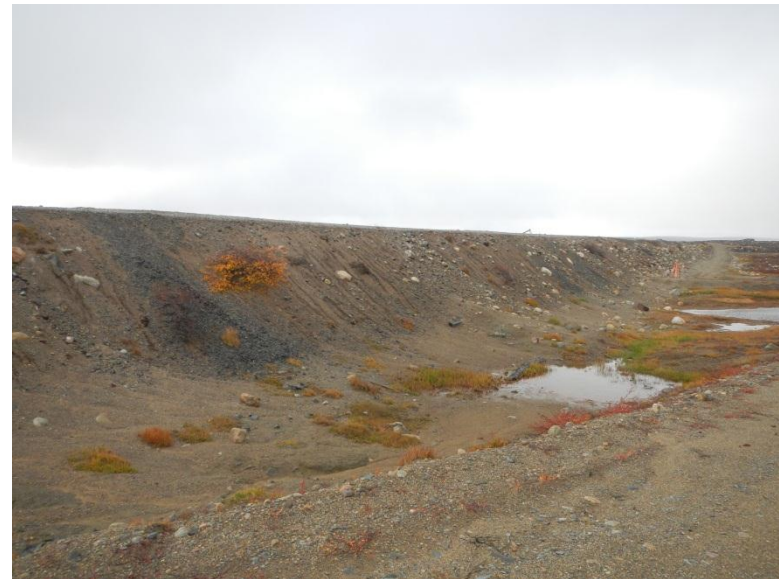
A previous annual inspection found seepage in the western buttress toe of Dam 4 into Ferguson Lake and the northern buttress toe of Dam 2 into Dam 2 Lake. The seepage has either stopped or reduced significantly; it was not observed during the current inspection. A cofferdam was placed at the toe of Dam 2 to collect seepage to be pumped back into Pond 2 when it pooled. The seepage reported at Dam 4 in 2011 (TBT 2011) was not observed. Additionally, the minor cracks in Dam 1C, which were noted last year, were not observed during this inspection. They were either repaired or filled in naturally with material over time.

Seep at Dam 2

Seepage Collection at Dam 2

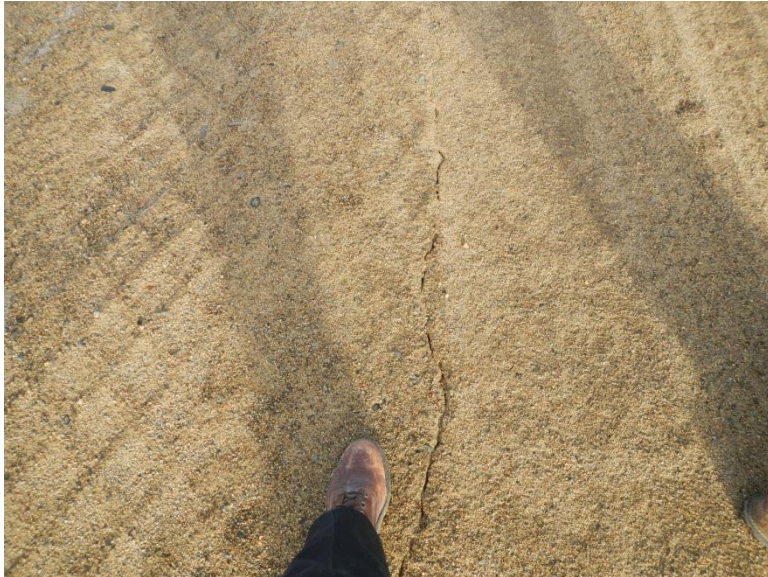
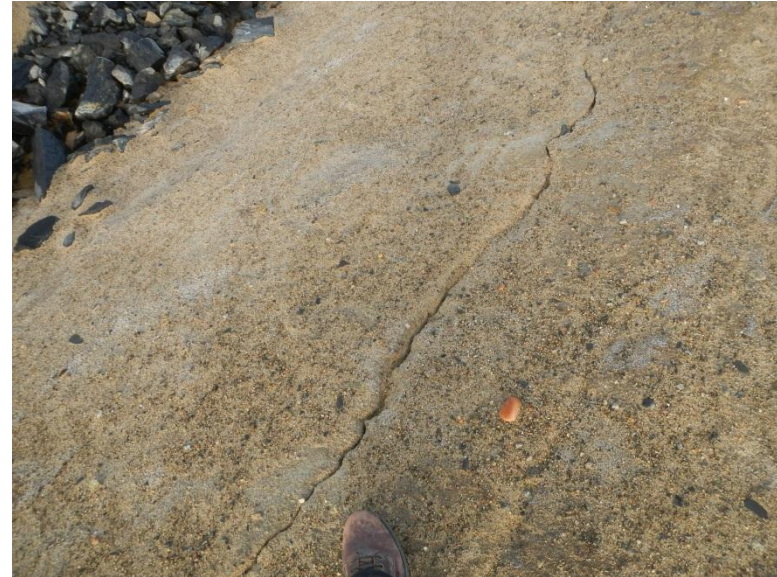
Minor Cracks in Dam 3

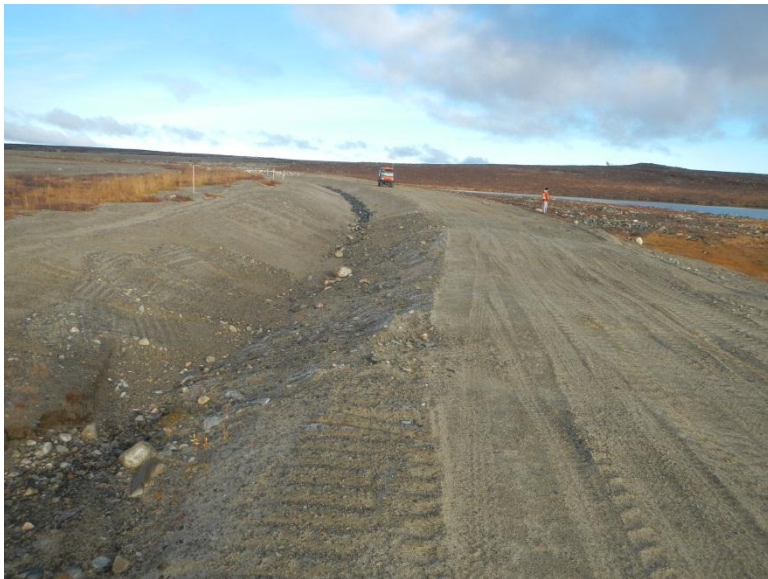
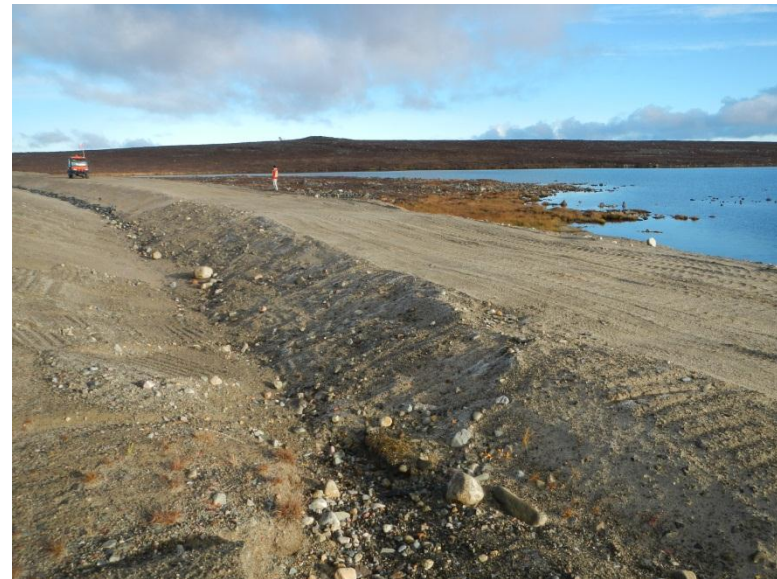
The storm ditch built within top 2 m of Dam 3 was damaged somewhat in the 2012 freshet. The damage has since been repaired but it was observed that the ditch is not properly graded to allow the freshet runoff water to free drain. This appears to be the main cause of the previous damage. Because there is poor grading, the water pooled, froze, and created an ice dam; which in turn forced the freshet water to breach the ditch and a small portion of Dam 3.

Storm Ditch in Dam 3

Dam 3	Surface erosion and loose material on dam crest. Ponding in the storm ditch.	Compact the loose material and maintain the surface erosion. Clean out and regrade, to remove accumulated material in storm ditch and permit flow.	Minor surface erosion. Despite repairs to the storm ditch, it does not yet have a free-draining grade.	Consider surface maintenance. Regrade ditch to minimize ponding and monitor during freshet to prevent ice blockages.
Dam 4	Erosion gullies and loose fill placed between dam and old coffer dam for seepage control.	Compact the loosely-placed material to improve resistance to erosion. Maintain deep erosion gullies.	Surface erosion with a number of deep erosion gullies. Exposed geogrid or similar synthetic reinforcements observed near the eastern downstream toe of the dam.	Repair the deep erosion gullies and maintain the surface. Monitor the exposed geogrid for erosion and water seepage.

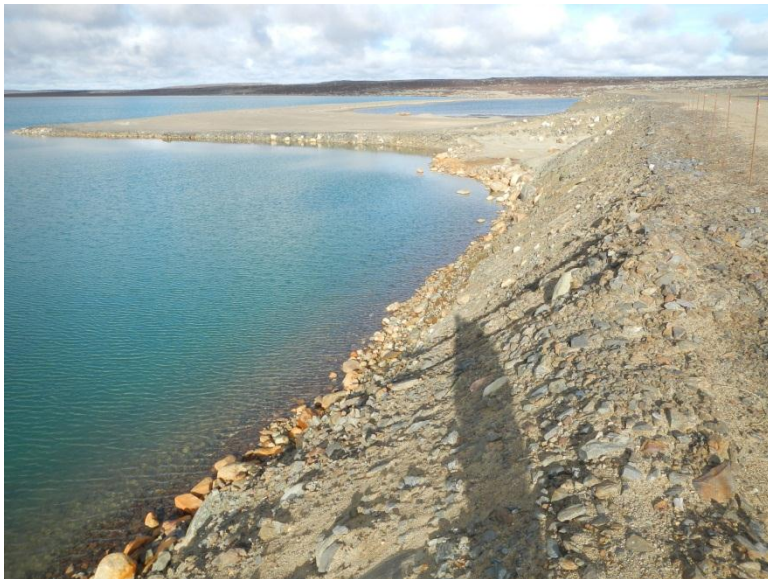
DS slope below Tension Crack in Dam 4

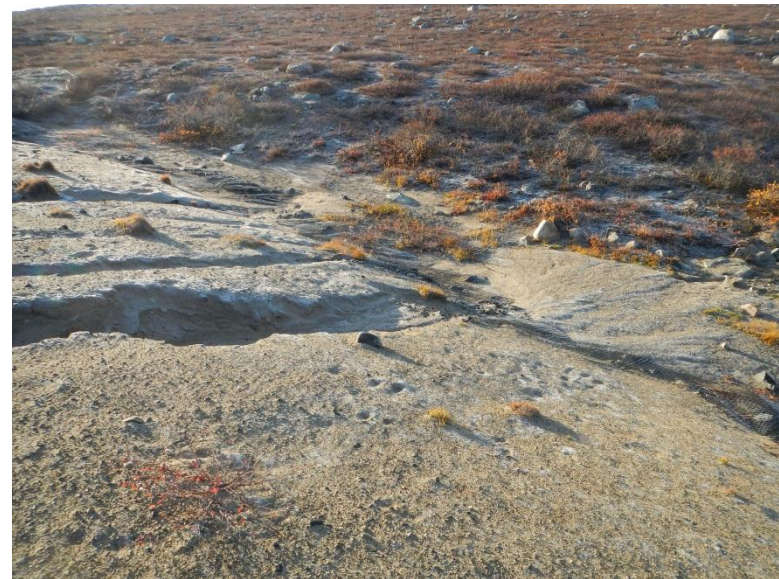
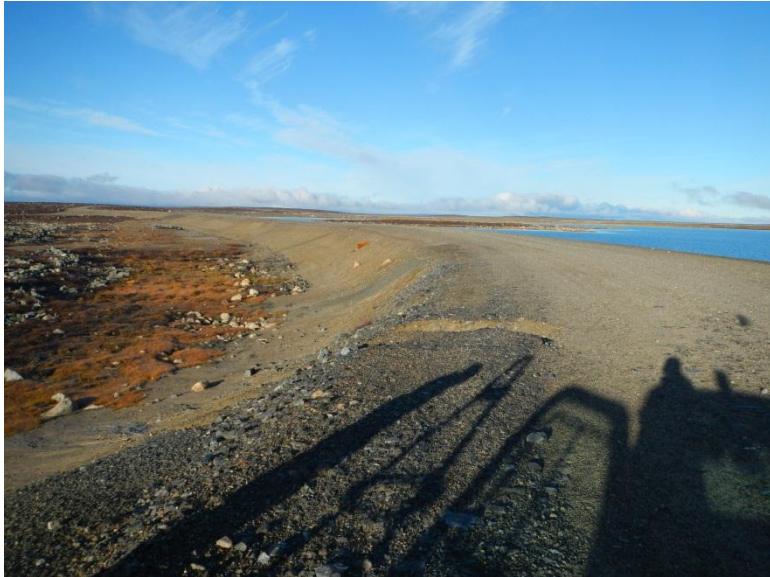
Erosion Gullies and Exposed Geogrid in Dam 4

Erosion Gullies in Dam 4

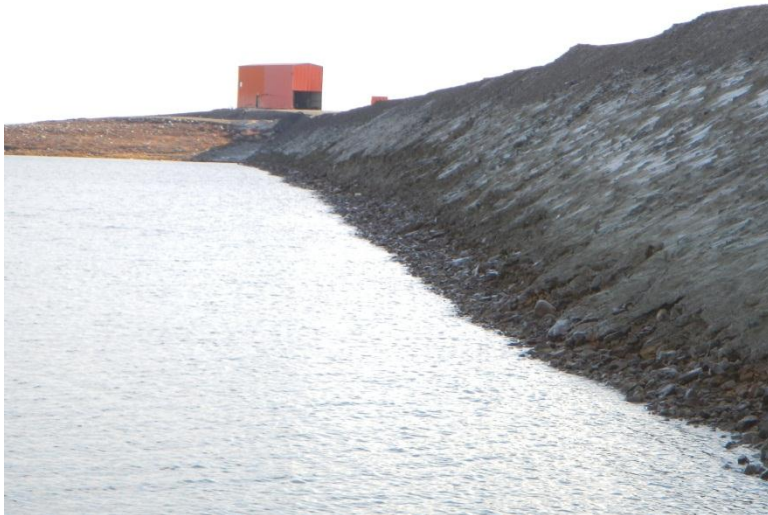
Undercutting in Dam K

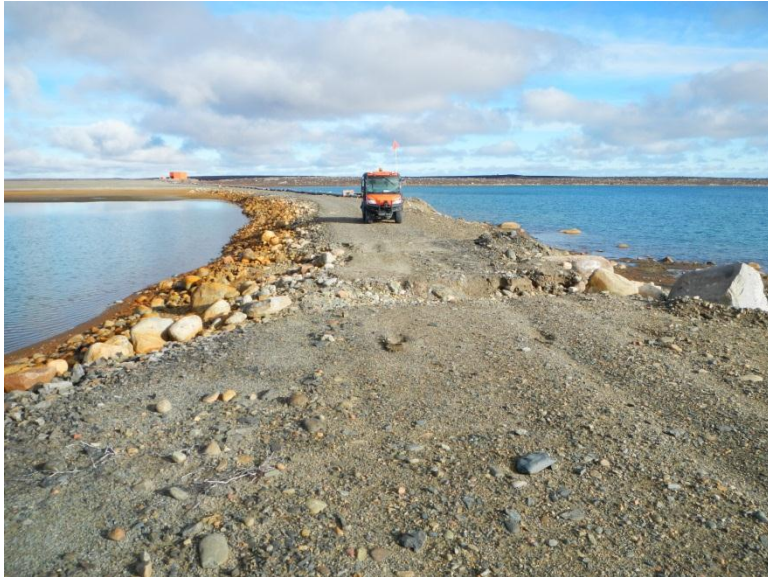
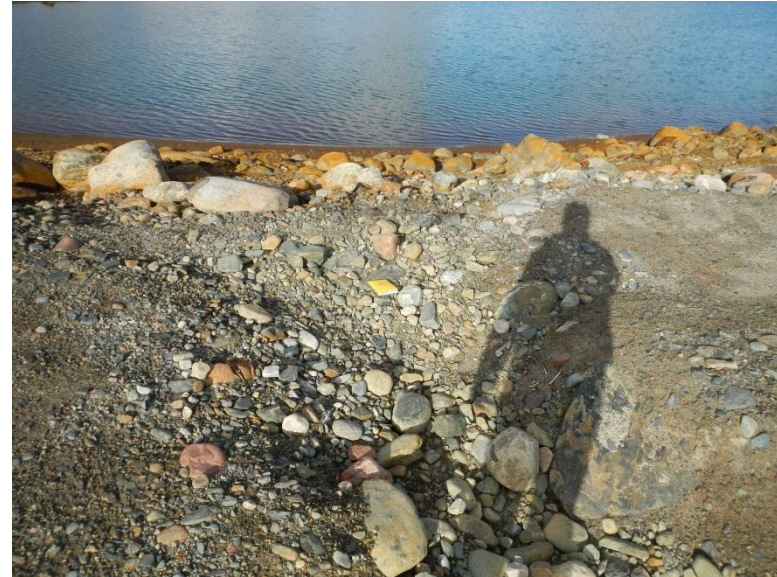
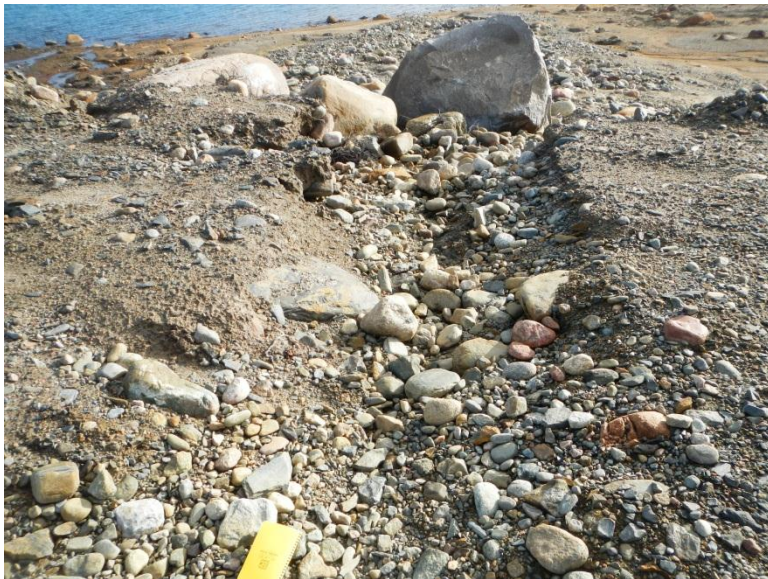
During the inspection, a substantial erosion breach was observed at the south end of Dam L. It is assumed that the erosion was caused by the freshet where the water from the uncovered portion of Cell 3 breached into Cell 4. From physical observation and conversation with site staff, it appears that the Cell 3 water level has not been managed in recent years. This raised water level breached the lowest point in Dam L and discharged into Cell 4. Section 4 of this report provides recommendations to deal with the breached section in Dam L.

Dam L			Minor slope surface erosions and some minor undercutting at toe. Breach at southern section of dam near buttress. Seepage observed at 0.5 L/min below breach.	Consider surface maintenance. Monitor regularly to ensure dam toe is not undercut. If so, place riprap at the problematic area for protection. Repair with compacted well-graded esker material. Monitor and manage water in Cell 3 to prevent freshet overflow.
Dam M			Slope surface erosion. Major tension crack observed over an approximate 15 m section near Dam N. Cracks are up to 6 m long and deeper than 30 cm.	Consider surface maintenance. Reference section 4.1 for detailed mitigation measures.

Breach in Dam L

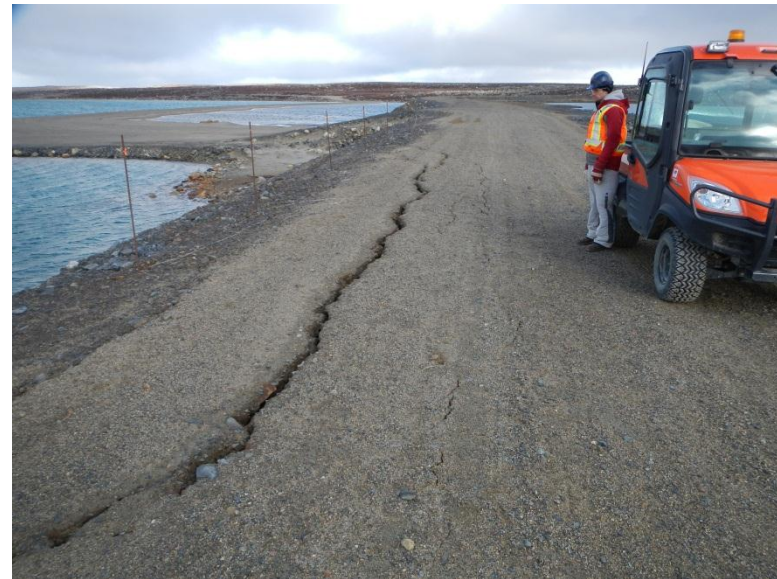
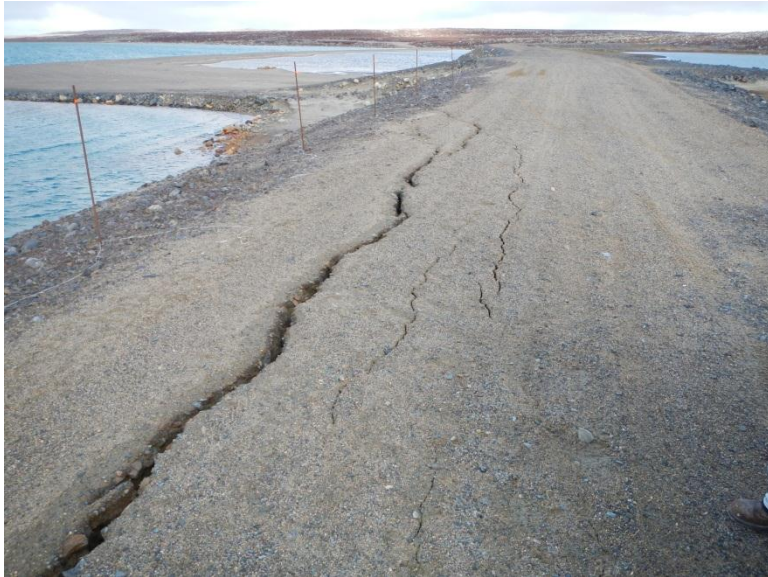
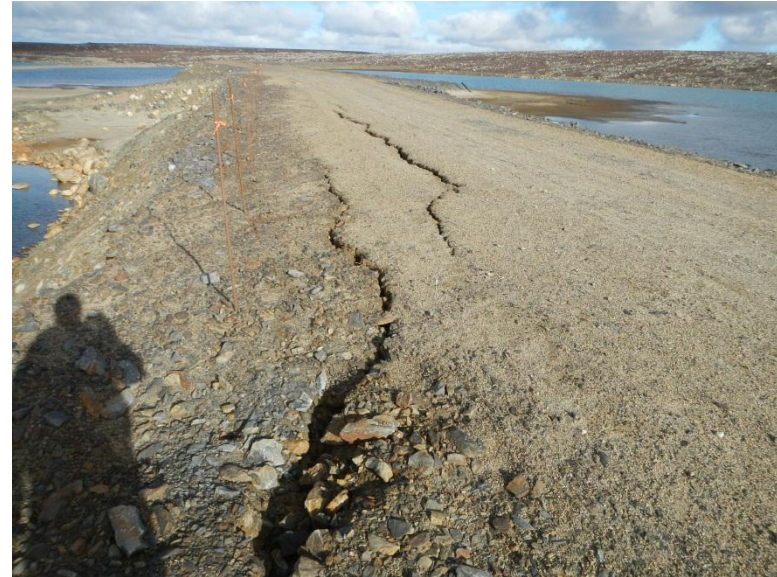
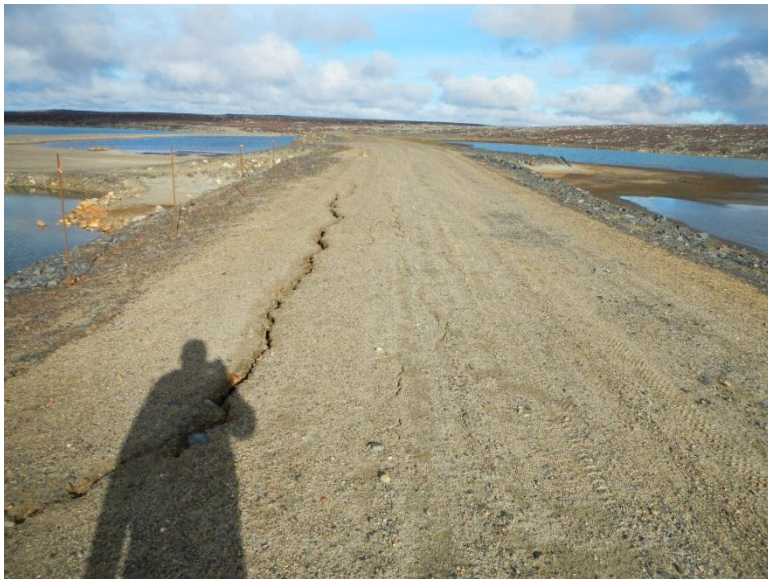
A significant series of tension cracks observed on Dam M are a cause for concern. Potentially, this failed portion of the dam could breach. Because of the severity of the cracks and potential breach, Mr. Dave Vokey was advised that all vehicle traffic should avoid this section for safety reasons and that regular monitoring should be carried to determine if the cracking is progressing. Section 4.1 provides recommendations to address the risks and potential for failure.

Based on a visual inspection of the tension cracks in Dam M, possible causes could include pore water pressure from Cell 5, undercutting of the toe from wave action in Pond 2 and/or foundation “creep” (movement between the active layer and permafrost). To better understand the mechanism behind the tension cracks a detailed investigation would be required.

Tension Crack in Dam M

In the short term, all vehicles should avoid this section of the dam for safety reasons. SRK further recommends that a monitoring program be established as soon as possible to determine the rate of

movement. The program should include three pairs of monitoring monuments placed perpendicular to the cracks: one at each end and one in the middle of the failing section, each with a matching monitor on the stable section of the crest. Site personnel should measure and record the distances between each set of monuments on a weekly basis. Results should be compiled and reviewed each week.

In addition to the above, SRK recommends that LMI undertake a risk assessment of the consequences of failure of the Dam M into Pond 2. This assessment should be completed prior to the 2013 freshet. If the consequence of failure is deemed significant then remediation measures should be implemented. SRK recommends that one of these measures should involve the construction of a toe buttress with a minimum crest width of 3m. The buttress should be constructed of compacted, well-graded esker material, and placed with a downstream slope of 2H:1V (horizontal to vertical) and extend up to half the height to the existing dam crest. The buttress should extend a minimum of 5 m beyond the failing section at each end. Assuming remediation is required, LMI should make preparations for the placement of this buttress in 2013. If the monitoring program indicates no movement, the construction of the buttress can be delayed until just before the 2013 freshet. However if movement is detected, the buttress should be constructed as soon as possible.
