Appendix 1: 2AM-LUP0914 PHOTOS OF INSPECTION, July 15 2014

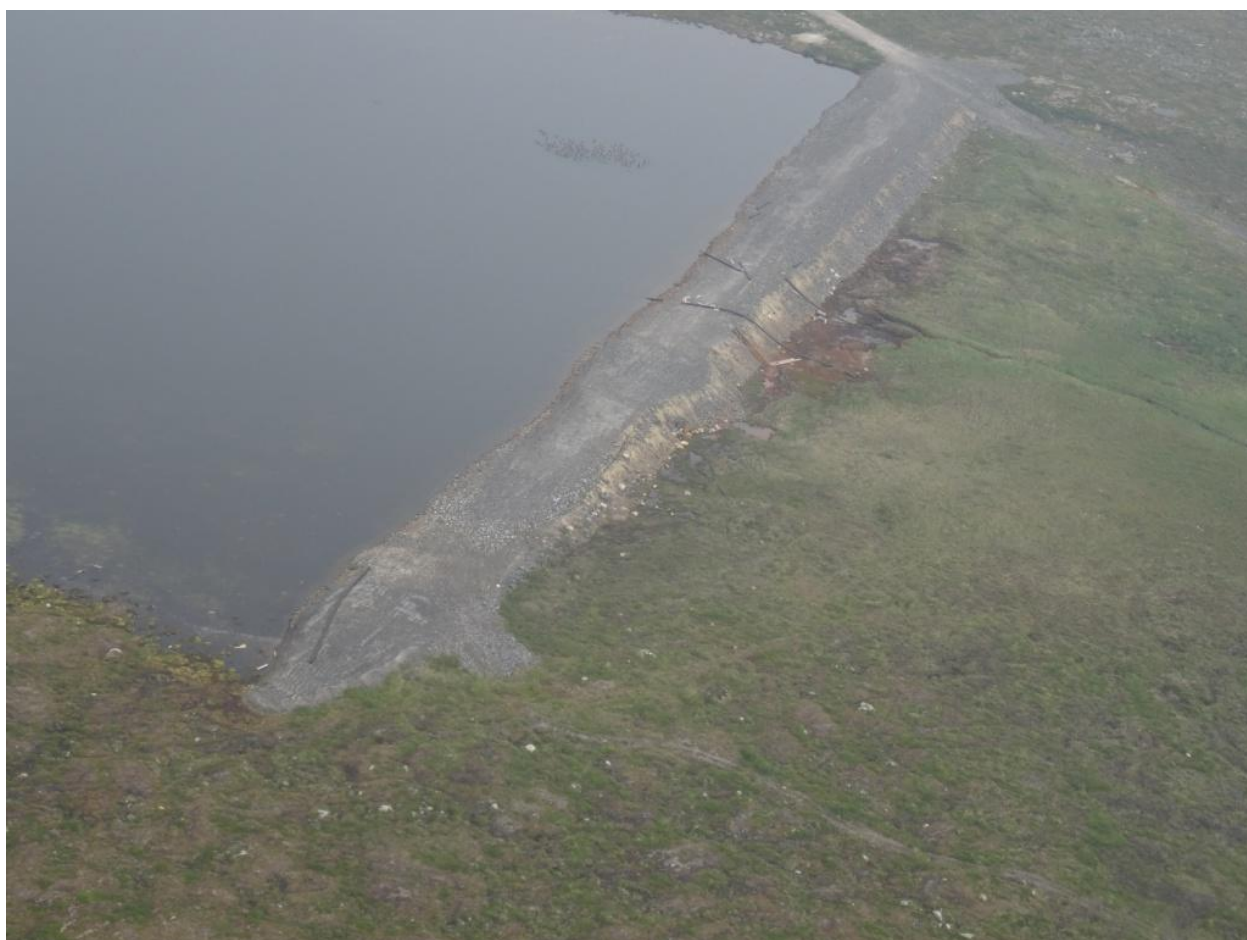
Figure 2. Aerial view of the dam at Lower Sewage Lagoon (LSL).

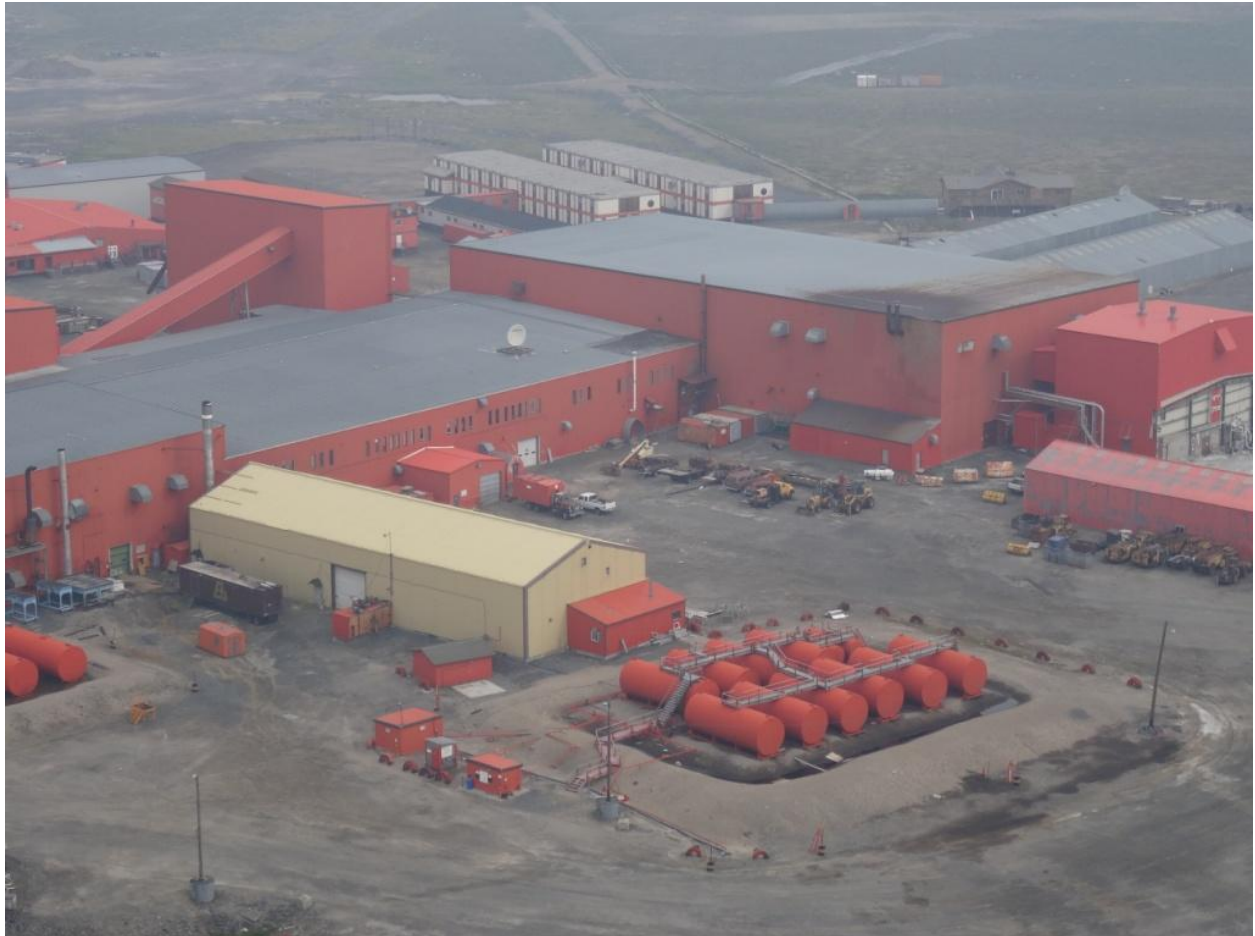
Figure 7. Satellite Tank (STF) Farm from the air. Heavy staining visible within and without.

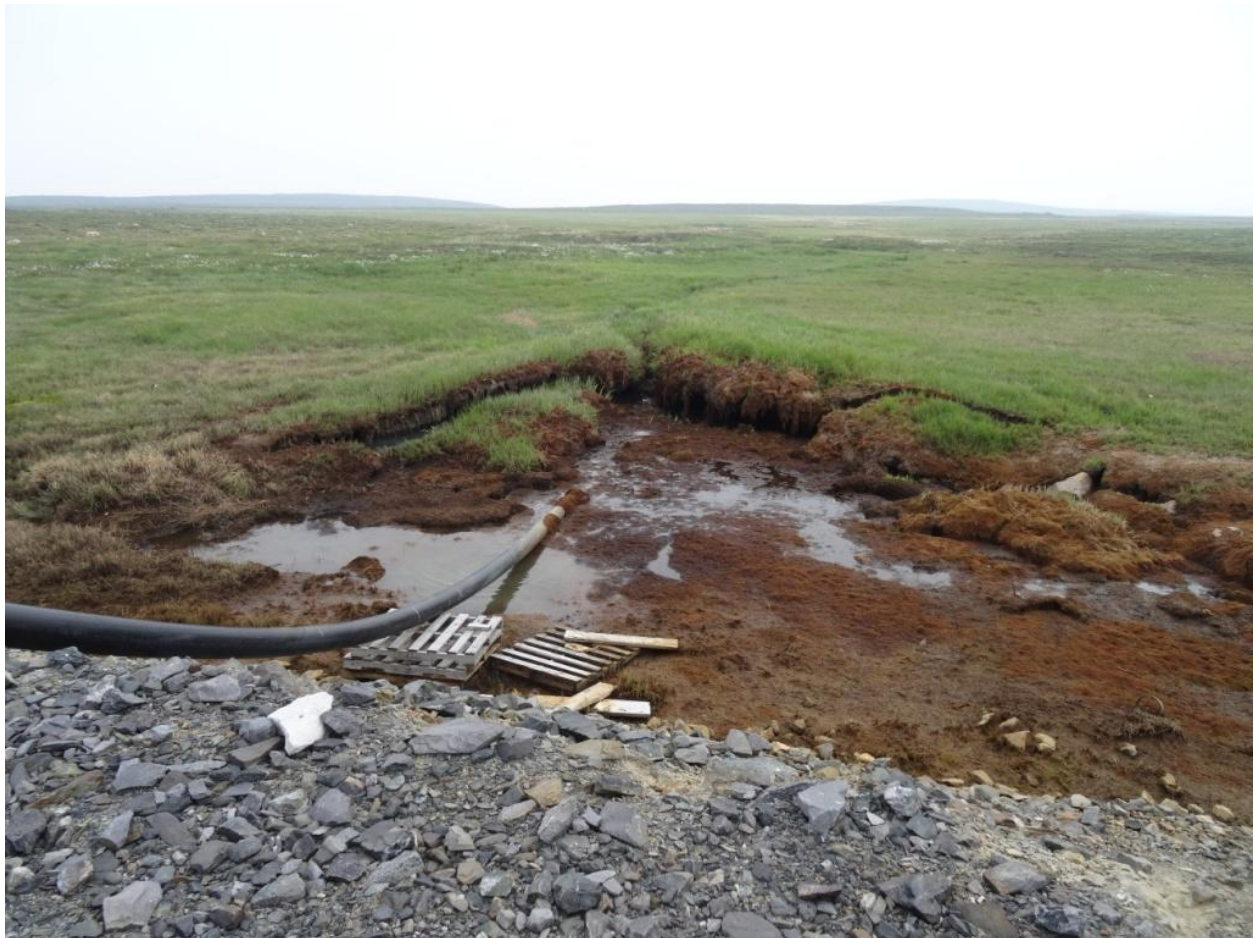
Figure 11. Permafrost degradation noted at discharge from LSL.
