Memo

To:	George Friesen	Client:	Lupin Mine Incorporated
From:	Alvin Tong	Project No:	1CL008.001
Cc:	Peter Healey; Arlene Laudrum	Date:	October 29, 2014
Subject:	Addendum to 2014 Lupin TCA Geotechnical Inspection Report

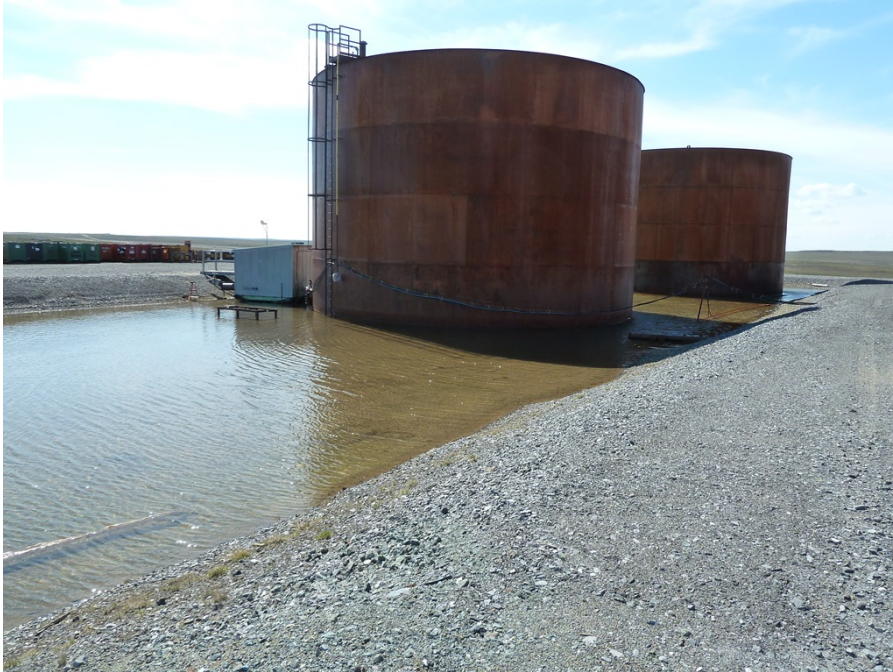
Picture 1: South view from the front of the main tank farm with shallow ponding water inside.

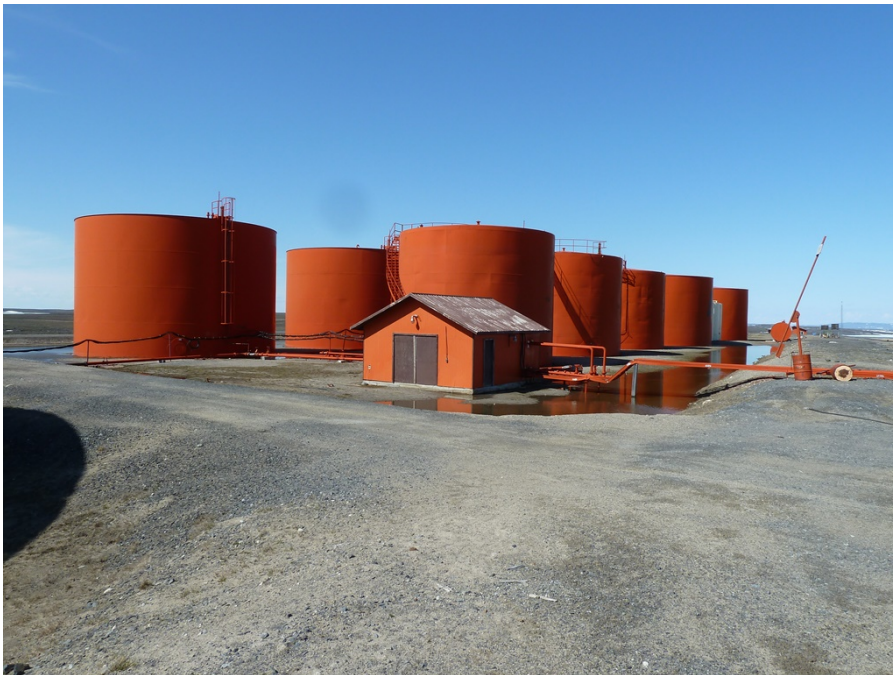
Picture 2: North view from the front of the main tank farm with shallow ponding water in the front of the containment.

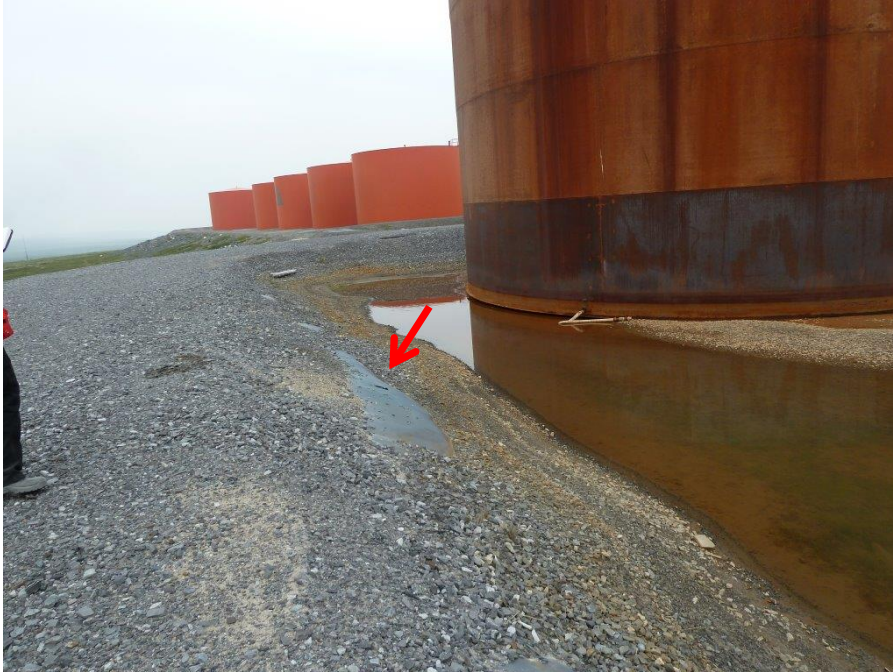
Picture 3: North view from the back of the tank farm with shallow ponding water. Note the exposed and damaged liner.

Prior to adding new fuel in the tank farms, it is recommended that any noted damage to the liner to be repaired to ensure containment and the sand overliner be replaced over the exposed liner to provide for long-term protection. In addition to repairs on visually identified liner damages,

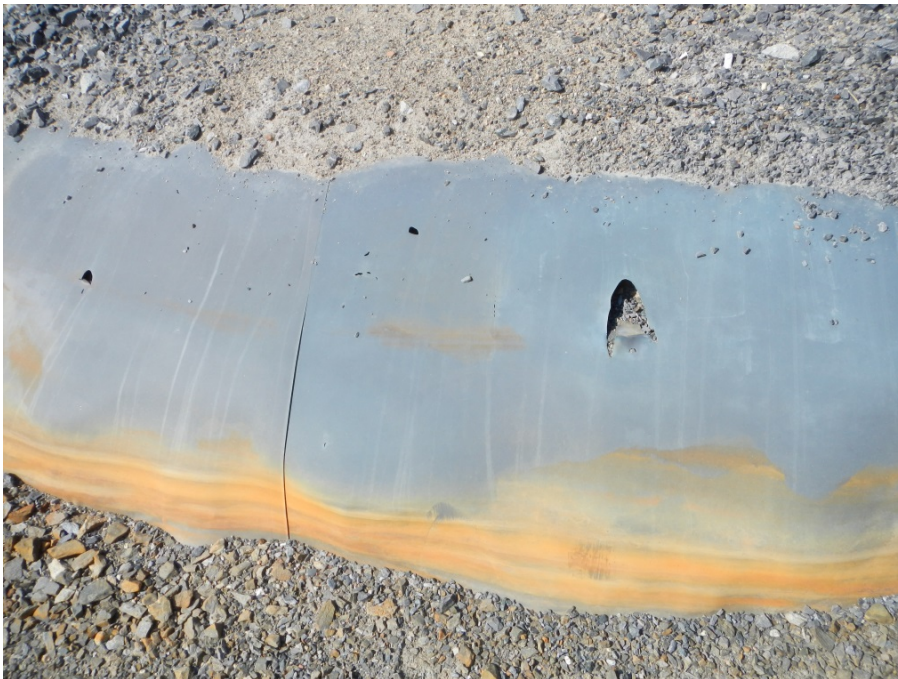
Picture 4: Closure up view of the damaged liner.

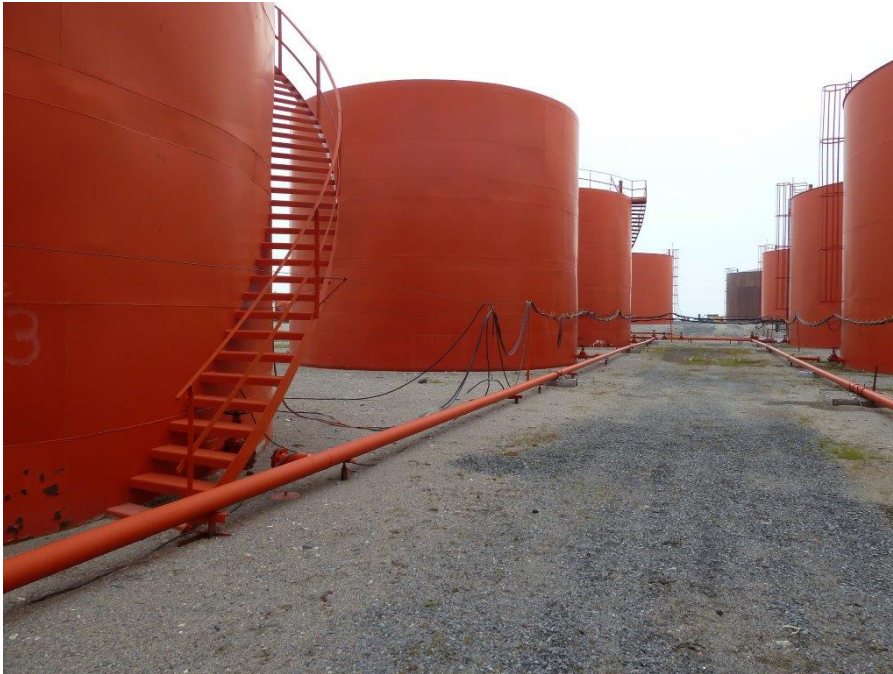
Picture 5: South view from inside of the main tank farm.

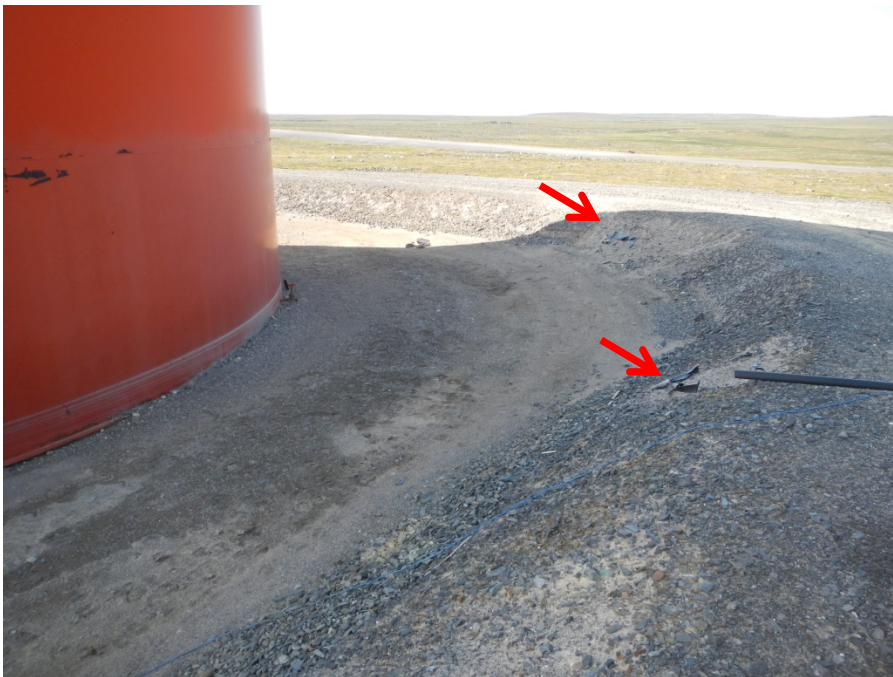
Picture 6: View of the damaged liner in the northwestern corner of the main tank farm.

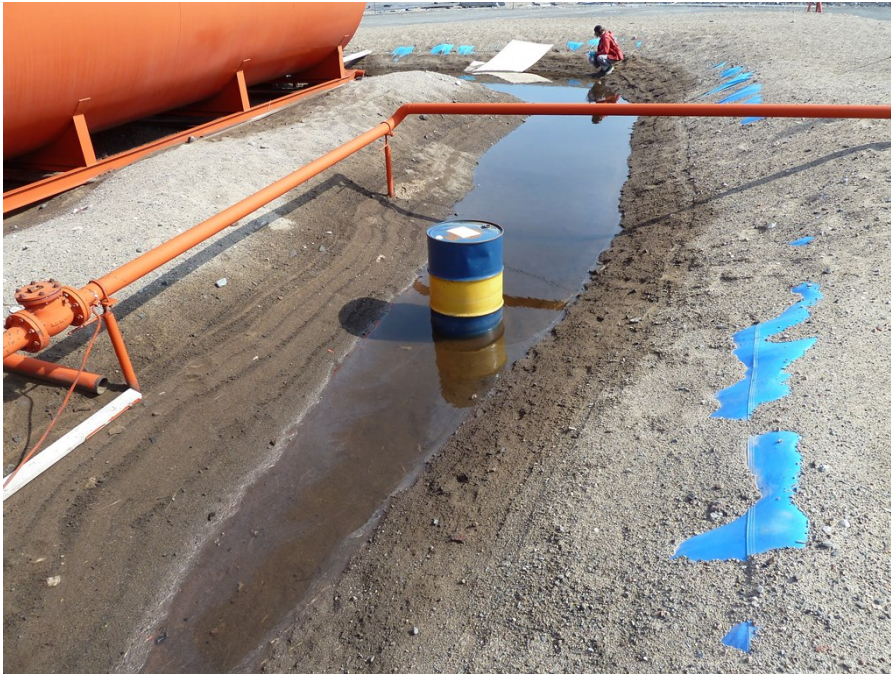
Picture 7: South view of the southwestern corner of the satellite tank farm with exposed liner.

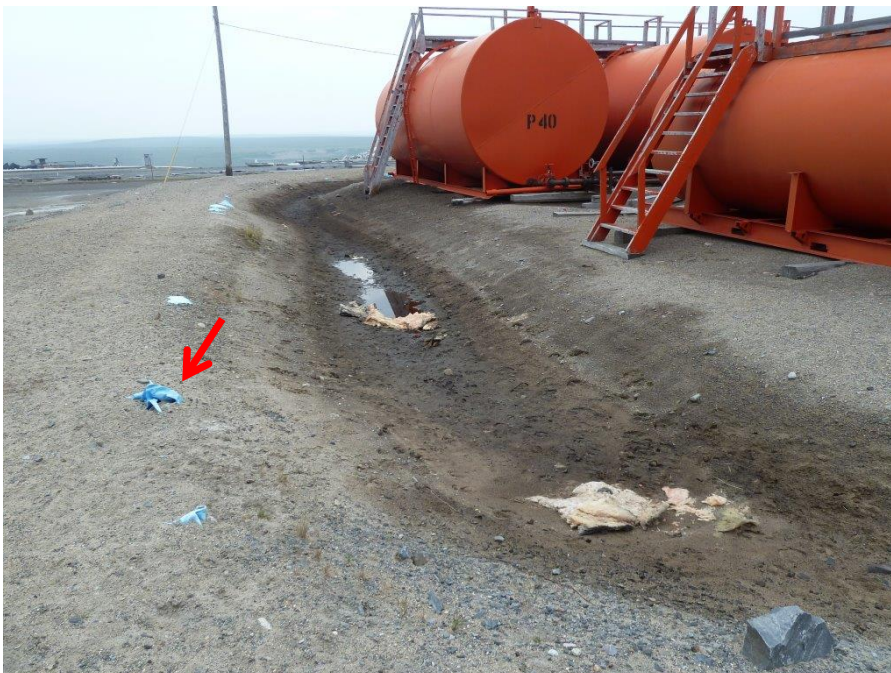
Picture 8: South view of the eastern embankment of the satellite tank farm with exposed and damaged liner.
