WATER LICENCE INSPECTION FORM

| Lupin Mines Inc. | | Karyn Lewis | |
| 2AM-LUP0914(expired)(amended) | | | |
| 14/07/2015 | | Eva Paul | |

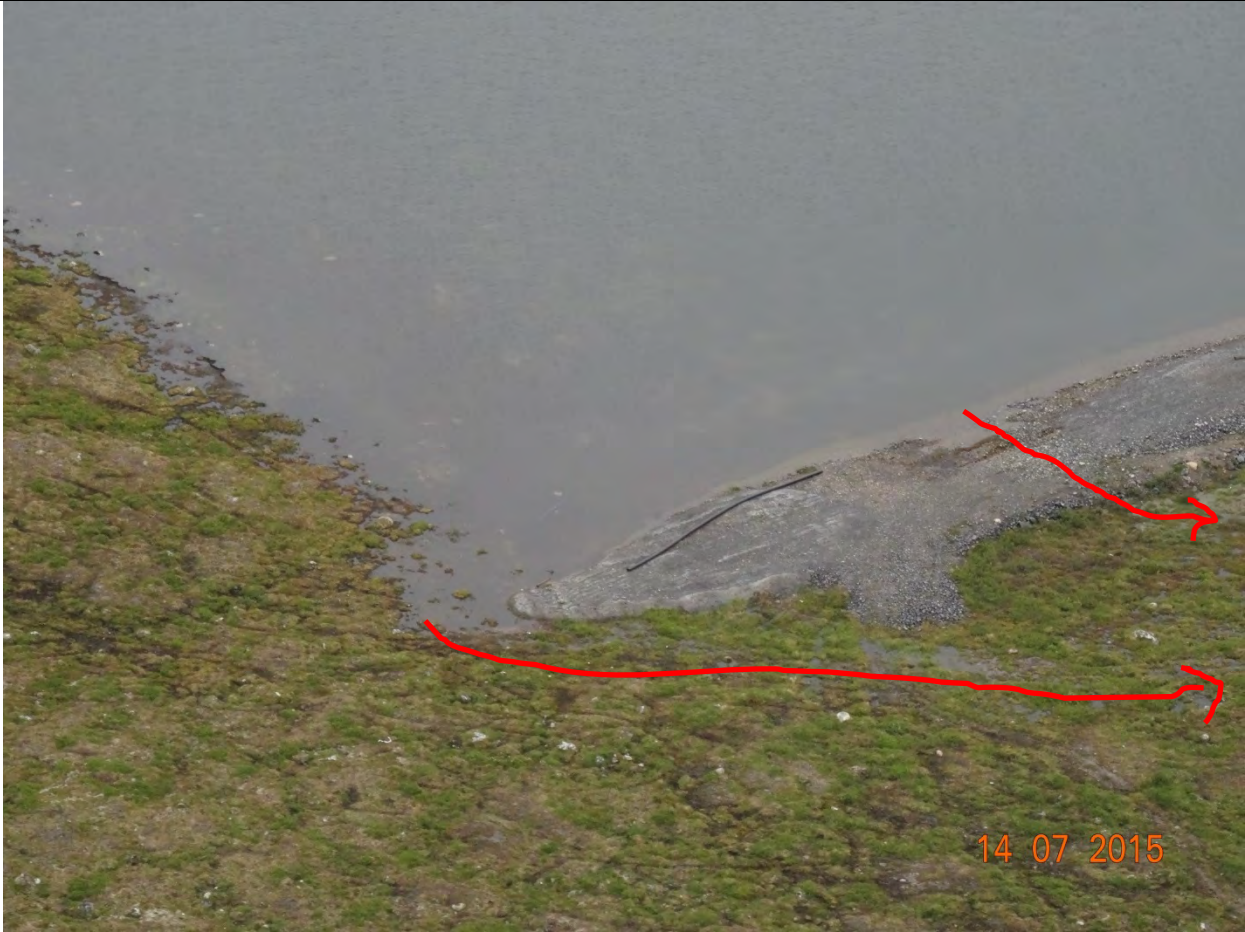
| Date | Camera | Inspector | Authorization |
|---|---|---|---|
| Photo Log # 1 | | Location (NAD 83 DD MM SS.SS) | |

**Description:** Aerial view of south end of Lower Sewage Dam. Arrows demonstrating flow of effluent are added for illustrative purposes.

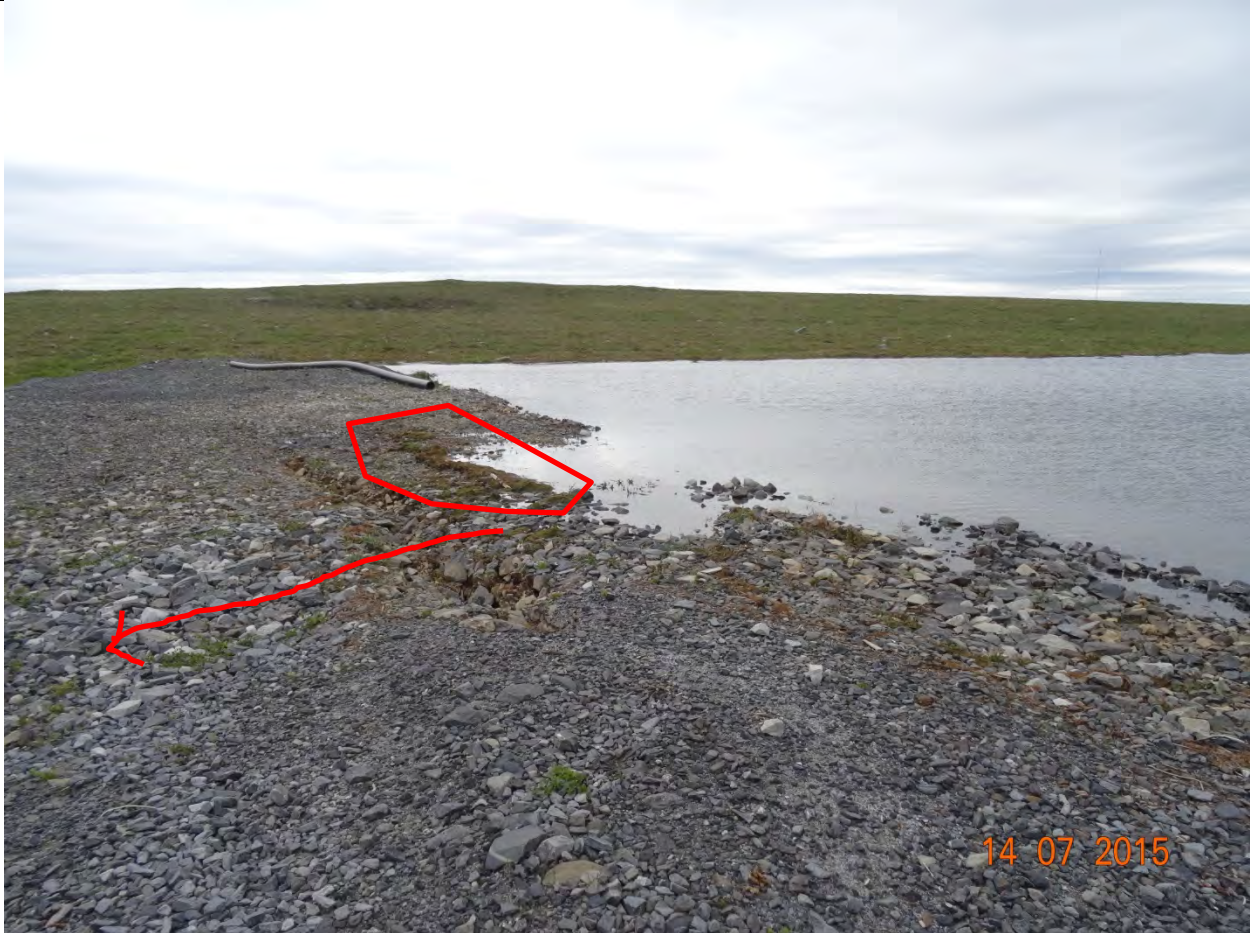
| Photo Log # 2 | Location (NAD 83 DD MM SS.SS) |

**Description:** Compromised section of Lower Sewage Dam. Effluent was trickling over this section at the time of the inspection in the direction of the arrow. It is suspected that the flow was greater prior to the inspection. Contents of LSL are pushed onto the berm (circled area).

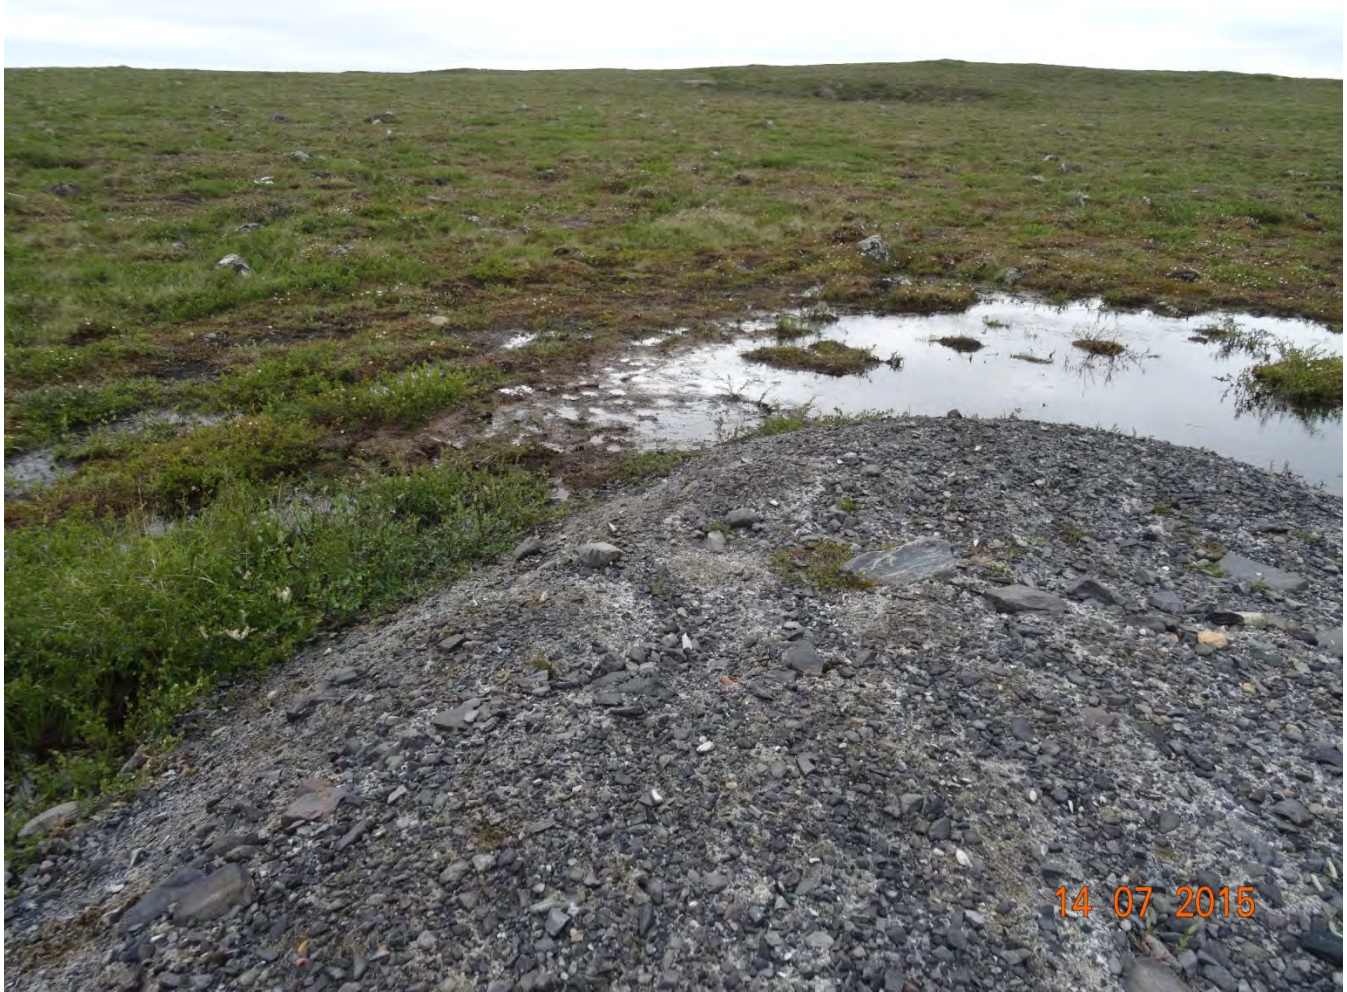
Photo Log # 3

**Description:** South end of Lower Sewage Dam looking south. Effluent is flowing around the end of the dam.

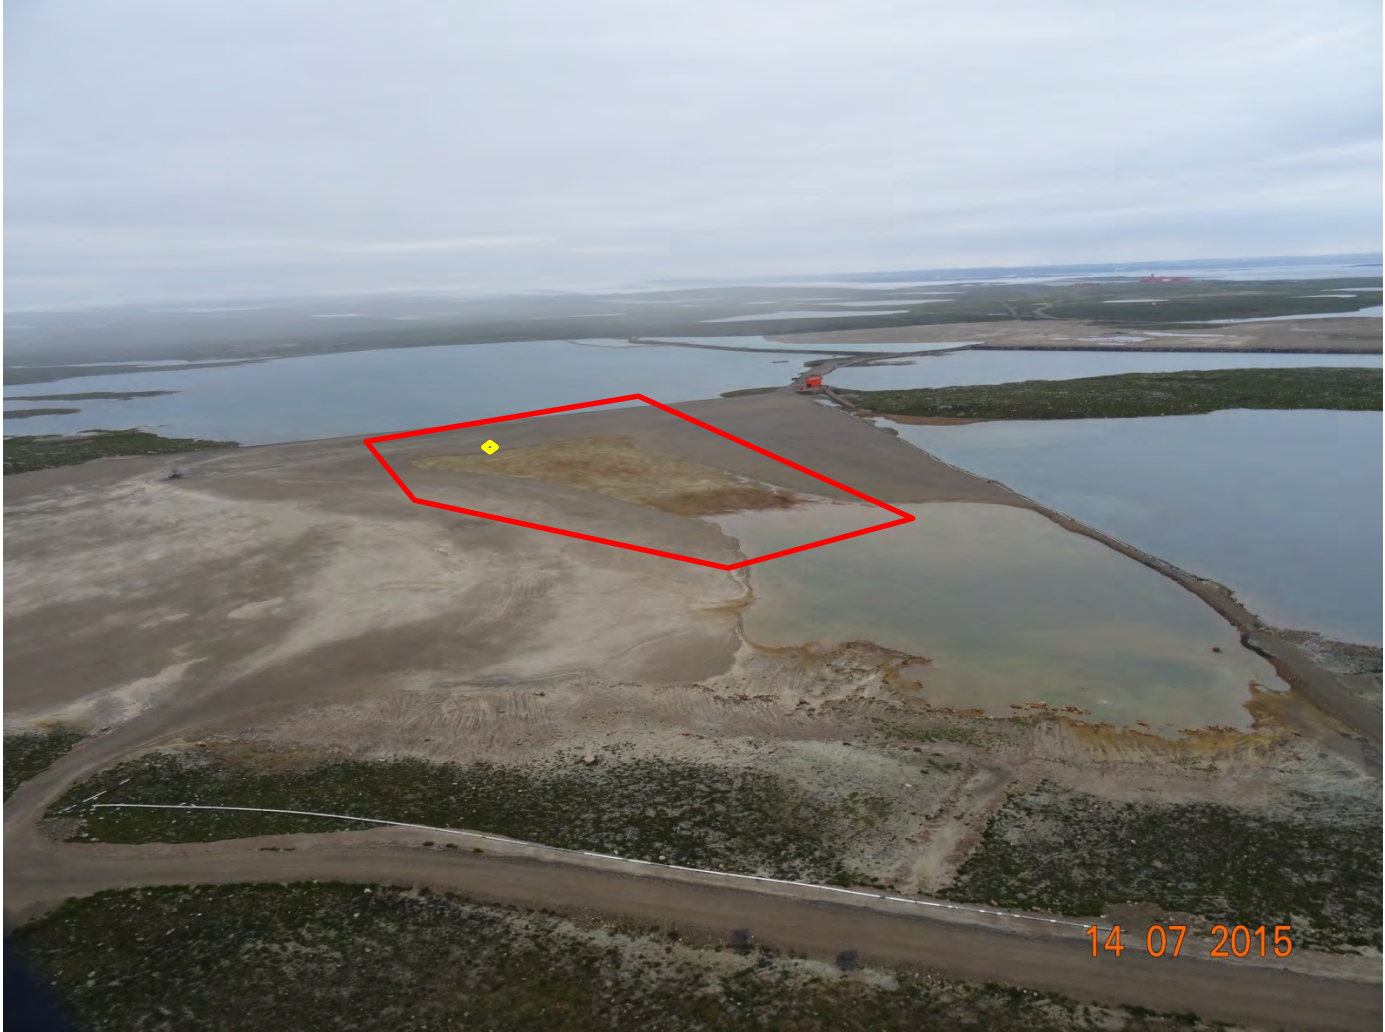
Photo Log # 4

**Description:** Aerial view of Cell 3 looking roughly north. Uncovered and exposed tailings shown in outlined area. Yellow marker denotes approximate location where Photo 5 was taken.

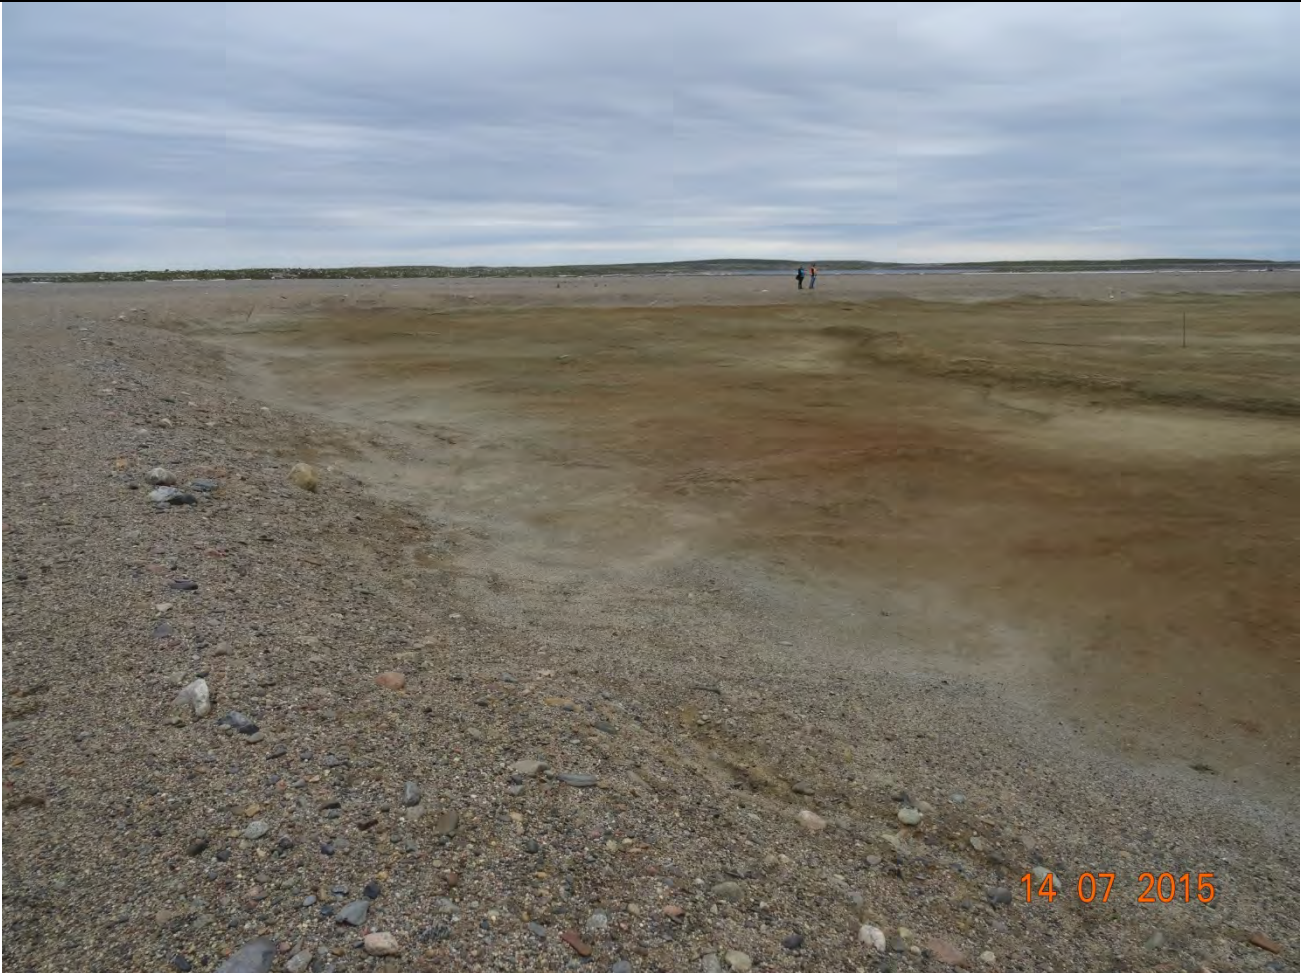
Photo Log # 5

**Description:** View of the uncovered tailings taken from the north side near K Dam, looking south-east. Approximate location shown in Photo 4. I proceeded to walk across the tails southwards towards the water.

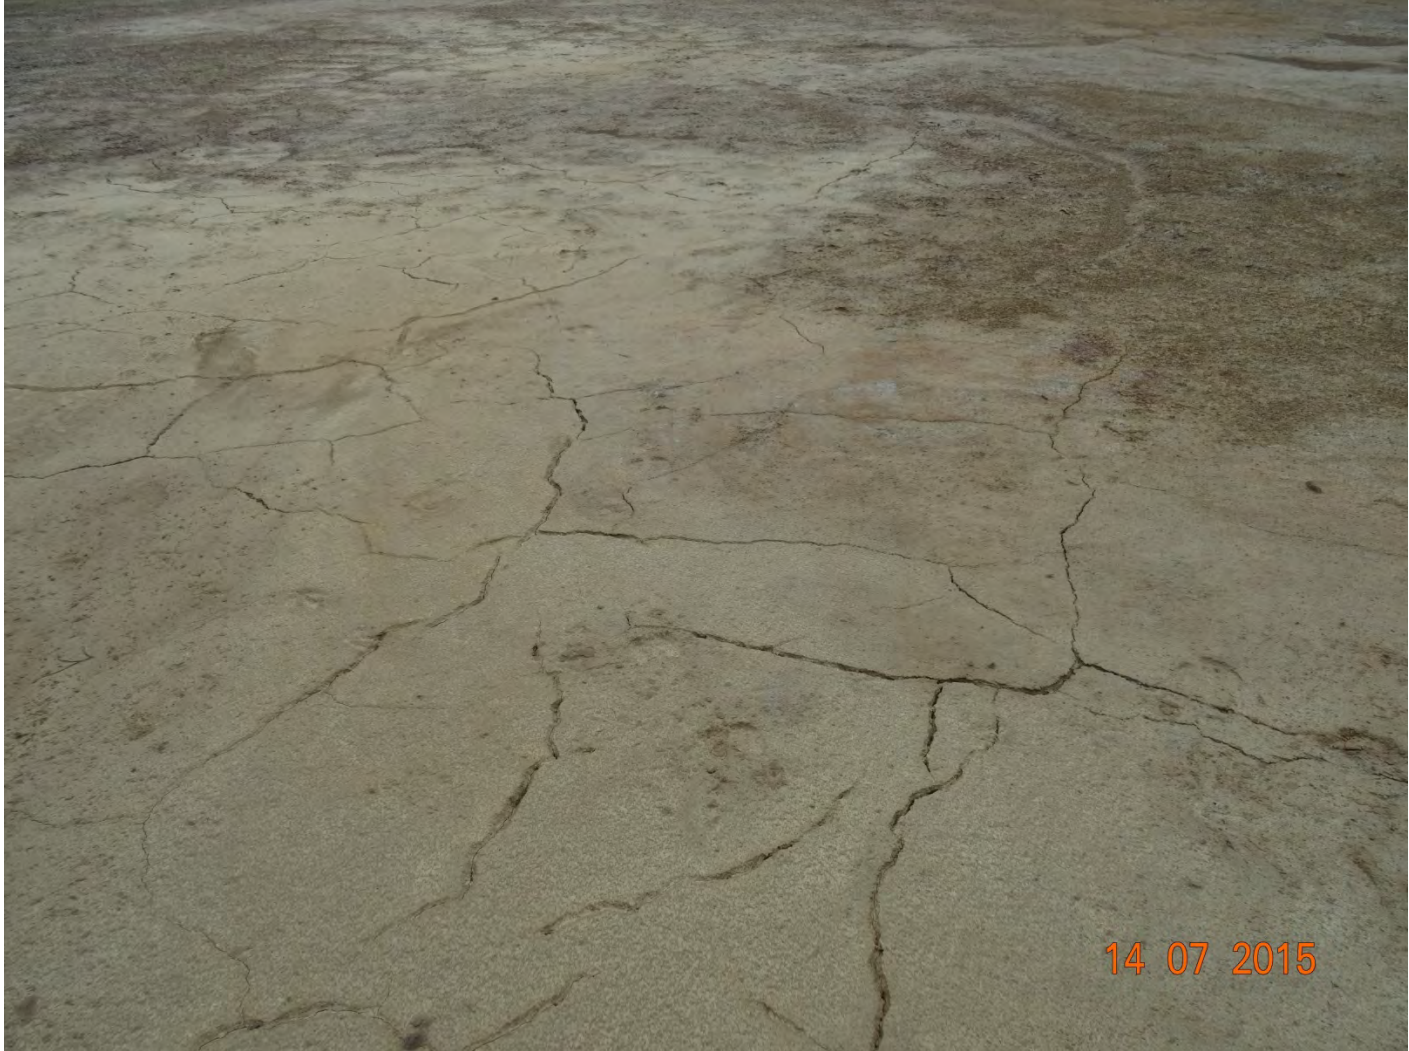
Photo Log # 6

**Description:** Cracked surface of tailings. Numerous animal tracks were visible.

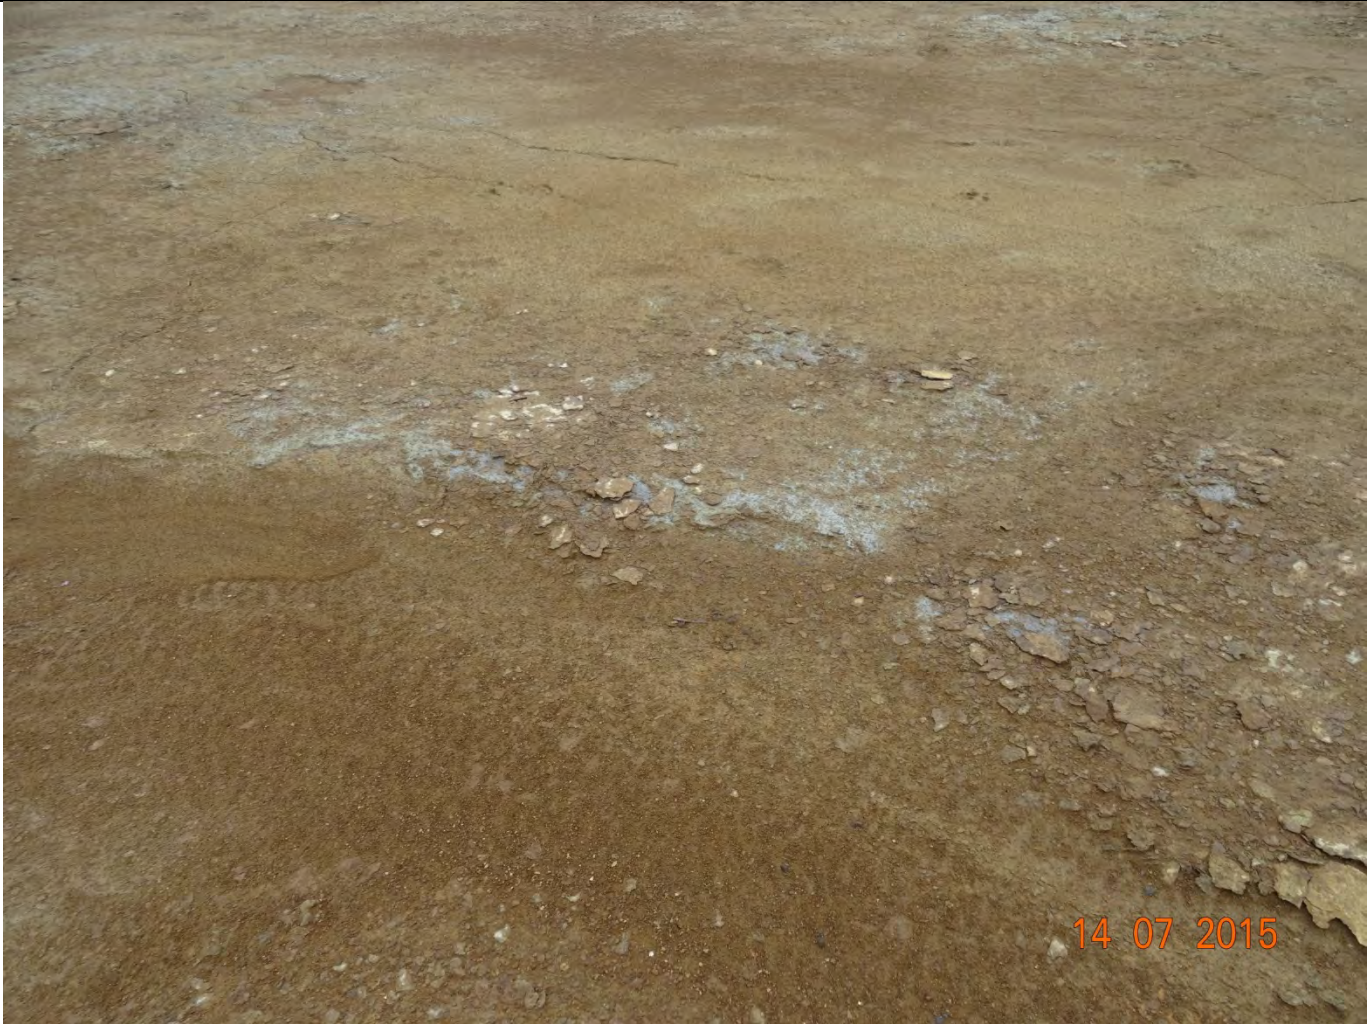
Photo Log # 7

Description: Shiny metallic flakes visible on the surface of the exposed tailings.

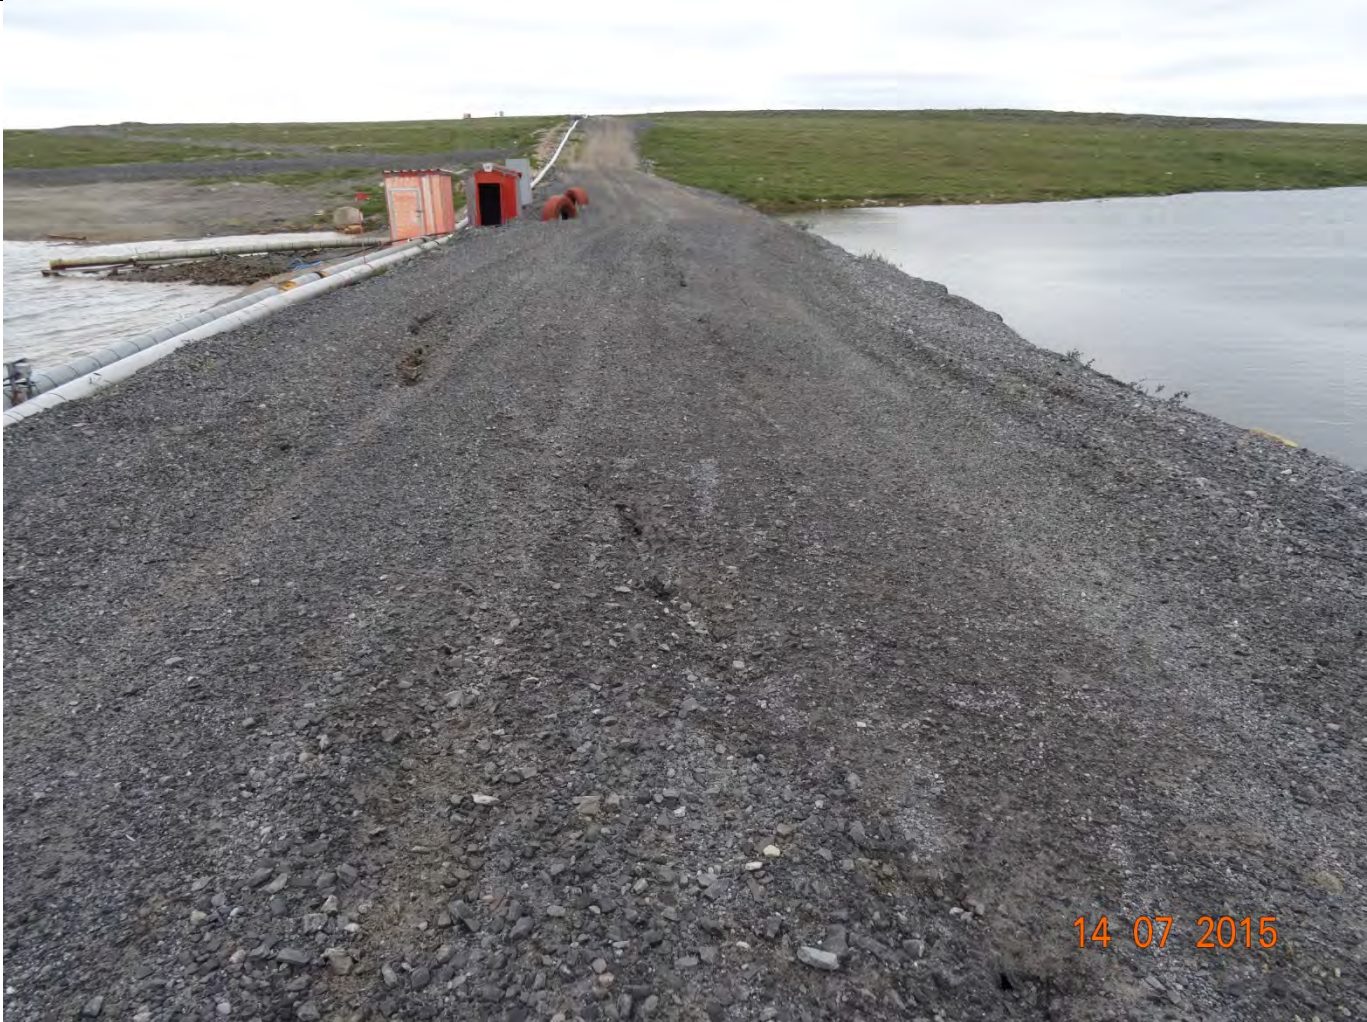
Photo Log # 8

resulting in a failure to contain effluent within the facility. The Upper Sewage Dam long, lengthwise cracks; one appears to be greater than 0.5 m in depth. These cracks were not noted in 2014. Slumping is noted on the west side of the dam. [Photos 8-10]

Description: View of Upper Sewage Dam facing southward away from the mine site. Cracks visible in dam that were not noted in 2014.

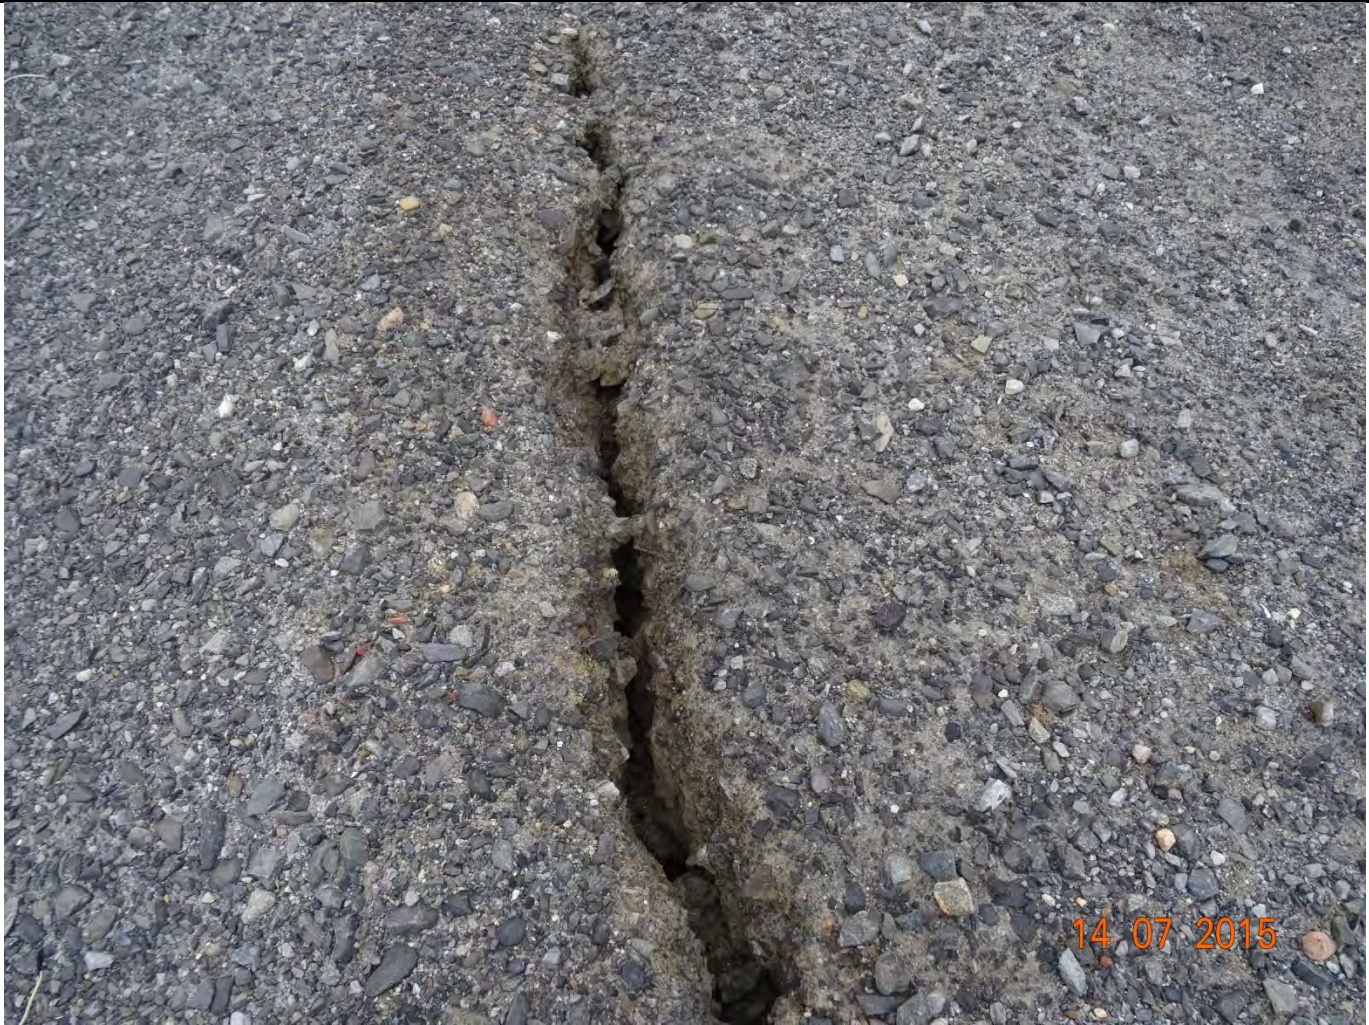
Photo Log # 9

Description: Close-up of large crack in Upper Sewage Dam estimated to be greater than 0.5 m deep.

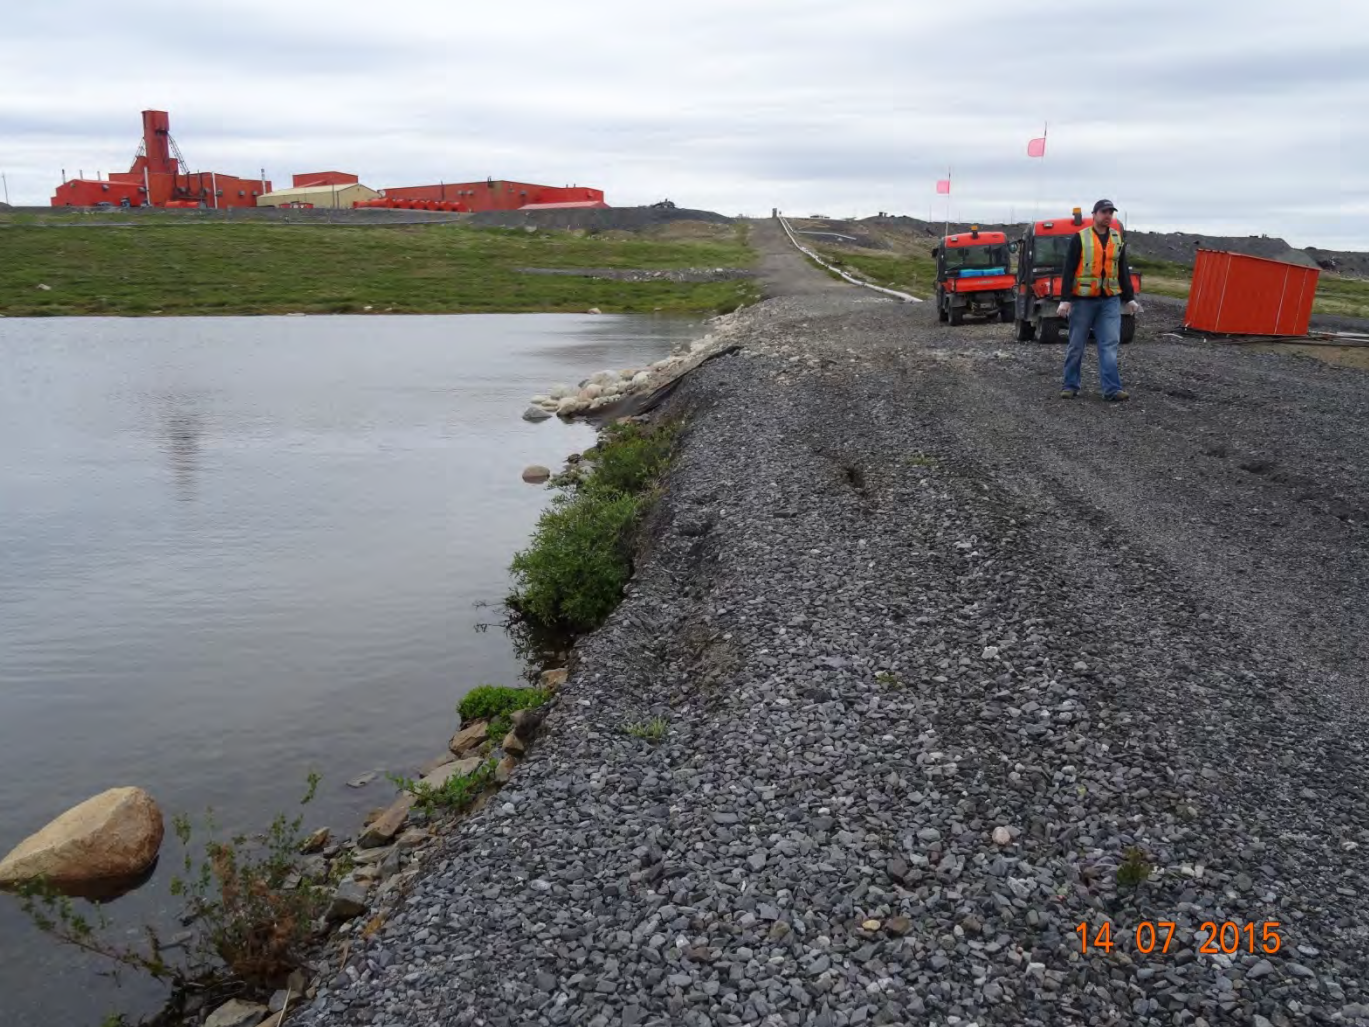
Photo Log # 10

Description: Upper Sewage Dam looking north towards mine site. Slumping visible on the west (left) side of the dam.

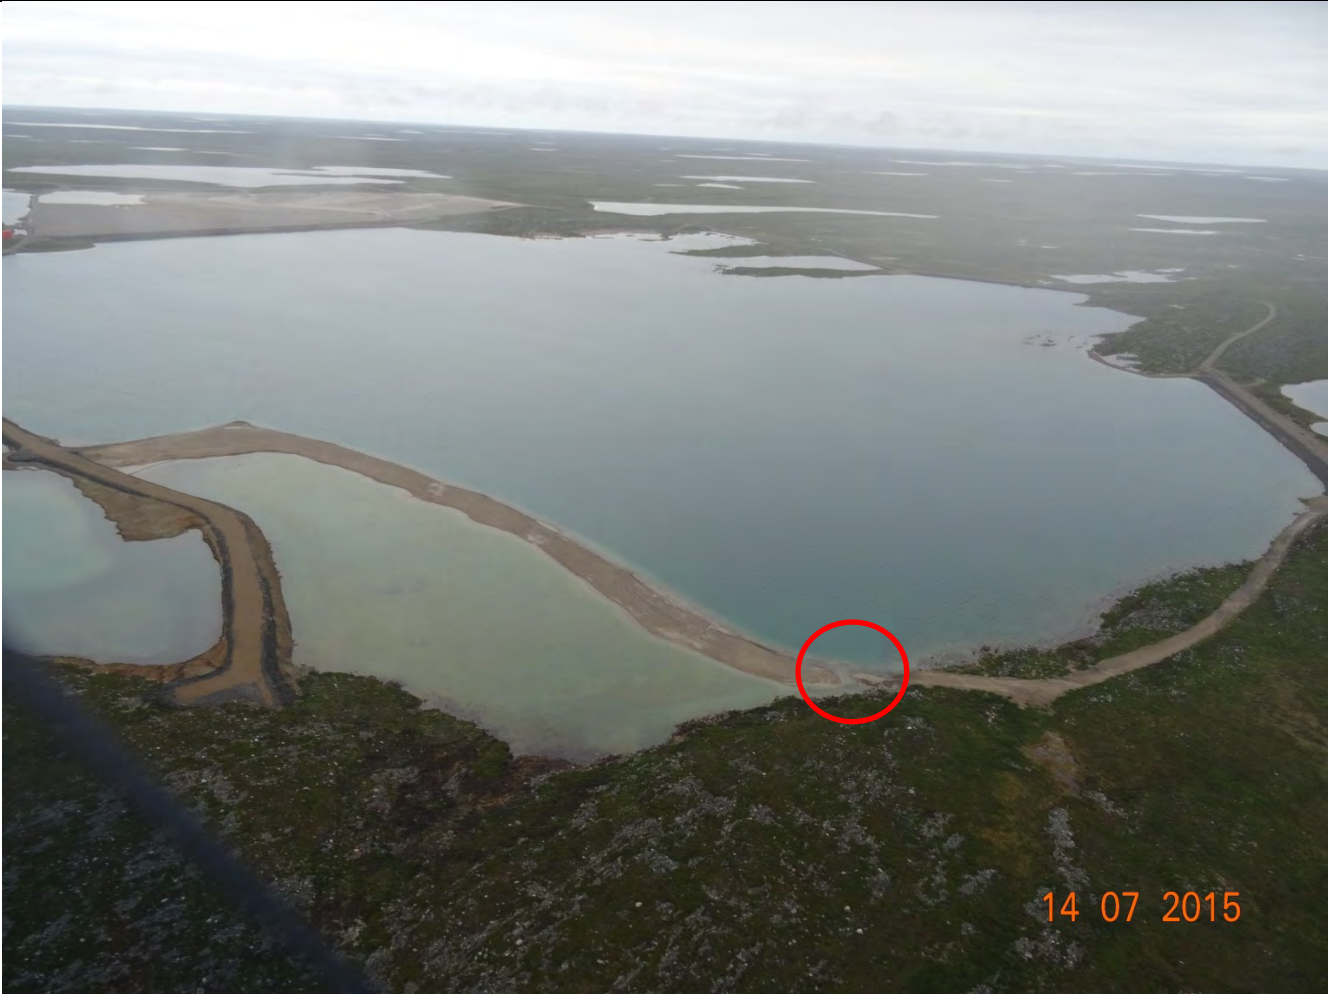
Photo Log # 11

B) At the time of the inspection there remained approximately 1.5 m freeboard in the TCA Pond 2. Mr. Beaudoin indicated at the lowest point in the pond wall there was approximately 1.2 m freeboard. 1 m of freeboard is required to be maintained in the facility, and the levels have increased more than 1 m from last year. [Direction 2015-KIT002-EP was issued on July 22 to decant the TCA]. [Photo 11]

**Description:** Aerial view of "N" Dam and Pond 2 looking south-west. Pondwater from Pond 2 has surpassed "N" Dam (circled in red).

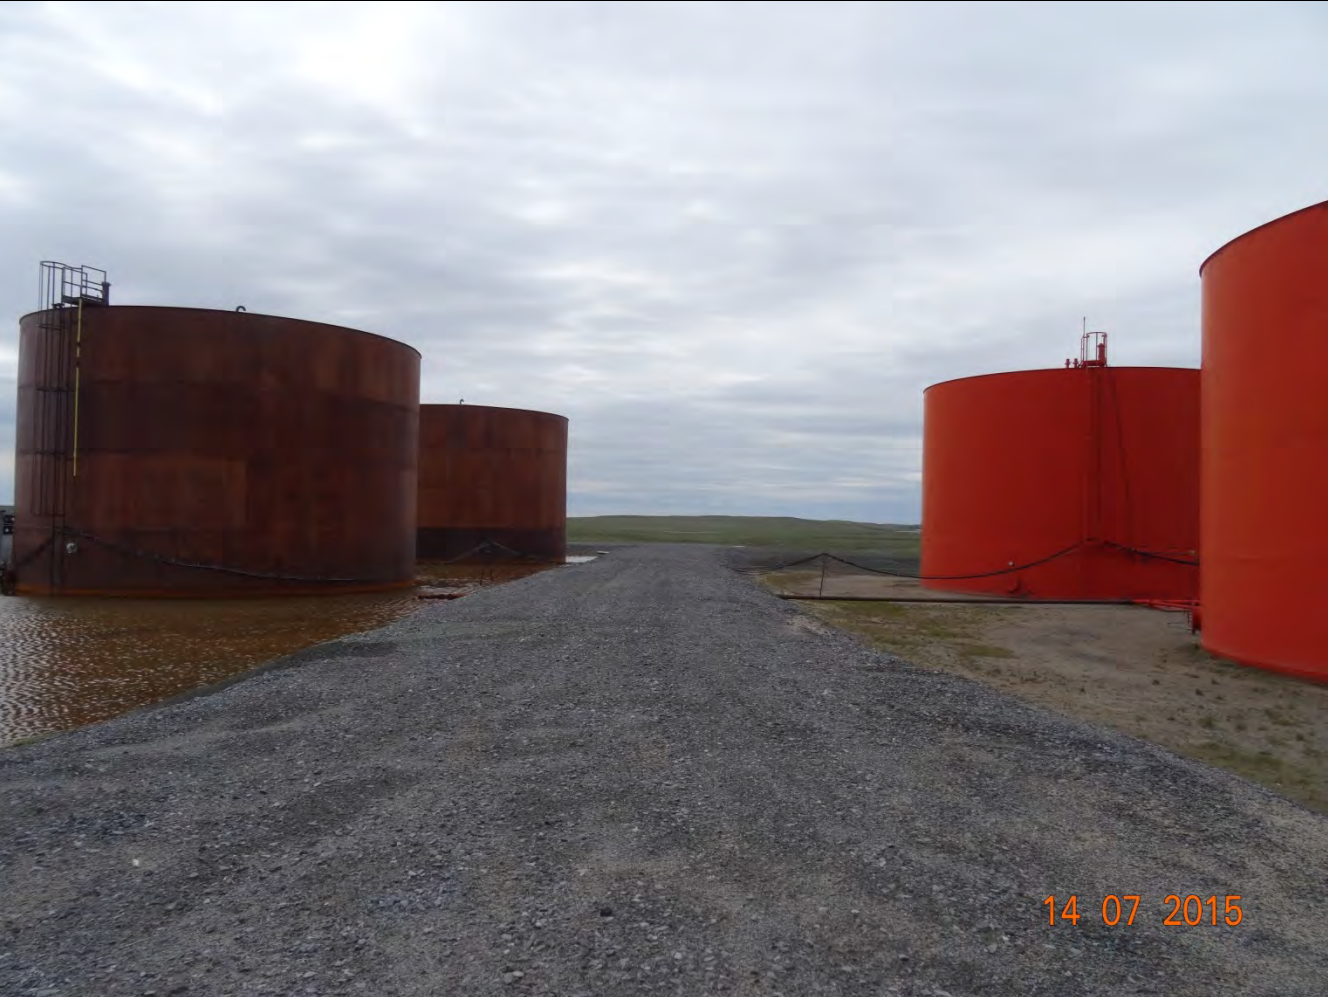
Photo Log # 12

C) My observations at the main fuel farm are contrary to those of LMI's consultant in 2014 (*2014 Lupin Fuel Tank Farm Inspection*). Mr. Tong observed water ponding in the main tank farm, and did not observe active seepage at the time of his visit (August 19, 2014). Conversely, I noted that one berm (the cell with two orange tanks, immediately south of the largest berm) contained no ponding water while the berms on either side of it contained significant ponded water. Further, there was a clear seepage channel at the toe of that berm, with water flowing west toward the airstrip. I did not note any other obvious source for the flow of water. [Photos 12-16]

**Description:** Main tank farm berm, looking west. South-most cell is holding water, the central cell (shown on right) is not.

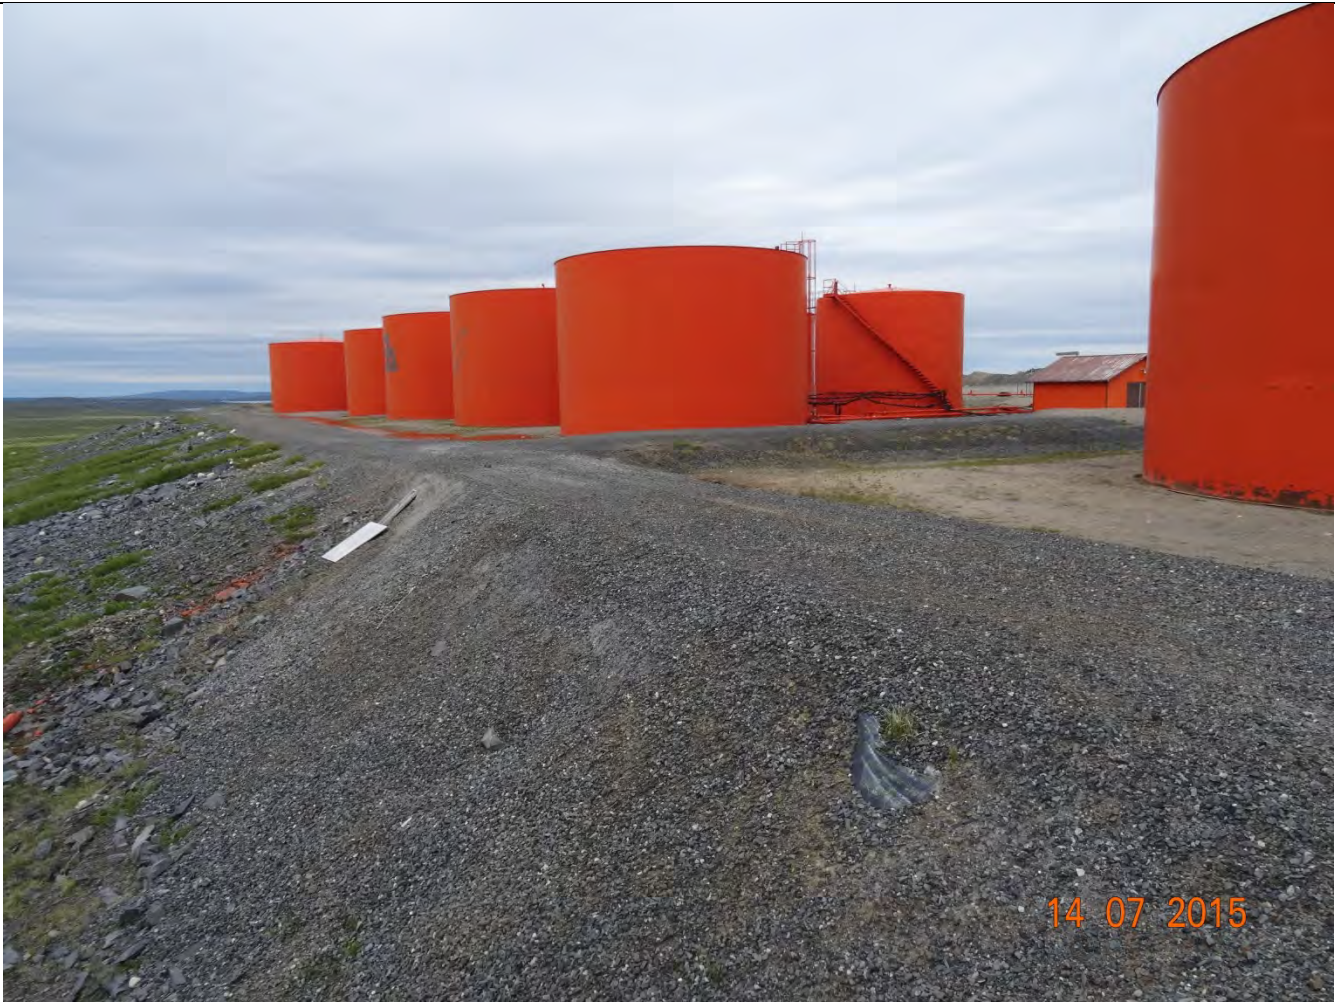
Photo Log # 13

**Description:** West berm of the fuel farm looking roughly North. Note dry cell in foreground and water ponded in the larger cell (orange reflection of tanks off water). Note the orange spray paint down-slope to the left for reference in Photos 14 and 15.

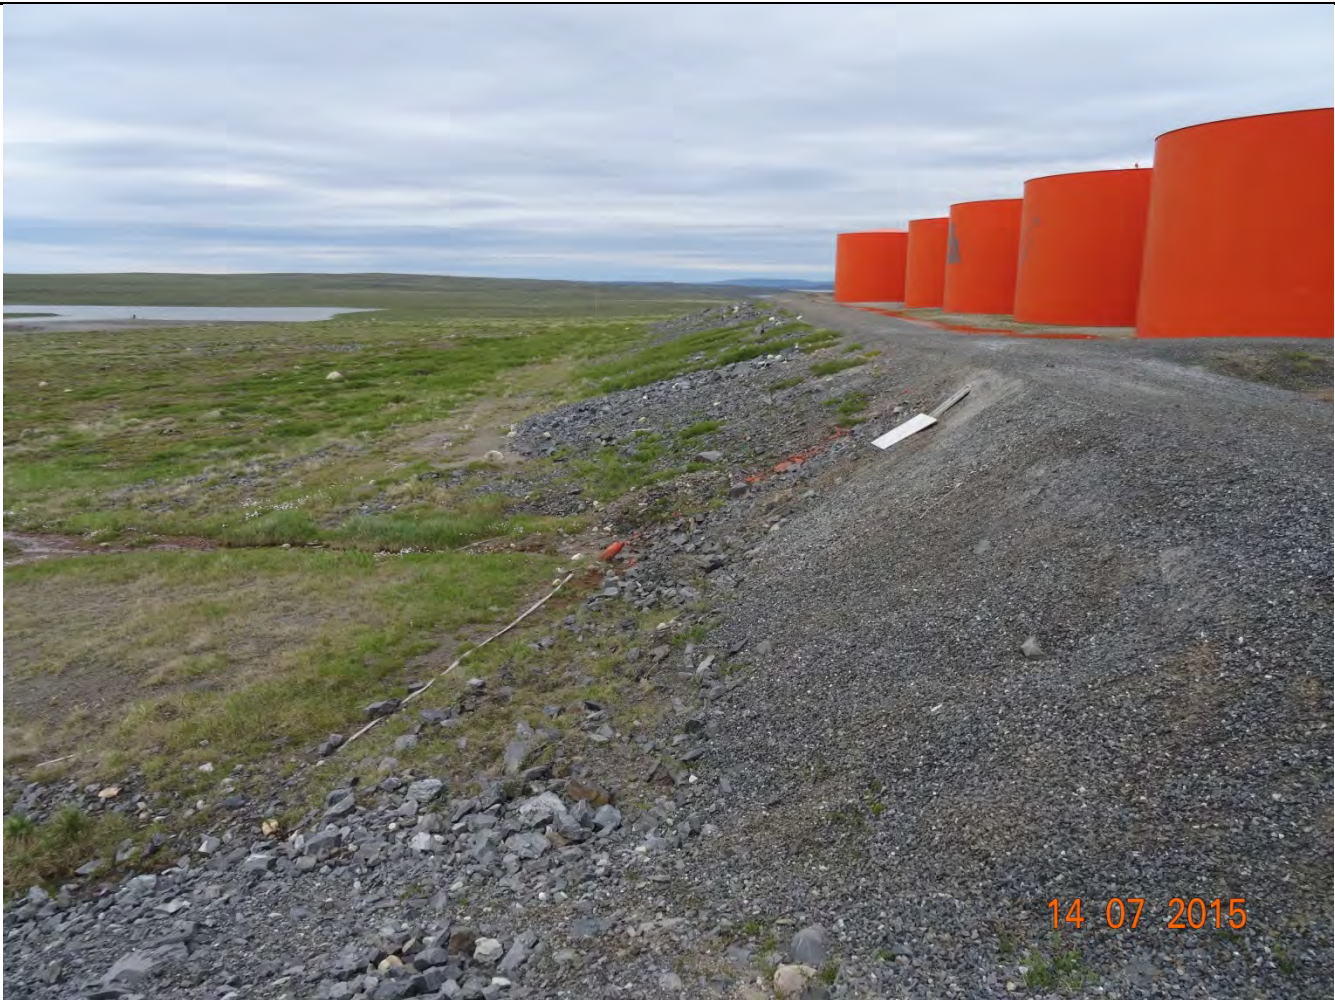
Photo Log # 14

**Description:** Note the flow path of water down-hill from the orange paint. The area is otherwise dry. Photos 15 and 16 are taken from point 't'.

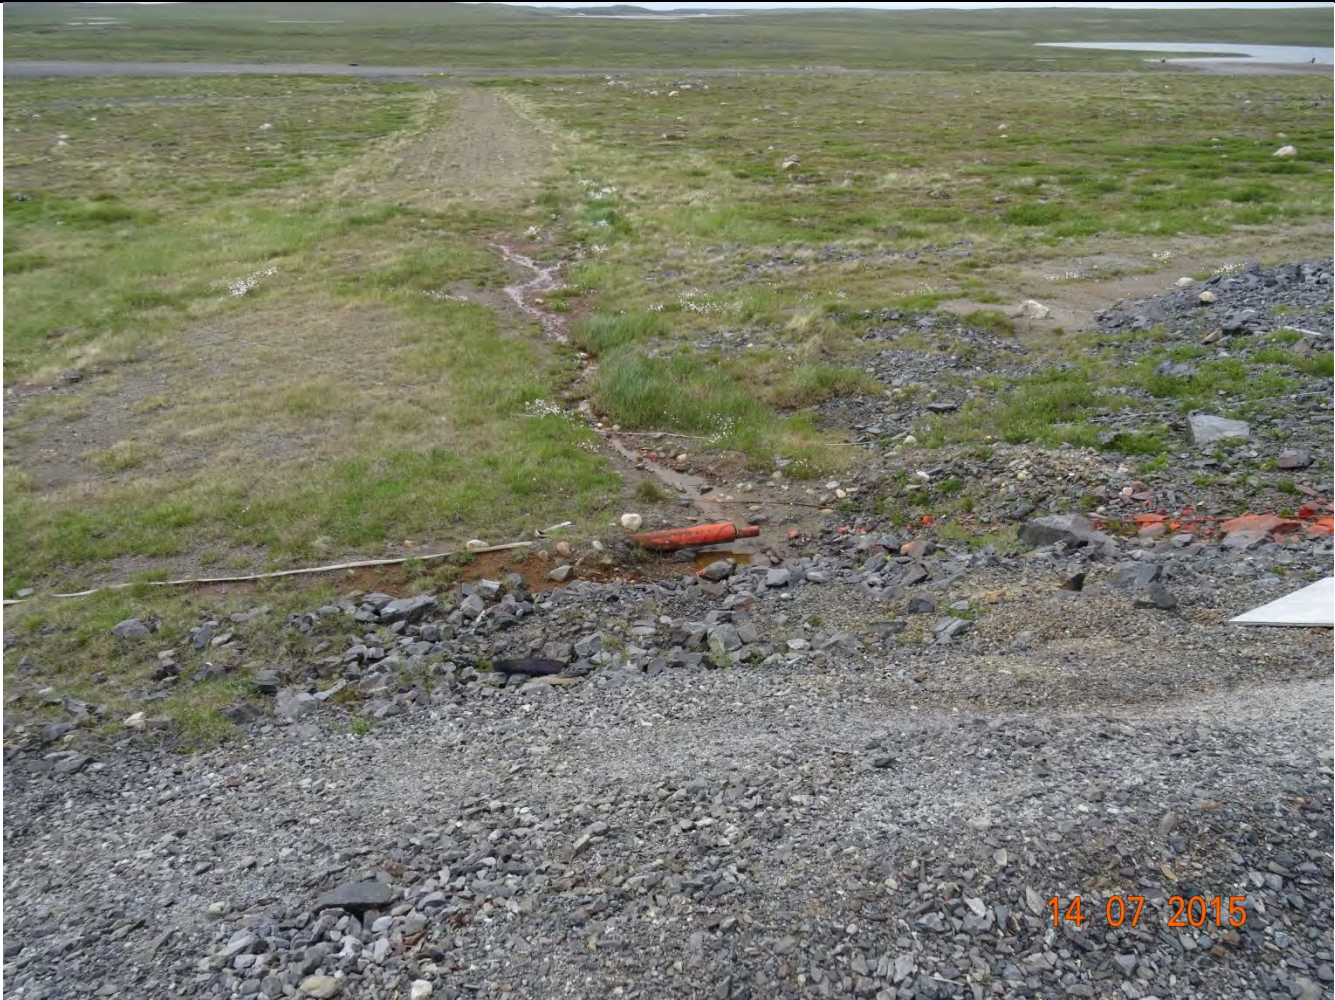
Photo Log # 15

Description: Flow of water down-slope from point 't'.

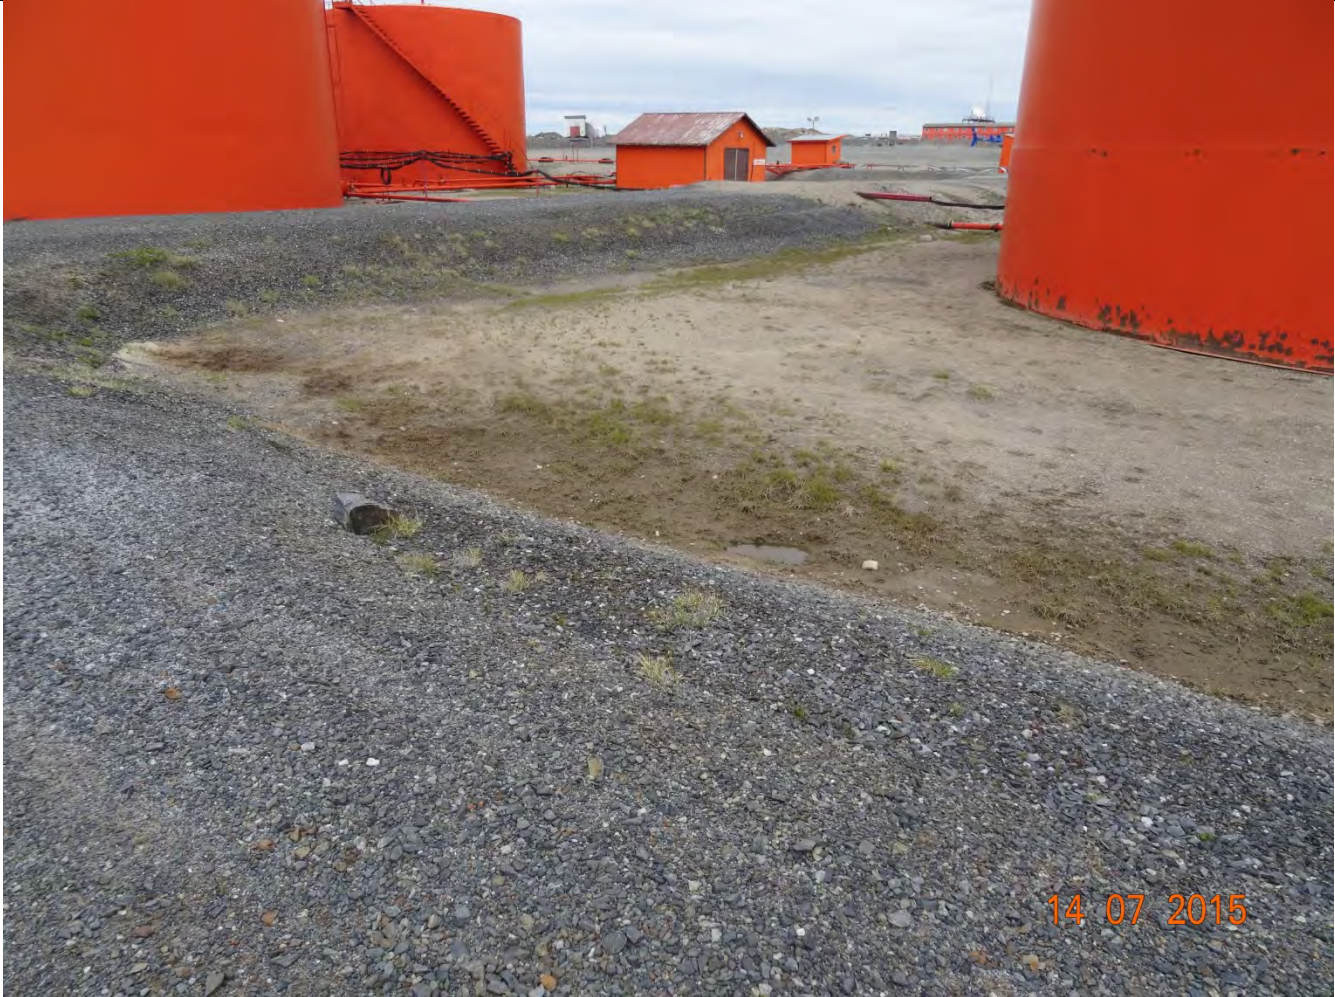
Photo Log # 16

Description: Looking into the berm from point 't'.
