WATER LICENCE INSPECTION FORM

| Lupin Mines Inc. | | Karyn Lewis | |
| 2AM-LUP0914(expired)(amended) | | | |
| 14/07/2015 | | Eva Paul | |

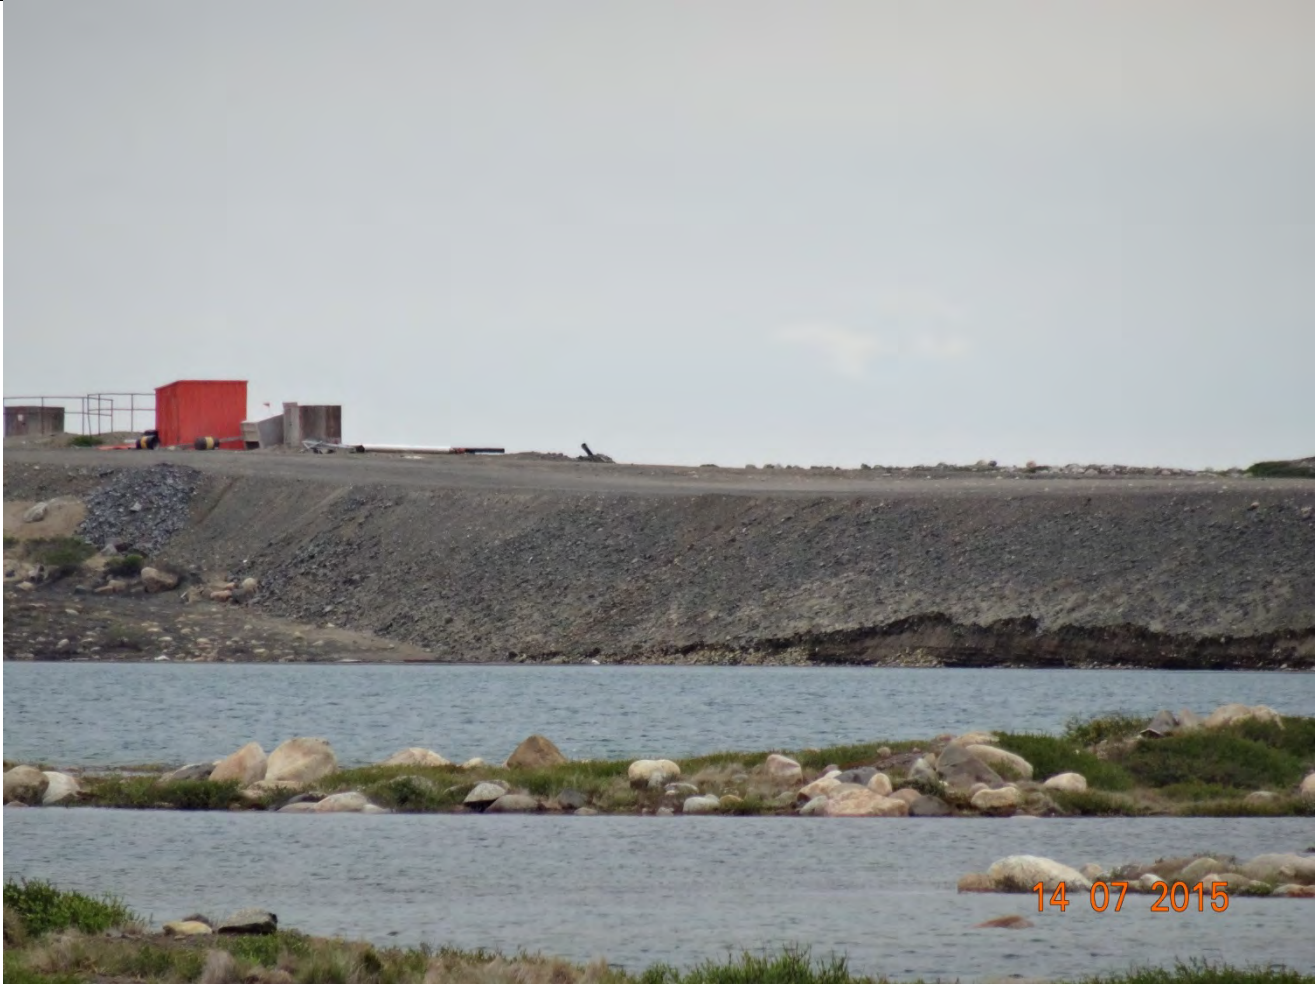
Photo Log # 17

- 5. Erosion of the Lower Sewage Dam, Upper Sewage Dam, and the Tailings Containment structures [Photo 17] was evident at the time of the inspection.
- 6. No signage identifying the monitoring stations was noted.

Description: View of eroded internal TCA dam.
