August 6, 2015  
Project No: 1CL008.003

**RE: Inspector's Direction Issued on July 22, 2015**

## Attachment A: Key Photographs for Observations

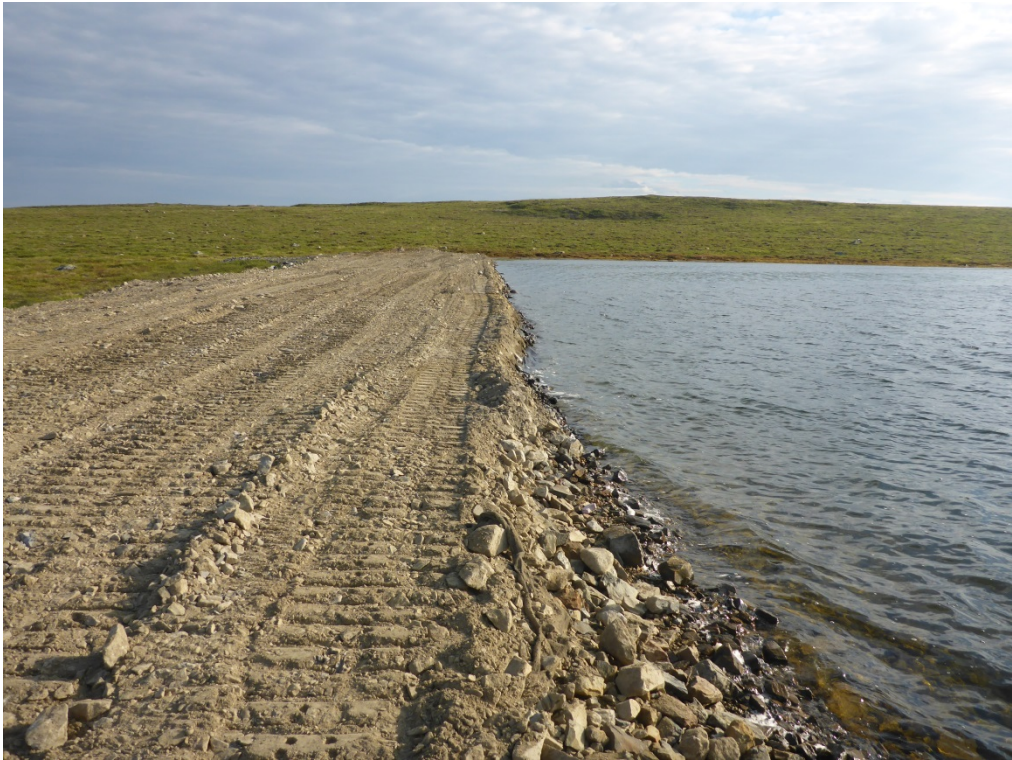
**Photo 1:** Looking south at the repair work complete on the upstream face on the Lower Sewage Dam along the 2014 identified southern area.

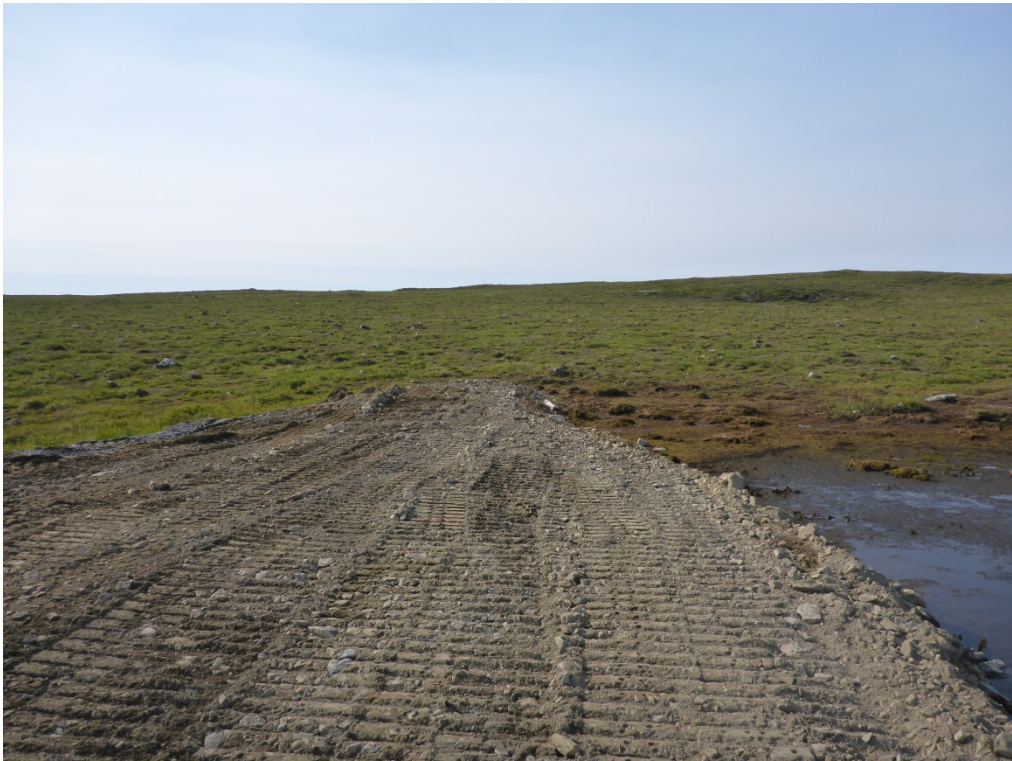
**Photo 3:** Looking south at the repair work complete on the southern abutment on the Lower Sewage Dam along the 2014 identified low area.

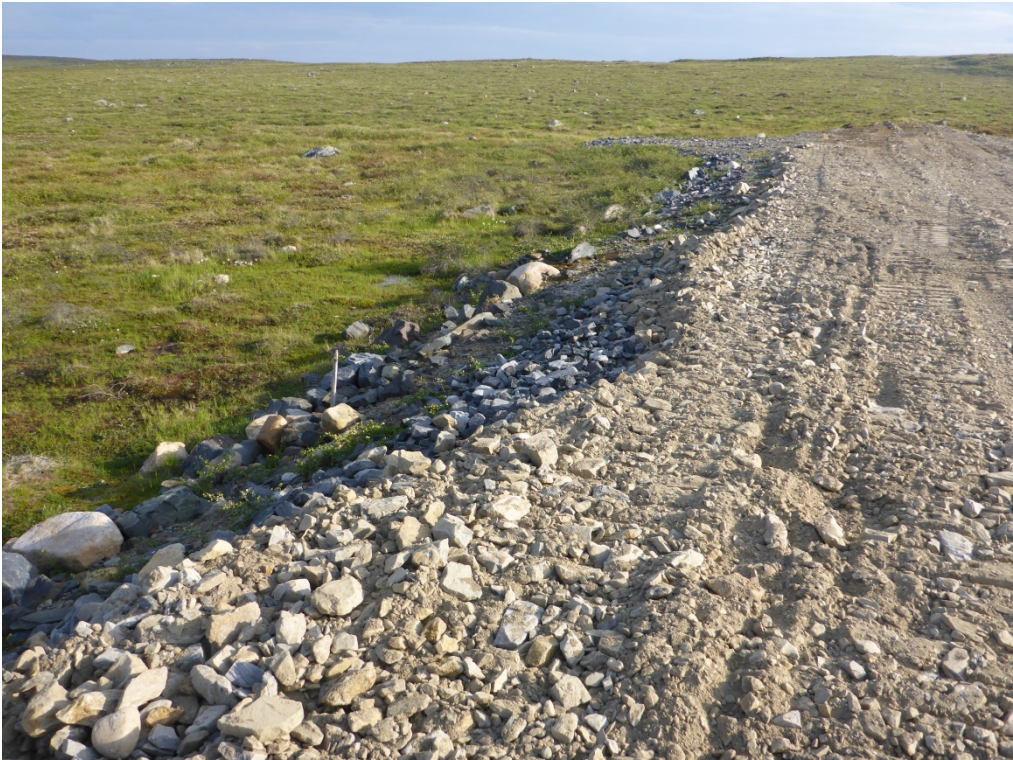
**Photo 2:** Looking south at the repair work complete on the downstream face on the Lower Sewage Dam along the 2014 identified southern area.

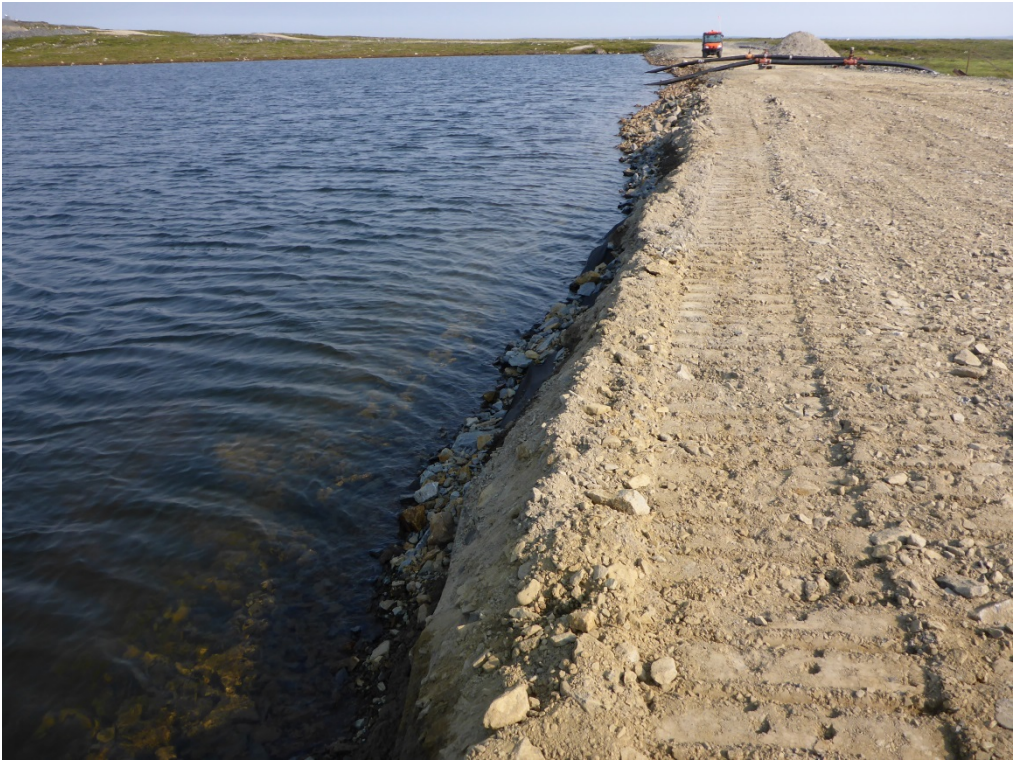
**Photo 4:** Looking north at the repair work complete on the upstream face on the Lower Sewage Dam. Note the siphons in background actively lowering the water level.
