WATER LICENCE INSPECTION FORM

| Licensee LUPIN MINES INC. | | Licensee Representative KARYN LEWIS | |
| Licence No. / Expiry 2AM-LUP1520 | | Representative's Title | |
| Date of Inspection 14 JUNE 2016 | | Inspector EVA PAUL | |

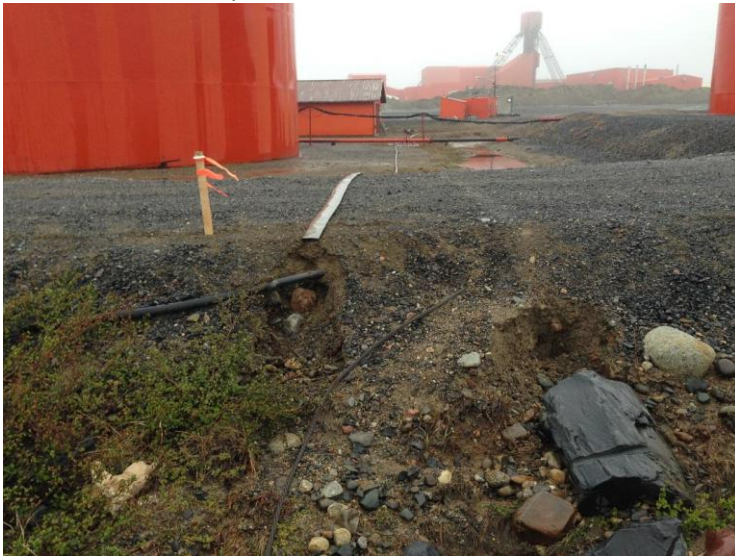
Photo 1 – before repairs

General sediment/erosion seen along roads and airstrip. Pump discharge from main tank farm was discharged onto sandy berm wall, causing erosion to main tank farm berm wall. Hose should be extended to rocky area to mitigate erosion.

In the future, LMI will make sure that the hose discharging to the environment is placed further down the rocky embankment to minimize erosion. The erosion in photo 1 below, as noted during your inspection, has subsequently been repaired as shown in photo 2 below.
