## WATER LICENCE INSPECTION FORM

<b>Licensee</b> Lupin Mines Inc.	<b>Licensee Representative</b> Karyn Lewis
<b>Licence No. / Expiry</b> 2AM-LUP1520	<b>Representative's Title</b>
<b>Land / Other Authorizations</b> NI	<b>Land / Other Authorizations</b> NI
<b>Date of Inspection</b> 05-06/10/2016	<b>Inspector</b> Eva Paul
<b>Activities Inspected</b>	
<input checked="" type="checkbox"/> Camp <input type="checkbox"/> Drilling <input type="checkbox"/> Mining <input checked="" type="checkbox"/> Construction <input checked="" type="checkbox"/> Reclamation <input checked="" type="checkbox"/> Fuel Storage <input checked="" type="checkbox"/> Roads/Hauling <input type="checkbox"/> Other: <input type="checkbox"/> Other:

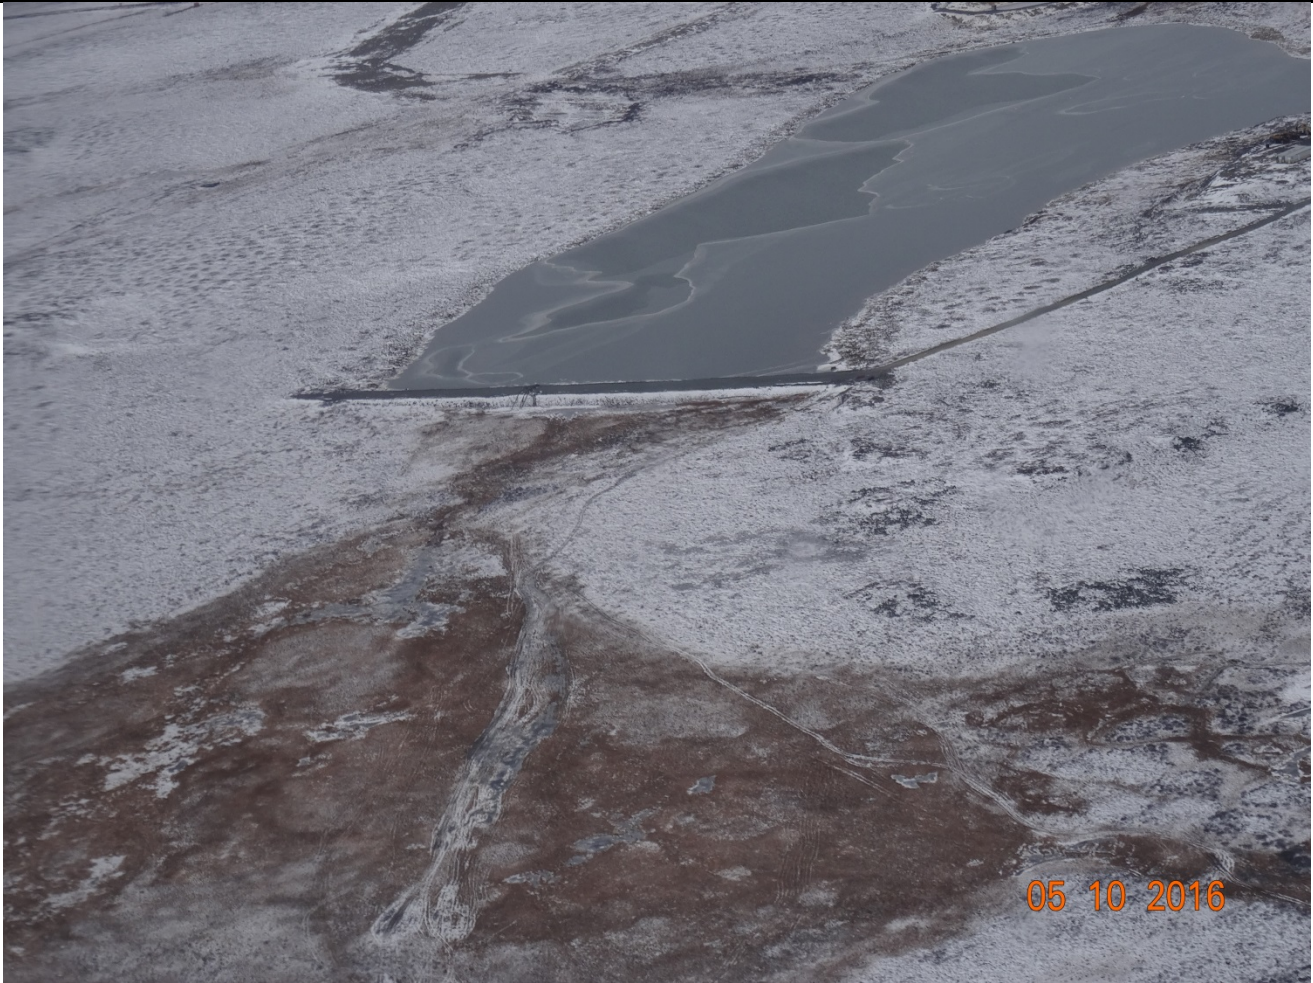
Photo Log # 1	Location (NAD 83 DD MM SS.SS)
Photo DSC06152	N W

Description: Aerial view of Lower Sewage Lake dam.

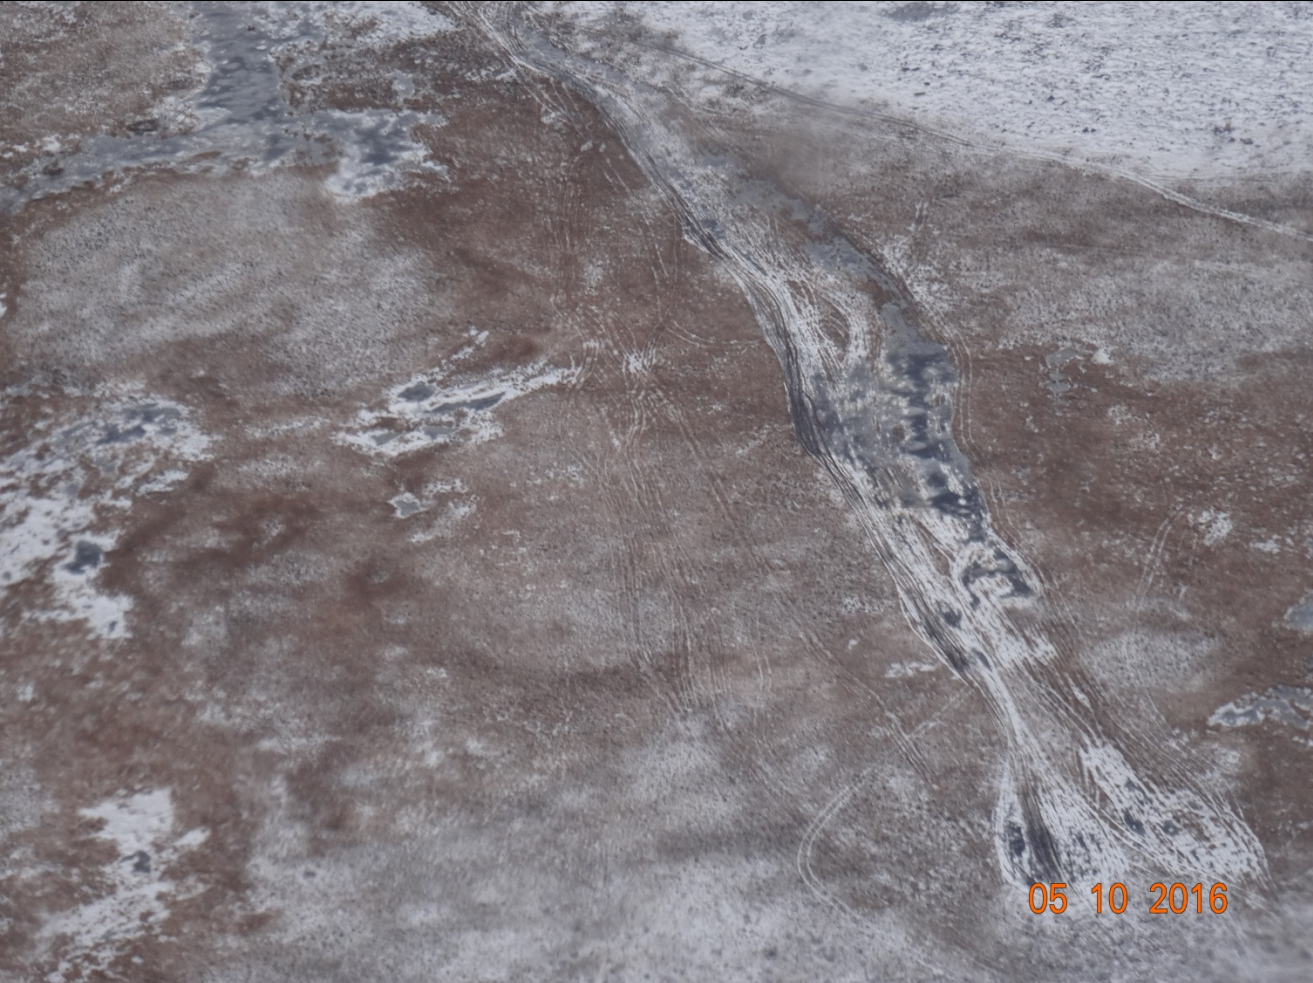
Photo Log # 2	Location (NAD 83 DD MM SS.SS)
Photo DSC06153	N W

Description: Quad tracks downstream of Lower Sewage Lake.

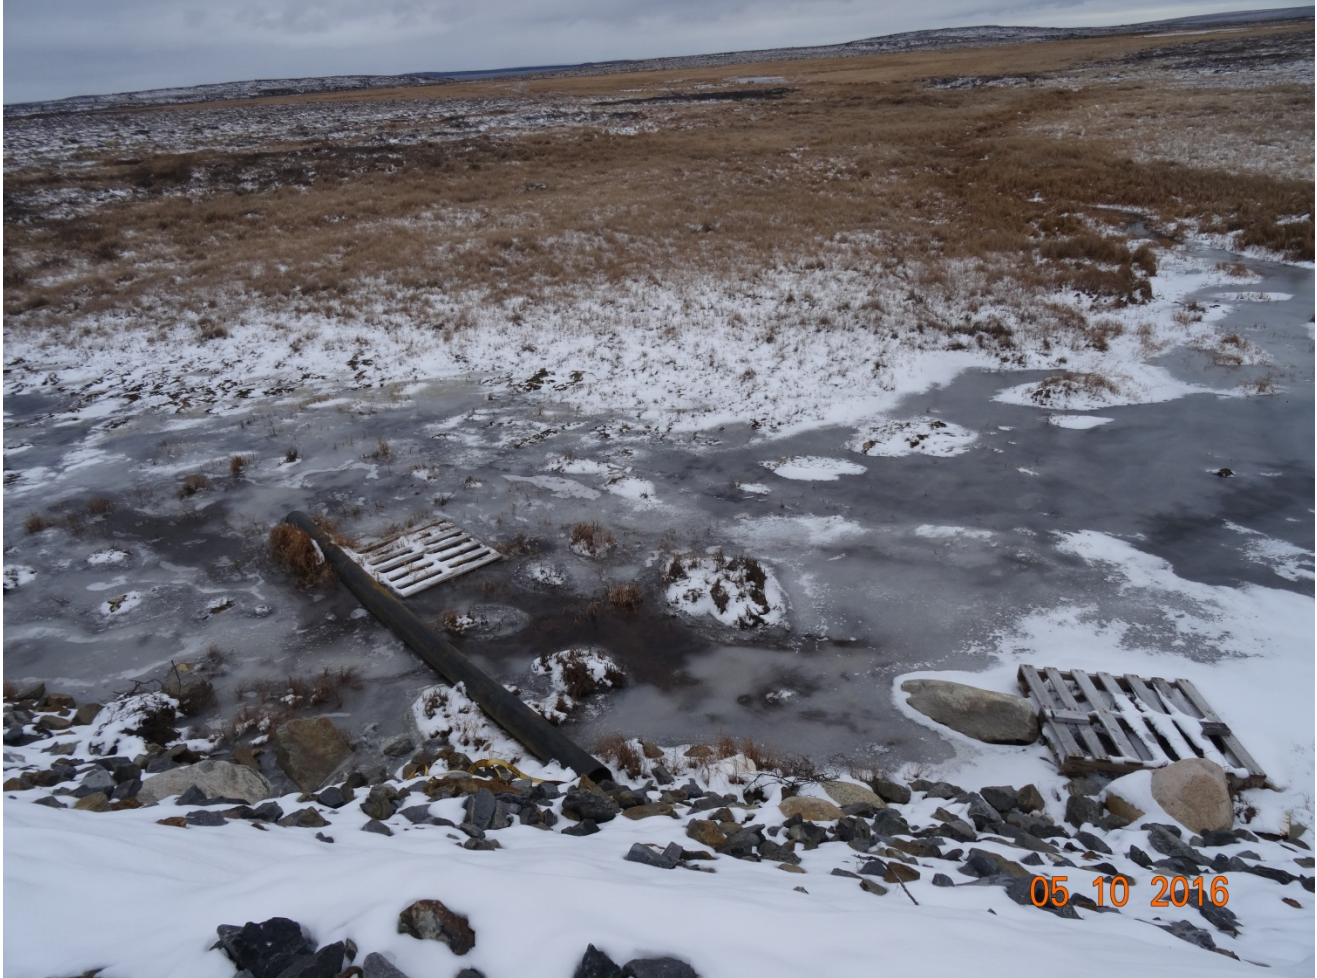
Photo Log # 3

2. Sewage Lakes Disposal Facility was in use for sewage and grey water. No further discharge for 2016 was being contemplated; at the time of the inspection there was greater than 1m freeboard in Lower Sewage Lake and the SLDF was freezing over. Pallets and debris are noted downslope of the Lower Sewage Lake dam, as well as extensive quad tracks in the wetland downstream. No discharge was undertaken from the TCA in 2016. Barrels stored in the 3<sup>rd</sup> Party Berm were labelled, and waste water stored therein is reportedly to be used in the landfarm in the future.

Description: Debris downslope of Lower Sewage Lake dam.

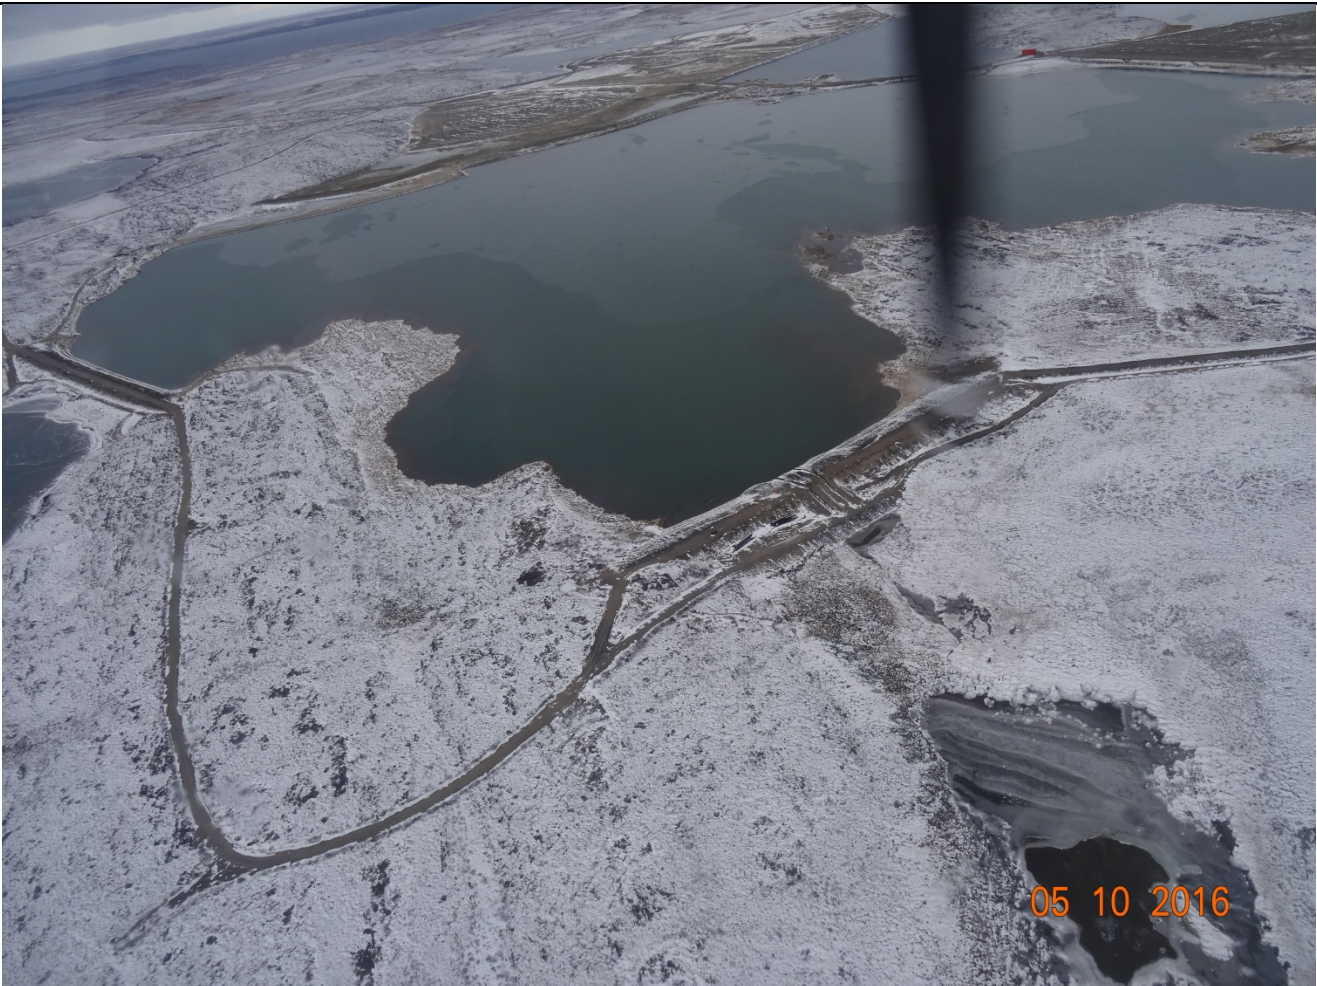
Photo Log # 4

5. Repairs were undertaken on TCA internal Dam M as per recommendations in the geotechnical inspections. This repair was required before work could be done in Cell 5 to cover the tailings. PAG material was being removed from the 'ball diamond' and placed in the TCA, and is to be covered in esker material. Approximately 6,000 m<sup>3</sup> of material had been placed on Cell 5 at the time of the inspection. Repairs to cover in Cell 1 were also being undertaken.

Description: TCA from the air.

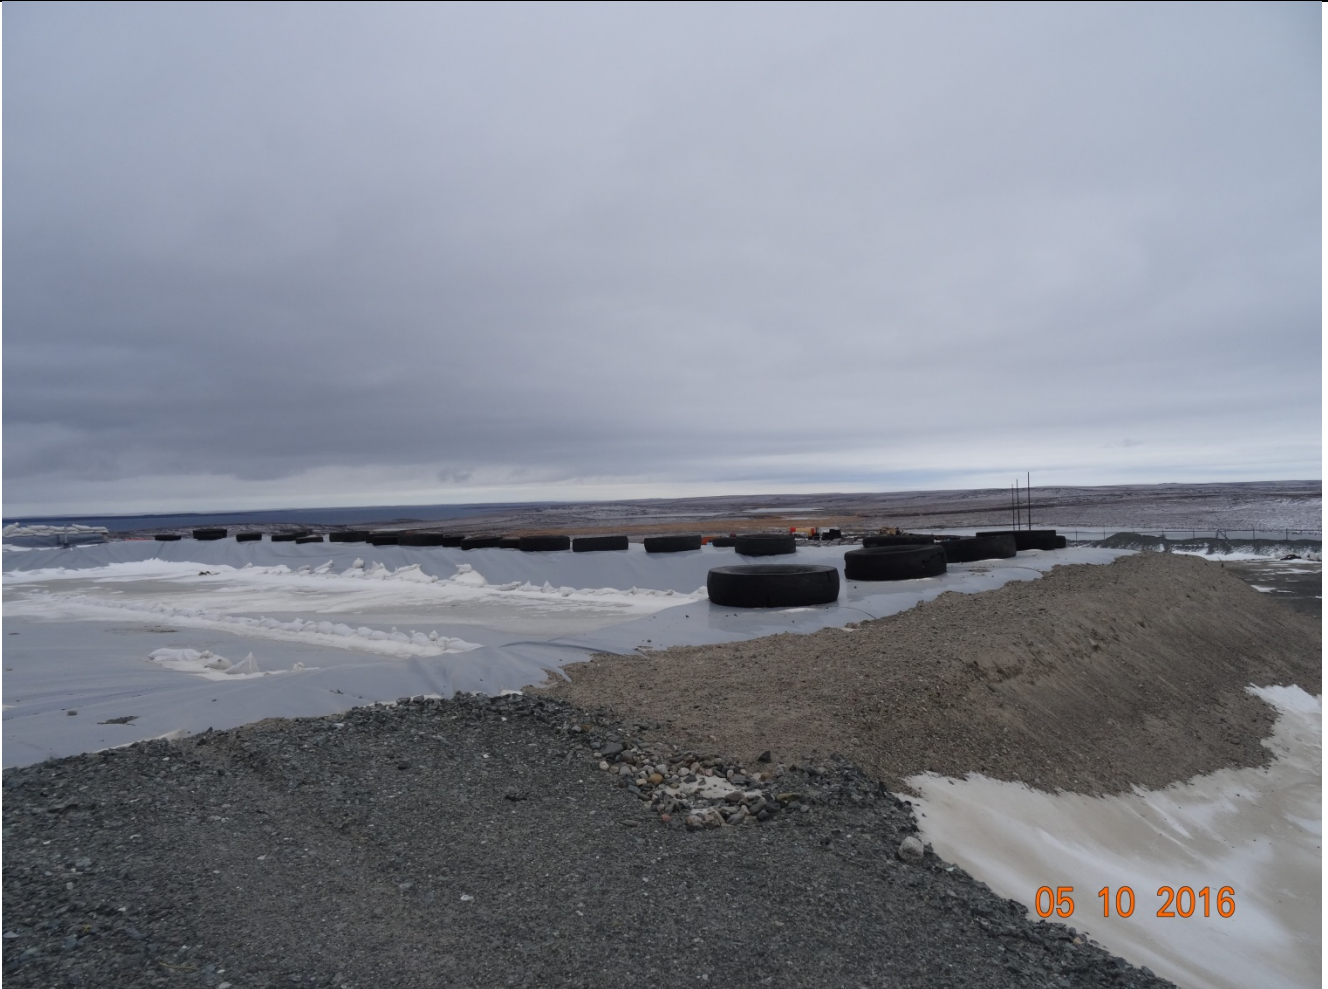
Photo Log # 5

3. The Licensee has maintained records of waste backhaul and has removed all hazardous waste from the storage facility. The landfarm construction was substantially complete, with the liner held in place by sandbags. Snow and water will be removed in the spring and the facility will be ready for use once aggregate has been placed and once monitoring wells have been installed (E.25), or any changes to monitoring of this facility have been clarified and approved by the Board (see also comment 6).

Description: Landfarm construction.

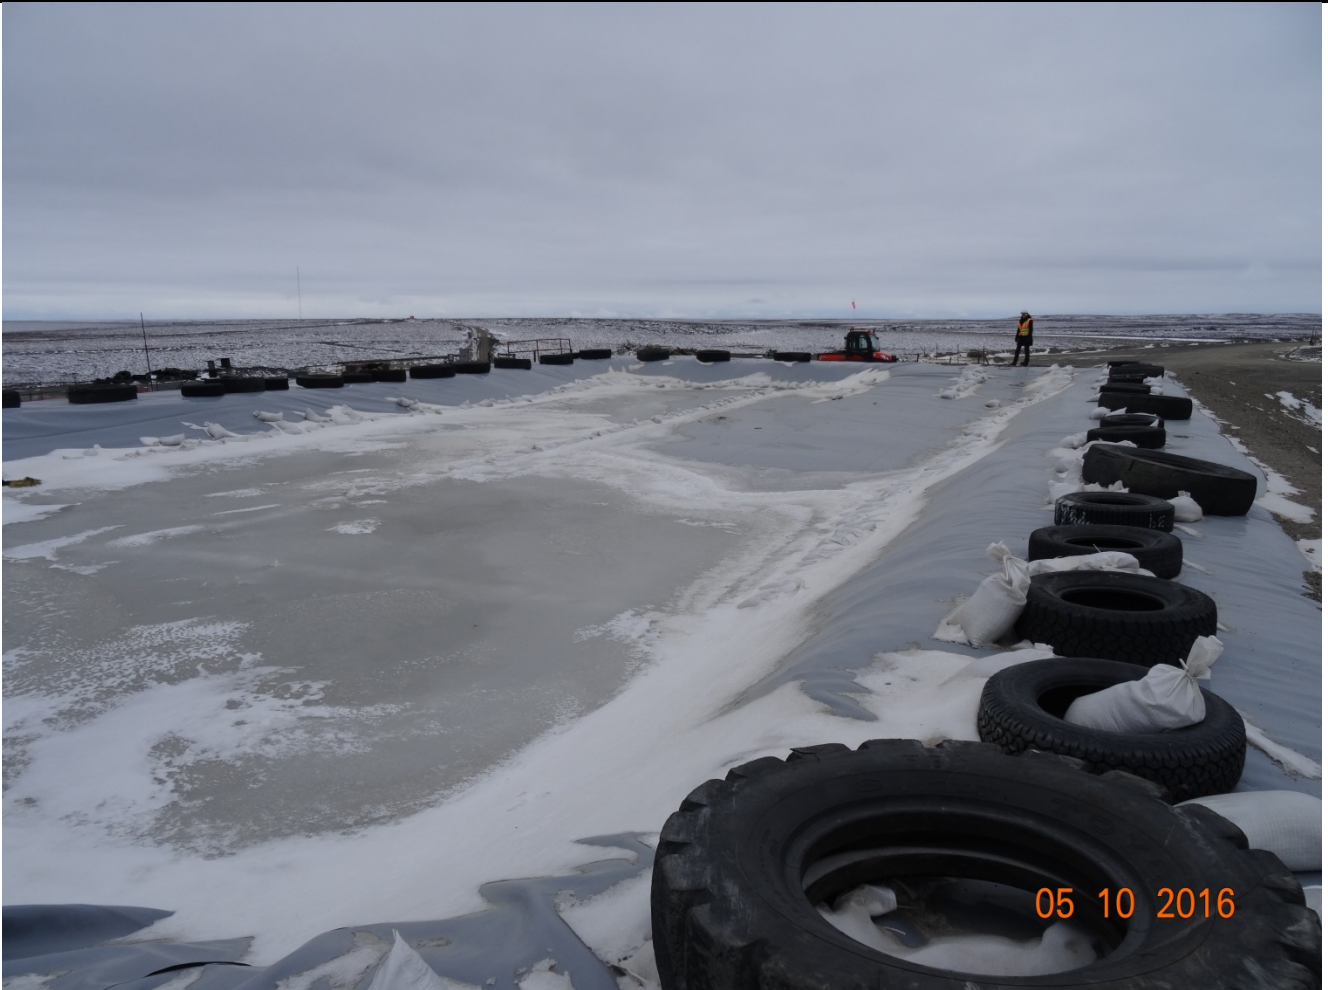
Photo Log # 6

Description: Landfarm construction.

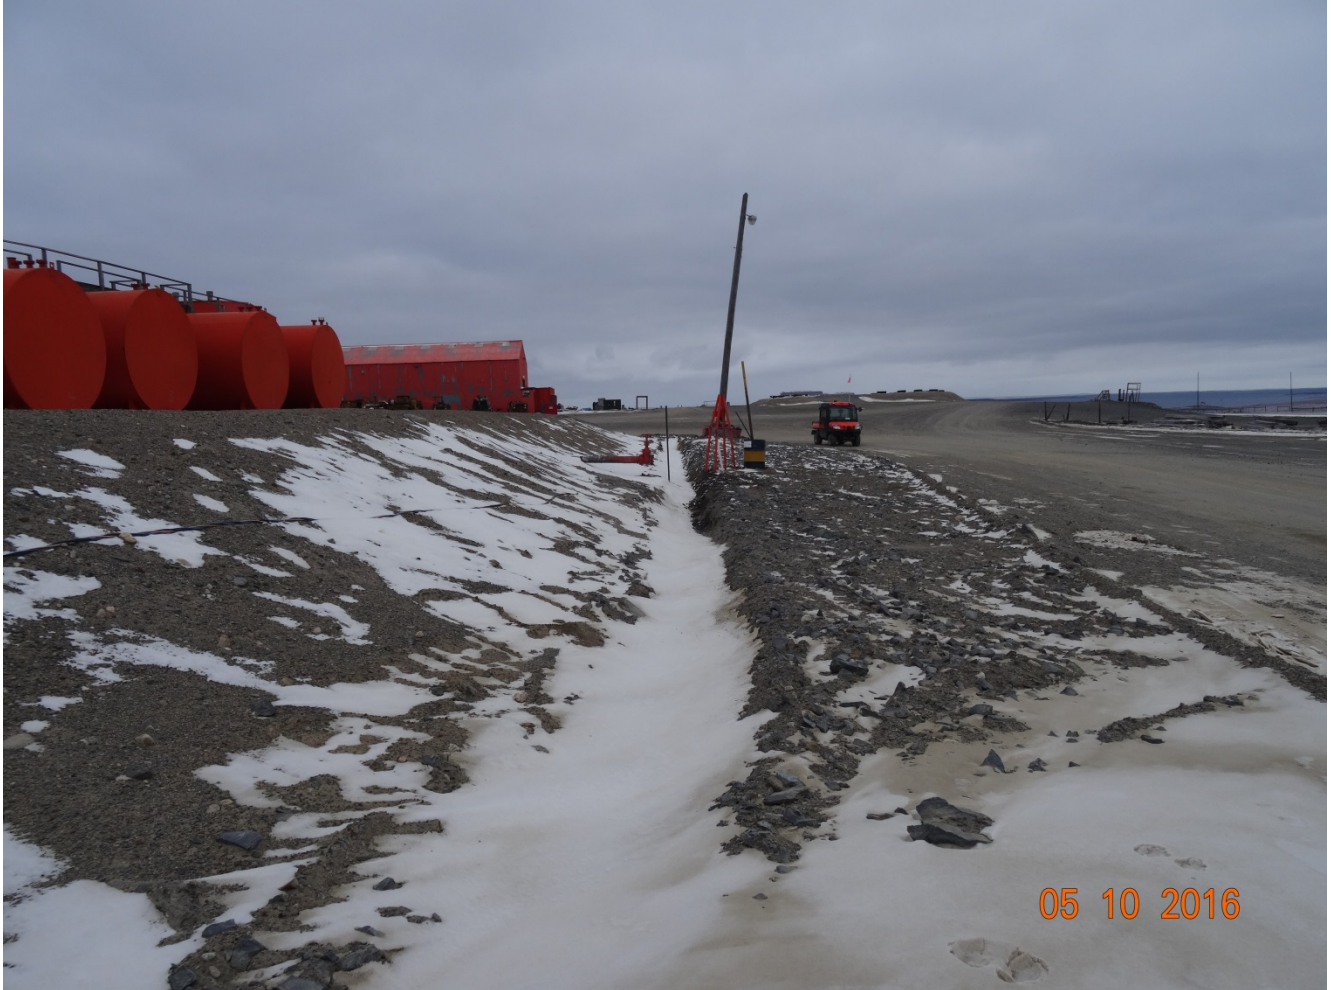
Photo Log # 7

4. A miscommunication occurred with respect to temporary mitigation of the STF spill, which had been requested as a precaution, in case the landfarm was not constructed in a timely fashion. Rather than trenching around the contaminated area to prevent further spread, as was intended, it appears that a trench was dug through the most contaminated area, and the contaminated soil placed outside of the trench. While photos of the work had been requested by the Inspector in August at a point where it could have been addressed, nothing was provided until October. As it was late in the season, nothing further was requested at the time, on the understanding that the decommissioning of the STF and removal of contaminated soil to the landfarm will be a priority for 2017. It is unacceptable to the Department that the Licensee has taken 5 years to begin addressing the remediation of this spill (identified in 2012).

**Description:** Trench outside STF, which does not serve to contain the spread of hydrocarbons.

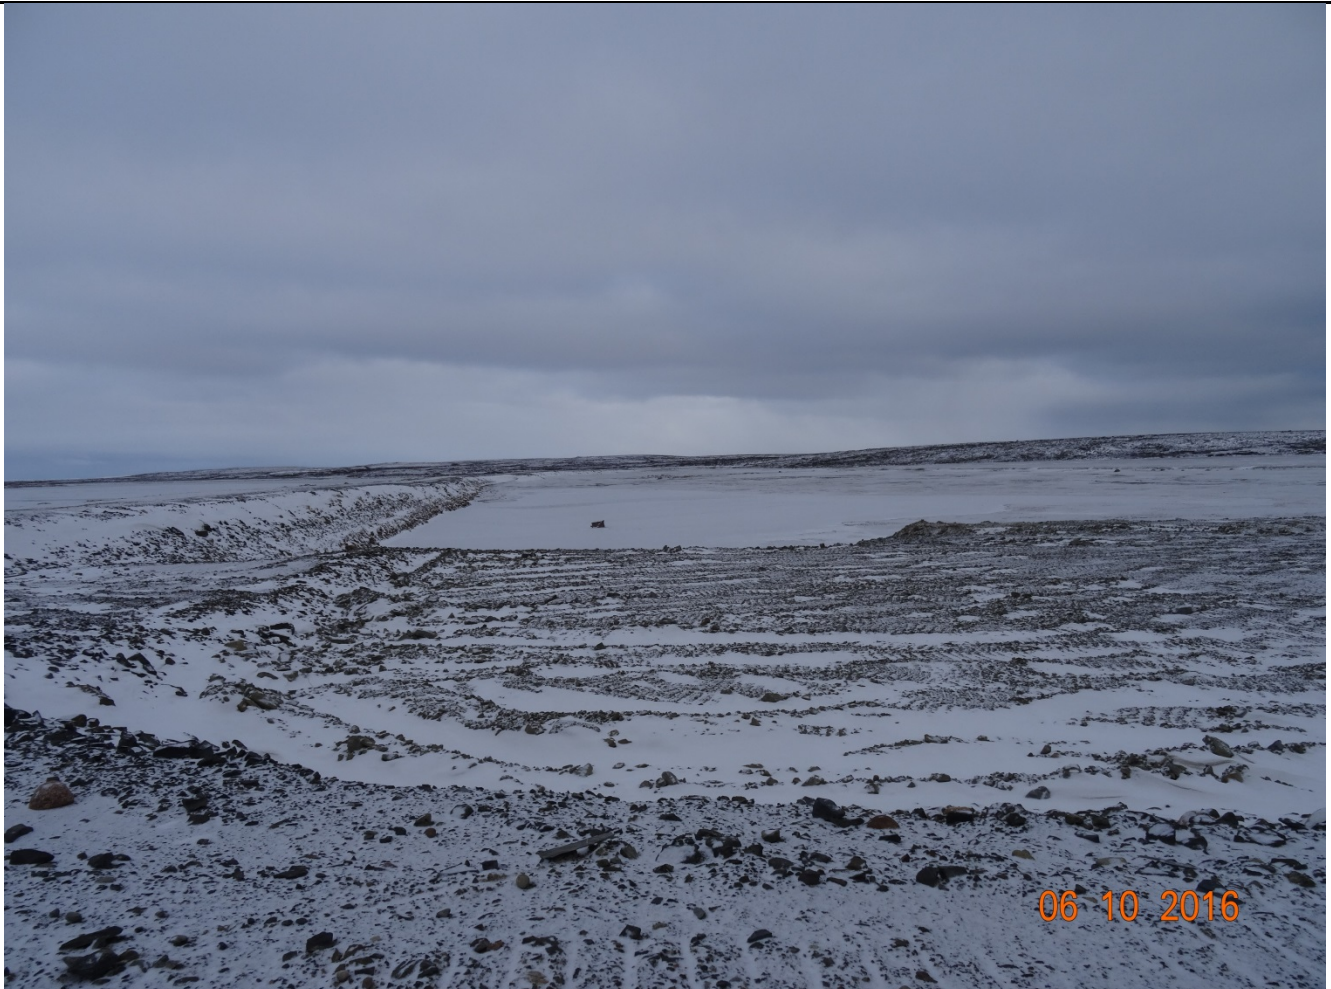
Photo Log # 8

**Description:** Recent work in the TCA.
