WATER LICENCE INSPECTION FORM

Licensee		Licensee Representative	
Lupin Mines Inc		Karyn Lewis	
Licence No. / Expiry		Representative's Title	
2AM-LUP1520 (Amendment No 1)			
Land / Other Authorizations		Land / Other Authorizations	
Lease inspections to be prepared separately			
Date of Inspection		Inspector	
11/07/2017		Eva Paul	
Activities Inspected			
<input checked="" type="checkbox"/> Camp	<input type="checkbox"/> Drilling	<input checked="" type="checkbox"/> Mining	<input type="checkbox"/> Construction
<input type="checkbox"/> Roads/Hauling	<input type="checkbox"/> Other:		<input checked="" type="checkbox"/> Reclamation
			<input checked="" type="checkbox"/> Fuel Storage

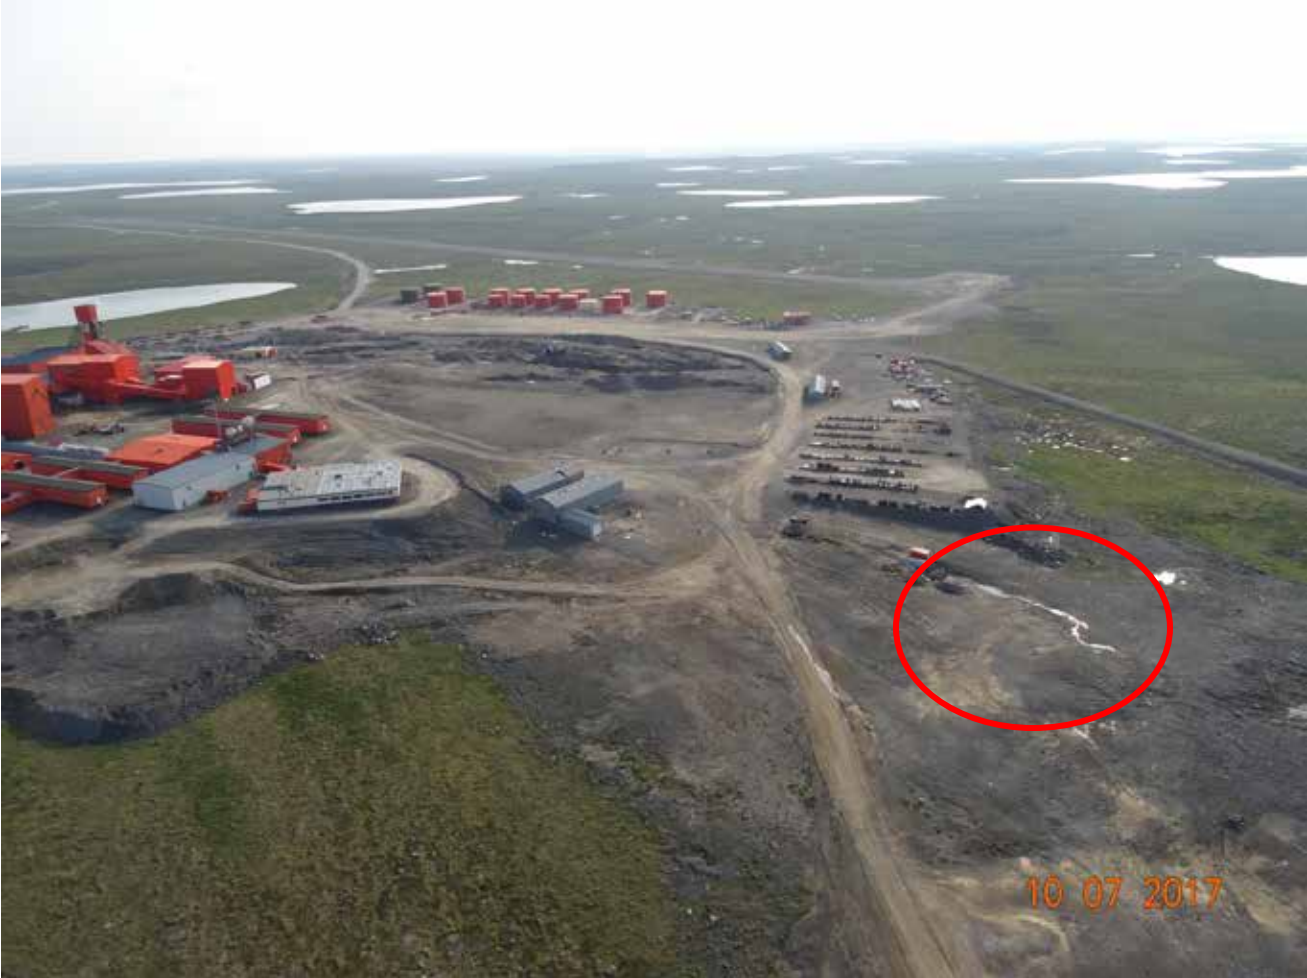
Date	Camera	Inspector	Authorization
10 July 2017	SONY DSC-HX50V	Eva Paul	2AM-LUP1520
Photo Log # 1		Location (NAD 83 DD MM SS.SS)	
Photo DSC07359		N65 46 06.5 W111 13 31.1 (approx. from air)

Description: Flow/seep visible from the portal entrance.

- A. Ensure that tools are available to treat effluent from berms and potentially from the landfarm to meet discharge criteria.
- B. Contain and manage potentially-contaminated effluent from the portal as per item E.12 of the licence. Please provide an update by August 4, 2017 on this matter, demonstrating the action taken.
- C. Please copy the inspector on follow-up correspondence with the NWB on the Landfarm approval.

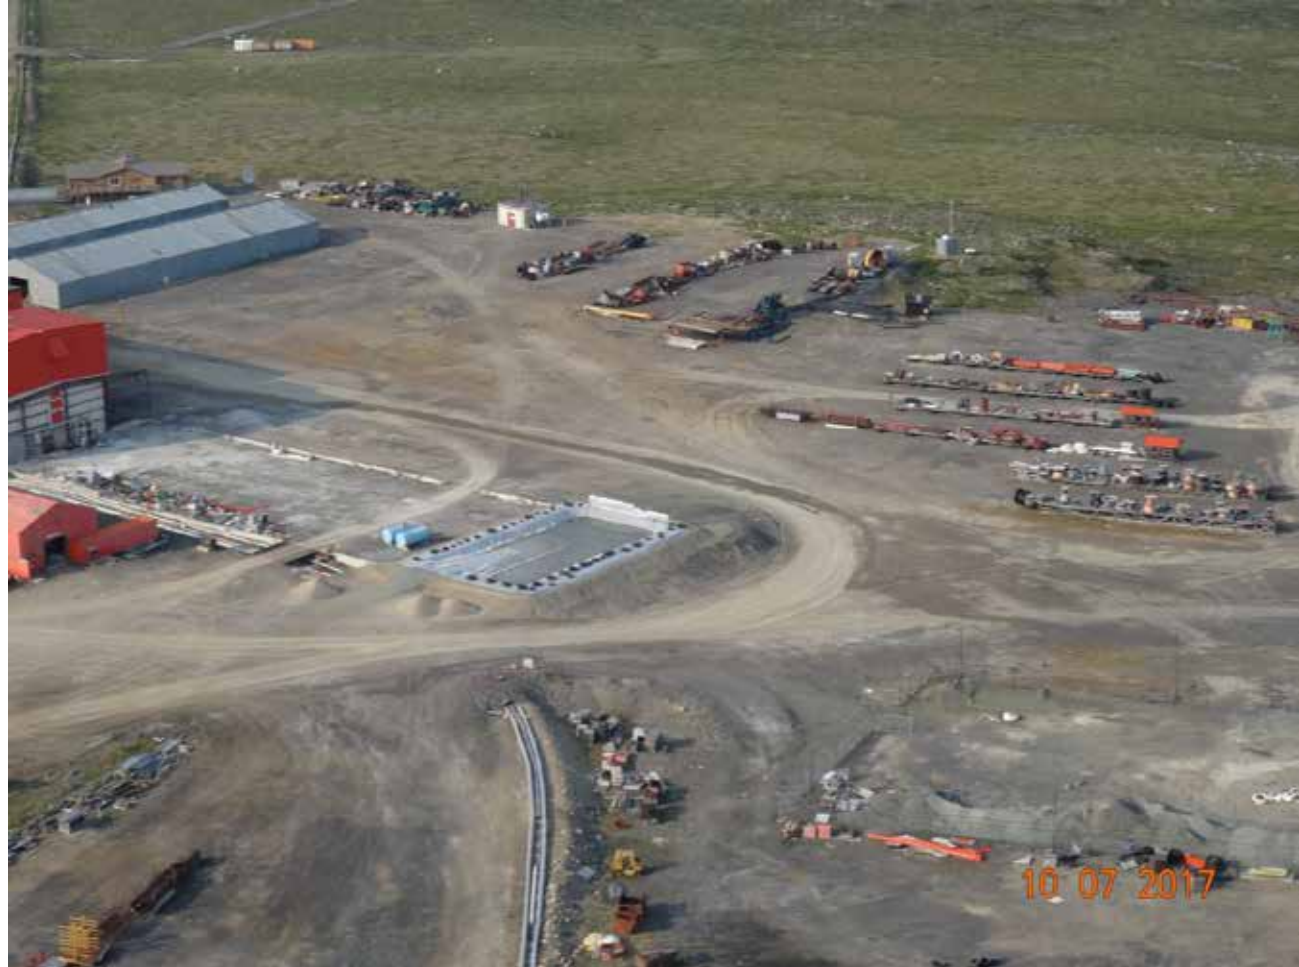
Photo Log # 2	Location (NAD 83 DD MM SS.SS)
Photo DSC07369	N65 45 36.5 W111 13 50.9 (approx. from air)

Description: View of landfarm from the air. Awaiting NWB approval and final fill prior to use. Water present in the liner at this time is non-contact water, accumulated from precipitation.

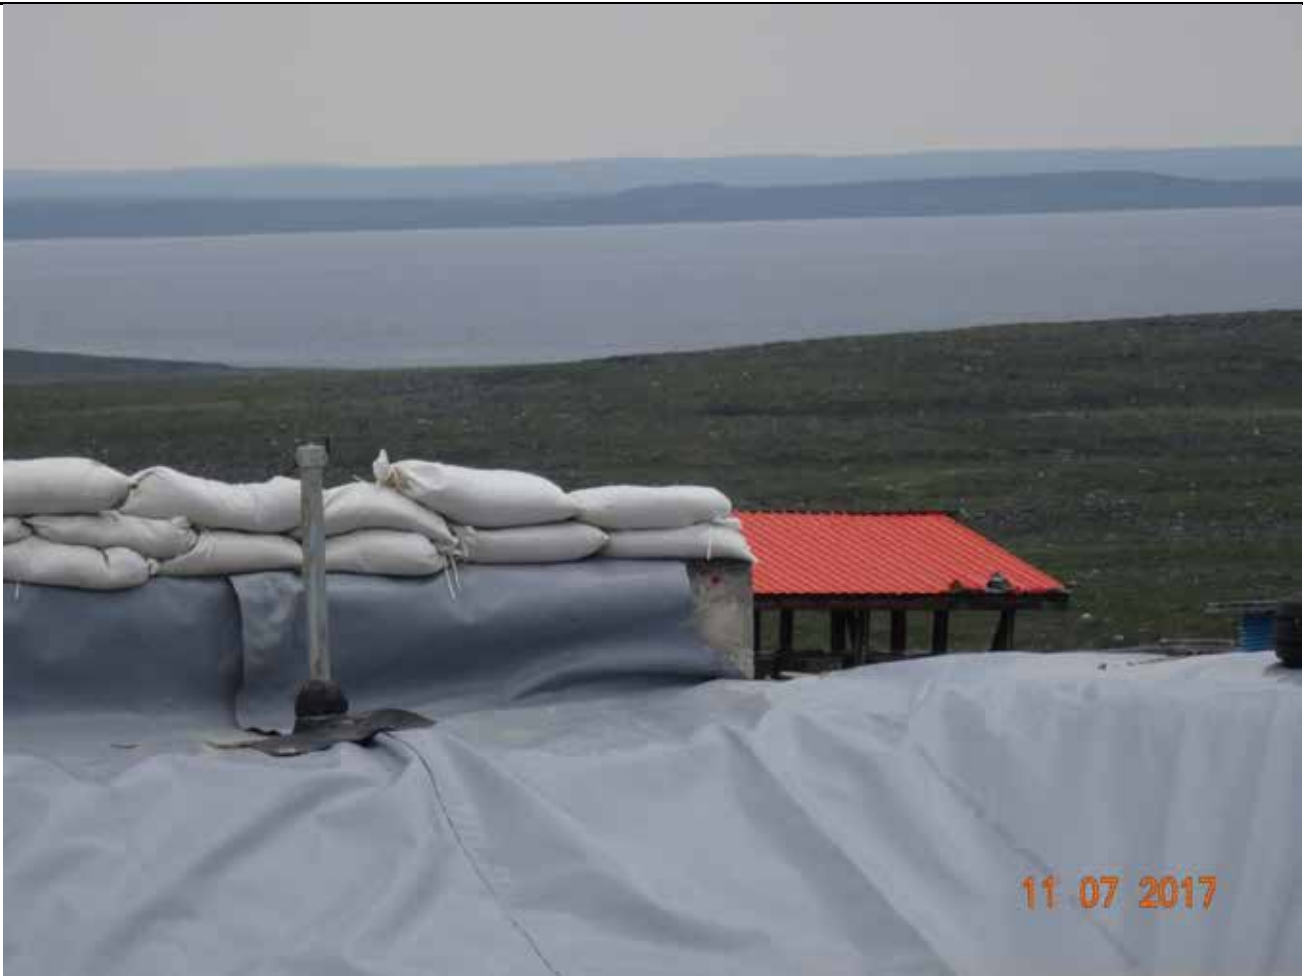
Photo Log # 3	Location (NAD 83 DD MM SS.SS)	
Photo DSC07537	N65 45 46.9	W111 13 40.1

Description: Leak detection system built into landfarm.

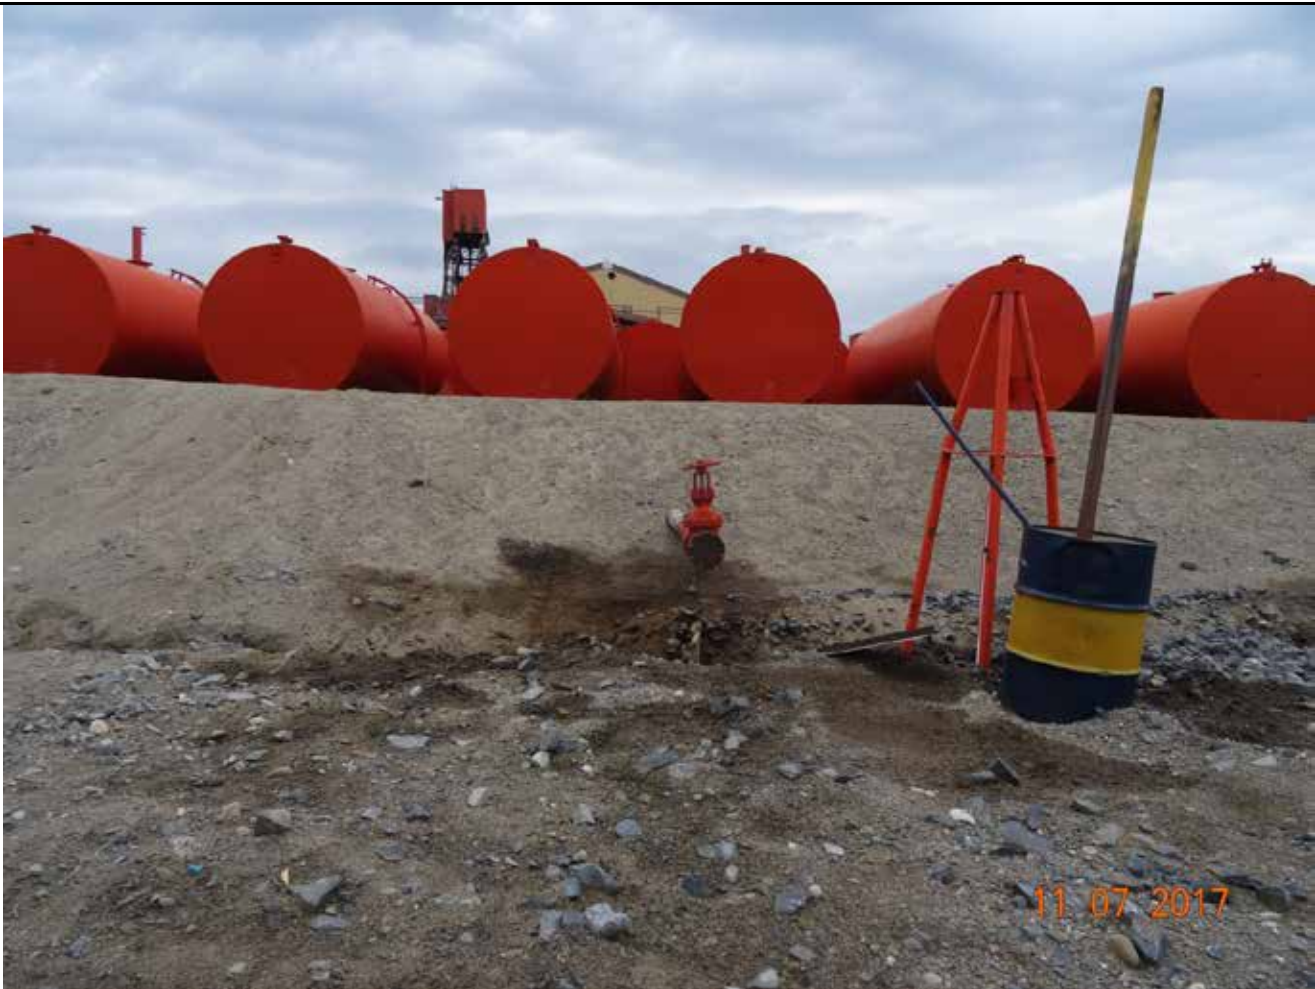
Photo Log # 4	Location (NAD 83 DD MM SS.SS)	
Photo DSC07544	N65 45 46.2	W111 13 48.1

Description: Persistent staining at satellite tank farm.

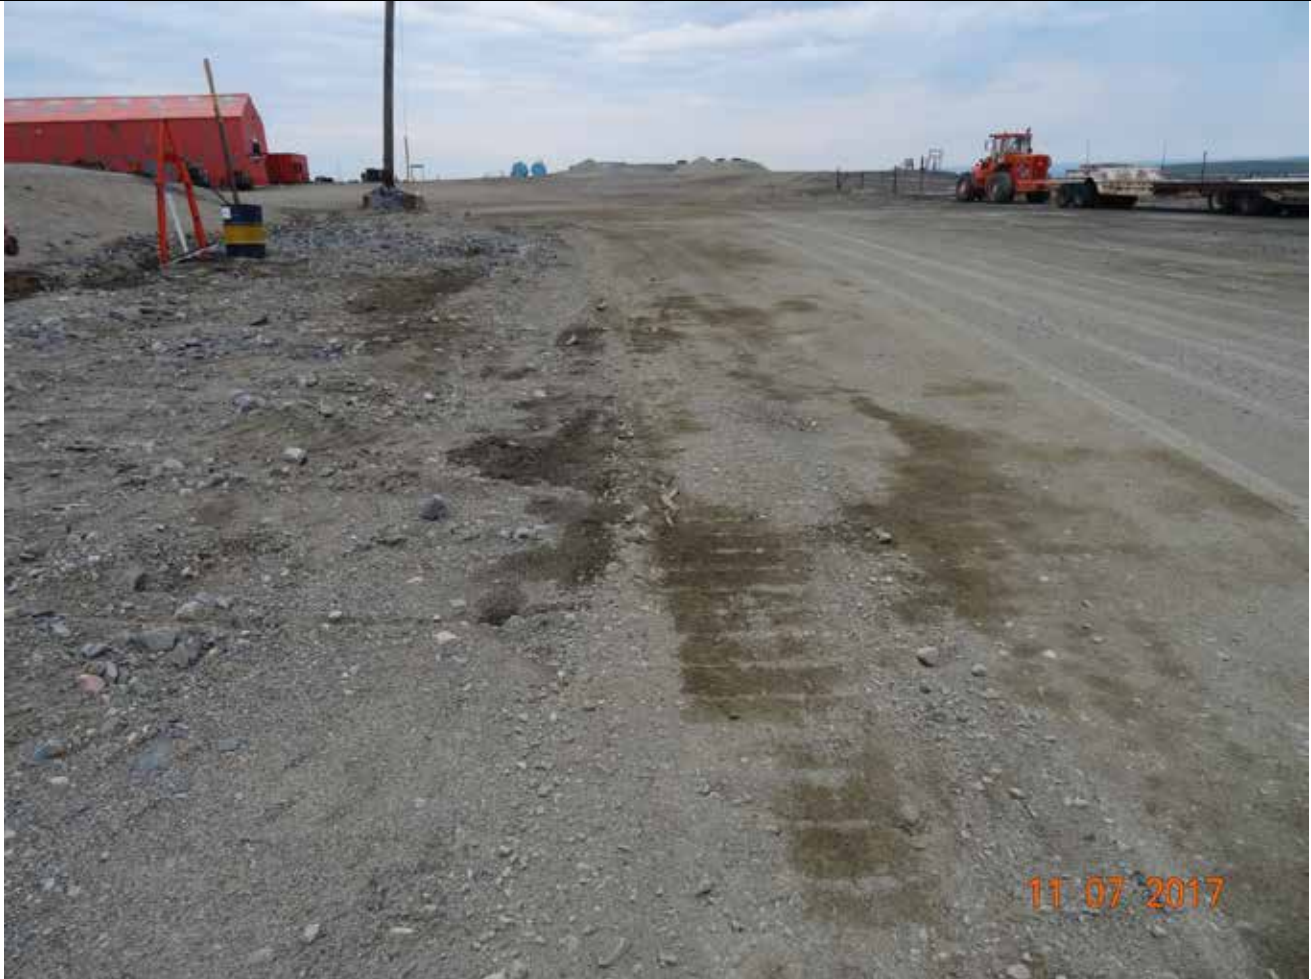
Photo Log # 5

Description: Persistent staining at satellite tank farm.

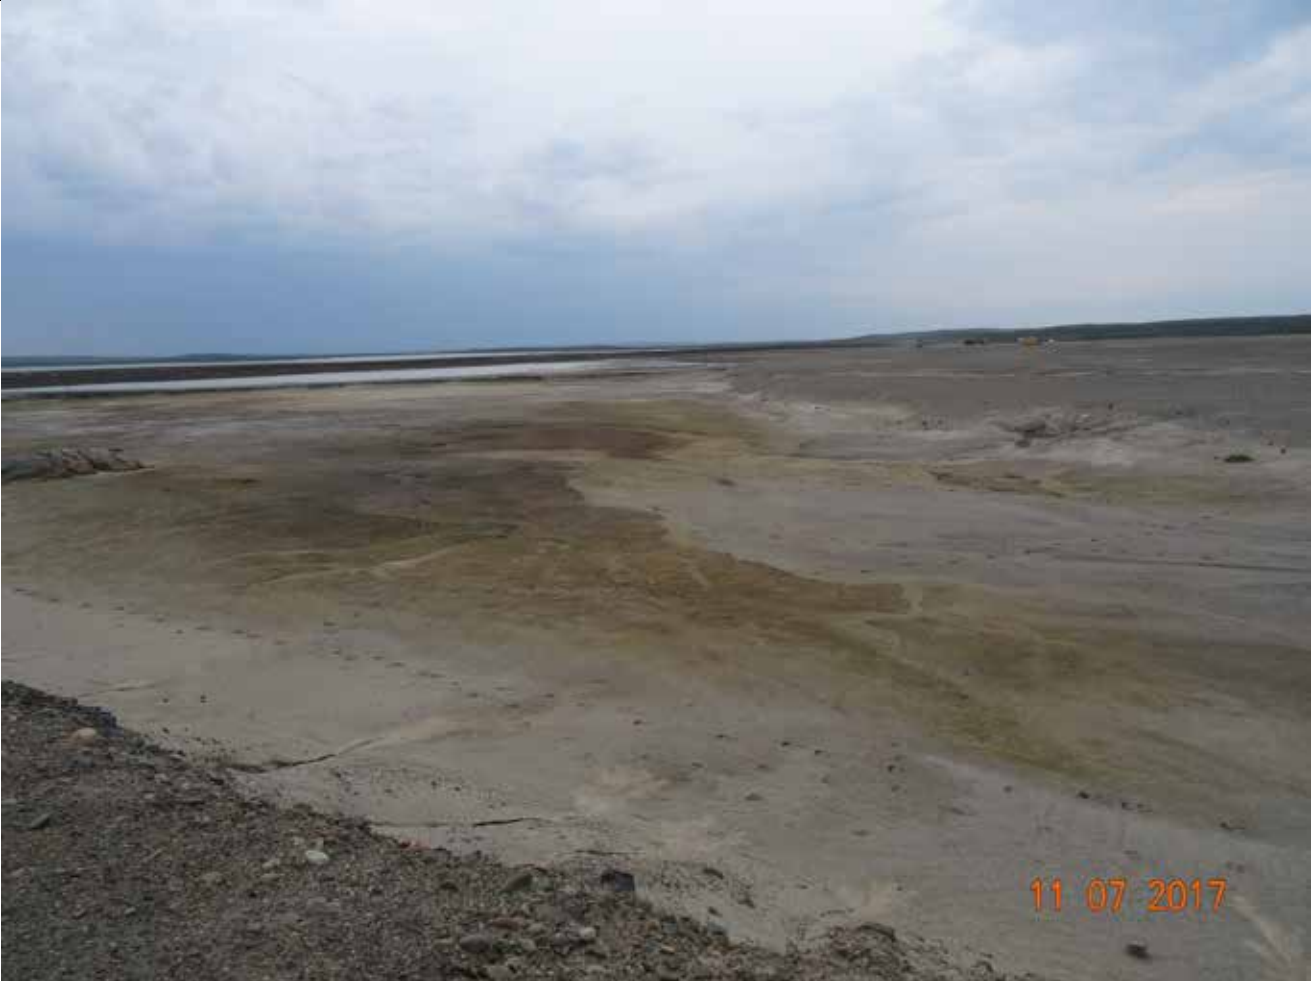
Photo Log # 6

Description: Crews working to cover exposed tailings in Cell 5.
