WATER LICENCE INSPECTION FORM

Licensee		Licensee Representative	
Lupin Mines Inc		Karyn Lewis	
Licence No. / Expiry		Representative's Title	
2AM-LUP1520		Project Manager	
Land / Other Authorizations		Land / Other Authorizations	
Date of Inspection		Inspector	
2019 June 9		Baba Pedersen	
Activities Inspected			
<input checked="" type="checkbox"/> Camp	<input type="checkbox"/> Drilling	<input type="checkbox"/> Mining	<input type="checkbox"/> Construction
<input type="checkbox"/> Roads/Hauling	<input type="checkbox"/> Other:	<input checked="" type="checkbox"/> Other: Care & Maintenance	<input checked="" type="checkbox"/> Reclamation
<input checked="" type="checkbox"/> Fuel Storage

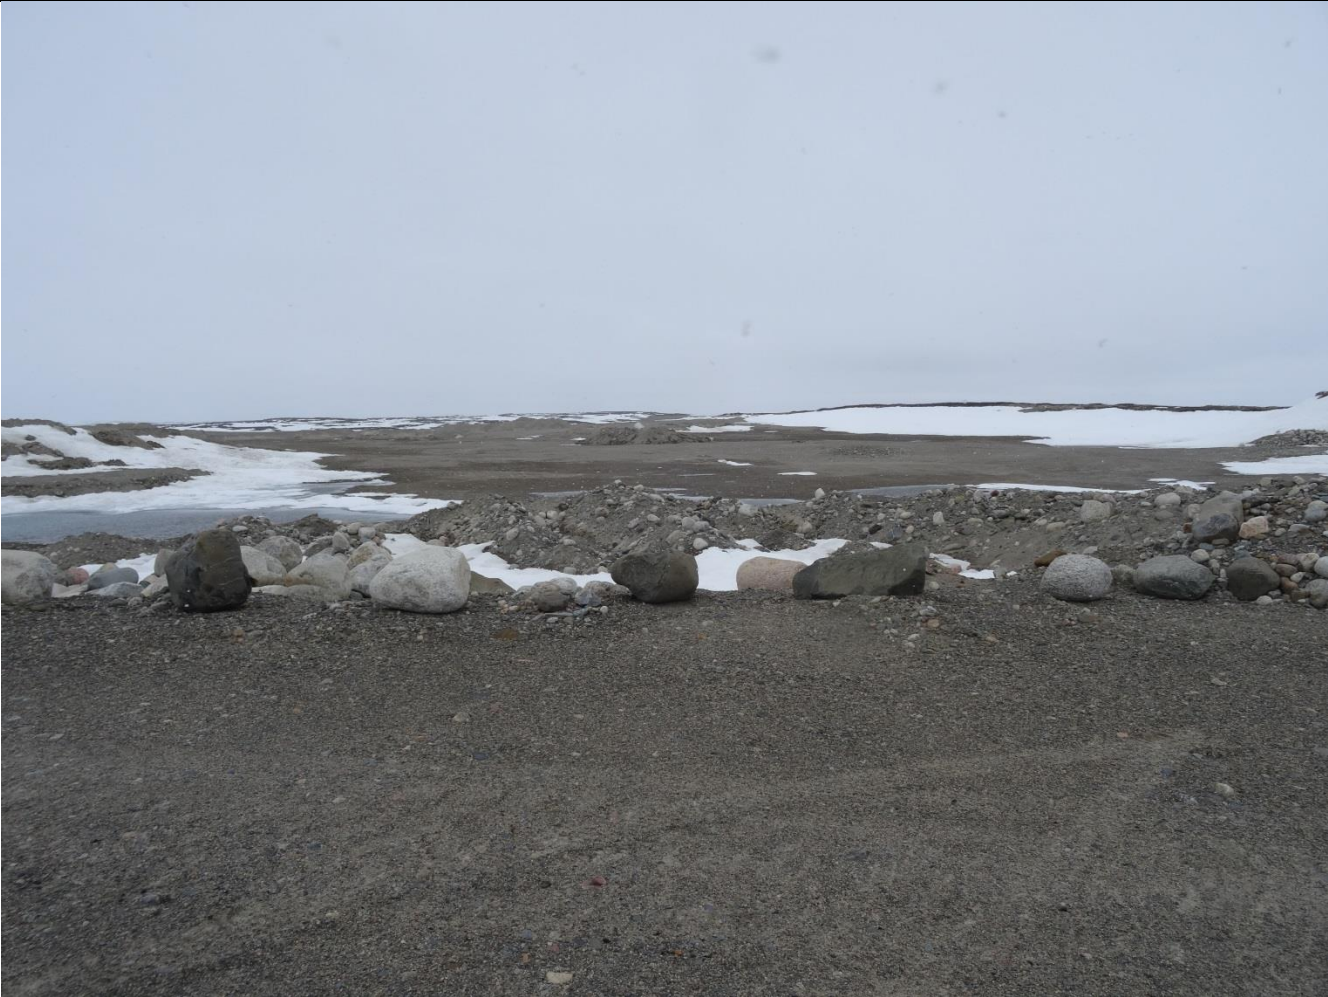
Photo 3

Description: View #1 of the Fingers Lake Quarry Area

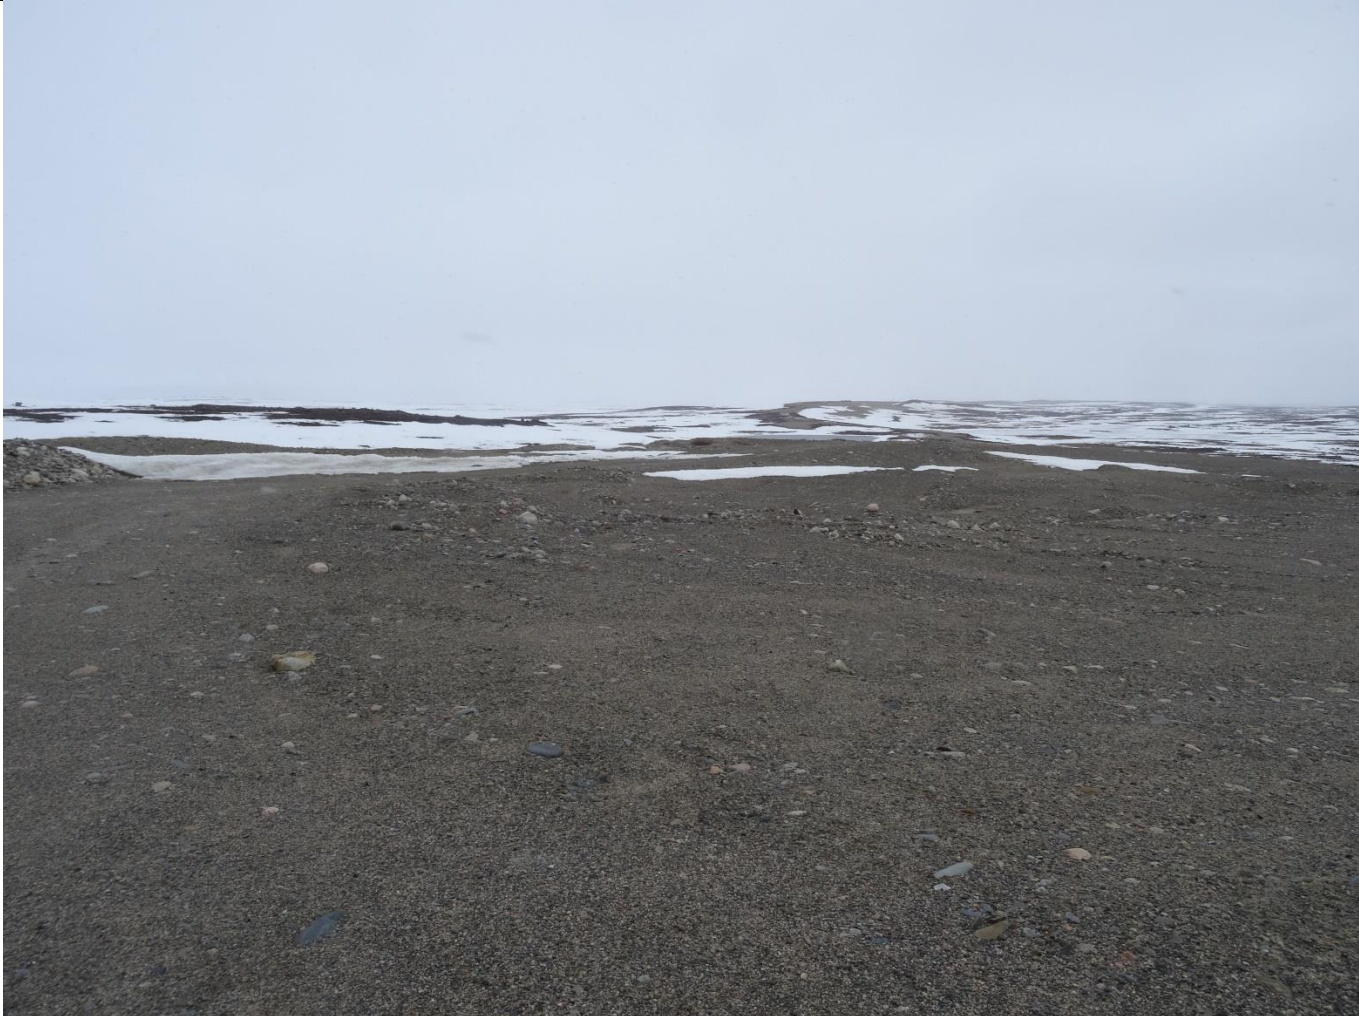
Photo 4

Description: View #2 of the Fingers Lake Quarry Area

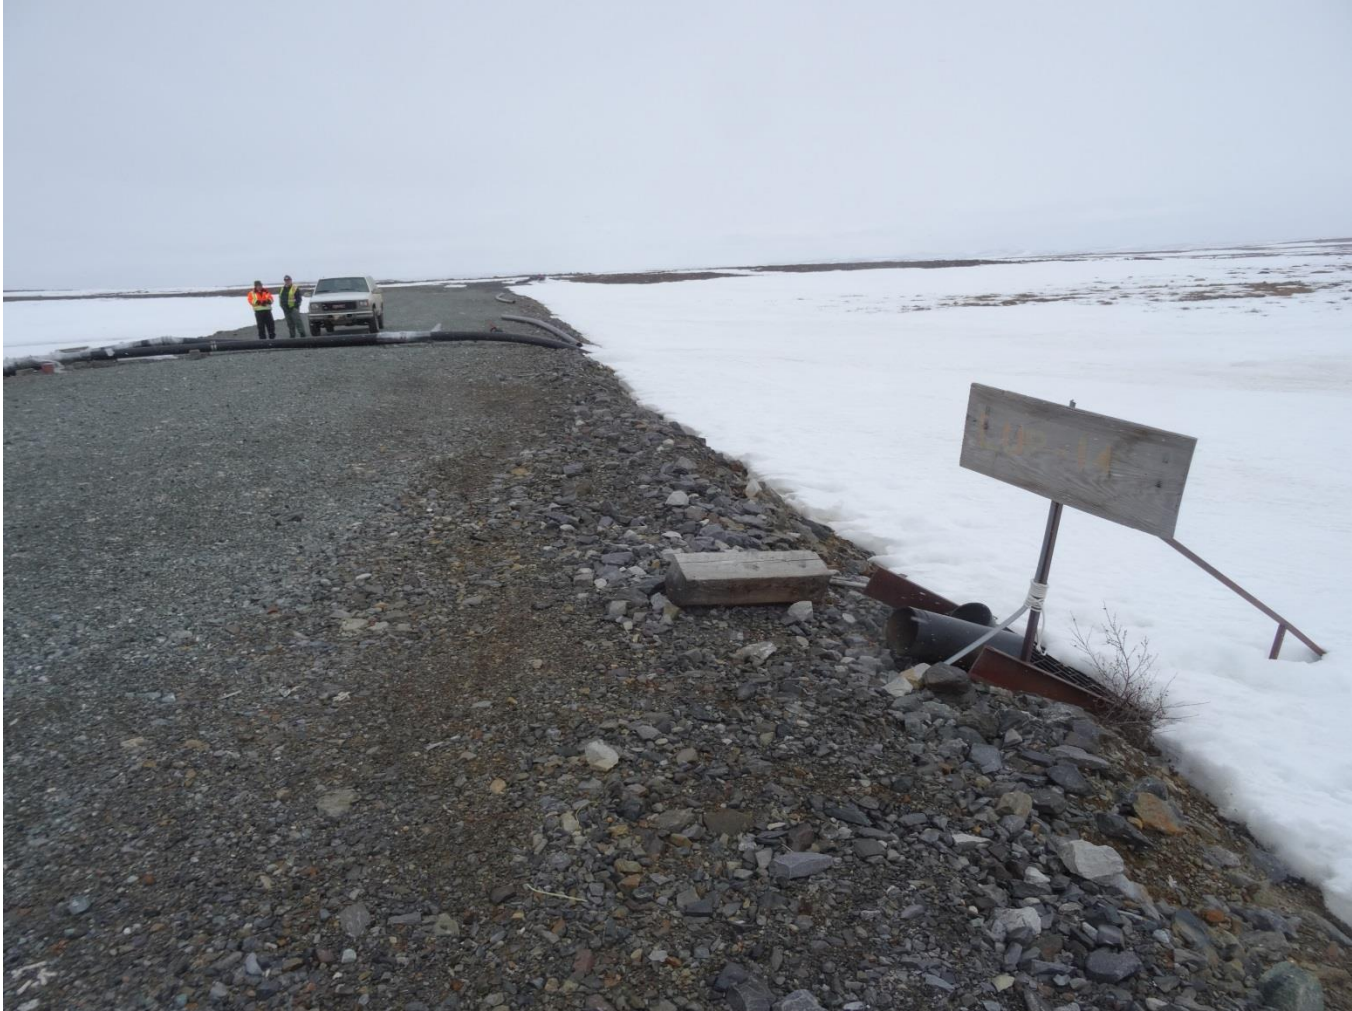
Photo 5

SECTION 3	<input type="checkbox"/> Comments	<input type="checkbox"/> Non-Compliance with Act or Licence	<input checked="" type="checkbox"/> Action Required
I was not able to see as much as I planned because the ground was still covered with snow in a lot of places and LMI had not been able to start much of their plans due to this. 1. As they have just opened for the season, Water Consumption is well within allowable limits, 2. The Fingers Lake Quarry Area is in a Clean, Organized and Acceptable State, 3. The Liming Station is in Care & Maintenance and is an acceptable state, 4. Only Tank #13 and Tank #15 have any Product in them with a combined total of 869,510 Litres, all other Tanks on Site are now empty. 5. LMI/Nahanni will be requesting permission to Decant as soon as possible. Samples have already been taken and sent to the Lab.

Description: Sample Station LUP-14 and the Sewage Decant Area

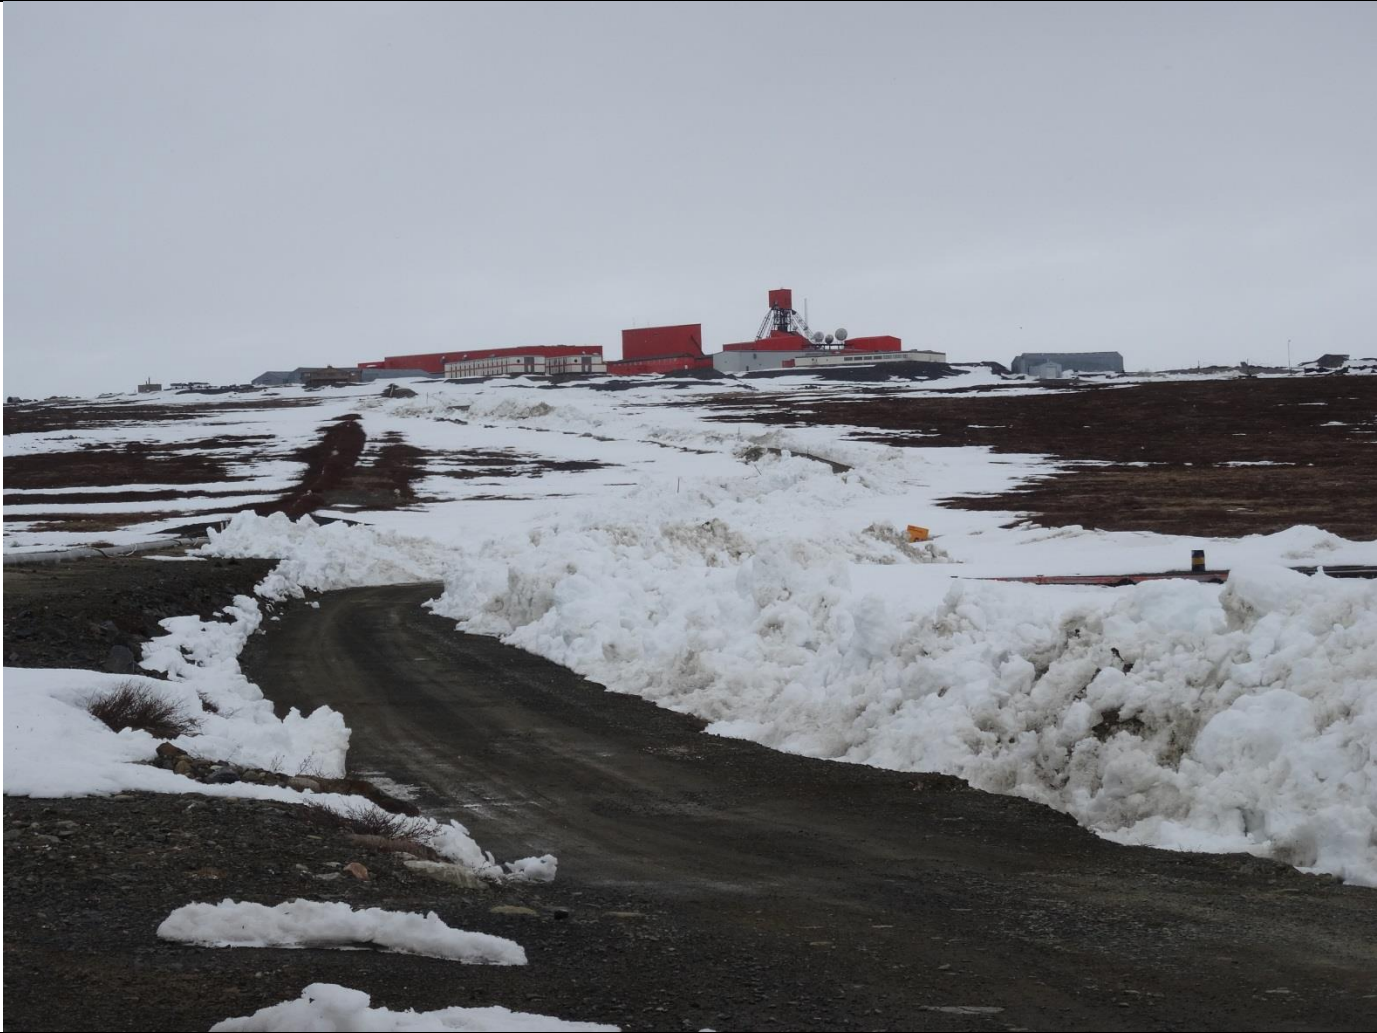
Photo 6

Description: View of the Lupin Mine Site as seen from the North
