WATER LICENCE INSPECTION FORM

Licensee		Licensee Representative	
Lupin Mines Inc		Karyn Lewis	
Licence No. / Expiry		Representative's Title	
2AM-LUP2032		Project Manager	
Land / Other Authorizations		Land / Other Authorizations	
Date of Inspection		Inspector	
2020 July 2		Baba Pedersen	
Activities Inspected			
<input checked="" type="checkbox"/> Camp	<input type="checkbox"/> Drilling	<input type="checkbox"/> Mining	<input type="checkbox"/> Construction
<input type="checkbox"/> Roads/Hauling	<input type="checkbox"/> Other:	<input checked="" type="checkbox"/> Other: Mine Reclamation	<input type="checkbox"/> Reclamation
<input type="checkbox"/> Fuel Storage

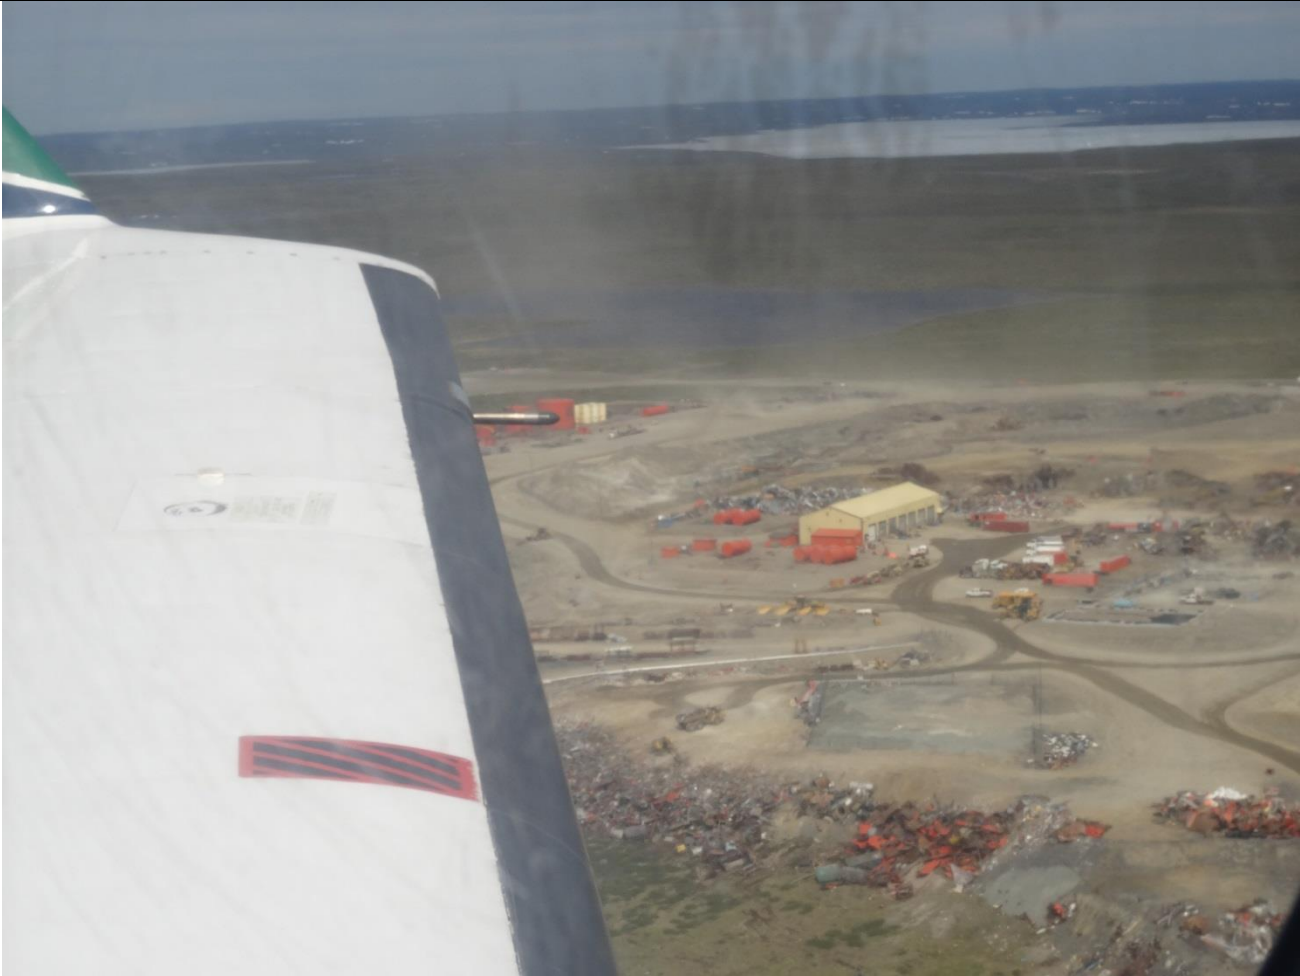
Photo 1

Description: Lupin Mine Site Photo taken on arrival on July 2, 2020

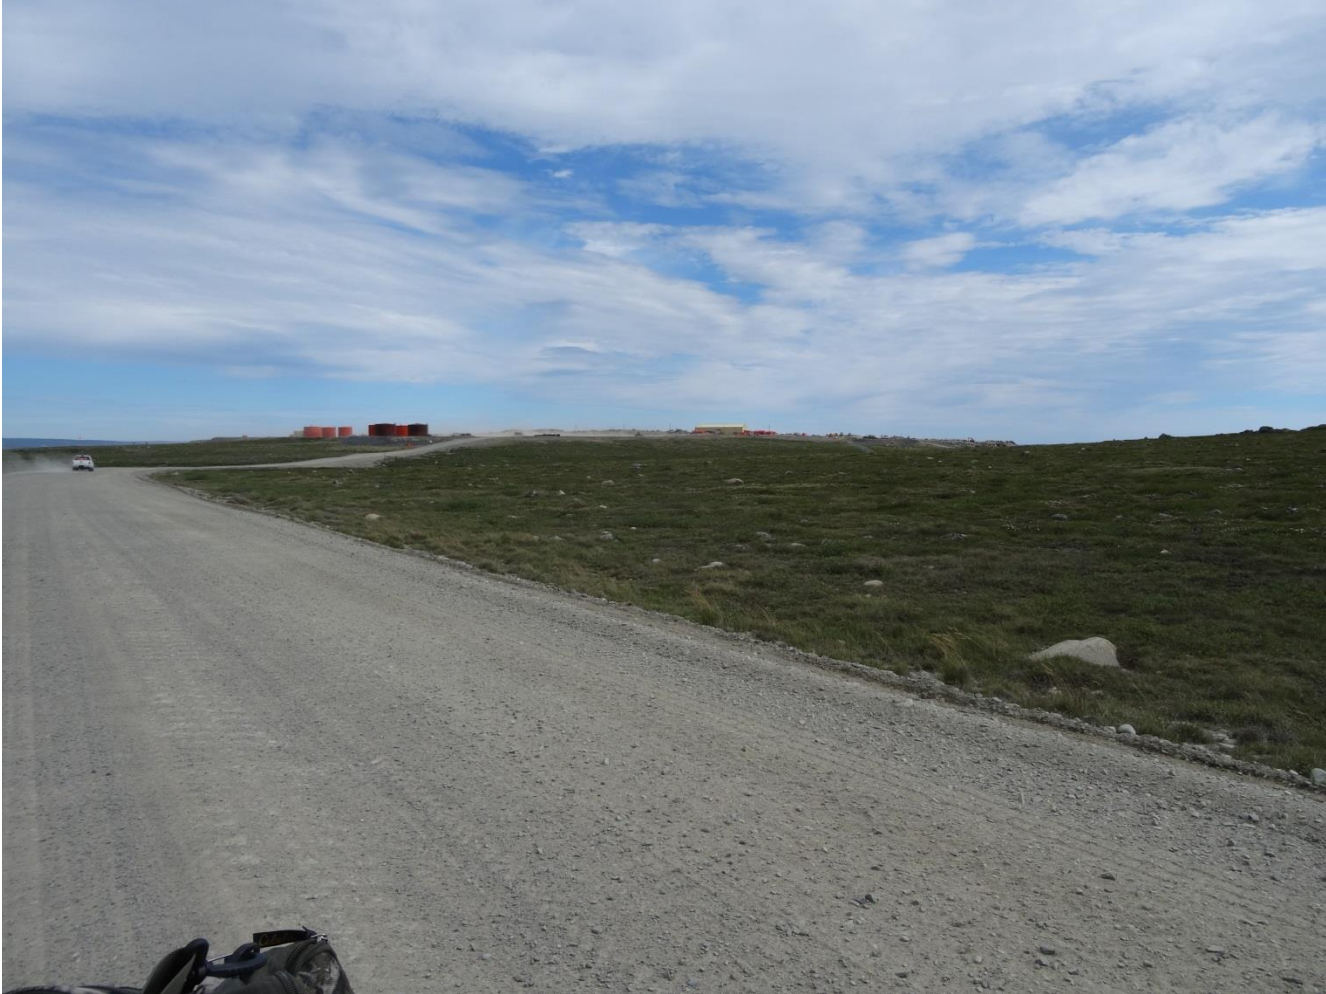
Photo Log # DSC05644	Location
Photo 2

Description: Lupin Mine Site

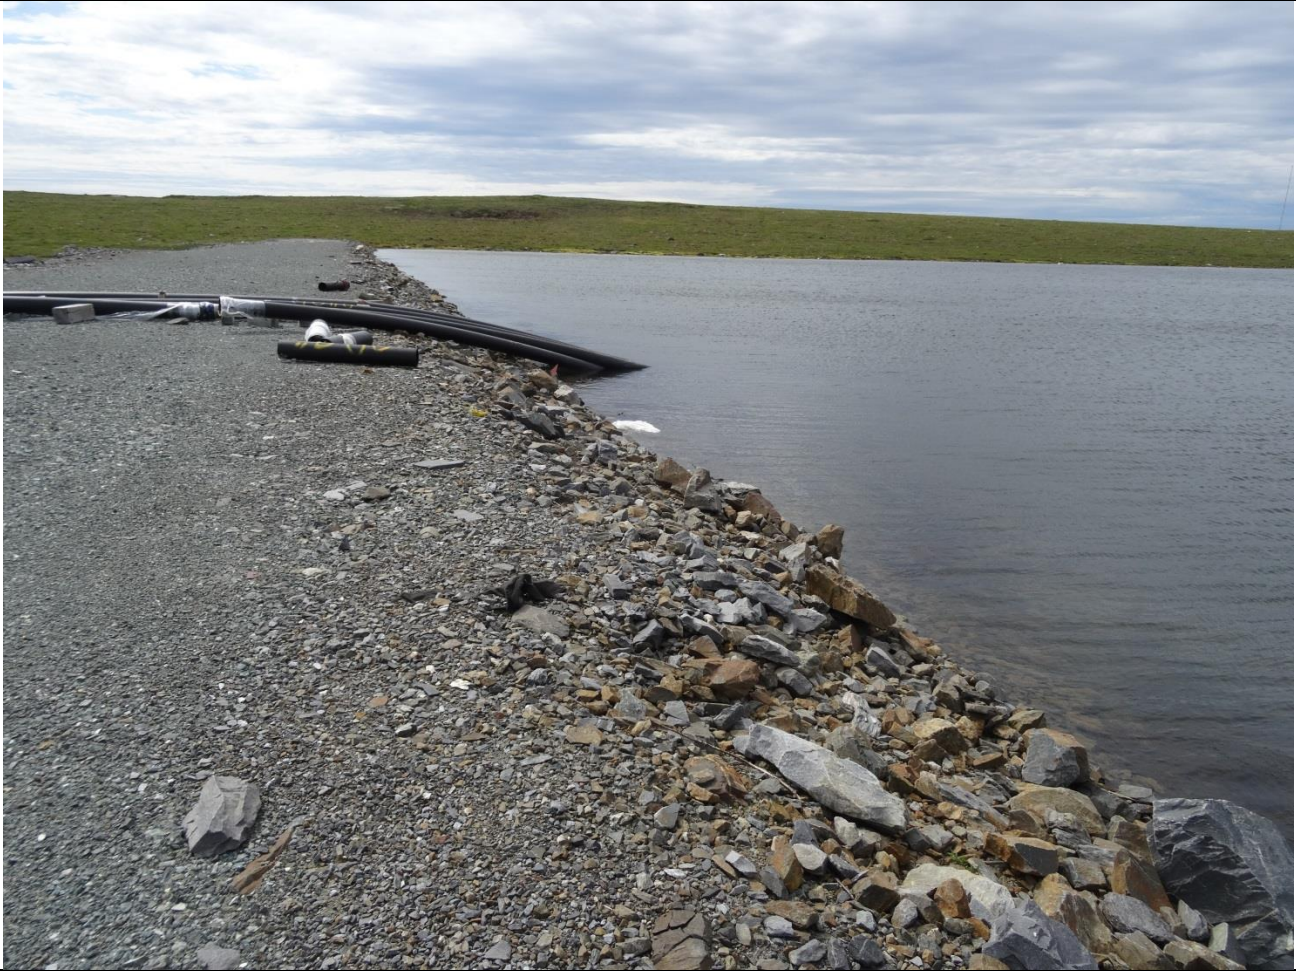
Photo 3

Description: Sewage Lagoon

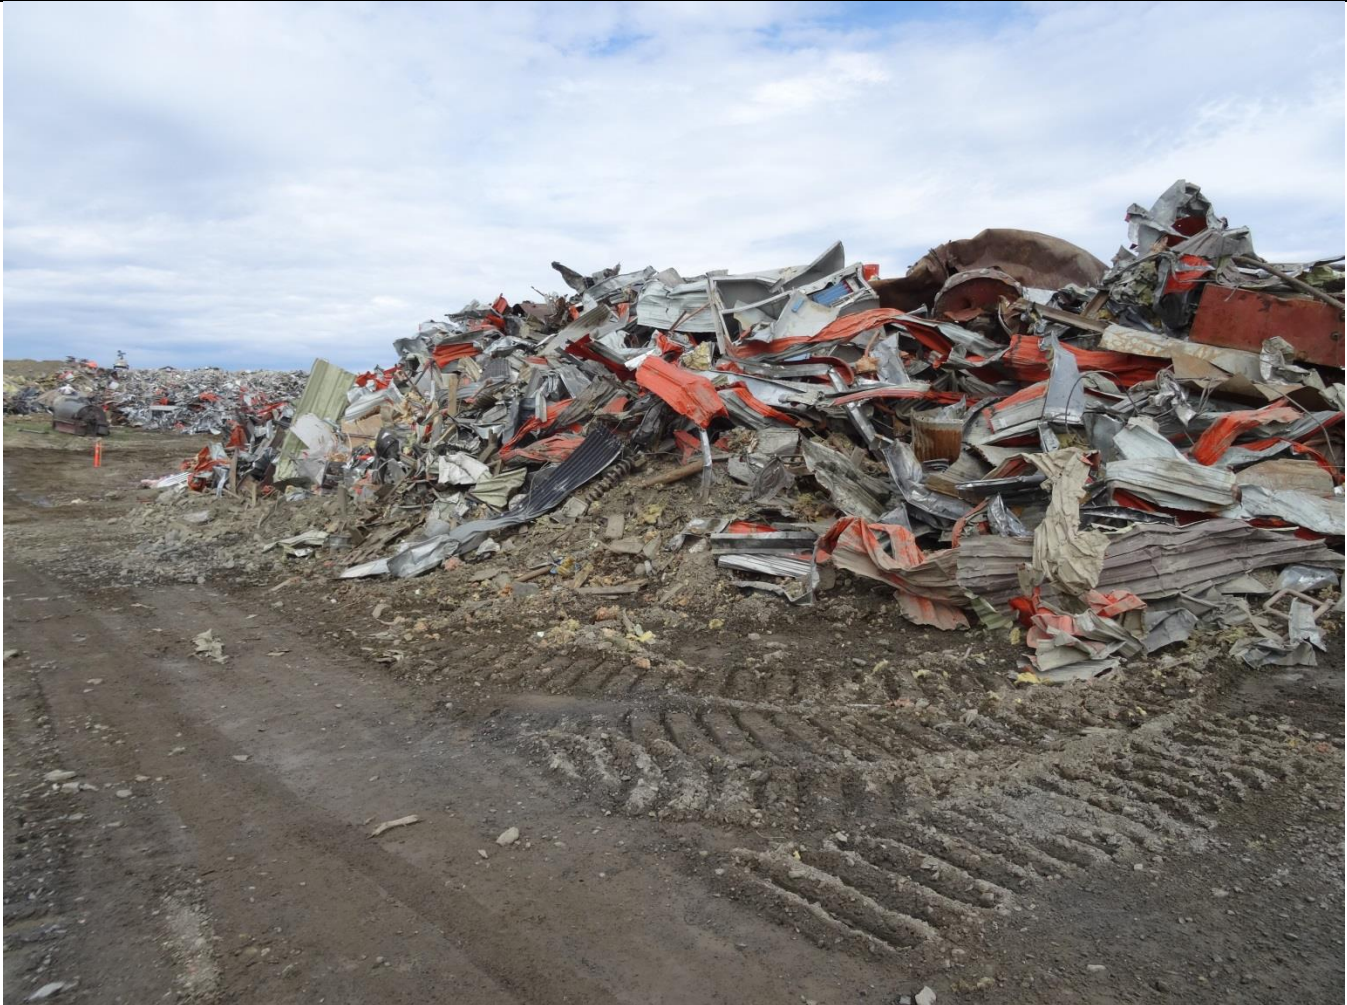
Photo 4

Description: Temporary Storage of Demolished Debris – View 1

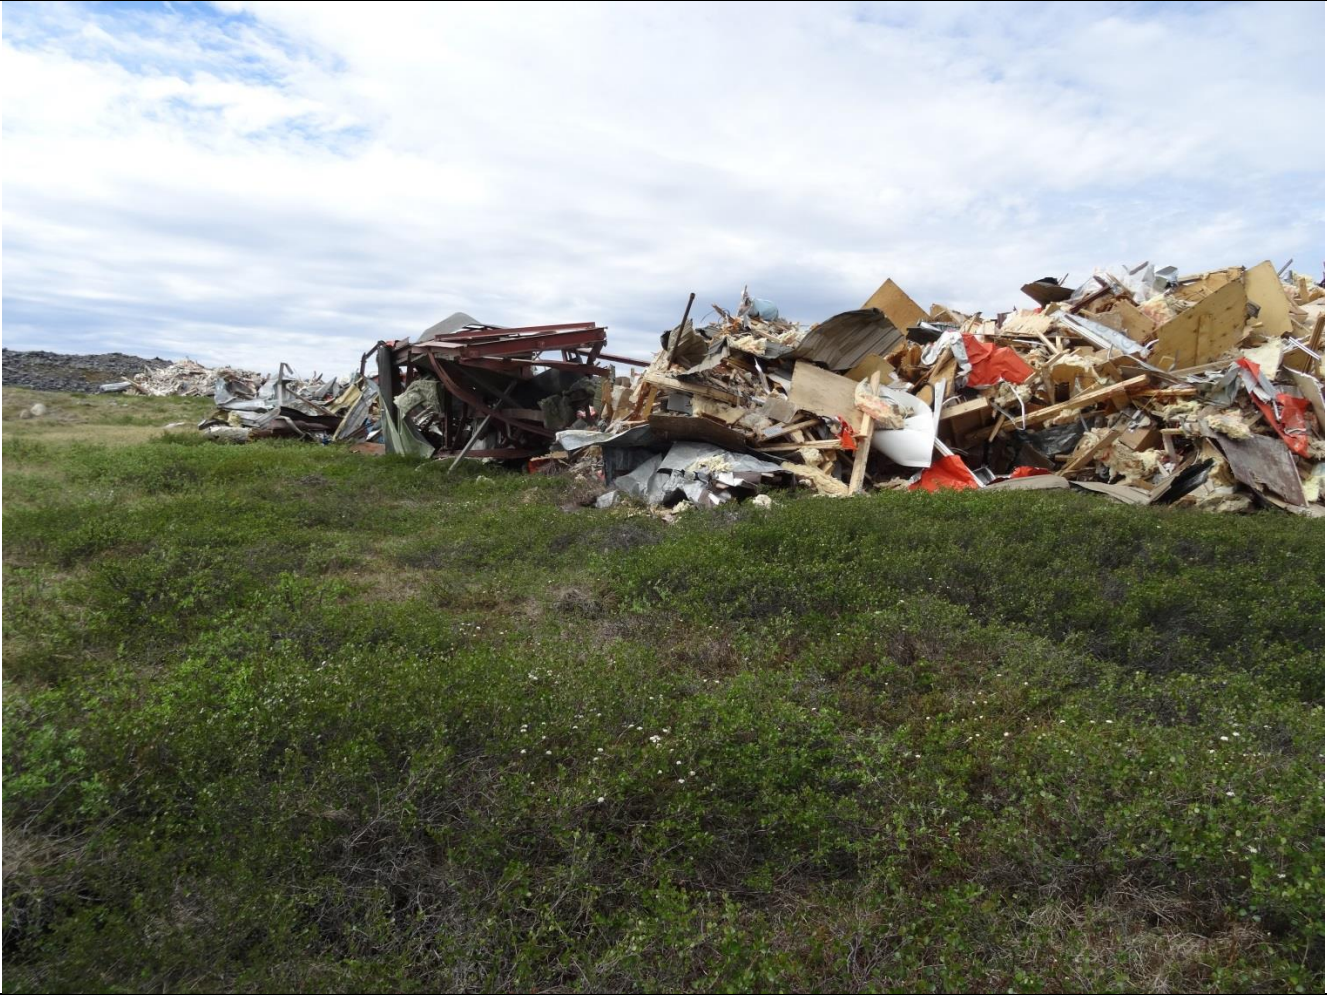
Photo 7

Description: Temporary Storage of Demolished Debris – View 4

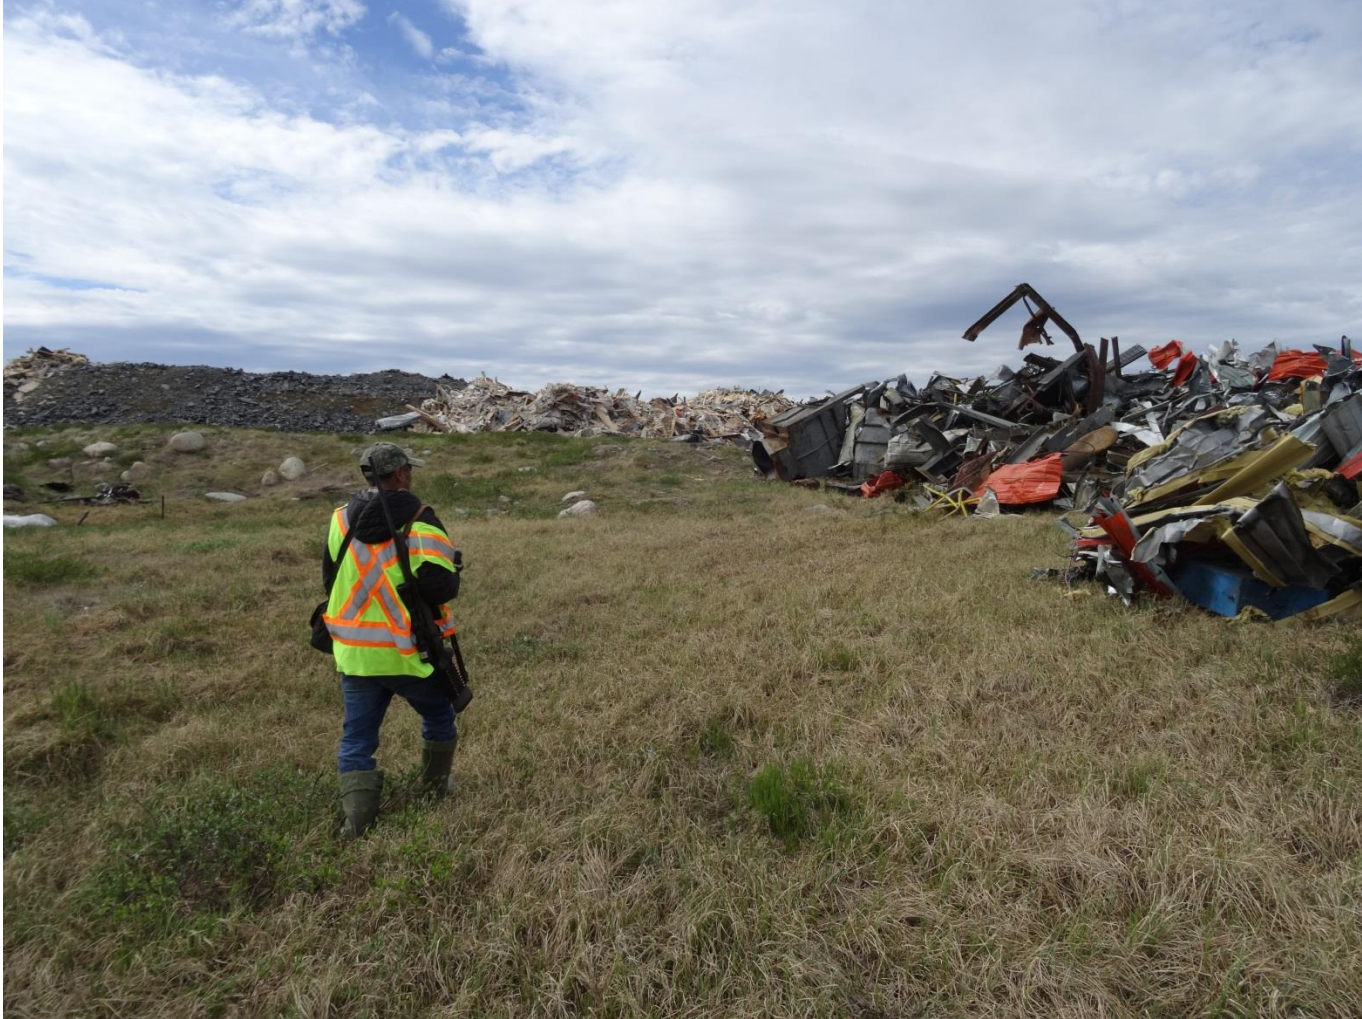
Photo 8

Description: Temporary Storage of Demolished Debris – View 5

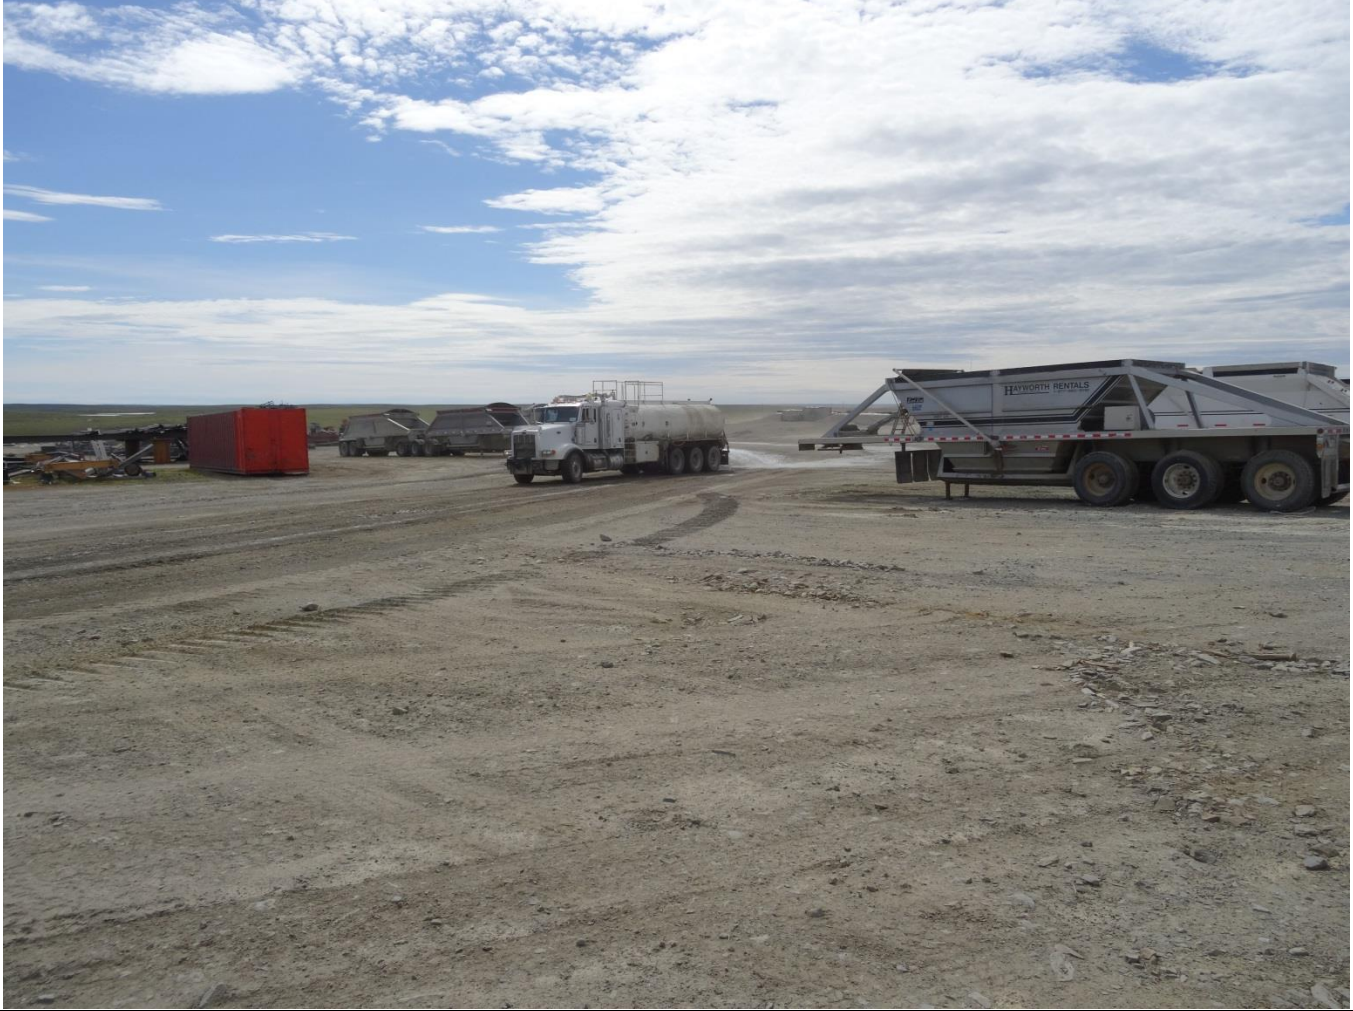
Photo 9

Description: Truck Watering Road

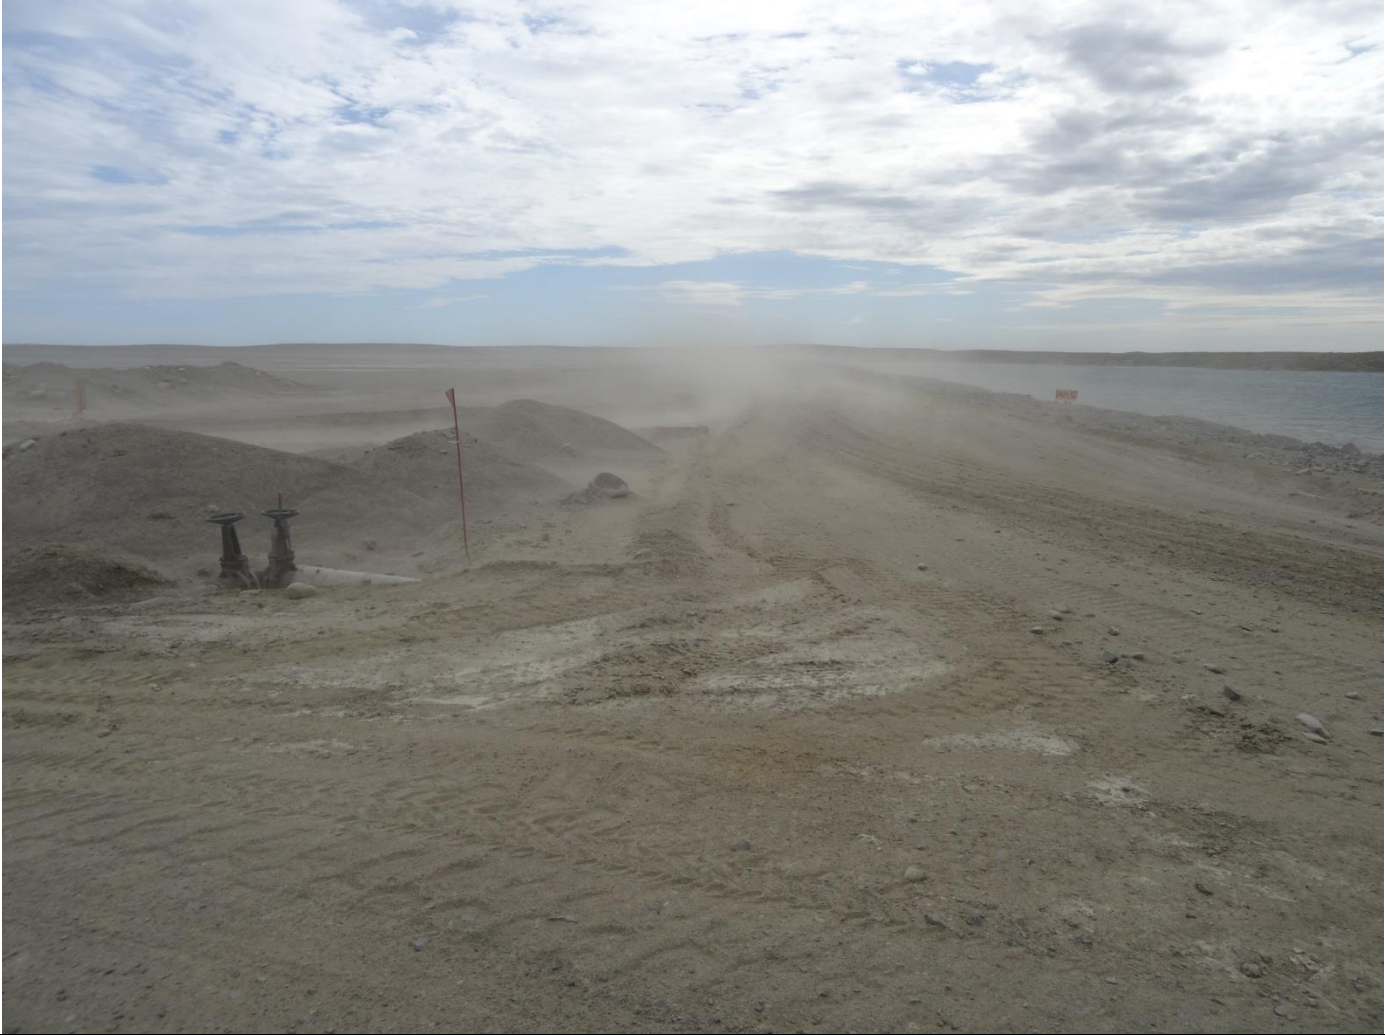
Photo 10

Description: Wind Blown Sand Dust – View 1

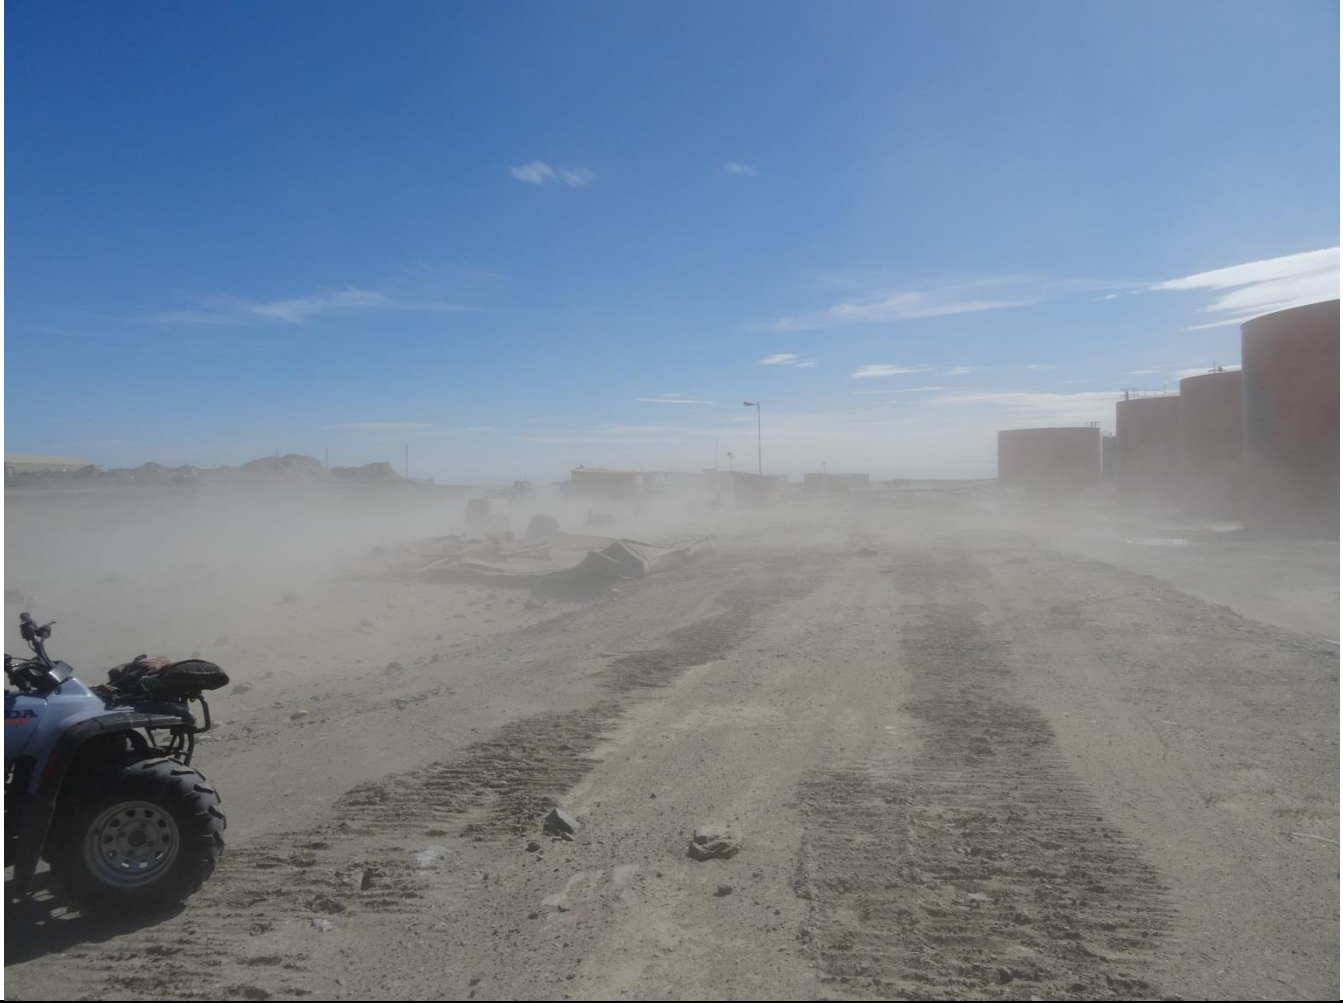
Photo 11

Description: Wind Blown Sand Dust – View 2

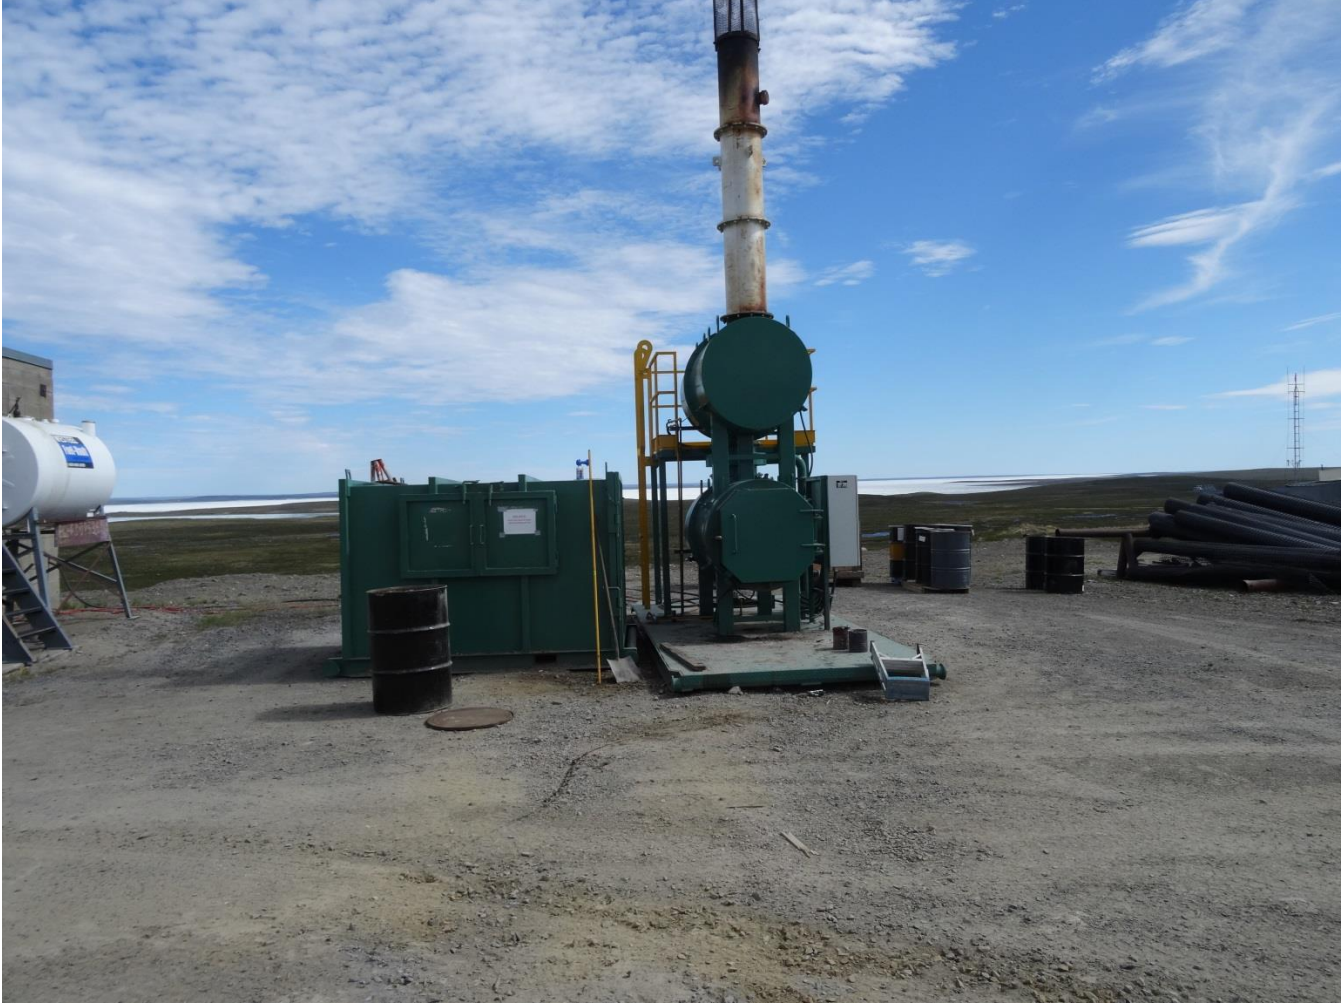
Photo 12

4. Incineration of Camp Food Waste (Photo 12) is done daily with a large Incinerator.
5. Potable Water is taken from the Contwoyto Lake Intake (Photos 13 and 14). LMI has recently emailed the writer a copy of Water Consumption Records showing they are well within allowable limits.
6. LMI has verbally told the writer that they and their Contractor, Nahanni, may try and complete the planned 2 year project in 1 year only.
7. The writer gave Nahanni verbal instructions to ensure all Signage for Sample Stations were In-Place before the writer’s next scheduled Inspection.

Description: Incinerator for Camp Food Waste

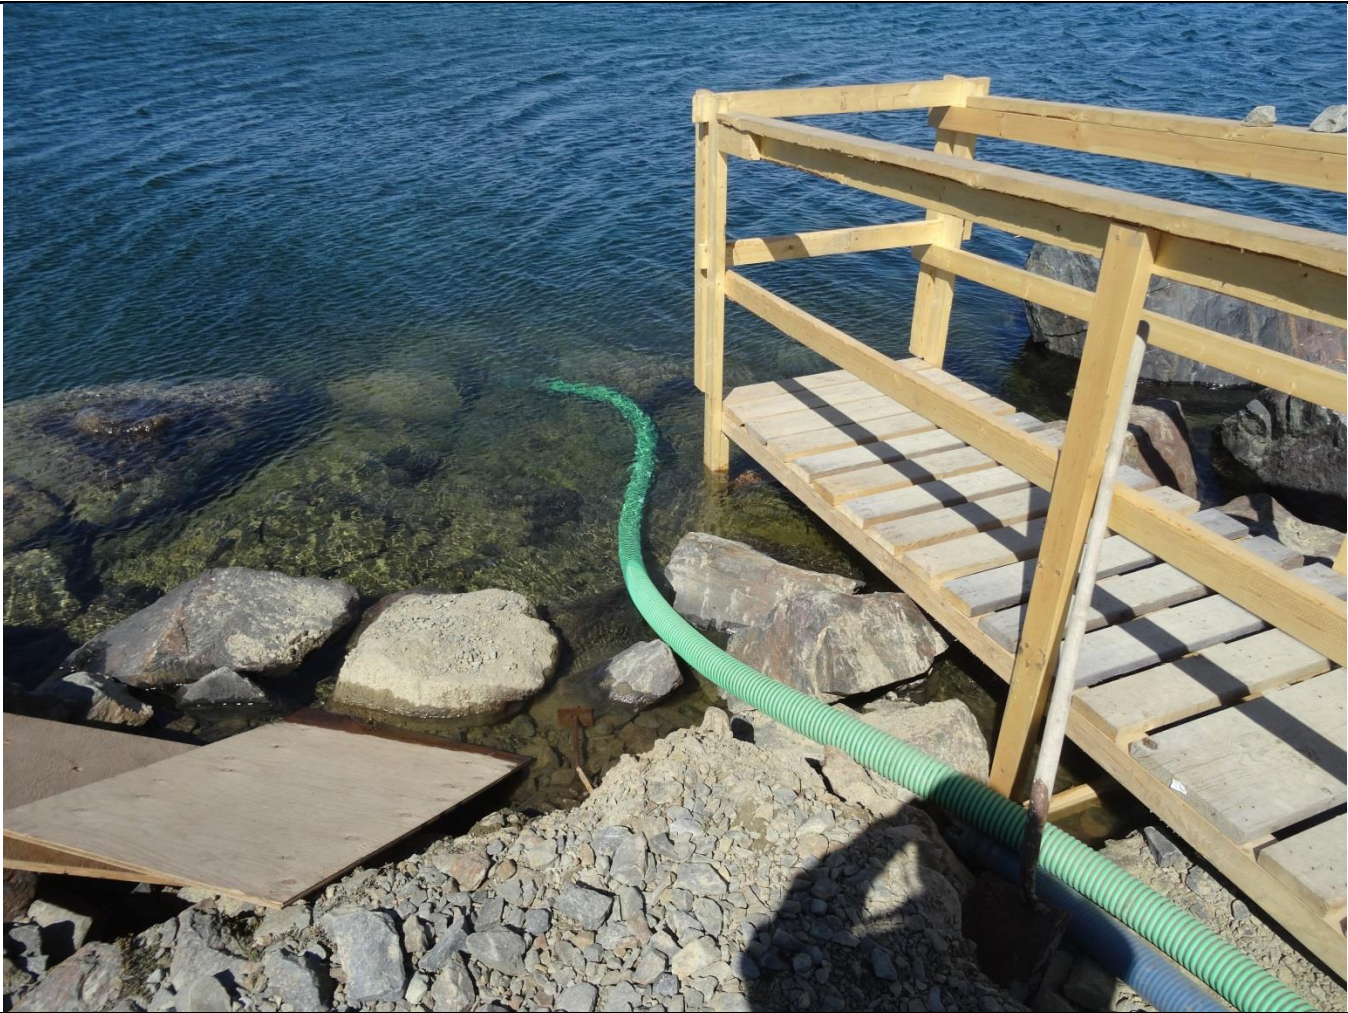
Photo 14

Description: Water Intake – View 2
