WATER LICENCE INSPECTION FORM

Licensee		Licensee Representative	
Lupin Mines Inc		Karyn Lewis	
Licence No. / Expiry		Representative's Title	
		Project Manager	
Land / Other Authorizations		Land / Other Authorizations	
2AM-LUP2032			
Date of Inspection		Inspector	
2020 August 27		Baba Pedersen	
Activities Inspected			
<input type="checkbox"/> Camp	<input type="checkbox"/> Drilling	<input type="checkbox"/> Mining	<input type="checkbox"/> Construction
<input type="checkbox"/> Roads/Hauling	<input type="checkbox"/> Other:	<input checked="" type="checkbox"/> Other: Reclamation Security	<input type="checkbox"/> Reclamation
<input type="checkbox"/> Fuel Storage

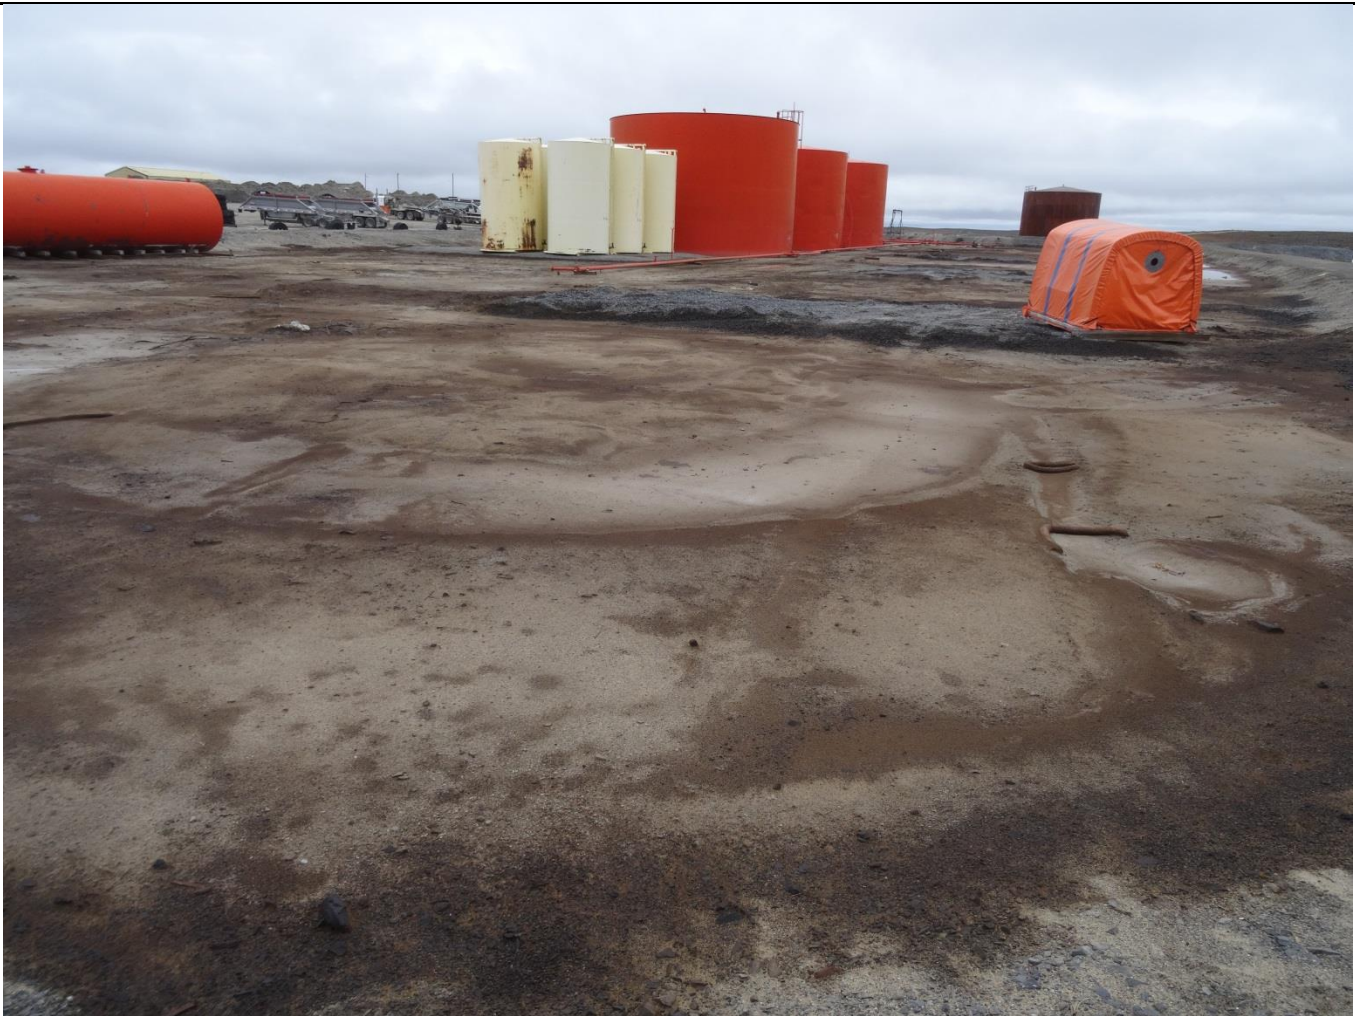
Photo 3

Tanks M-16, M-17, M-18, M-19, M-20, M-21 and M-22 have been Cleaned and Decommissioned, but remain Standing

The Main Pump Shack Remains in Place within the Tank Farm

Pump Station #1, Pump Station #2 and all associated Pipeline located just Outside the East Side of the Tank Farm have all been Cleaned, Dismantled and Placed in the Land Fill

Description: Main Tank Farm – View 1

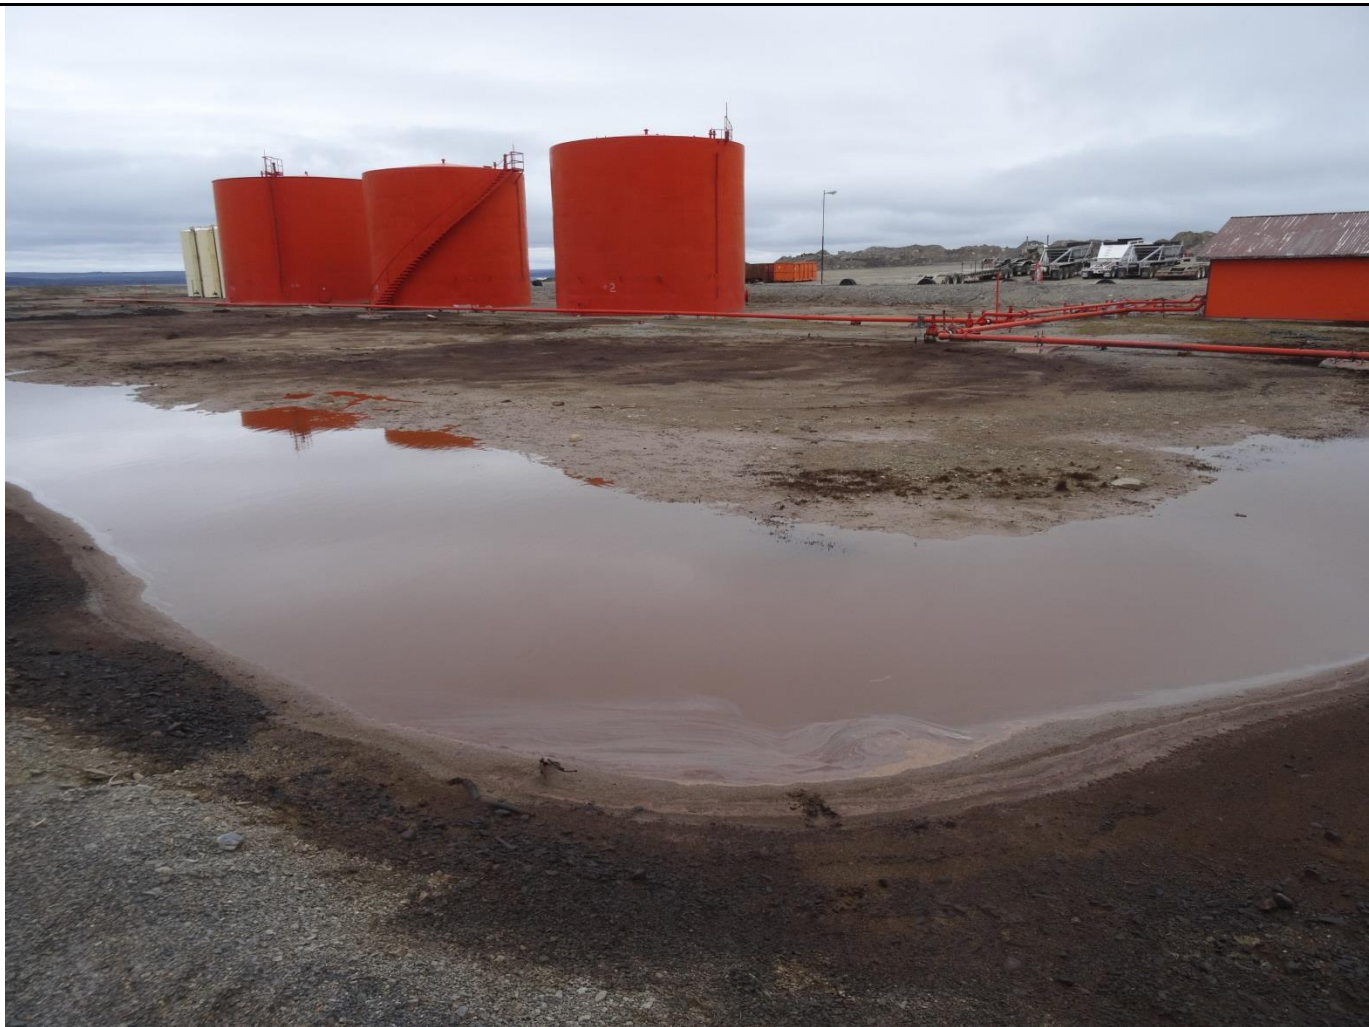
Photo 4

Description: Main Tank Farm – View 2

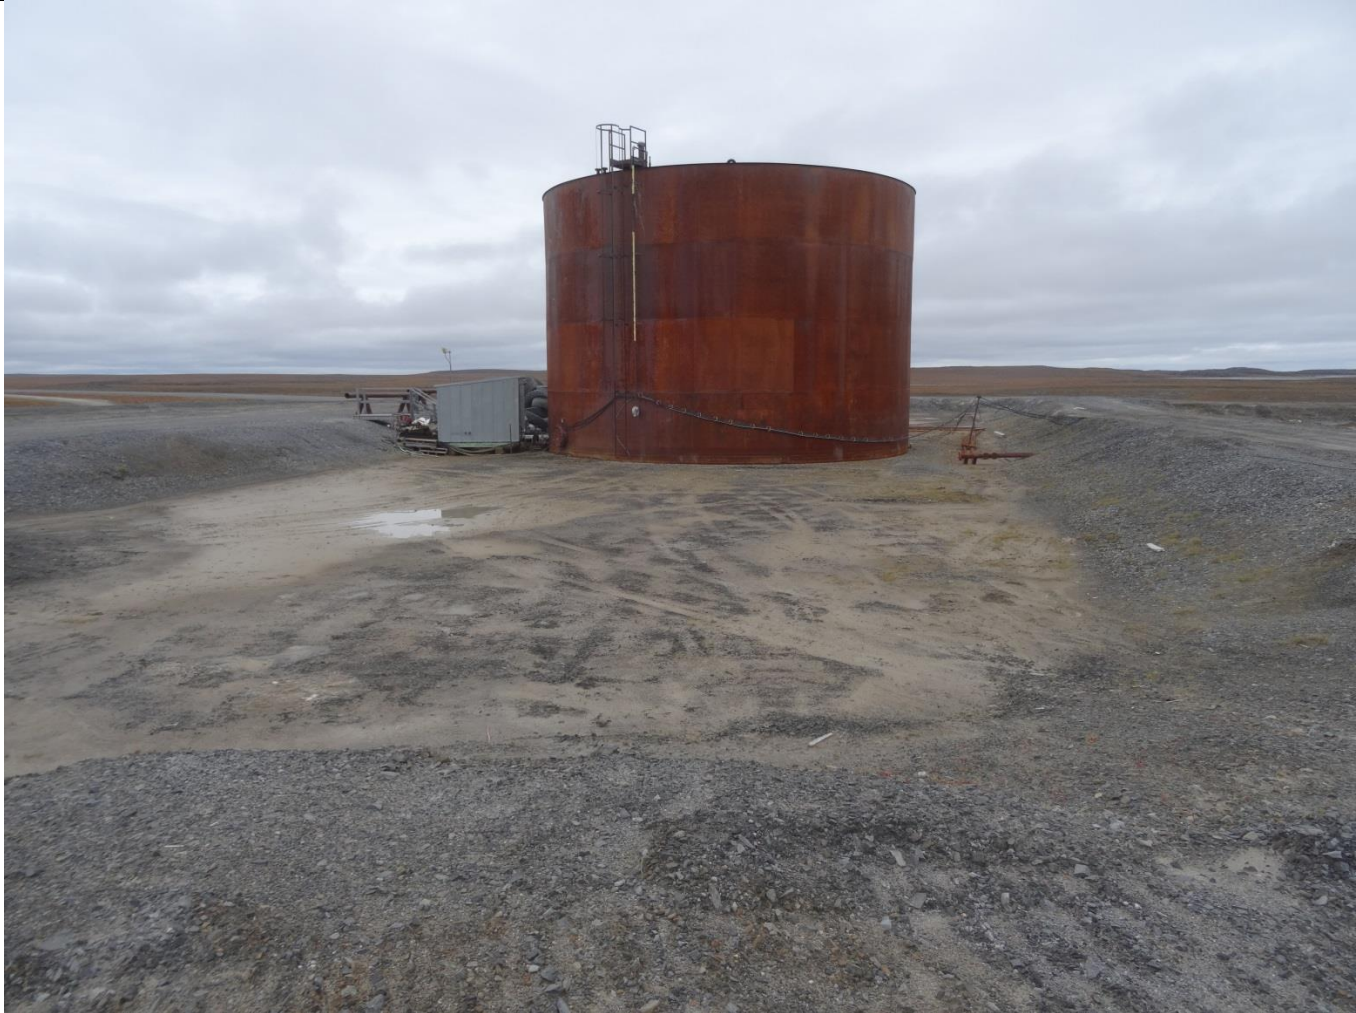
Photo 6

The M-14 Tank has been Cleaned, Dismantled and Placed in the Land Fill including it's associated Pipeline

The M-15 Tank is Still Standing and contains approximately 382,000 Ltrs of Jet-A Fuel, it,s associated Pipeline and Pump Station Remains in Place.

Description: Jet-A Tank Farm

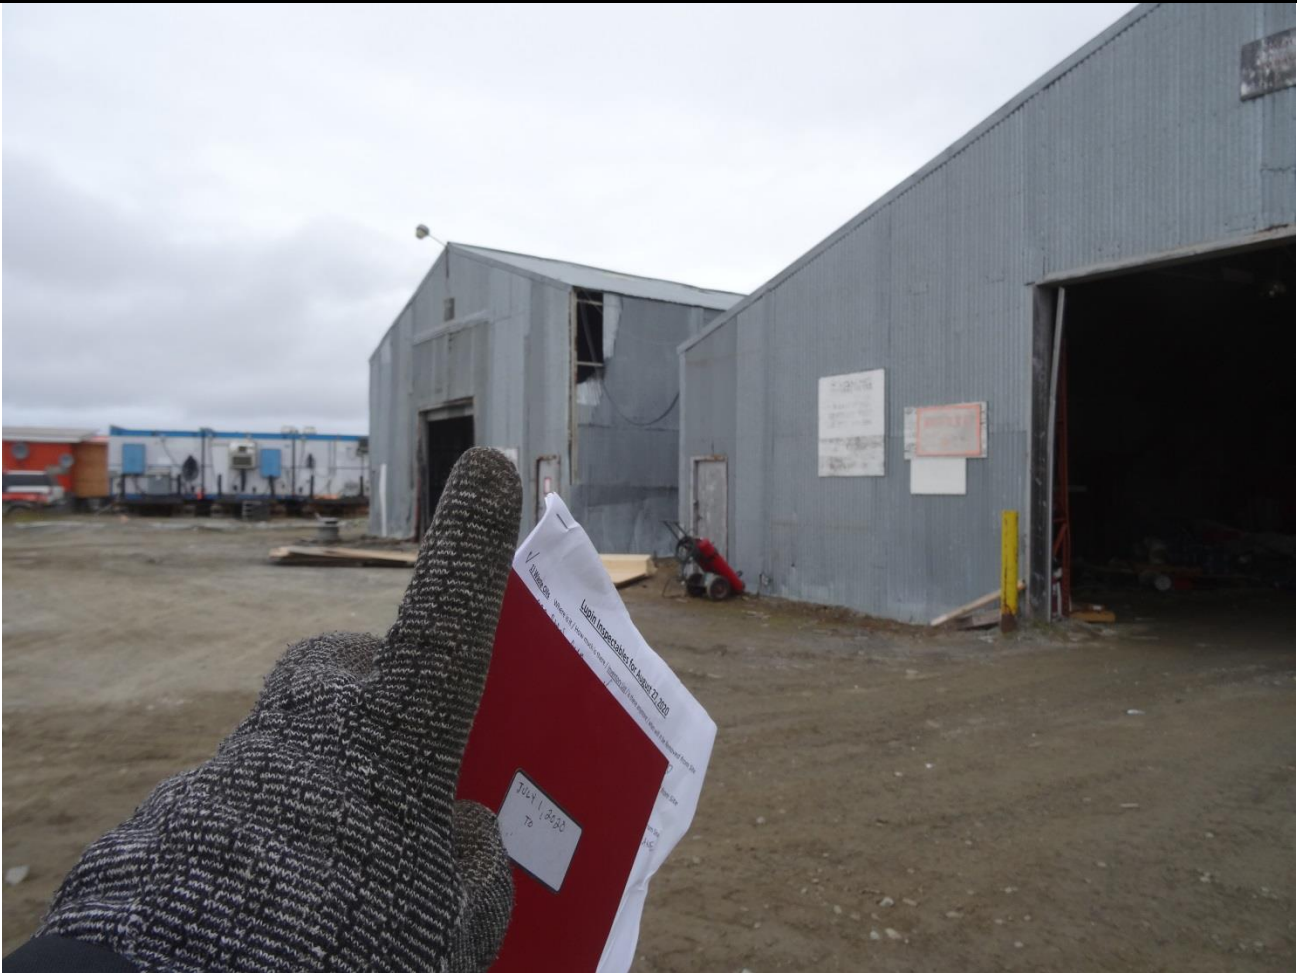
Photo 7

Is the Left Hand (North) Side of the 2 Buildings

This Building is still Standing and scheduled to be Demolished in 2021

Description: Cold Storage Building #1 – On Left Side

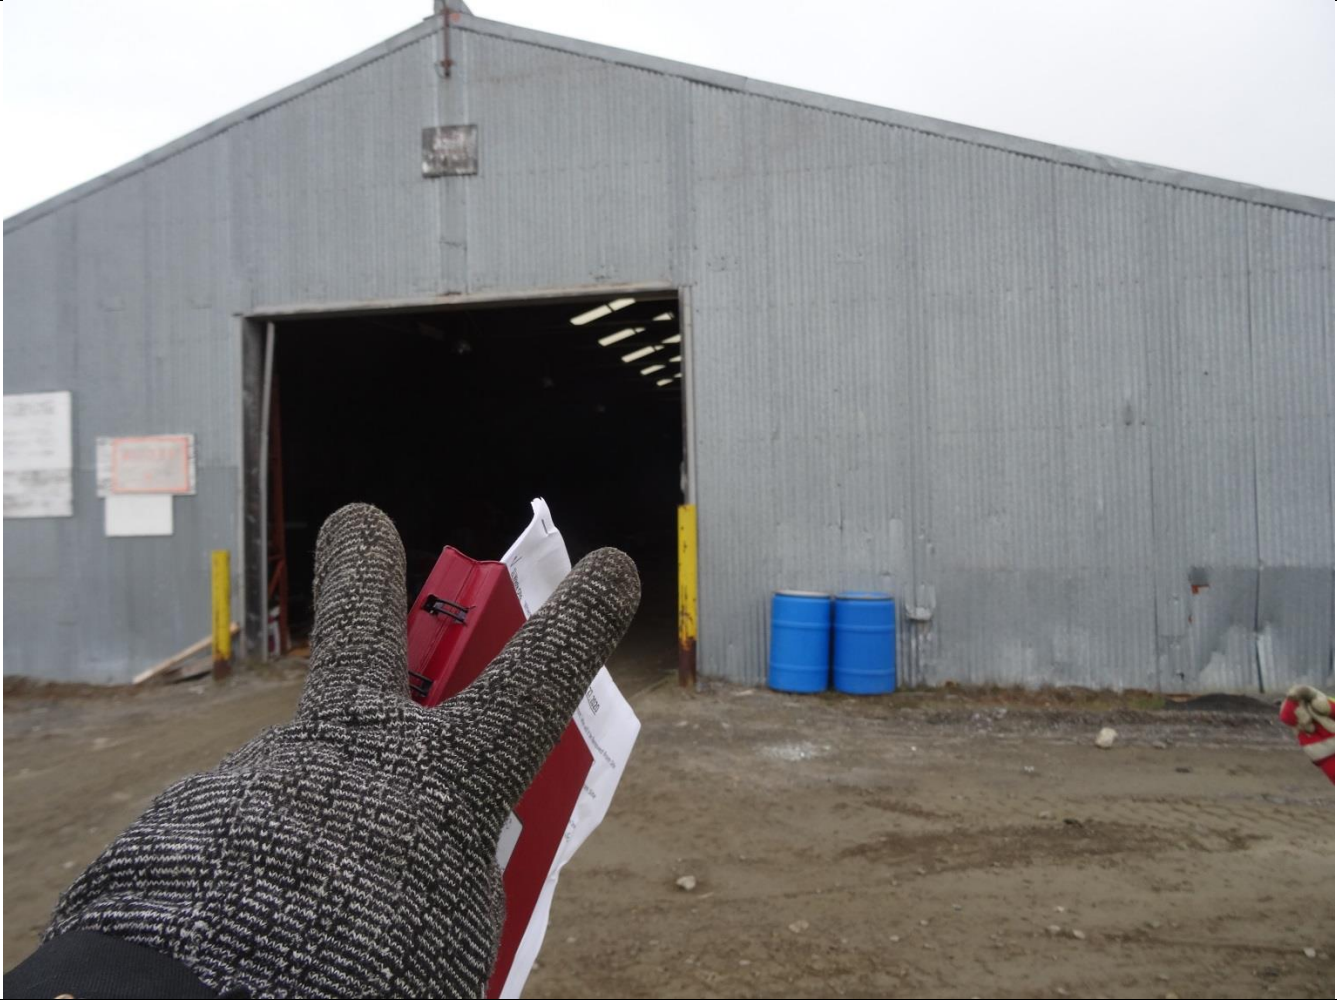
Photo 8

Is the Right Hand (South) Side of the 2 Buildings

This Building is still Standing and scheduled to be Demolished in 2021

Description: Cold Storage Building #2, aka #20 ATV Building

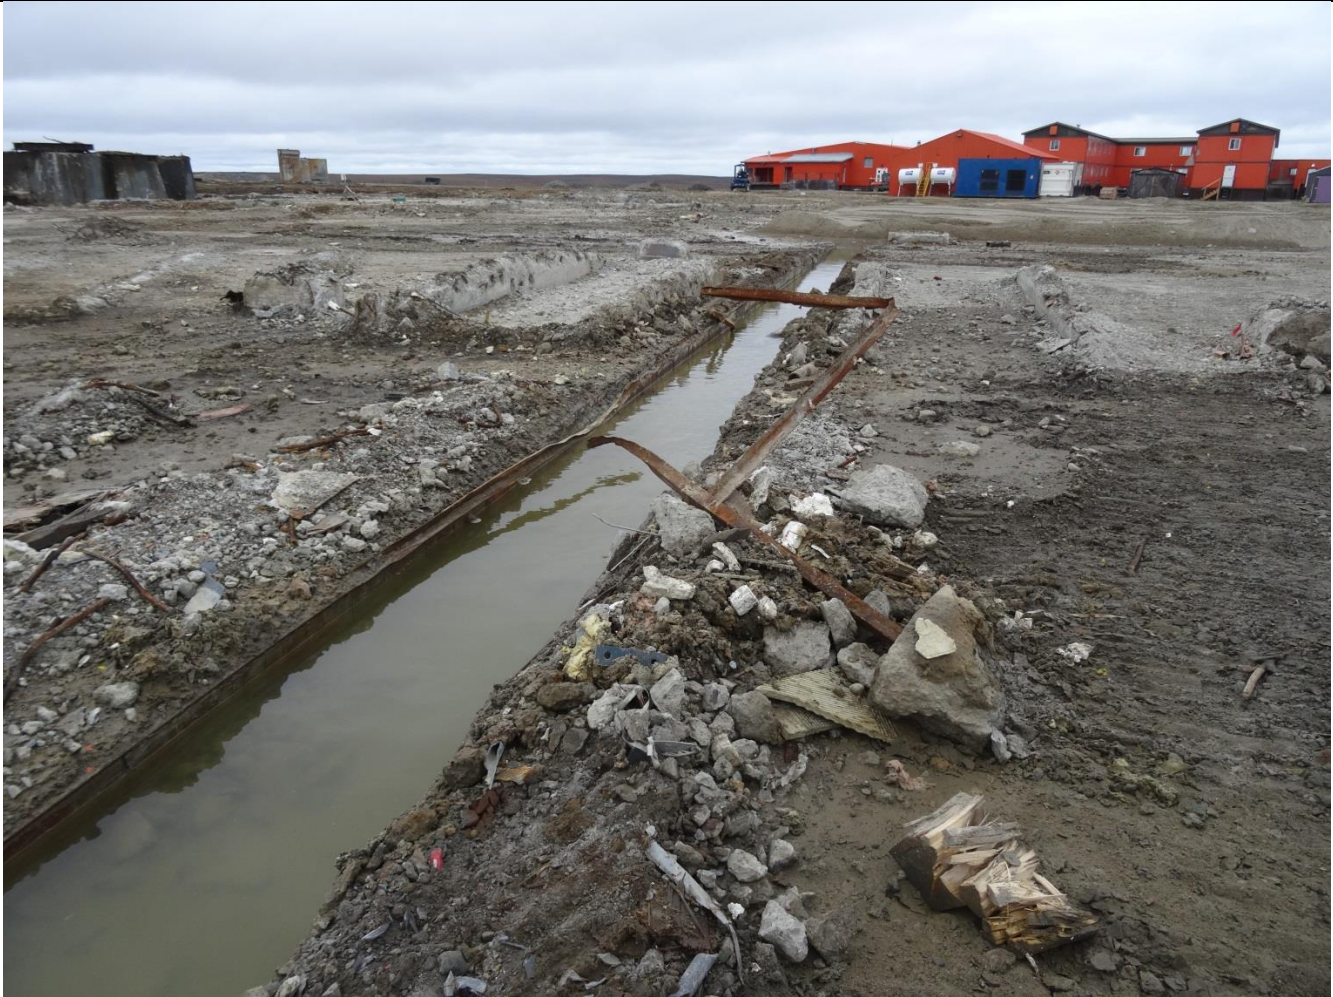
Photo 11

The Concrete Foundation, some Large Concrete Blocks and a Trench in the Concrete Foundation remain in place. The Trench is filled with water that requires draining.

Description: #11 Mill, View 2 – Trench requires Draining and Cover Material

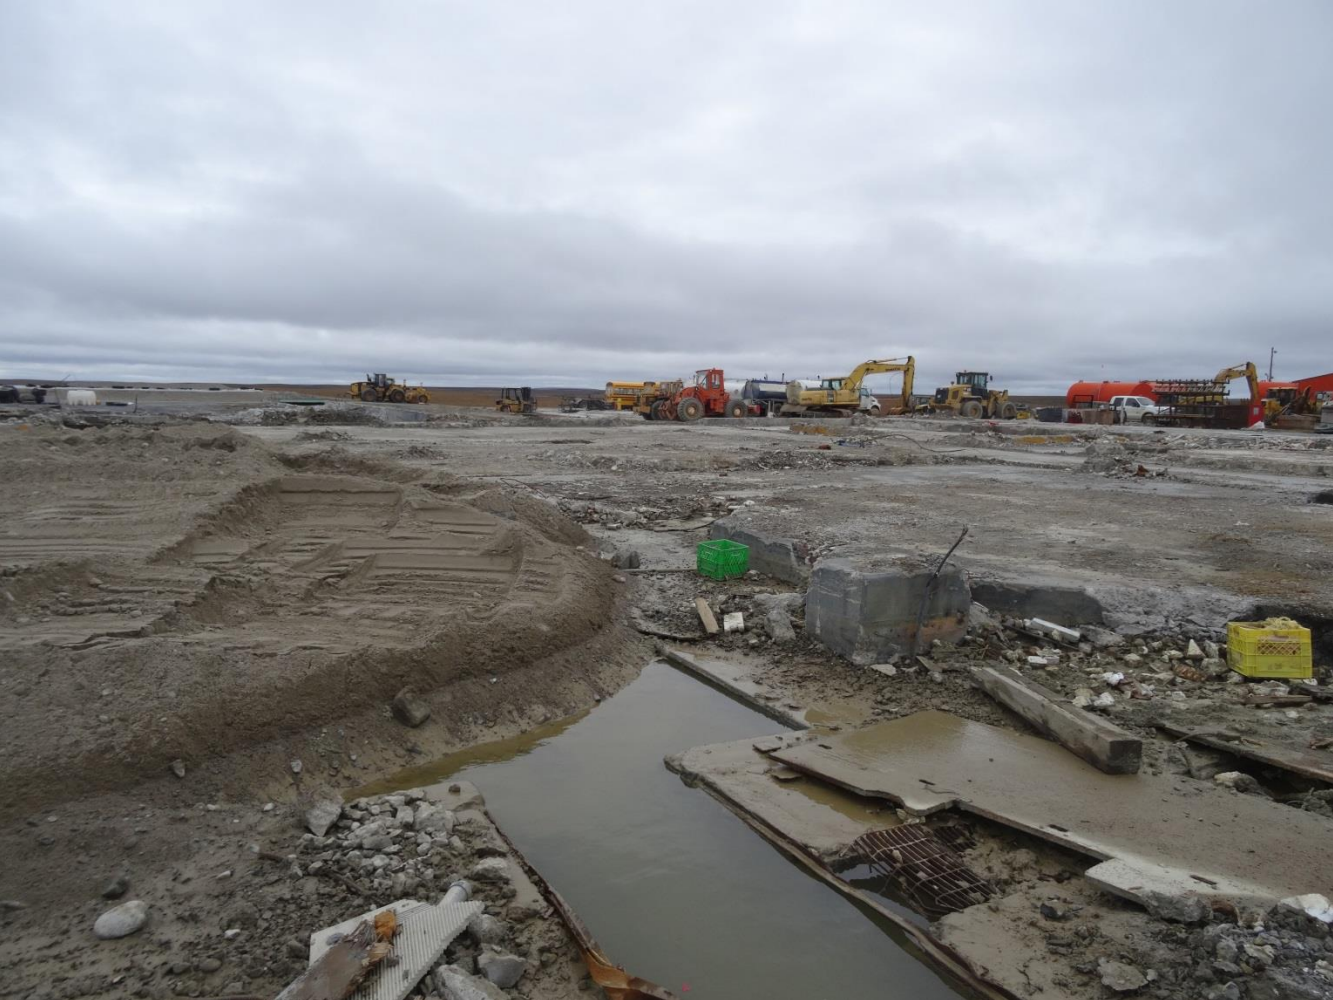
Photo 12

All Debris has been removed and placed in the Land Fill

The Concrete Foundation Remains in place

Description: #15 Carpenter Shop – Concrete Foundation Remains – All Debris has been Removed and Placed into the Land Fill

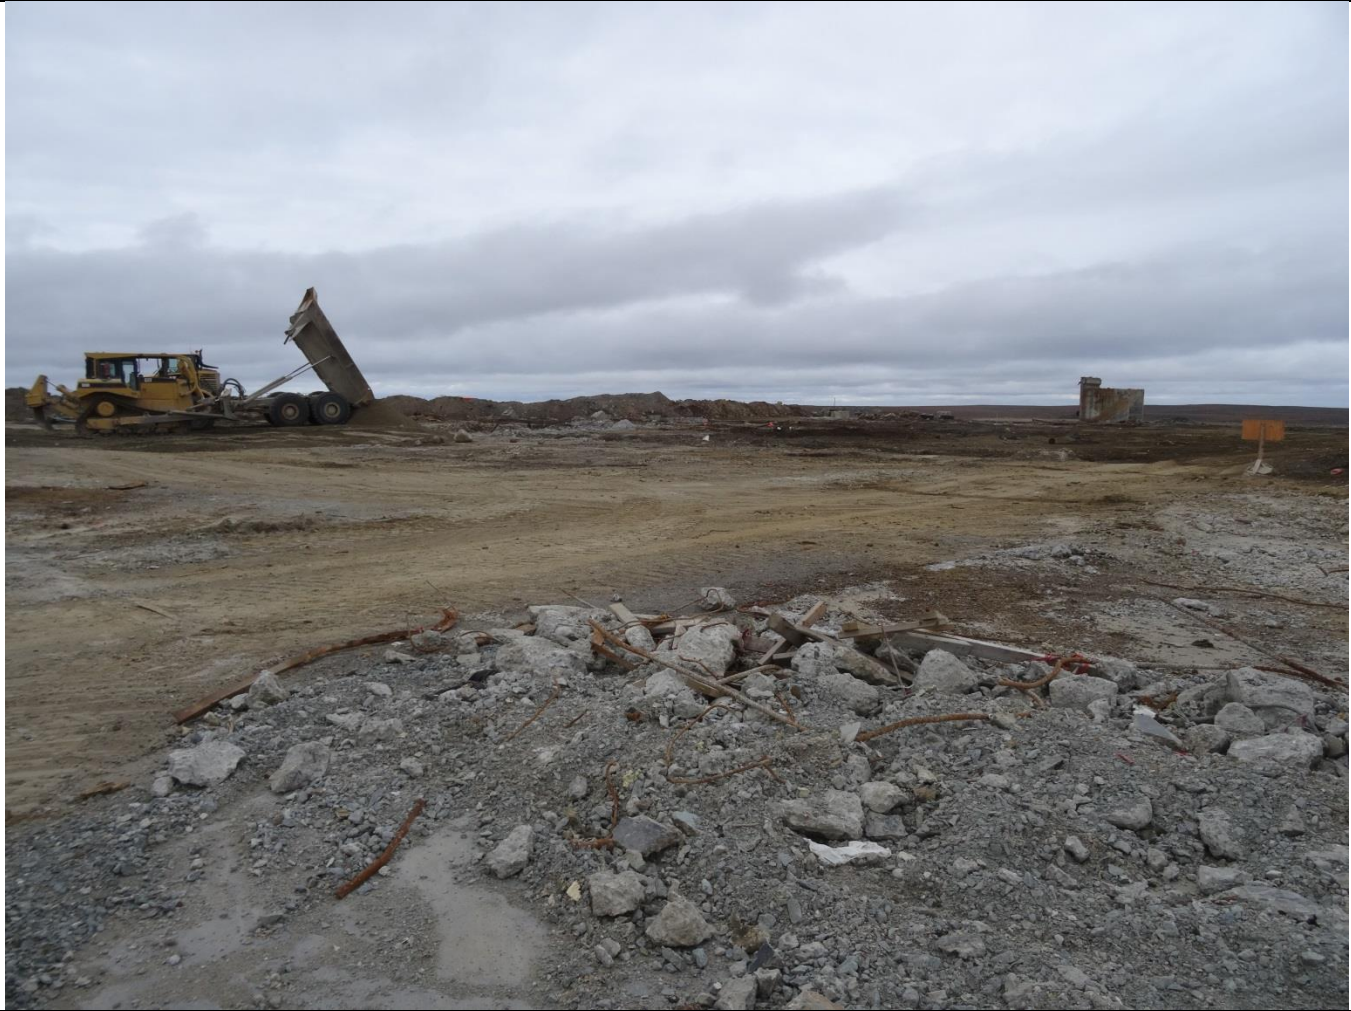
Photo 14

All Debris has been removed and placed in the Land Fill

Description: #8 Hoist Room – All Debris has been Removed and Placed into the Land Fill

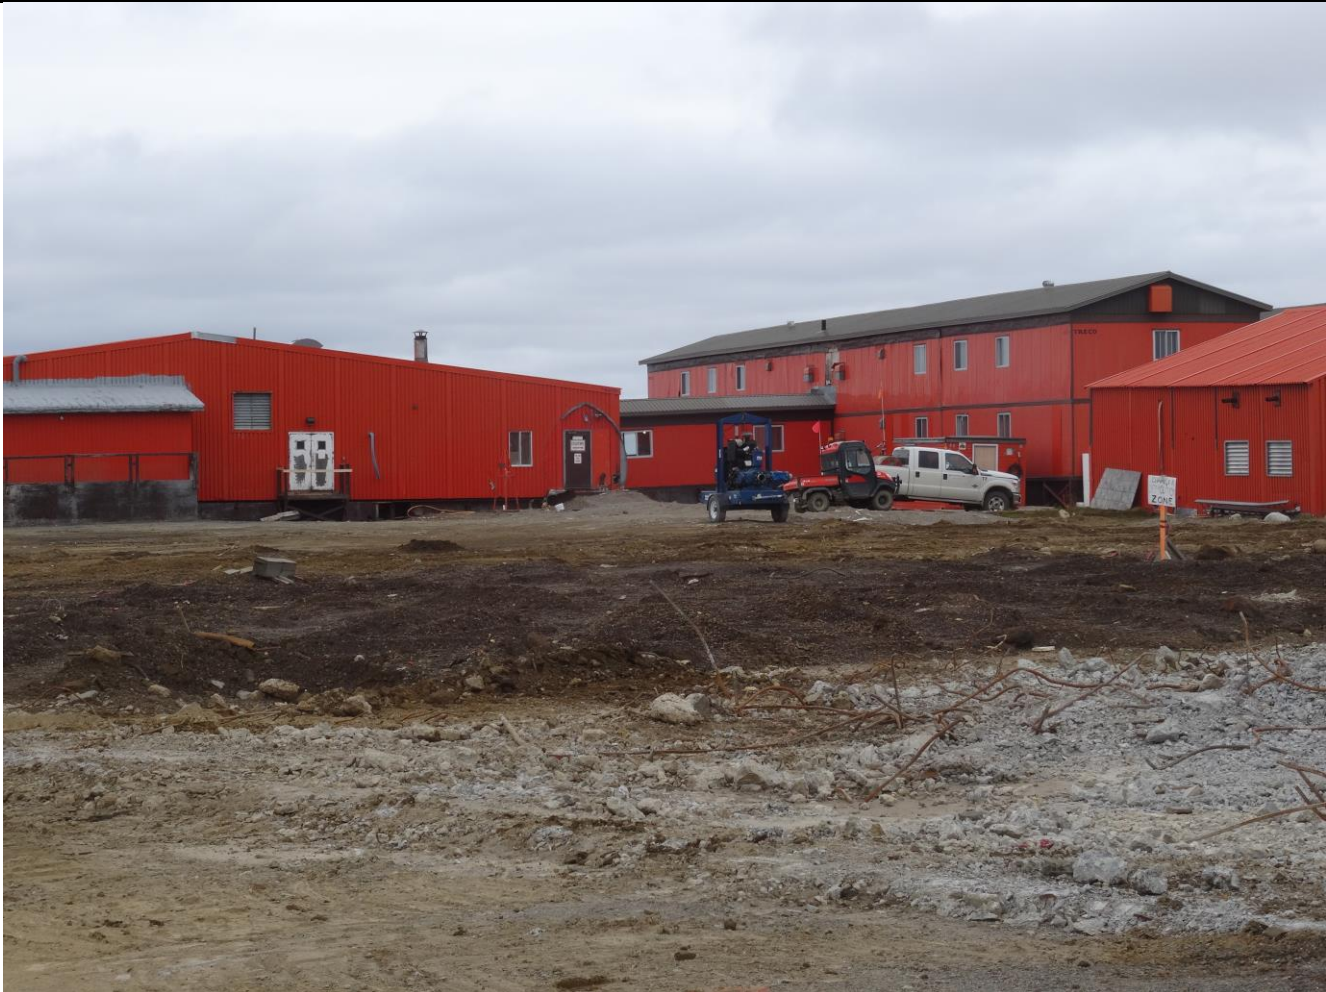
Photo 20

All Debris has been removed and placed in the Land Fill

This area has been covered in Sand

Description: #16 Fire House – Dark Sand Area in Foreground – All Debris has been Removed and Placed into the Land Fill

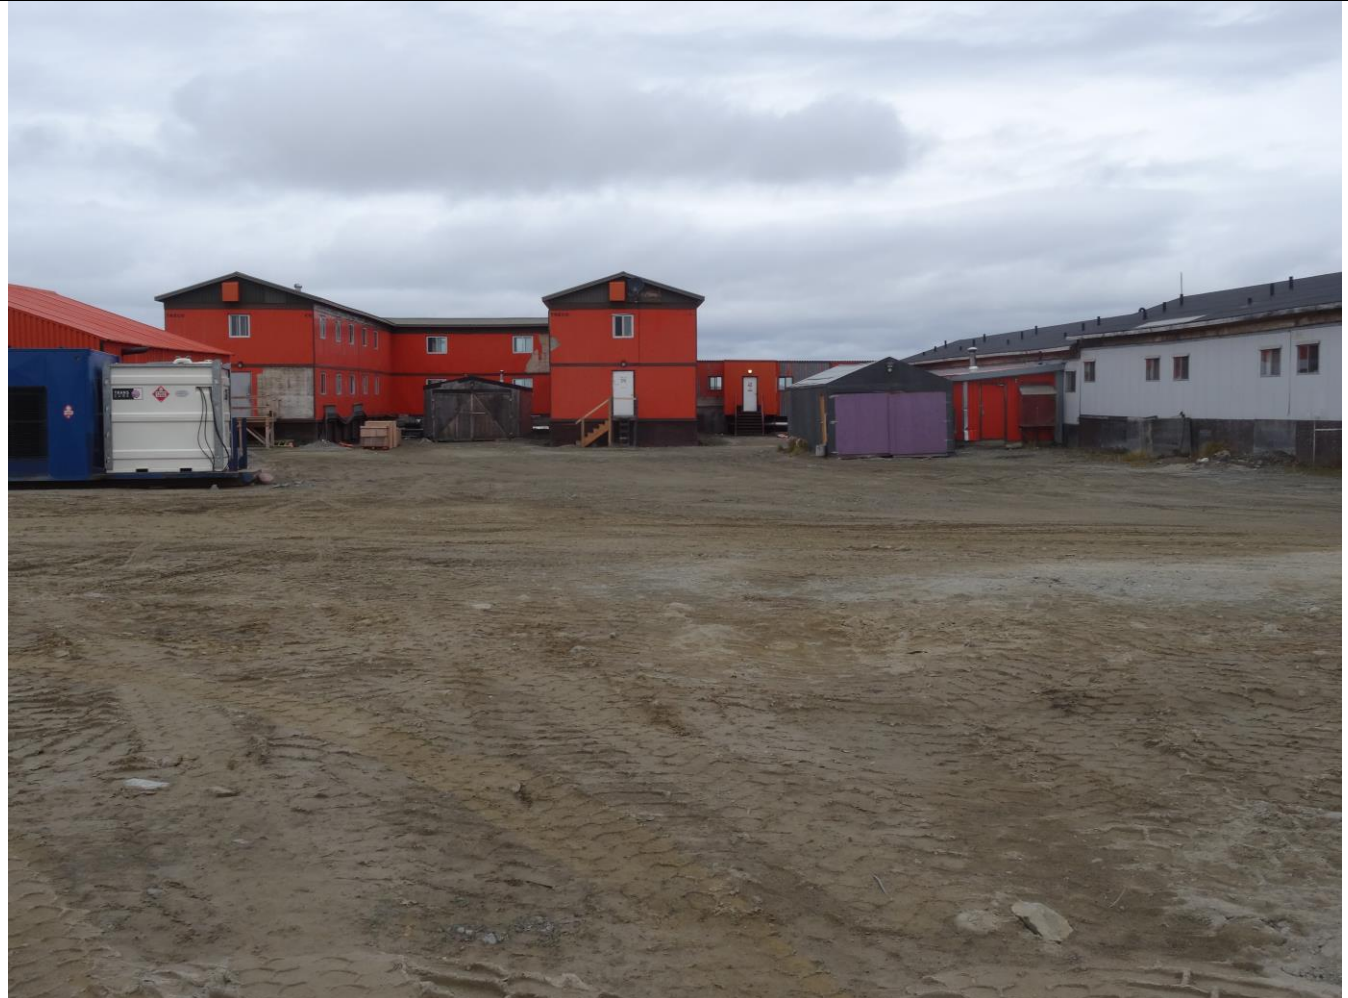
Photo 22

These Buildings are still Standing and scheduled to be Demolished in 2021

Description: 500/600/700/800 Dorm Complexes - Two 2-Storey Buildings in Background with Brown Roofs

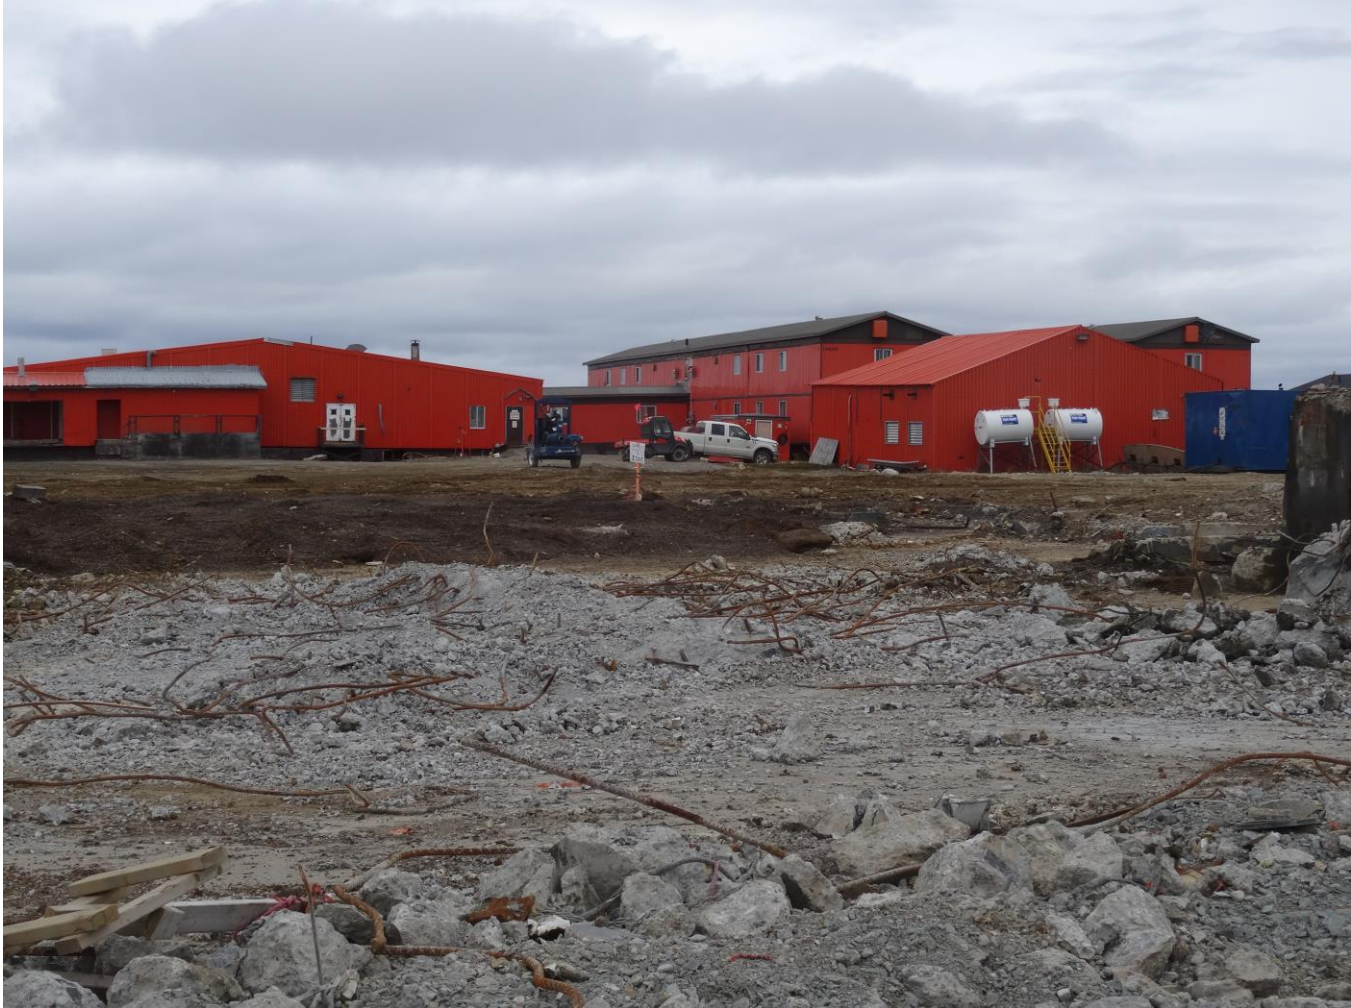
Photo 23

This Building is still Standing and scheduled to be Demolished in 2021

Description: Generator Building for 1300 Dorm – Building on Right with 2 White Fuel Tanks

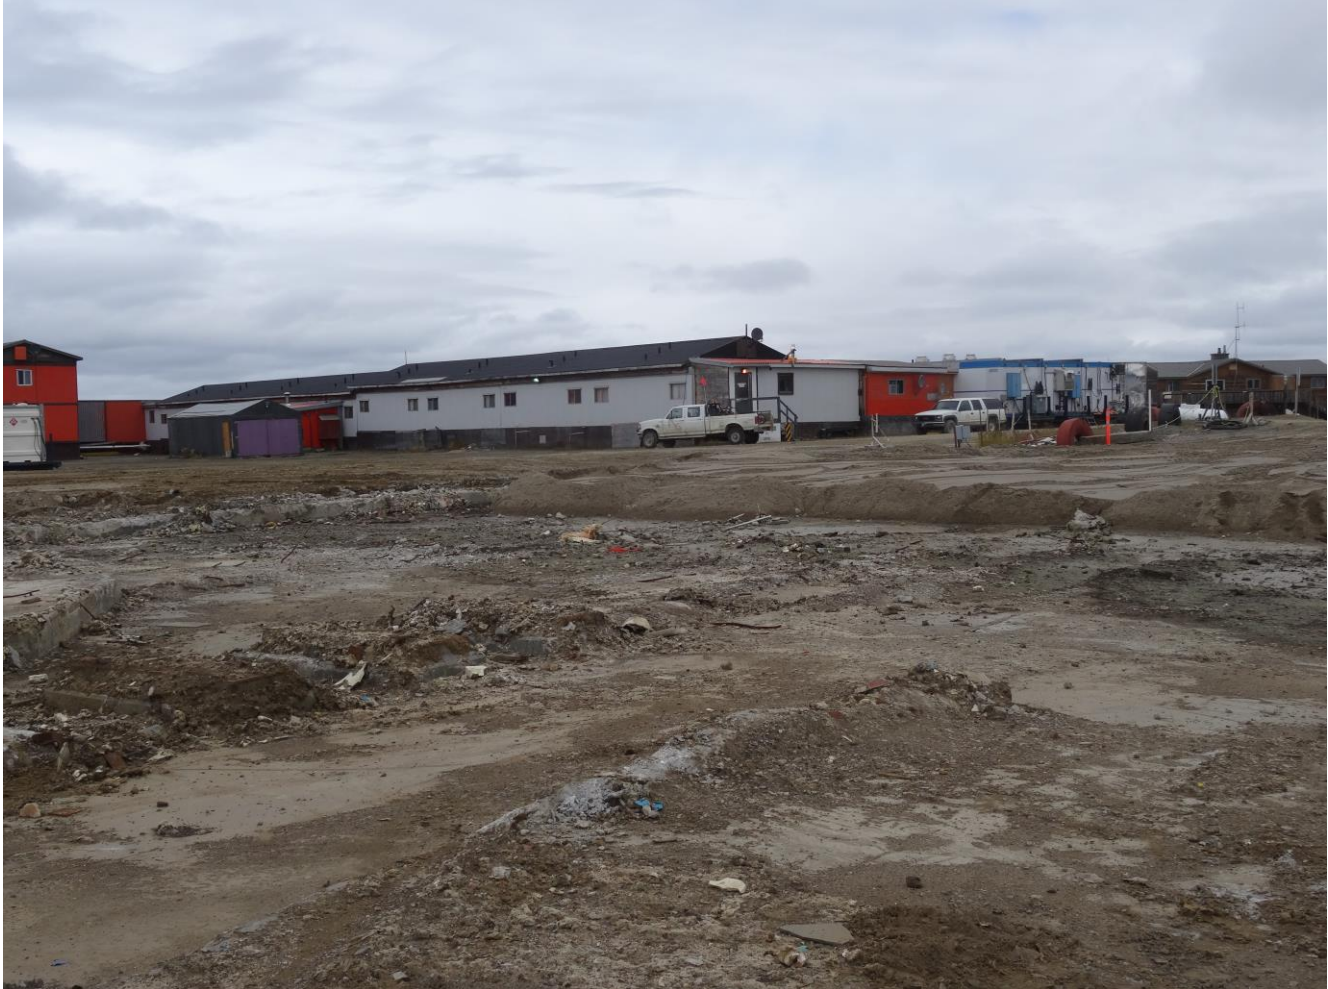
Photo 24

This Building is still Standing and scheduled to be Demolished in 2021

Description: 1300 Dorm Complex – White Building

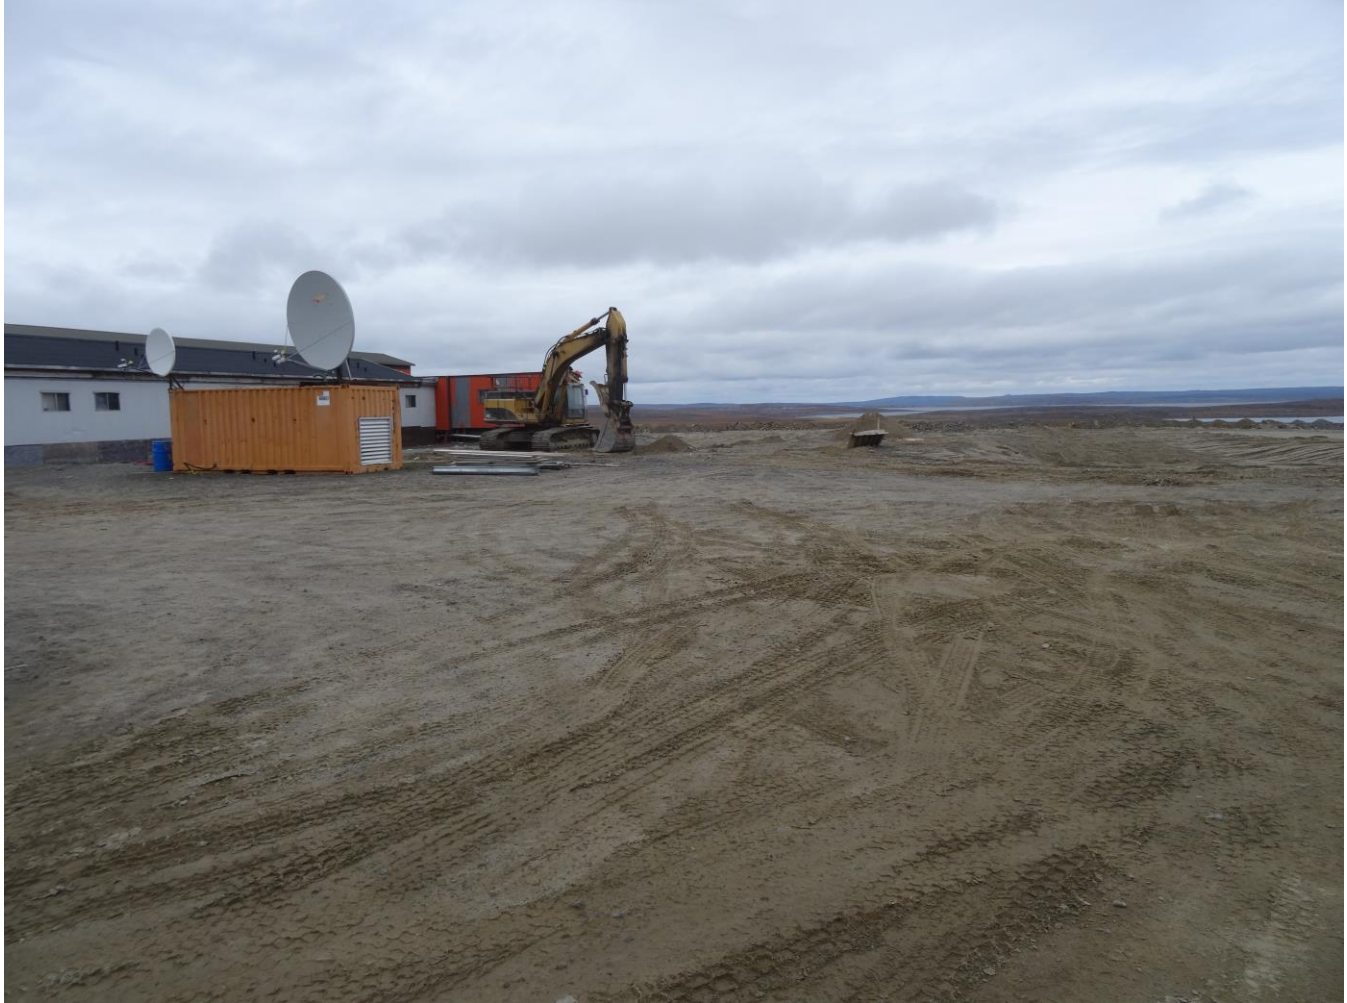
Photo 25

All Debris has been removed and placed in the Land Fill

This area has been covered with a Gravel Pad

Description: #4 900/1000/1100/1200 Dorm Complexes – All Debris Removed and placed into the Landfill

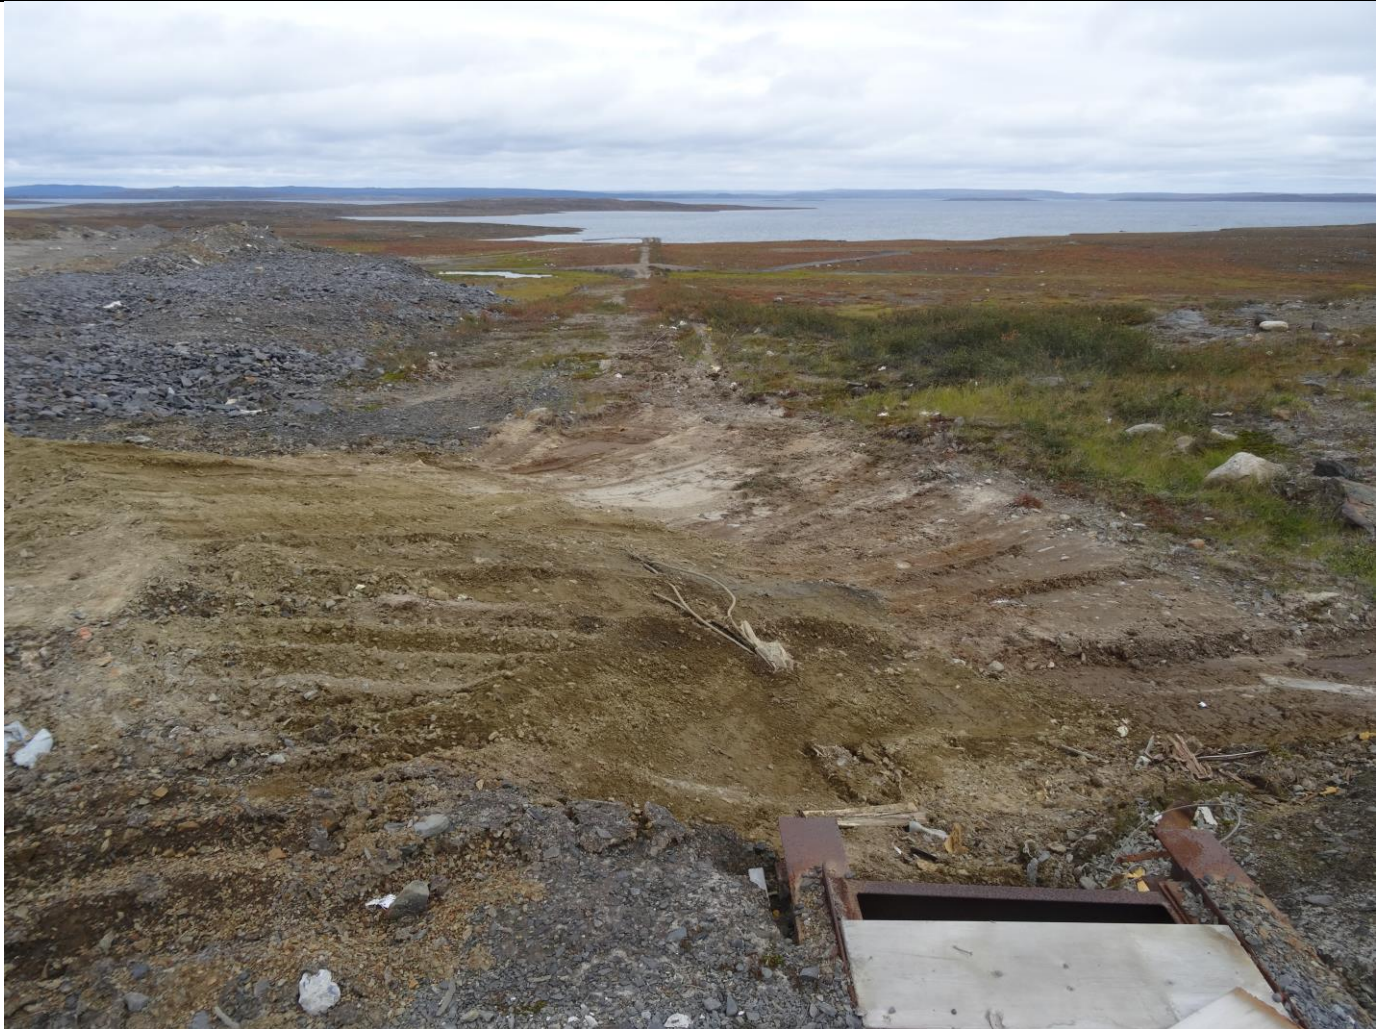
Photo 27

The Water Line has been removed from the Pump House at Contwoyto Lake up to the Log Guest House (approximately 90% of Line).

All Debris has been removed and placed in the Land Fill

Description: Water Line – From here all the way down to Contwoyto Lake in the Background – ALL Debris Removed into the Land Fill

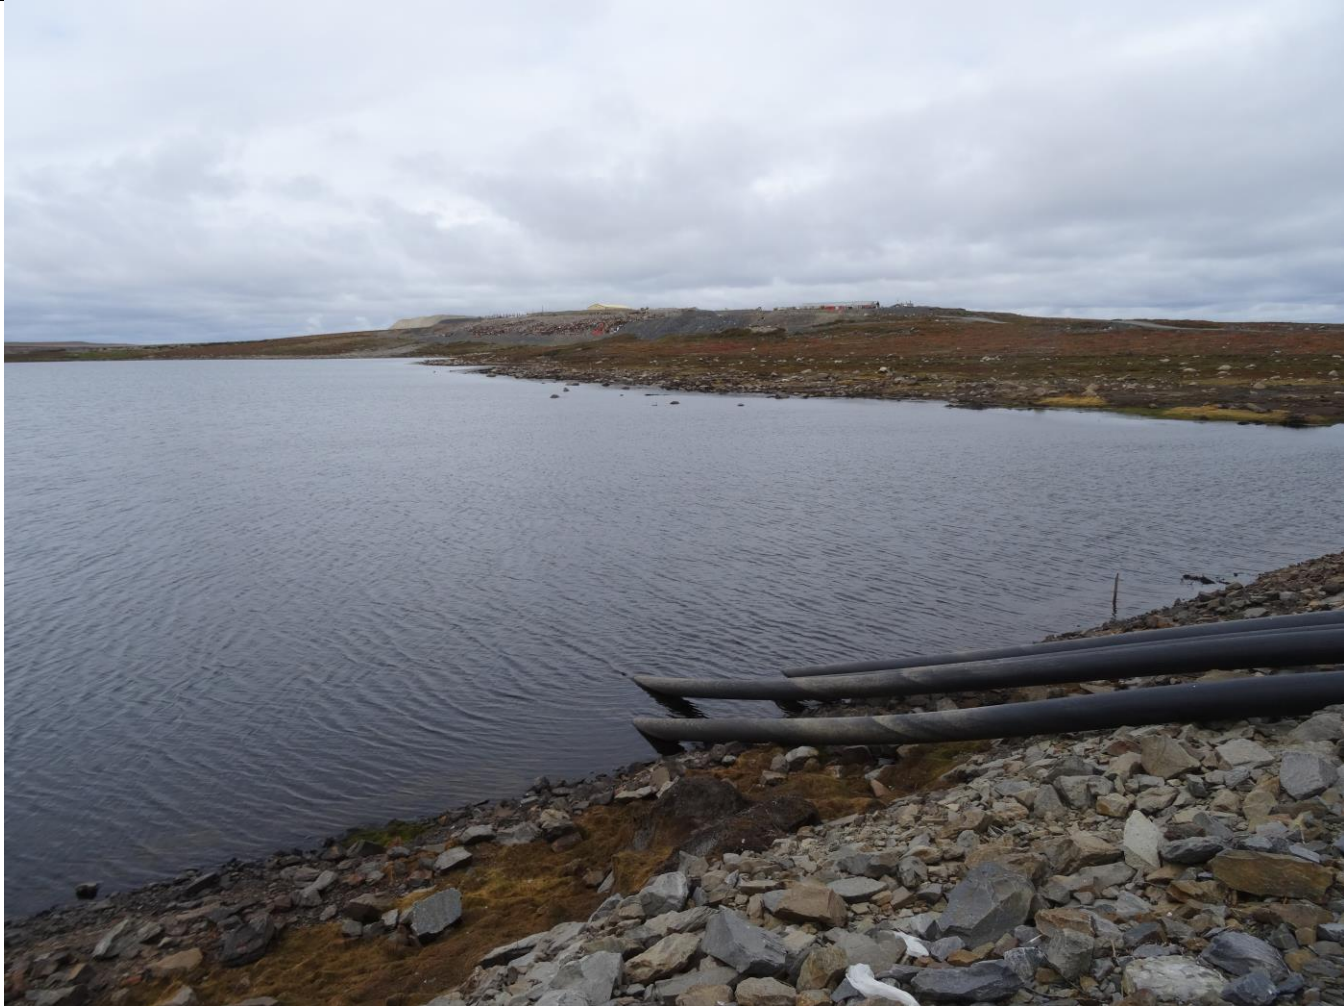
Photo 28

The Decant Program in the Lower Sewage Lagoon is almost complete with only 1 or 2 days left. The levels are the lowest I have ever seen with an estimated 4 meters of Freeboard. After completion, they will then start Decanting the Upper Sewage Lagoon into the Lower Section

Description: Lower Sewage Lagoon

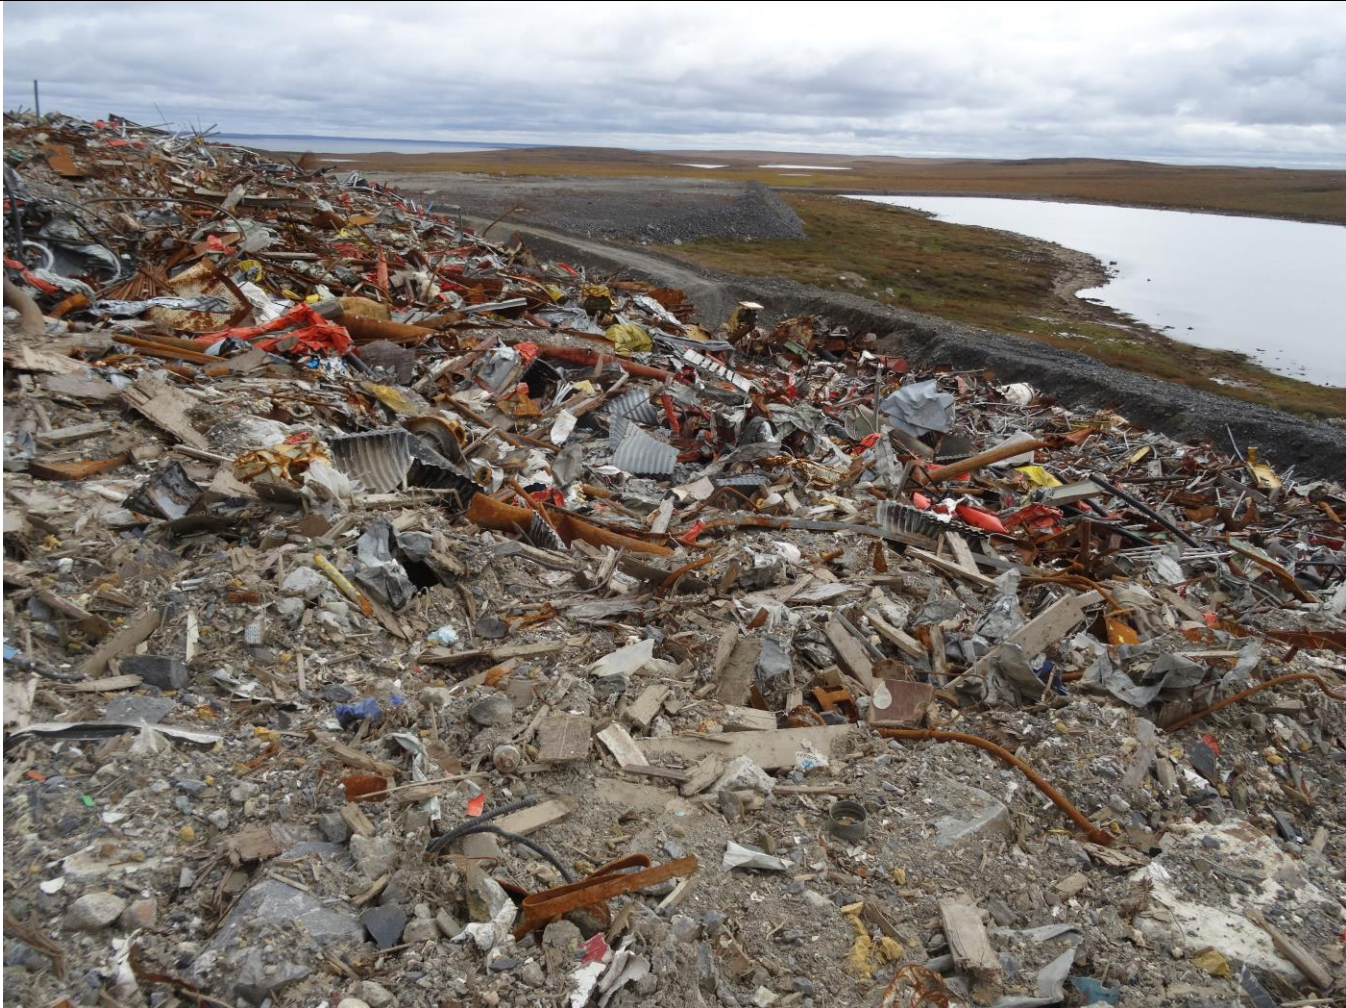
Photo 31

The Land Fill area is actively being used and filled up. I walked and viewed the area from the Bottom, Middle Level and the Top. Nahanni is compacting the material as they go by “Track Packing” with the Excavator and Bulldozer  
The Debris is piled in Lifts/Layers that are between 4 and 5 meters thick  
They have put a 2 meter layer of Gravel as an Intermediate Fill between the Lifts/Layers of Debris  
The Final Cover of Gravel will be a minimum of 2 meters thick when completed  
The completed Land Fill will have a 4 to 1 Slope down towards the Lower Sewage Lagoon

Description: Land Fill – Top View
