WATER LICENCE INSPECTION FORM

Licensee		Licensee Representative	
Lupin Mines Inc		Karyn Lewis	
Licence No. / Expiry		Representative's Title	
		Project Manager	
Land / Other Authorizations		Land / Other Authorizations	
2AM-LUP2032			
Date of Inspection		Inspector	
2020 August 27		Baba Pedersen	
Activities Inspected			
<input type="checkbox"/> Camp	<input type="checkbox"/> Drilling	<input type="checkbox"/> Mining	<input type="checkbox"/> Construction
<input type="checkbox"/> Roads/Hauling	<input type="checkbox"/> Other:	<input checked="" type="checkbox"/> Other: Reclamation Security	<input type="checkbox"/> Reclamation
<input type="checkbox"/> Fuel Storage

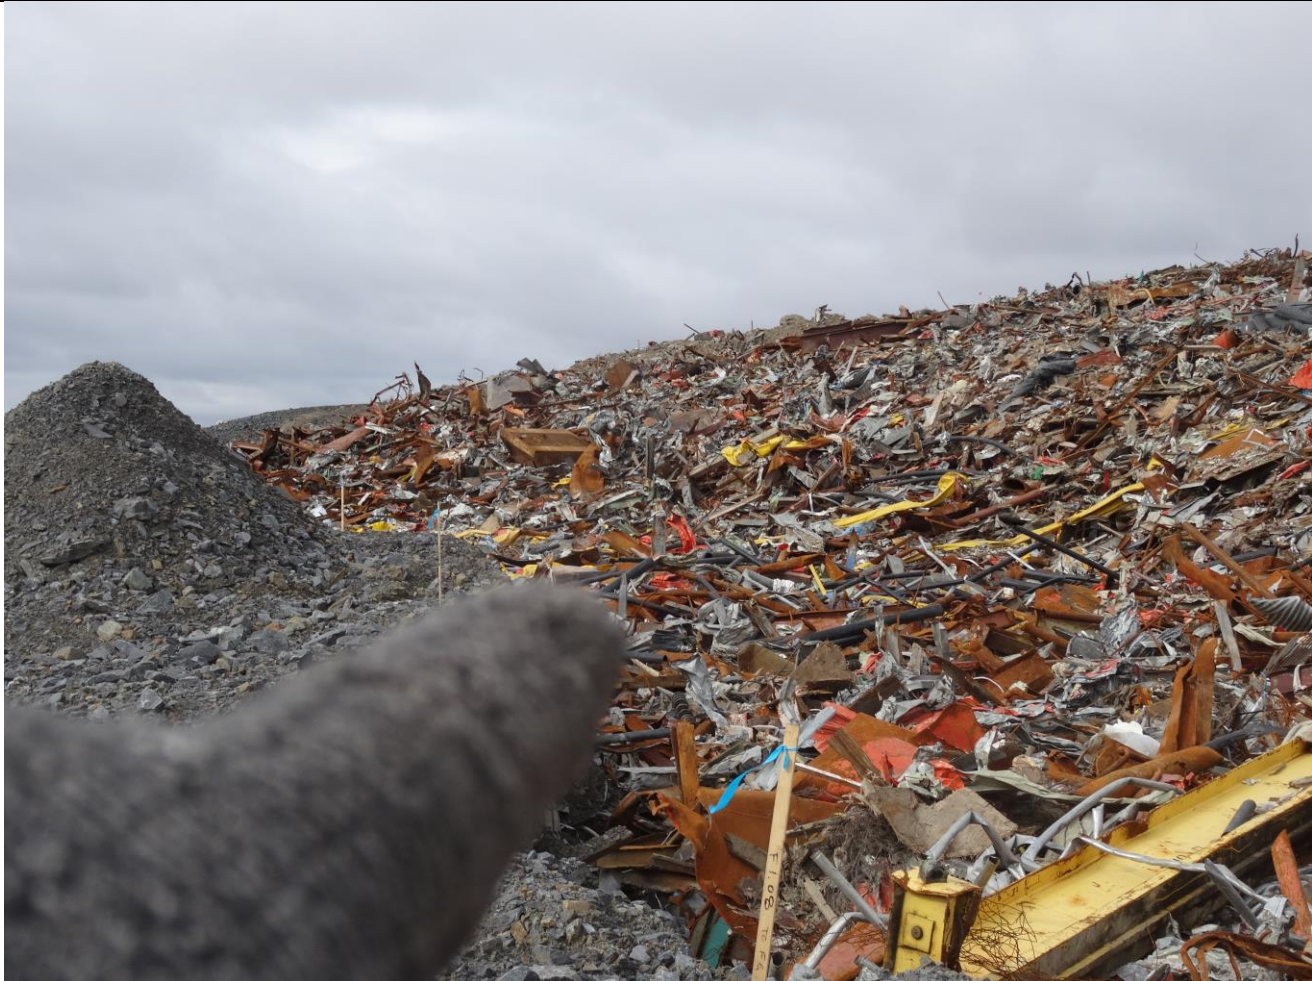
Photo 32

All Asbestos has already been cleaned up and Buried under the Land Fill Area and covered with 3 meters of Gravel  
Approximate location is under the large brown box in the center of the picture  
Nahanni has provided a detailed Inventory List of this previously

Description: Asbestos Burial Pit– Approximate Location is under the large Brown Box in the Center of the Picture
