WATER LICENCE INSPECTION FORM

Licensee		Licensee Representative	
Lupin Mines Incorporated		Dave Hohnstein & Dave Vokey	
Licence No. / Expiry		Representative's Title	
2AM-LUP2032			
Land / Other Authorizations		Land / Other Authorizations	
Date of Inspection		Inspector	
2021 June 24		Baba Pedersen	
Activities Inspected			
<input checked="" type="checkbox"/> Camp	<input type="checkbox"/> Drilling	<input type="checkbox"/> Mining	<input type="checkbox"/> Construction
<input type="checkbox"/> Roads/Hauling	<input type="checkbox"/> Other:	<input type="checkbox"/> Other:	<input checked="" type="checkbox"/> Reclamation
			<input checked="" type="checkbox"/> Fuel Storage

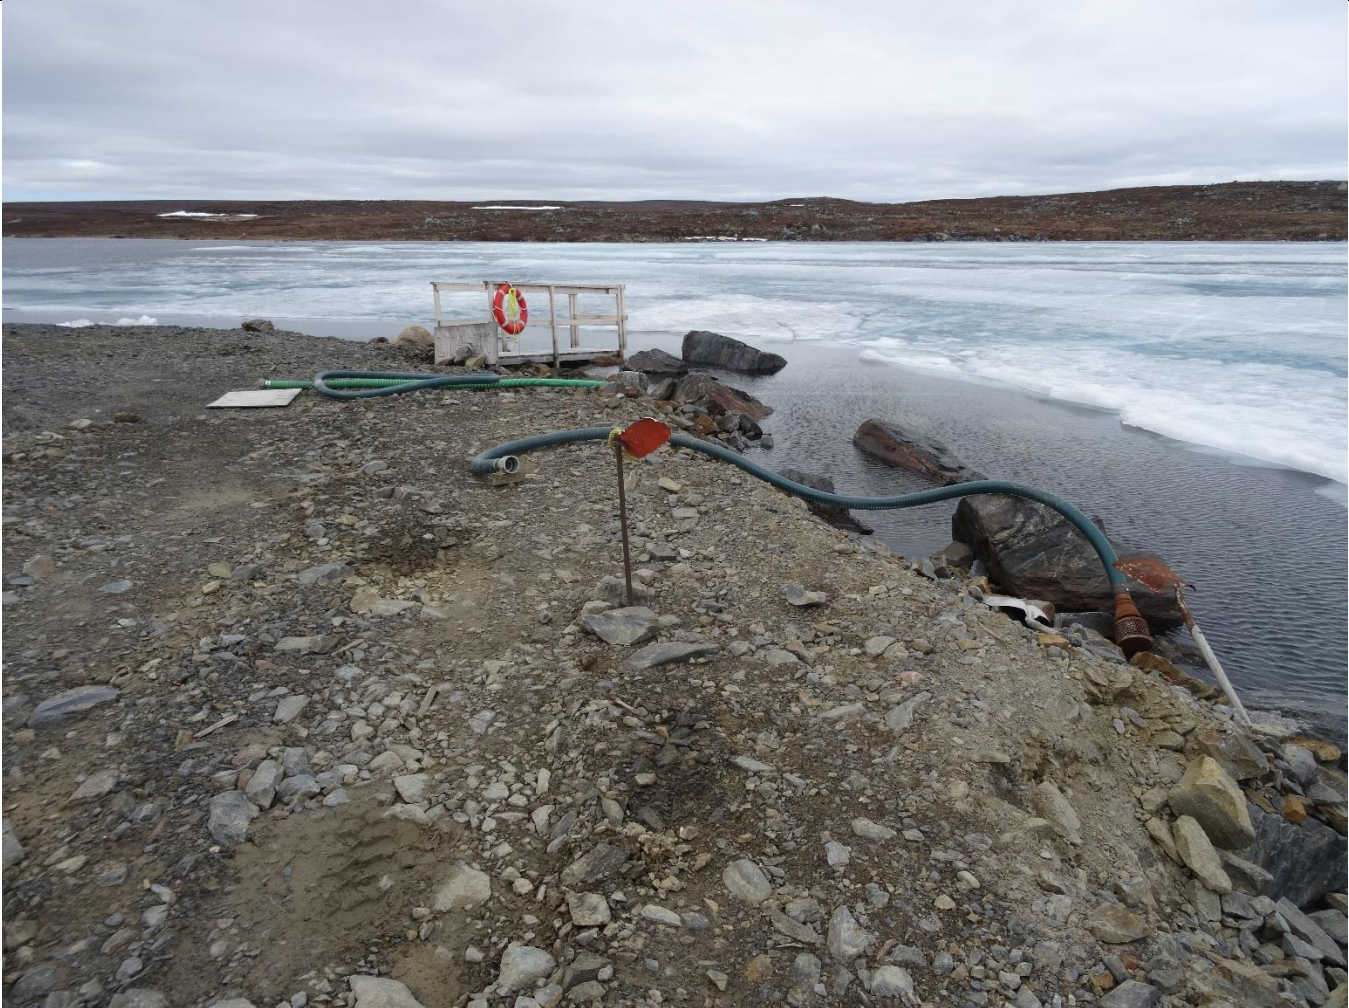
Photo 1

Description: LUP-01 Water Intake Location on Contwoyto Lake

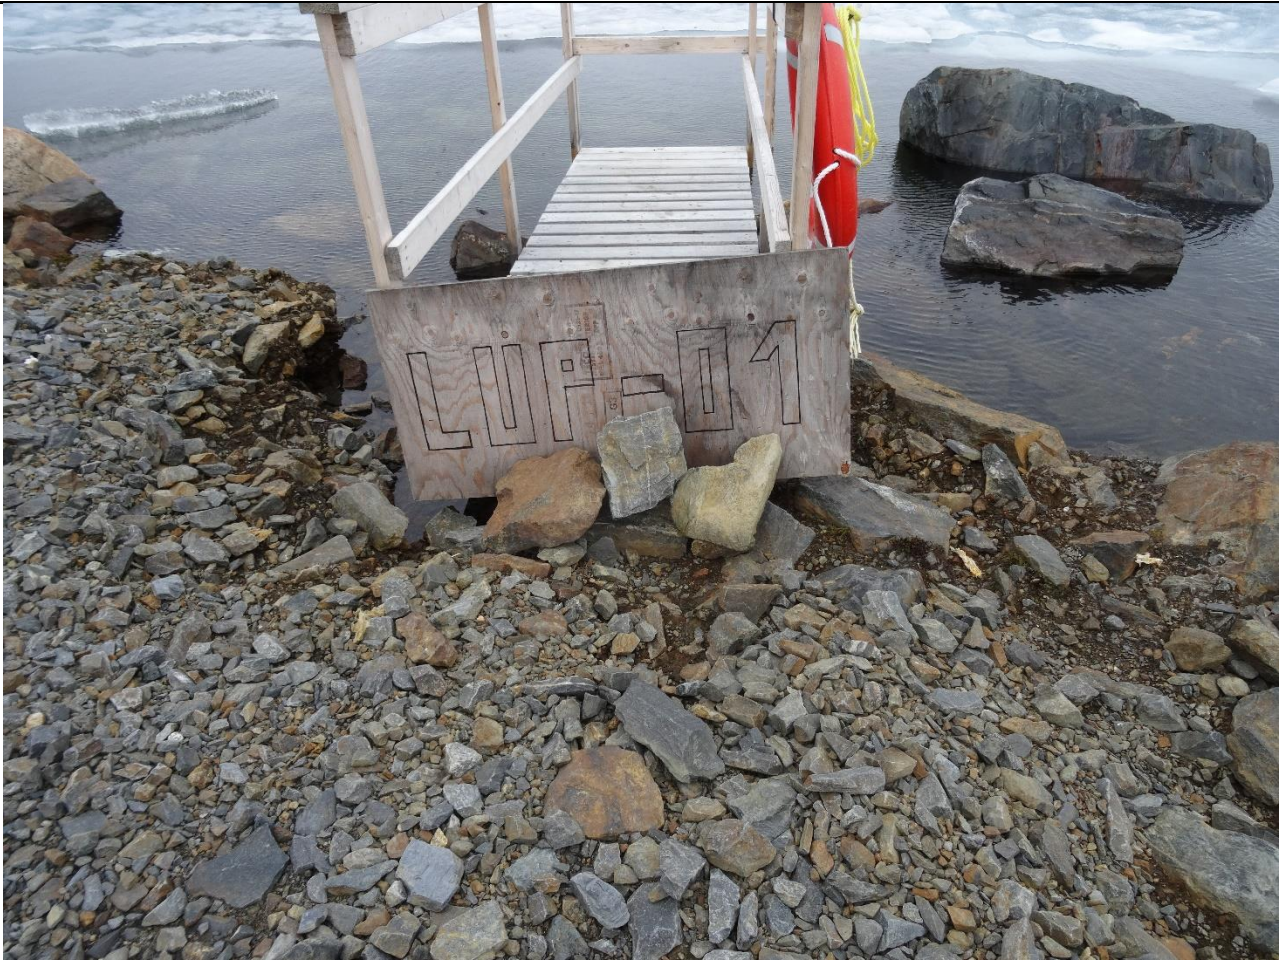
Photo 2

Description: LUP-01 Water Intake Location on Contwoyto Lake

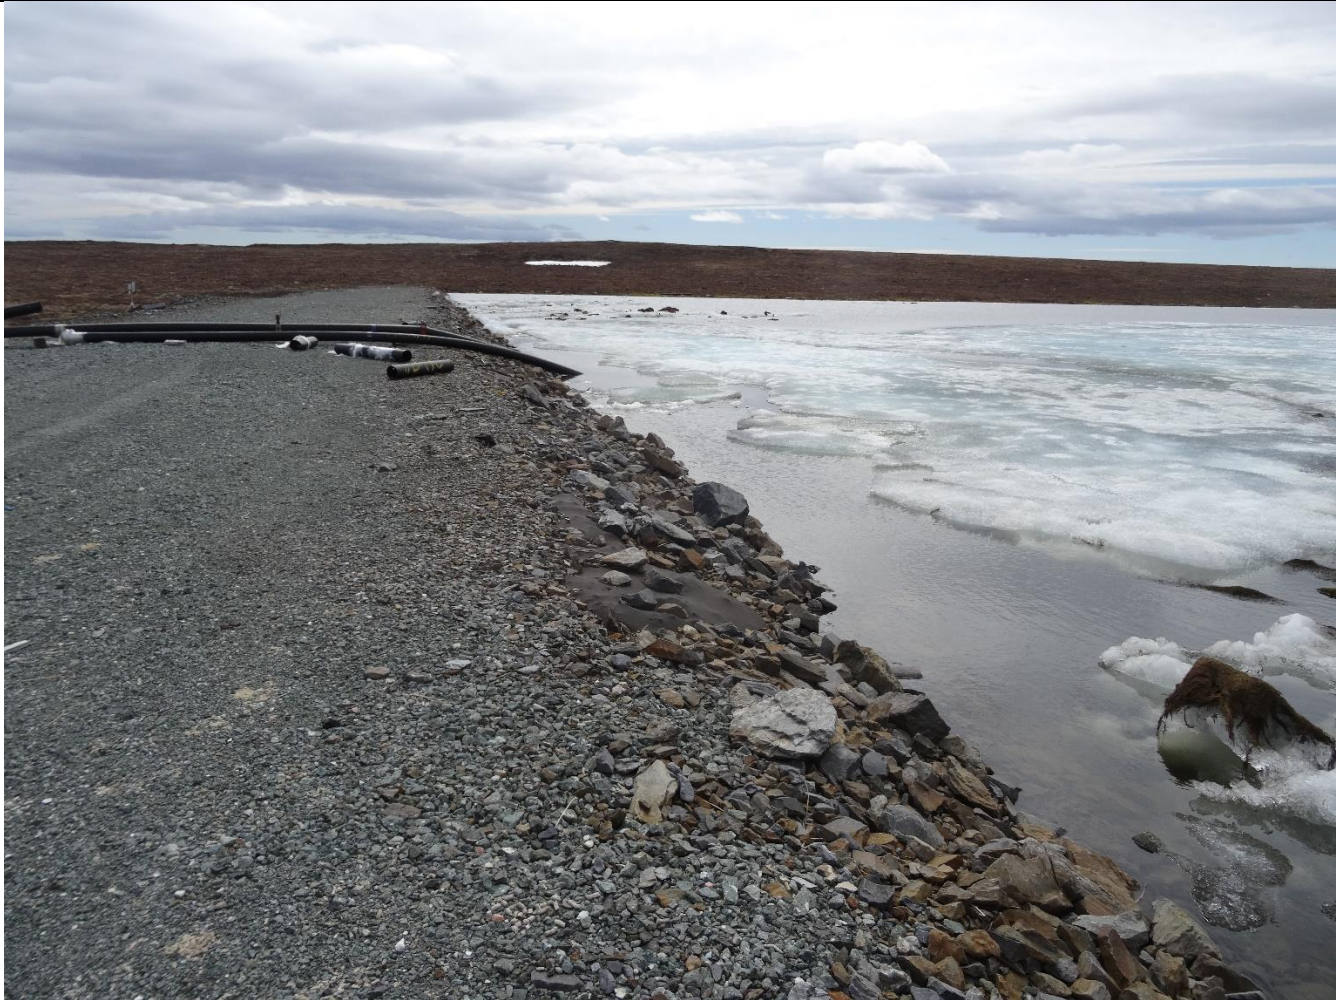
Photo 3

Description: Sewage Lagoon View 1

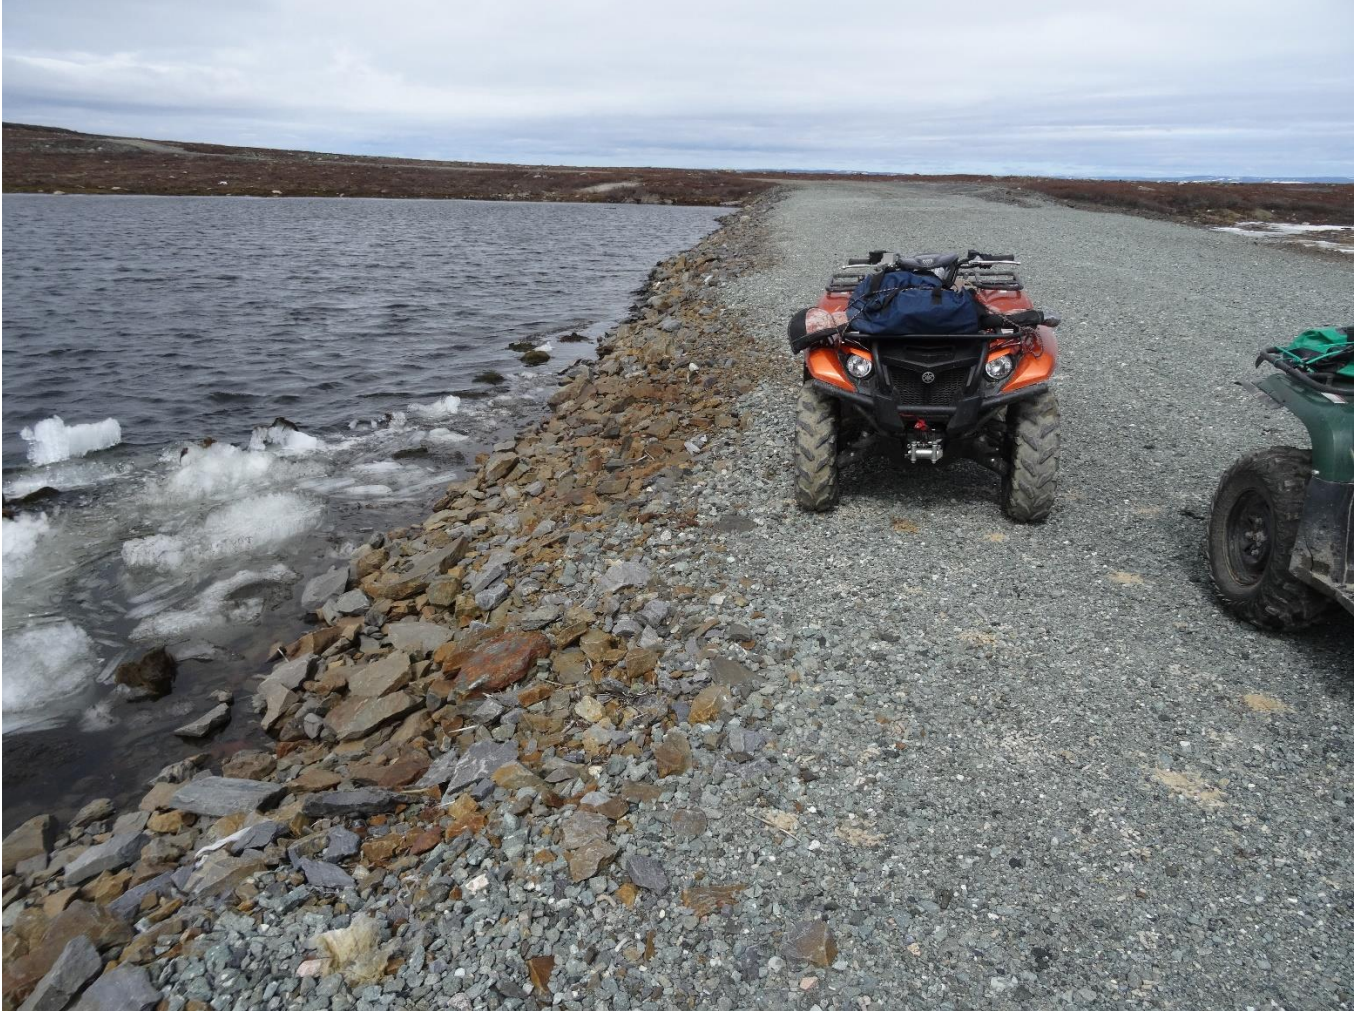
Photo 4

Description: Sewage Lagoon View 2

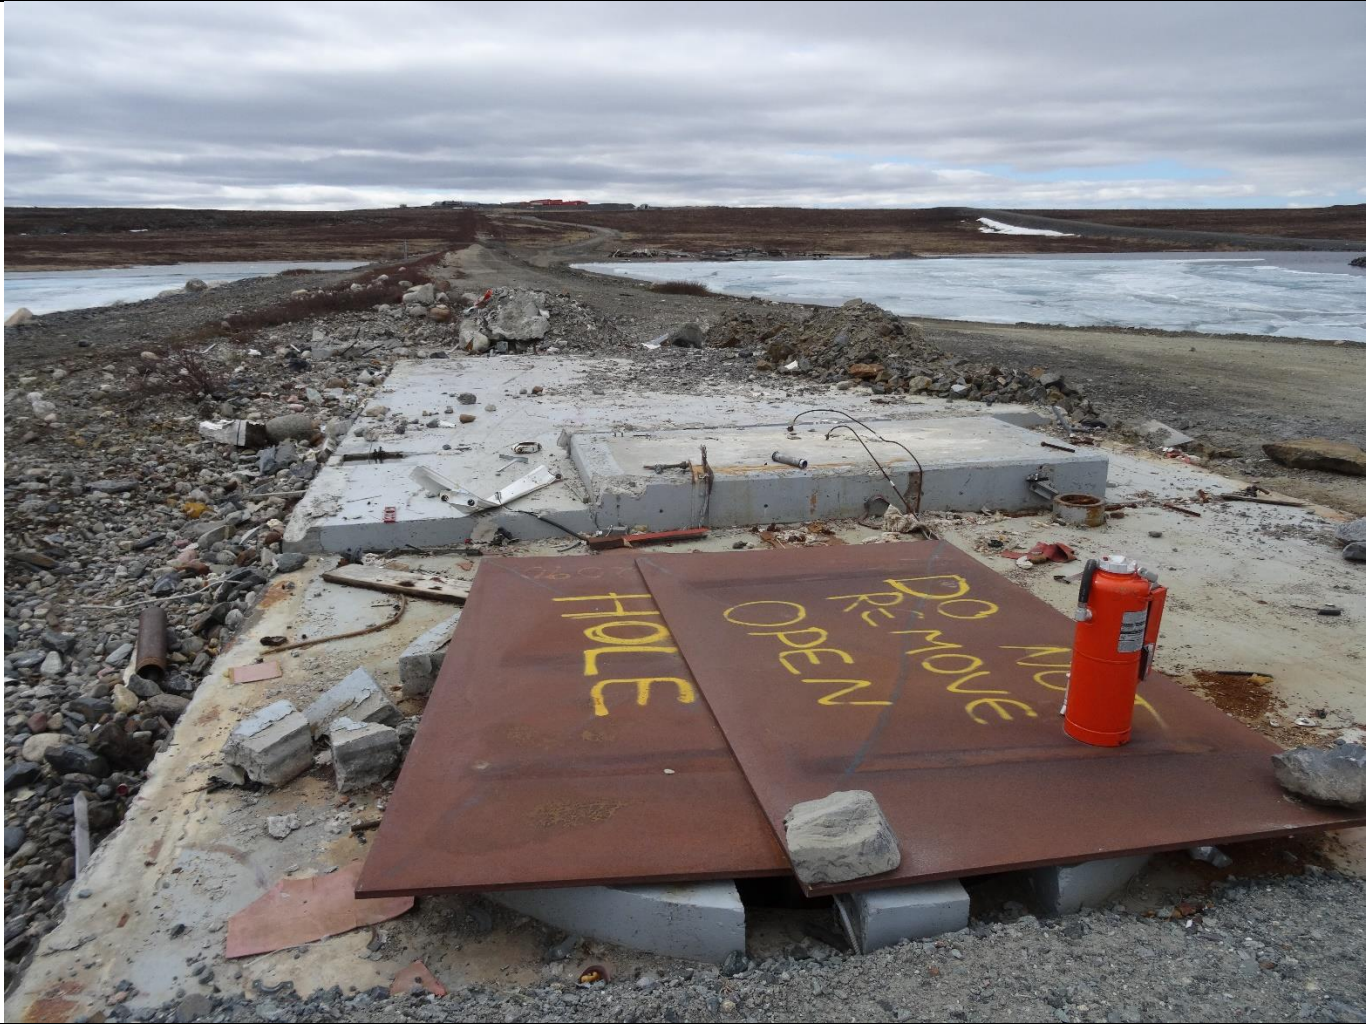
Photo 5

Description: Foundation of old Water Pump House Building

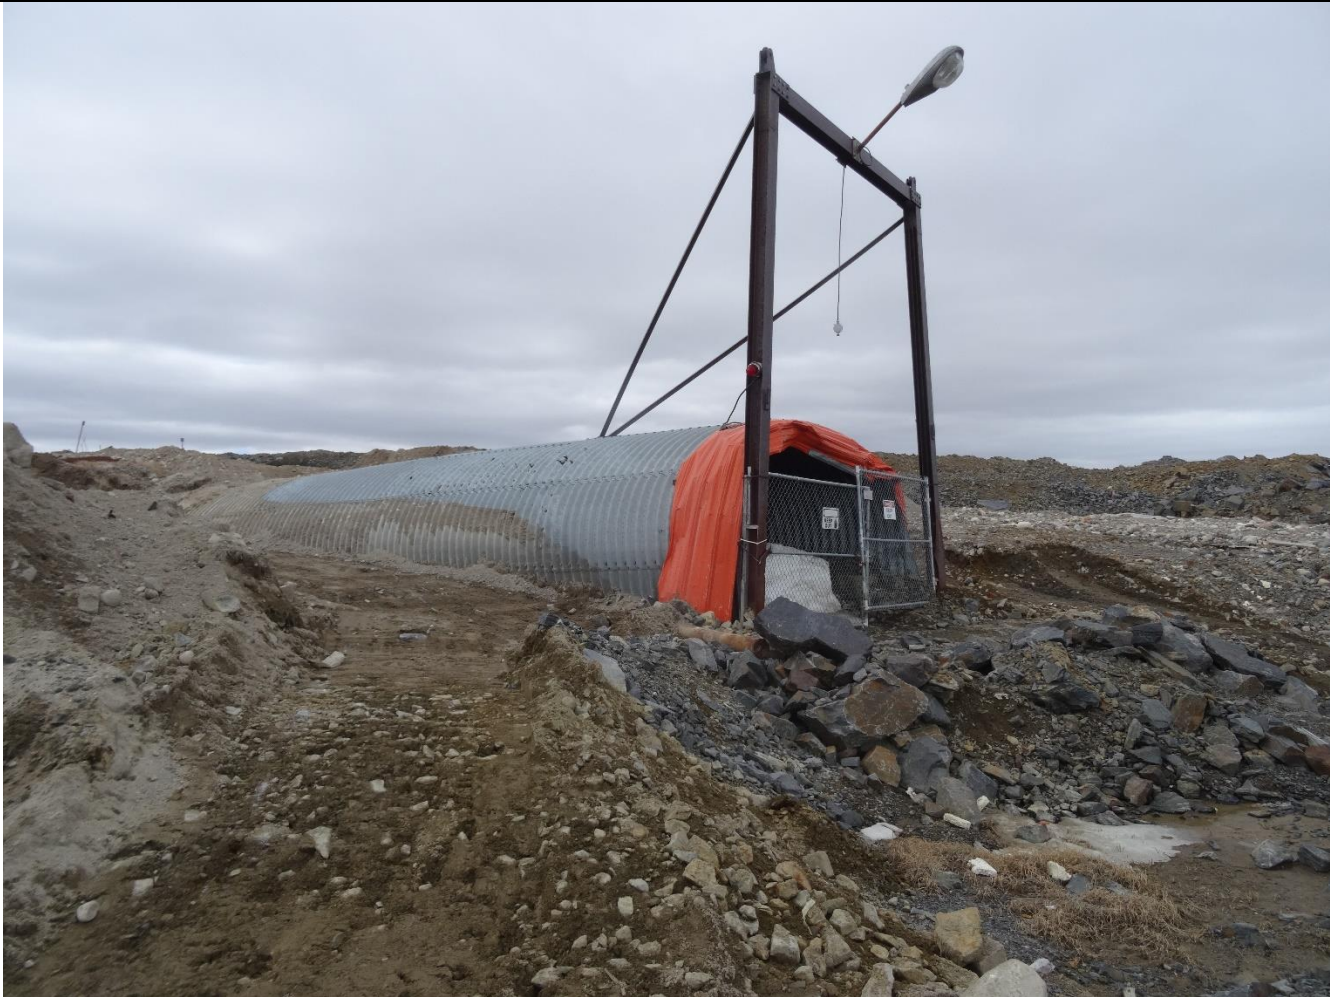
Photo 6

Description: Portal

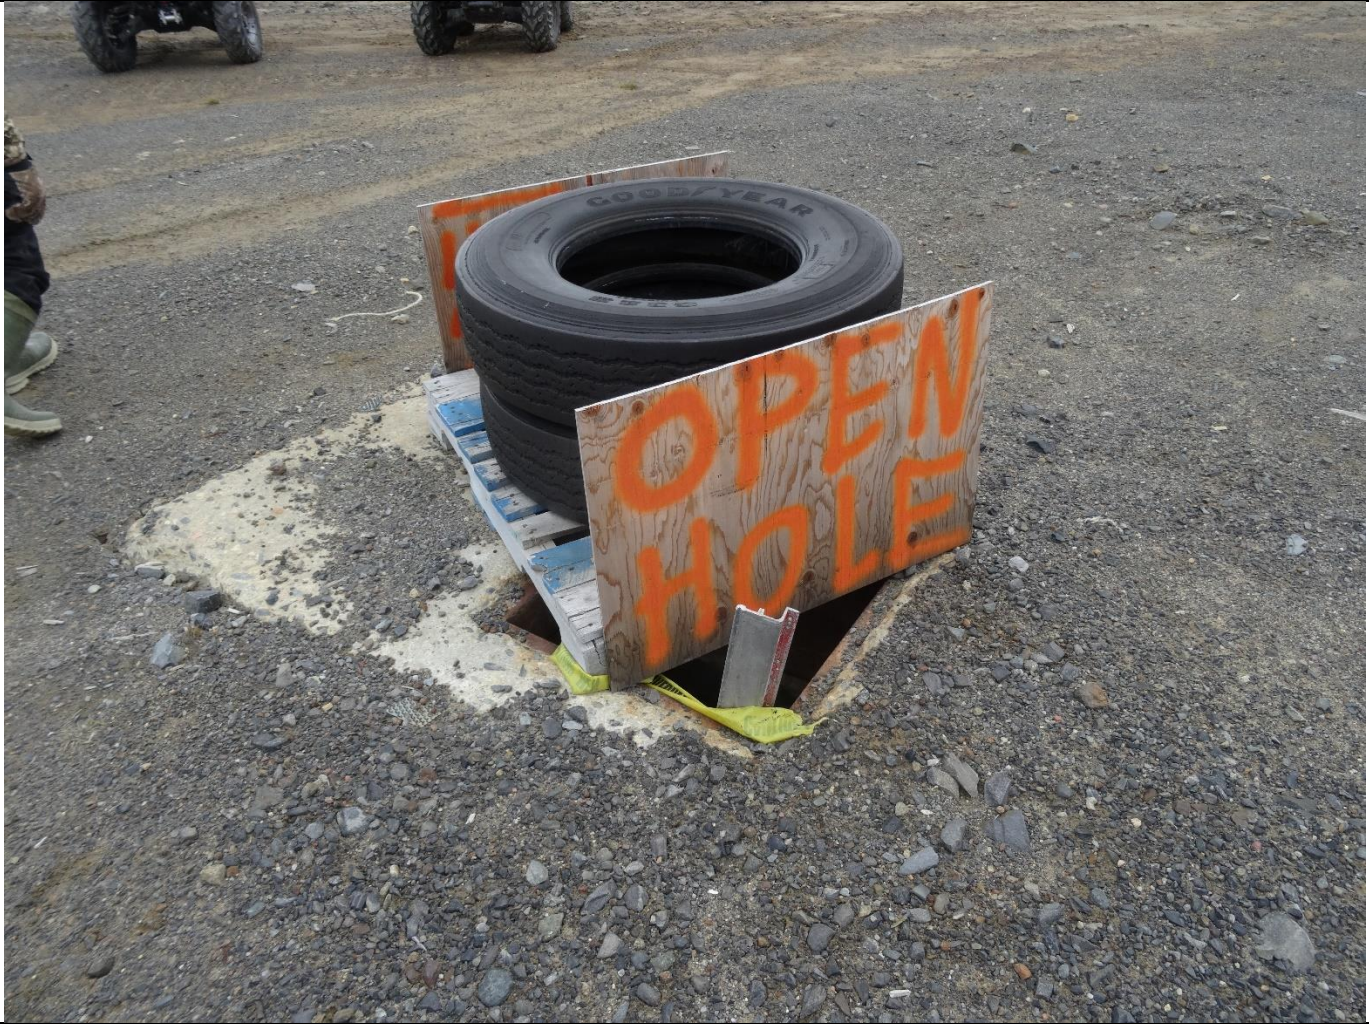
Photo 7

Description: Open Hole

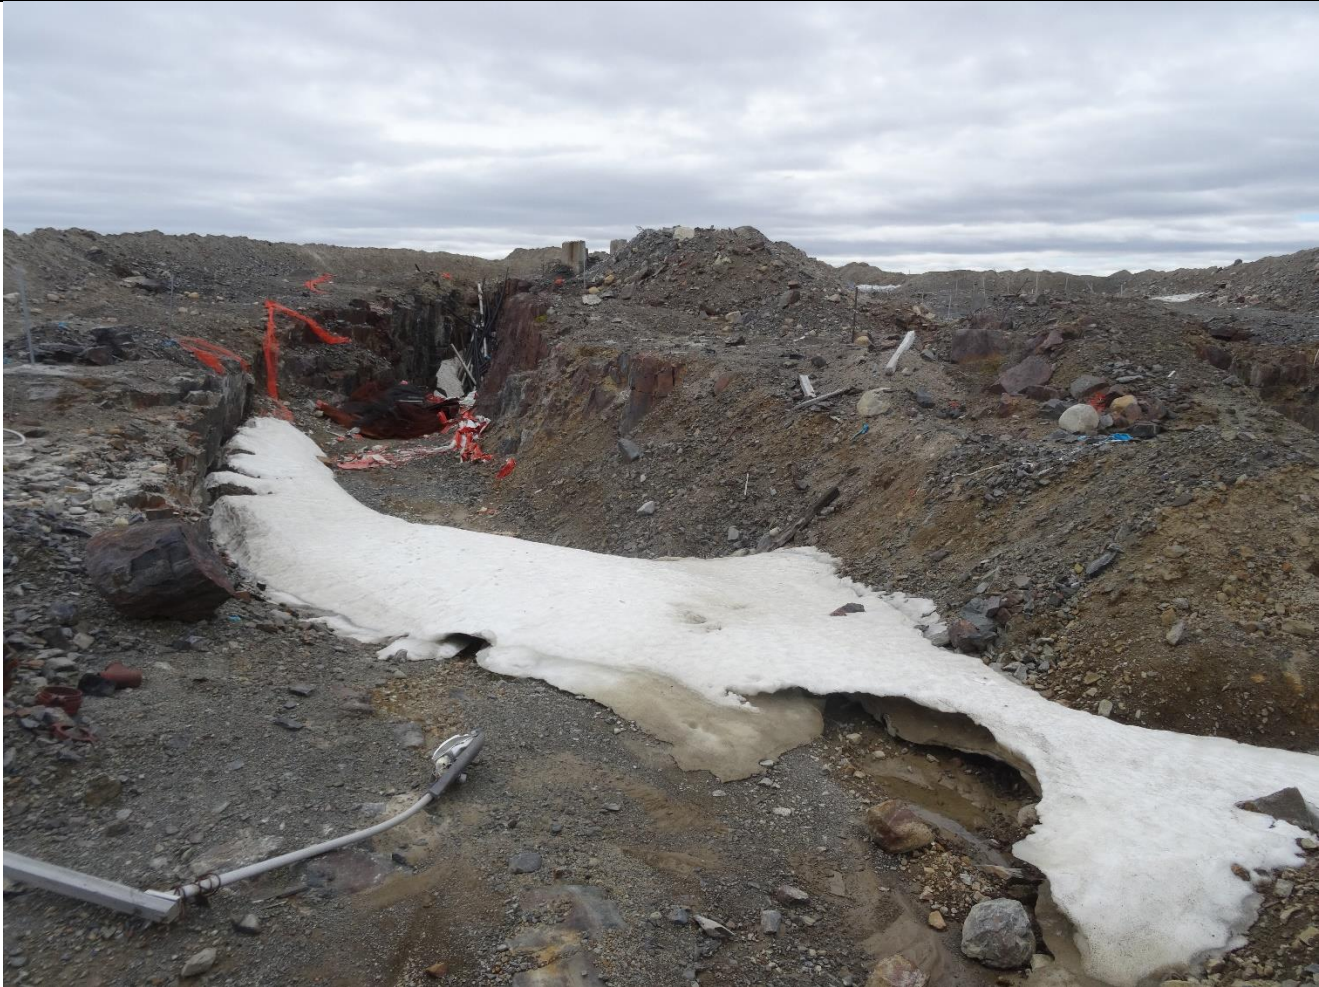
Photo 8

Description: The Center Zone

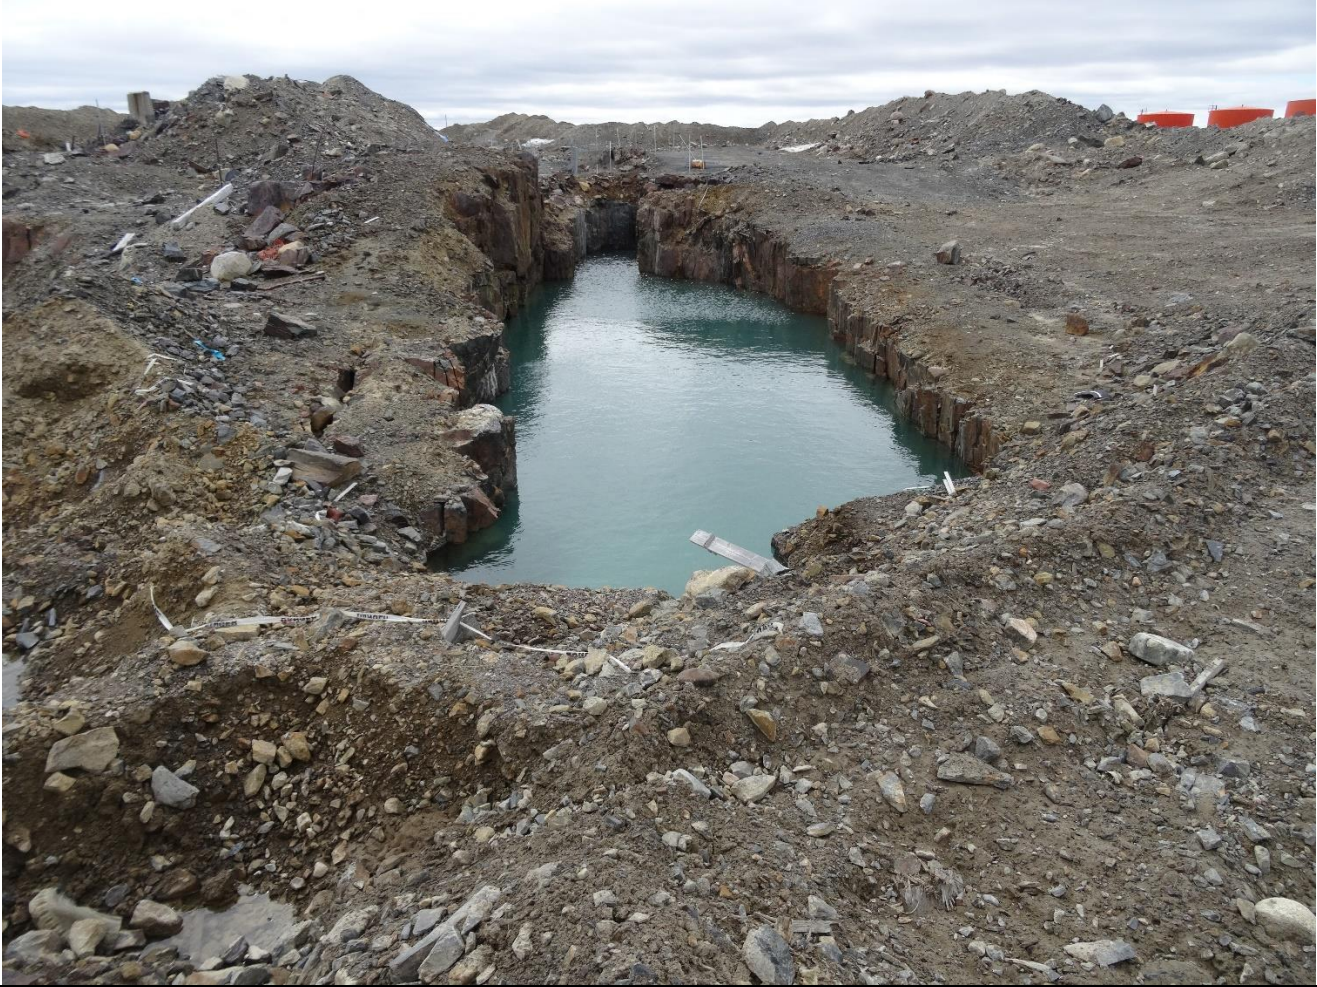
Photo 9

Description: The West Zone

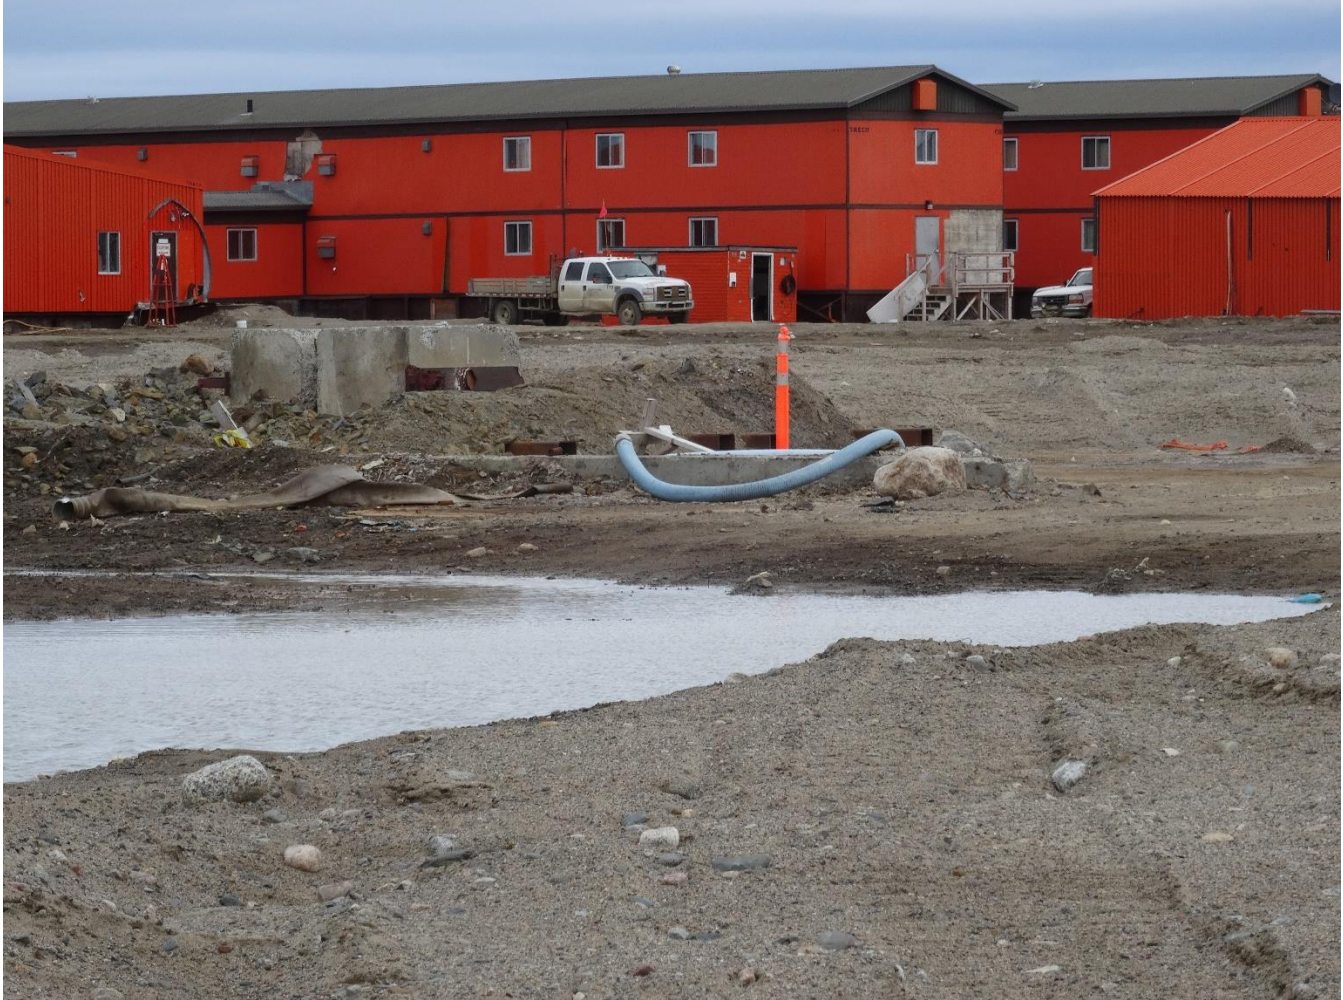
Photo 10

Description: The Elevator Main Shaft, shown with Orange Pylon (at the time of the photo it was unsafe for me to get any closer due to active Cover Work)

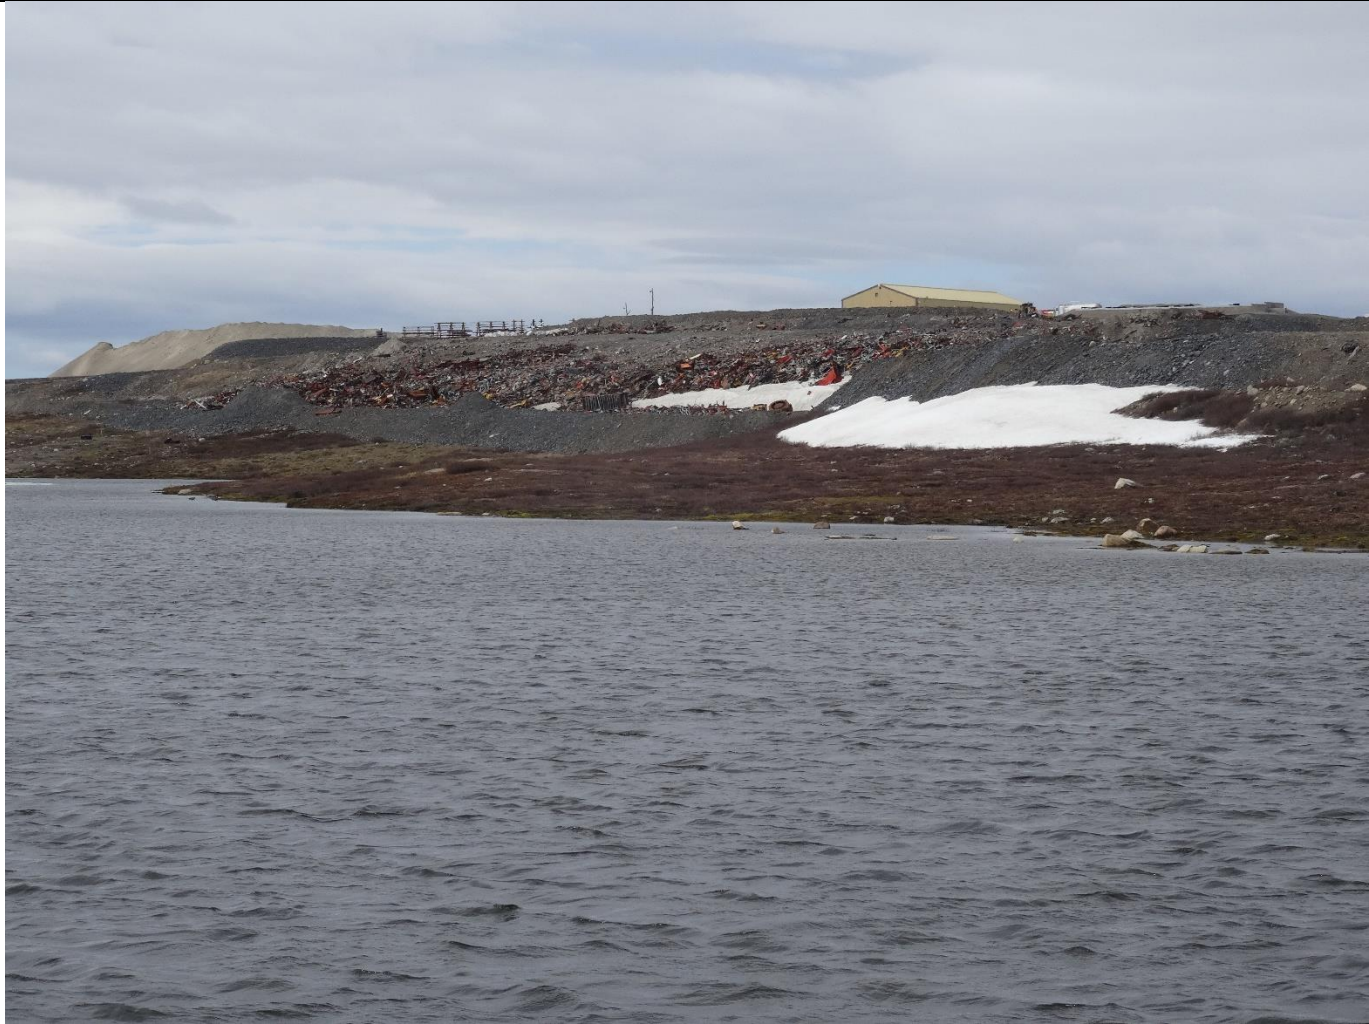
Photo 13

Description: Land Fill Area (View from Sewage Lagoon Decant Area)

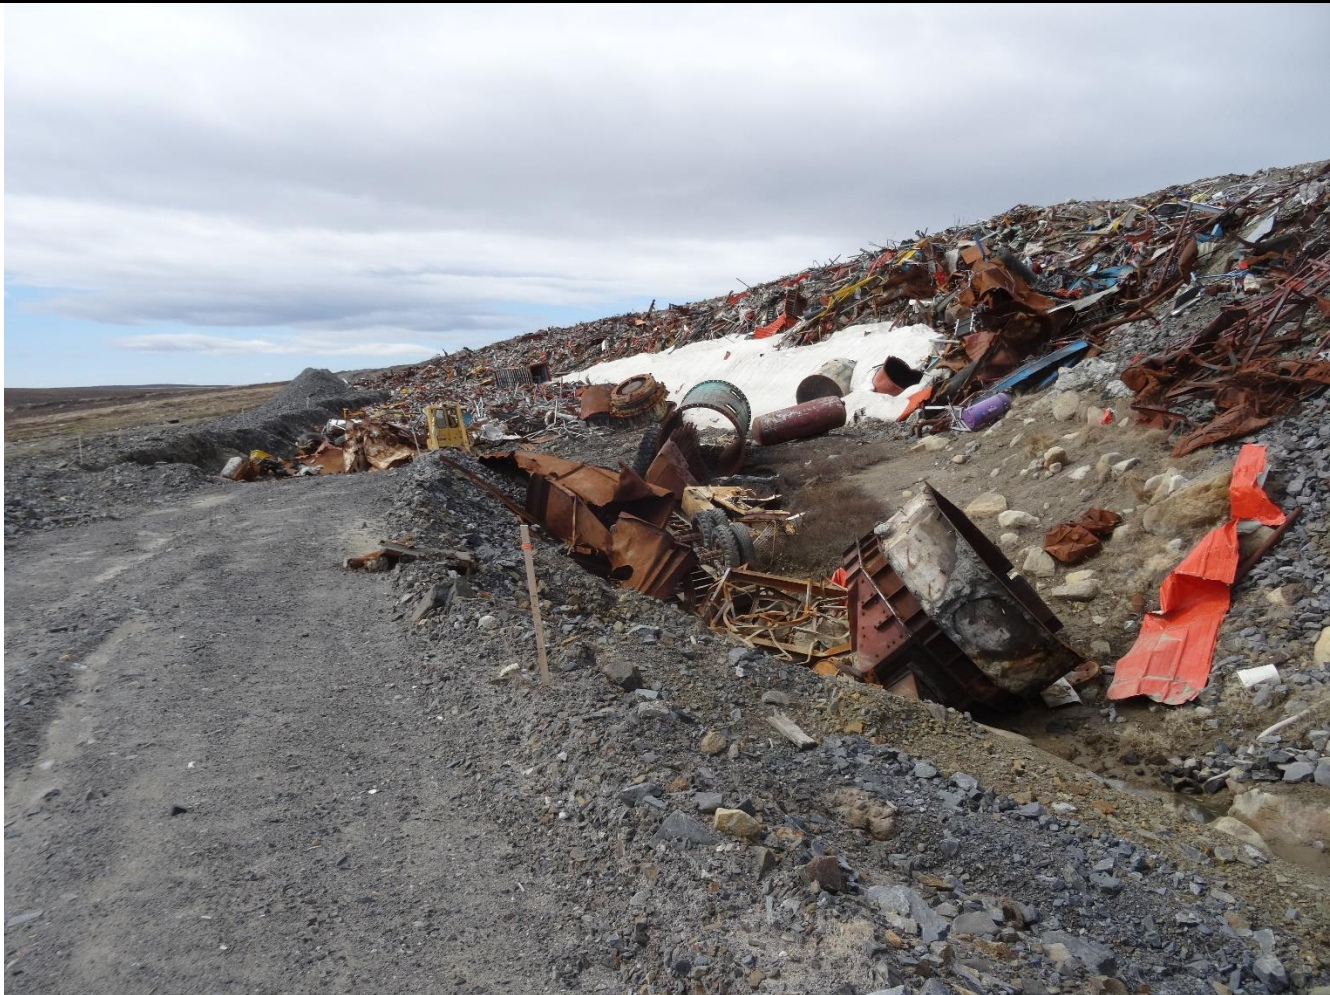
Photo 14

Description: Land Fill Area – Bottom View

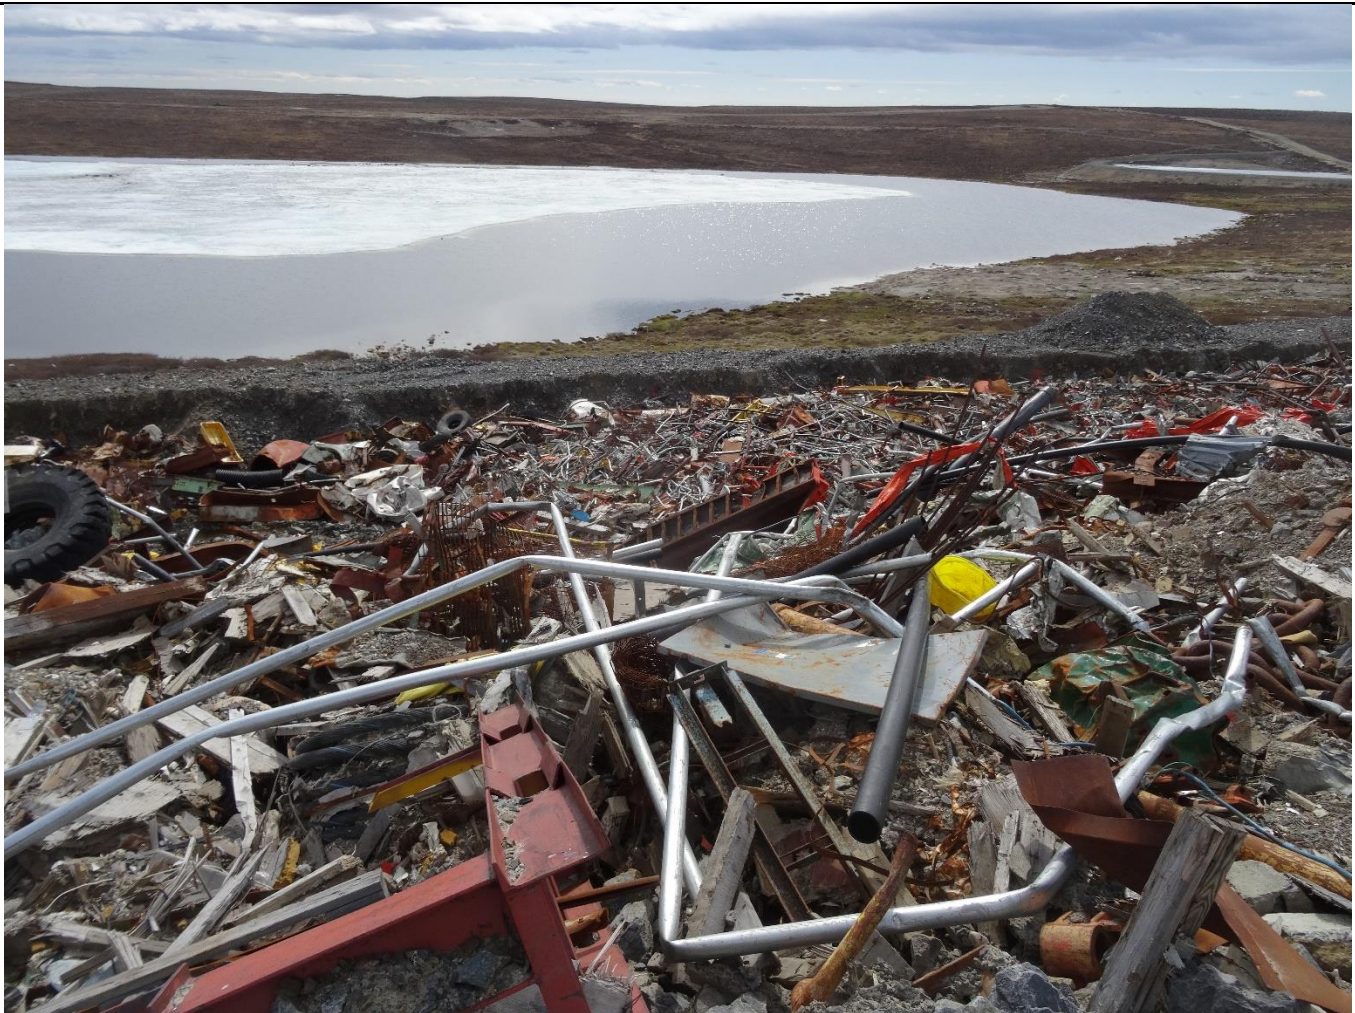
Photo 15

Description: Land Fill Area – Top View

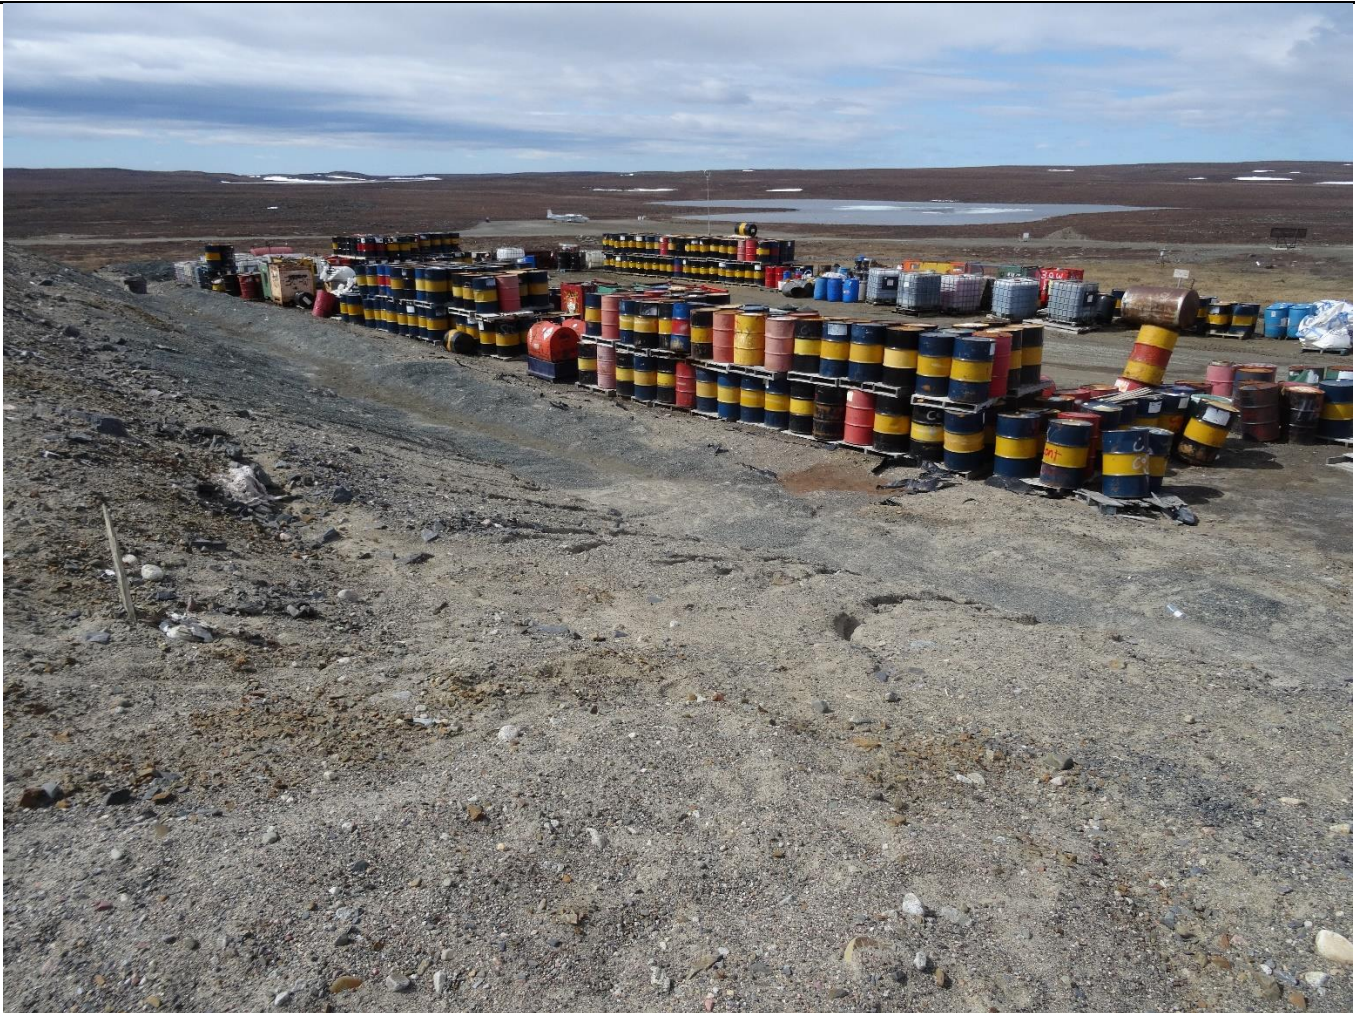
Photo 16

Description: 3rd Party Berm

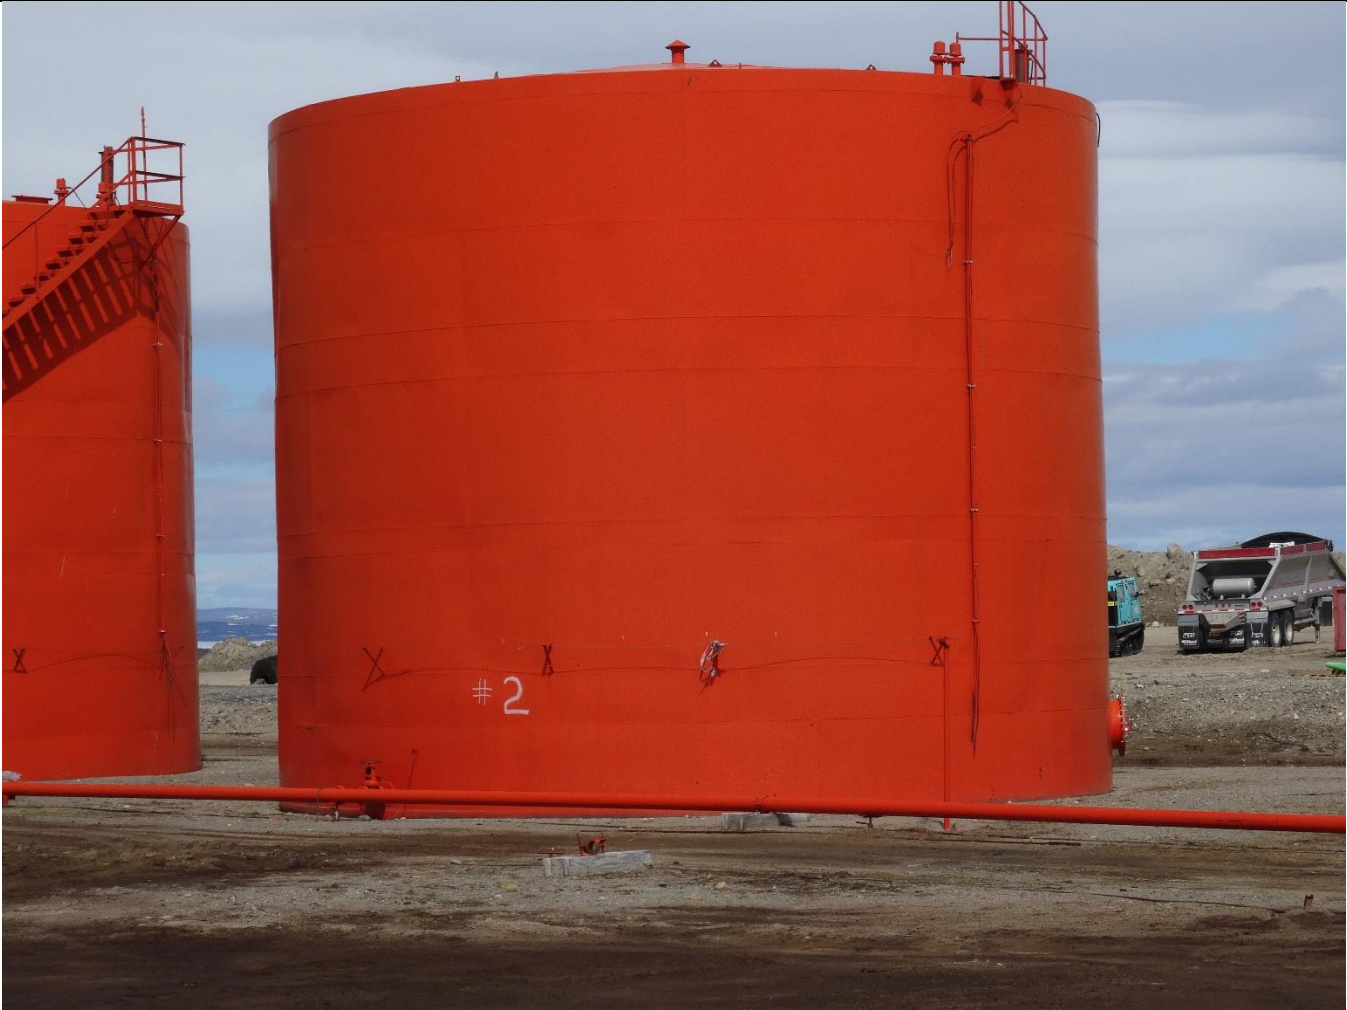
Photo 17

Description: Fuel Storage Tank #2

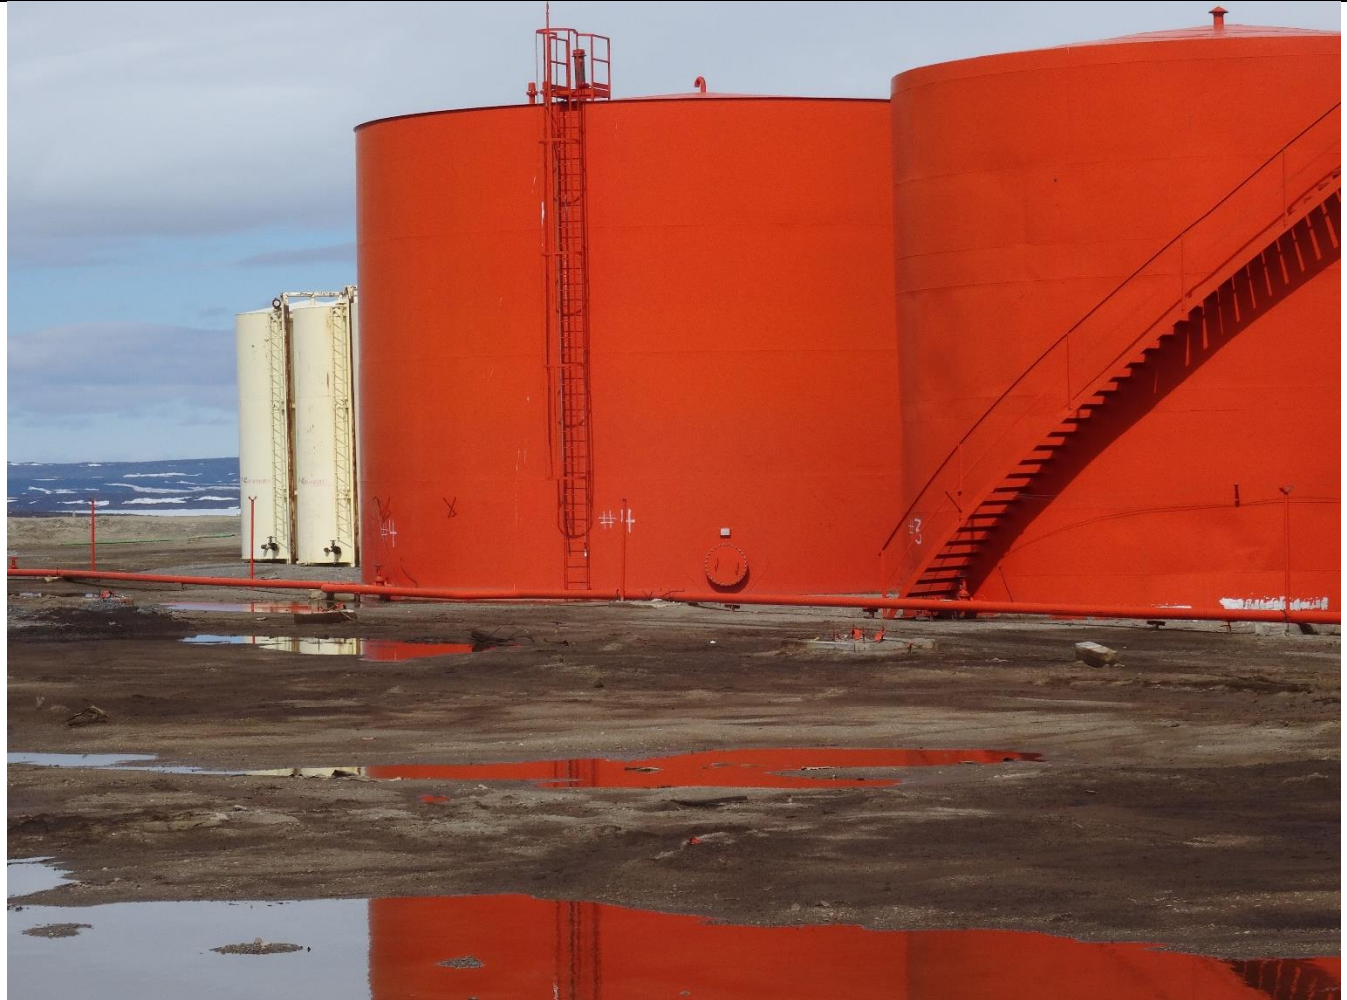
Photo 18

Description: Fuel Storage Tank #4

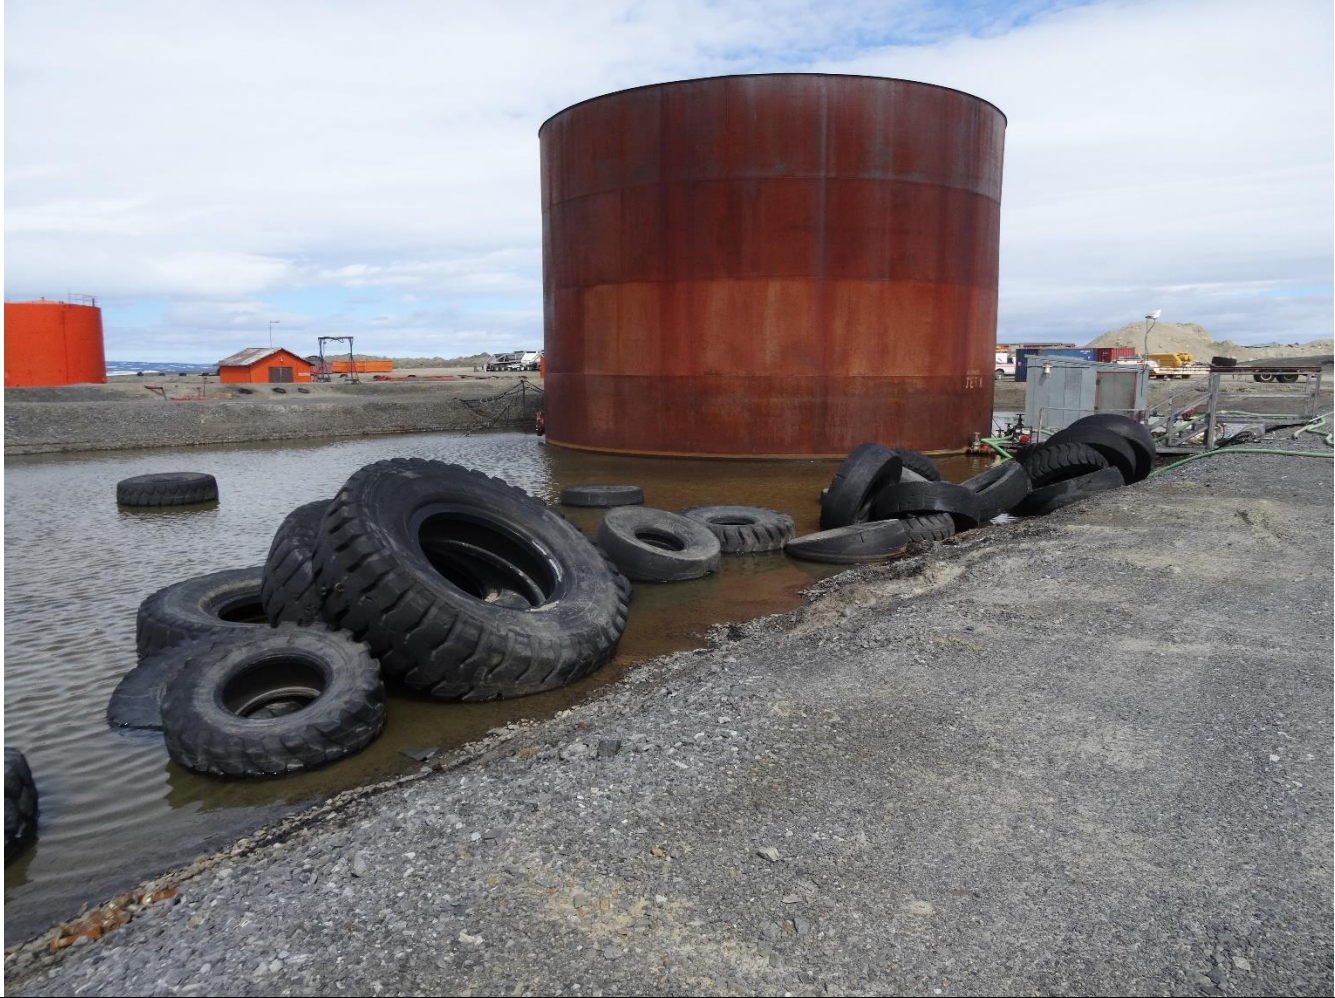
Photo 19

Description: Fuel Storage Tank #15 (Labeled JET A)
