WATER LICENCE INSPECTION FORM

Licensee		Licensee Representative	
Lupin Mines Incorporated		Dave Hohnstein & Dave Vokey	
Licence No. / Expiry		Representative's Title	
2AM-LUP2032			
Land / Other Authorizations		Land / Other Authorizations	
Date of Inspection		Inspector	
2021 June 24		Baba Pedersen	
Activities Inspected			
<input checked="" type="checkbox"/> Camp	<input type="checkbox"/> Drilling	<input type="checkbox"/> Mining	<input type="checkbox"/> Construction
<input type="checkbox"/> Roads/Hauling	<input type="checkbox"/> Other:	<input type="checkbox"/> Other:	<input checked="" type="checkbox"/> Reclamation
			<input checked="" type="checkbox"/> Fuel Storage

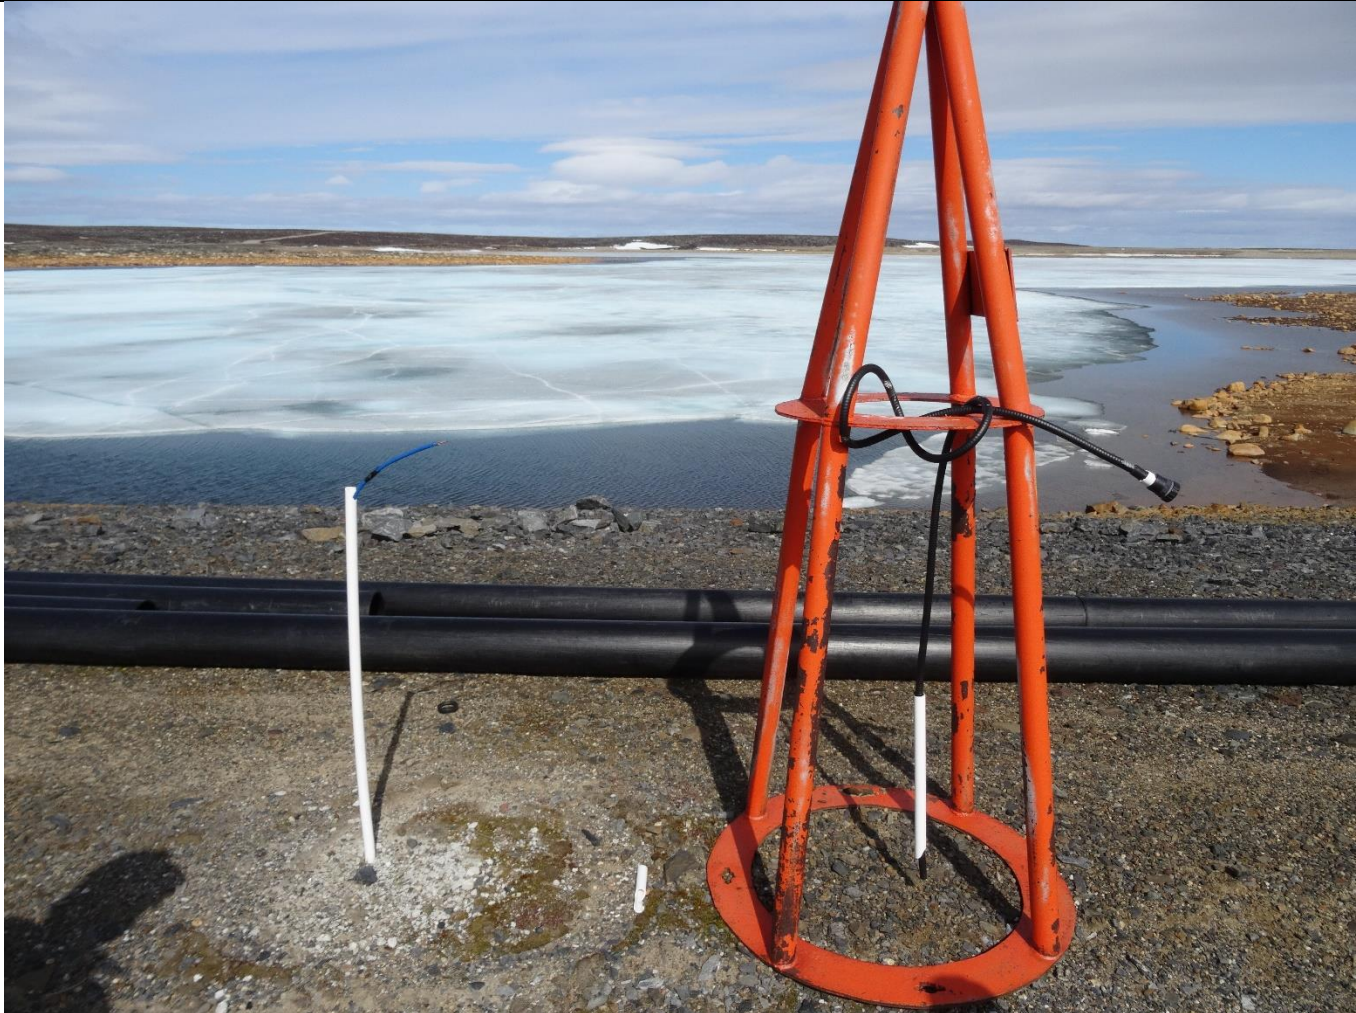
Photo 20

Description: Thermistor D1A-00-01S located on DAM 1A

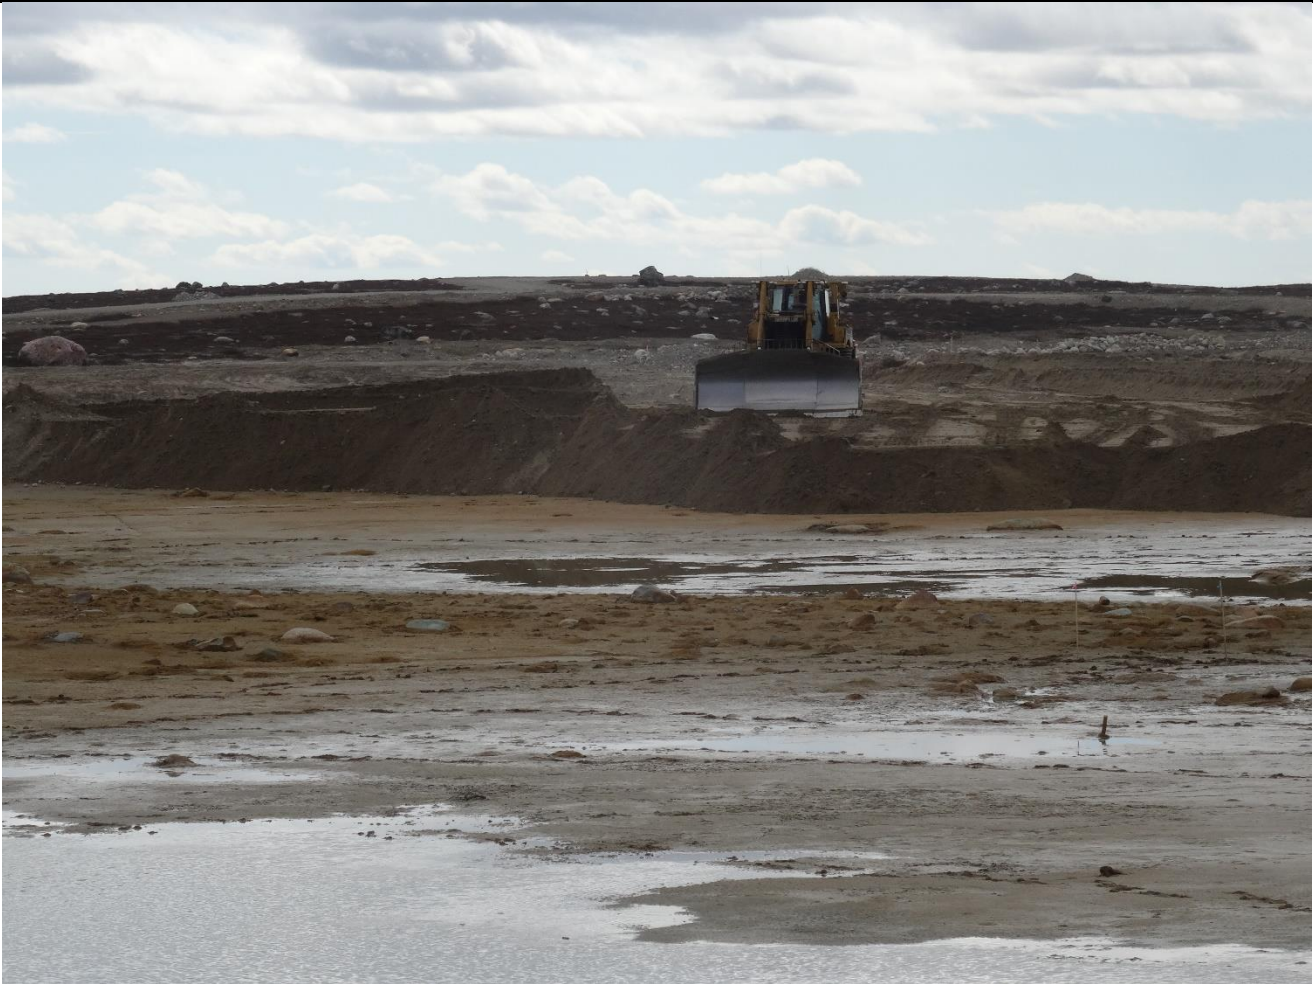
Photo 22

Description: Crews Filling/Covering Cell 3 near the L Dam
