WATER LICENCE INSPECTION FORM

Licensee		Licensee Representative	
Lupin Mines Incorporated (LMI)		Dave Vokey	
Licence No. / Expiry		Representative's Title	
2AM-LUP2032			
Land / Other Authorizations		Land / Other Authorizations	
Date of Inspection		Inspector	
2021 October 10		Baba Pedersen	
Activities Inspected			
<input checked="" type="checkbox"/> Camp	<input type="checkbox"/> Drilling	<input type="checkbox"/> Mining	<input type="checkbox"/> Construction
<input type="checkbox"/> Roads/Hauling	<input type="checkbox"/> Other:	<input checked="" type="checkbox"/> Other: Security Reduction	<input checked="" type="checkbox"/> Reclamation
<input type="checkbox"/> Fuel Storage

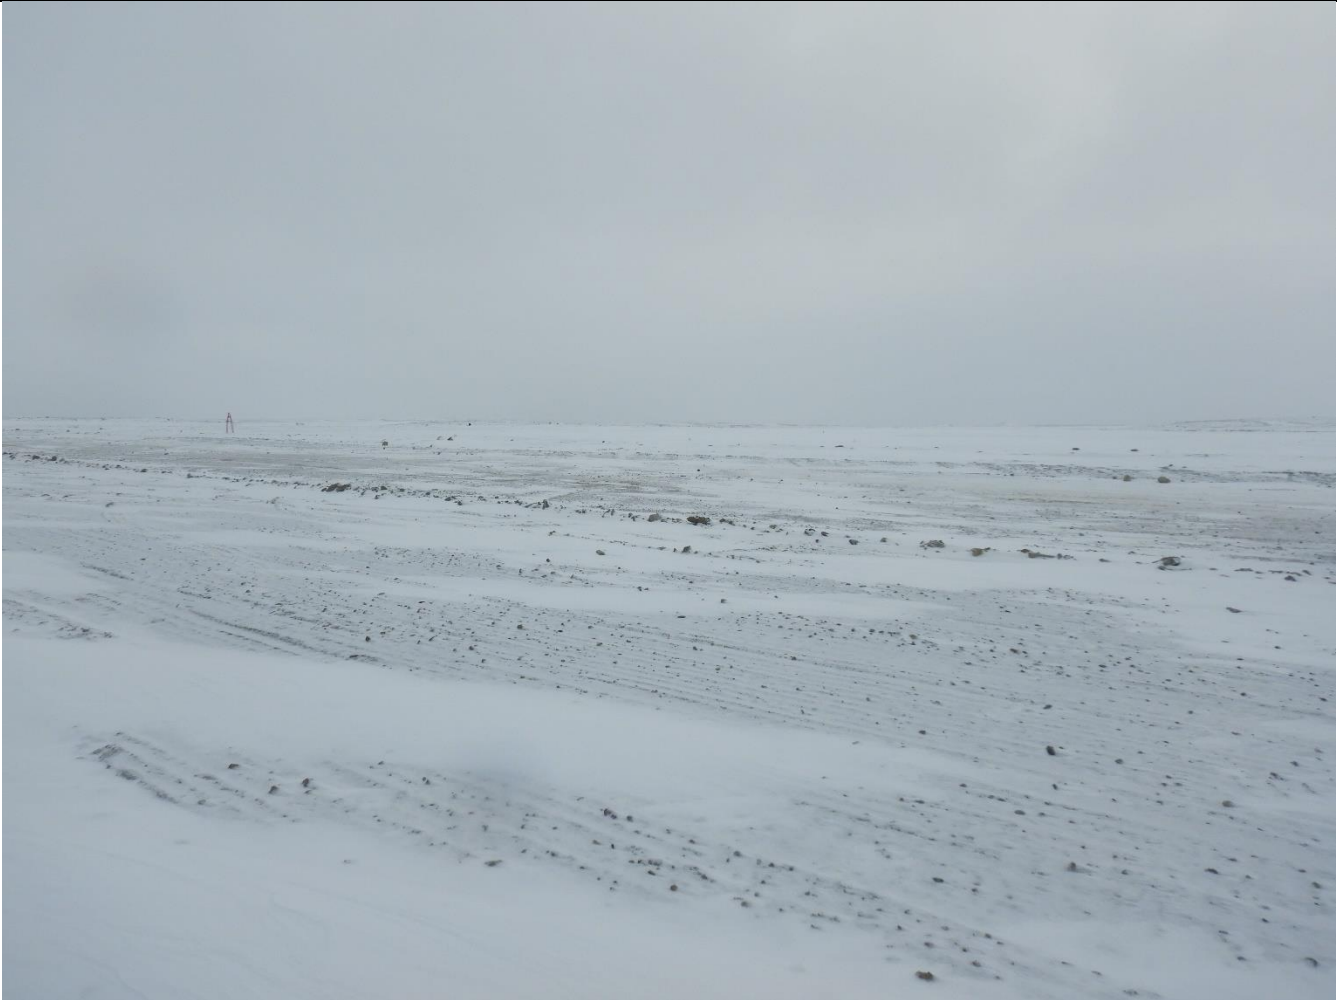
Photo 5

The Cell 3 Cover is now Complete

Description: Cell 3, View 1

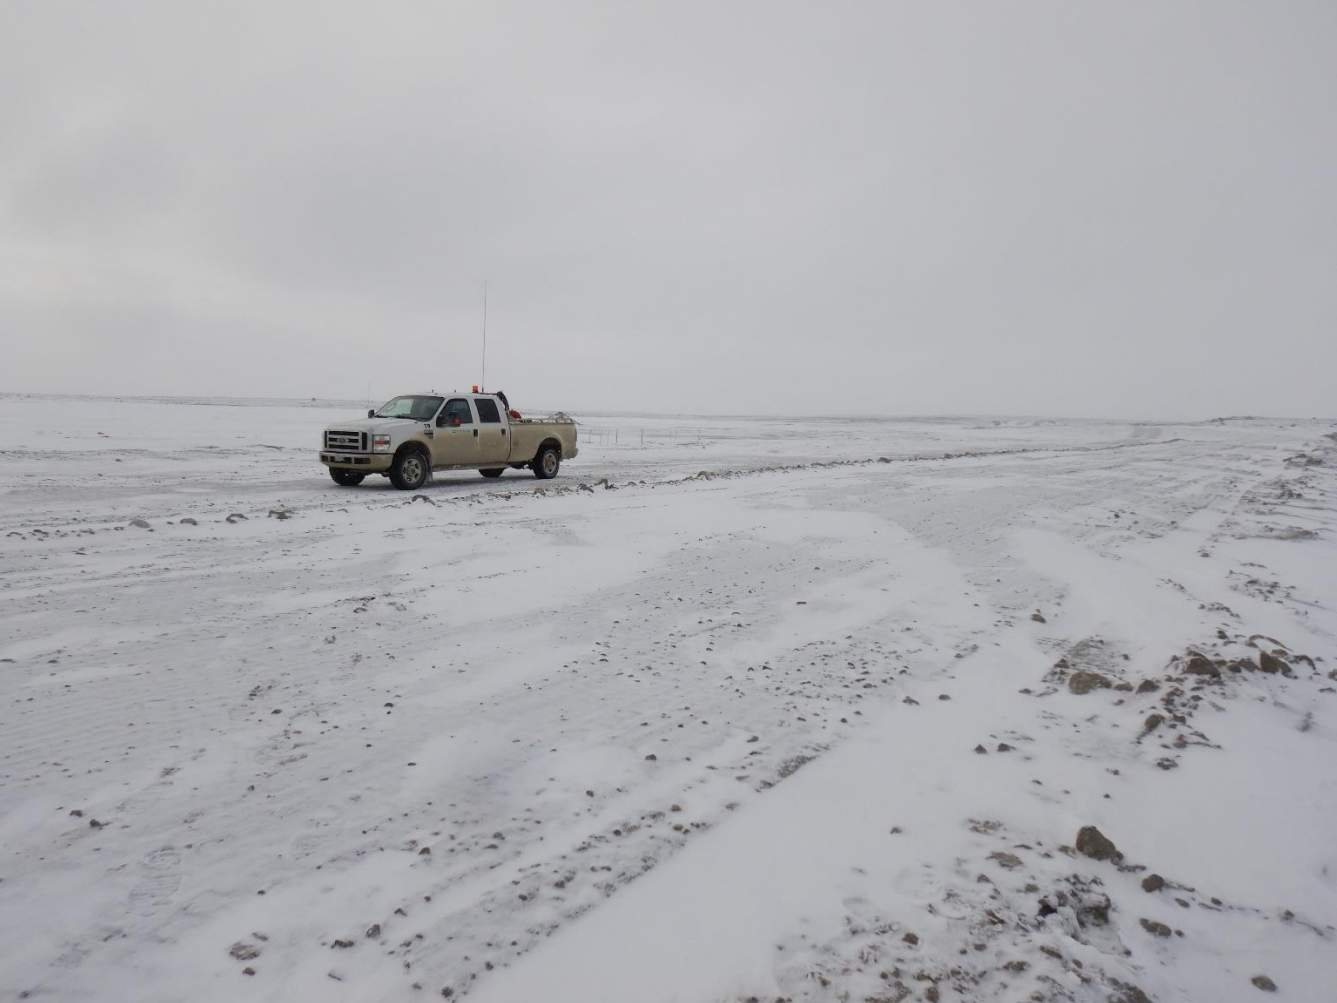
Photo 6

Description: Cell 3, View 2

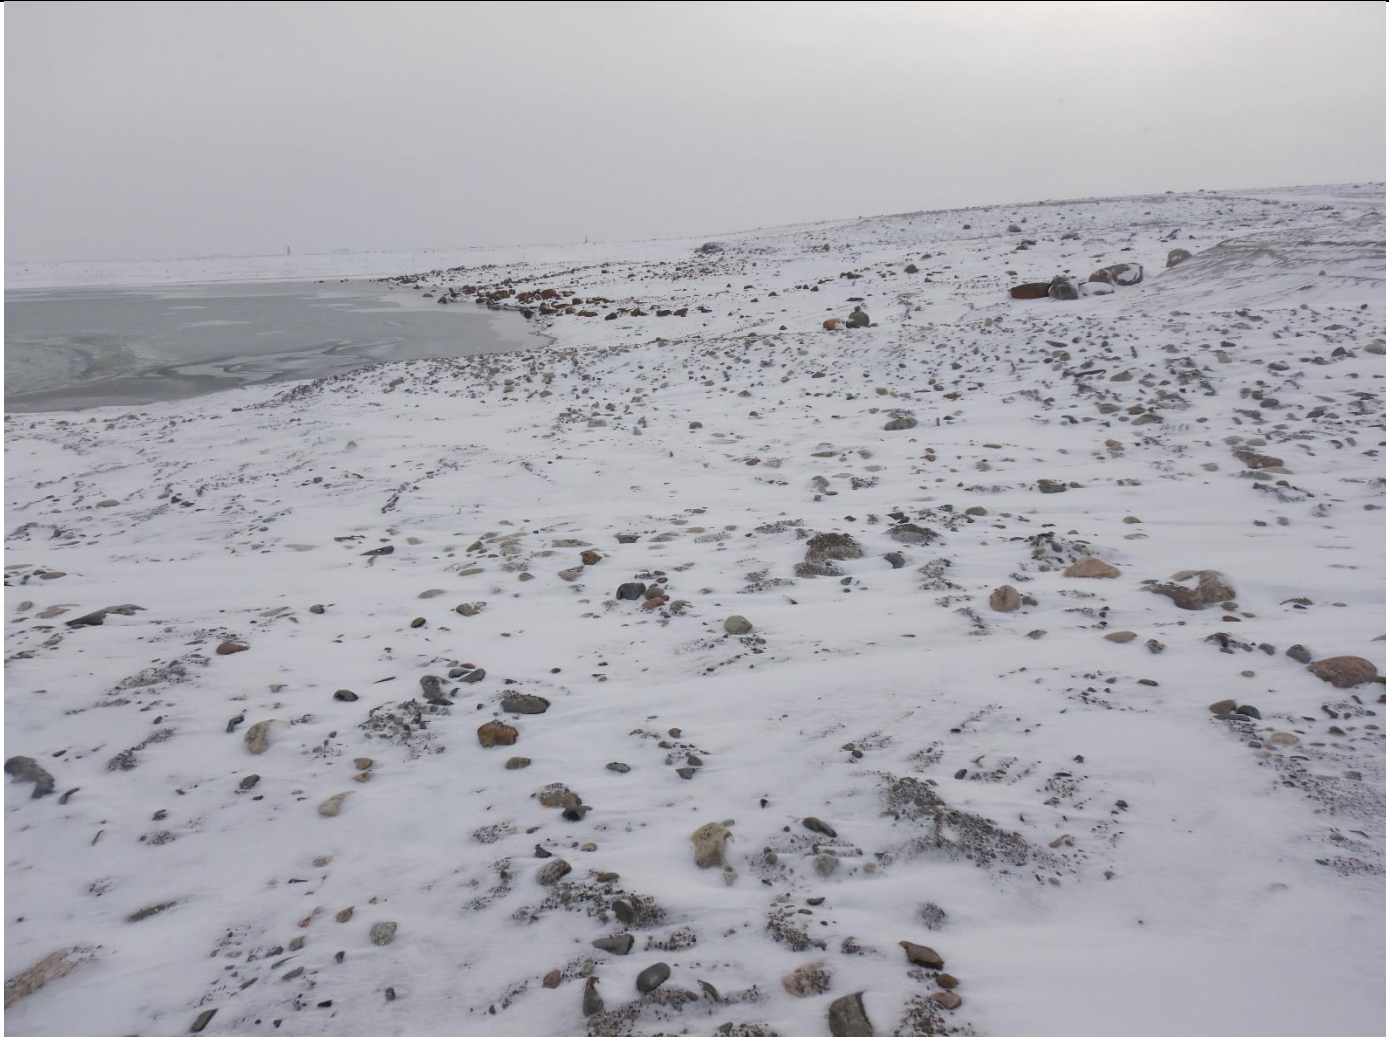
Photo 7

The Lined Drainage Ditch for the Overflow Spillway from Cell 3 going into the Upstream End of Cell 4 at approximately N 65° 43' 08.2" and W 111° 16' 35.6" is Complete

Description: Drainage Ditch Overflow Spill Way from Cell 3 into Cell 4, View 1

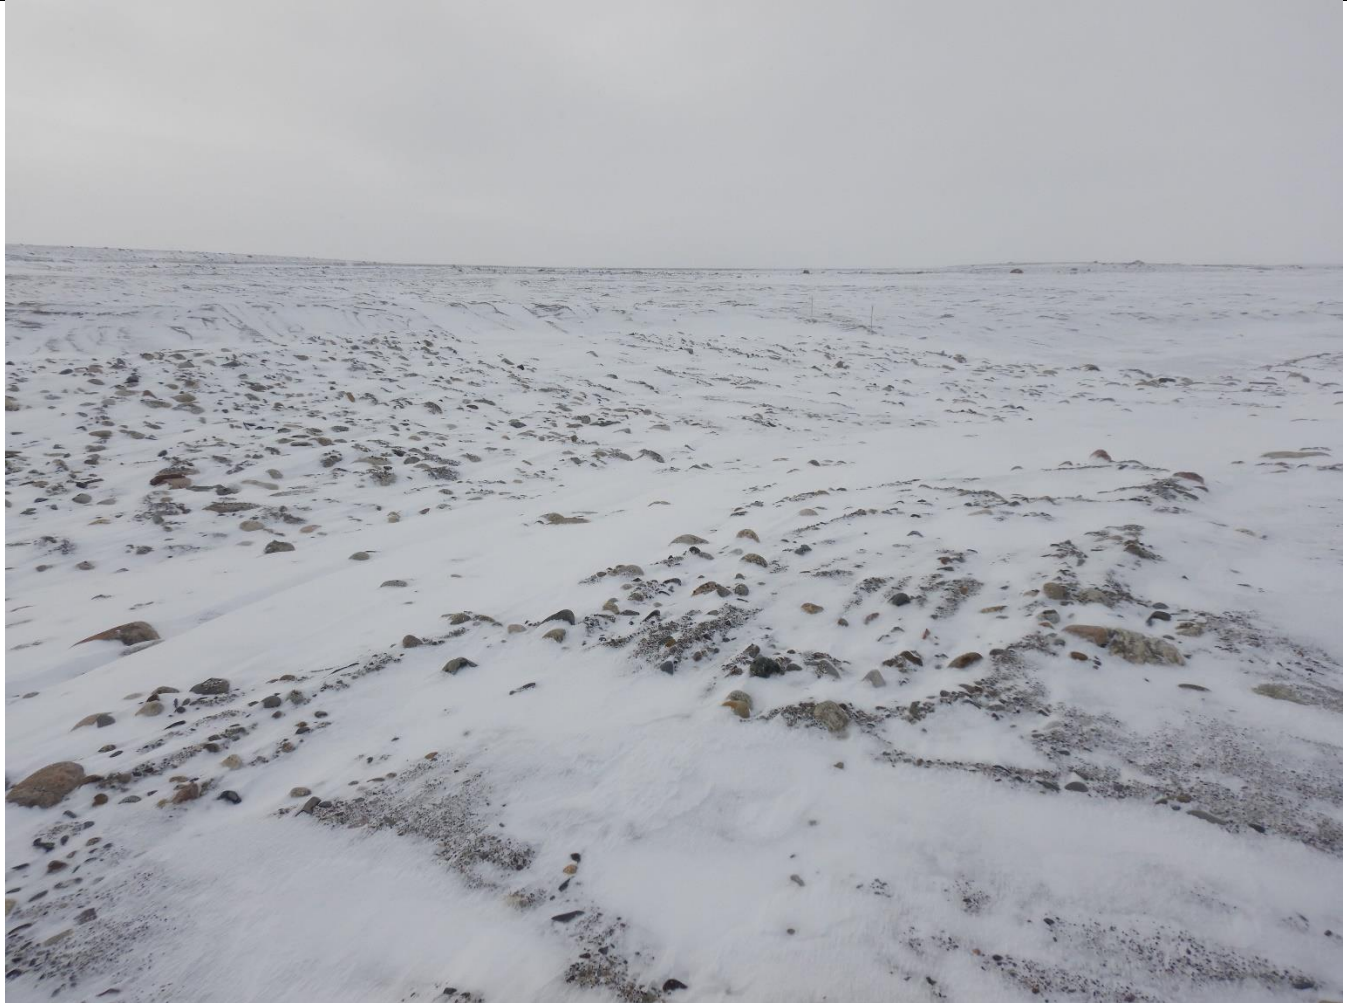
Photo 8

Description: Drainage Ditch Overflow Spill Way from Cell 3 into Cell 4, View 2

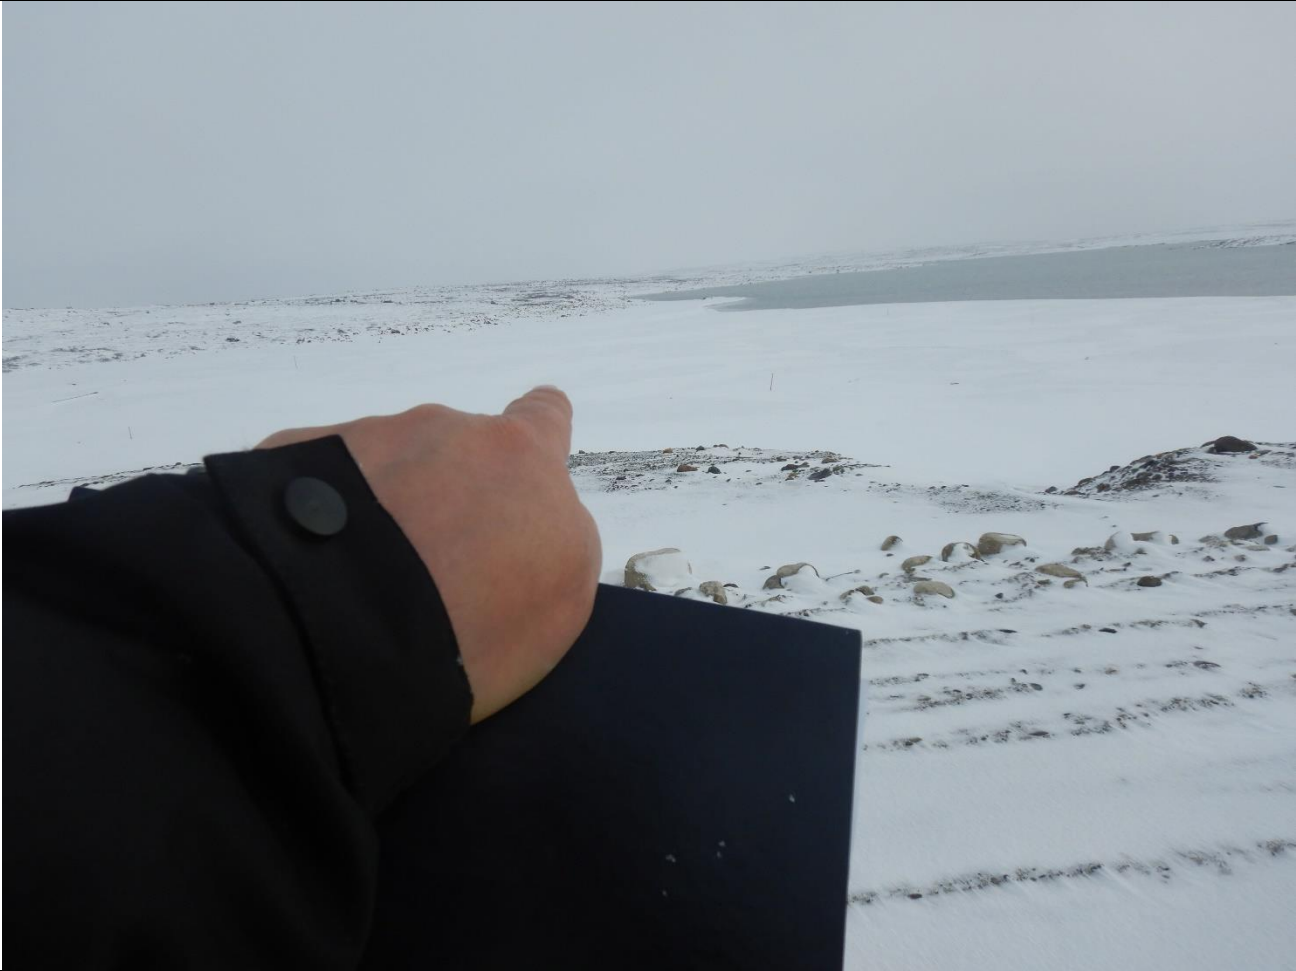
Photo 9

Dave Vokey showed the Inspector where there are still some Exposed Tailings (covered in Snow) in the North West Corner of Cell 4 as seen from where the Inspector was standing on the L-Dam at approximately N 65° 43' 21.7" and W 111° 16' 40.7"

Description: Exposed Tailings (under Snow Cover) in North West Corner of Cell 4

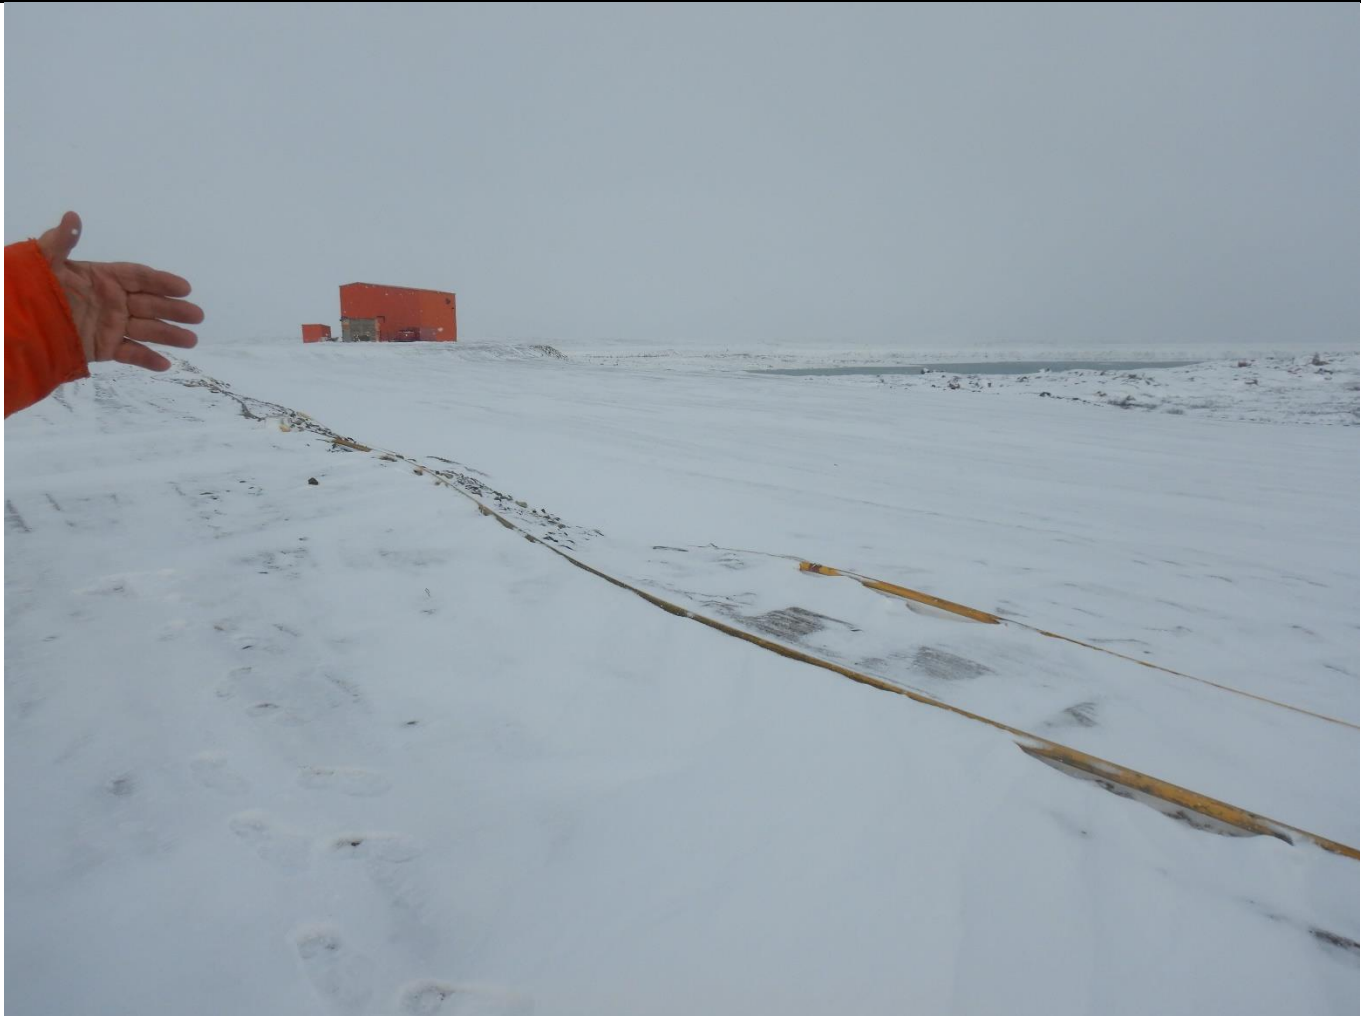
Photo 10

Dave Vokey showed the Inspector an Inlet in Cell 4 where they have Placed and Covered Exposed Tailings with a minimum of 1 Meter of Fill. Photos are from where the Inspector was standing at approximately N 65° 43' 26.4" and W 111° 16' 42.6"

Description: Tailings that have been Covered with at least 1 Meter of Fill located in an Inlet from Cell 4, View 1

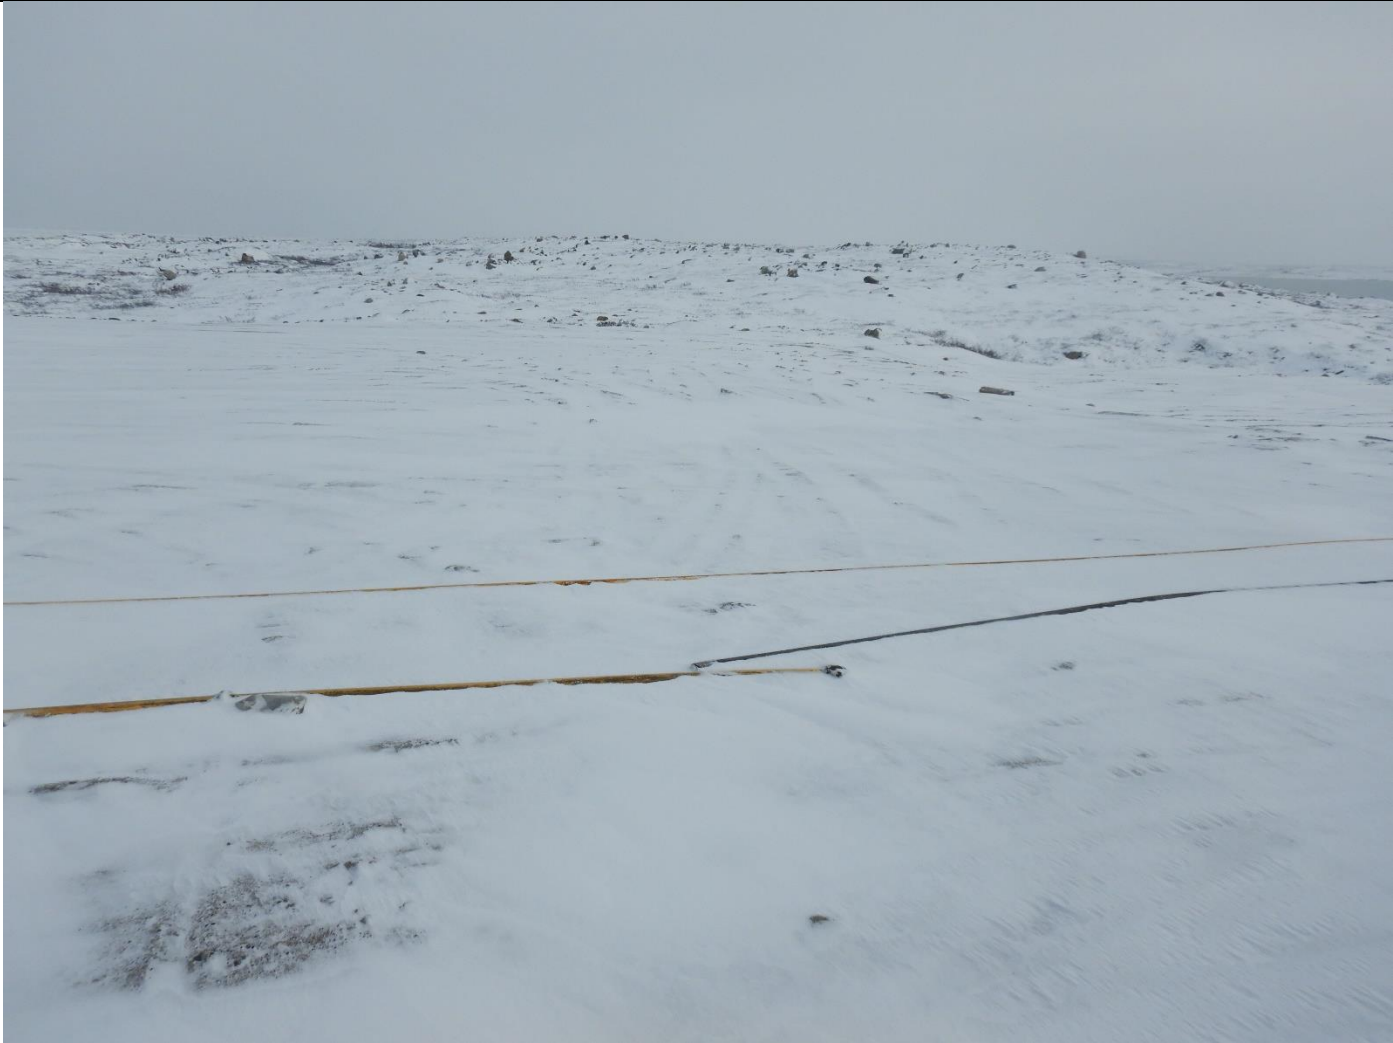
Photo 11

Description: Tailings that have been Covered with at least 1 Meter of Fill located in an Inlet from Cell 4, View 2

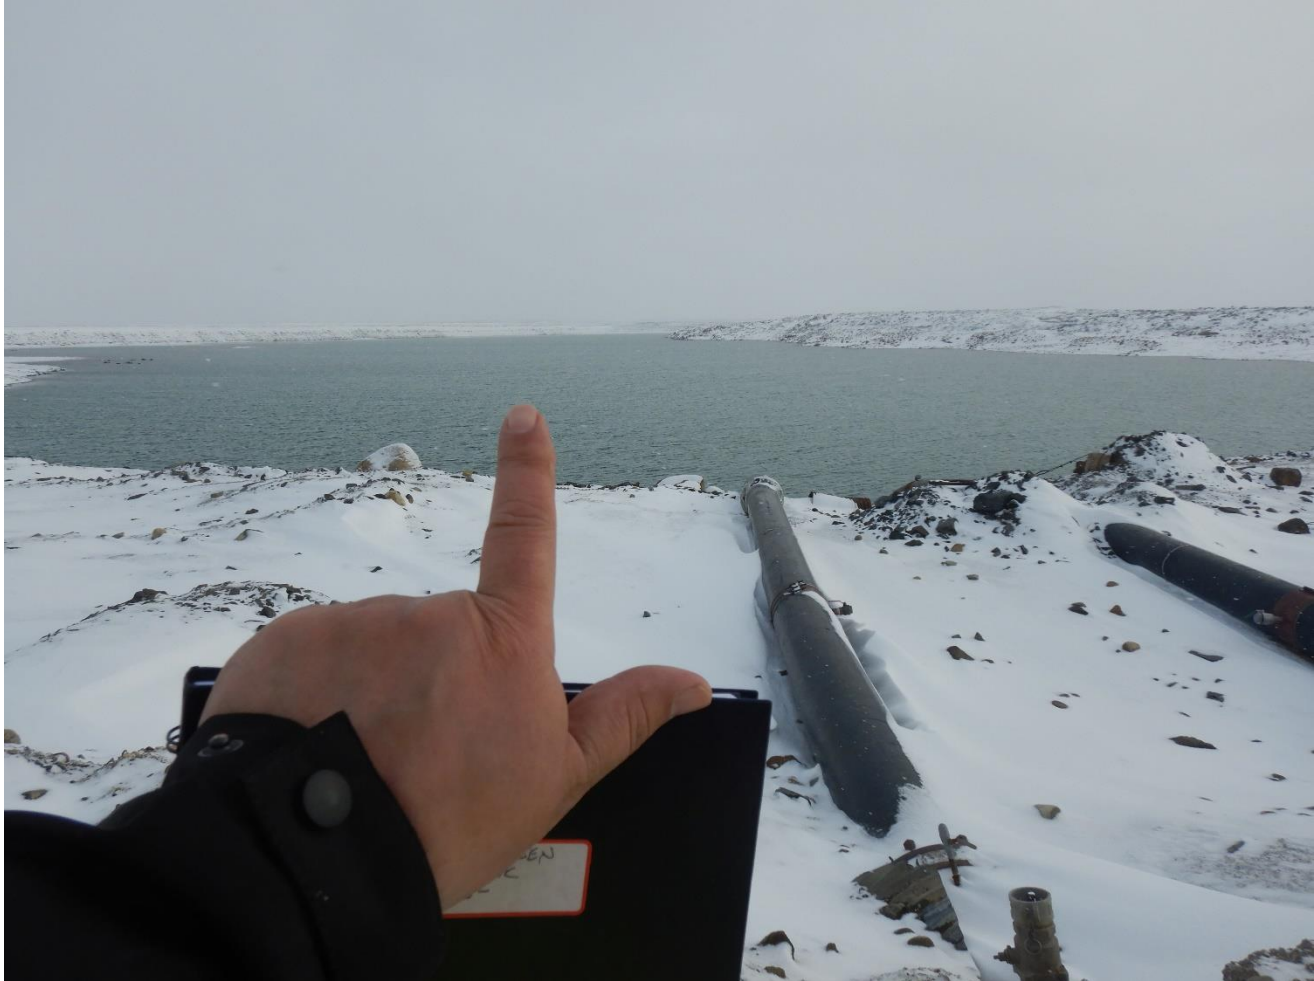
Photo 12

The Inspector saw the Syphons over J-Dam where Water is pumped from Pond 1 into Pond 2.
Eventually they will construct a Spill Way at this location

Description: Syphons over J-Dam from Pond 1 into Pond 2, View 1

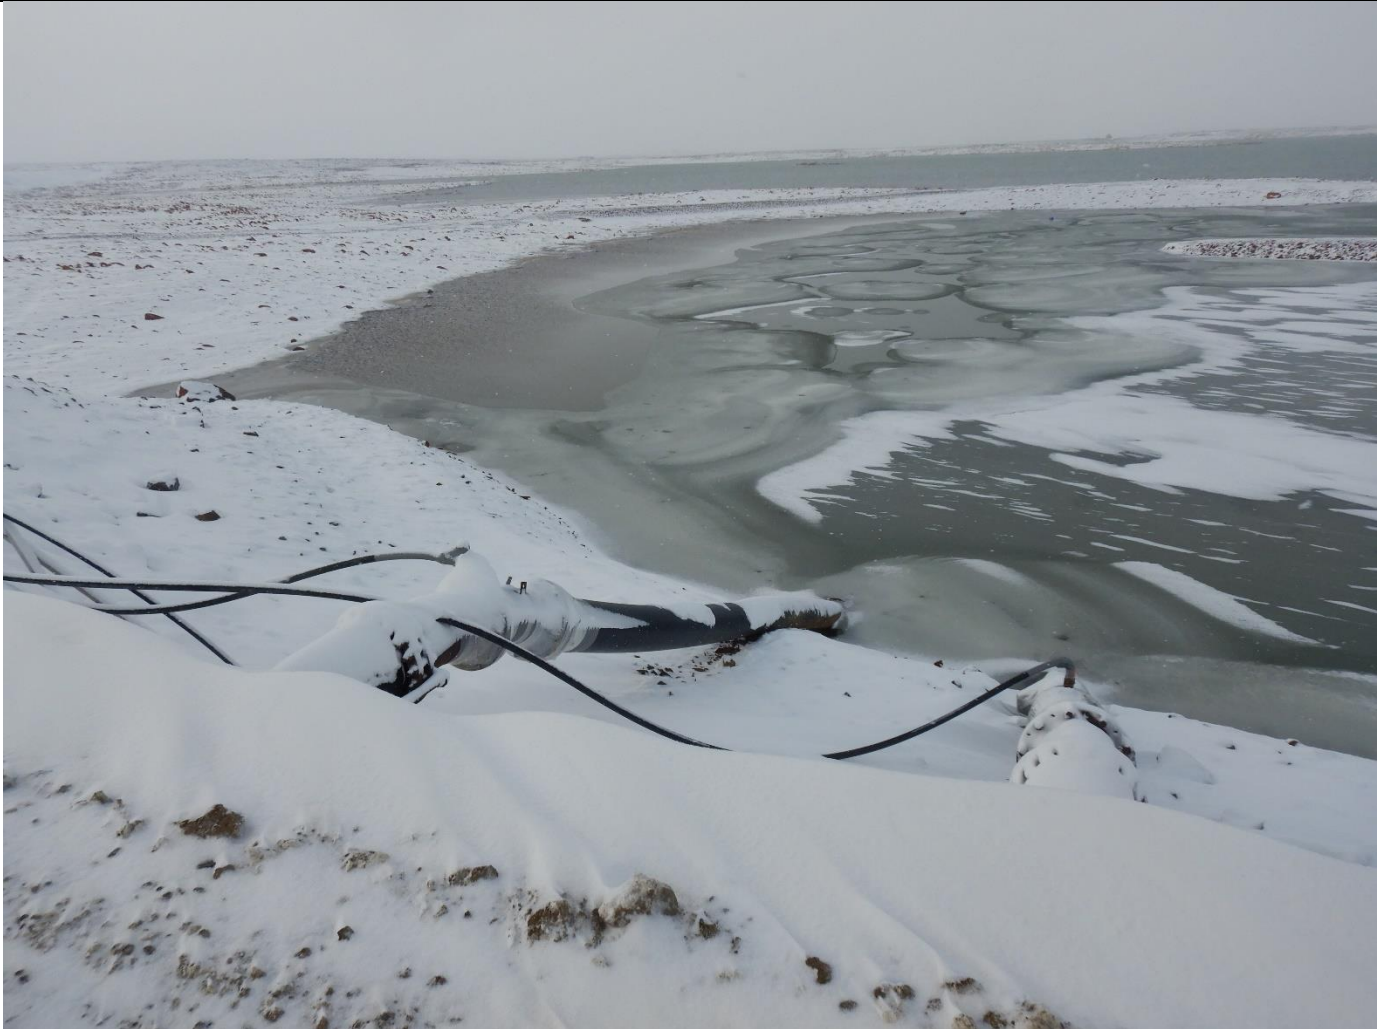
Photo 13

Description: Syphons over J-Dam from Pond 1 into Pond 2, View 2

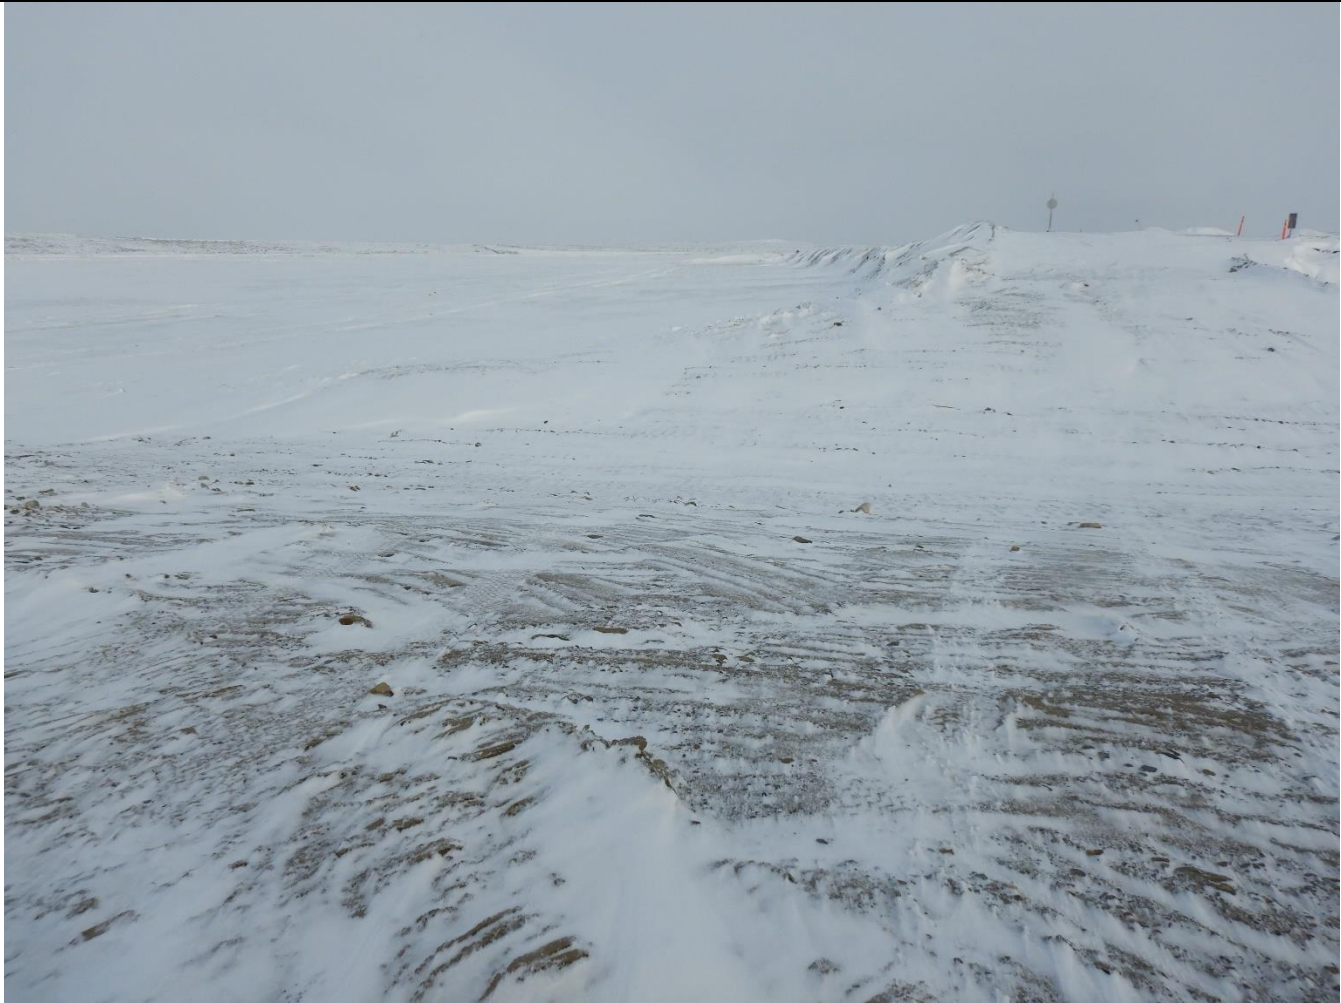
Photo 14

They have Completed the Outflow Channel between Cell 5 (on the left) and Pond 1 (on the right), Water Flow is from Left to Right

Description: Out Flow Channel between Cell 5 (on the left) and Pond 1 (on the right), Water Flow is from Left to Right – View 1

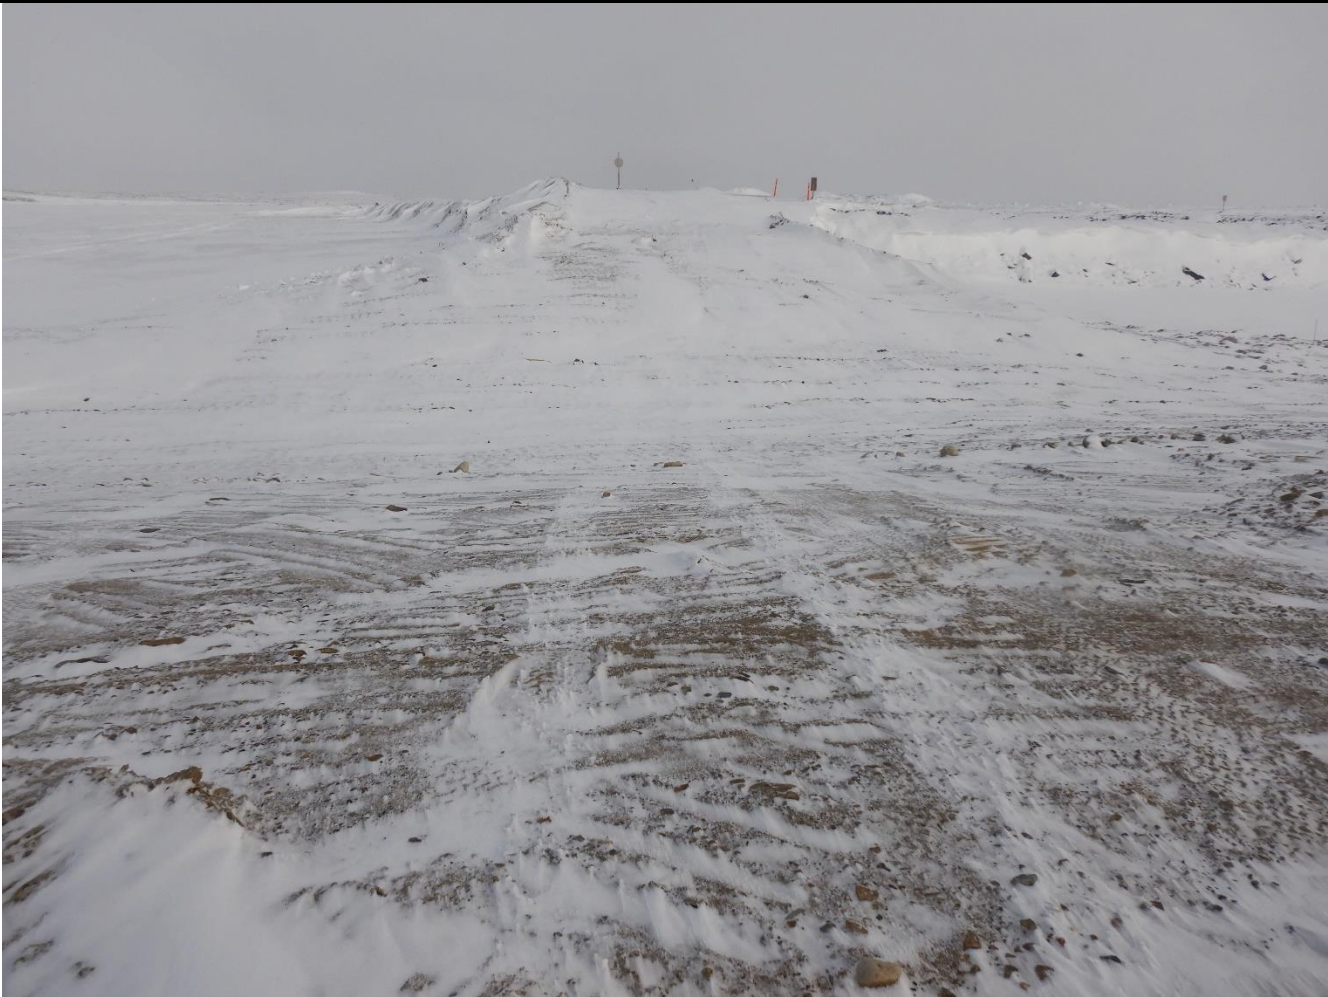
Photo 15

Description: Out Flow Channel between Cell 5 (on the left) and Pond 1 (on the right), Water Flow is from Left to Right – View 2

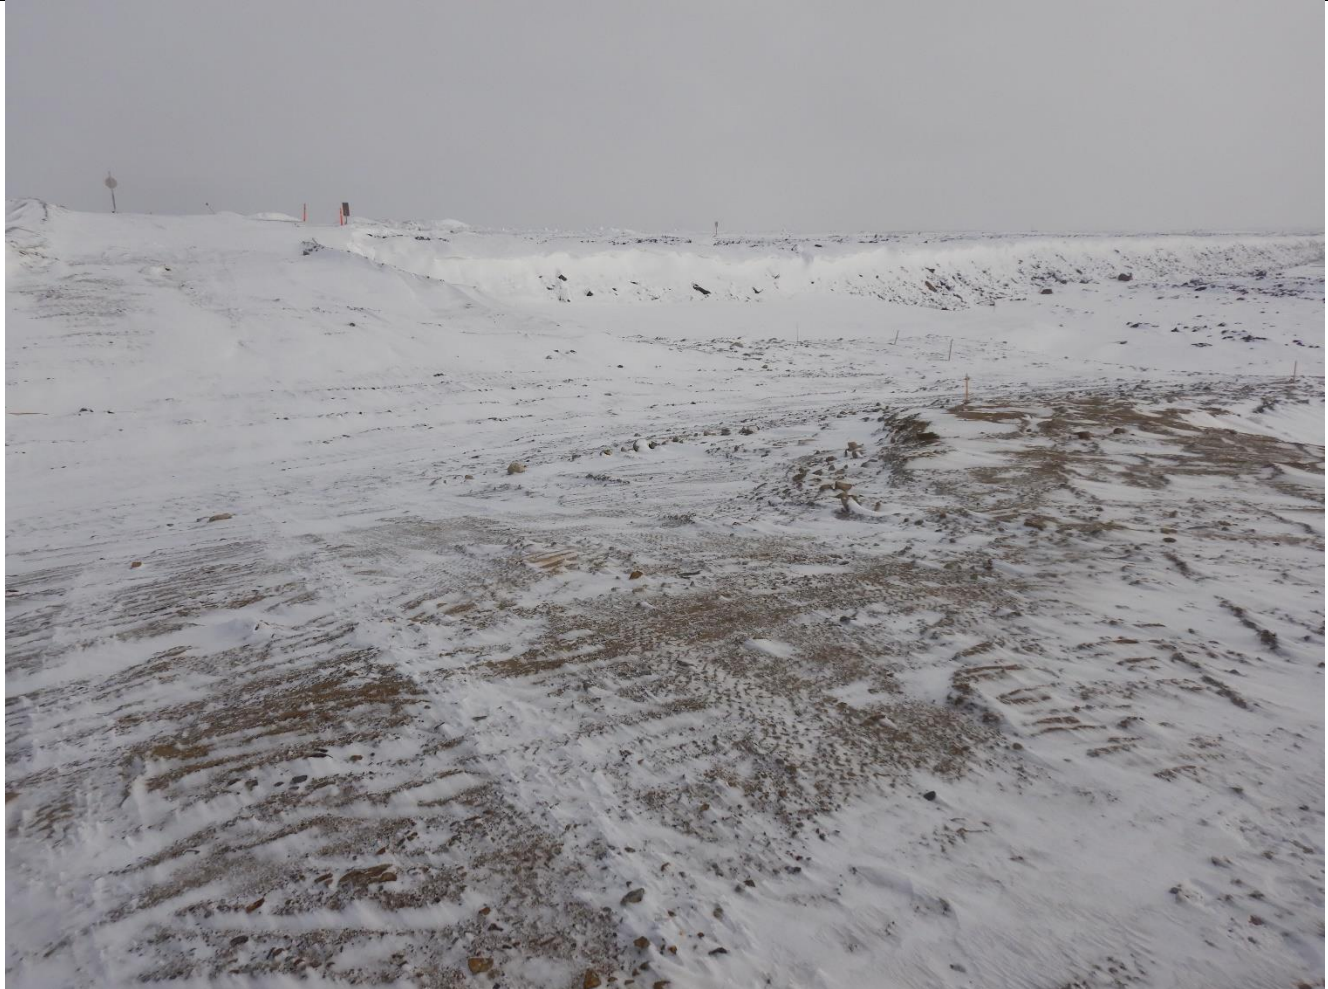
Photo 16

Description: Out Flow Channel between Cell 5 (on the left) and Pond 1 (on the right), Water Flow is from Left to Right – View 3

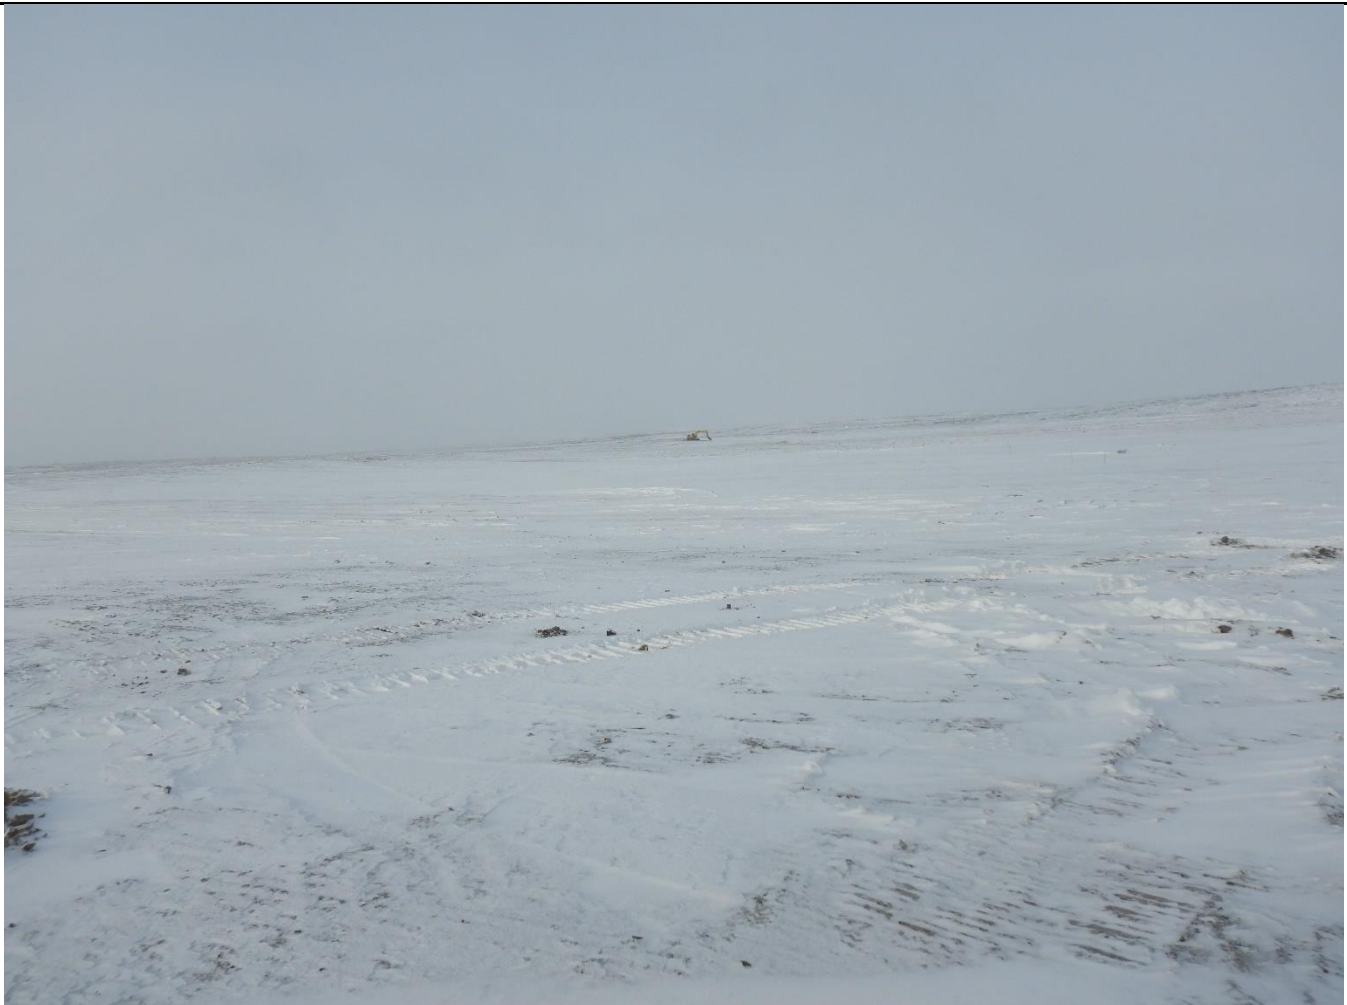
Photo 17

Cell 5 is now Complete, Stantec will have a Final Report within 2 Months.

Description: Cell 5 is now Completed – View 1

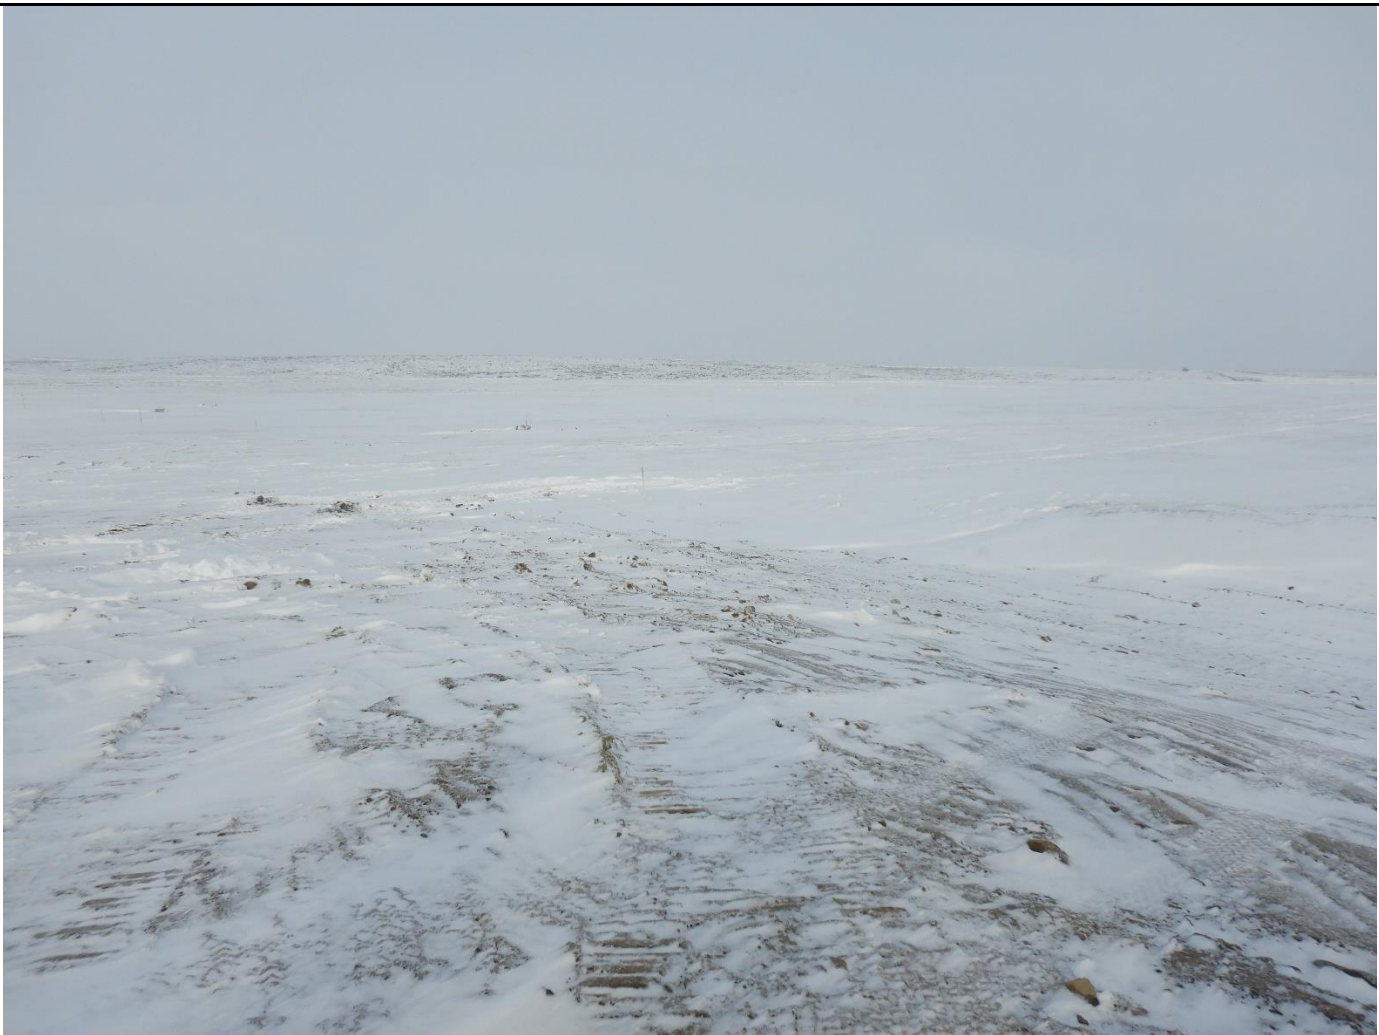
Photo 18

Description: Cell 5 is now Completed – View 2

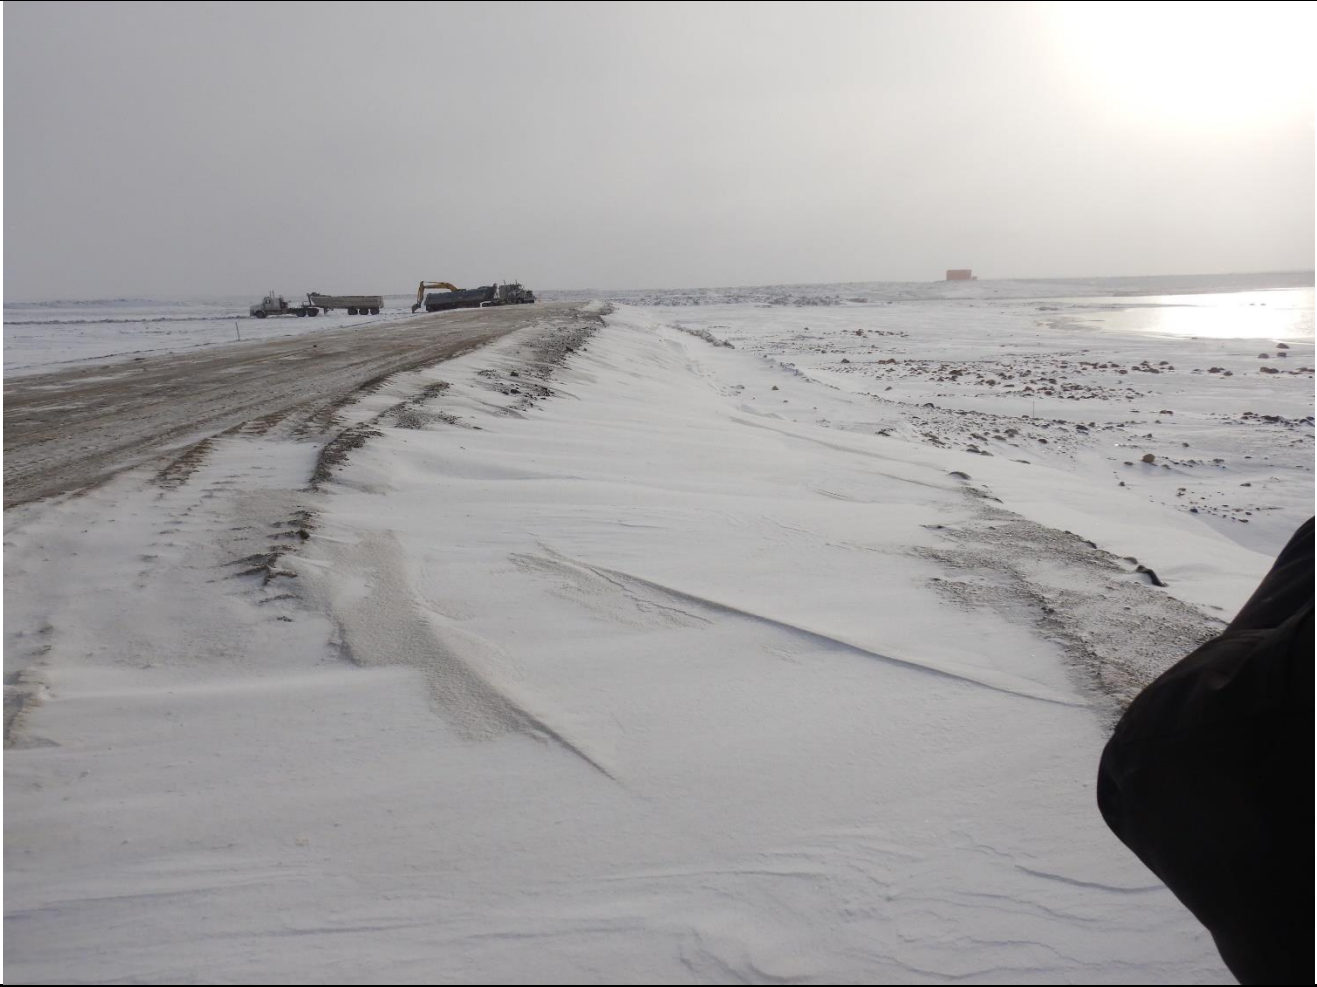
Photo 19

The Repairs to the M-Dam (under snow on right hand side) were Completed on October 5th, Thomas Milks from DST Englobe has photos of the repair work taken on Oct 5th.

Description: Location where Repairs were Completed on the M-Dam (covered in snow)

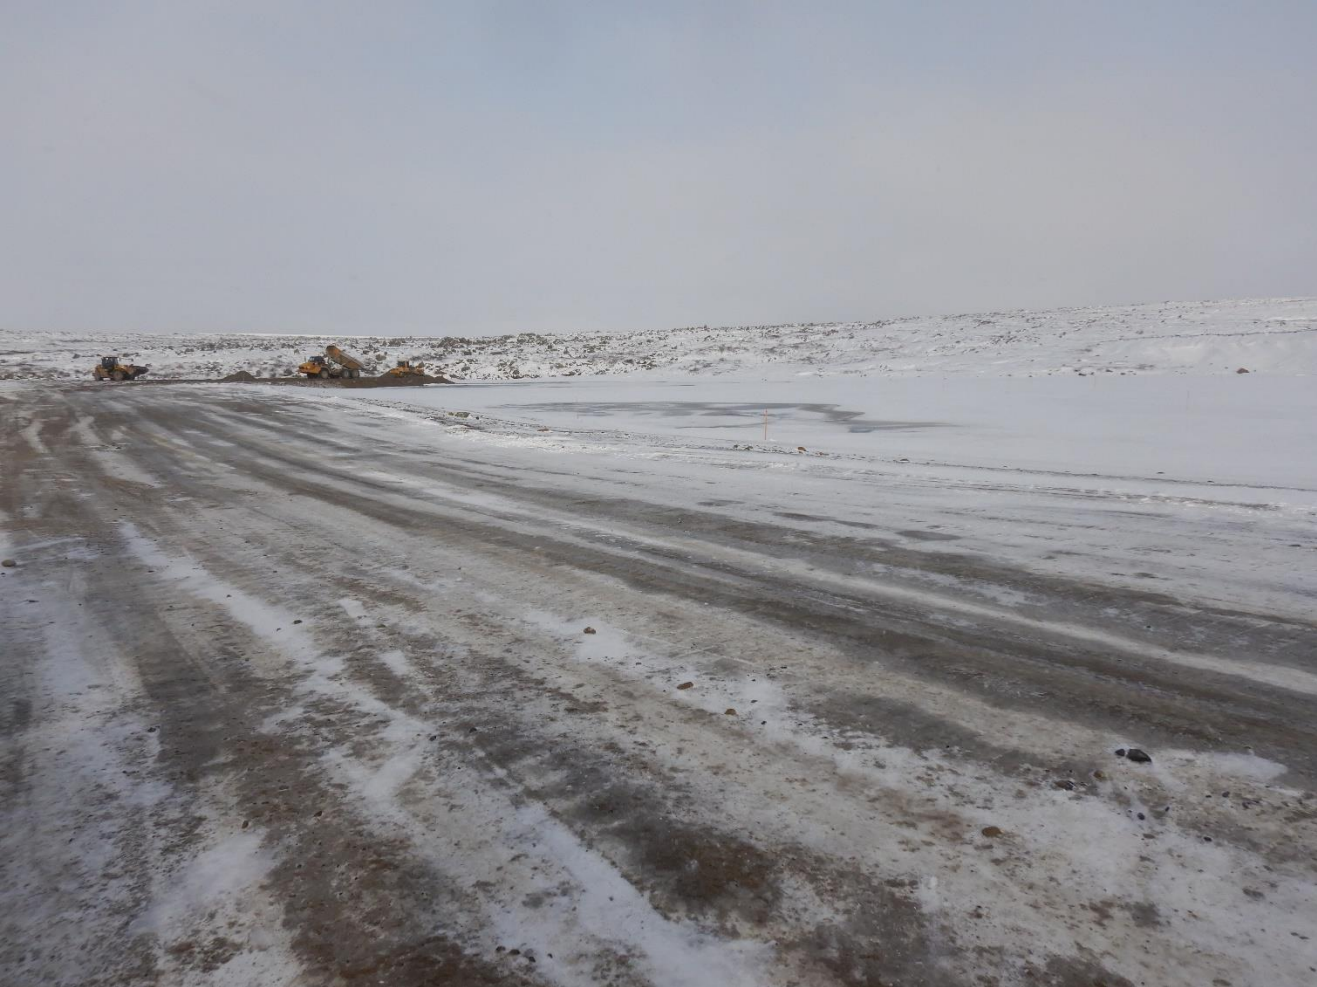
Photo 20

Lots of Heavy Equipment was actively Filling In Cell N (which is Part of Cell 5) while I was on Site.
This is their Main Project until Closure for the Season within 1 Week

Description: Crews Filling In Cell N (which is part of Cell 5)
