WATER LICENCE INSPECTION FORM

Licensee		Licensee Representative	
Lupin Mines Incorporated (LMI)		Dave Vokey	
Licence No. / Expiry		Representative's Title	
2AM-LUP2032			
Land / Other Authorizations		Land / Other Authorizations	
Date of Inspection		Inspector	
2021 October 10		Baba Pedersen	
Activities Inspected			
<input checked="" type="checkbox"/> Camp	<input type="checkbox"/> Drilling	<input type="checkbox"/> Mining	<input type="checkbox"/> Construction
<input type="checkbox"/> Roads/Hauling	<input type="checkbox"/> Other:	<input checked="" type="checkbox"/> Other: Security Reduction	<input checked="" type="checkbox"/> Reclamation
<input type="checkbox"/> Fuel Storage

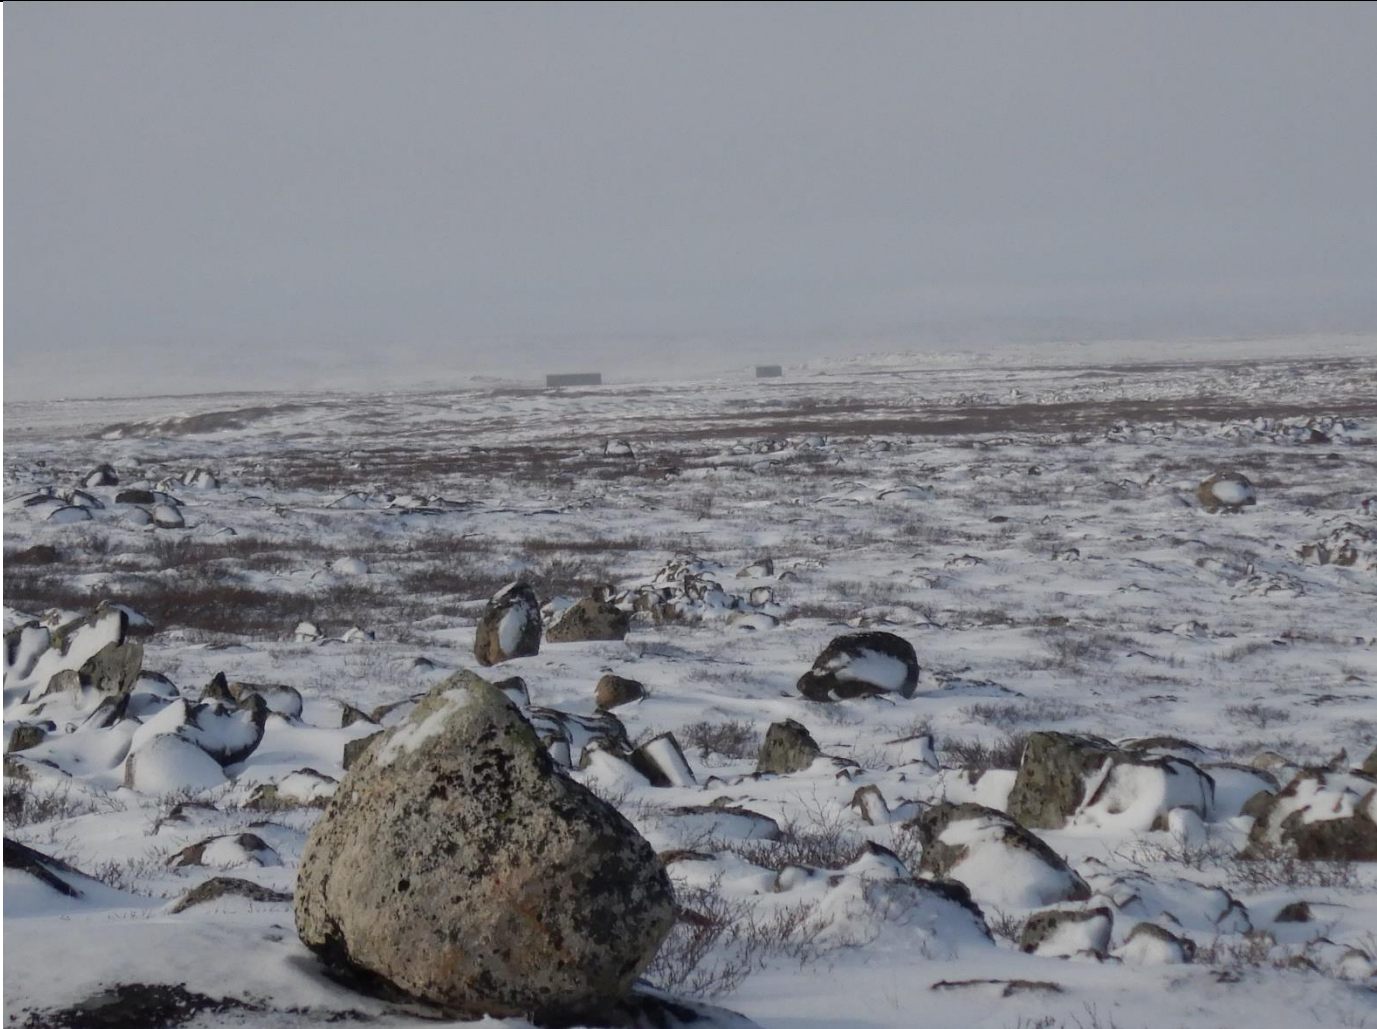
Photo 21

The Explosives Building, way off in the distance, is now Empty. The access road was not passable on this day due to snow drifts.
Thomas Milks with DST Englobe has photos of this from earlier in the season

Description: Explosives Storage Buildings as seen from a distance due to access road not usable on this day from snow drifting

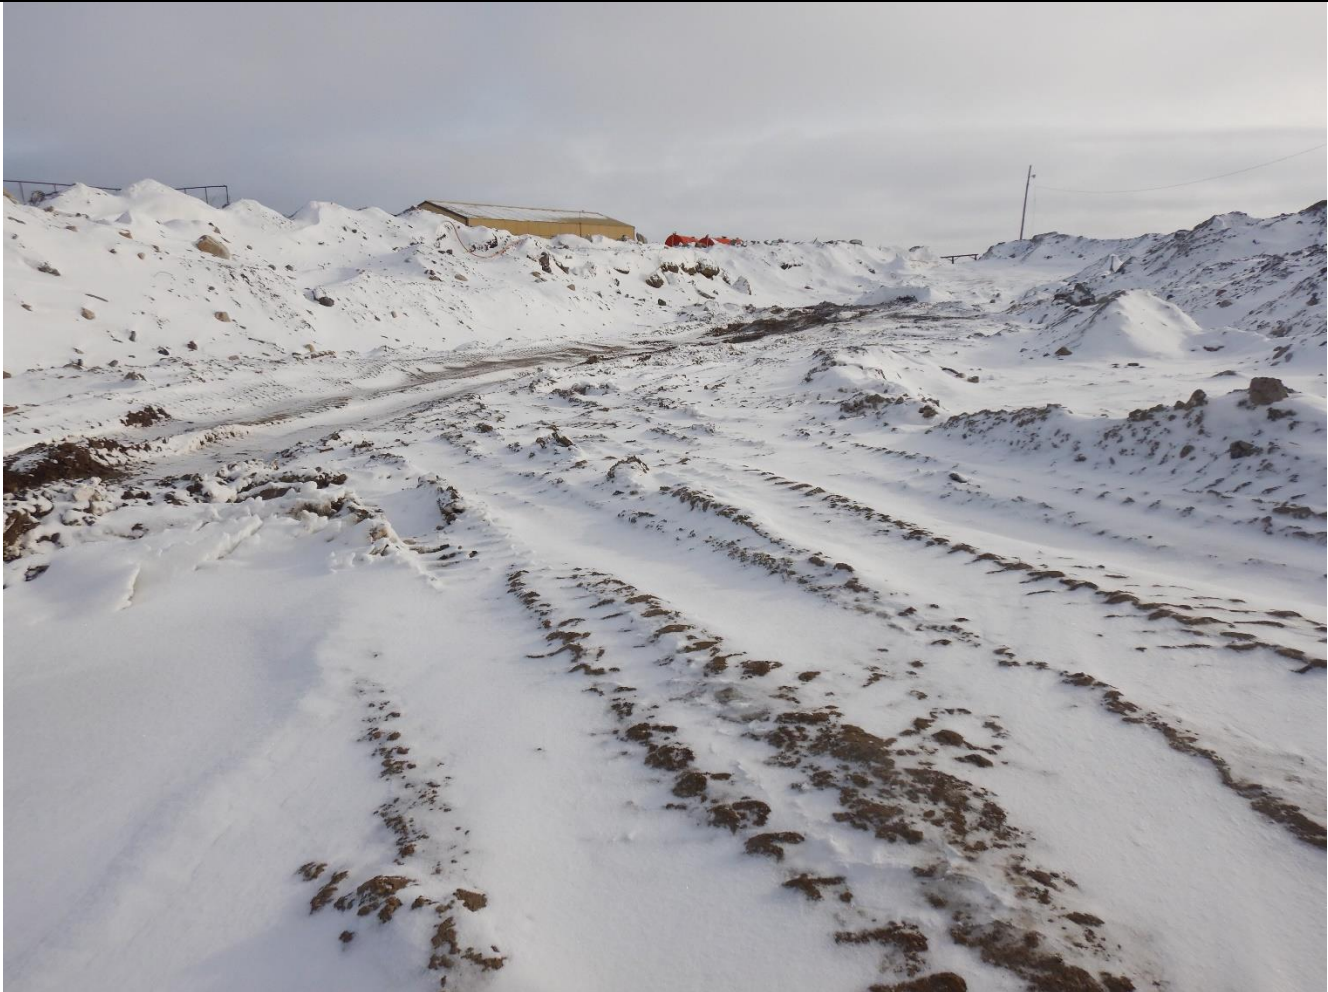
Photo 22

The Crown Pillar Area has been Drilled and Blasted then Filled with Contaminated Soils. Approximately 4 to 5 Meters Deep of Fill will be added next year as part of the Capping Process in this entire area.
This photo was taken from approximately N 65° 45' 51.4" and W 111° 14' 03.3"

Description: Crown Pillar Area after being Drilled and Blasted then Filled with Contaminated Soils – View 1

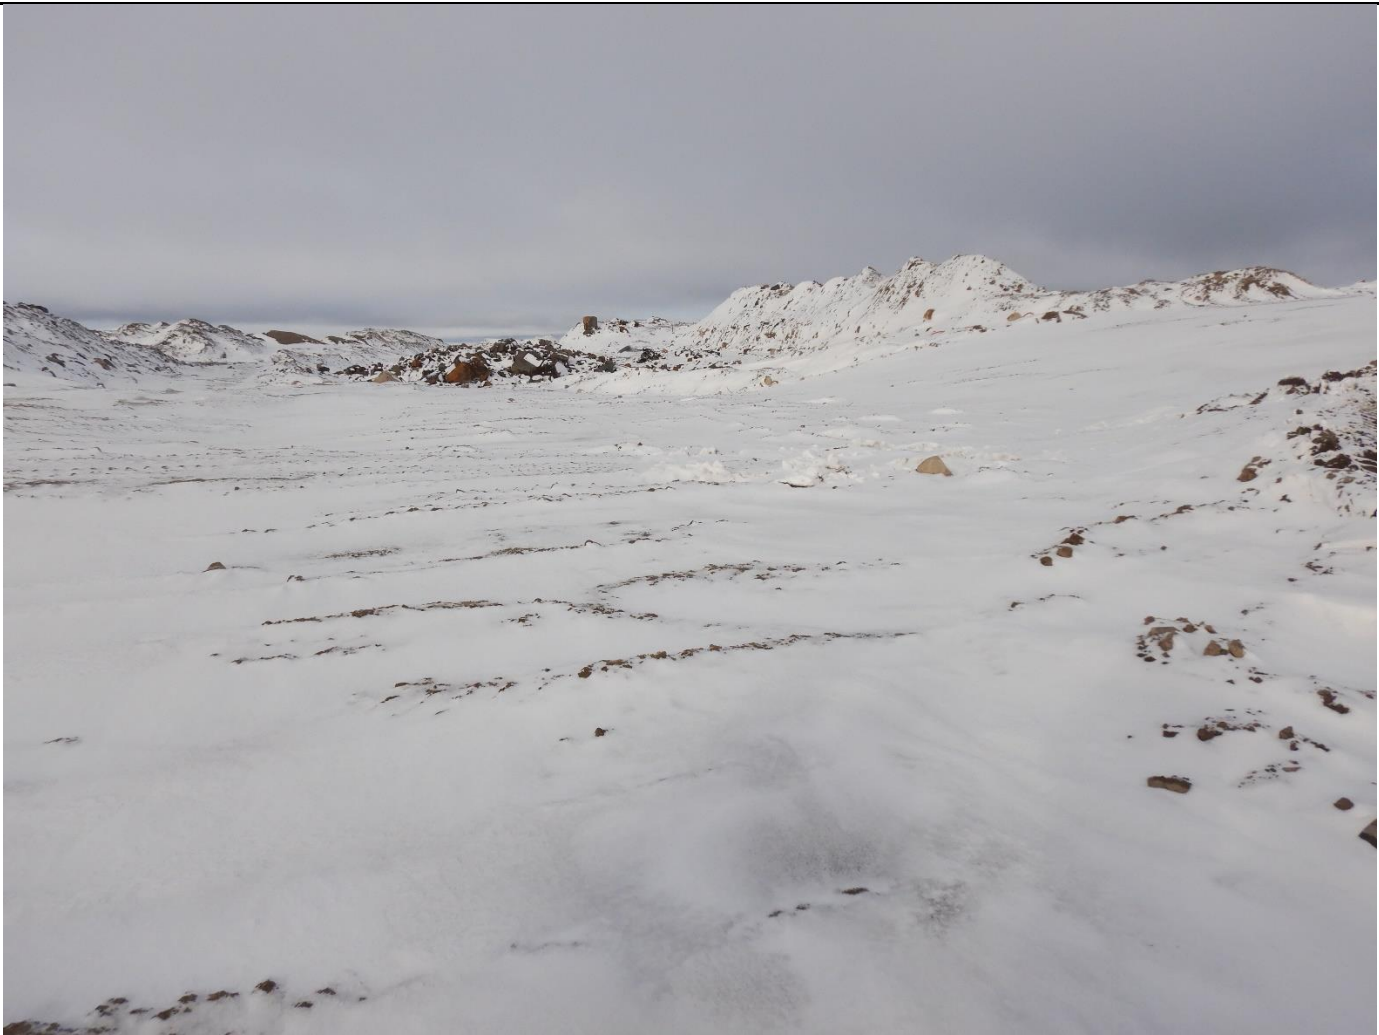
Photo 23

Description: Crown Pillar Area after being Drilled and Blasted then Filled with Contaminated Soils – View 2

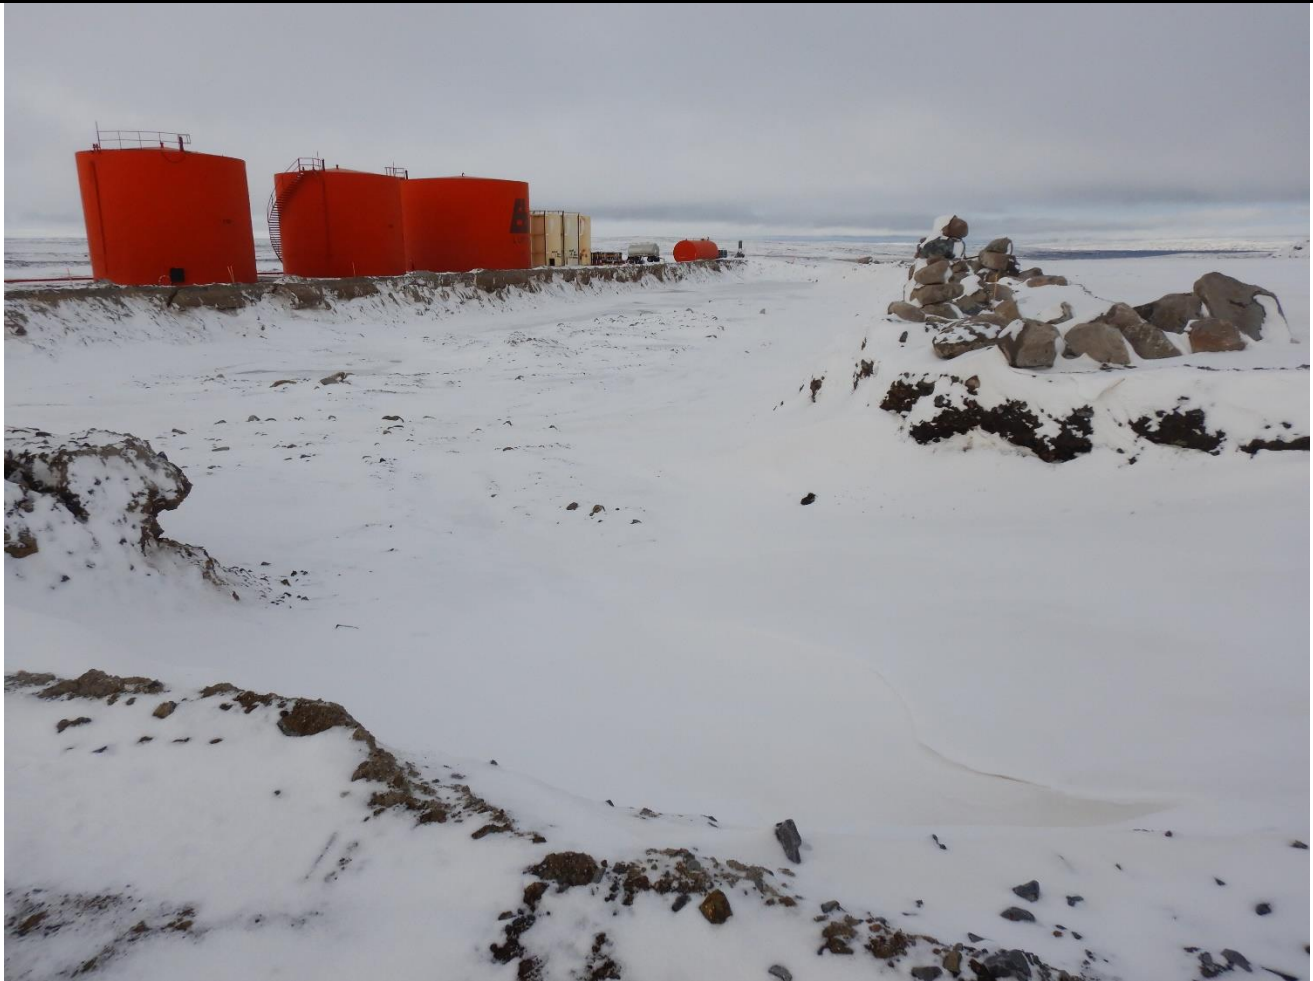
Photo 24

All Contaminated Soil from the Main Tank Farm has been Removed, they still need to refill the hole with Clean Gravel

Description: Excavated Main Tank Farm Area

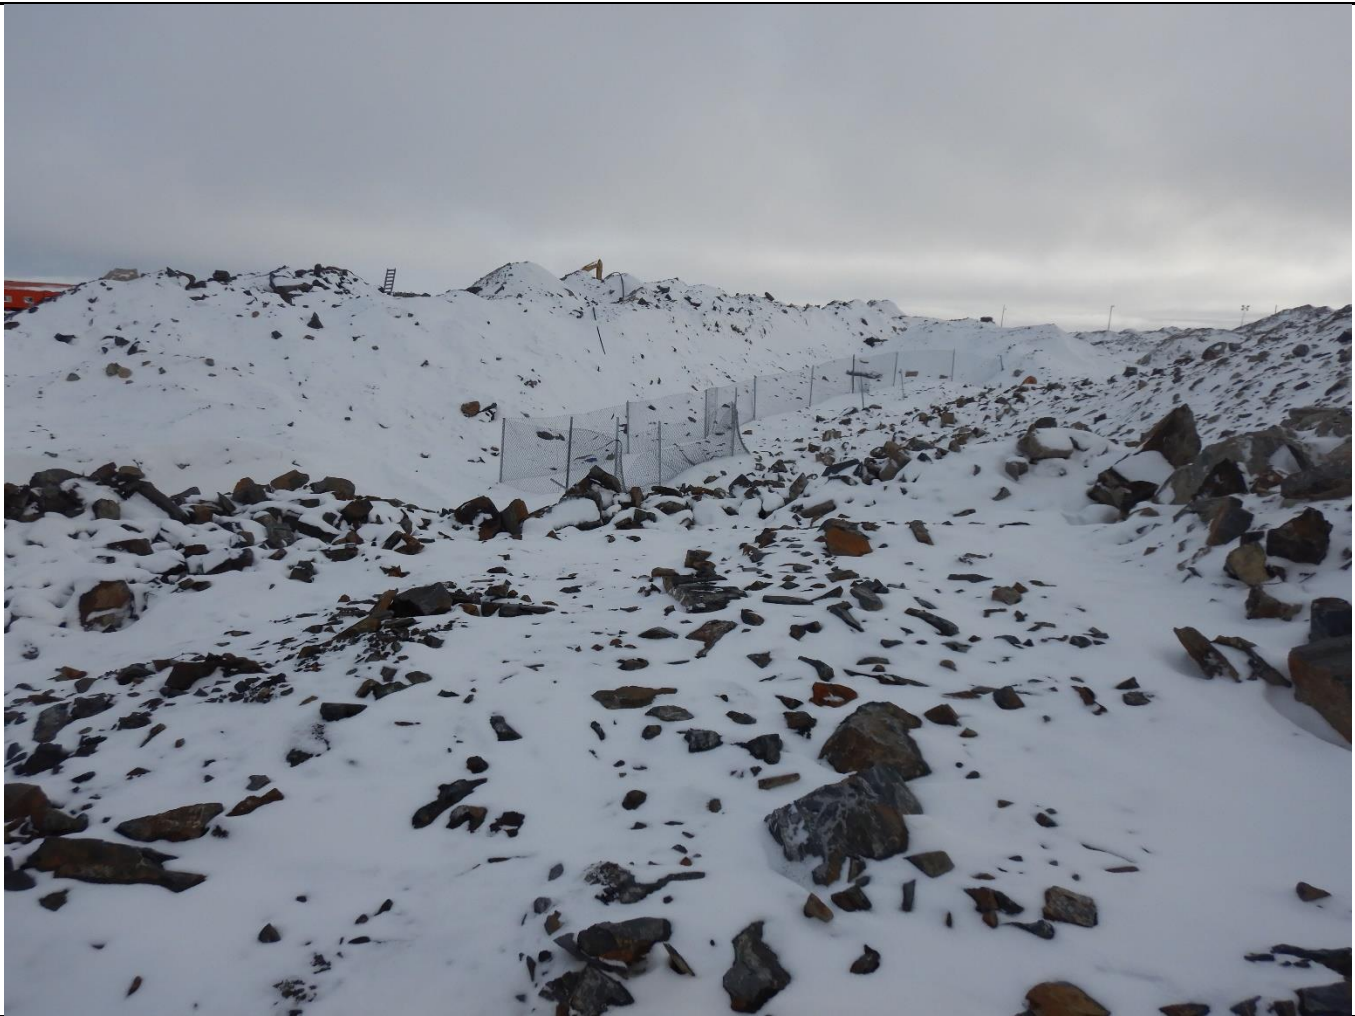
Photo 25

The West Zone of the Crown Pillar area still needs to be Drilled and Blasted, then this is where all remaining Contaminated Soils will be placed next year

Description: The West Zone of the Crown Pillar Area which will be Drilled, Blasted and Filled with Contaminated Soils next year – View 1

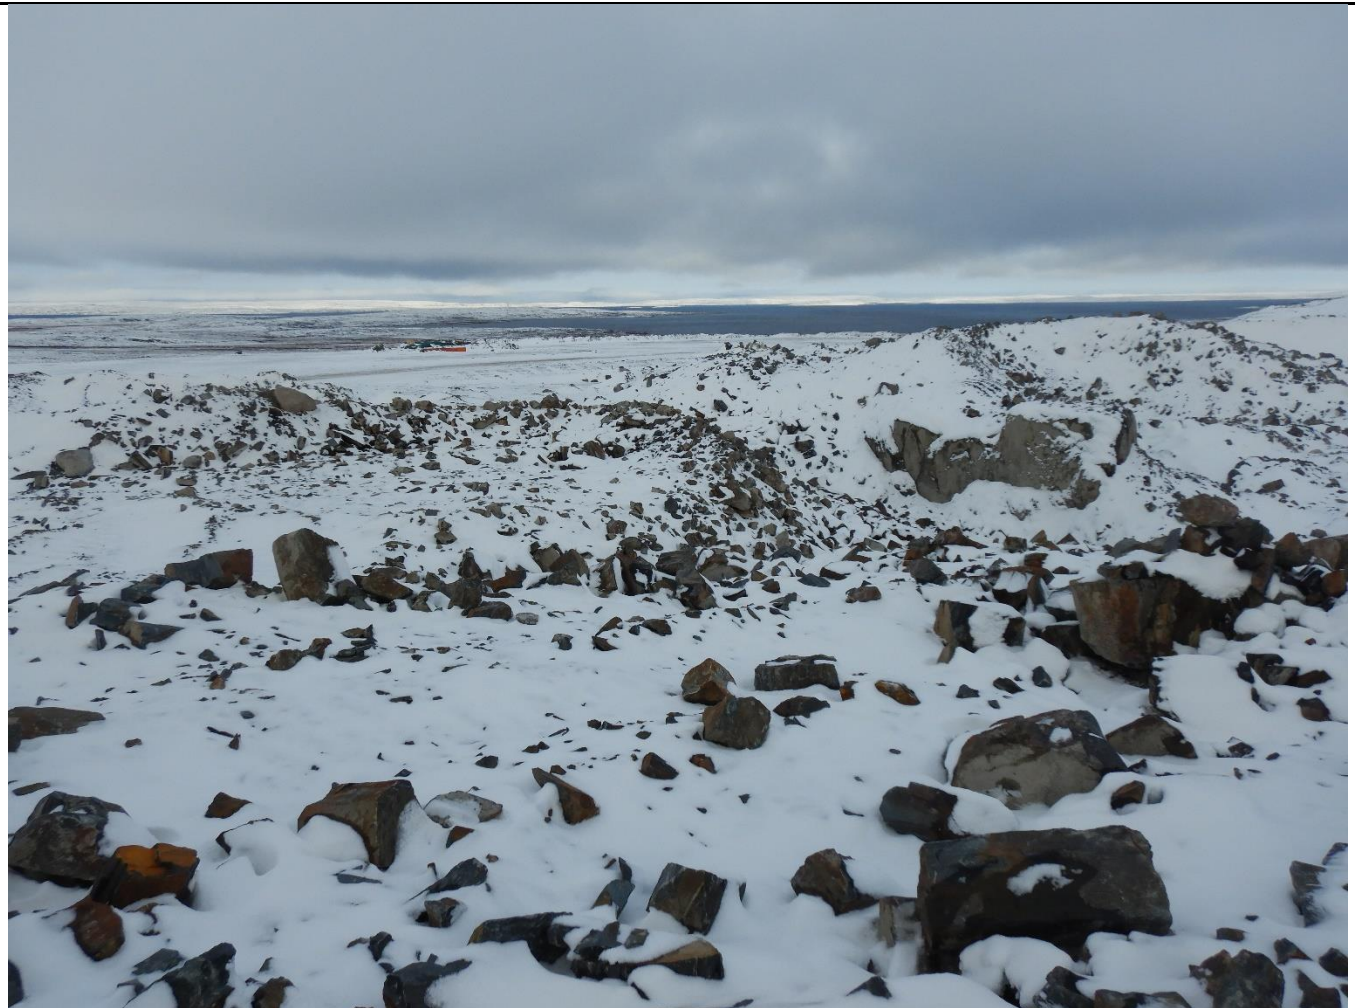
Photo 26

Description: The West Zone of the Crown Pillar Area which will be Drilled, Blasted and Filled with Contaminated Soils next year – View 2

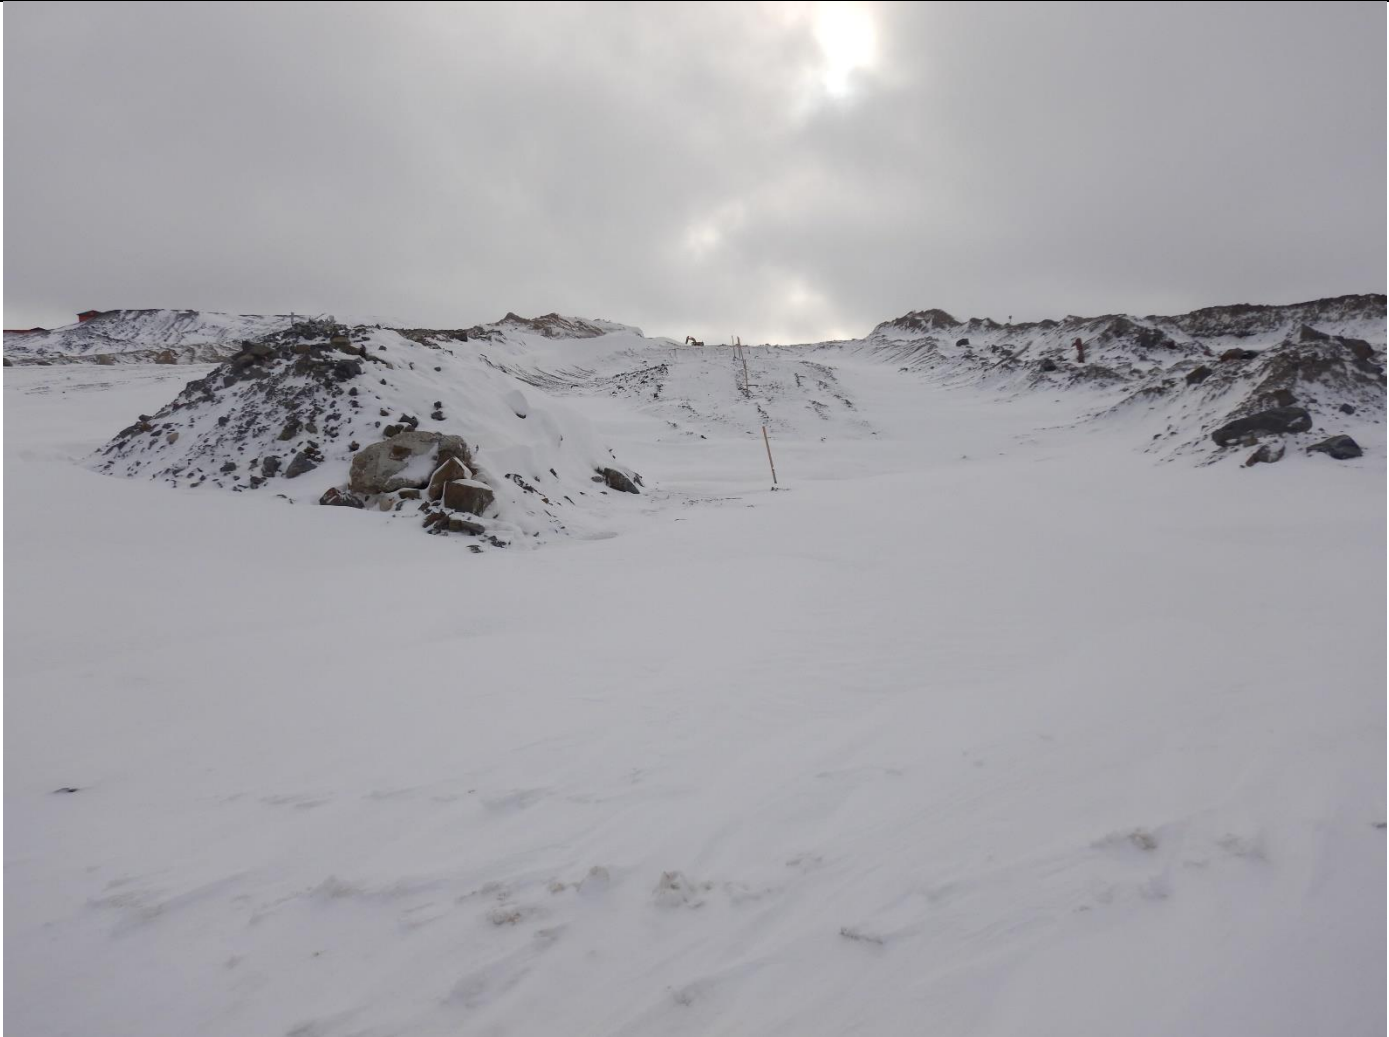
Photo 27

The Portal has been Cut Down and the Hole has been Filled.
They still need to add approximately 1 to 2 Meters of Fill across the Top as part of the overall Cap.

Description: The Portal Area

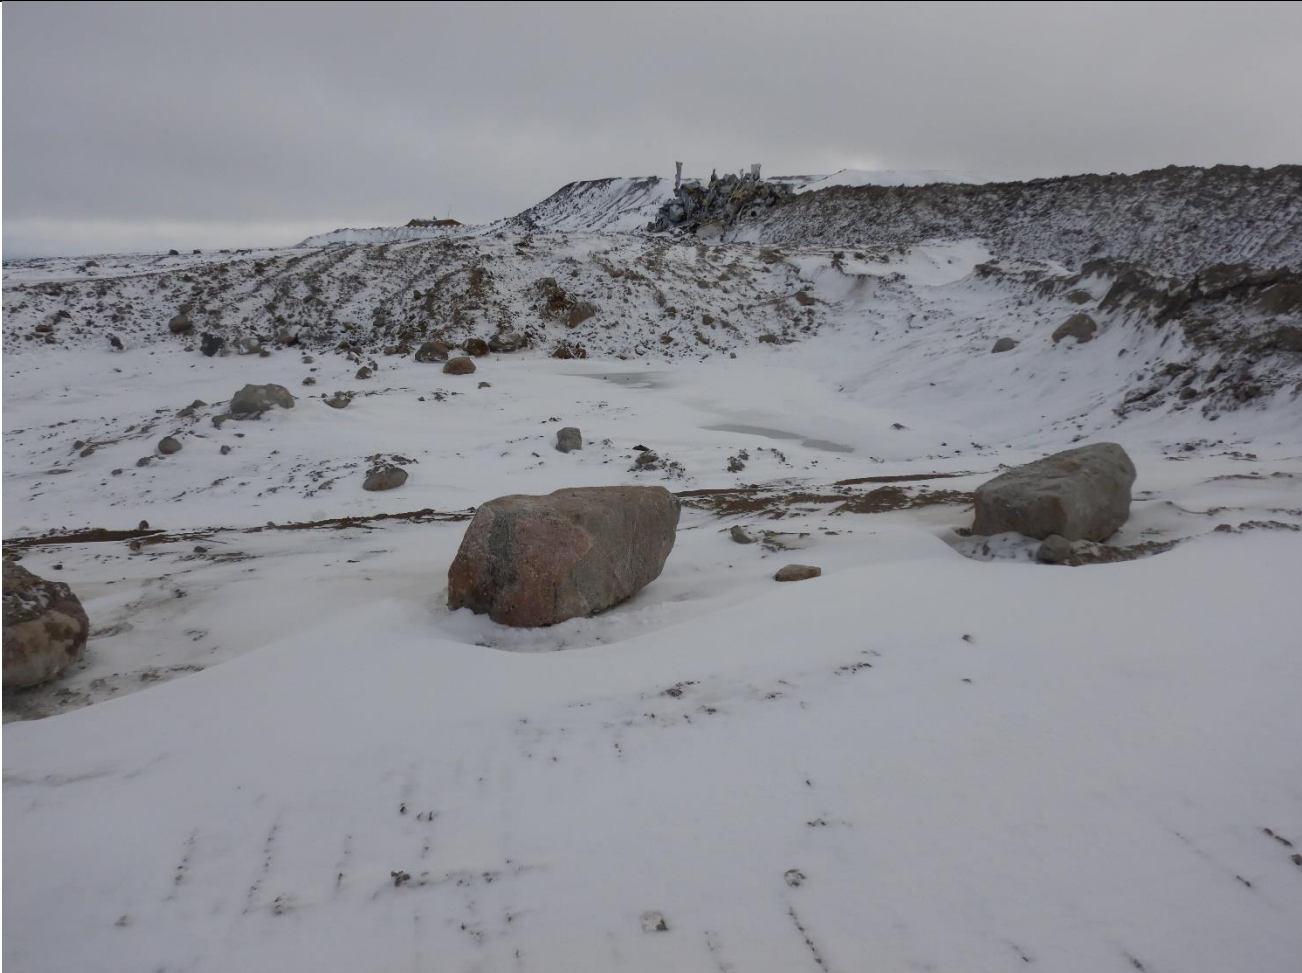
Photo 28

All Contaminated Soil has been Removed, and the Area has been Cleaned and Approved to be Back Filled

Description: Excavation Area # 9 where a Storage Garage used to be

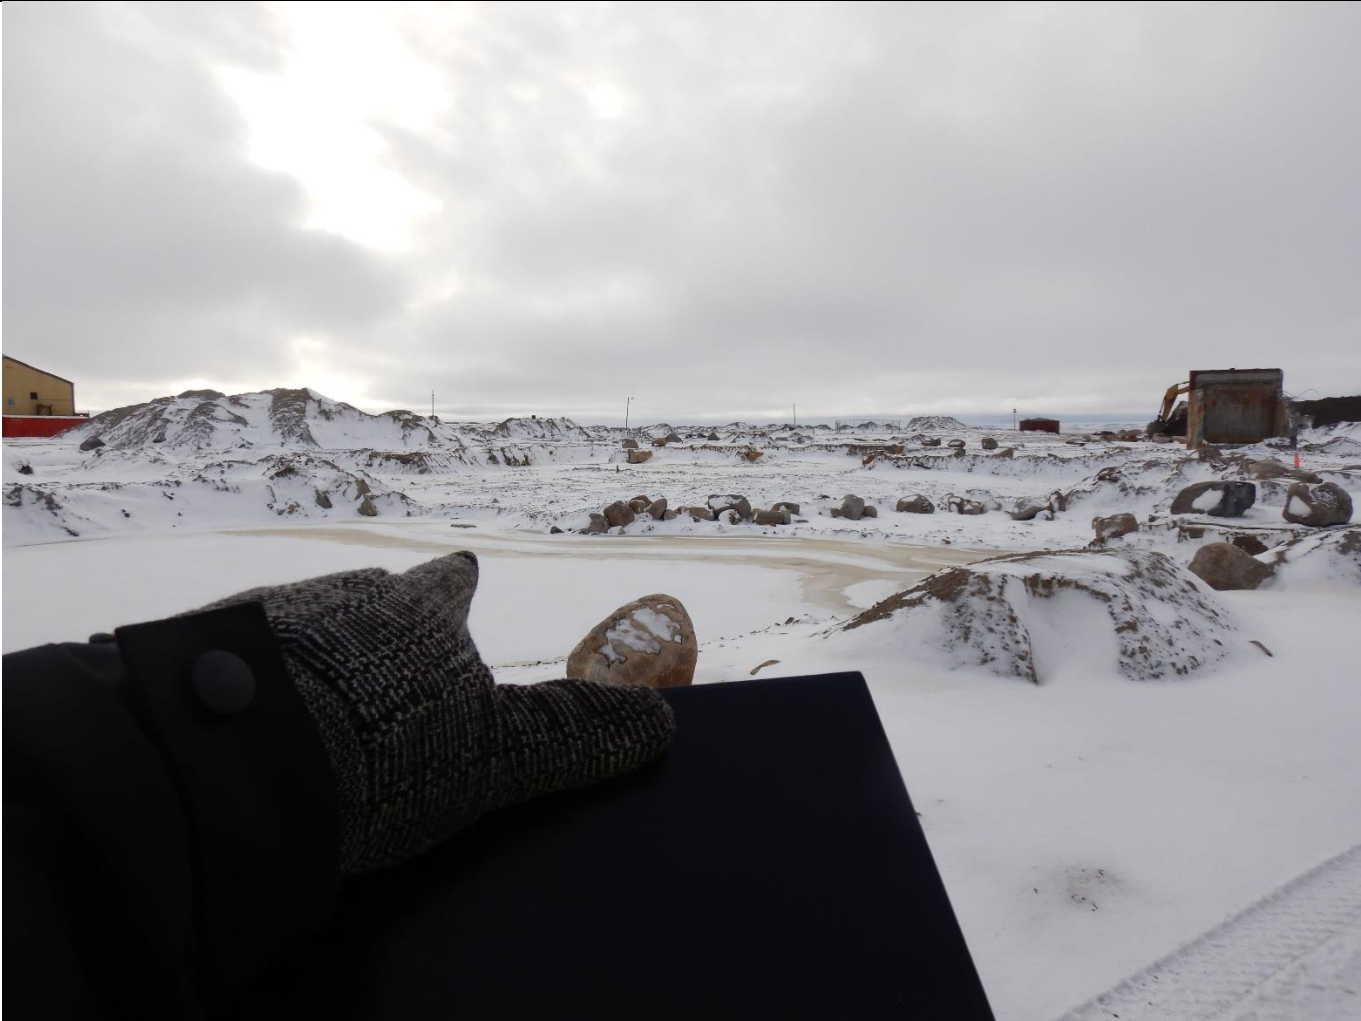
Photo 29

All Contaminated Soil has been Removed, and the Area has been Cleaned and Approved to be Back Filled

Description: Excavation Area # 16 where the Mill was and also the site of an Arsenic Excavation

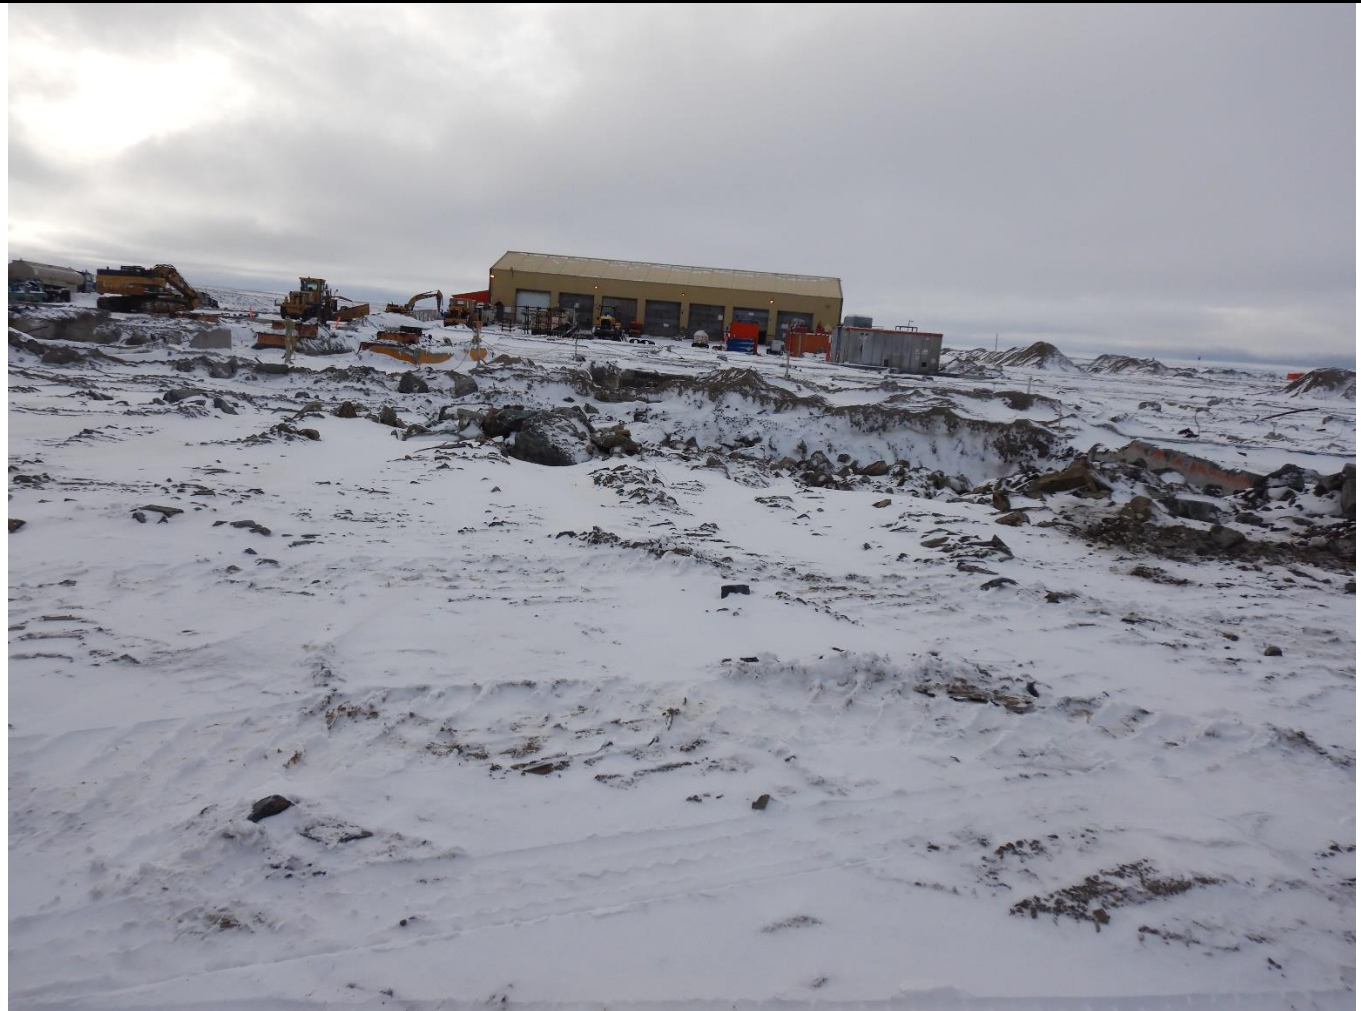
Photo 30

They plan to put Rock Fill in to make area flush with the ground this week.
The Concrete Floors have had Holes punched through and the area will be covered next year

Description: Excavation Areas # 22 & # 23, Concrete Floors have had Holes Punched through

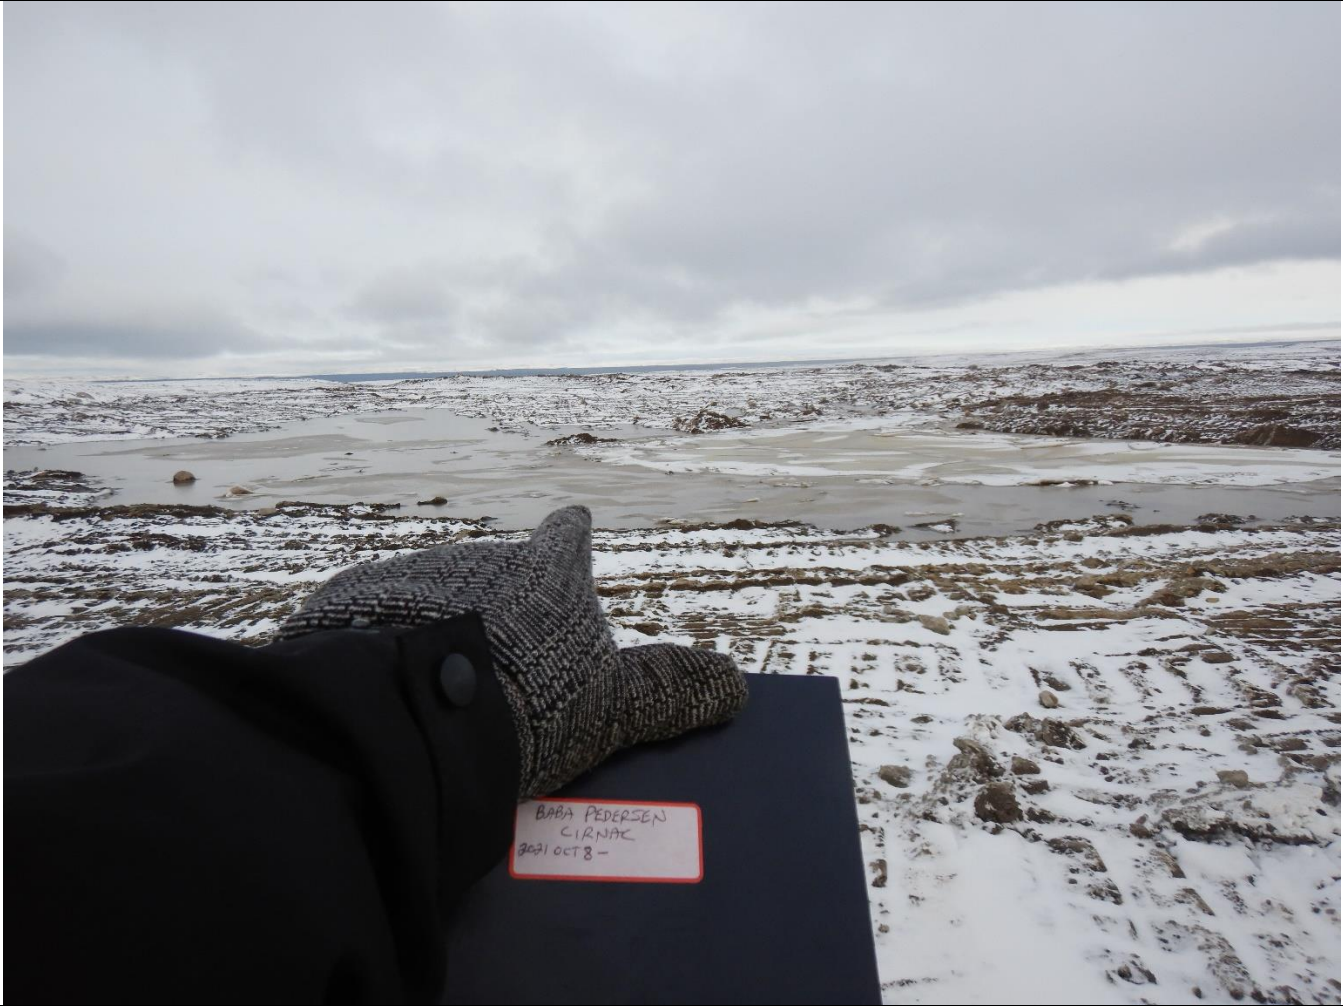
Photo 31

All Contaminated Soil has been Removed, and the Area has been Cleaned and is waiting to be Back Filled

Description: Excavation Areas # 12 & # 15 where the Contaminated Materials Storage Area and Burn Pit were located

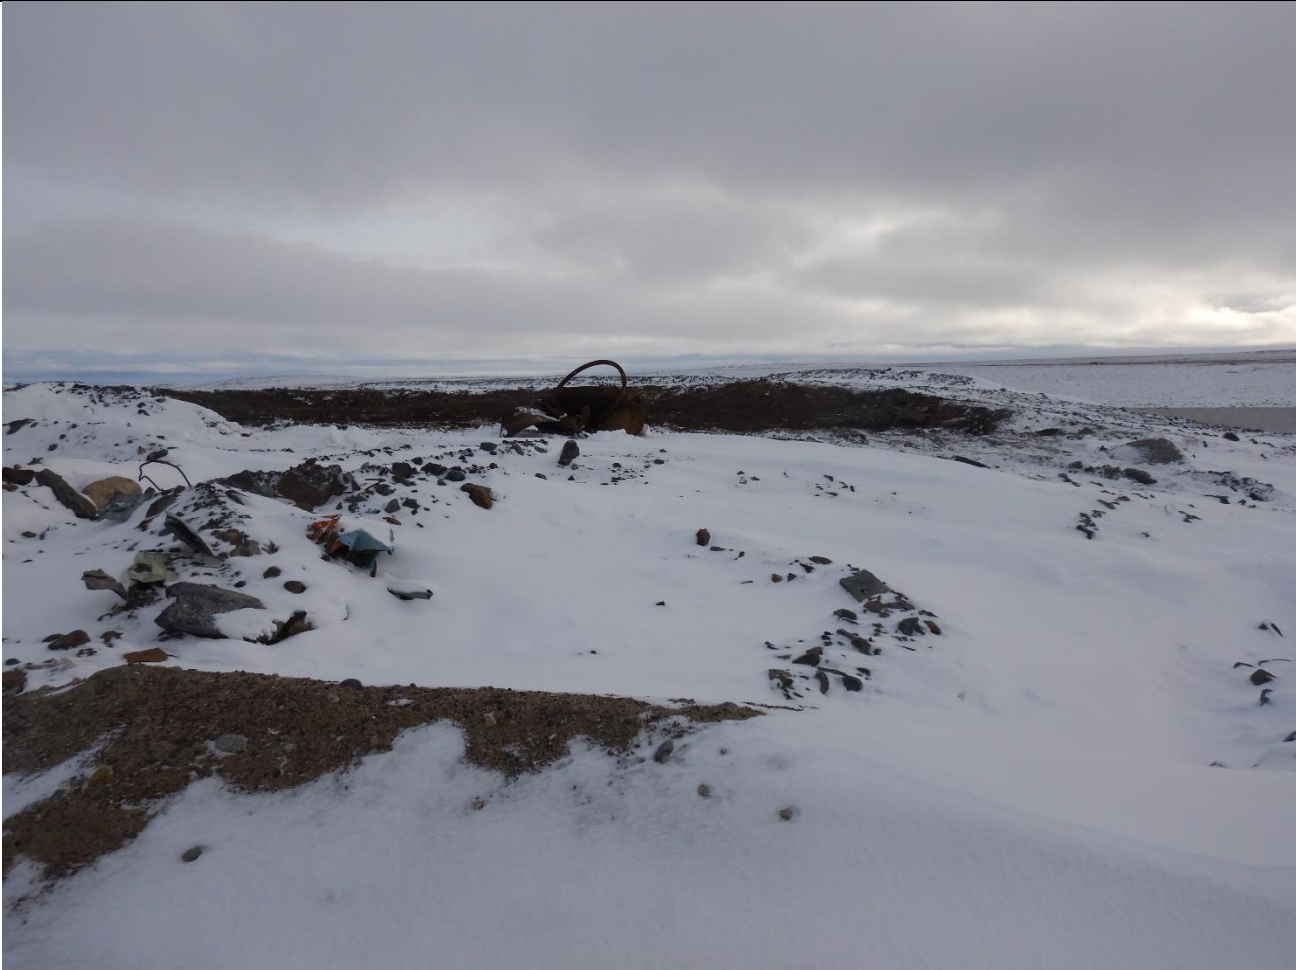
Photo 32

All Contaminated Soil has been Removed, and the Area has been Cleaned and is waiting to be Back Filled

Description: The Old Bone Yard Area

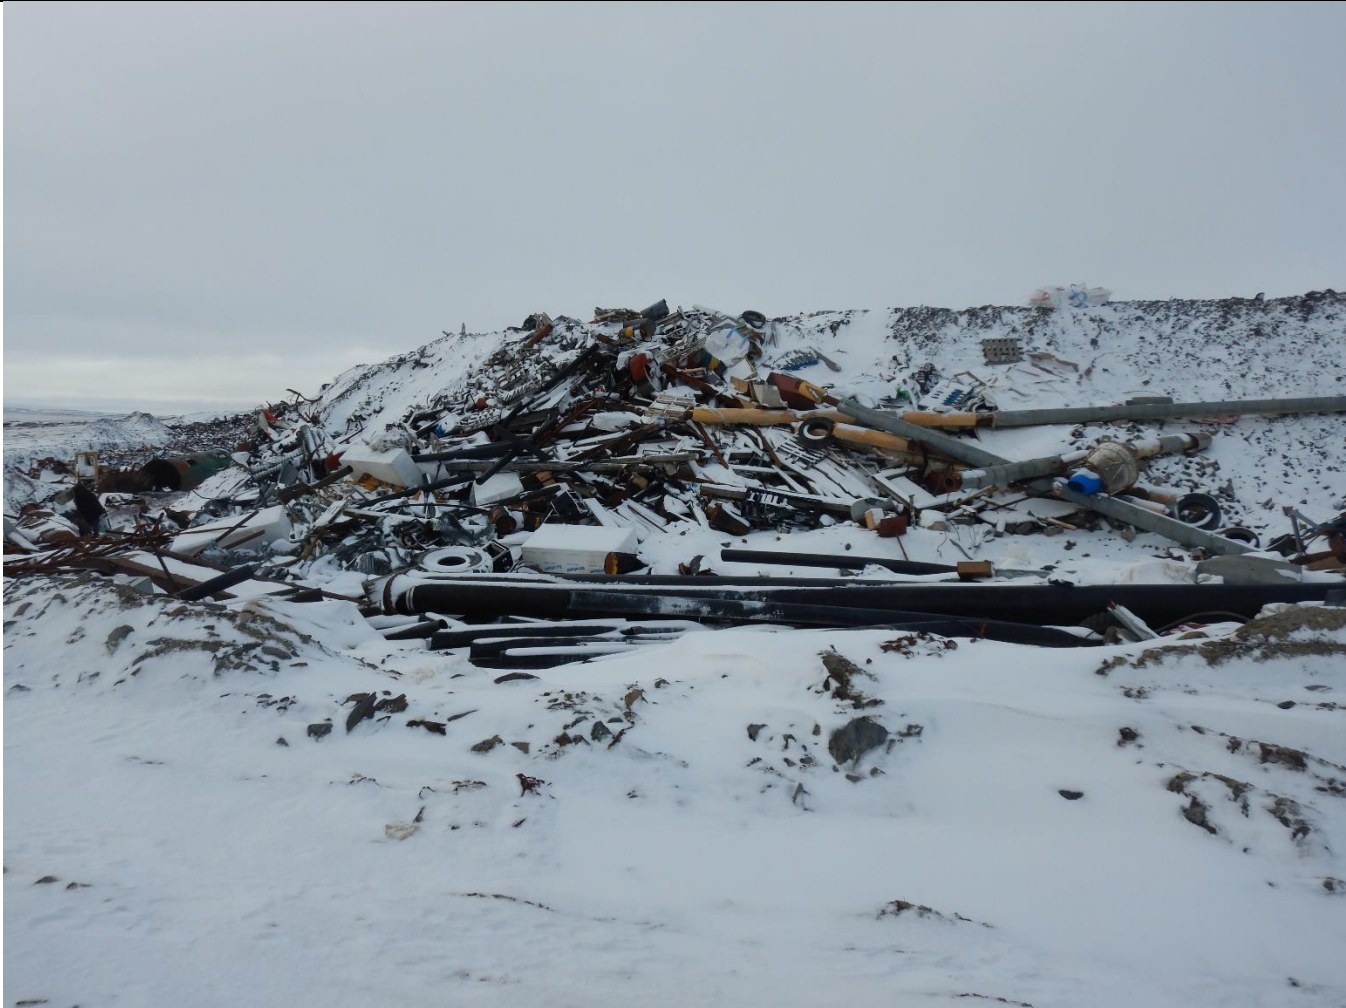
Photo 33

The Land Fill Area is still in Use and still needs to be Covered after all items have been placed within before project completion

Description: Land Fill Area – View 1

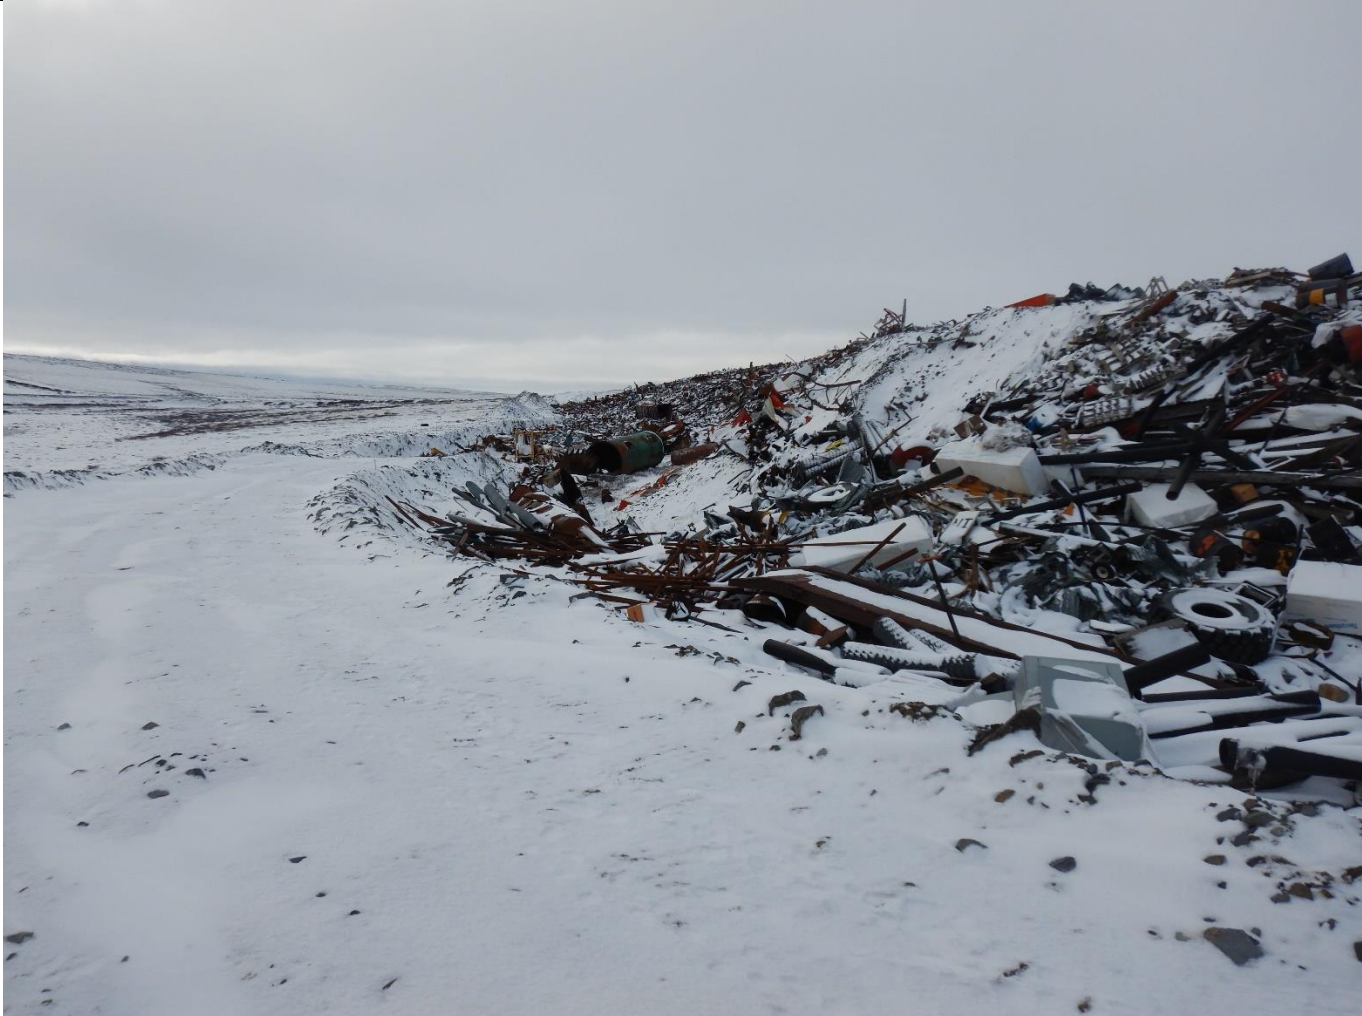
Photo 34

Description: Land Fill Area – View 2

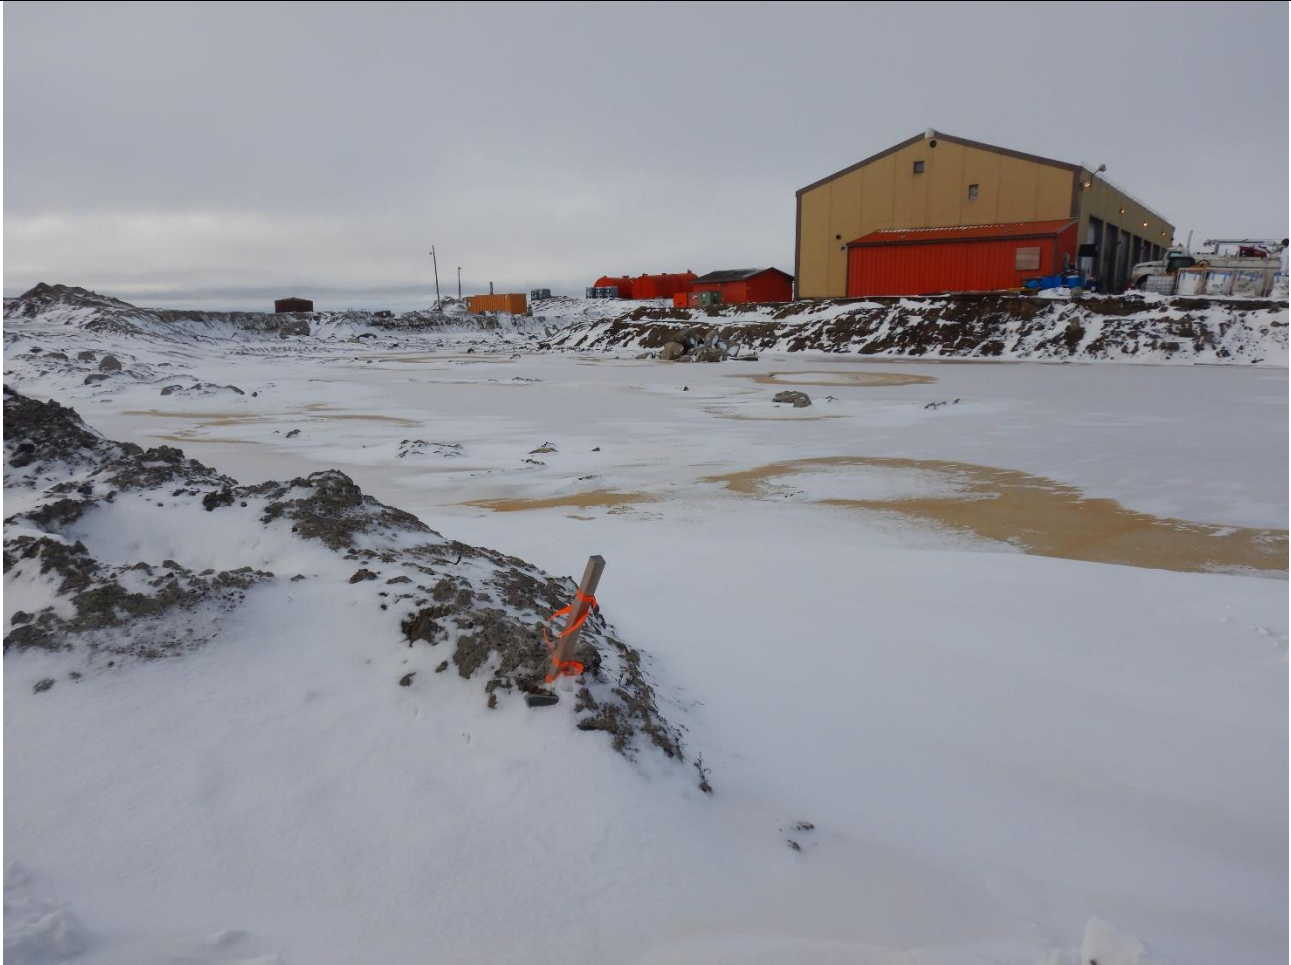
Photo 35

This area has been Started but it is not Completed yet

Description: Excavation Areas # 17 & # 18 where the Satellite Tank Farm was located

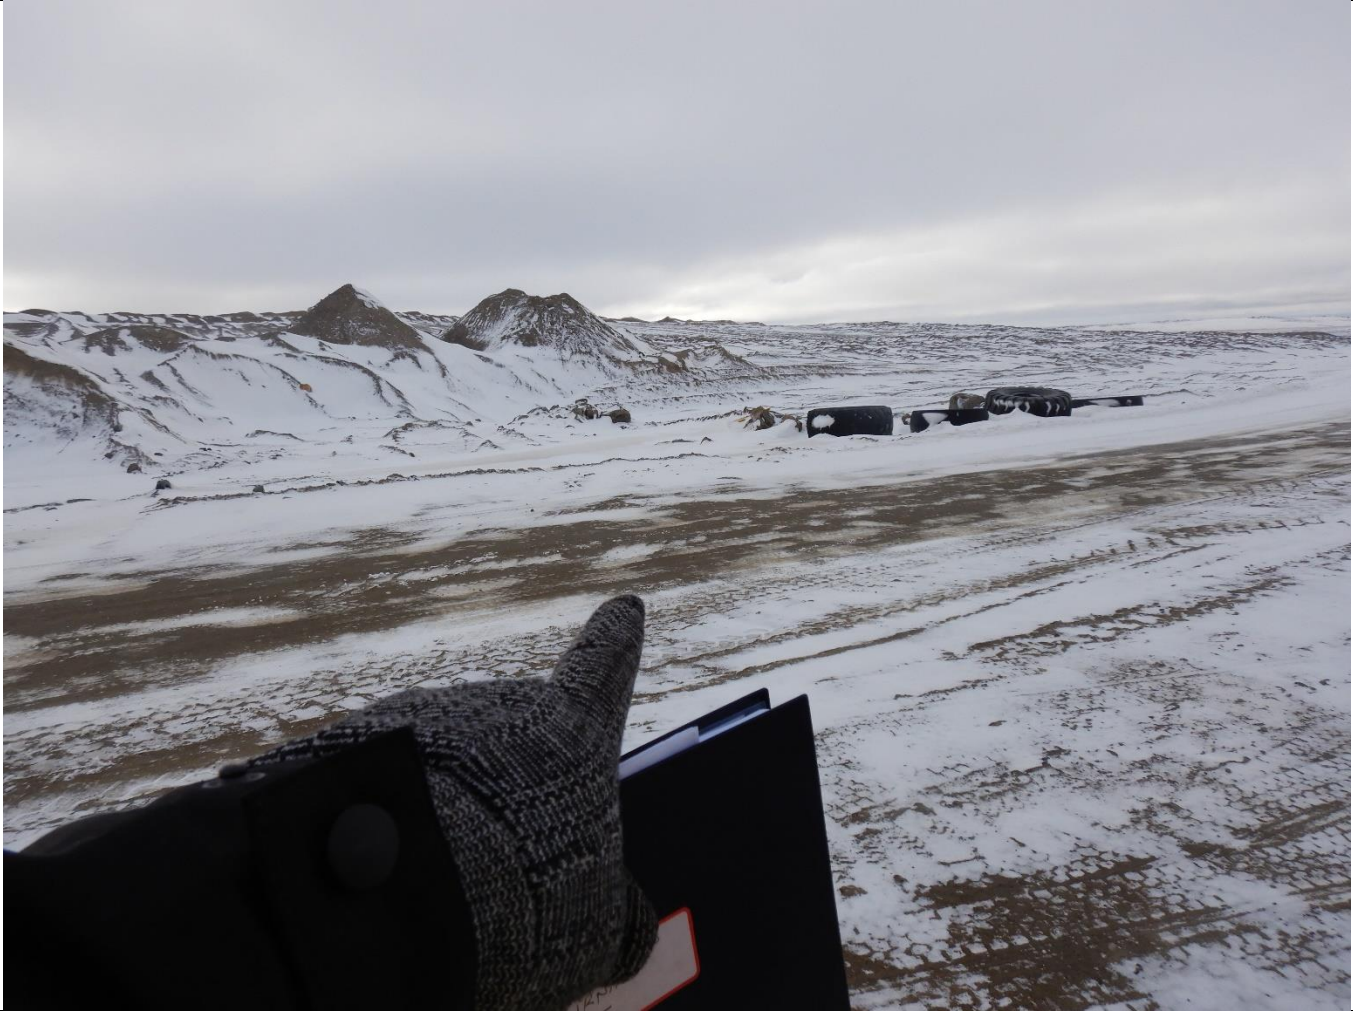
Photo 36

All Contaminated Soil has been Removed, and the Area has been Cleaned and is waiting to be Back Filled

Description: Excavation Area # 20 which was Contaminated from an Old Oil Spill where 3 Sea Cans were located
