WATER LICENCE INSPECTION FORM

Licensee		Licensee Representative	
Lupin Mines Incorporated (LMI)		Dave Vokey	
Licence No. / Expiry		Representative's Title	
2AM-LUP2032			
Land / Other Authorizations		Land / Other Authorizations	
Date of Inspection		Inspector	
2021 October 10		Baba Pedersen	
Activities Inspected			
<input checked="" type="checkbox"/> Camp	<input type="checkbox"/> Drilling	<input type="checkbox"/> Mining	<input type="checkbox"/> Construction
<input type="checkbox"/> Roads/Hauling	<input type="checkbox"/> Other:	<input checked="" type="checkbox"/> Other: Security Reduction	<input checked="" type="checkbox"/> Reclamation
<input type="checkbox"/> Fuel Storage

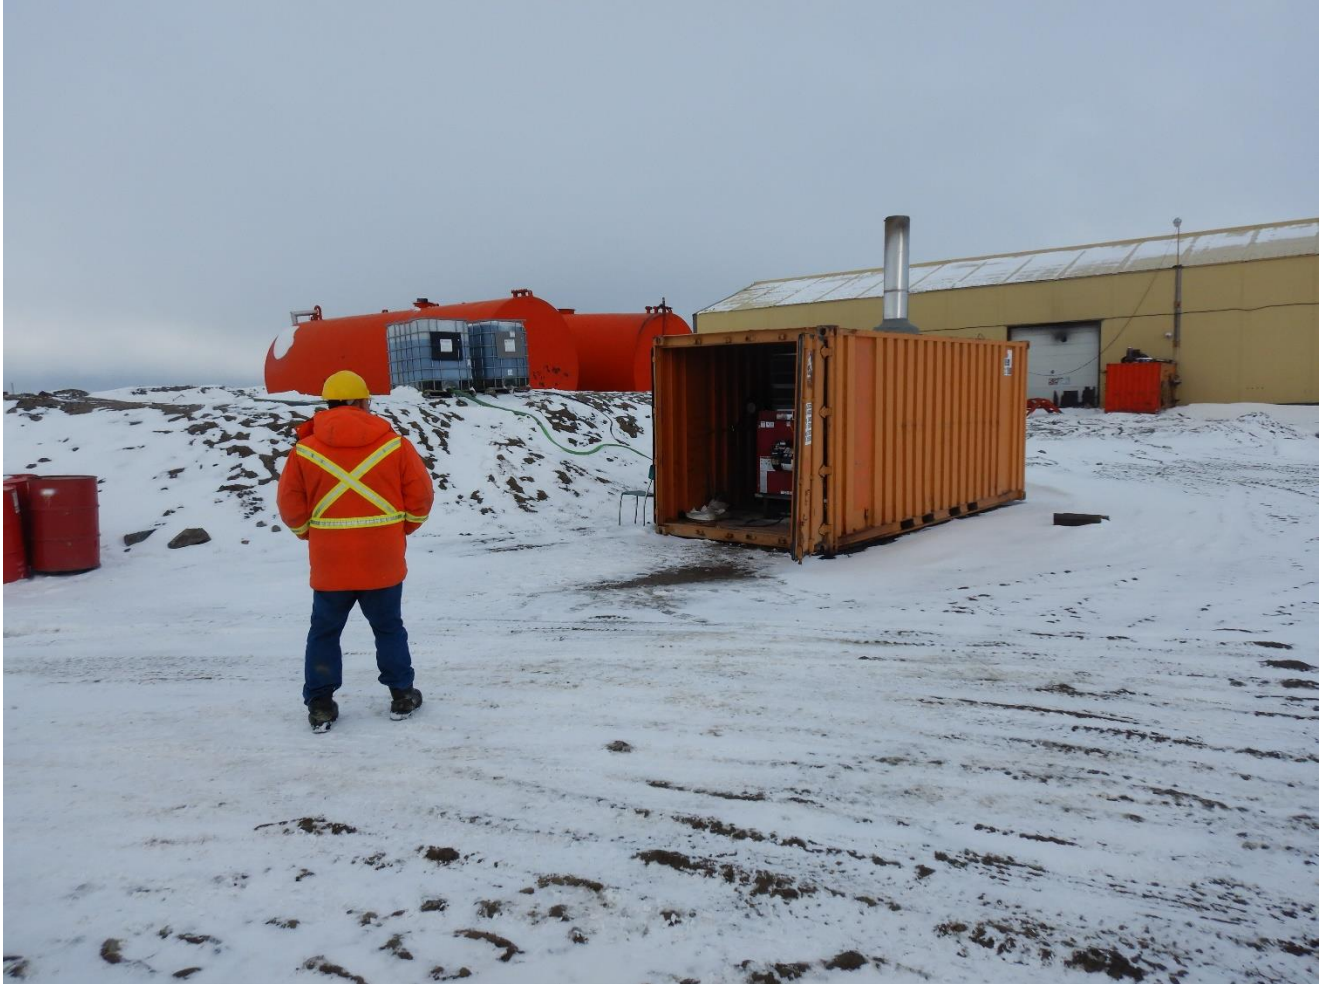
Photo 37

This Season’s Plan was to Burn Off all Used Oils from the Old Powerhouse that has been Stored in the 2 Orange Tanks in the background of Photo # 37. 17 Cubes (each Cube is 1000 Liters) have been Removed and Burned Off from the Tank on the Right, it is now Empty. They are now Burning Off the Product in the 2nd Tank which is on the Left.

Description: The Waste Oil Burn Container Area in Active Use

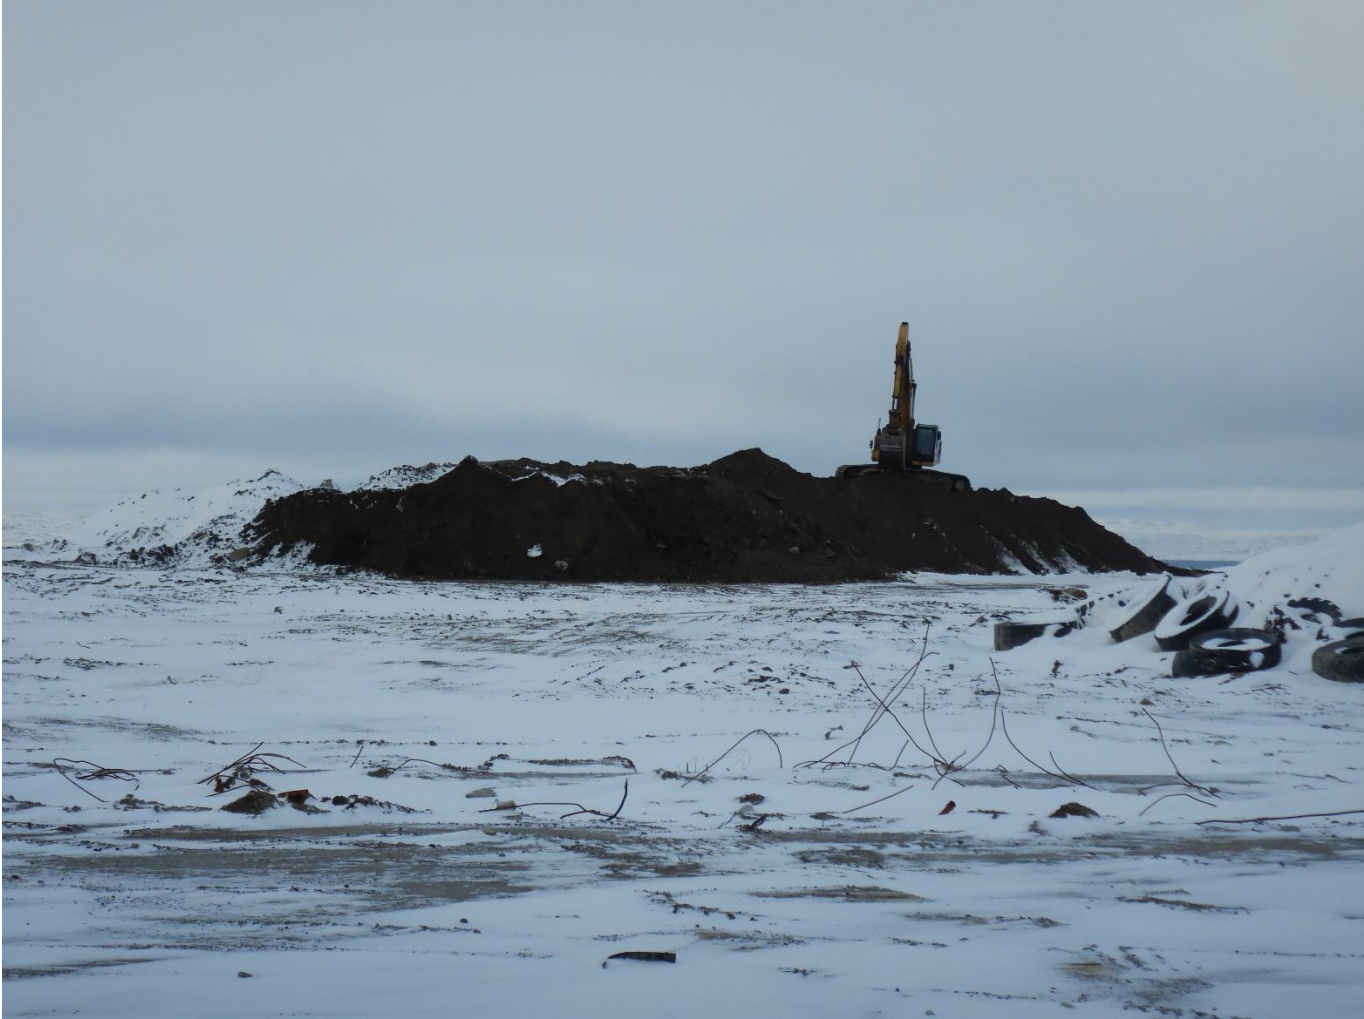
Photo 38

This is where All Contaminated Soils are being Stored prior to be being placed in the Crown Pillar Areas.
So far this year they have placed 1,400 Loader Bucket Loads into the Crown Pillar Area.

Description: The Contaminated Soils Stock Pile which still has to be placed into the West Zone of the Crown Pillar Area next year
