# LUPIN MINES INCORPORATED

August 18, 2015

**Re: Notice of Compliance to Lupin Mines Inc. (“LMI”) Water Licence Inspection Form dated August 5, 2015**

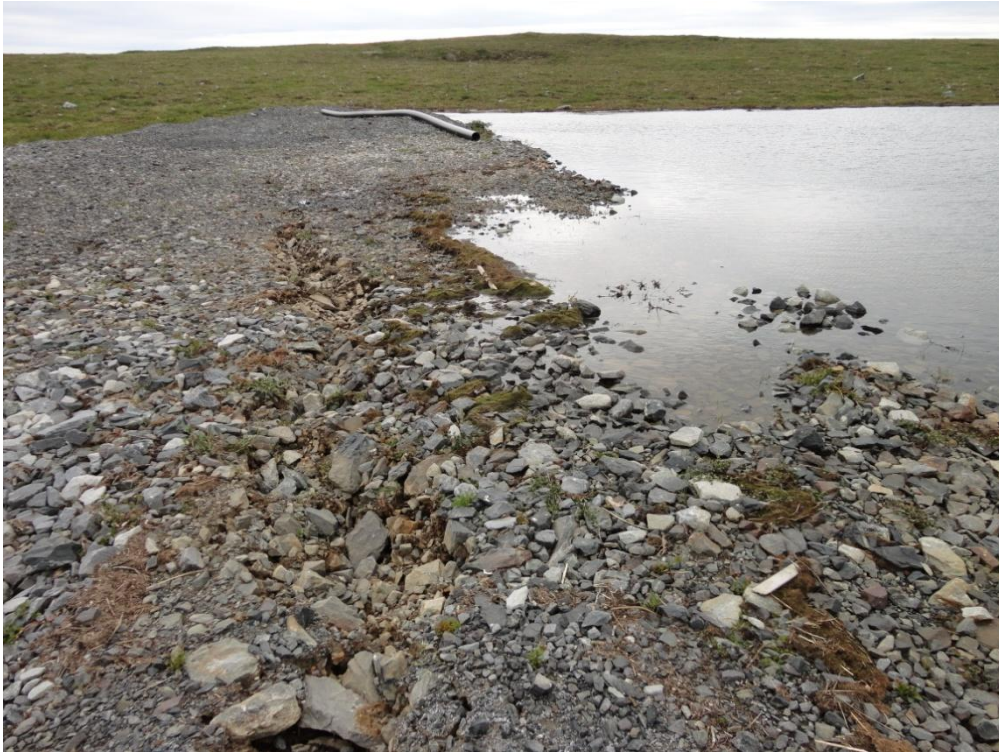
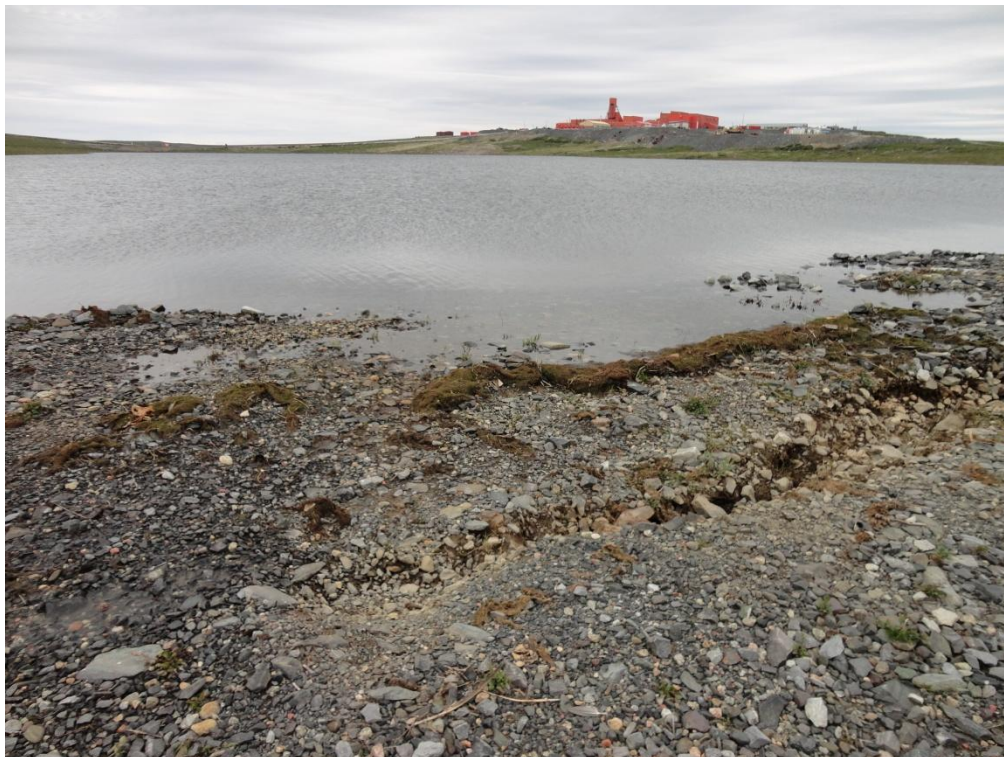
**APPENDIX A: PHOTOGRAPHS OF LOWER SEWAGE LAGOON**

LMI has diligently inspected, maintained and repaired the sewage lagoons. First, the site conditions at the time of the Inspection did not reveal any water “*trickling over a compromised section of the lower sewage dam.*” Please see the photographs attached as Appendix A taken during the Inspection which clearly do not show trickling over of the dam. Second, we respectfully disagree with your conclusion that a greater flow happened on site prior to your arrival. We did observe some minor seepage around the south end of the dam to an area of tundra over 2 km from any water body (see attached photos in Appendix A). A spill report is not required because it is not seeping into or anywhere near a waterbody. In addition, we note that in all previous inspections the seepage was not considered reportable by any AANDC inspector, including you. Third, as discussed at the time of your Inspection, LMI had taken steps to discharge from the lower sewage lagoon in accordance with its amendment to its Type A Water Licence and LMI was waiting for laboratory results prior to discharge.

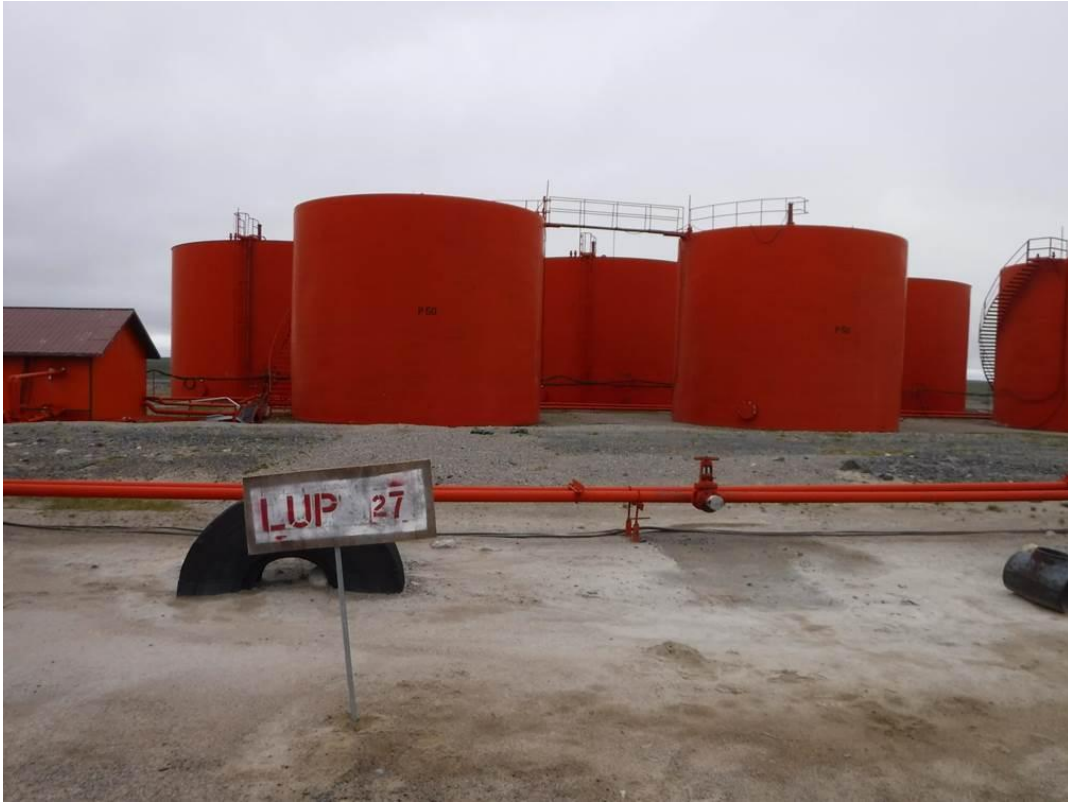
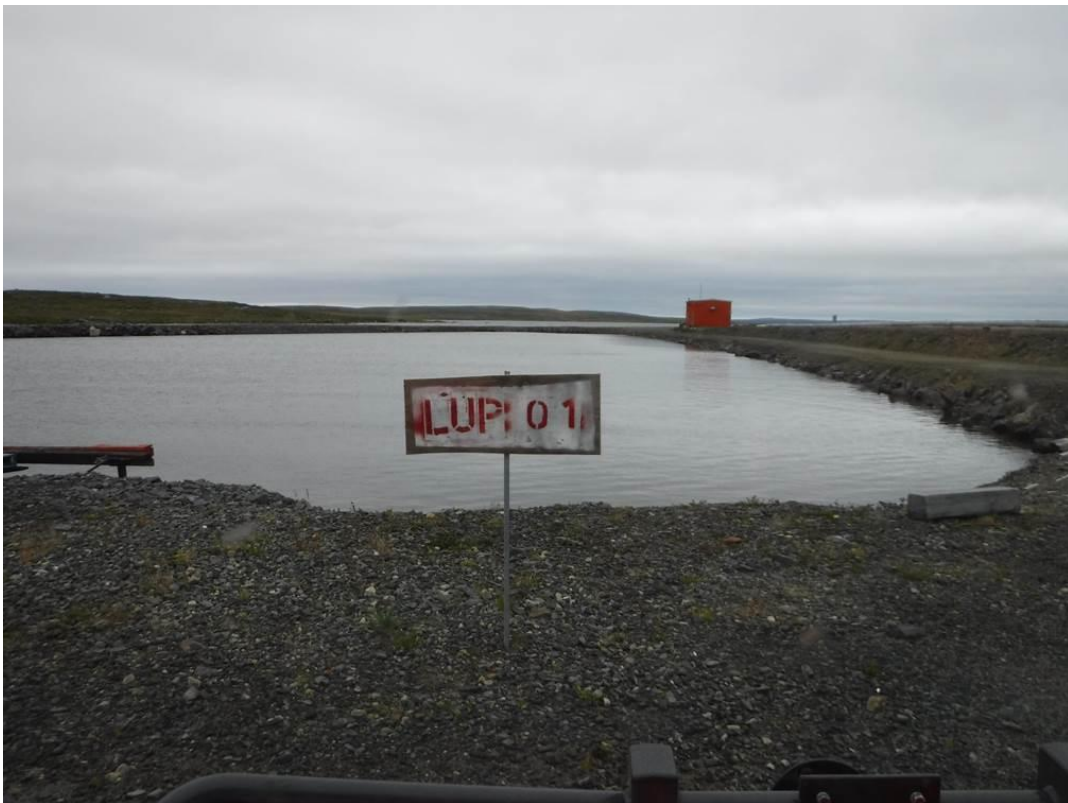
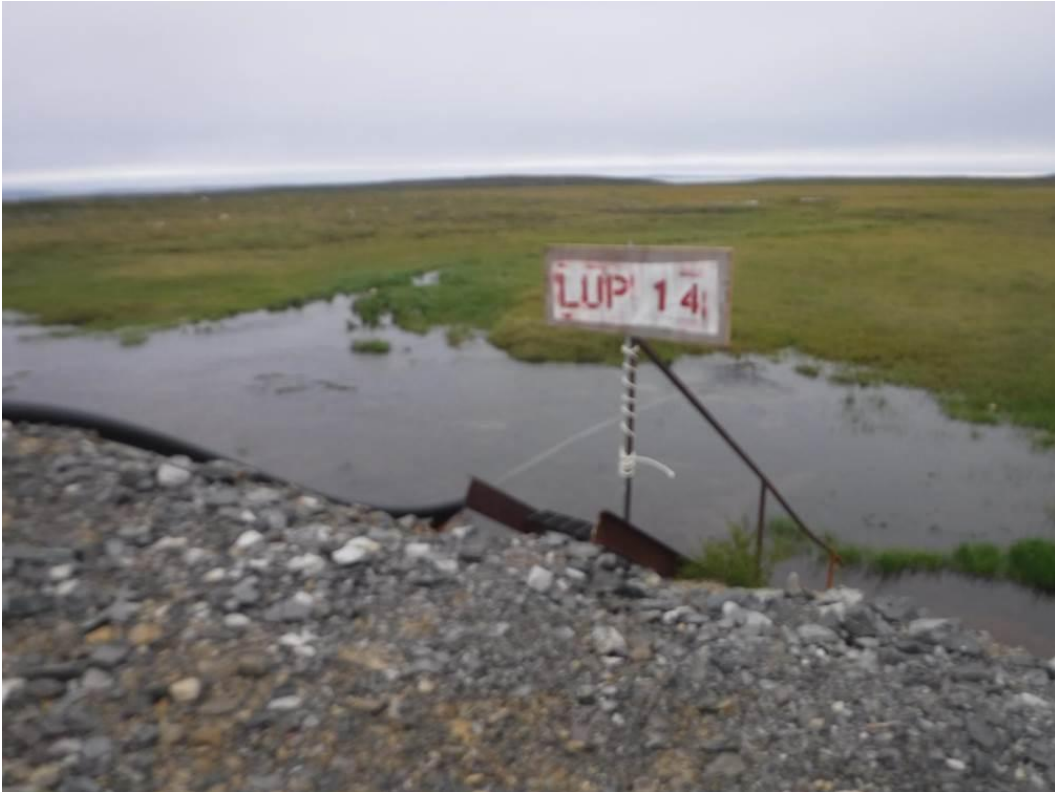
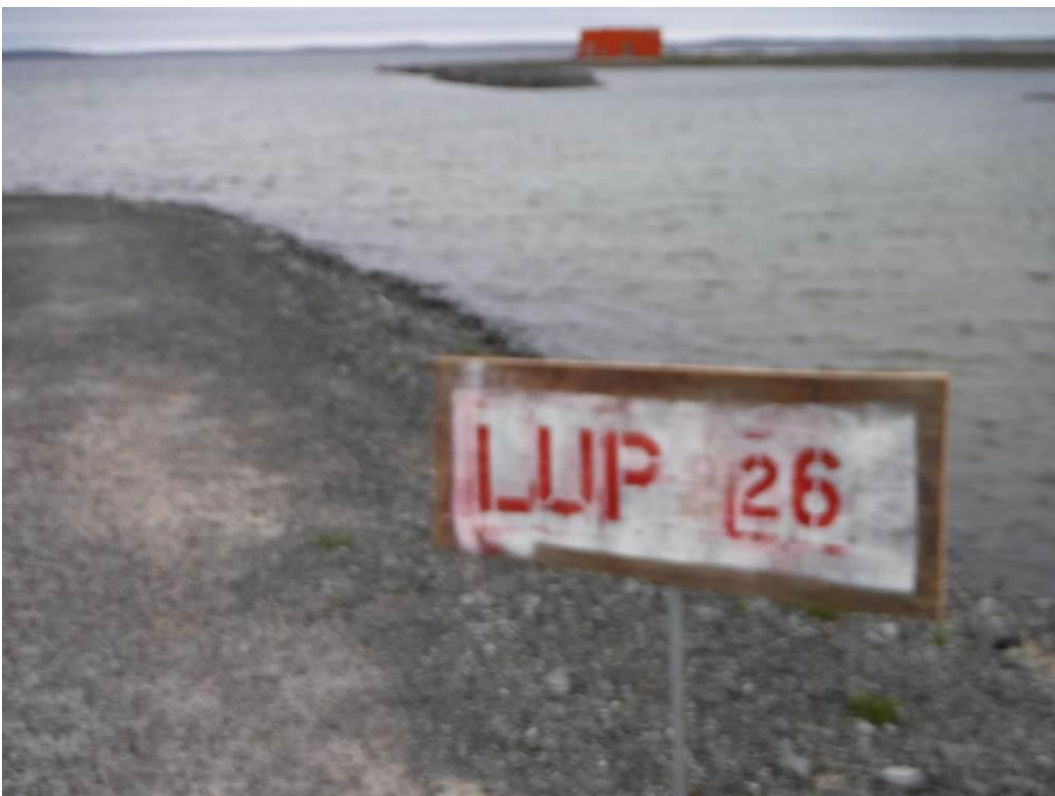
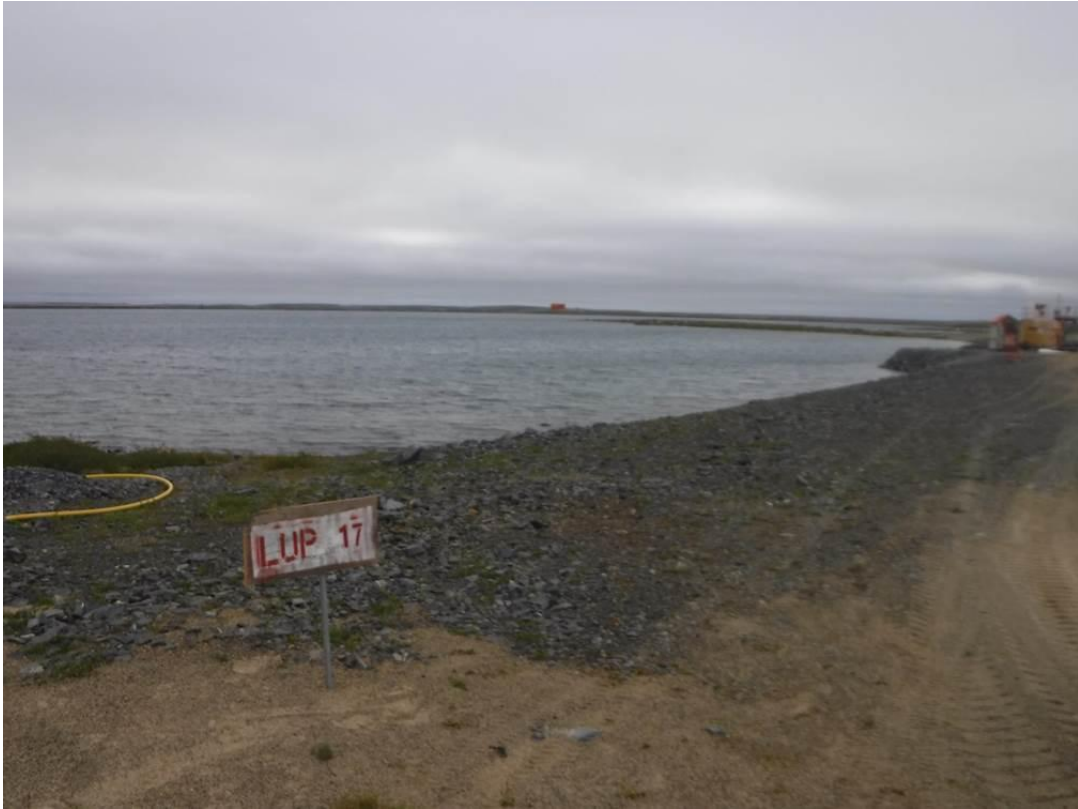
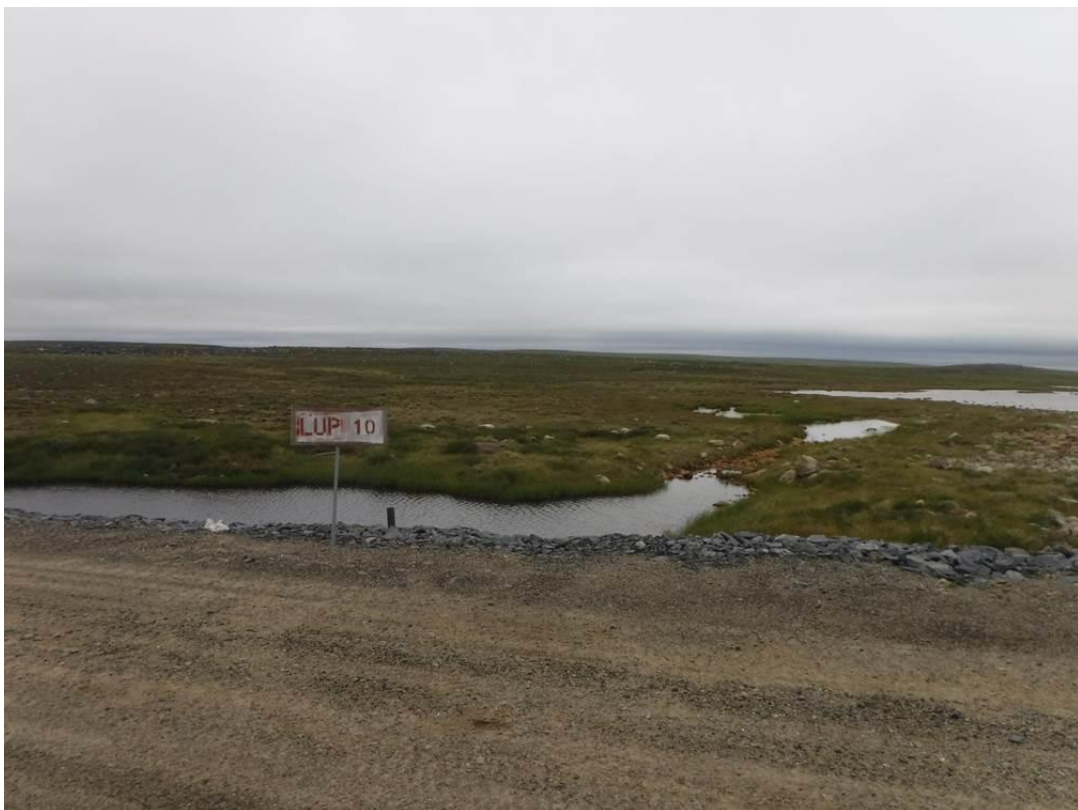
**APPENDIX C: PHOTOGRAPHS OF MONITORING STATION SIGNAGE**

The Inspection Report states that no signage identifying the monitoring stations was noted. We believe all of the required signs to be in place and do not know of any missing monitoring signs. Please find enclosed as Appendix C photographs representing a sample of the monitoring signs that are in place in accordance with the expired Type A Water License.
