PROJECT ANNUAL INSPECTION OF PERIMETER TAILINGS DAMS		
TITLE DAM 1A INSPECTION PHOTOS		
PROJECT No.	DWG. No.	REV.
0256-009-02	5	0

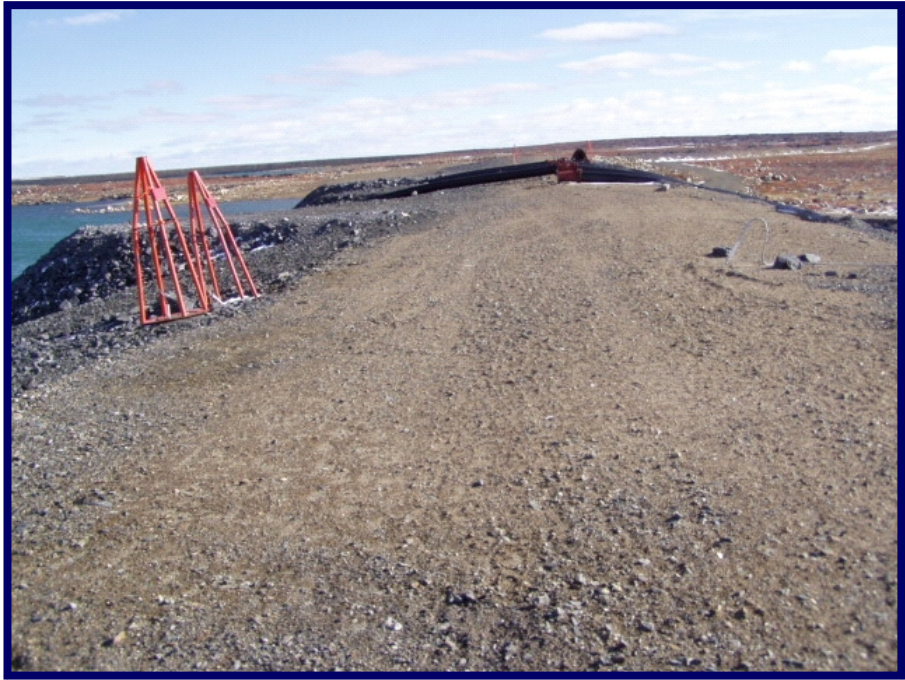
Photo 17 shows a view of the crest looking towards the south abutment.

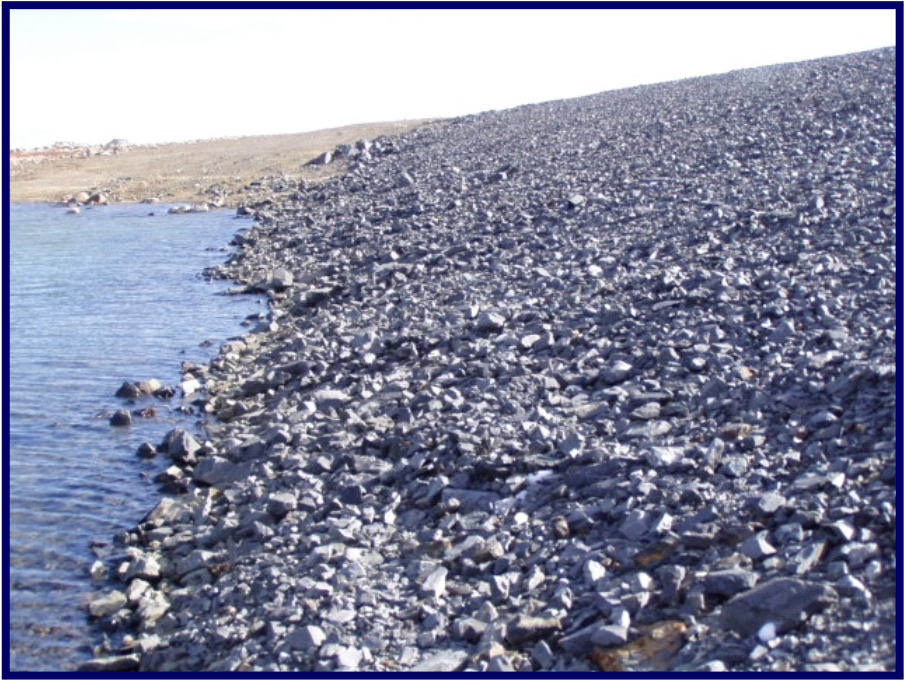
Photo 19 shows a view of the riprap on the upstream side. The distance from the water level to the crest of this dam is approximately 3.5 metres.

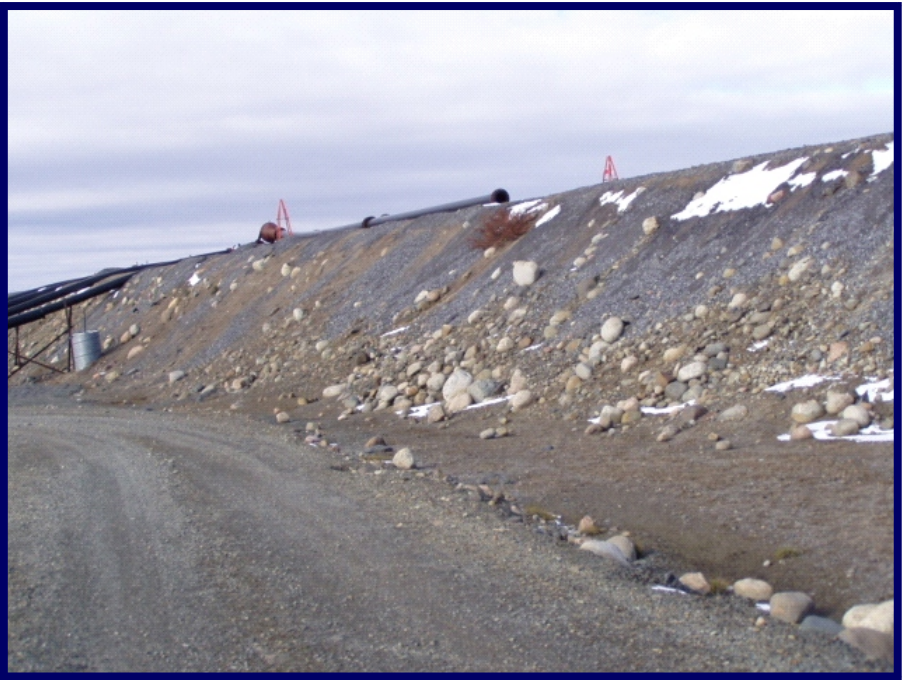
Photo 23 shows the alternating colour pattern of the dark grey angular rock over top of the light brown esker sand and gravel on the downstream slope.

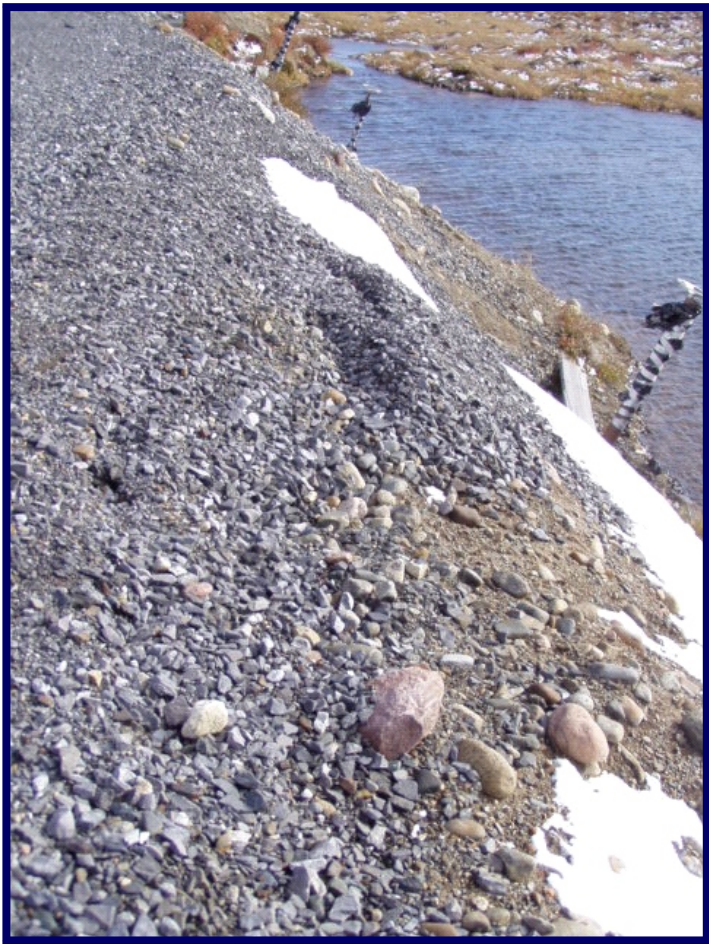
Photo 27 shows some longitudinal cracks formed in the angular rock fill. These cracks were previously noted proximal to the valve locations.
