KINROSS
Gold Corporation

PROJECT ANNUAL INSPECTION OF PERIMETER TAILINGS DAMS		
TITLE DAM 1B INSPECTION PHOTOS		
PROJECT No. 0256-009-02	DWG. No. 6	REV. 0

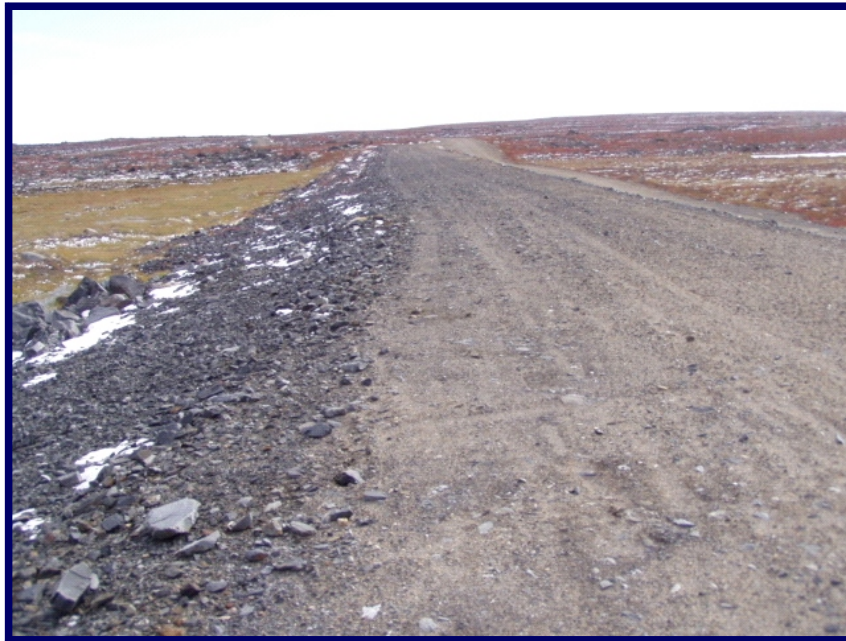
Photo 29 is a view of the crest on the upstream side. As previously noted, the riprap on the upstream side is relatively undulating. This dam does not currently retain any water.

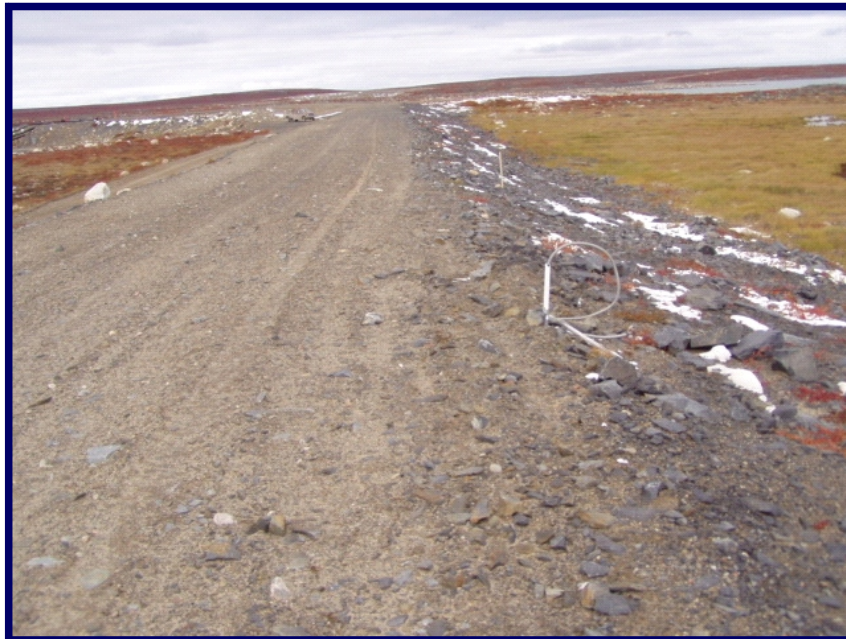
Photo 31 is a view of the crest on the upstream side again looking towards the north.
