CLIENT: **KINROSS**
Gold Corporation

BGC Engineering Inc.
AN APPLIED EARTH SCIENCES COMPANY

PROJECT ANNUAL INSPECTION OF PERIMETER TAILINGS DAMS		
TITLE DAM 1C INSPECTION PHOTOS		
PROJECT No. 0256-009-02	DWG. No. 7	REV. 0

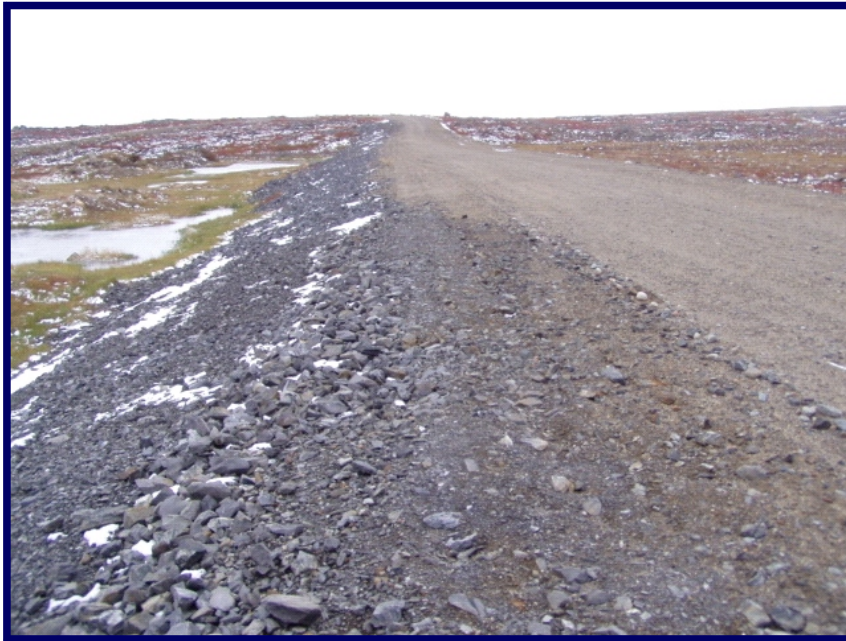
Photo 35 shows the upstream side and the crest. We do have a slight undulating nature to the riprap, likely a result of construction traffic activity.

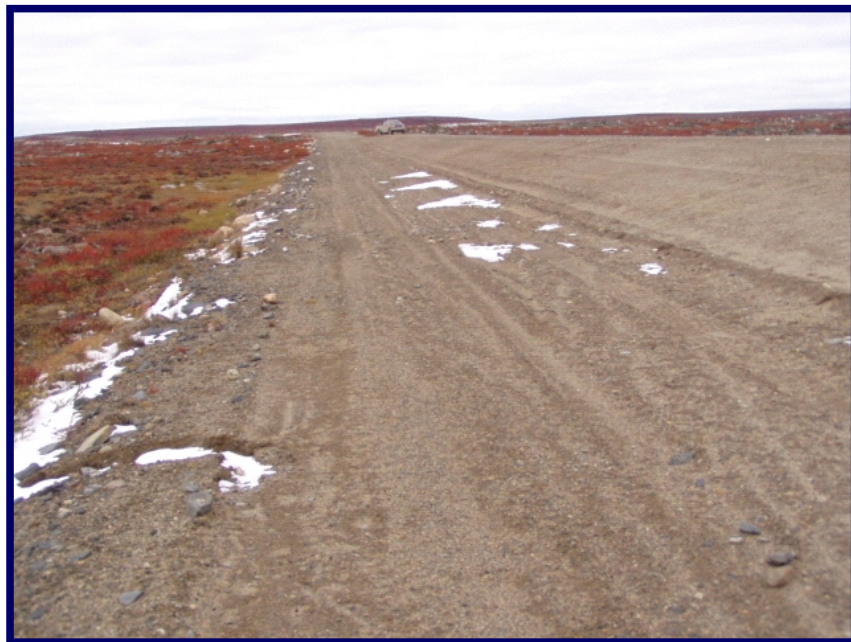
Photo 38 is a view along the access road toe berm. The downstream side has no signs of deformation or cracking from this perspective.
