PROJECT    ANNUAL INSPECTION OF PERIMETER TAILINGS DAMS		
TITLE    DAM 2 INSPECTION PHOTOS		
PROJECT No.	DWG. No.	REV.
0256-009-02	8	0

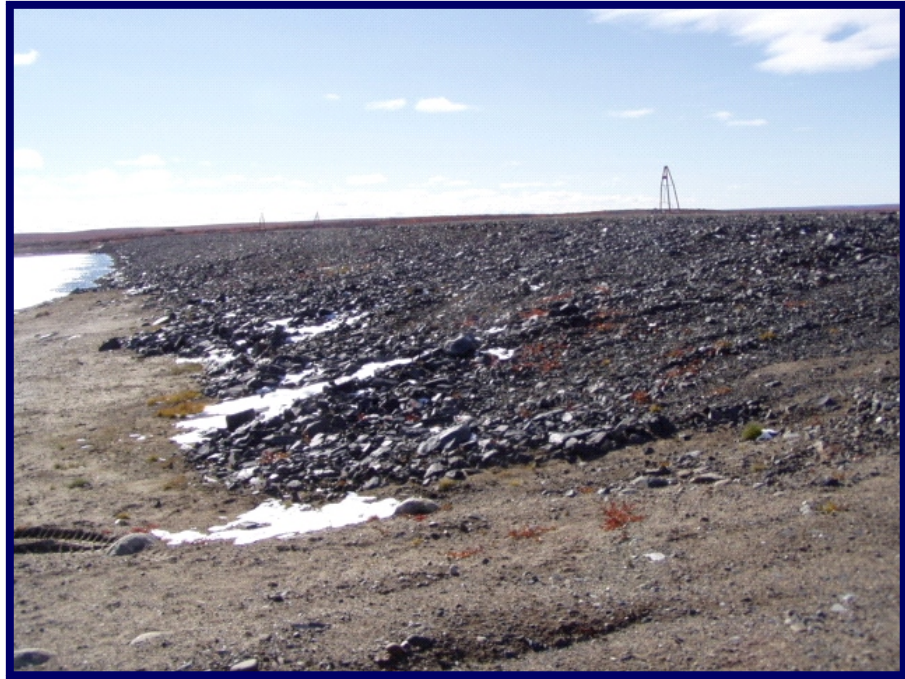
Photo 2 shows a view of the upstream side. The condition of the riprap appears to be satisfactory.

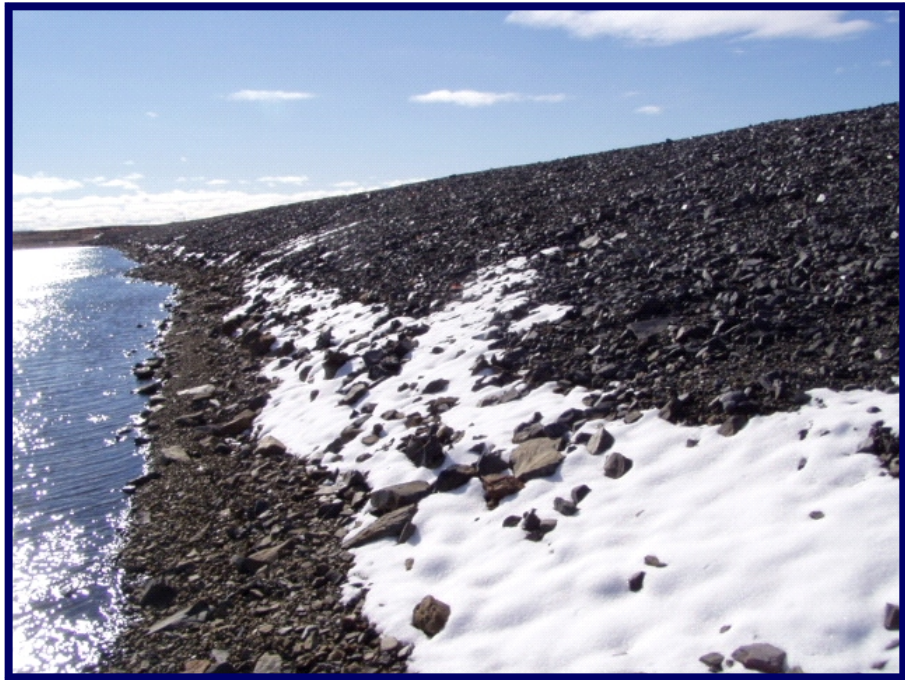
Photo 4 is a view of the upstream side. The distance from the current pond level to the crest is approximately 3.5 metres. Occasional small scarp form at the water level.

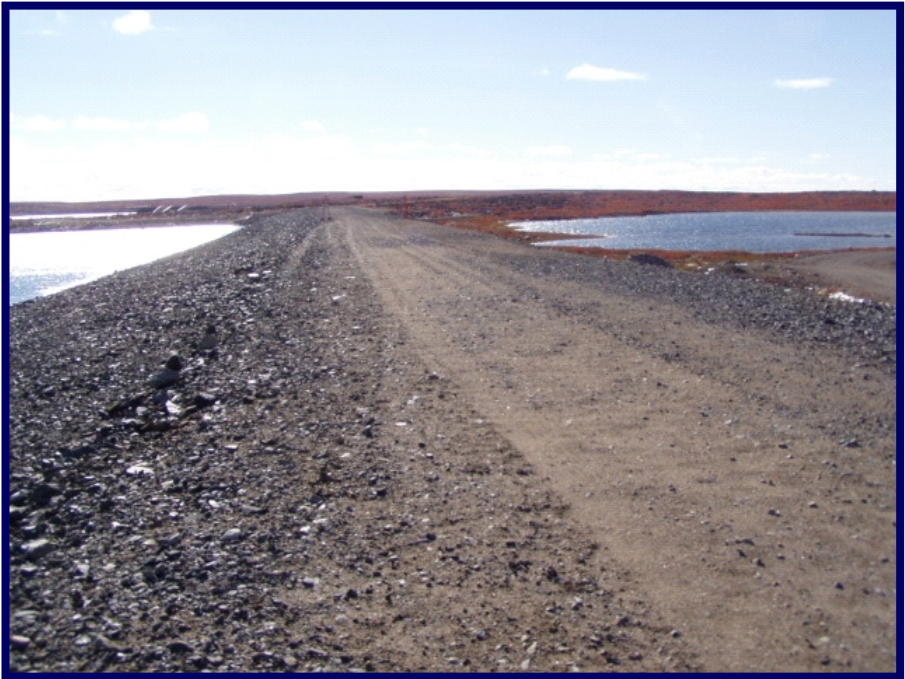
Photo 3 shows the condition of the crest looking towards the south. From this perspective, there are no signs of settlement or cracking.

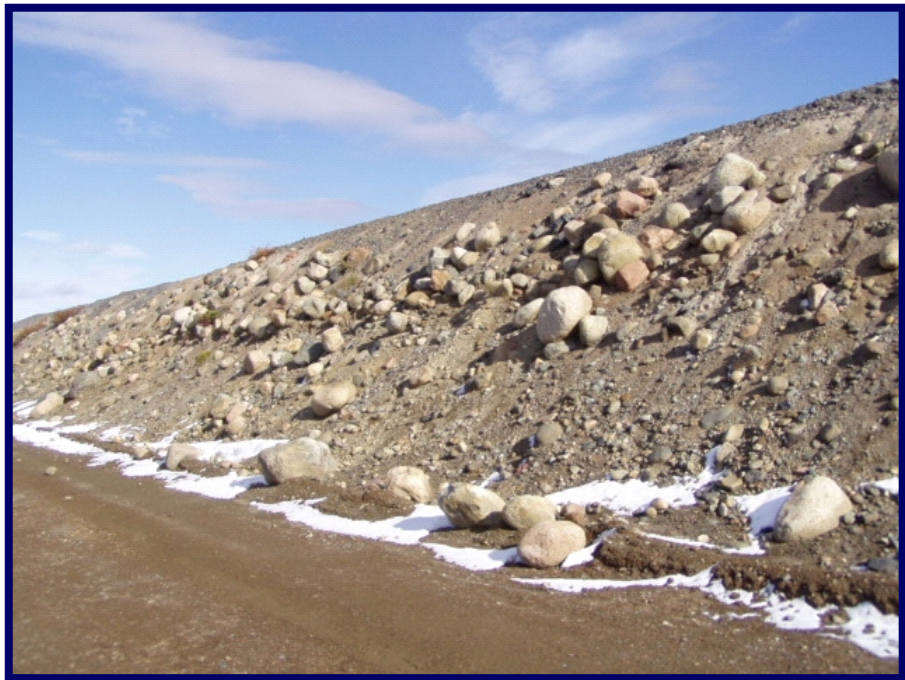
Photo 8 is just another view of the downstream face.
