PROJECT	ANNUAL INSPECTION OF PERIMETER TAILINGS DAMS		
TITLE	DAM 3 INSPECTION PHOTOS		
PROJECT No.	DWG. No.	REV.	
0256-009-02	9	0

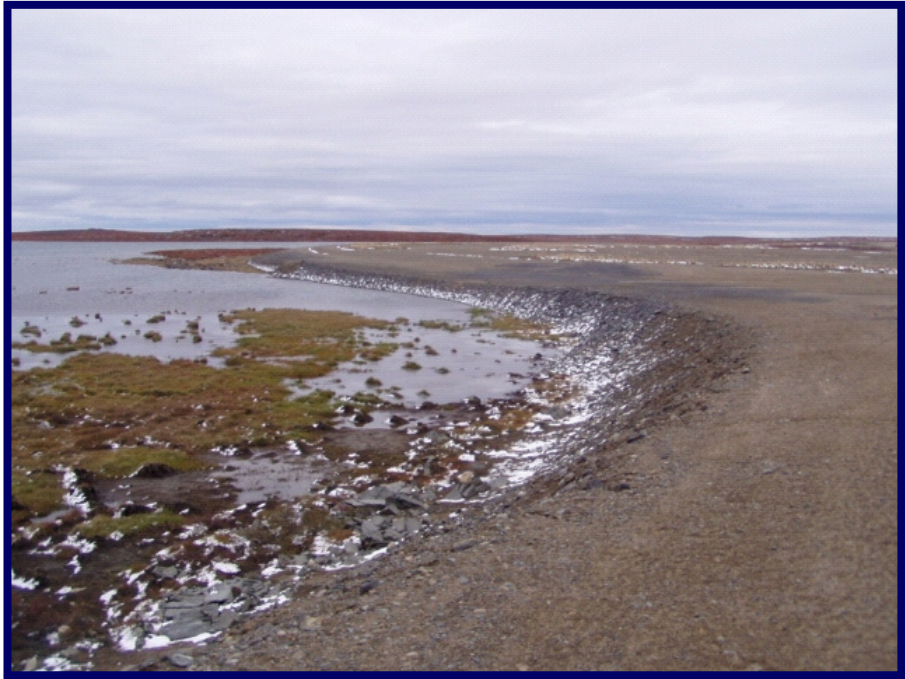
Photo 72 shows a view of Dam 3 with Boomerang Lake on the left.

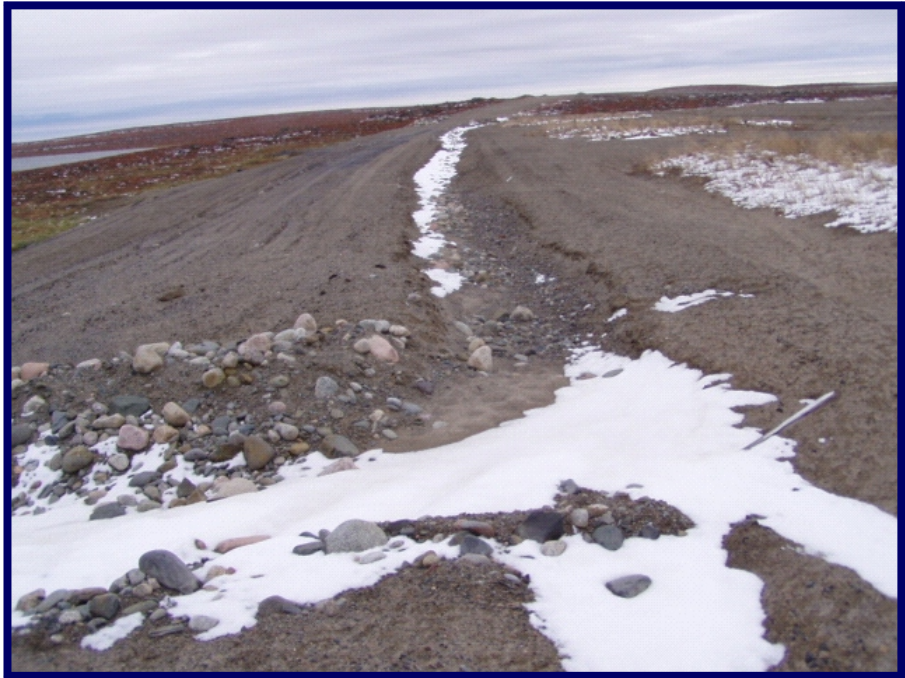
Photo 79 shows a small ditch which runs from the south end towards the north and then bends 90 degrees to the east across the crest of this dam. It is used to direct some of the surficial drainage and from this perspective, looks in satisfactory condition.

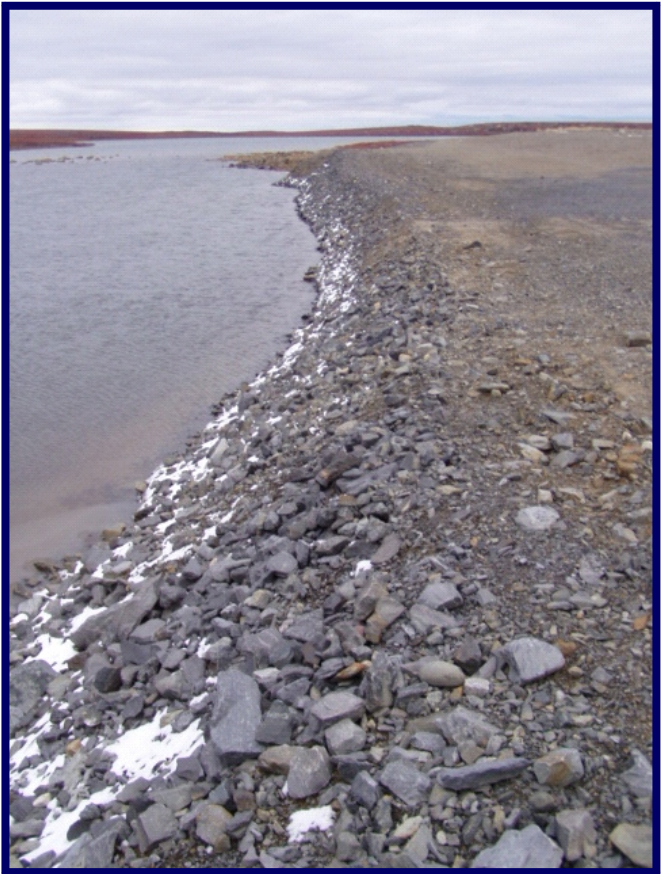
Photo 73 shows the toe edge where it meets Boomerang Lake. This is the area where historically cracking has been seen, No significant sloughs are noted right now.

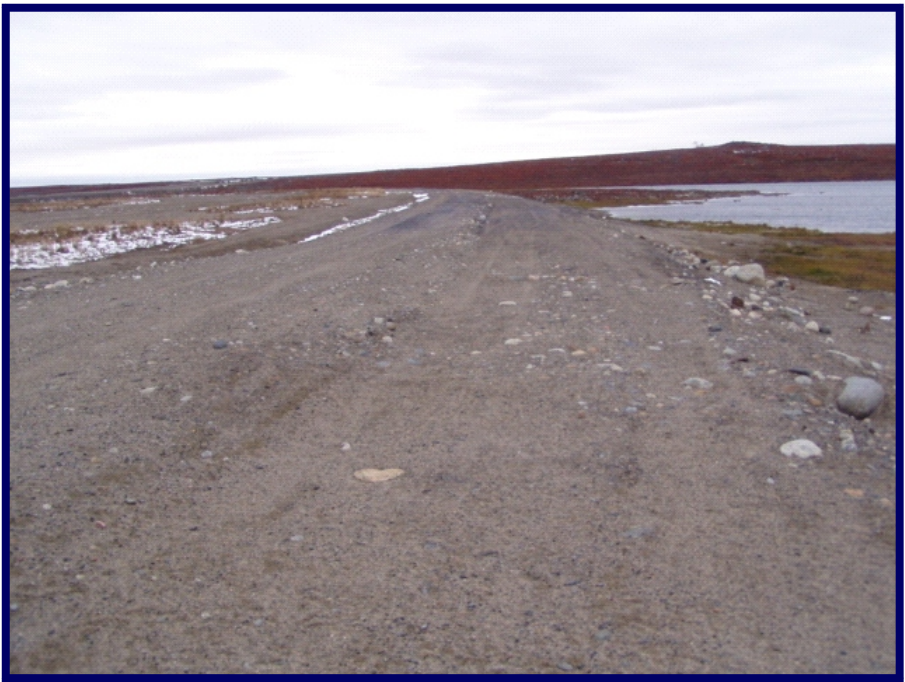
Photo 80 shows the condition of Dam 3 looking towards the north along the toe of this dam. There are no signs of significant erosion or any seepage discharging from this reclaimed dam.
