KINROSS Gold Corporation

PROJECT ANNUAL INSPECTION OF PERIMETER TAILINGS DAMS				
TITLE				
DAM 4 INSPECTION PHOTOS				
PROJECT No.		DWG. No.	REV.	
0256-009-02		10	0

BGC Engineering Inc. AN APPLIED EARTH SCIENCES COMPANY

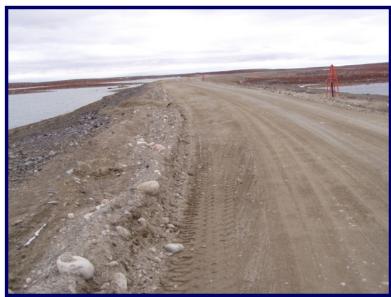
Photo 60 shows a significant windrow which has been formed on the crest of Dam 4 at its west abutment. This crest will have to be regraded to a proper grade to prevent future erosion.

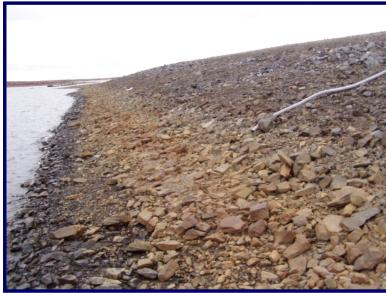
Photo 62 shows the riprap on the upstream side of Dam 4.

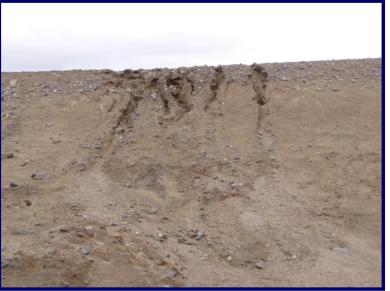
Photo 68 shows four erosional gullies which should be backfilled.
