CLIENT: **KINROSS**
Gold Corporation

PROJECT ANNUAL INSPECTION OF PERIMETER TAILINGS DAMS		
TITLE DAM 5 INSPECTION PHOTOS		
PROJECT No. 0256-009-02	DWG. No. 11	REV. 0

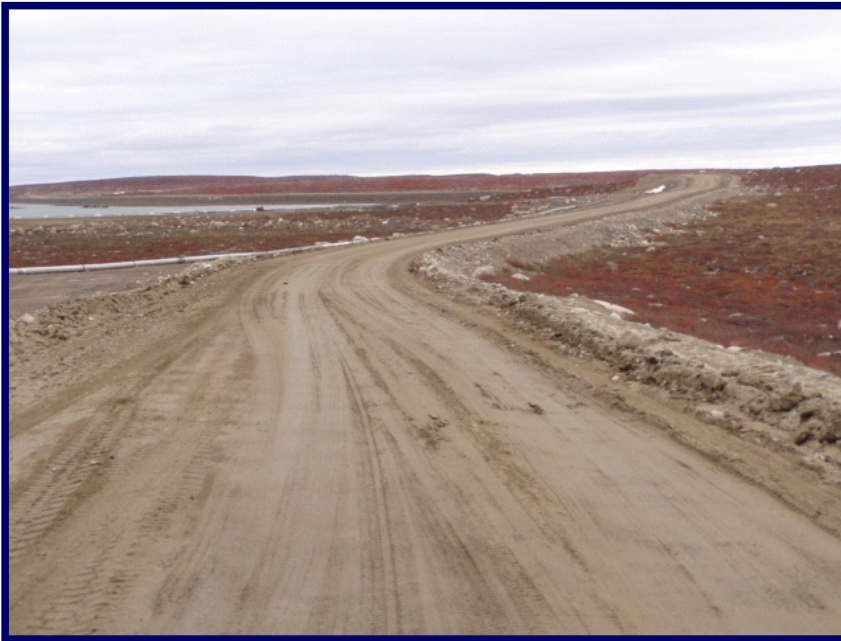
Photo 54 shows the crest of this dam and the downstream side. Windrows have been formed by recent grading activity for vehicle access.

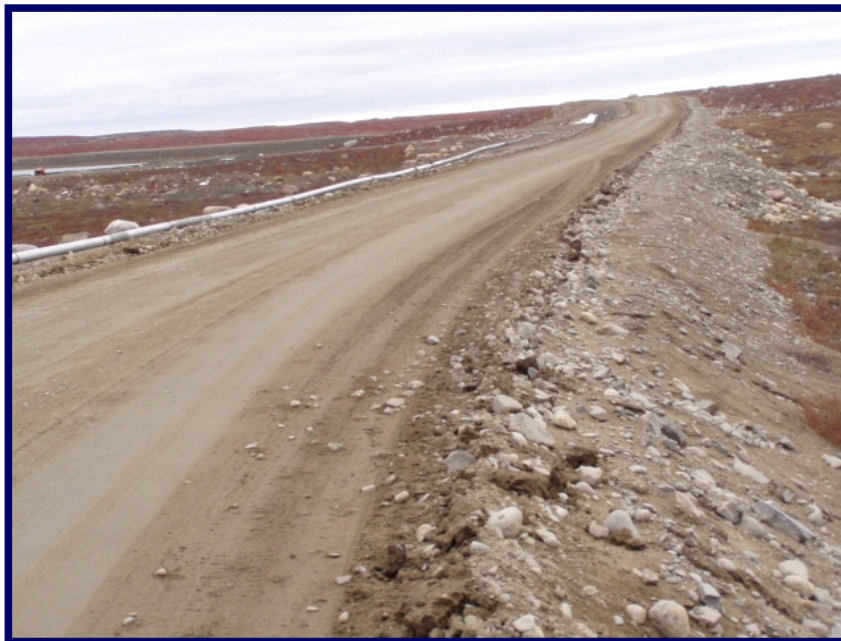
Photo 56 shows the view of the downstream face on the crest.
