PROJECT	ANNUAL INSPECTION OF PERIMETER TAILINGS DAMS		
TITLE	DAM 6 INSPECTION PHOTOS		
PROJECT No.	DWG. No.	REV.	
0256-009-02	12	0

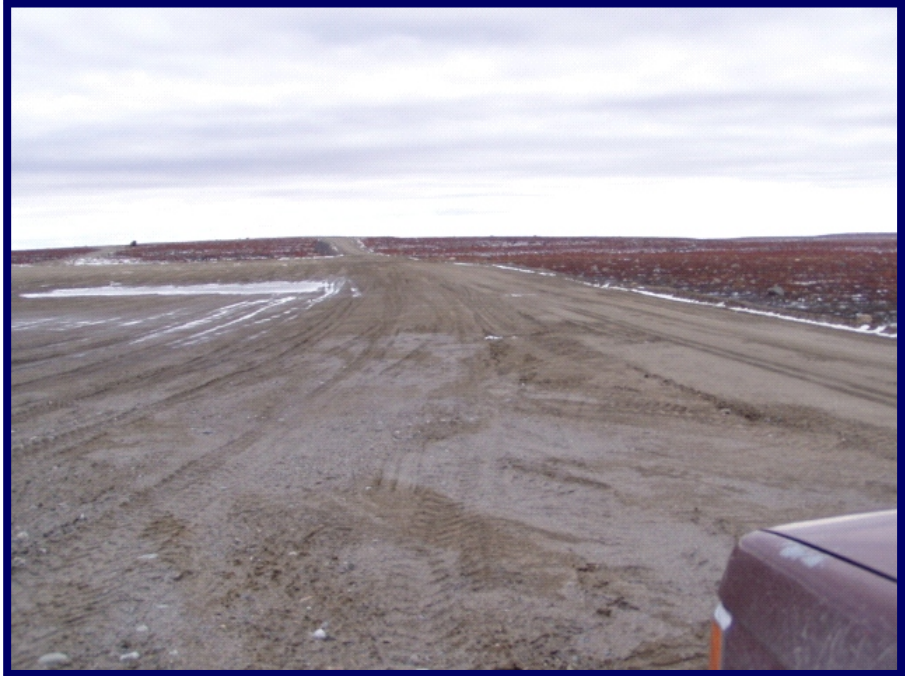
Photo 41 shows the crest of Dam 6 looking towards the south abutment. As can be seen, reclamation and placement of cover has occurred on the upstream side hence, covering over the majority of the tailings.

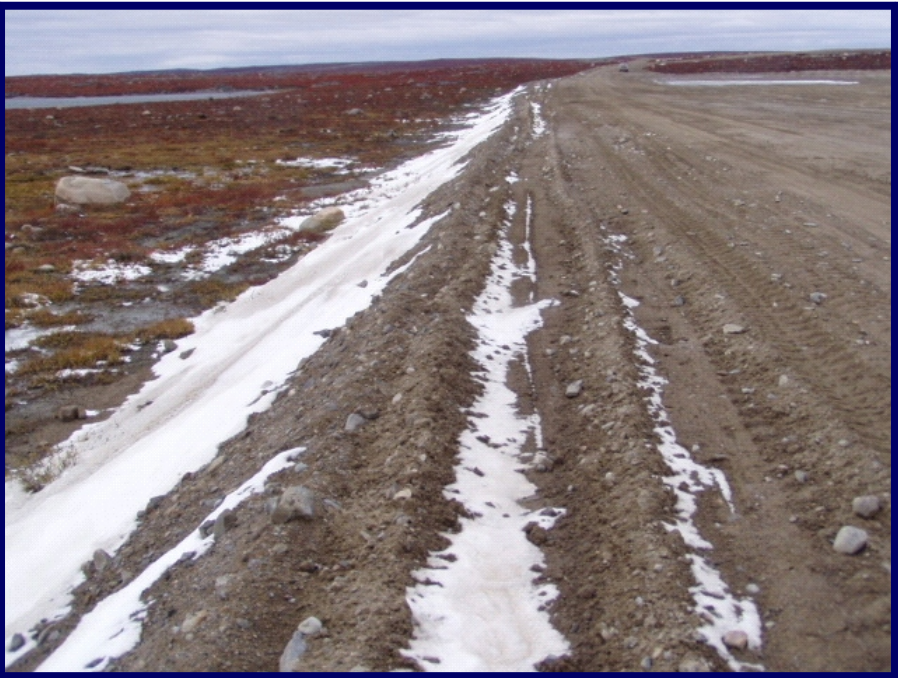
Photo 47 shows a view of the downstream toe looking towards the north. Construction traffic has caused a number of ruts and pushed up some windrows on the toe crest.

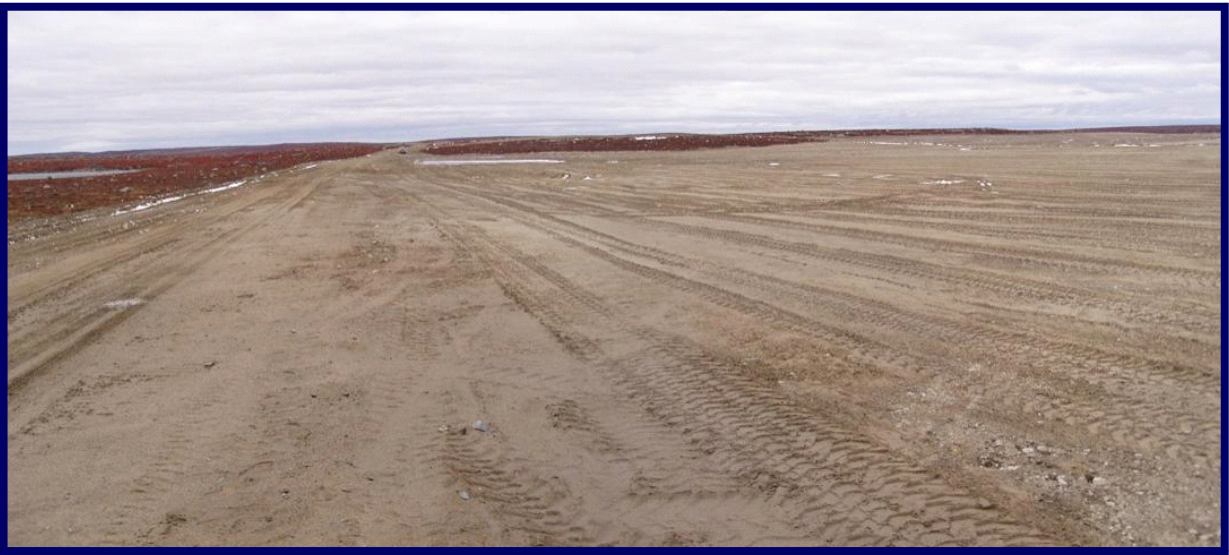
Photo 45 & 46 are a two shot panoramic showing the upstream side and the crest of Dam 6. A local high point exists some 100 metres to the east of this dam. As a result, localized drainage reports to the remnant pond.

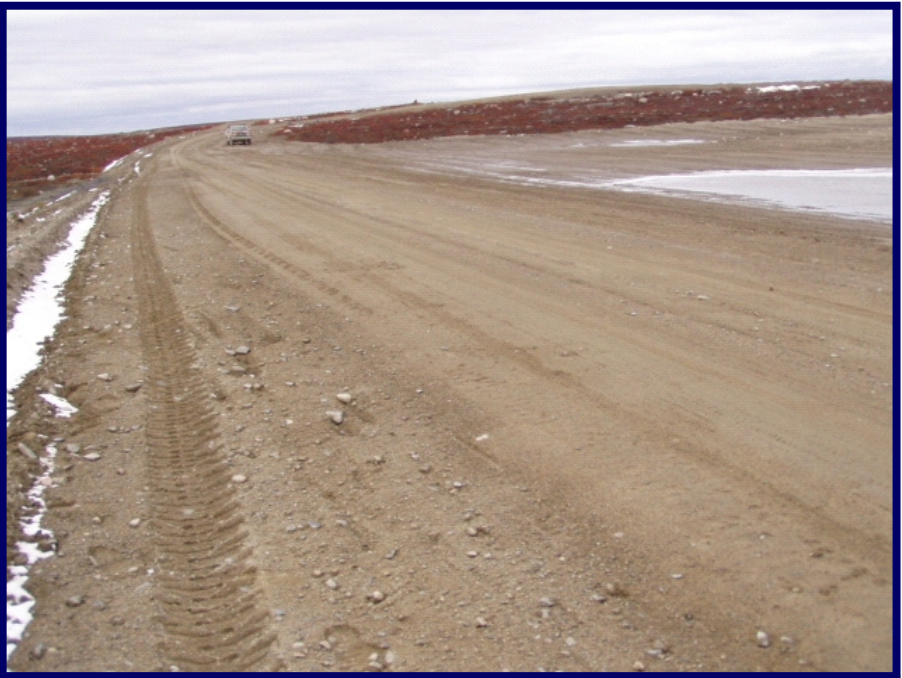
Photo 49 shows a view of the remnant pond versus the crest of this dam.
