**RE: Echo Bay Mines Ltd., Lupin Gold Mine, Contwoyto Lake, NT; Water Licence
No. NWB1LUP0008; 2001 Annual Report**

2001
ANNUAL REPORT
LUPIN GOLD MINE

**WATER LICENCE NWB1LUP0008
NUNAVUT WATER BOARD**

Date: March 18, 2002
Prepared by: David Hohnstein, C.E.T.
Environmental Coordinator, Lupin

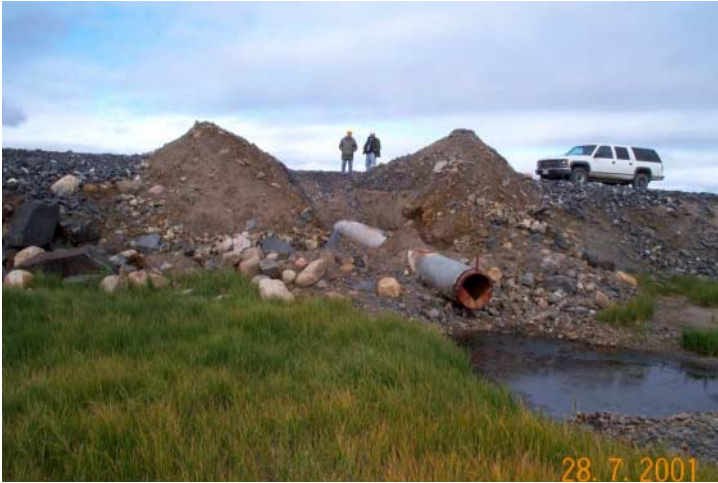
Photo 1

Minimal modification and routine maintenance work was carried out on the water supply and sewage disposal facilities in 2001. Repairs made in 2000 to the gated culvert on the No.2 Sewage Lake discharge were again required due to damage caused by ice in the late spring. In addition to the repair on the gate valve, the discharge side of the culvert had to be excavated to determine the source of water flow along the outside of the culvert. The flow had resulted from the full volume pipe flow and subsequent pressure. A failure of the culvert pipe was suspected. Photos 1 through 3, included in the appendix, show the excavation work, repair to a separated section of the culvert pipe and the completed backfilling of the excavation. The separation was repaired by installation of a clamp over top the pipe to hold the sections together.

Decant control structure;
discharge excavation for
repairs.

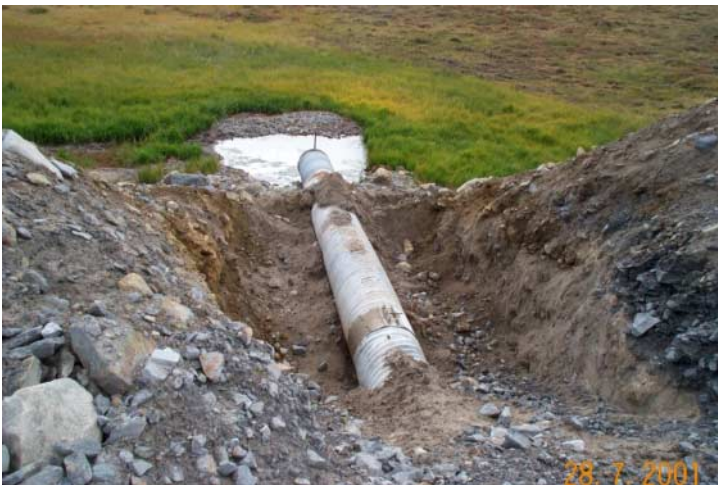
Photo 2

Decant control structure;
discharge excavation (top view
showing location of clamp).

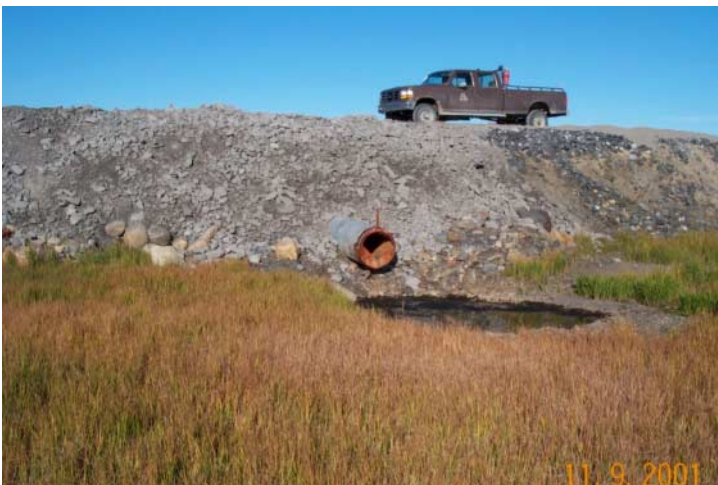
Photo 3

Sewage decant control
structure; completed backfill.

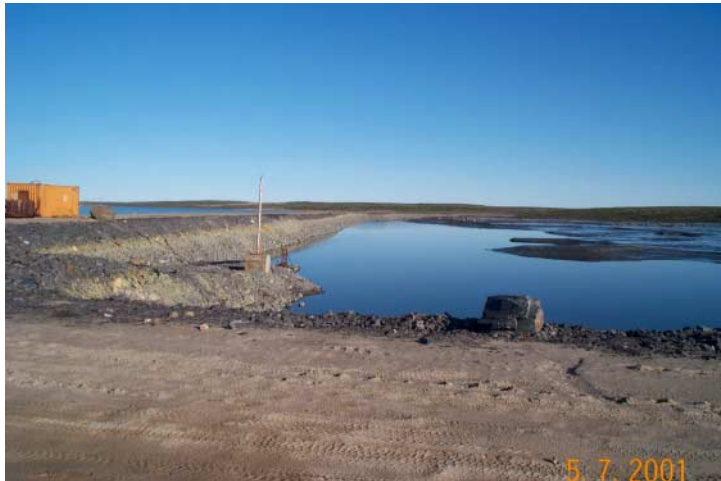
Photo 4

During the spring, prior to pumping of water from Cell No.5, a minor seepage from Cell No.5 through to Pond No.2 was noted near the abutment of the Mdam with Jdam. Once the snow had cleared, it was obvious that the water flow was emitting from fractures in the rock that ran parallel with the Jdam and originated within Cell No.5. A catchment pond was created on the Pond No.2 side of the Mdam and the contained water was pumped back into Cell No.5 to limit

Cell No.5; Mdam pumping station. South end.

Containment berm was placed adjacent to the pump station ramp and filled with tailings.

Pumping of Cell No.5 water was then initiated and water levels were lowered. Water flow through to the Pond No.2 side of Mdam was stopped. To permanently address the seepage problem, a containment berm was built on the upstream side and filled with tailings (solids) to seal the fractures in the bedrock. No further seepage was noted. Photos 4 and 5 show the Mdam structure.

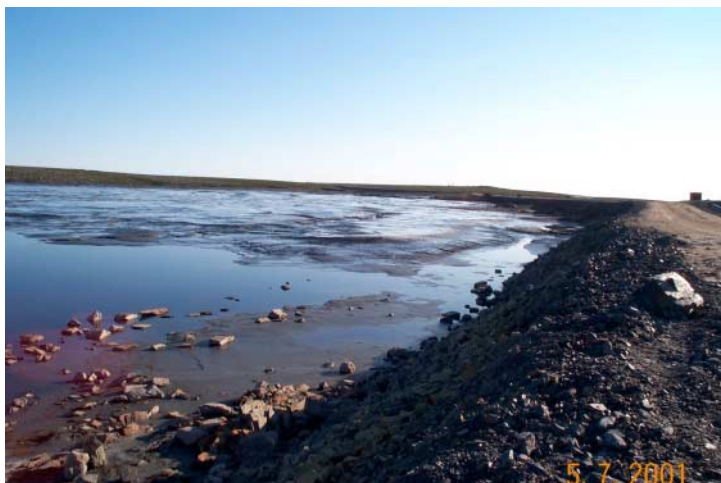
Photo 5

Cell No.5; Mdam, north end

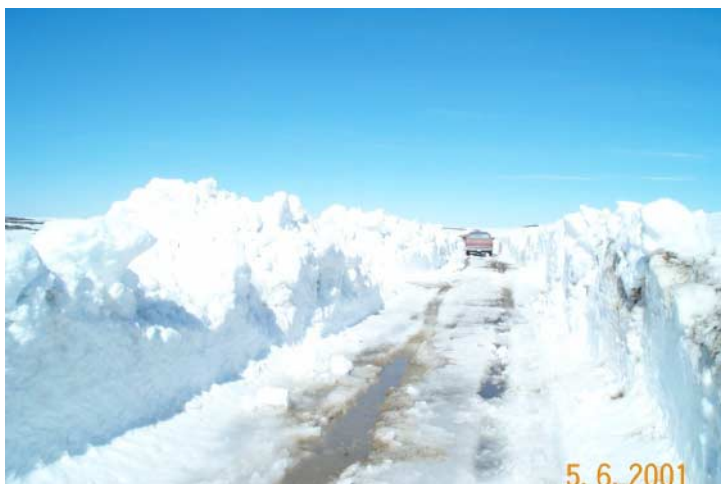
the higher than average annual precipitation (snowfall and accumulation) that had occurred. Total precipitation for 2001 was 285.6 mm compared to 253.8 mm in 2000 and the total snowfall in 2001 was 172.8cm compared to 143.2cm in 2000. The snowfall and accumulation (through drifting) plays a significant role in the total precipitation and runoff (catchment) that reports to the sewage lakes system in the spring. Data provided by the Lupin site weather station. Photo 6 shows some of the typical snowfall drifting that occurred in 2001.

Tailings Containment Area;
Typical snow accumulation
around End Lake area access
road.

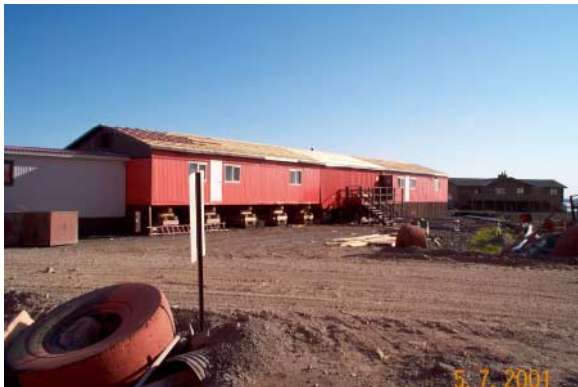
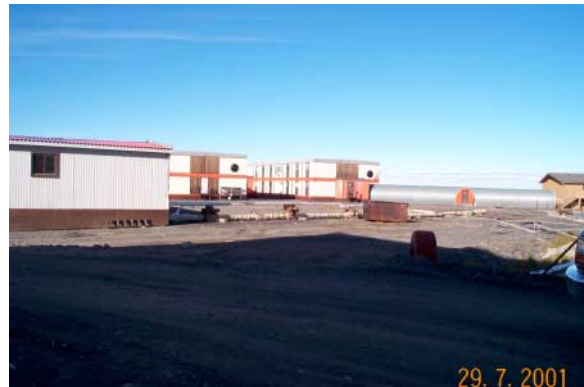
Activity during 2001 included the removal of several camp accommodation annexes (Photos 7 through 10) and the dismantling/removal of an approximate six kilometre length of six inch tailings line; see Photo 11. This line was used initially during startup of the mill (1982) and was taken out of service in 1989 when it was replaced with an eight inch line in conjunction with a mill expansion.

Photos 7&8 Removal of A and B accommodation units in July 2001.

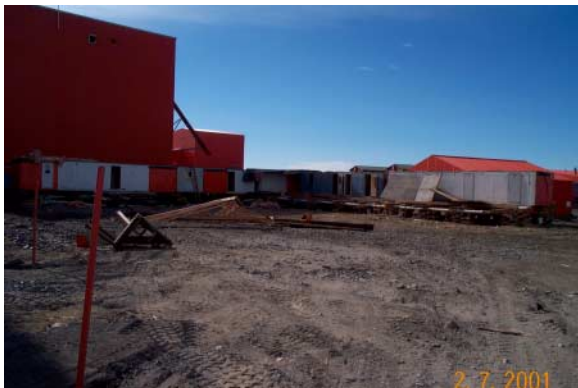
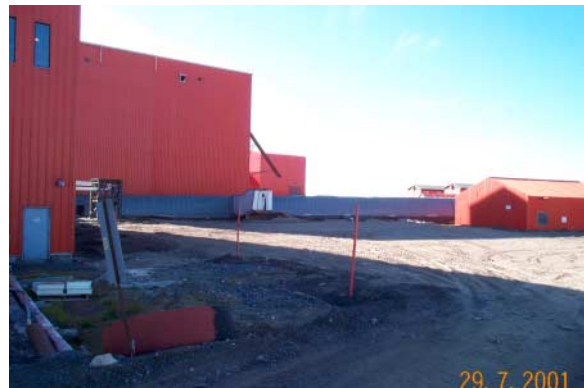
Photos 9&10 Removal of Redpath accommodation units in July 2001.

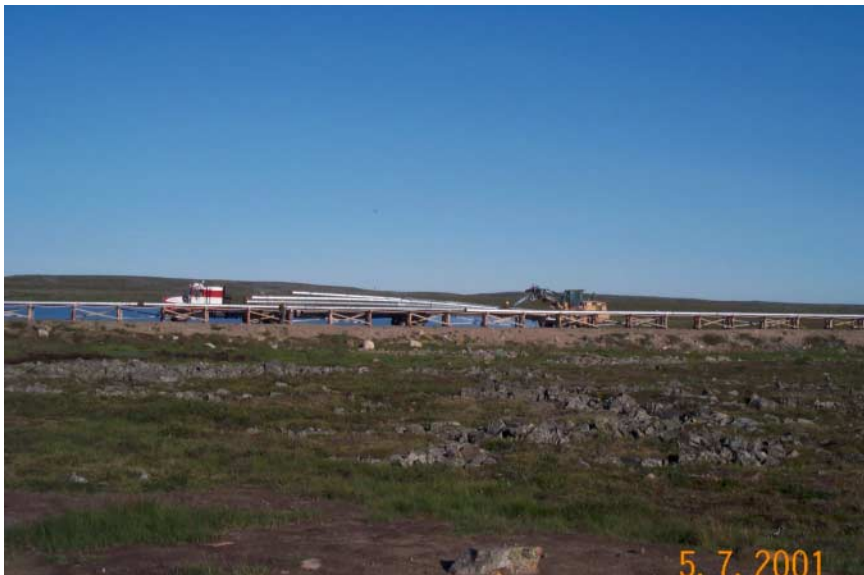
Photo 11

Removal of original
six inch tailings line;
a distance of
approximately 6km.
