# **2009 Annual Geotechnical Inspection Perimeter Dams Tailing Containment Area Lupin Mine, Nunavut**

**Prepared For:  
MMG Resources Inc.**

**Prepared By:  
TBT Engineering Consulting Group**

December 1, 2009

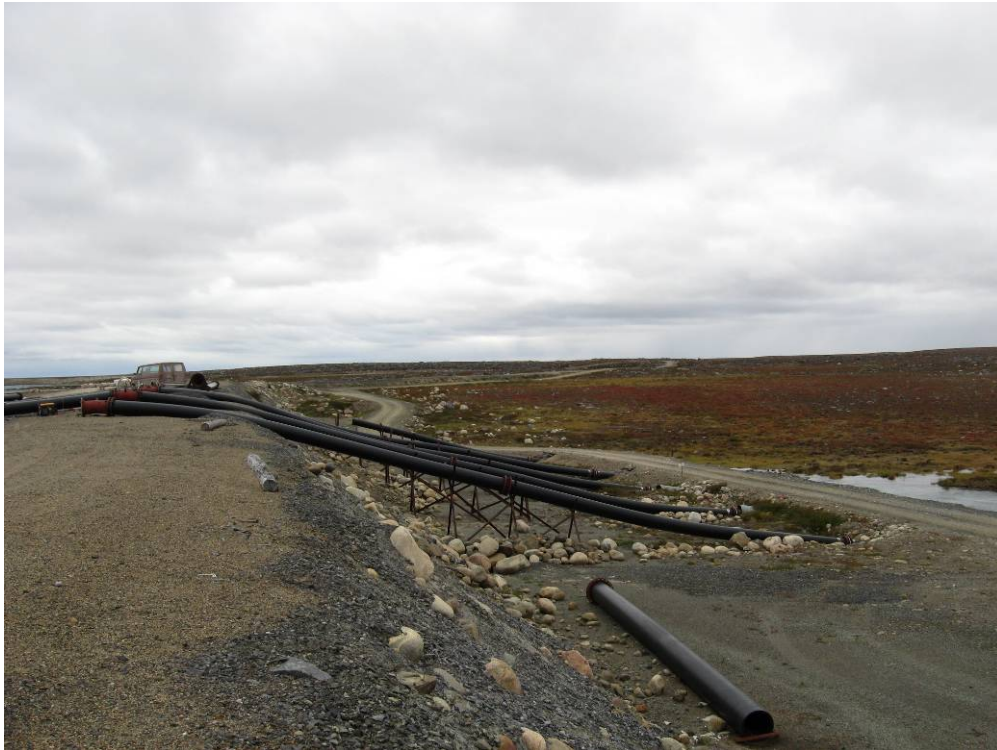
Dam 1A: Downstream

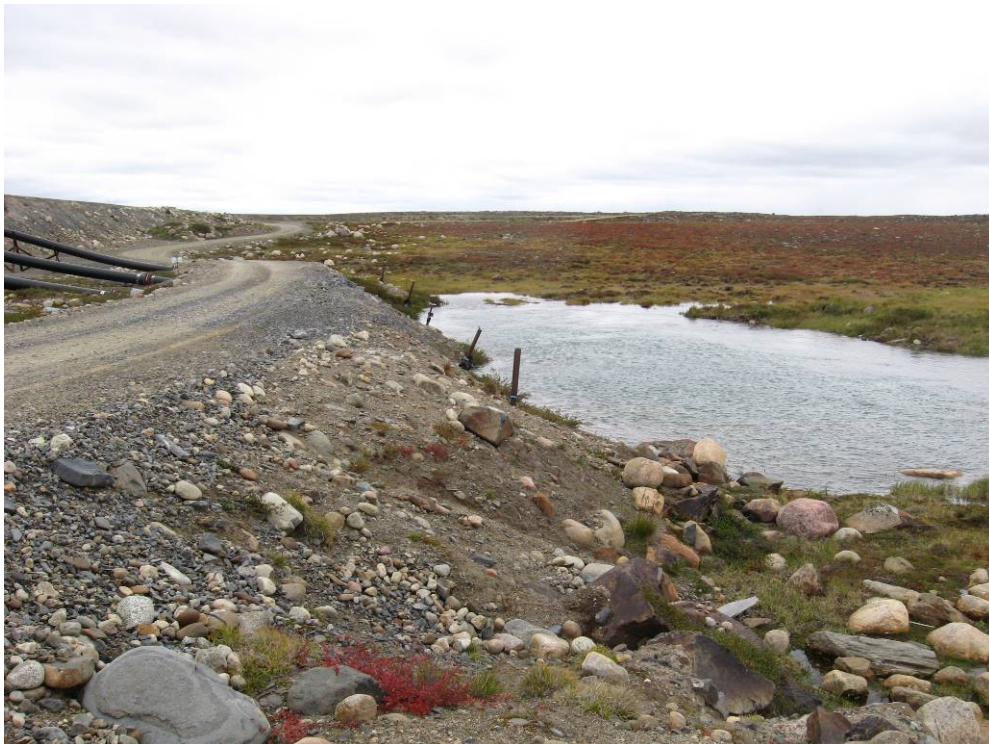
| <b>ACCESS ROAD TOE BERM</b> | Longitudinal cracking, associated settlement and sinkhole formation is occurring on the downstream edge of the downstream access road berm, near the siphon valves. |

Dam 1A: Downstream Access Road toe Berm

| <b>MAINTENANCE RECOMMENDATIONS:</b> | Flatten slope of access road toe berm and provide additional coarse granular as erosion protection. |

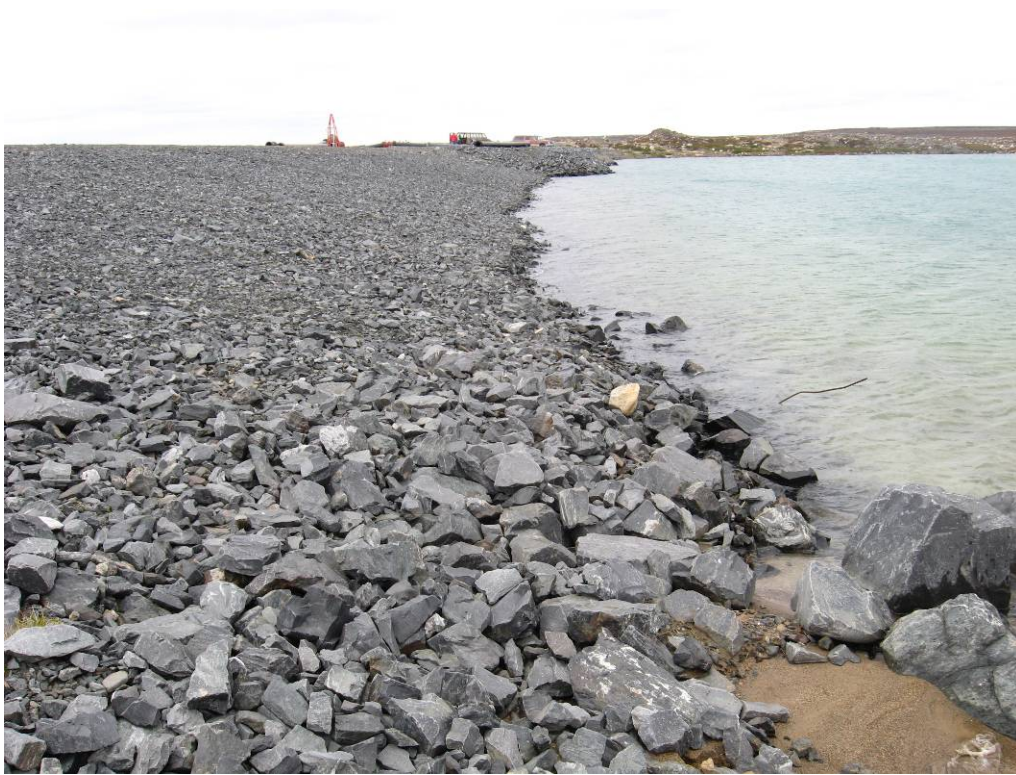
Dam 1A: Upstream

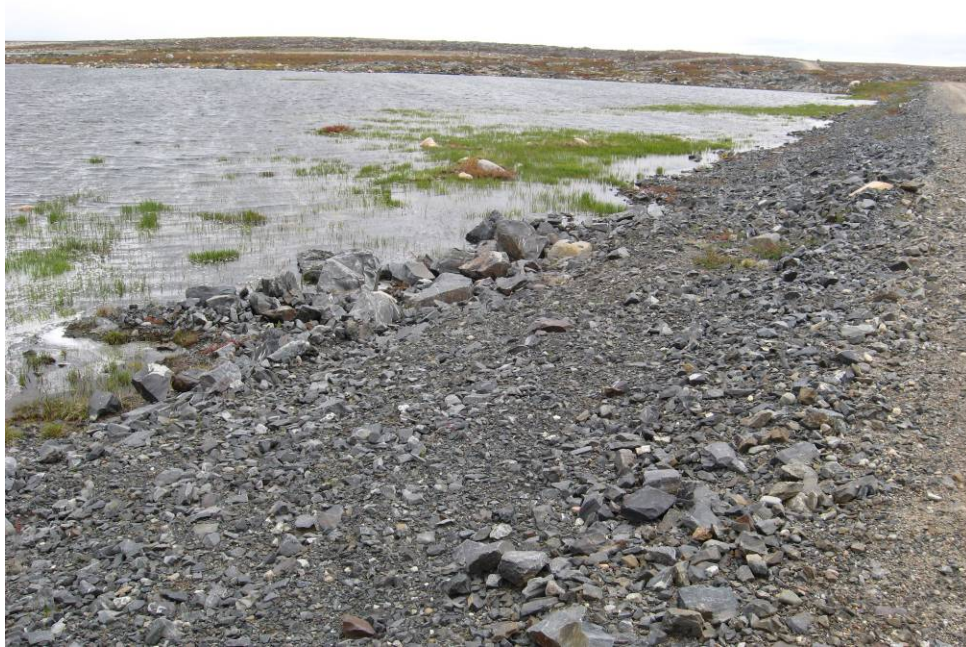
Dam 1B: Upstream

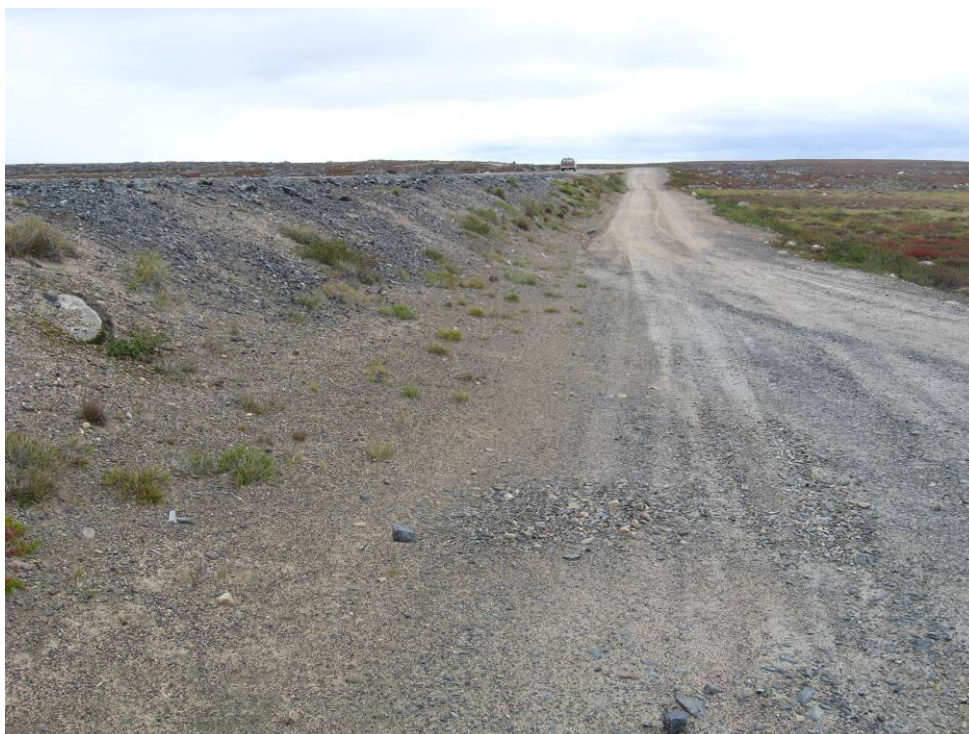
Dam 1B: Downstream

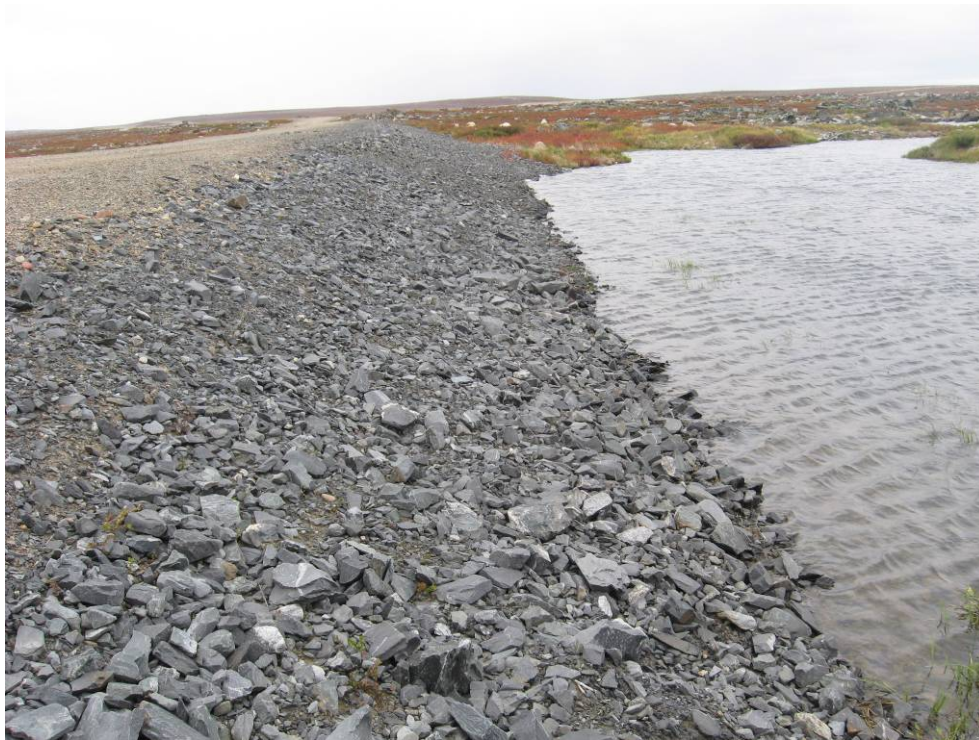
Dam 1C: Upstream

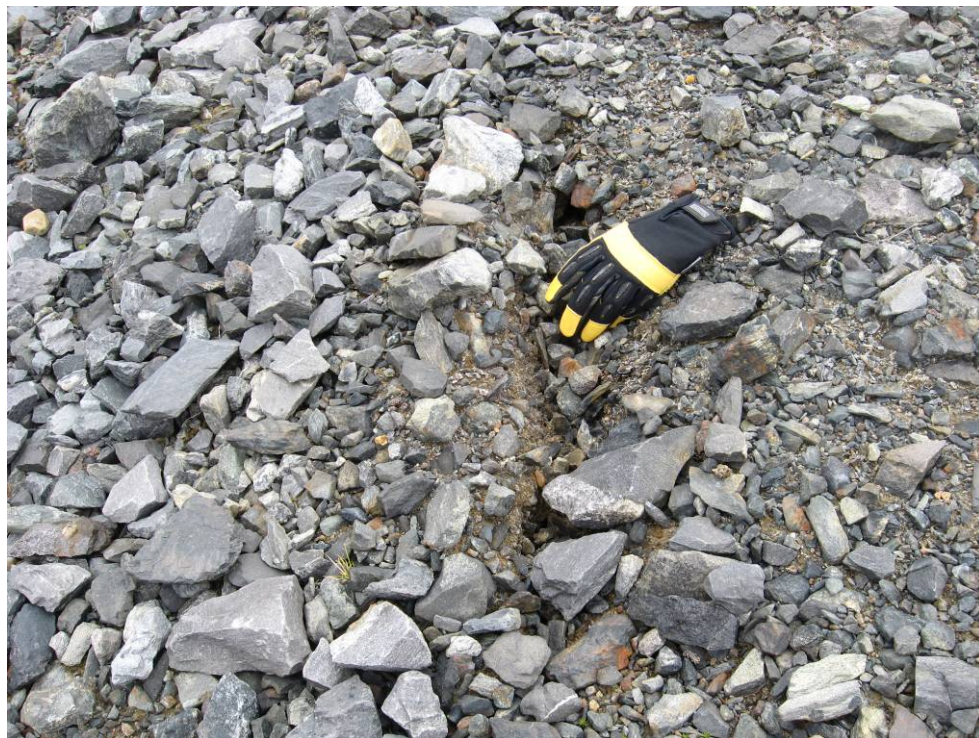
| <b>RIPRAP:</b> | Run of Mine rockfill; Cracking noted over 2/3 of dam length, approx. 0.6 m above water level (see photo following page). Potentially due to thaw of subgrade with increase in pond water level. |

Dam 1C: Upstream-Minor Cracking

| <b>MAINTENANCE<br/>RECOMMENDATIONS:</b> | Review toe in spring. Re-grading and reshaping of toe likely required at that time. |

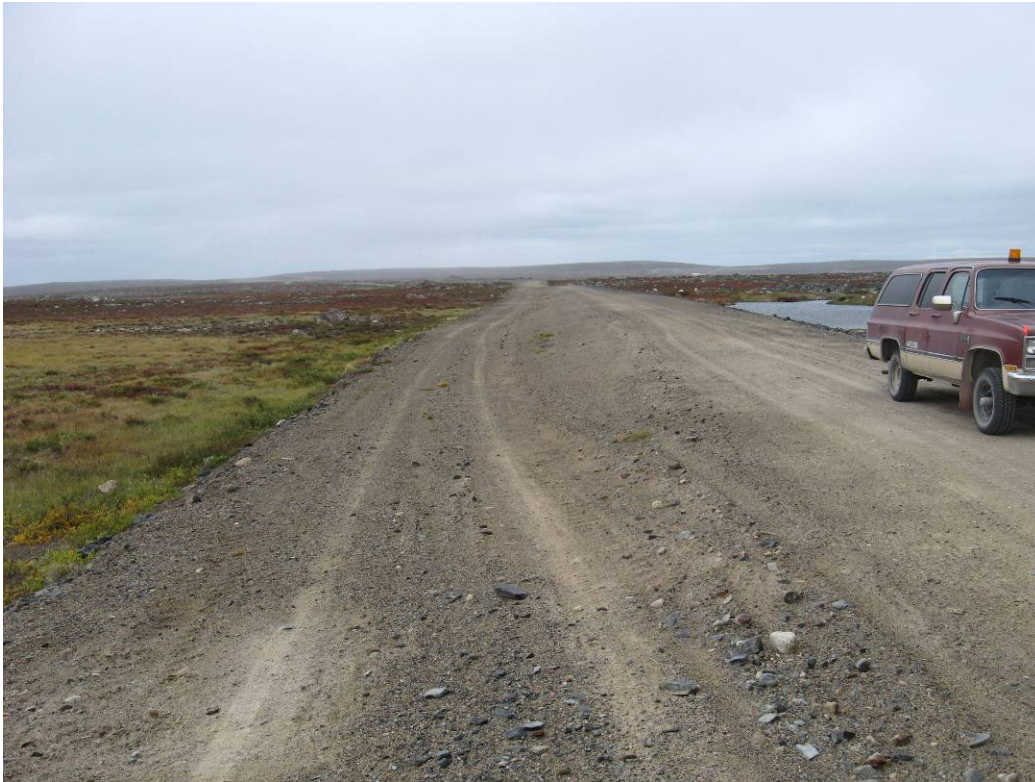
Dam 1C: Downstream

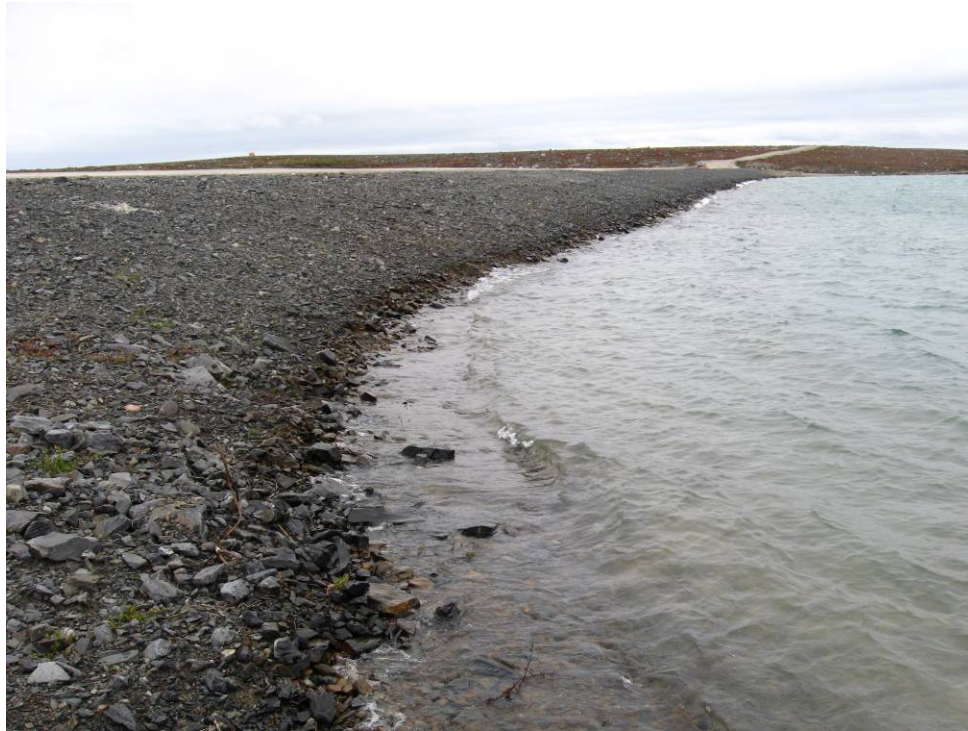
Dam 2: Upstream

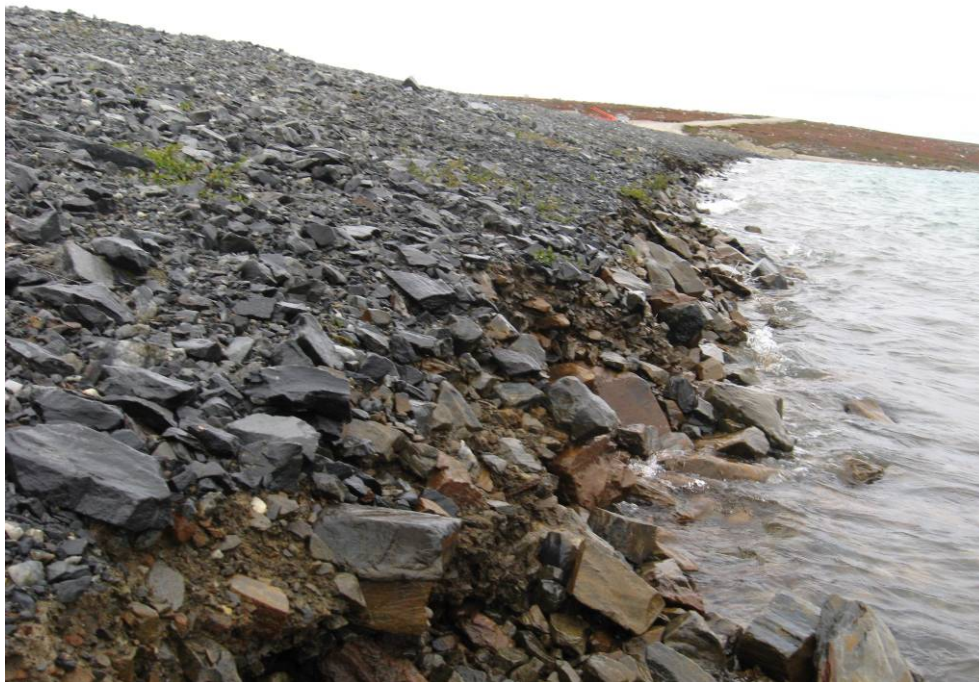
Dam 2: Upstream

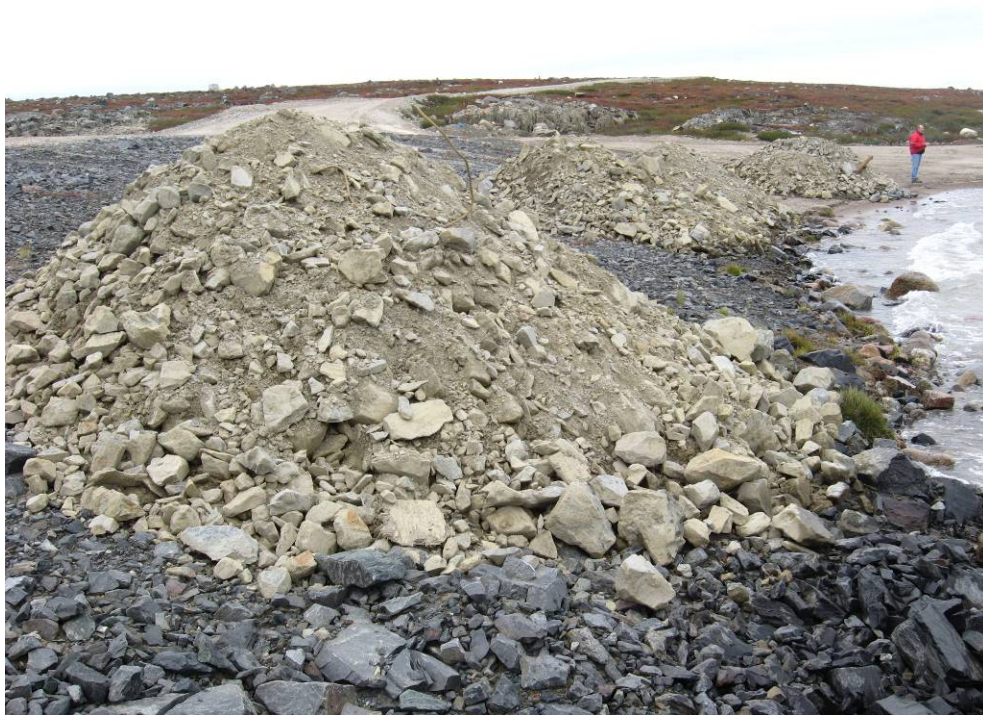
| <b>RIPRAP:</b> | Run of Mine rock forms convex-upward, gently sloped upstream face. A small erosion scarp has formed on the upstream side of the dam near the waterline, |

Dam 2: Upstream – New Riprap Material

| <b>MAINTENANCE RECOMMENDATIONS:</b> | The areas of upstream erosion scarp currently being backfilled as per 2008 recommendations. This project should continue to establish corrected slope.<br>. |

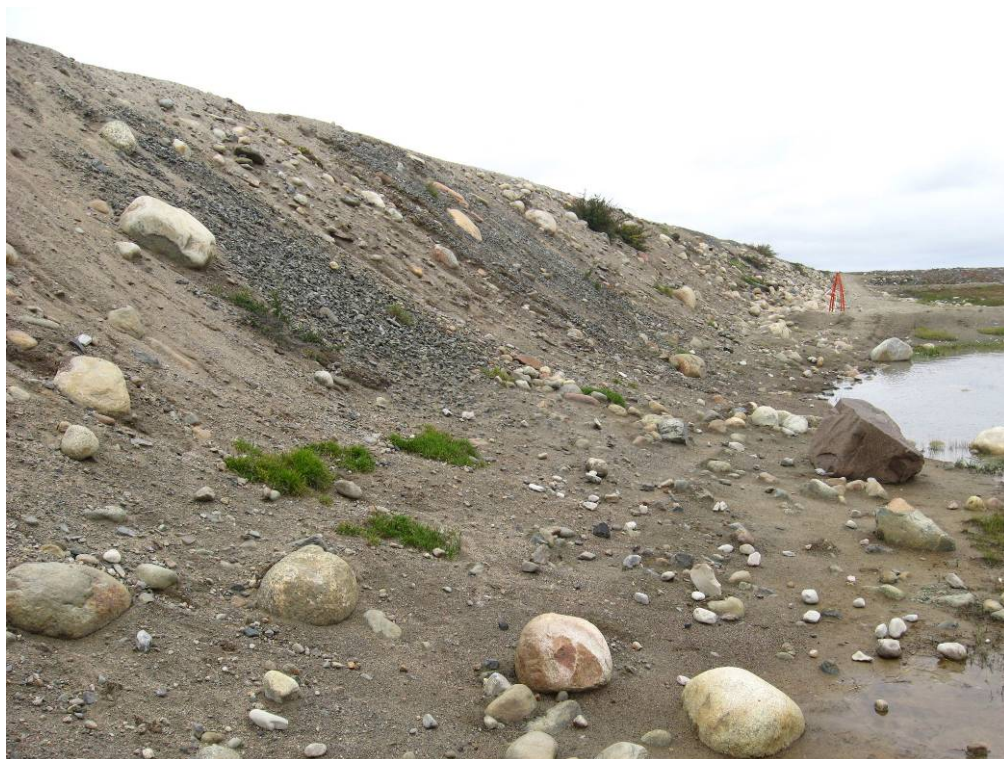
Dam 2: Downstream

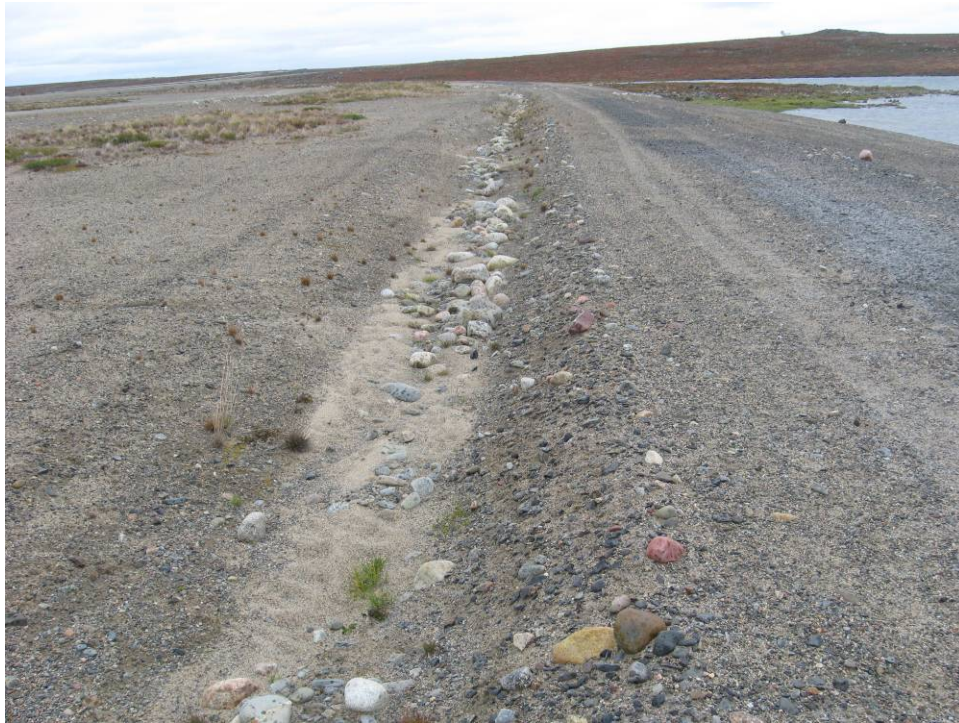
Dam 3: Upstream

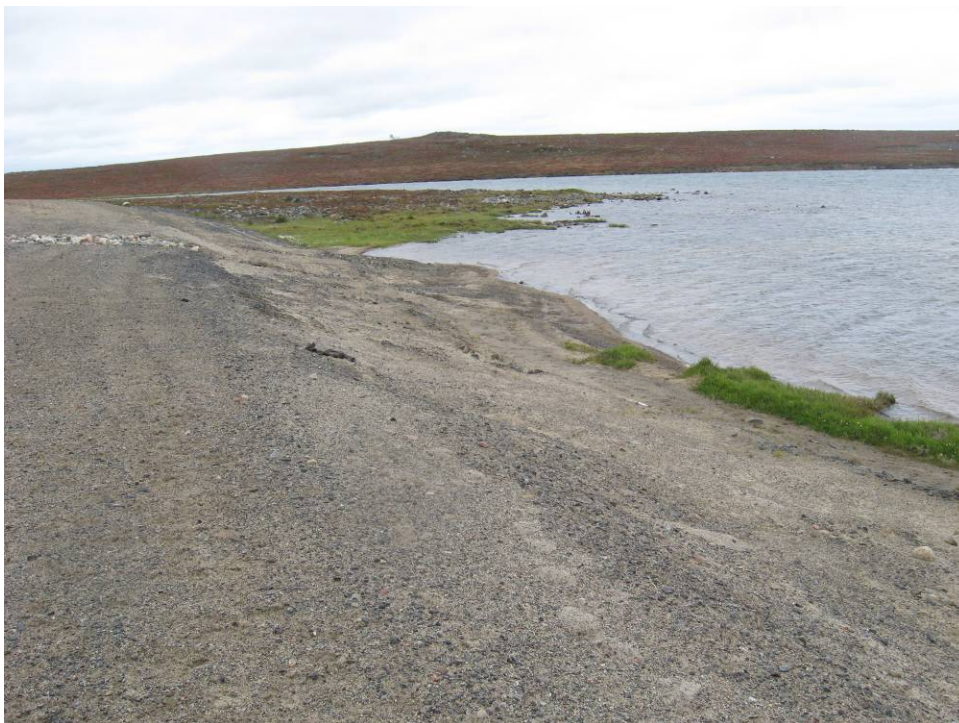
Dam 3: Downstream

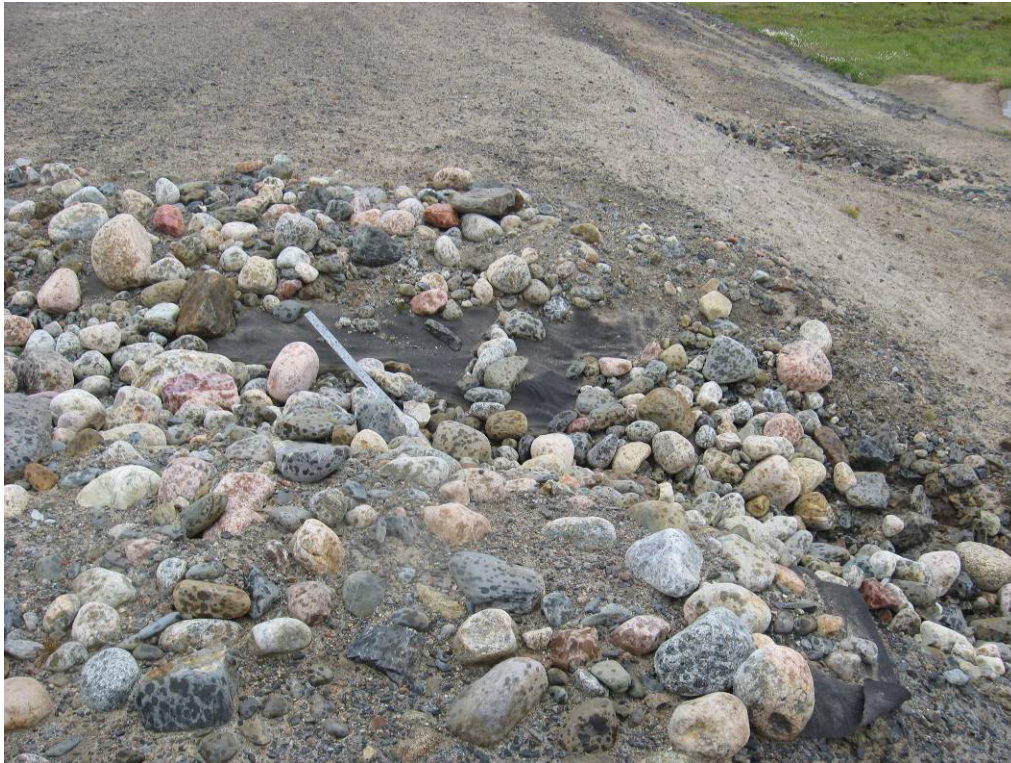
| <b>BACKSLOPE:</b> | Variable in inclination; locally meets the shoreline of Boomerang Lake. Storm channel constructed in back slope has eroded exposing geotextile below channel riprap. |

Dam 3: Downstream – Eroded Ditch

| <b>MAINTENANCE RECOMMENDATIONS:</b> | <p>The cracking on the crest of the dam should be re-graded and the ditch should also be re-graded to remove the accumulated material.</p> <p>The gully in the storm channel ditch also needs to be repaired and relined.</p> |

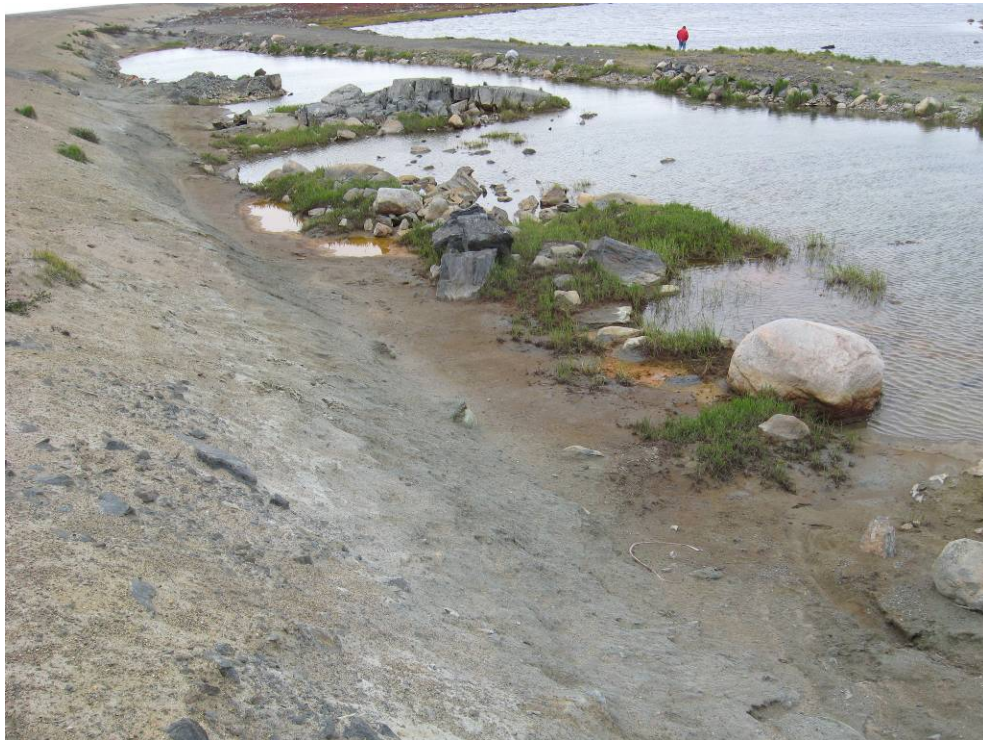
Dam 4: Downstream

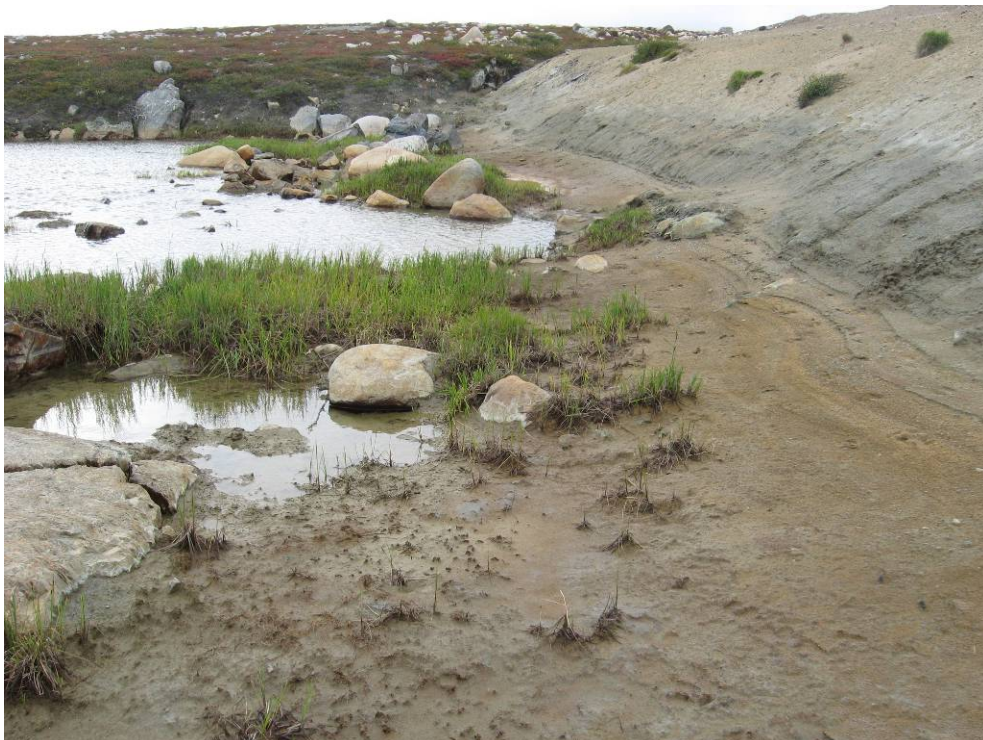
An exception to the above is Dam 4, where slight seepage at the downstream toe was noted. There is evidence of minor sloughing of the slope at the toe and some staining of the soils consistent with seepage. The pH of the water contained along the downstream toe of the dam,

within the cofferdam enclosure was measured at 3.8, which is consistent with the pH inside Cell 4 on the upstream side of the dam. From this observation, it is possible that the water ponding on the downstream side of the dam originates from seepage through the dam and/or under the dam, through the foundation soils.

| <b>SEEPAGE:</b> | Evidence of seepage noted over 1/3 of dam length at area of coffer dam. |

Dam 4: Downstream, note seepage line  
**TBT Engineering Limited**

| <b>MAINTENANCE RECOMMENDATIONS:</b> | A geotechnical investigation is recommended to establish the causes of the seepage at the toe of Dam 4. Once the cause of the seepage/sloughing is determined, remediation measures should be designed to address the seepage and the resultant sloughing. Field investigations, design and permitting activities |

should be scheduled for 2010. Construction of remediation measures may be scheduled for 2010, subject to some minor preventative measures being undertaken in 2011. A regular and more intensive monitoring program for Dam 4 should be initiated and documented. In addition, the water levels should be maintained as low as possible. The installation of a free draining granular flanking berm may be considered in the interim to improve stability. Collecting and pumping back seepage should also be considered.

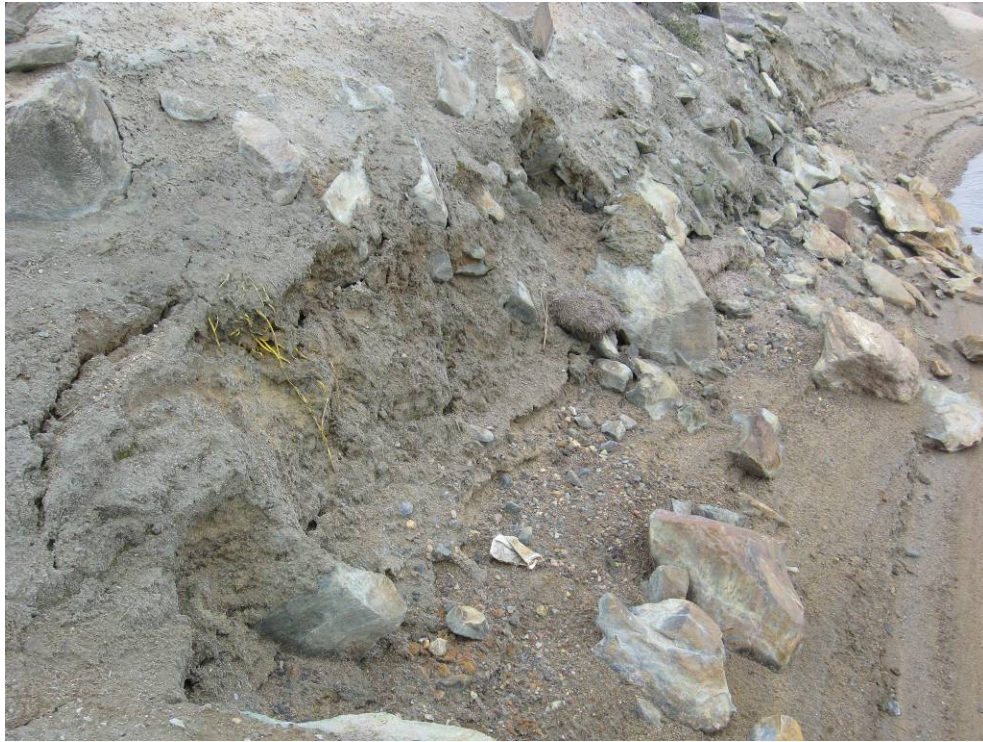
| <b>BACKSLOPE:</b> | <p>Esker sand; slope steeper in upper portion and flattens in the lower portion, approximately 2H: 1V. Slumping of downstream slope noted in areas of seepage. Some areas have slumped to a near 1:1 slope.</p> <p>Evidence of piping beginning in sandier soils. Zones of geo-grid exposed between surficial esker fill and underlying rock fill.</p> |

Dam 4: Downstream - sloughing zone

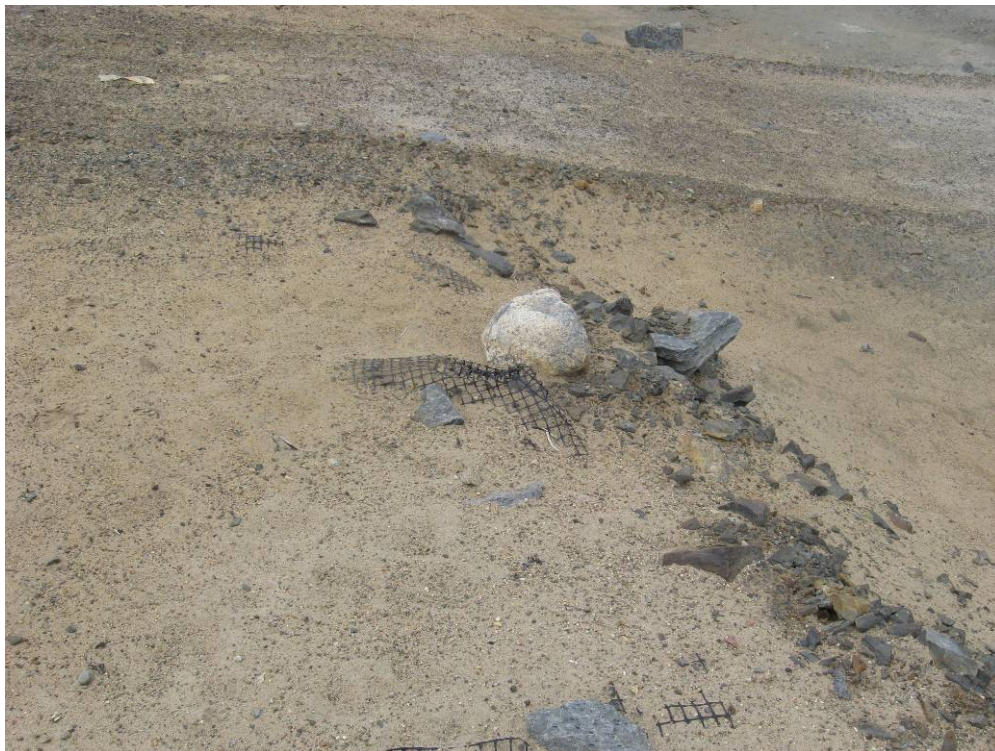
Dam 4: Downstream - exposed geogrid

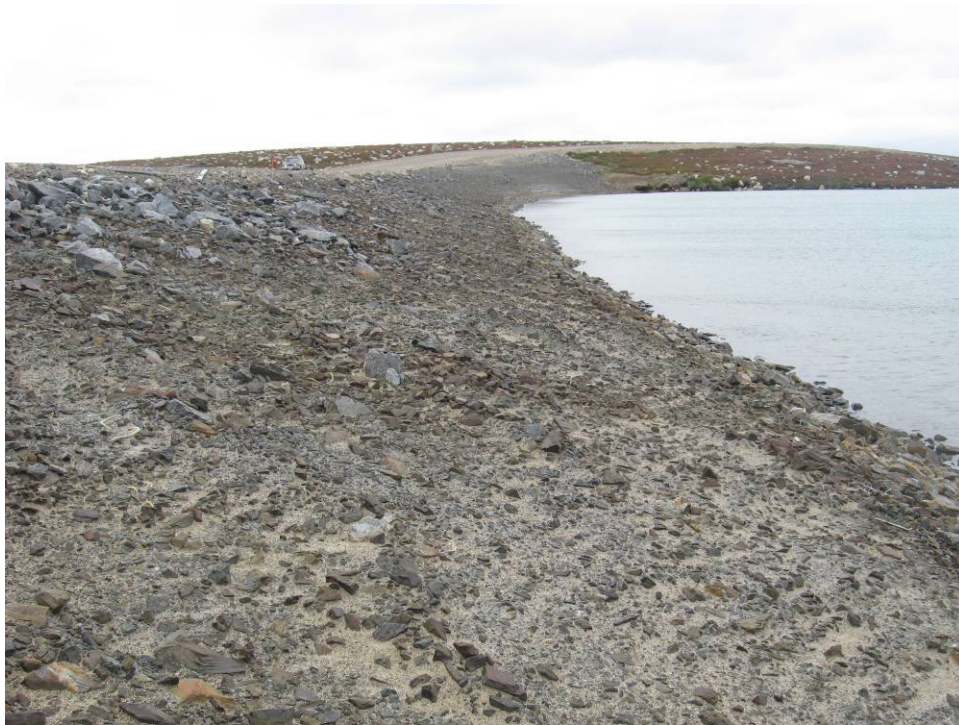
Dam 4: Upstream

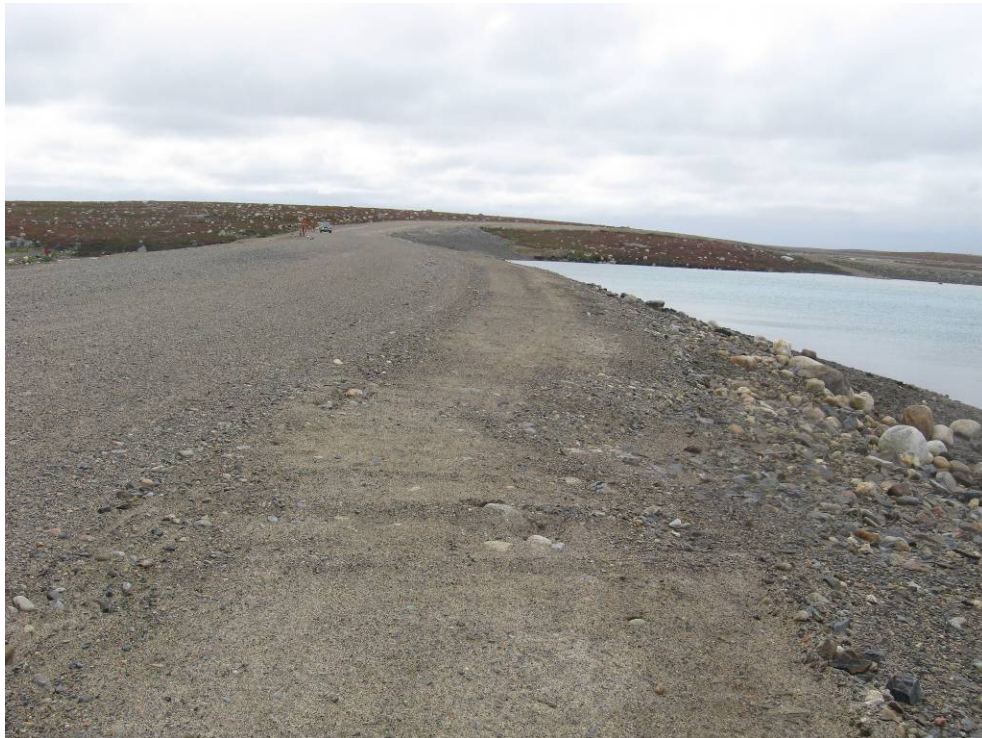
Dam 4: Upstream

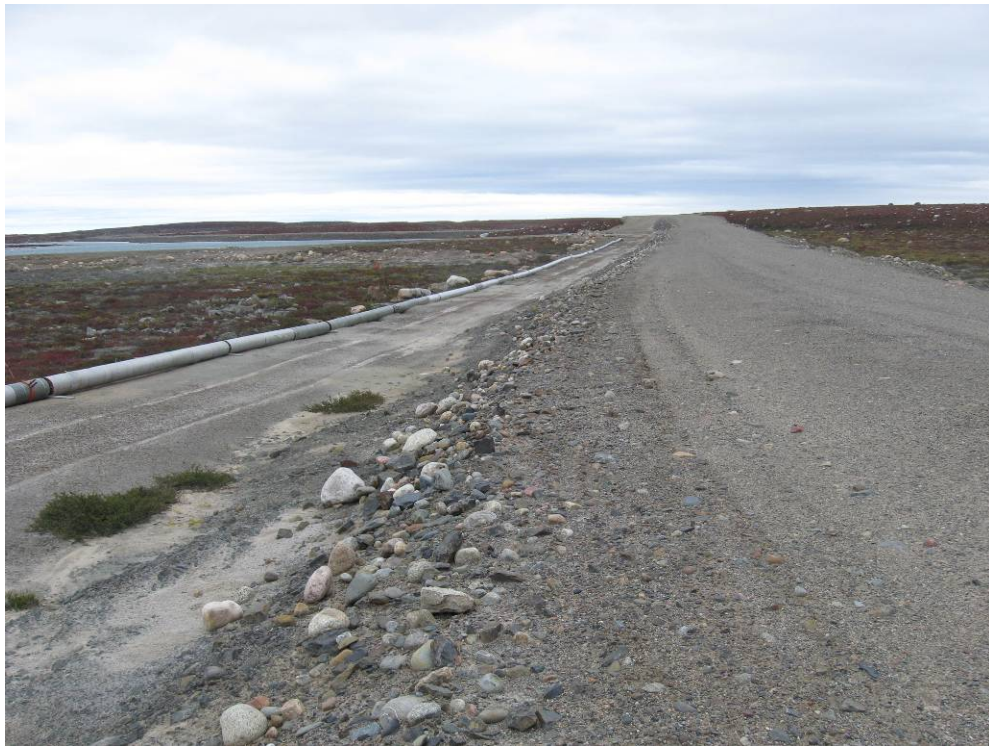
Dam 5: Upstream

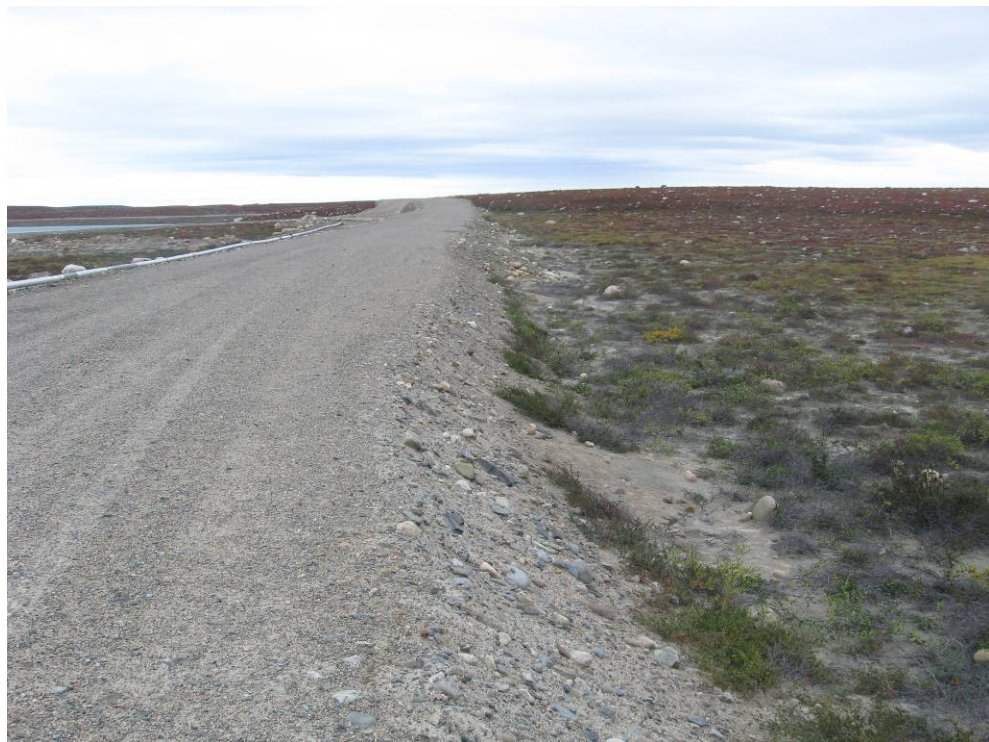
Dam 5: Downstream

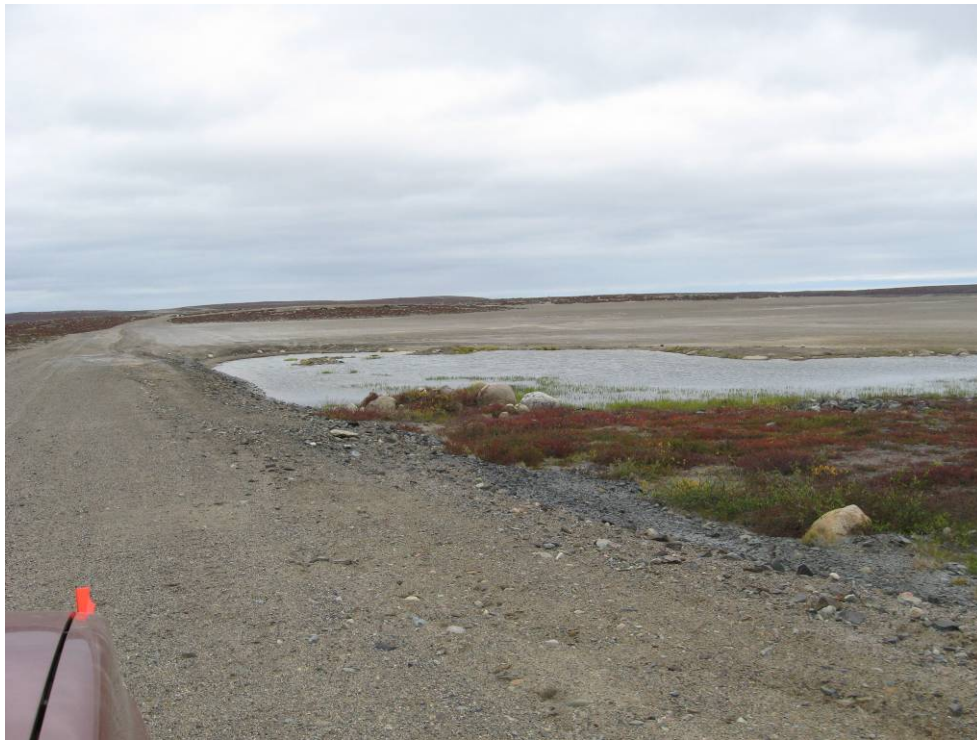
Dam 6: Upstream

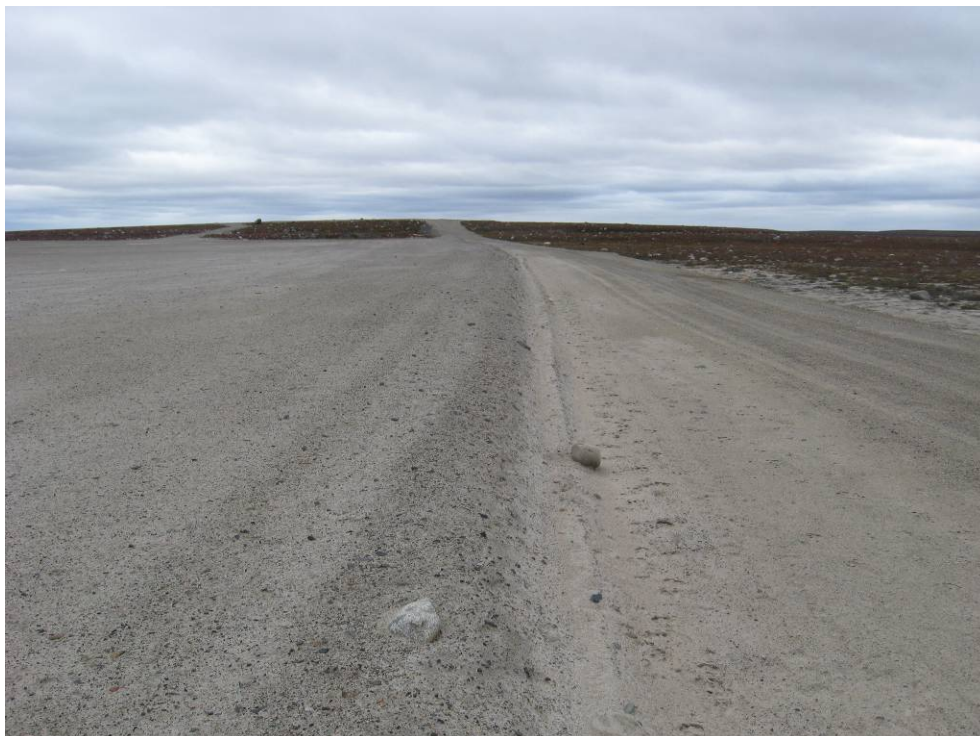
Dam 6: Upstream

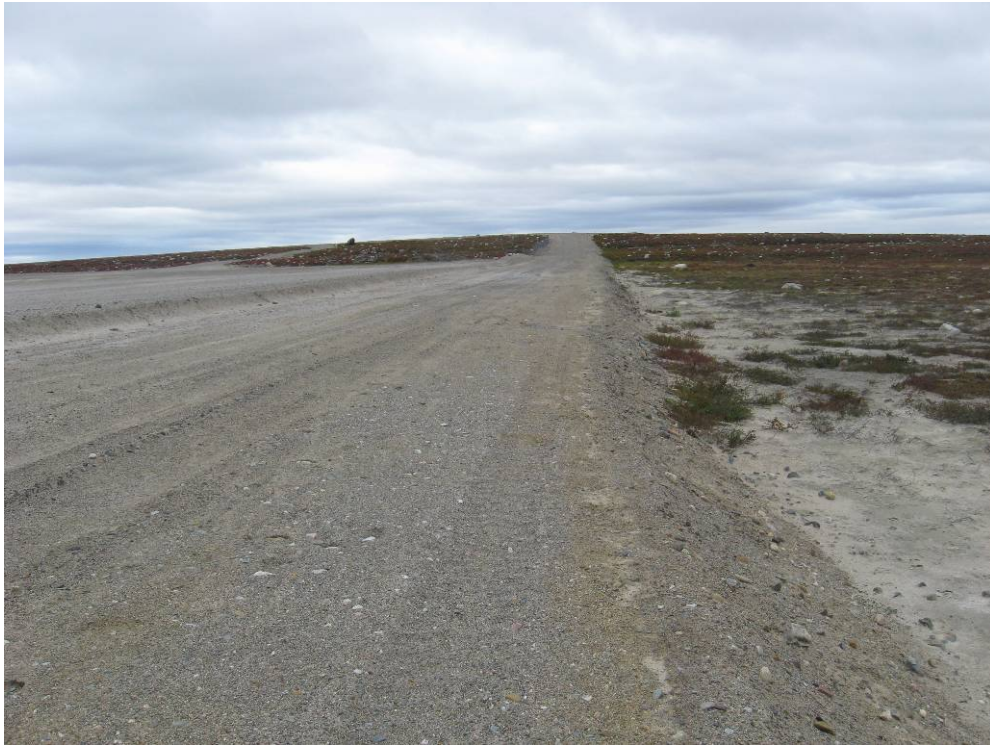
Dam 6: Down stream
