Canada – Lupin Mine NWB Water License No: 2AM-LUP0914

2010 Annual Report to the Nunavut Water Board

2010 Annual Geotechnical Inspection
Perimeter Dams Tailings
Containment Area
Lupin Mine, Nunavut

2010 GEOTECHNICAL INSPECTION
PERIMETER TAILINGS DAMS

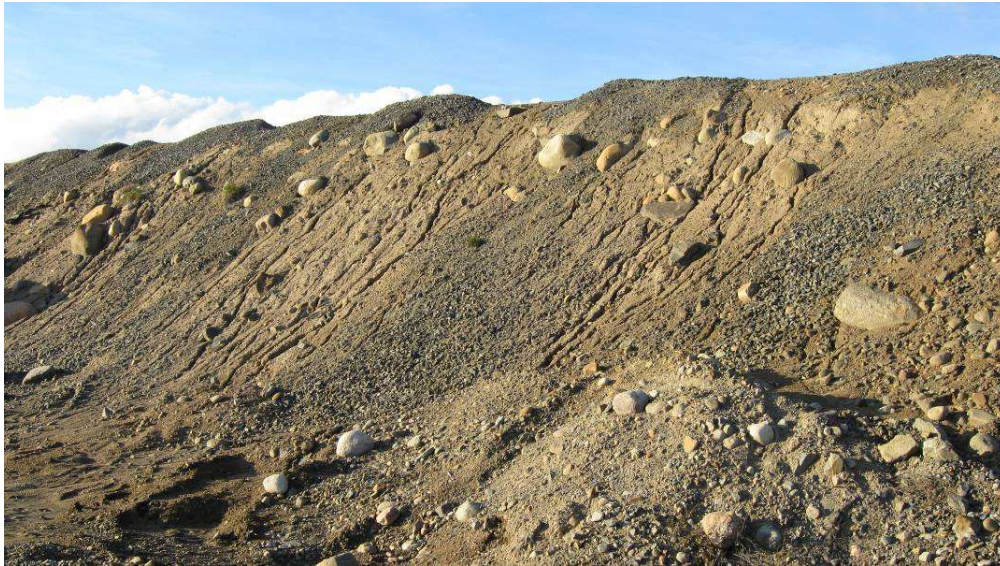
- Dam 1A: Widespread shallow erosion gullies and cracking near downstream crest
- Dam 1B: Minor runoff erosion rills and a few deeper erosion gullies, no cracking.
- Dam 1C: Minor erosion gullies with two cracks noted along downstream slope.
- Dam 2: Extensive erosion gullies, appears to be more extensive than last year.
- Dam 3: Minor erosion rills and sloughing.
- Dam 4: Extensive and deep erosion gullies (3 of which are up to 1 m deep).
- Dam 5: Two small surface cracks and a few small 150 mm deep erosion gullies.
- Dam 6: Extensive erosion gullies (up to 0.5 m deep).

Dam 1A – Downstream Slope (south side of Siphons) Erosion Gullies

A maintenance program to address and repair downstream erosion along all of the perimeters dams should be implemented to prevent further and eventually destabilizing erosion of the downstream slopes. A design of the erosion measures should be carried out and should consider various options to improve the erodability of the downstream slopes.

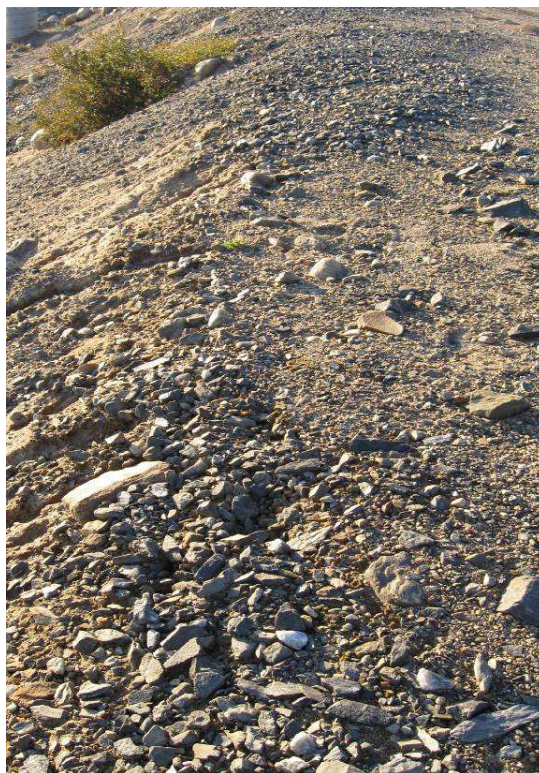
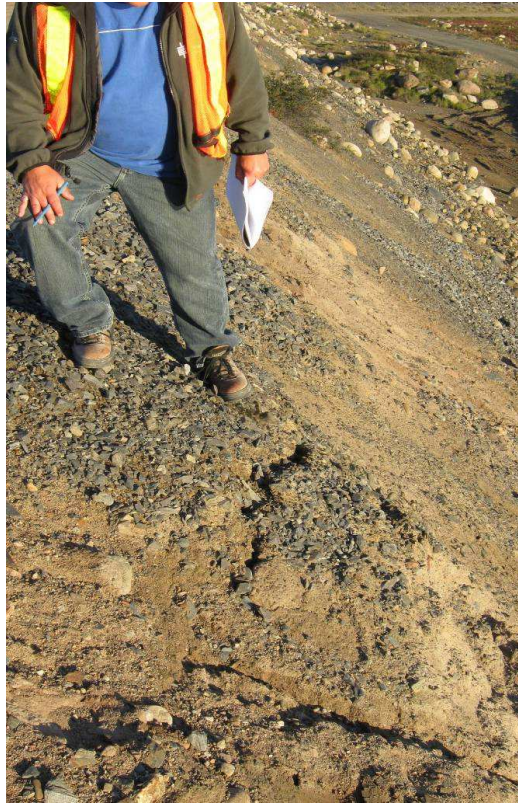
Downstream Crest: 1 m long narrow crack

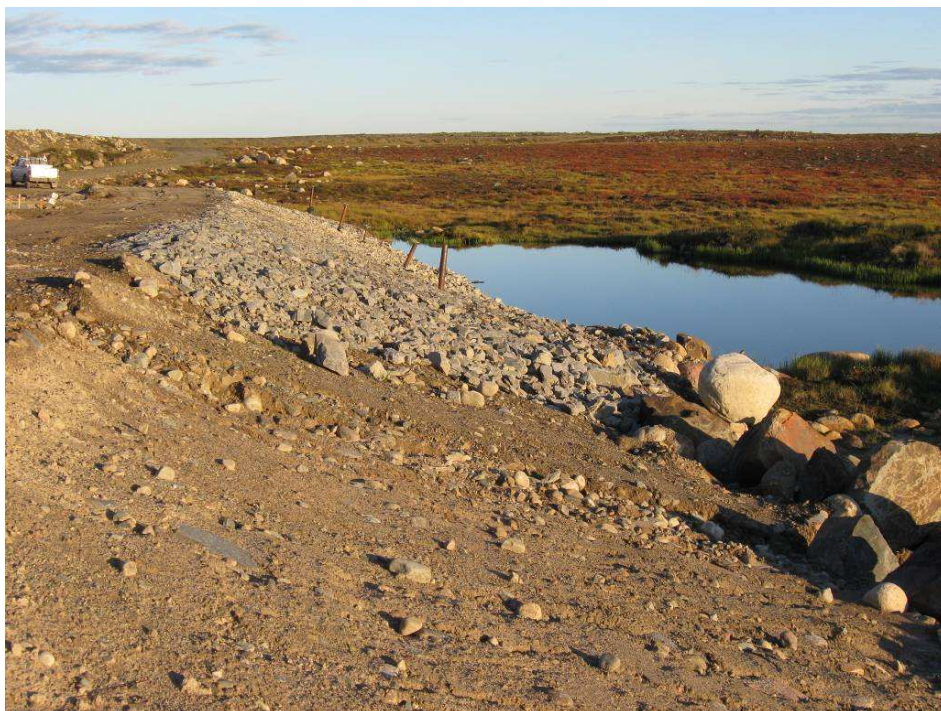
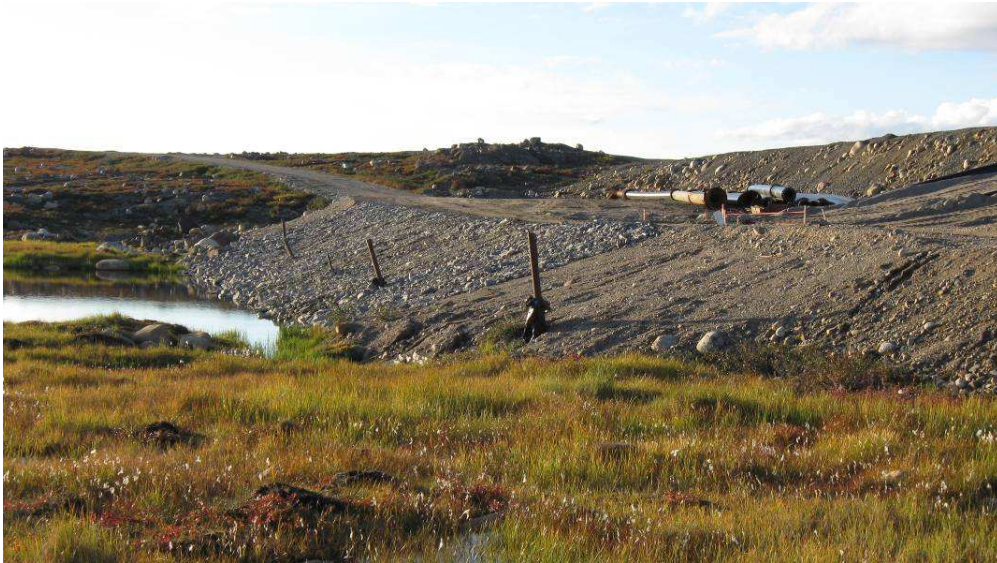
ACCESS ROAD TOE BERM	As per recommendations made last year, the downstream slope of the access road toe berm was regraded and provided with riprap over a 48 m long section. The downstream slope of the access road toe berm is approximately 2.5H:1V

Dam 1A: Downstream Access Road toe Berm Looking South (Note, Downstream Slope Regraded and Covered with Riprap in 2010).

Dam 1A: Downstream Access Road toe Berm Looking North (Note, Downstream Slope Regraded and Covered with Riprap in 2010).

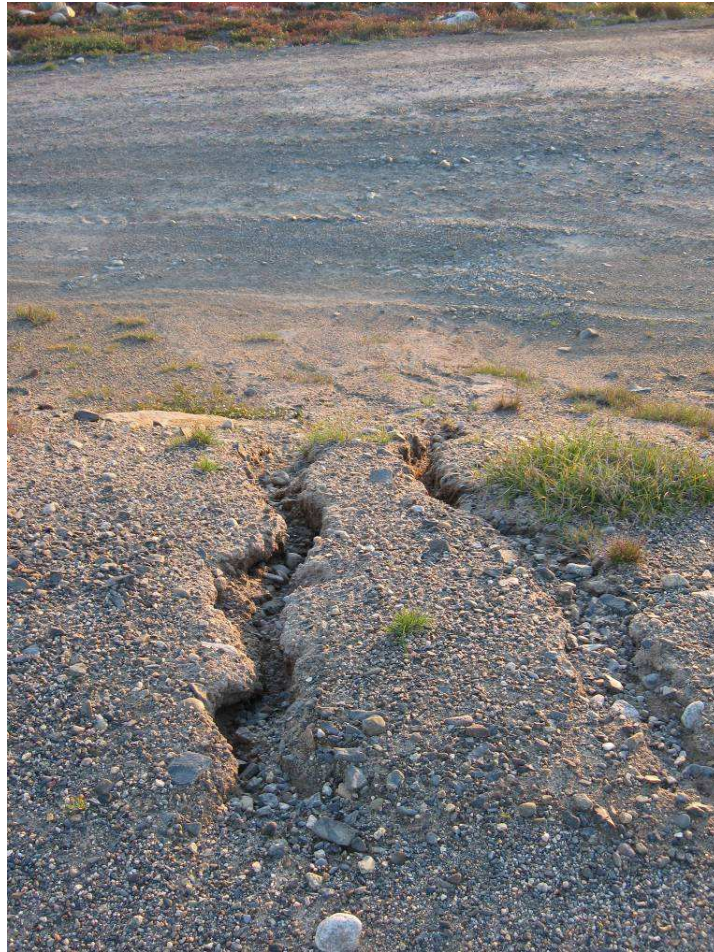
Dwonstream Slope: Erosion Gullies

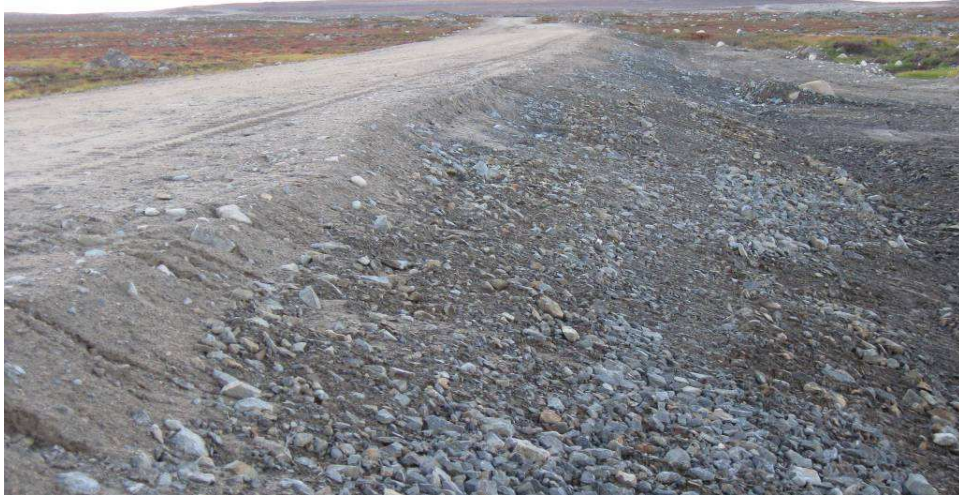
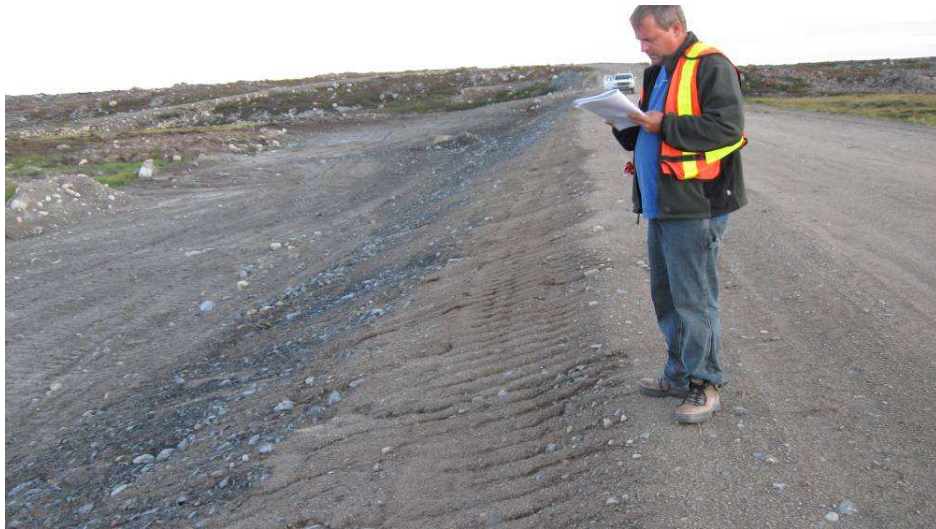
Dam 1C: Upstream (Minor Erosion Gullies on Shoulder of Granular Surfacing)

Dam 1C: Upstream (Minor Erosion Gullies on Shoulder of Granular Surfacing) Souther 2/3 of Upstream Slope Has Been Regraded/Extended with a Mixture of Rip Rap and Esker Material

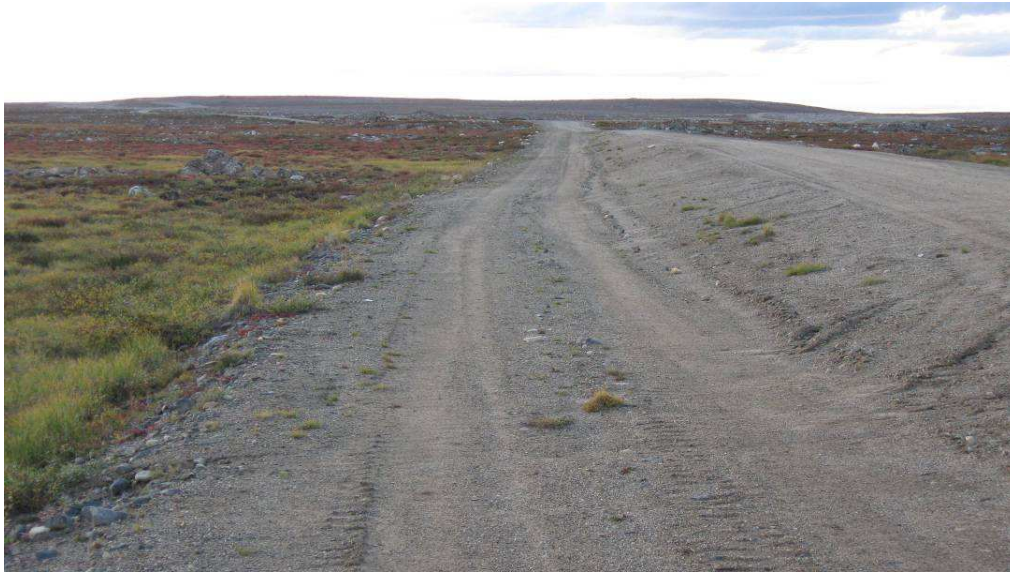
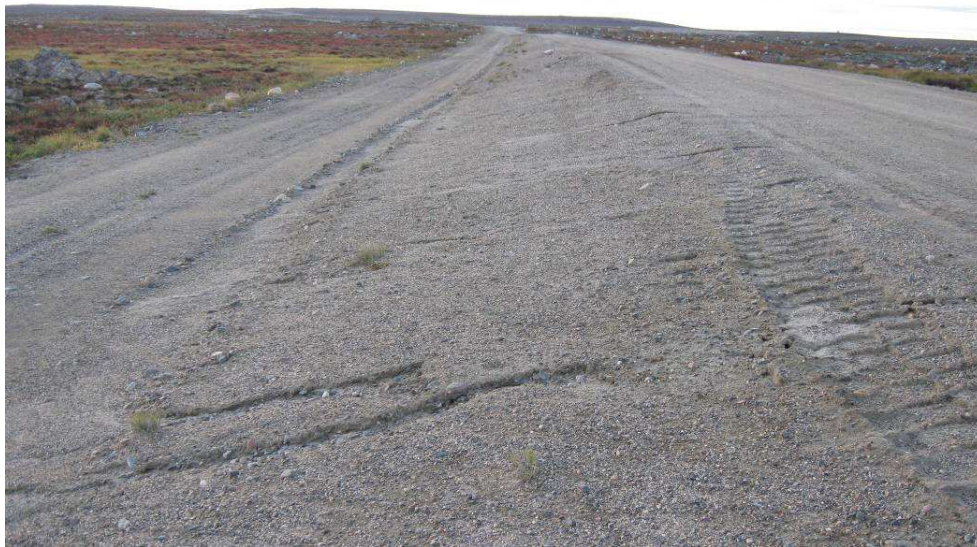
Dam 1C: Downstream Slope (Some Minor Erosion Gullies)

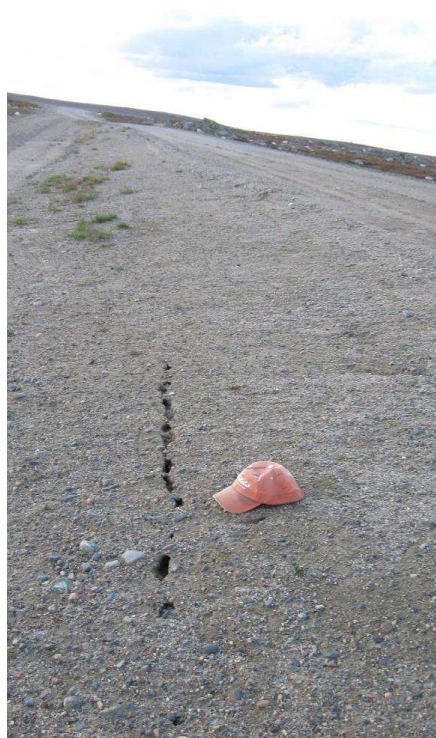
Downstream Slope (7 m long crack, 75 mm deep, north end of dam)

INSTRUMENTATION:	None
MAINTENANCE RECOMMENDATIONS:	Maintenance of cracking/sloughing conditions along downstream slope is recommended.
CONCLUSIONS:	The dam appears to be in a stable condition. Maintenance of downstream erosion and sloughing is recommended.

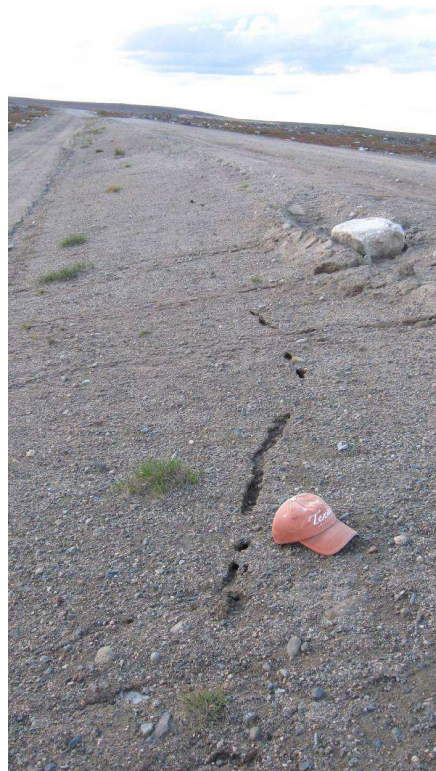
Downstream Slope (12 m long crack, middle of dam, 150 mm deep)

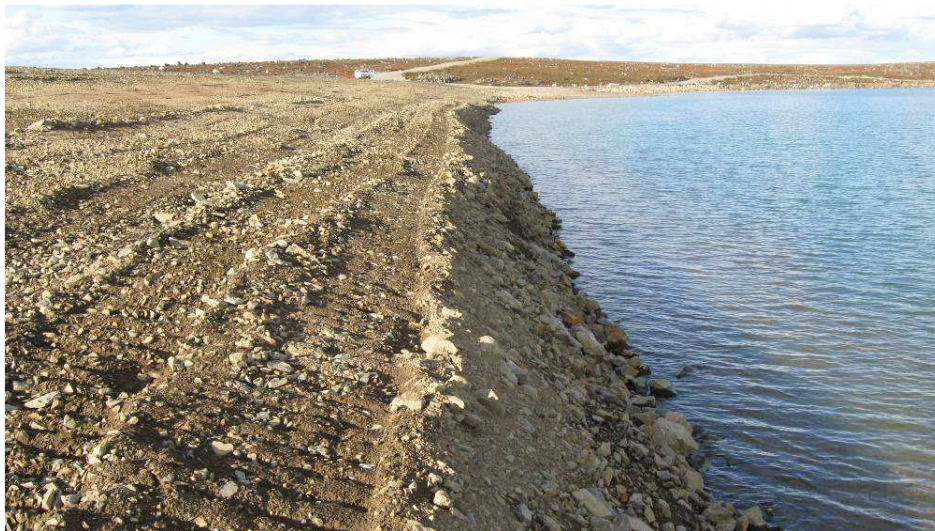
Dam 2: Upstream Slope Looking Northeast, Regraded with Riprap and Esker Material (graded at approx. 4.5H:1V upper portion, and at 1.5H:1V below about el. 483 m to pond level).

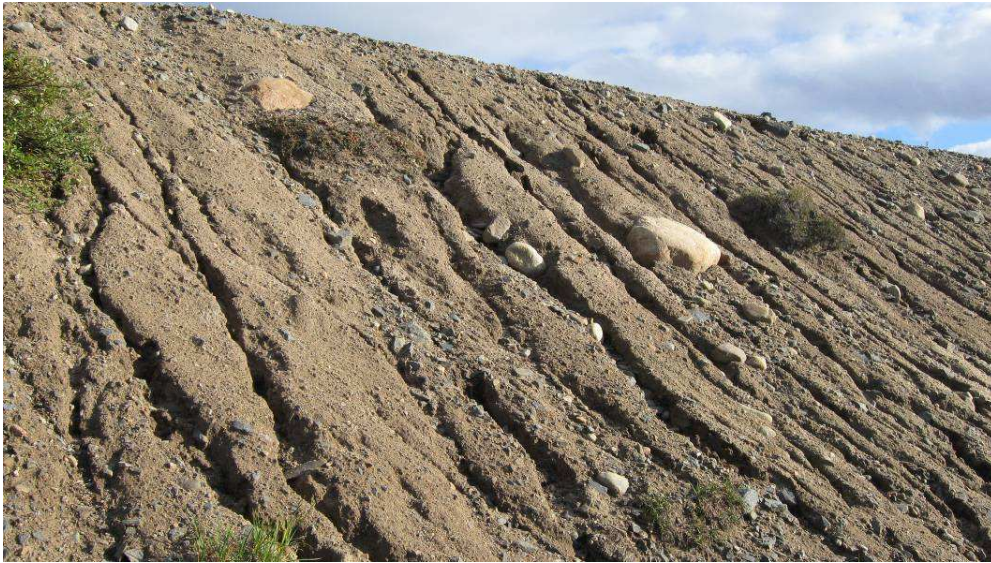
Dam 2: Downstream Slope Erosion Gullies and Rills

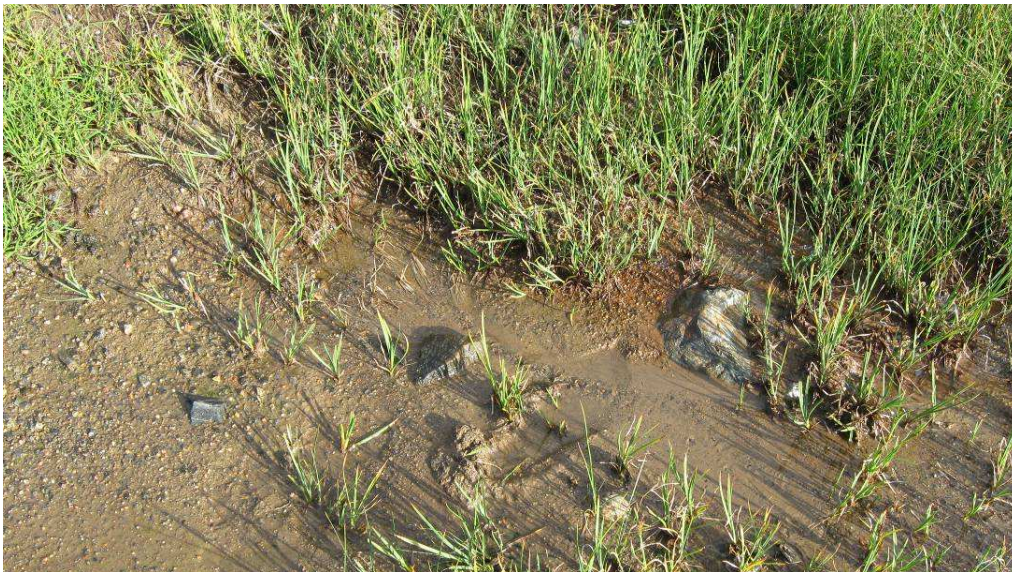
One small area of light seepage was noted along the downstream toe. At the time of this inspection, the seepage water was free of sediment and piping conditions were not evident. It is possible the seepage conditions may become worse over time and with an increase in level of Pond 2. It is possible that some of the water ponding on the downstream side of the dam

originates from seepage through the dam and/or under the dam, through the foundation soils. Seepage may also be related to recent precipitation that may have infiltrated the downstream portion of the dam. A sample of the seepage water should be collected to assess if the source can be Pond 2.

The dam currently appears to be in a stable condition. However, should seepage conditions continue and/or worsen, stability could be compromised. Further inspection and/or investigation with possible remediation may be required. In addition, the extensive downstream erosion should be repaired. Current seepage conditions should be monitored and investigated further or repaired if seepage continues are worsens.

Dam 2: Downstream Toe (approx. 20 m South of D2-00-02) Clear Seepage at a Rate of Approx. 2 liters/min.

The geotechnical conditions at Dam 2 should be investigated to determine the in situ fill conditions and to measure pore water levels in the dam. In addition, an additional thermistor string may be considered at the seepage location to review the depth of frozen ground. Once conditions at the site are determined, remediation of the downstream slope should be undertaken. Remediation options may involve construction of suitable granular filter zones and / or construction of a suitable impermeable barrier to significantly reduce seepage losses. Widening of the base of the dam to attract the aggradation of permafrost conditions into the deep foundation of the dam may also be considered as a design alternative.

The investigation and design and approvals work should be undertaken in 2011. With suitable monitoring and some temporary remediation efforts, construction of the slope improvements may be scheduled for 2012. In the interim, the water ponded downstream of the dam should be sampled to ensure environmental compliance and may require containment and pump back over the dam. The water level in Pond 2, should be lowered as much as possible to reduce seepage gradients until such time as the seepage conditions are understood and/or corrective measures can be implemented. The seepage conditions at Dam 2 should be monitored and the mine should be prepared to implement immediate temporary repair to the dam should conditions deteriorate.

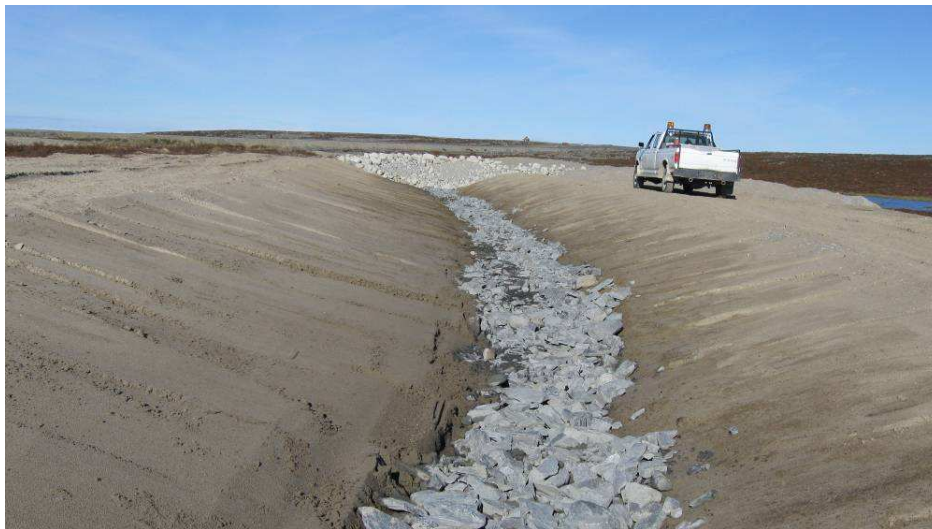
Dam 3: Upstream slope looking northwest at area of recent ditch regrading leading to reconstructed spillway. Ditch invert graded at about 3.5%. Tailings side ditch slope at about 4H:1, lake side ditch slope at about 3H:1V. Ditch invert lined with riprap (no geotextile observed).

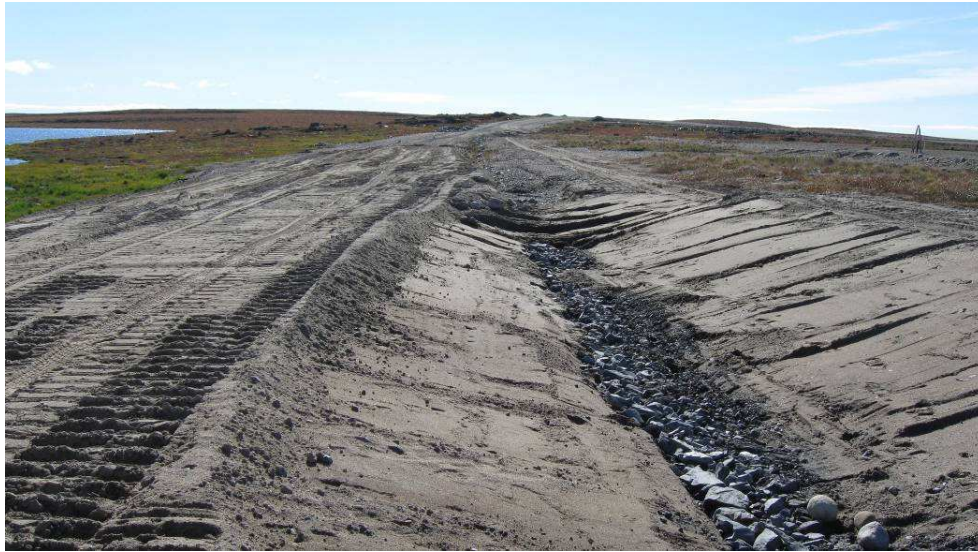
DAM 3: Upstream crest looking southeast. Loose fill on crest. End of ditch regrading. Ditching upstream of ditch regrading treatment contains some sediment.

Recent upgrades included relocation and construction of the existing upstream ditch spillway across the dam. In addition, the upstream ditch was extended to the new spillway location. Although the new spillway has significantly more capacity than the original, the new spillway was not constructed in strict accordance with the geometry recommended and may have slightly reduced flow capacity. It also appears the upstream ditch extension included the placement of riprap along the invert without the use of geotextile. The newly constructed ditch alignment and the new spillway should be monitored / inspected for signs of erosion and/or insufficient capacity. In addition, the existing upstream ditch (located south of the newly constructed portion) should be cleaned out.

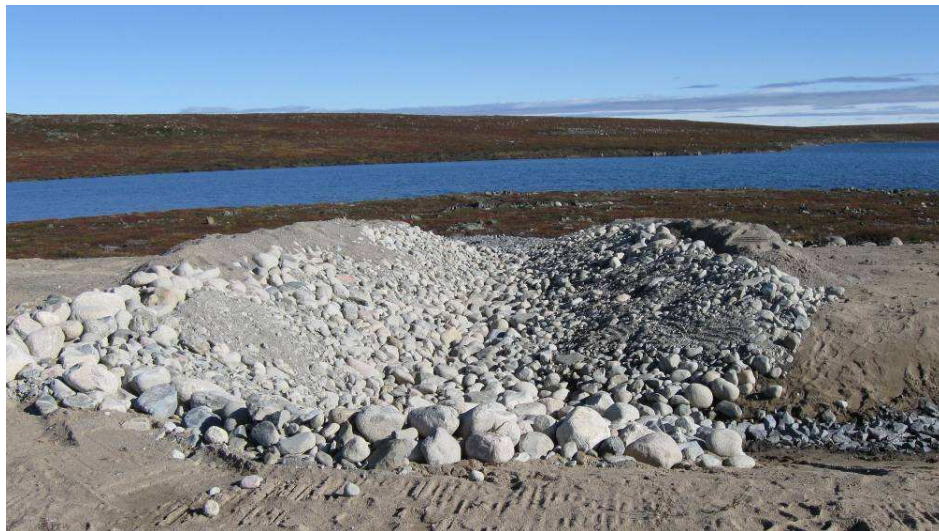
Dam 3: Spillway crossing dam at end of upstream ditch. Recently re-constructed with a grade of about 20H:1V (was specified at 30H:1V through the dam and 7H:1V along downstream slope). Through the dam crest, the new spillway has a channel base width of 2 m, not the specified 4 m. The spillway is lined with riprap and geotextile.

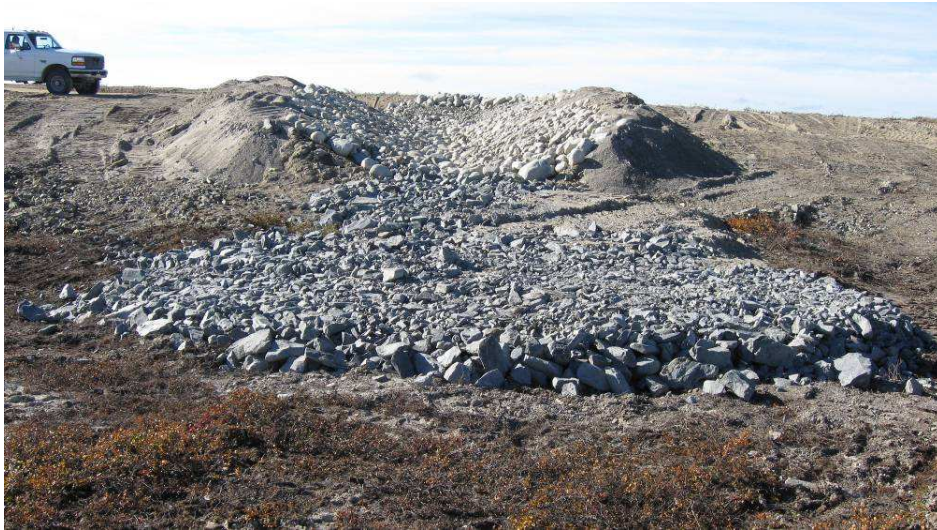
Dam 3: Downstream side of spillway (splash pad). Spillway side slope constructed at about 2.5H:1V (steeper than 3H:1V specified). Slopes on the outside of the spillway channel are also steeper than specified.

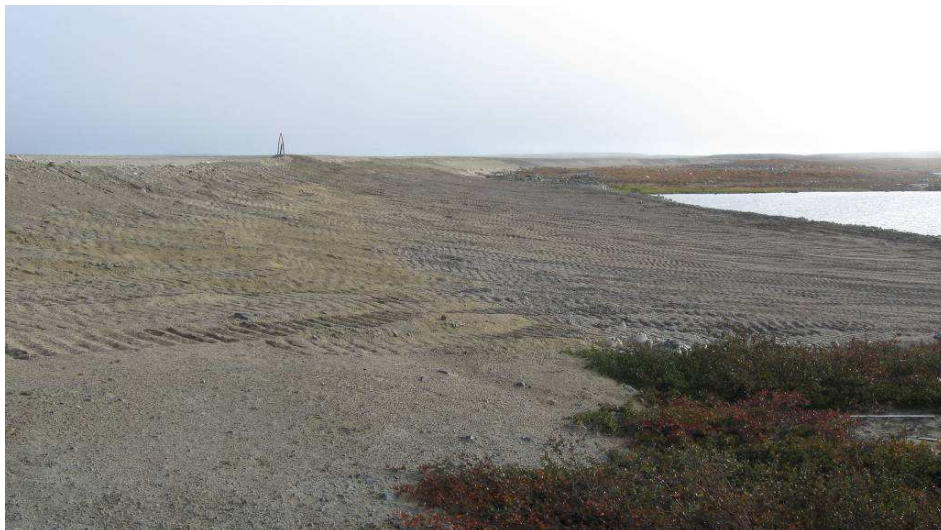
Measures to address a seepage issues noted last year along Dam 4 (in the area of the downstream coffer dam) have been carried out. This involved in filling the area between the downstream toe and coffer dam, thus flattening the downstream slope. However, the fill material appears to have been placed in a loose manner. As a minimum, surface compaction of the newly placed fill should be considered to improve erodability of the new fill surface.

Dam 4: Downstream side, west end of dam. Area between Dam and downstream coffer dam recently infilled with esker material to mitigate seepage conditions note in last years inspection. Base on inspection of completed surface, fill appears to be placed in a loose manner.

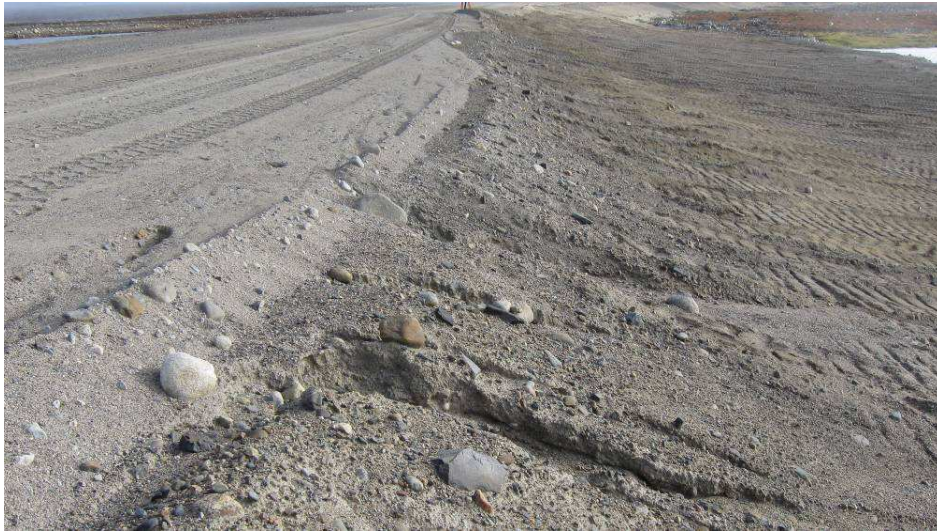
Dam 4: Downstream slope. Loose surface and erosion gullies on new infill between dam and cofferdam.

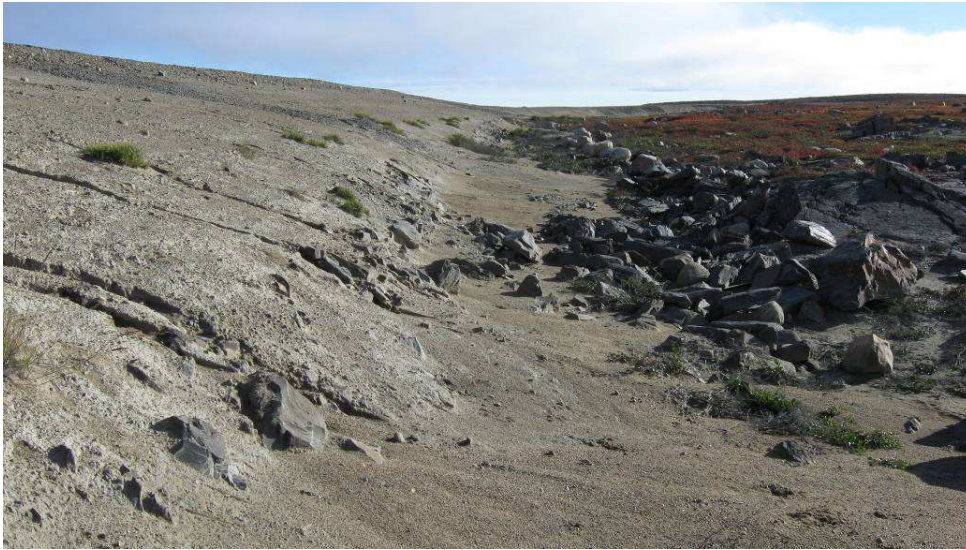
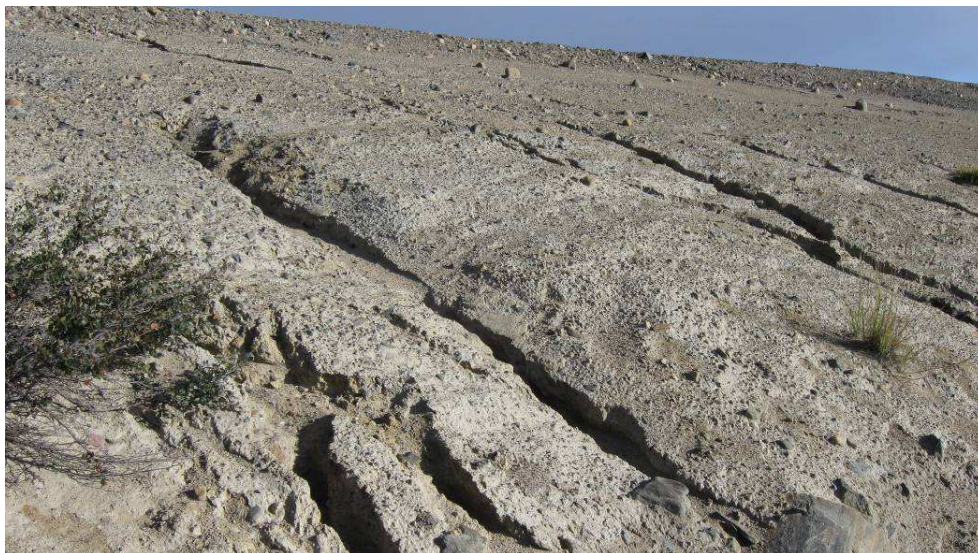
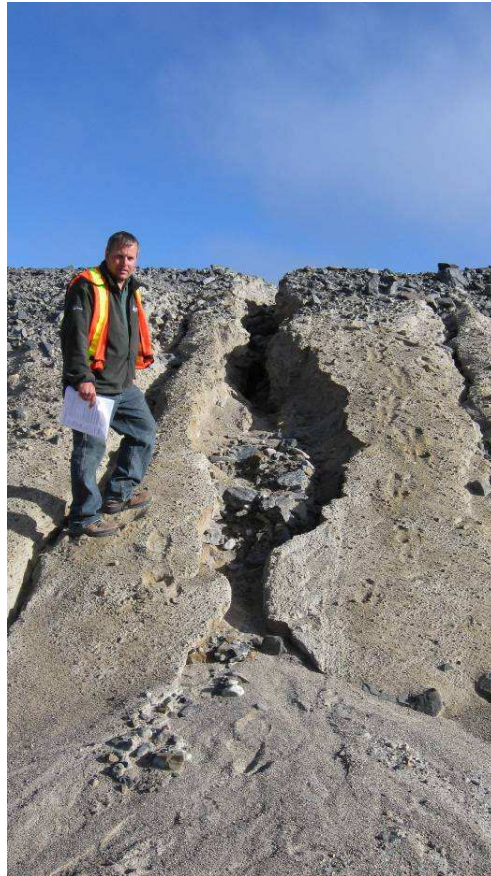
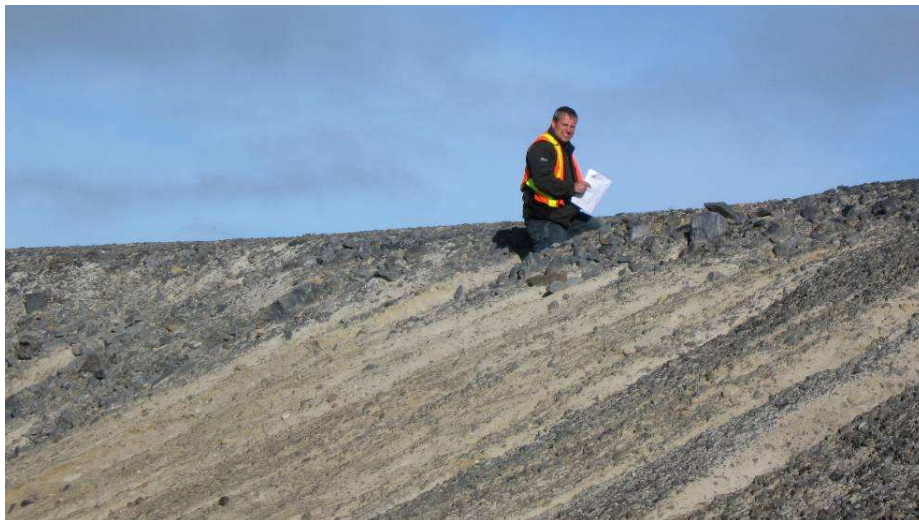
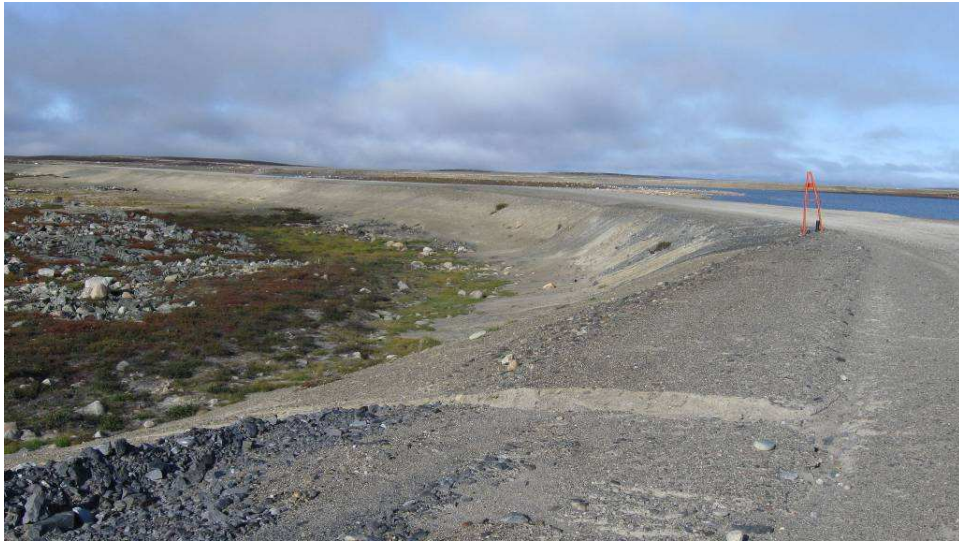
SEEPAGE:	No seepage observed.
INSTRUMENTATION:	Three of the original four thermistors remain Dam 4. From east to west across the crest, the four cables are numbered TD4-1 to 4. Thermistor TD4-2 was reported destroyed.
MAINTENANCE RECOMMENDATIONS:	Corrective measures have been implemented to address seepage in area of coffer dam noted last year. However, infilling appears to be in a loose manner and may be subject to erosion. Surface compaction is recommended to improve erodability. Extensive erosion with gullies up to 1 m deep have formed along the eastern 2/3 of the dam and should be repaired.

Dam 4: Downstream slope, east of cofferdam. Extensive erosion gullies (exposed geogrid).

Dam 4: Downstream slope, east of cofferdam. Extensive erosion gullies

Dam 4: Downstream slope, east of cofferdam. Extensive erosion gullies.

Dam 4: Downstream slope, east of cofferdam (looking west). Extensive erosion gullies

Dam appears to be in a stable condition. Maintenance of extensive downstream erosion should be carried out to prevent further deterioration of the dam.

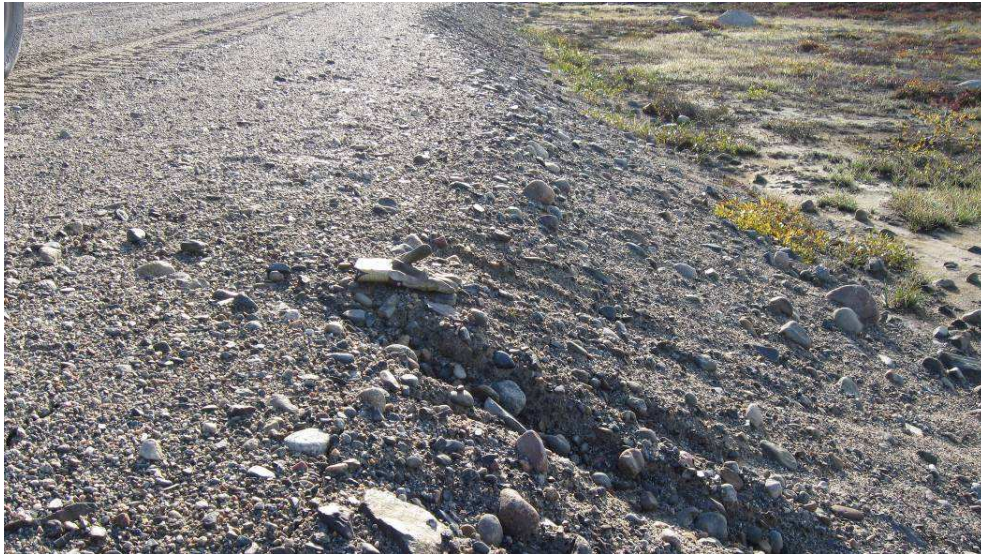
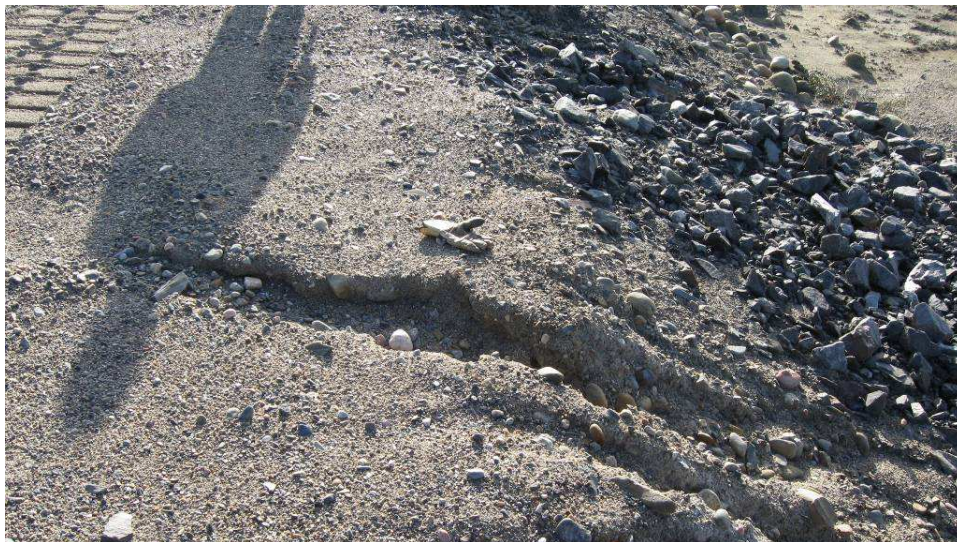
Dam 5: Downstream. Erosion gullies.

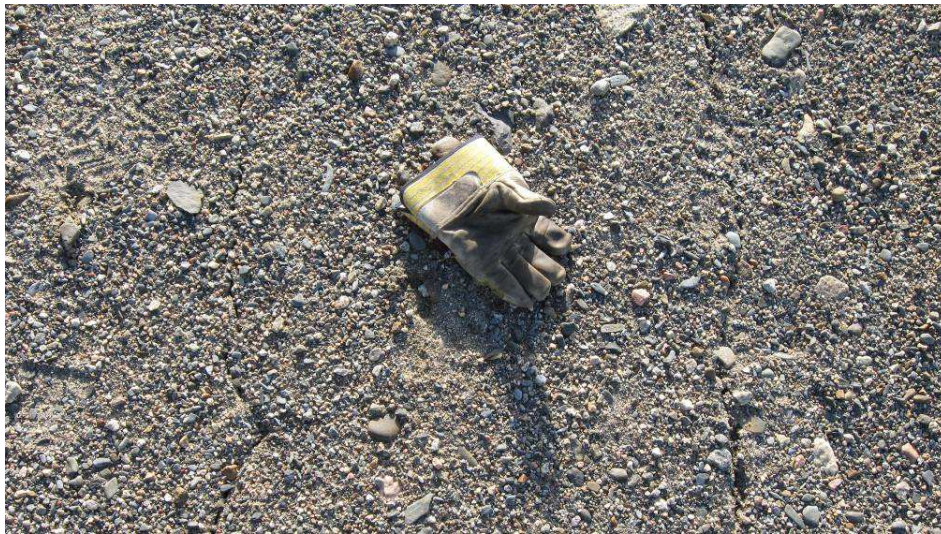
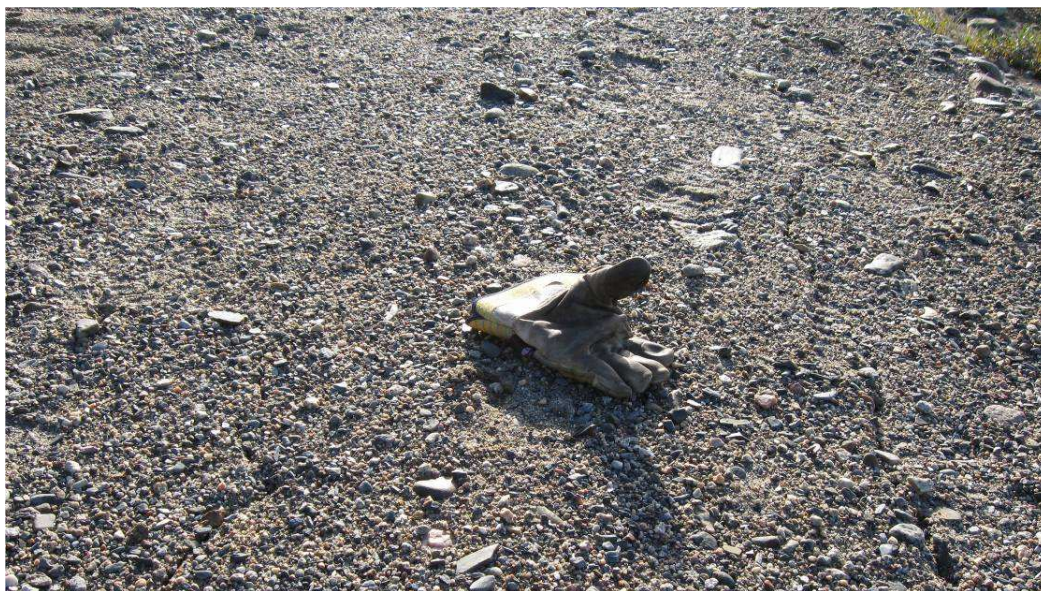
Dam 5: small crack near downstream shoulder

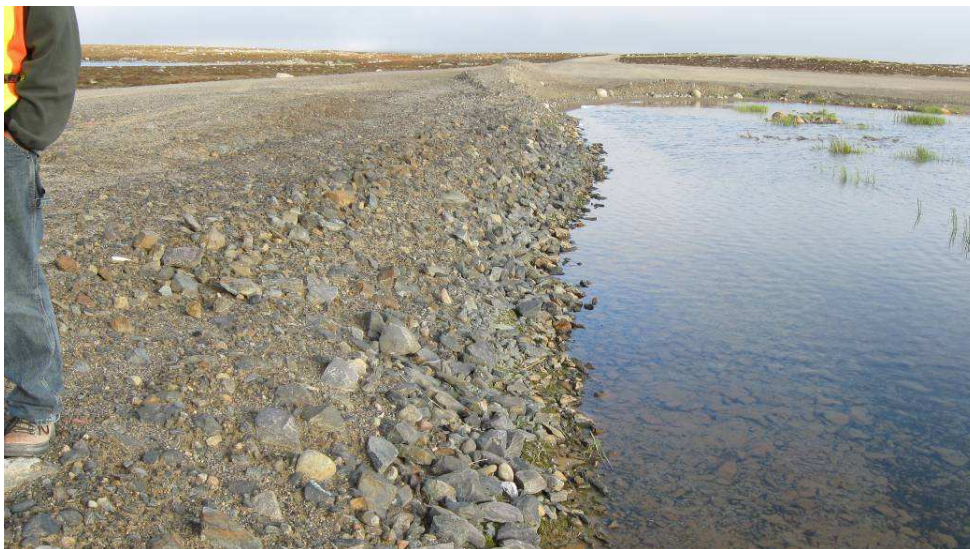
Dam 6: Upstream. Riprap in area of small pond.

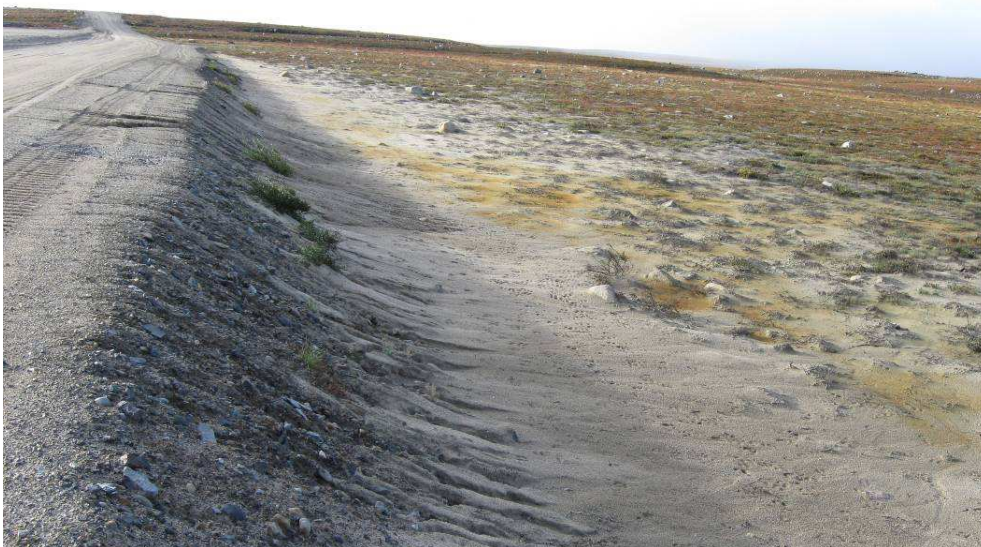
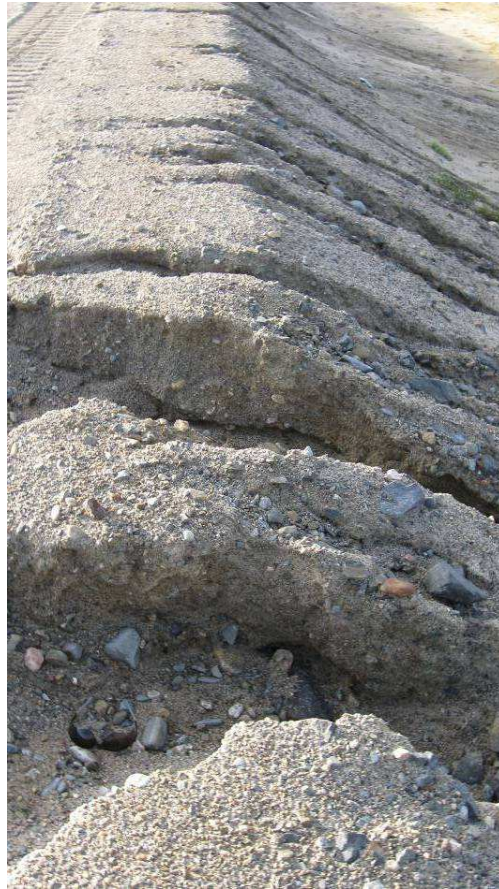
Dam 6: Downstream. Erosion gullies.

Dam 6: Down stream erosion gullies.
