## **Appendix B**

### **Compilation of Inspection Reports, Responses and Photos**

WATER LICENCE INSPECTION FORM

Appendix 1: 2AM-LUP0914 PHOTOS OF INSPECTION, July 15 2014

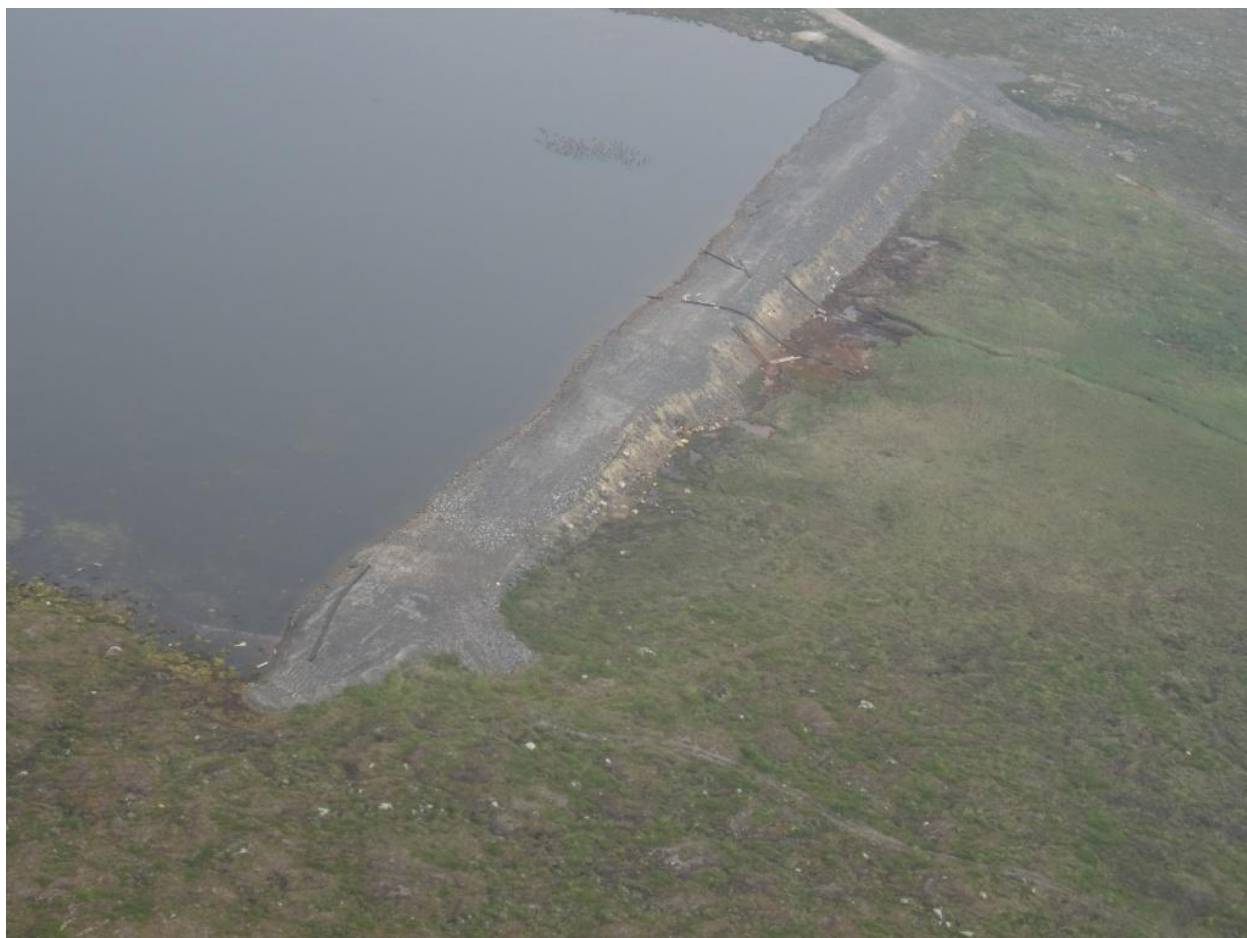
Figure 2. Aerial view of the dam at Lower Sewage Lagoon (LSL).

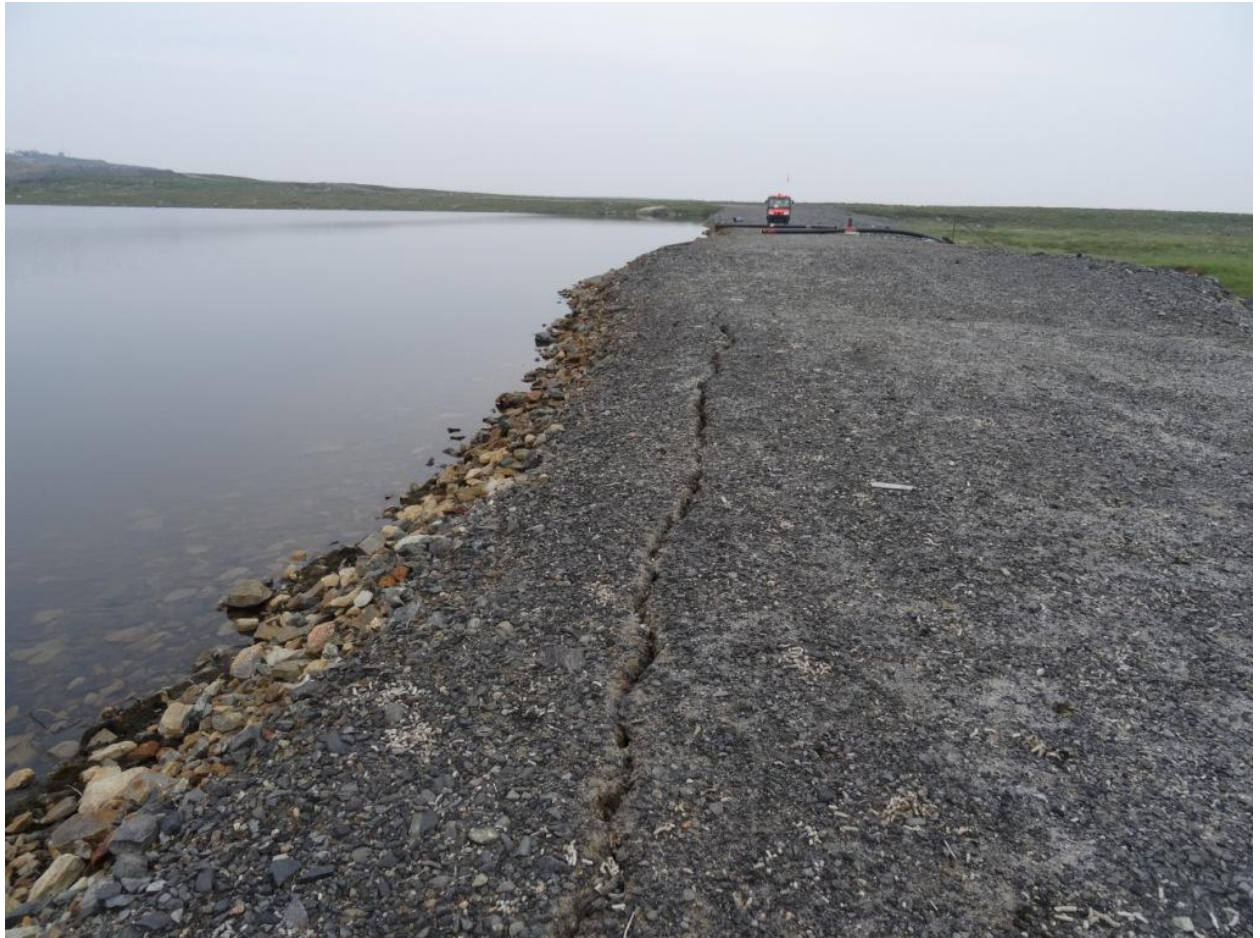
Figure 3. Crack in the dam at LSL.

4. On July 15, 2014 I conducted an inspection of Lupin Mine. In the subsequent inspection report, I identified concerns with the Lower Sewage Lagoon: less than 1 m freeboard in the cell, and a long crack running lengthwise in the lower berm. As the lower berm appeared considerably degraded from my previous inspections, I requested that a geotechnical inspection of the facility be undertaken.

9. Based on my recent and past inspections at Lupin Mine, there is deterioration occurring of the Lower Sewage Lagoon berm that may lead to the failure of this waste containment facility.

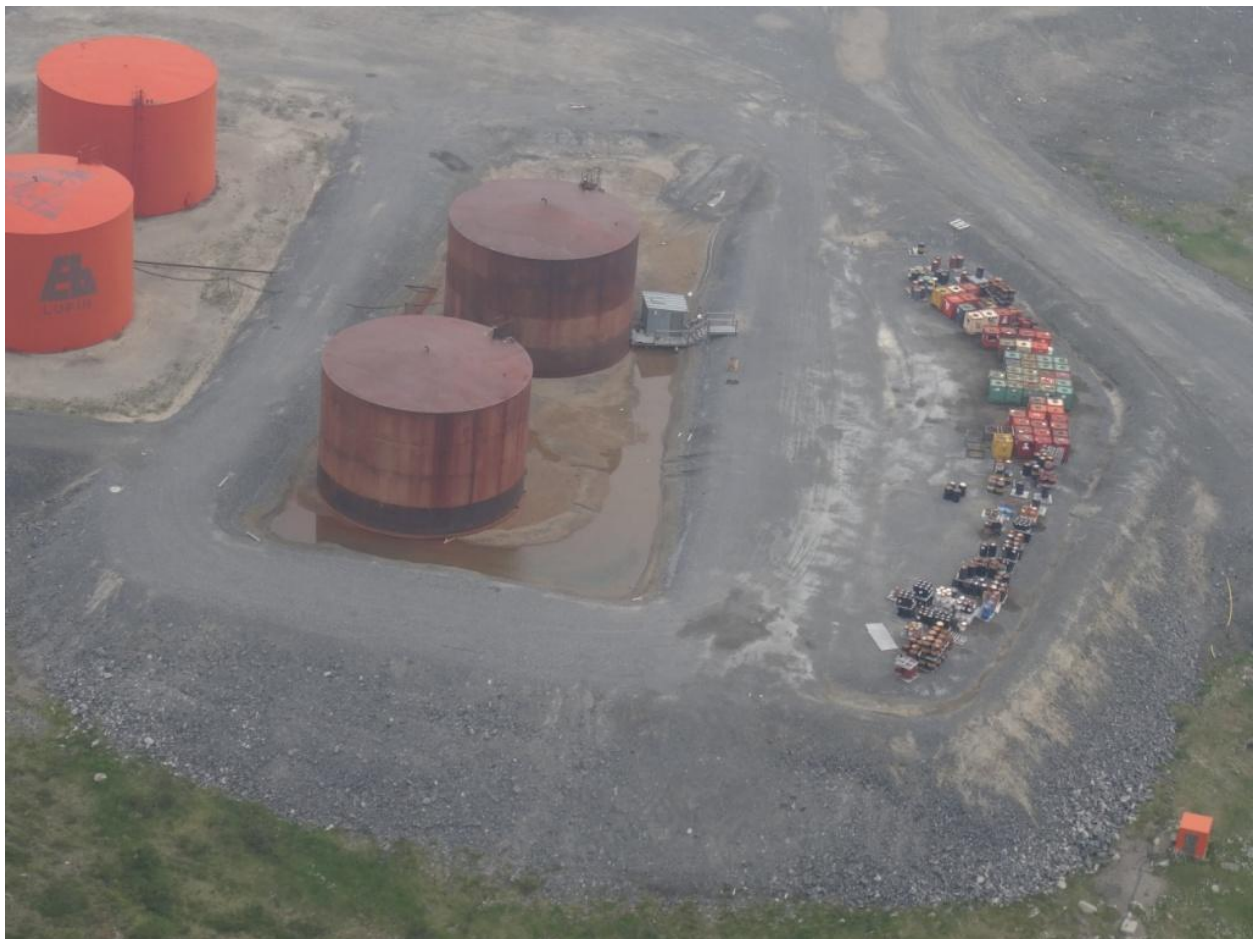
Figure 4. Main tank farm (MTF) and Hazardous Waste Storage.

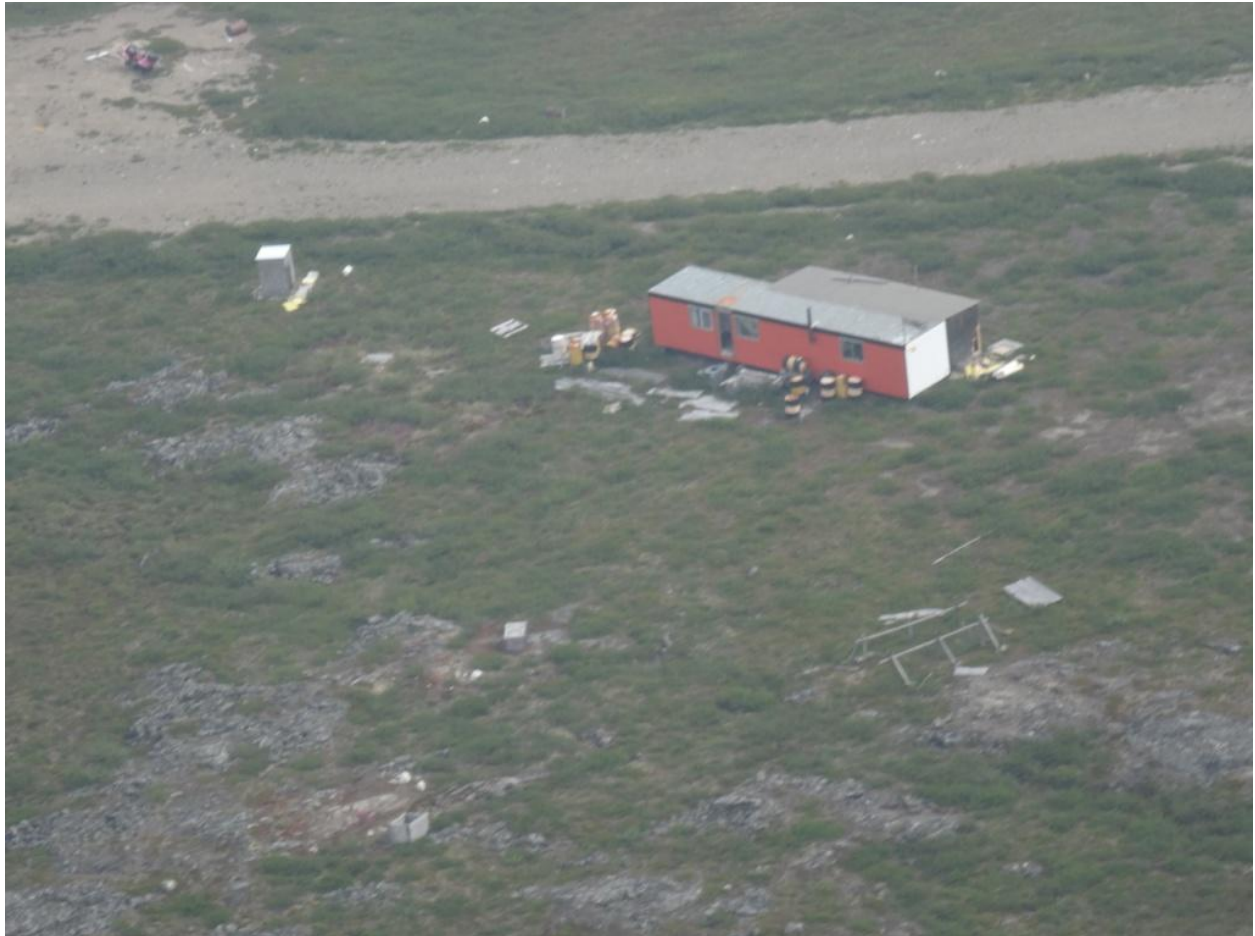
Figure 9. Barrels noted at shack past the quarry.

- a) *Numerous barrels were noted at the shacks down the road from the quarry.*

**LMI IS TO DEMONSTRATE WHETHER OR NOT THE SHACK IS LOCATED ON A CROWN LEASE. IF THIS IS THE CASE, AS WITH THE WSC BARRELS THAT WERE FOUND ON-SITE IN 2014, IT IS LMI'S RESPONSIBILITY TO ENSURE THAT ACTIVITIES CONDUCTED ON THE LEASE CONFORM TO REGULATORY REQUIREMENTS.**

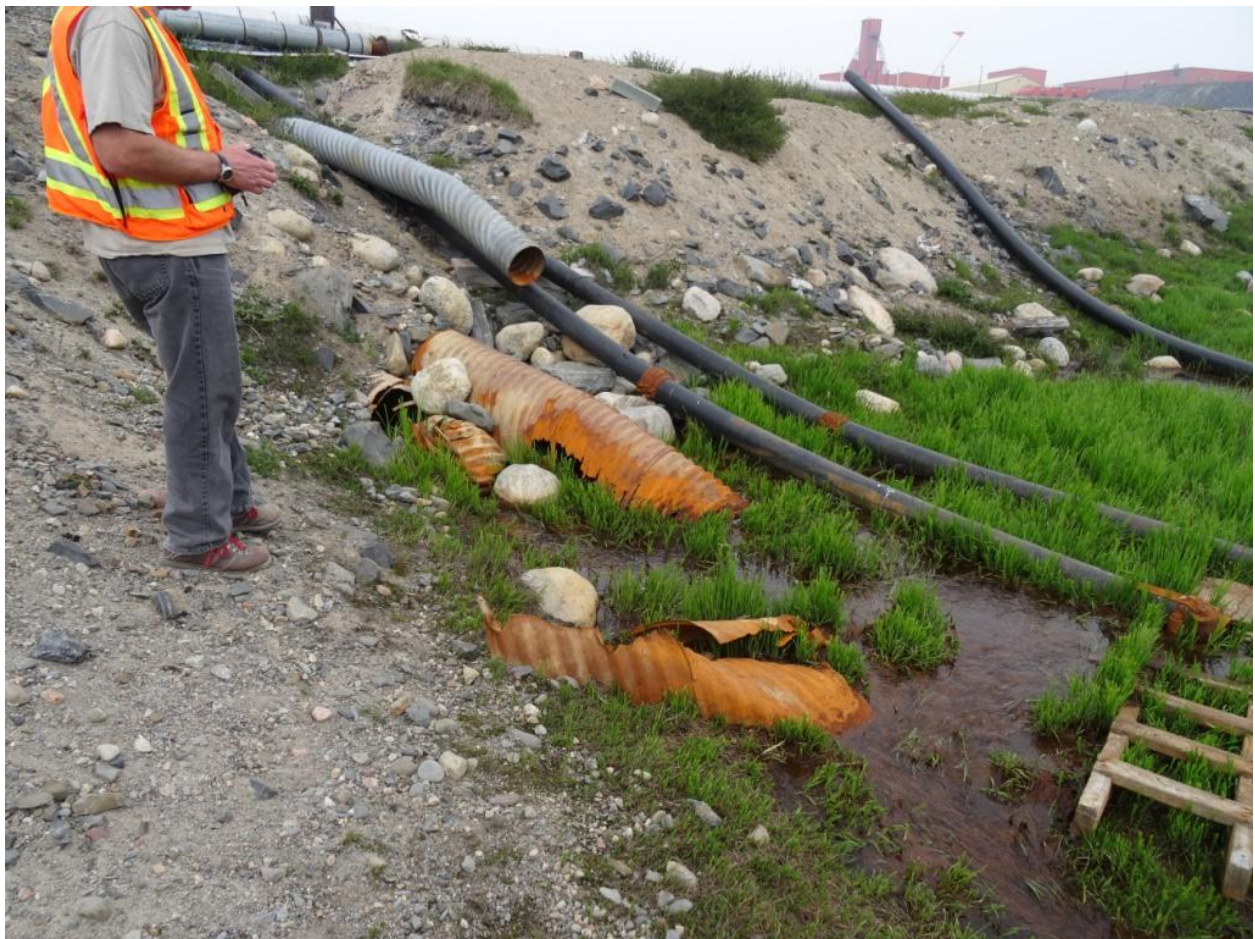
Figure 10. Steady flow seen through rusted culvert from the Upper Sewage Lagoon to the Lower Sewage Lagoon.

b) *There is a steady flow from Upper Sewage Lagoon to the Lower Sewage Lagoon (LSL) through a collapsed and rusted culvert.*

LMI's Response August 25, 2014: *"The culvert referred to in the report between the upper and lower lagoon is part of the design and although rusted it is still operating as designed."*

The geotechnical report received on November 4, 2014 indicates "this culvert is heavily corroded and partially filled with sand, and recommends periodic inspection and monitoring of seepage rate."

**LMI IS TO IMPLEMENT THE ENGINEER'S RECOMMENDATION AND REPORT ANNUALLY ON THE STATE OF THE SEWAGE LAGOON FACILITIES.**

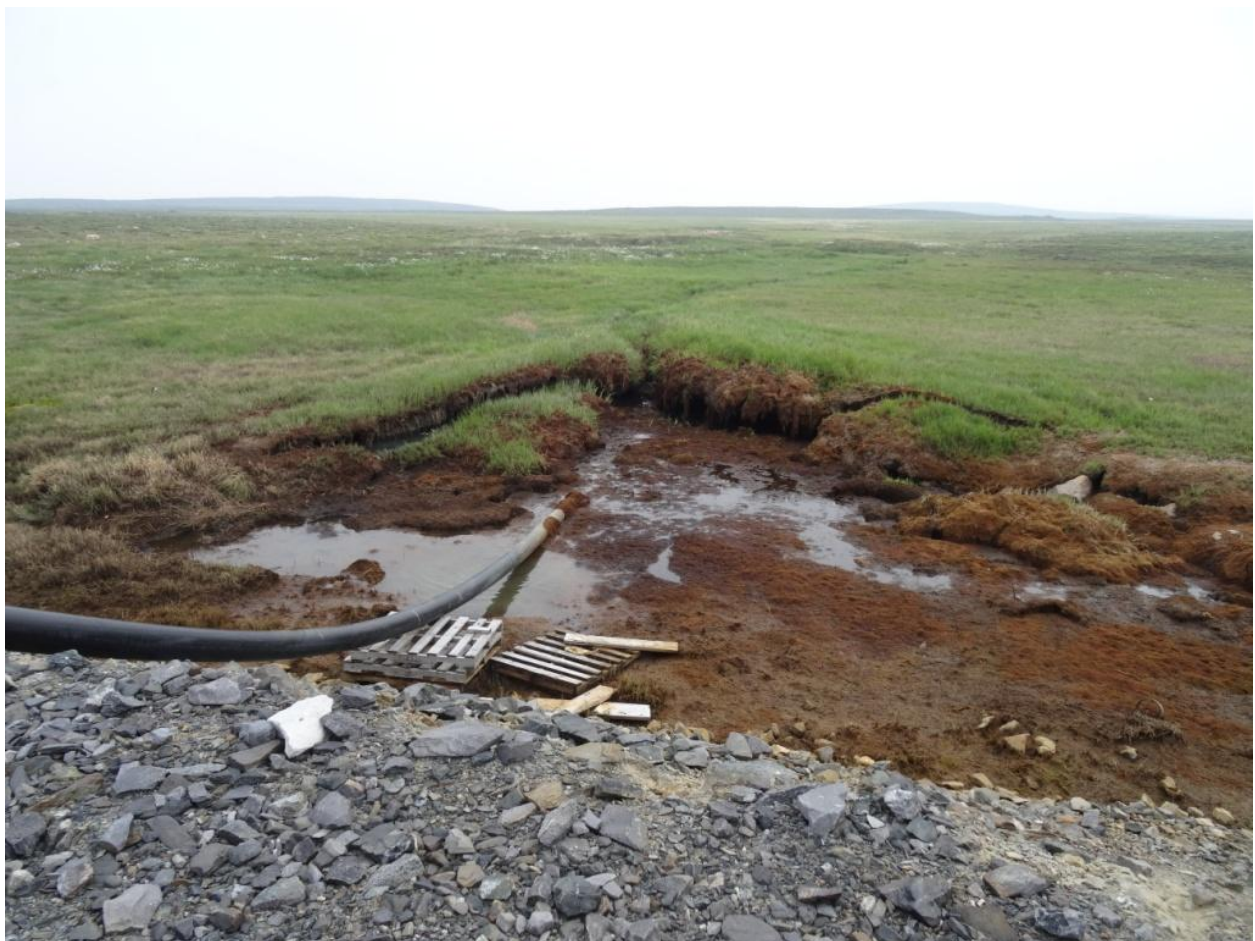
Figure 11. Permafrost degradation noted at discharge from LSL.

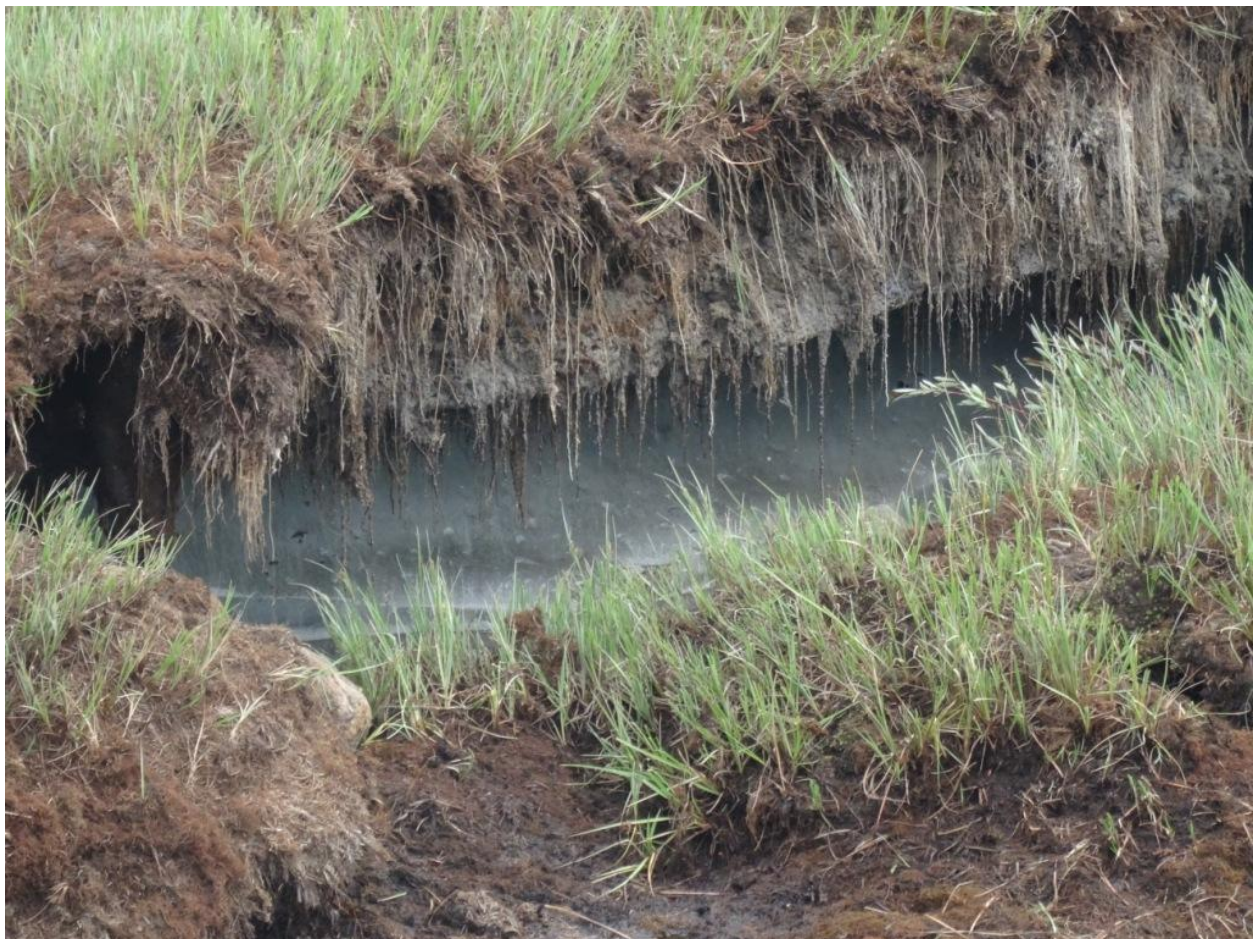
Figure 12. Ice lens forming at discharge from LSL. Closeup of Figure 11.

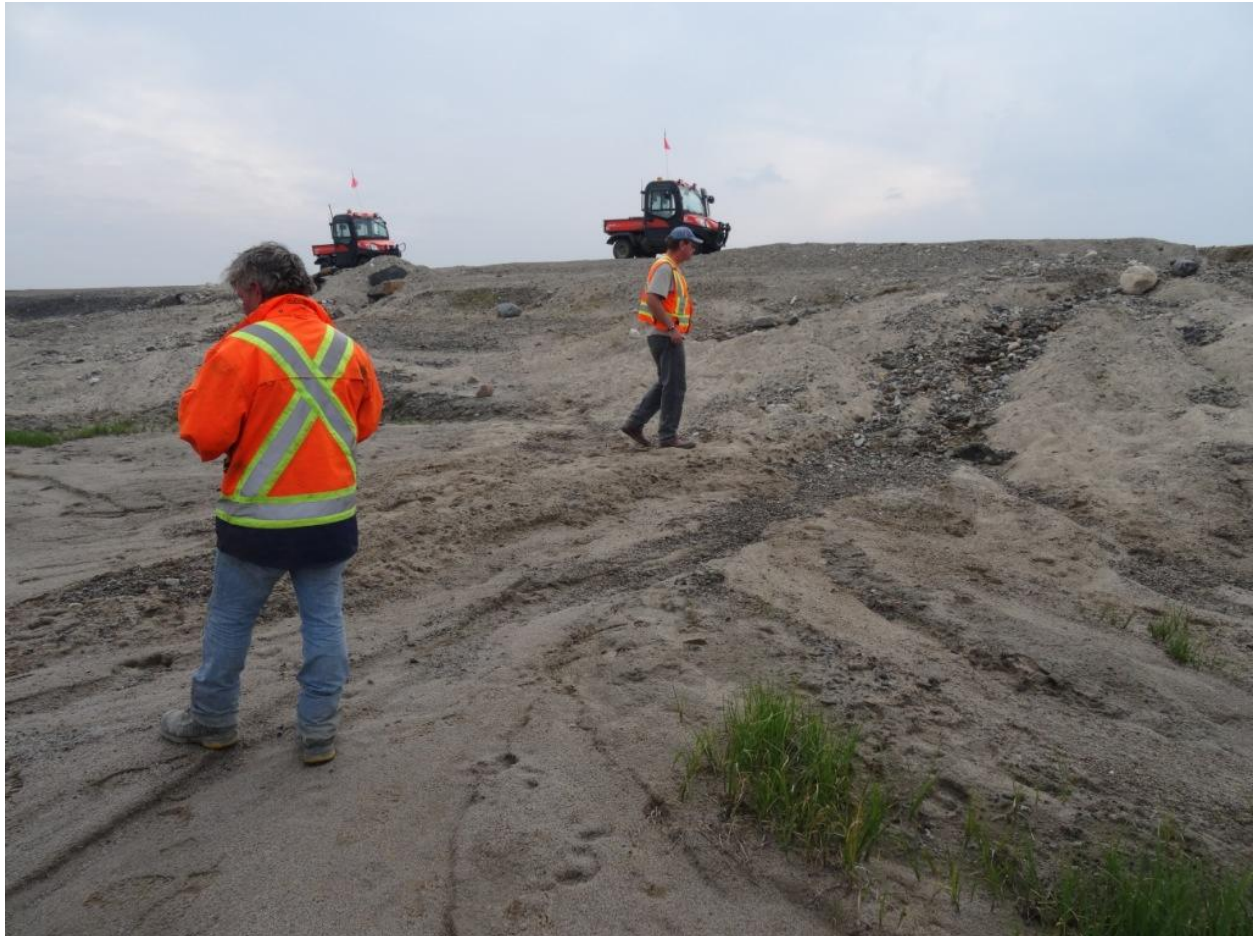
Figure 13. Recurring wash-out location at Dam 6. Aerial view in Figure 17.

4) All washouts on the TCA road are repaired when discovered. This is reported in our annual geotechnical reports.

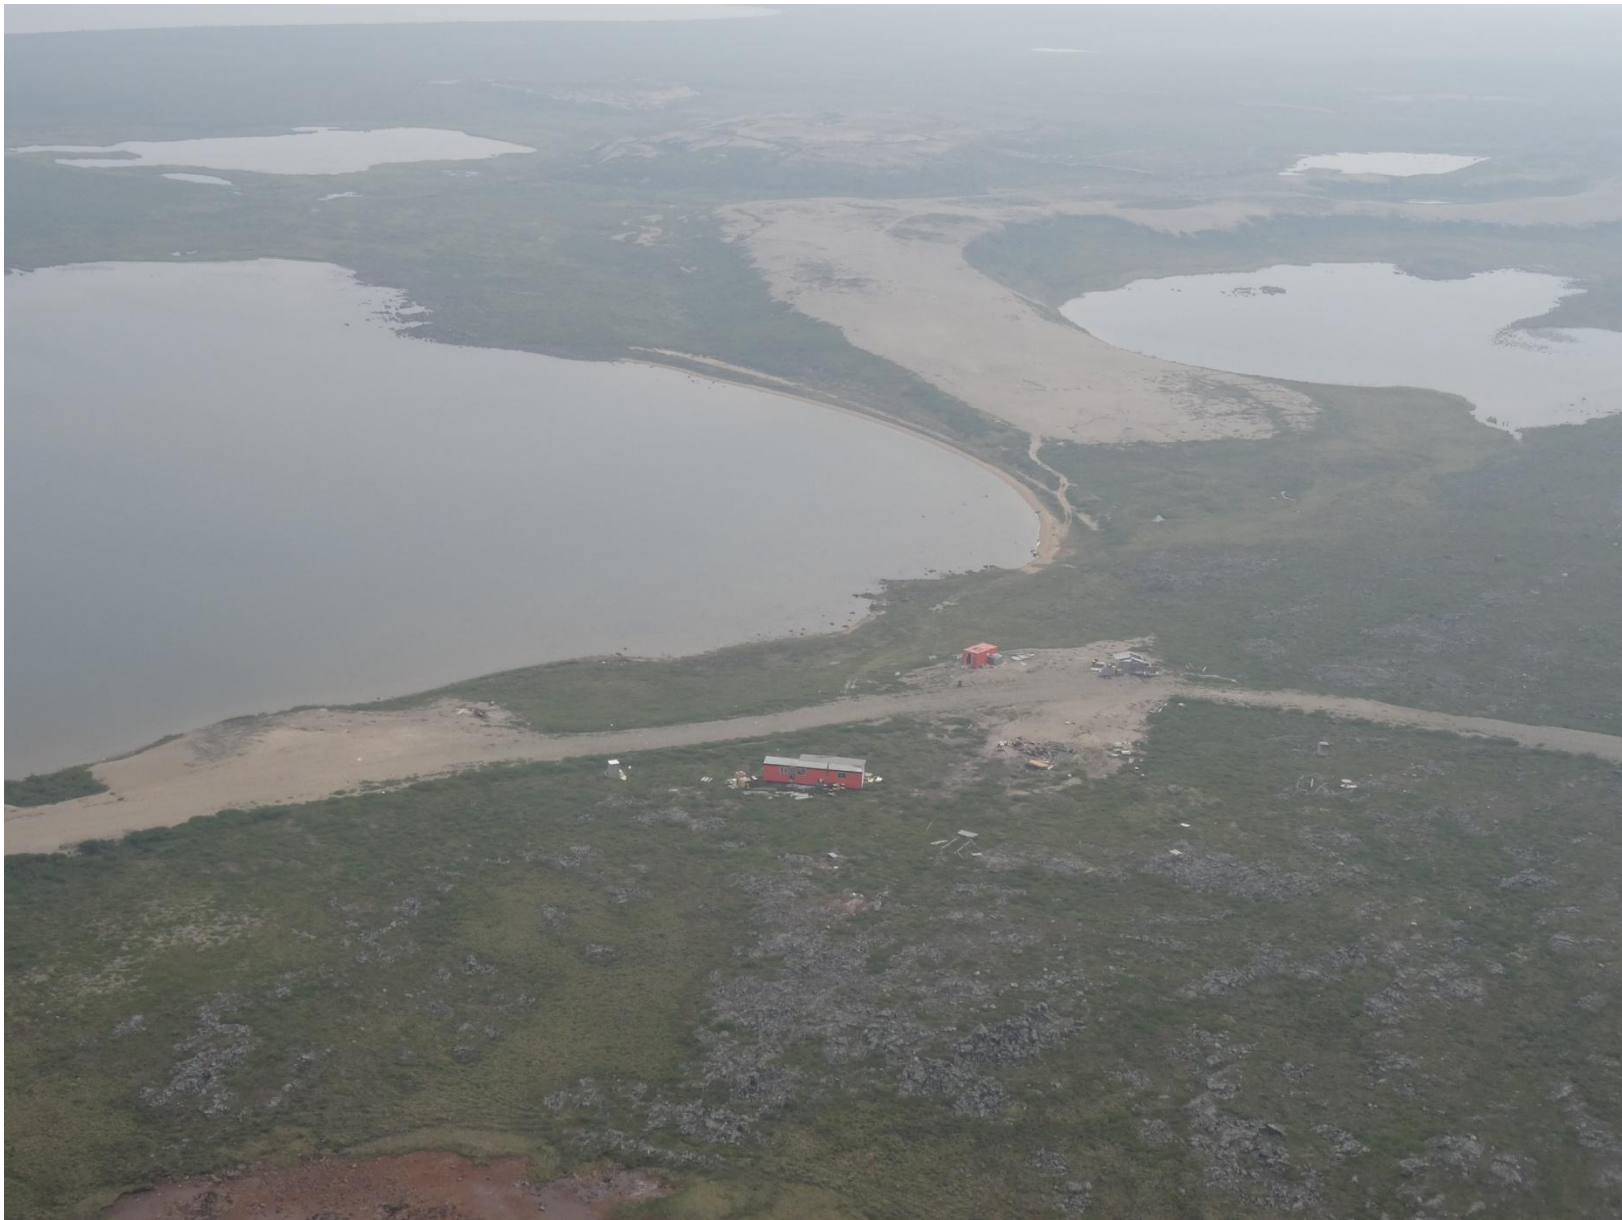
Figure 1. Photo looking SE at the south end of Esker Lake, from the road towards the 43.4 ha parcel of Lease 076E/11-2.

4) In regards to the shack by Esker Lake, as stated by the attendees at the Technical meetings in Kugluktuk (Agnes and John) it was confirmed that this "shacks" are owned by this Inuit family, that they moved several years ago to their lands. However it should also be noted that per AANDC's response to Agnes and John at that technical meeting, AANDC clearly stated that they are not concerned about any outposts that are located on crown land at the Lupin site.
