WATER LICENCE INSPECTION FORM

| Lupin Mines Inc. | | Karyn Lewis | |
| 2AM-LUP0914(expired)(amended) | | | |
| 14/07/2015 | | Eva Paul | |

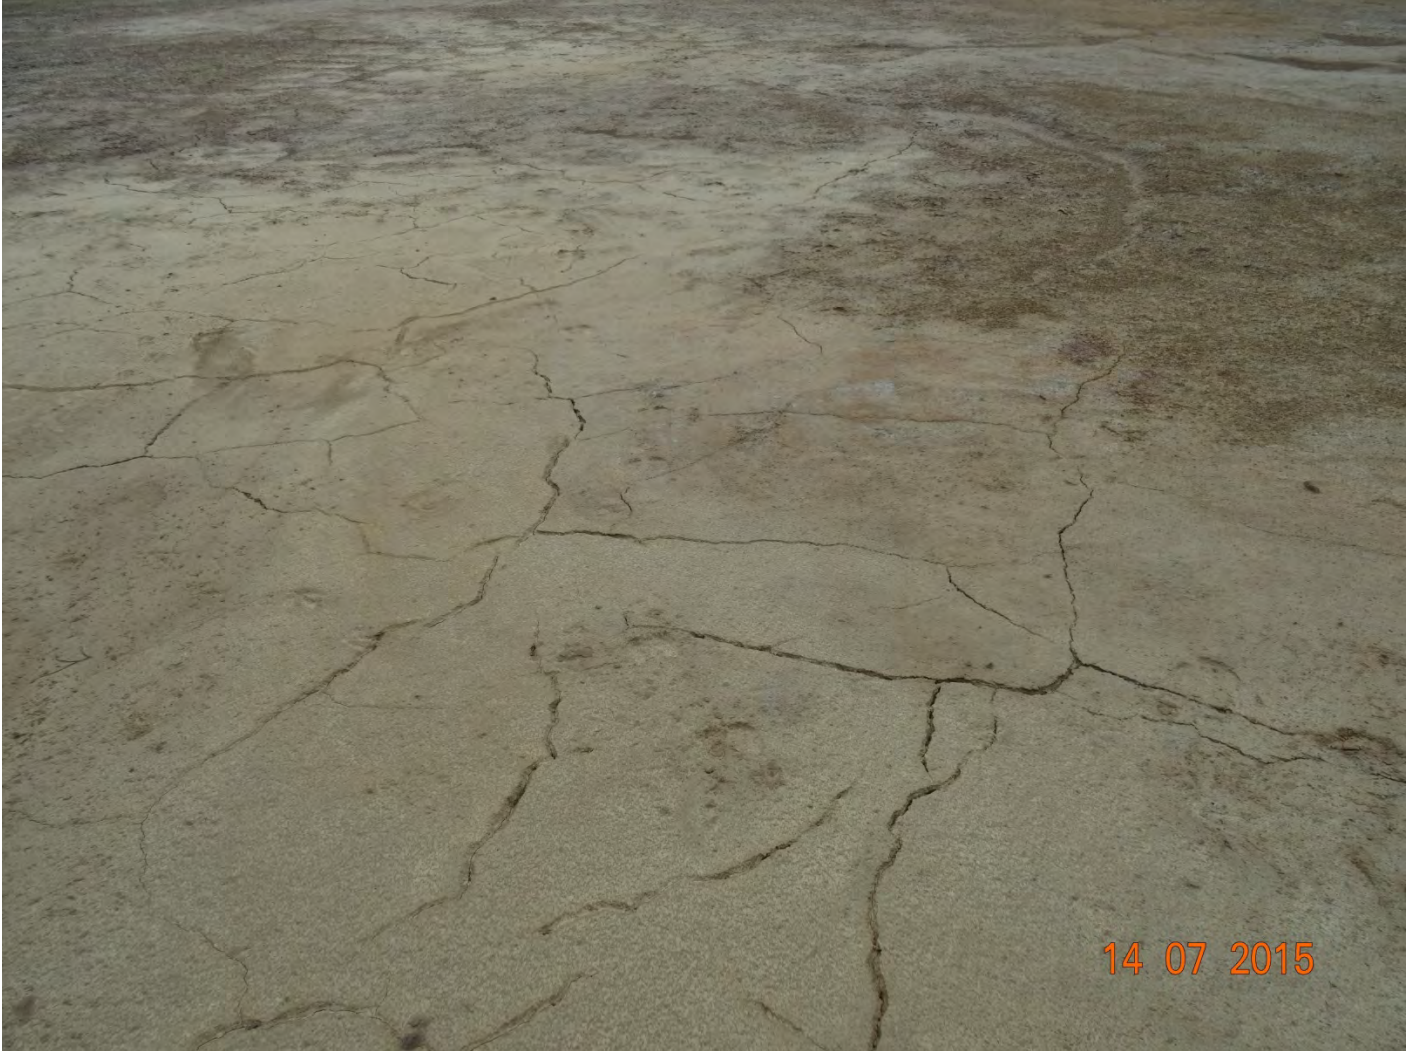
Photo Log # 6

**Description:** Cracked surface of tailings. Numerous animal tracks were visible.

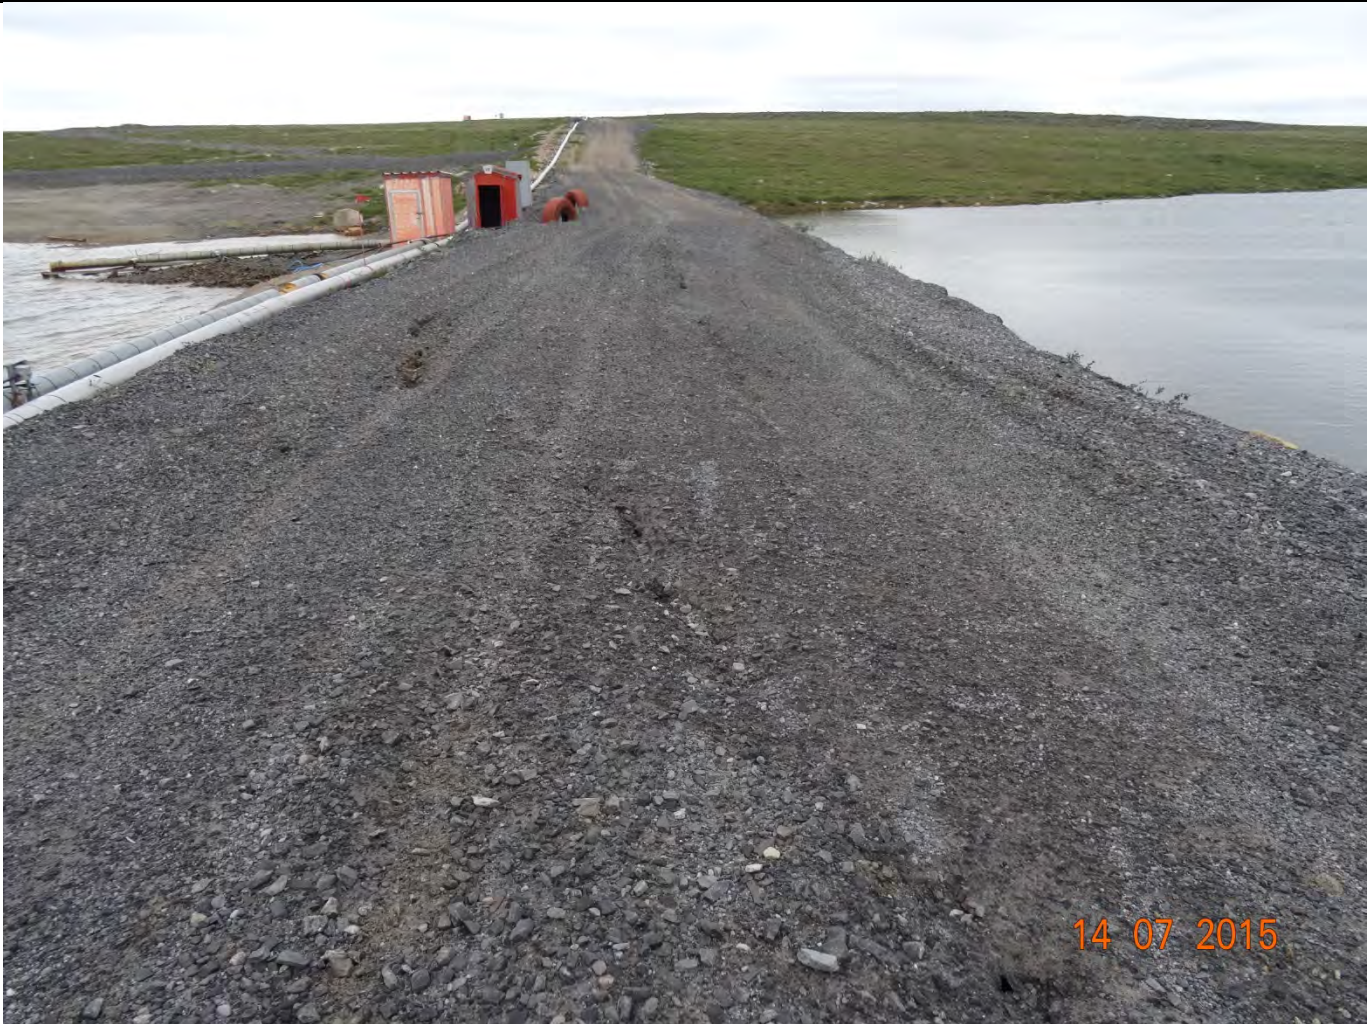
Photo Log # 8

resulting in a failure to contain effluent within the facility. The Upper Sewage Dam long, lengthwise cracks; one appears to be greater than 0.5 m in depth. These cracks were not noted in 2014. Slumping is noted on the west side of the dam. [Photos 8-10]

Description: View of Upper Sewage Dam facing southward away from the mine site. Cracks visible in dam that were not noted in 2014.

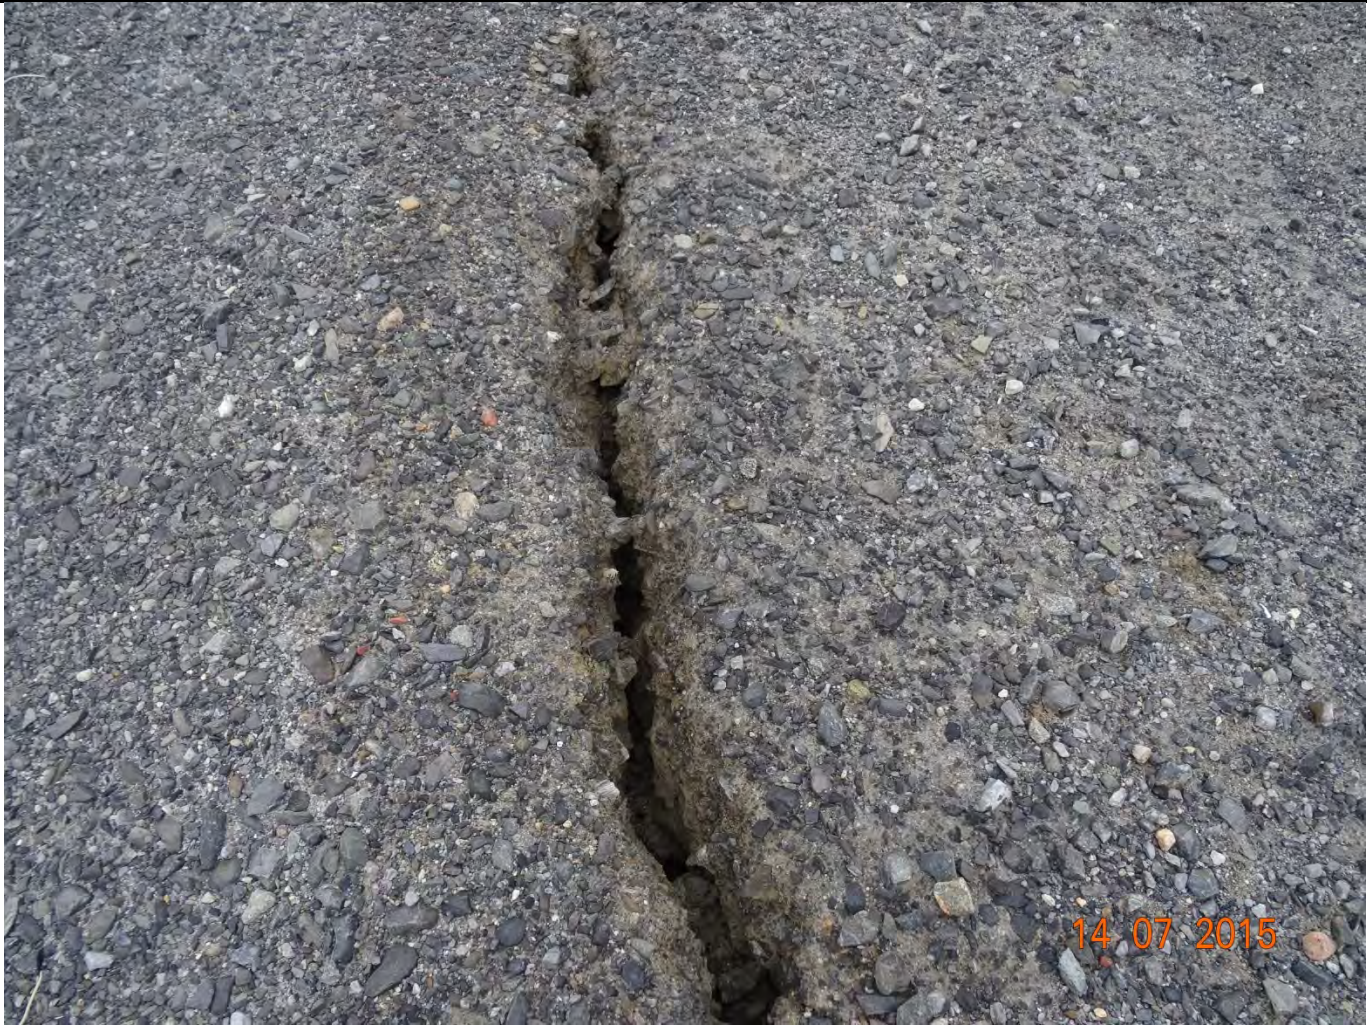
Description: Close-up of large crack in Upper Sewage Dam estimated to be greater than 0.5 m deep.

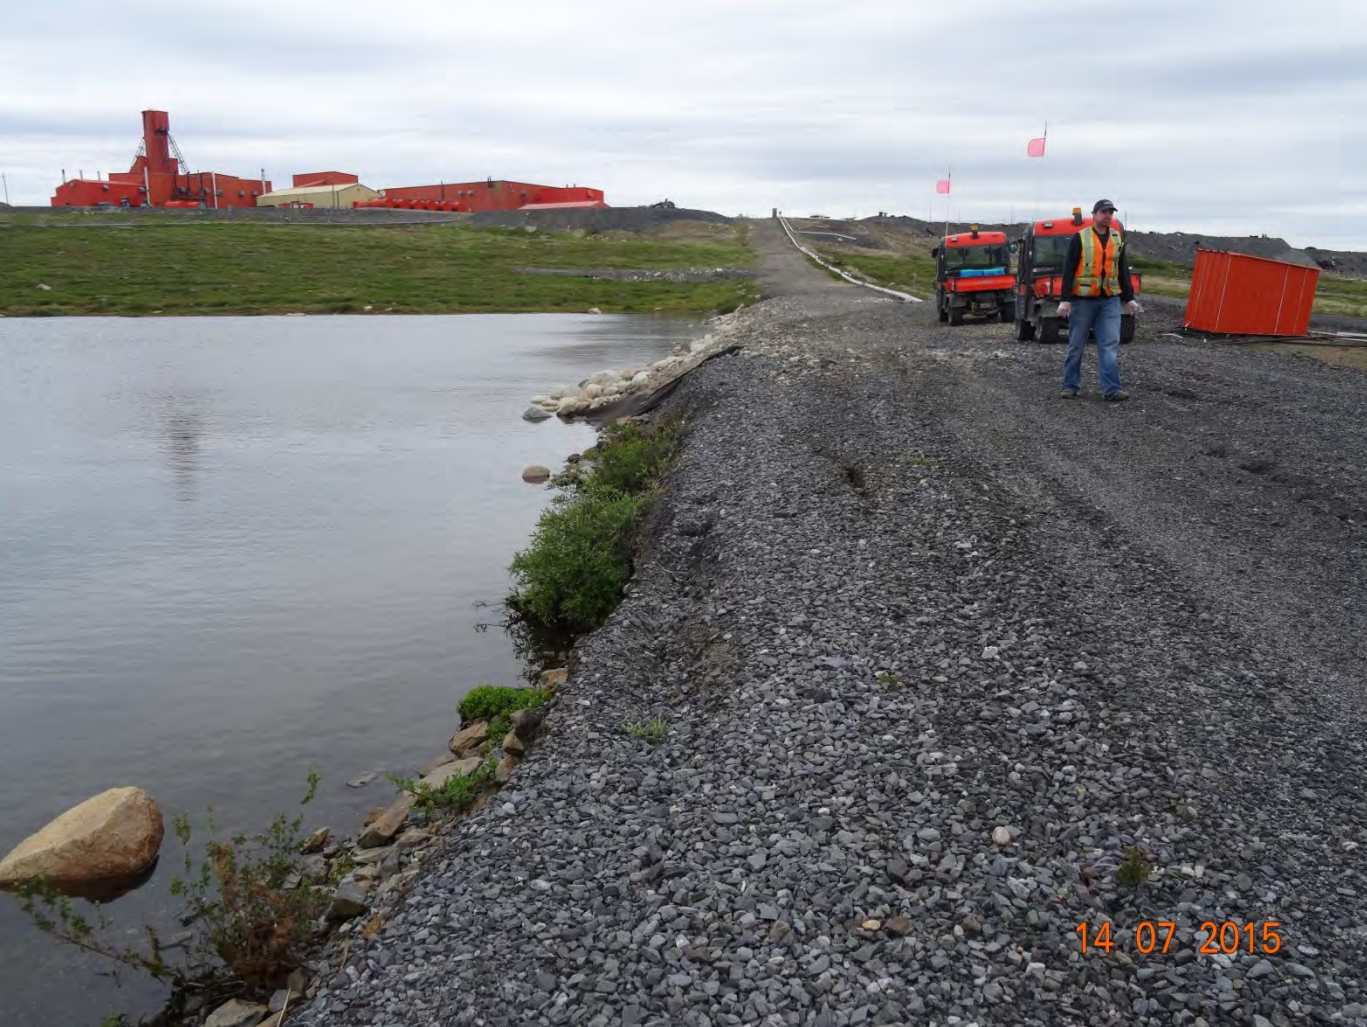
Photo Log # 10

Description: Upper Sewage Dam looking north towards mine site. Slumping visible on the west (left) side of the dam.
