Lupin Mines Incorporated

**RE: 2015 Annual Geotechnical Inspection – Lupin Mine Tailings Containment Area, Nunavut
Lupin Mine, Nunavut, License Number 2AM-LUP1520**

2015 Annual Geotechnical Inspection on
Perimeter Dams

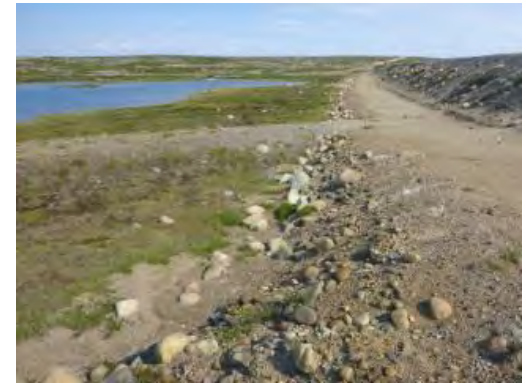
The previous annual inspection found seepage in the western buttress toe of Dam 4 into Ferguson Lake and the northern buttress toe of Dam 2 into a pond created by a cofferdam adjacent to Dam 2 Lake. Seepage at Dam 4 has not been observed since the 2011 inspection. Seepage at the toe of Dam 2 was observed in 2015, at similar flowrates since 2012. In 2015, this seepage was contained by the cofferdam downstream of north abutment and pumped back into Pond 2 when it pooled.

Photo 3: Looking southwest on Dam 2 near the northern abutment.

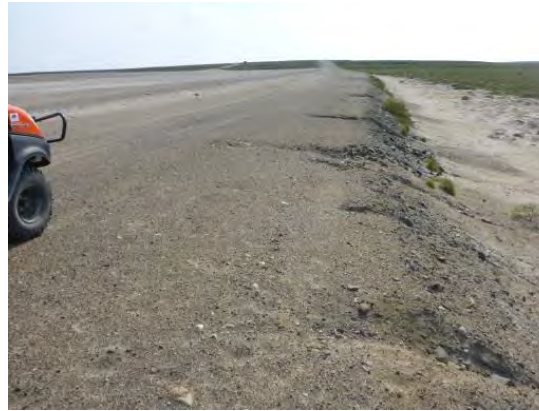
Photo 14: Close up look at one of the large erosion gully in Dam 6.

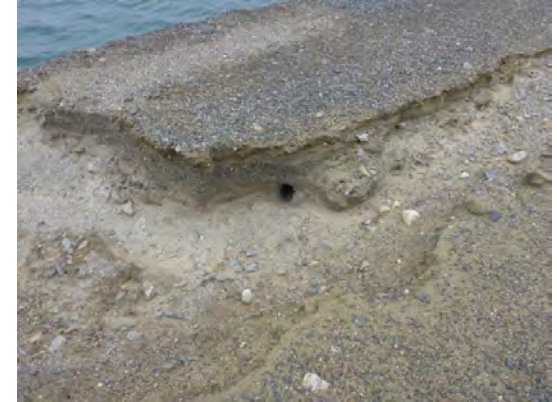
Photo 21: Close up of erosion gully in Dam 4, the burrow from ground animal.

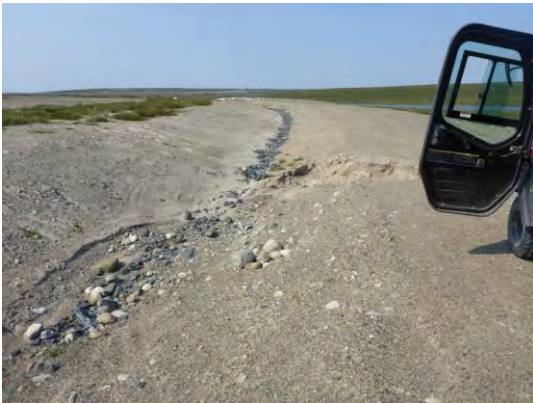
The storm ditch built within the top 2 m of Dam 3 has suffered some erosion damages from the 2014 freshet. It is believed that ponding in sections of the ditch is the main cause of the erosion damage. Because of the poor grading, the closure cover runoff water pooled, froze, and created an ice dam; which in turn forced the freshet water to overtop the ditch, over a small portion of Dam 3. Repair was completed on the damaged area in 2015 by constructing an armored channel along the alignment of the erosion, to let the drainage bypass the ponding section.

Photo 22: looking northwest at the storm ditch and erosion damage on crest of Dam 3.

Dam 3	N/A (no water is impounded by this dam)	Erosion has once again damaged the dam crest due to the poor storm ditch grading. Mitigation included converting the erosion gully into an armored storm ditch to provide proper drainage.	Repairs were completed on the eroded section by LMI after the inspection. Monitoring should be carried out to check that the new ditch is performing as intended.	Minor surface erosion. Despite repairs to the storm ditch, it does not yet have a free-draining grade.	Repairs were completed on the eroded section after the inspection by LMI. Consider to re-grade ditch to minimize ponding and monitor during freshet to prevent ice blockages.
Dam 4	~2 m	Surface erosion with a number of erosion gullies. Exposed geogrid observed near the eastern downstream toe of the dam.	Repair the deep erosion gullies, re grade surface and backfill and depressions monitor the exposed geogrid for further erosion and potential water seepage.	Surface erosion with a number of deep erosion gullies. Exposed geogrid or similar synthetic reinforcements observed near the eastern downstream toe of the dam.	Repair the deep erosion gullies and maintain the surface. Monitor the exposed geogrid for further erosion and potential water seepage.

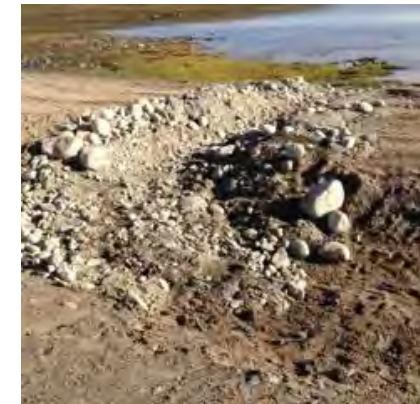
Photo 24: Looking north at the repair work completed over the eroded gully in Dam 3, including geotextile and riprap armoring.

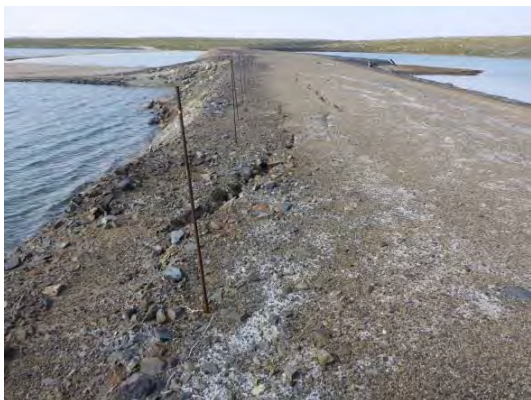
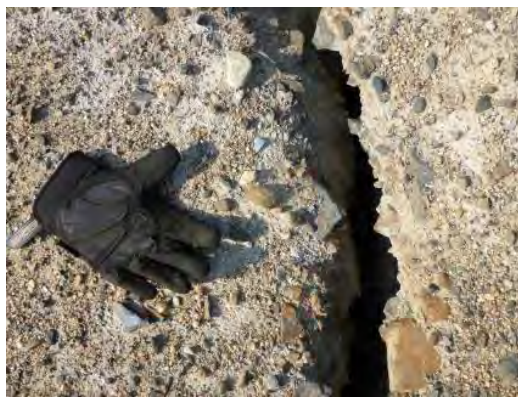
Eight significant tension cracks were observed on Dam M. Visual comparison between 2012 and 2015 photographs showed the existing cracks are widening and lengthening. Potentially, the failed portions of the dam could breach and allow the supernatant water and tailings to flow from Cell 5 into Pond 2. Because of the severity of the cracks and potential breach, LMI was advised that all vehicle traffic should avoid this section for safety reasons. A risk assessment was completed by SRK in 2012 to evaluate the potential impact on water quality and the environment in the event of a breach. The results of the assessment indicated that there would be minimal impact to the environment due to the presence of the perimeter dam containment (SRK 2012b). However, a breach in Dam M would be a concern for worker safety, site infrastructure access, future operations, and ongoing care and maintenance activities. Section 4.1 provides recommendations to address the potential risks in the event of a full breach.

Based on a visual inspection of the tension cracks in Dam M, possible causes could include pore water pressure from Cell 5, foundation “creep” (movement between the active layer and permafrost), or undercut erosion of toe material. It is recommended that LMI consults with the engineer-of-record to better understand the mechanism behind the tension cracks and appropriate repairs. This could involve an investigation program to determine the exact mode(s) of failure before designing the appropriate remedial measures.

Photo 28: Looking northwest at original tension cracks on Dam M, with Dam N and Pond 2 to the left.

Photo 29: Close up view of the original tension cracks on Dam M.

During the 2016 season LMI will consultant with the Engineer-of-Record (EOR) to initiate an emergency construction of a toe buttress at Dam M as priority, then Dam K; and initiate a consultation with the EOR on a detailed investigation for the potential failure mode(s) in Dams M and K.

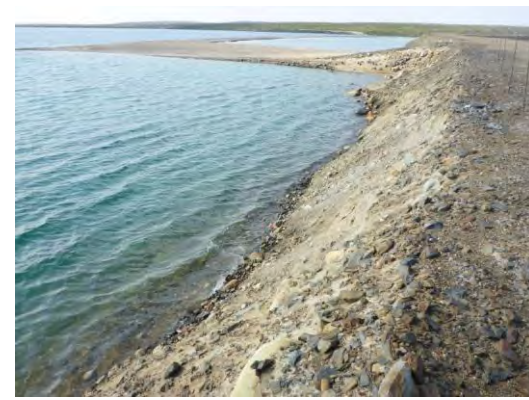
Photo 30: Looking northwest on Dam M at the over steepen slope directly downstream of the cracks, with Dam N and Pond 2 to the left.

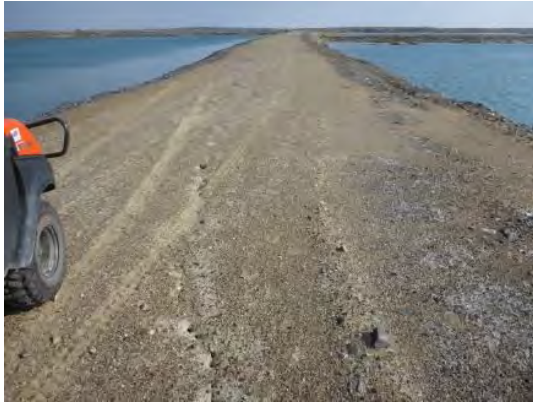
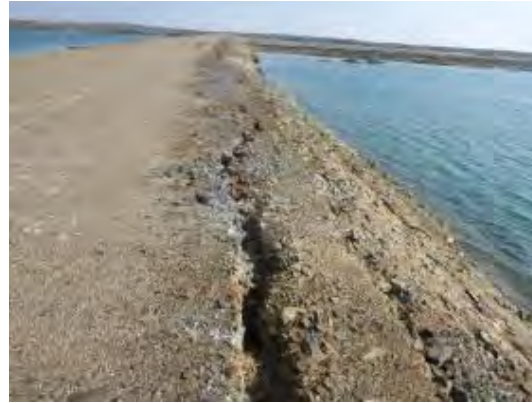
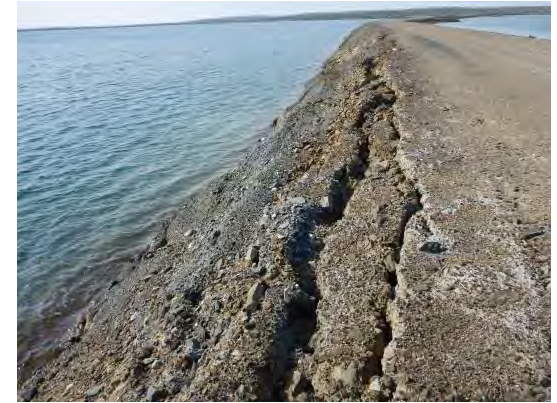
Photo 31: Close up view of Dam M at the new tension cracks observed in 2014, through the centerline of the dam, near the eastern abutment to Dam J.

Photo 32: Close up eastern view of Dam M at the new tension cracks observed in 2014, in face of the dam toward Pond 1.

Photo 33: Close up western view of Dam M the new tension cracks observed in 2014, in face of the dam toward Pond 1, upwards of 0.3m wide and 0.5m deep.

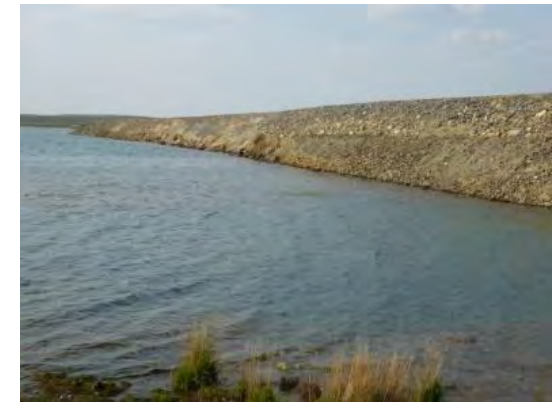
Photo 36: Looking northeast of at the Dam M facing toward pond 2. Note the failure surfaces at the toe.

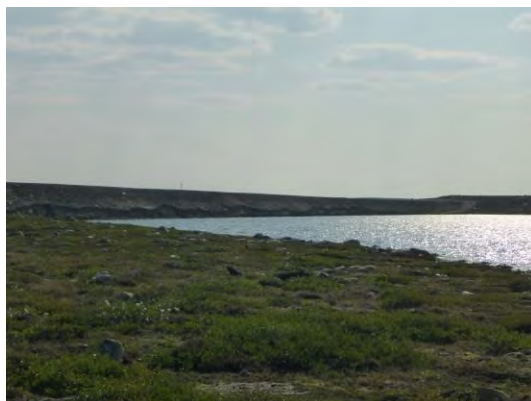
Dam K has historically experienced erosion (undercutting) at the toe of the slope due to wave action on the adjacent water in Pond 2. Minor tension cracks and a few erosion gullies were observed in the dam crest. Recent observations made by an SRK engineer during an inspection on October 7 indicate that there is in fact riprap armoring along the northern toe of Dam K. This riprap armoring was submerged during previous inspections and was only exposed recently as Pond 2 was lowered. Animal burrows were observed in the eroded gullies. It is unknown what type of animal made these burrows.

Photo 40: Looking south at Dam K facing pond 2. Note the under cut from at the toe of the dam.

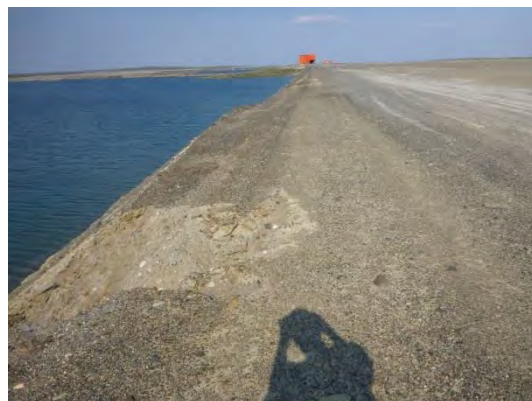
Photo 41: Close up view of erosion gully in Dam K facing pond 2.

During the 2016 season LMI will monitor Dam K to track the animal burrow activities; monitor and repair the erosion in Dam L; and monitor and surveillance the physical conditions and stability for Dam N.

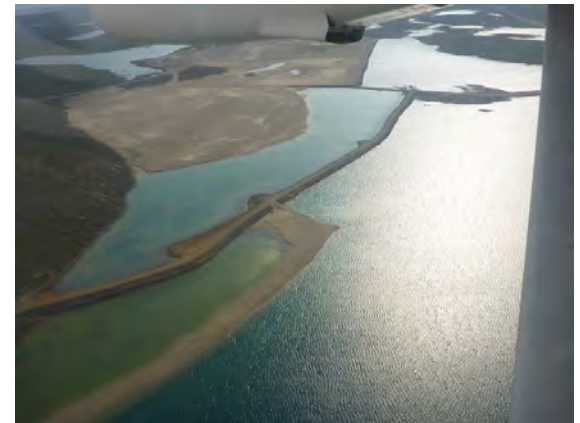
The water level in Pond 2 was higher than levels previously observed by SRK at the time of the site visits, just prior to discharge. Dam N was almost submerged. This made the dam surface difficult to travel on due to the fully saturated material. The difficulties in gaining access and the high water coverage on the dam made it difficult to carry out a proper inspection.

Dam N	0 m	Nearly submerged at the time of visit. Water is noted to pond in the western abutment.	Monitoring of the dam is recommended once the Pond 2 water level is lowered to allow observations.

Photo 45: Aerial view of Dam N. Note the near submergence due to the high water level in Pond 2 during the time of visit.

As water levels in Pond 2 lower during discharge, Dam N monitoring is recommended by site personnel at the direction of a qualified person and the surveillance data should be communicated to the qualified person for review.

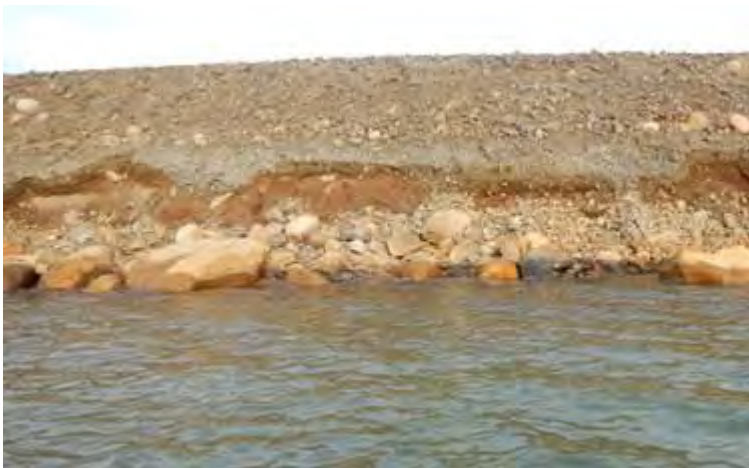
Photo 46: Picture taken on October 6th at Dam M showing the armored toe that was previously submerged in Pond 2.

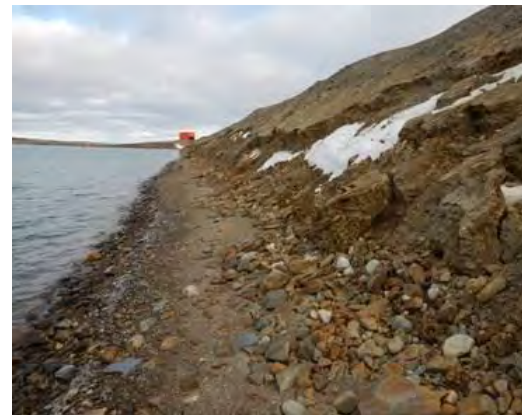
Photo 47: Picture taken on October 6th at Dam L showing the armored toe that was previously submerged in Pond 2.

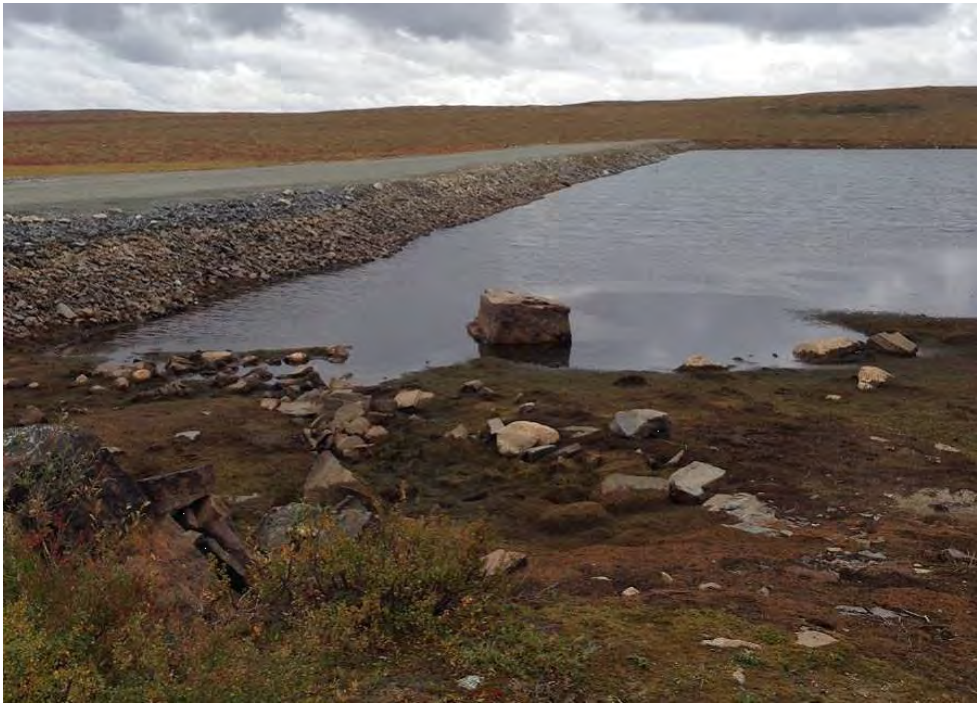
Photo 3: Look south from the Lower Sewage Dam North abutment on the repaired upstream slope and crest. Note the 1.3 meter freeboard available at the time of the photo.

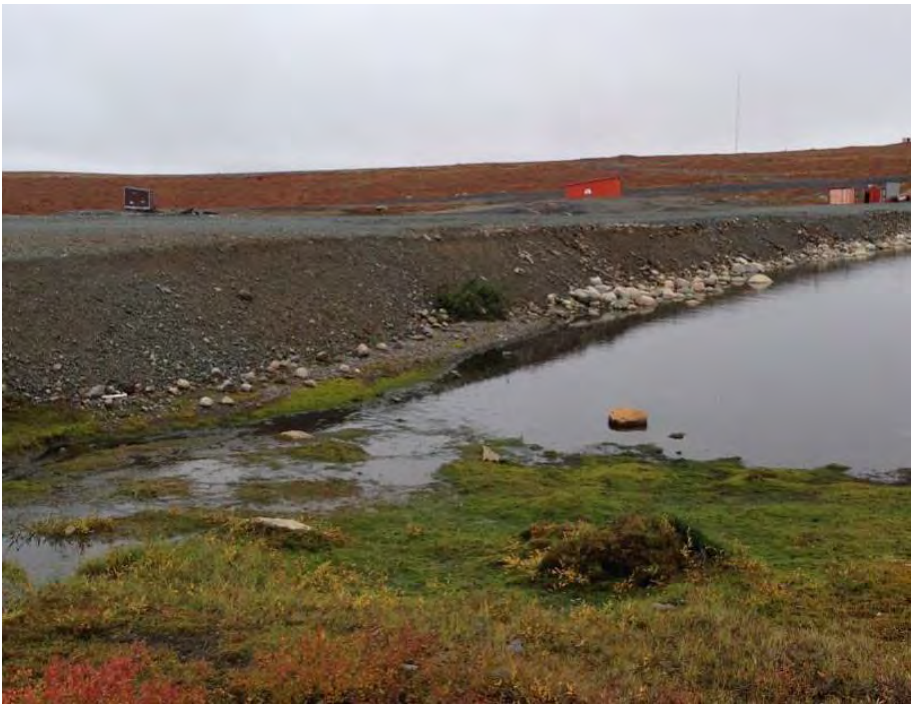
Photo 5: Looking at repaired upstream face and crest of the Upper Sewage Dam. Note the 1.8 meter freeboard available at the time of the photo.
